# **2019 Annual Dam and Dike Inspection Report**

**Bottom Ash Pond**

**Northeastern 3&4 Plant  
Public Service Company of Oklahoma  
Oologah, Oklahoma**

**December 2019**

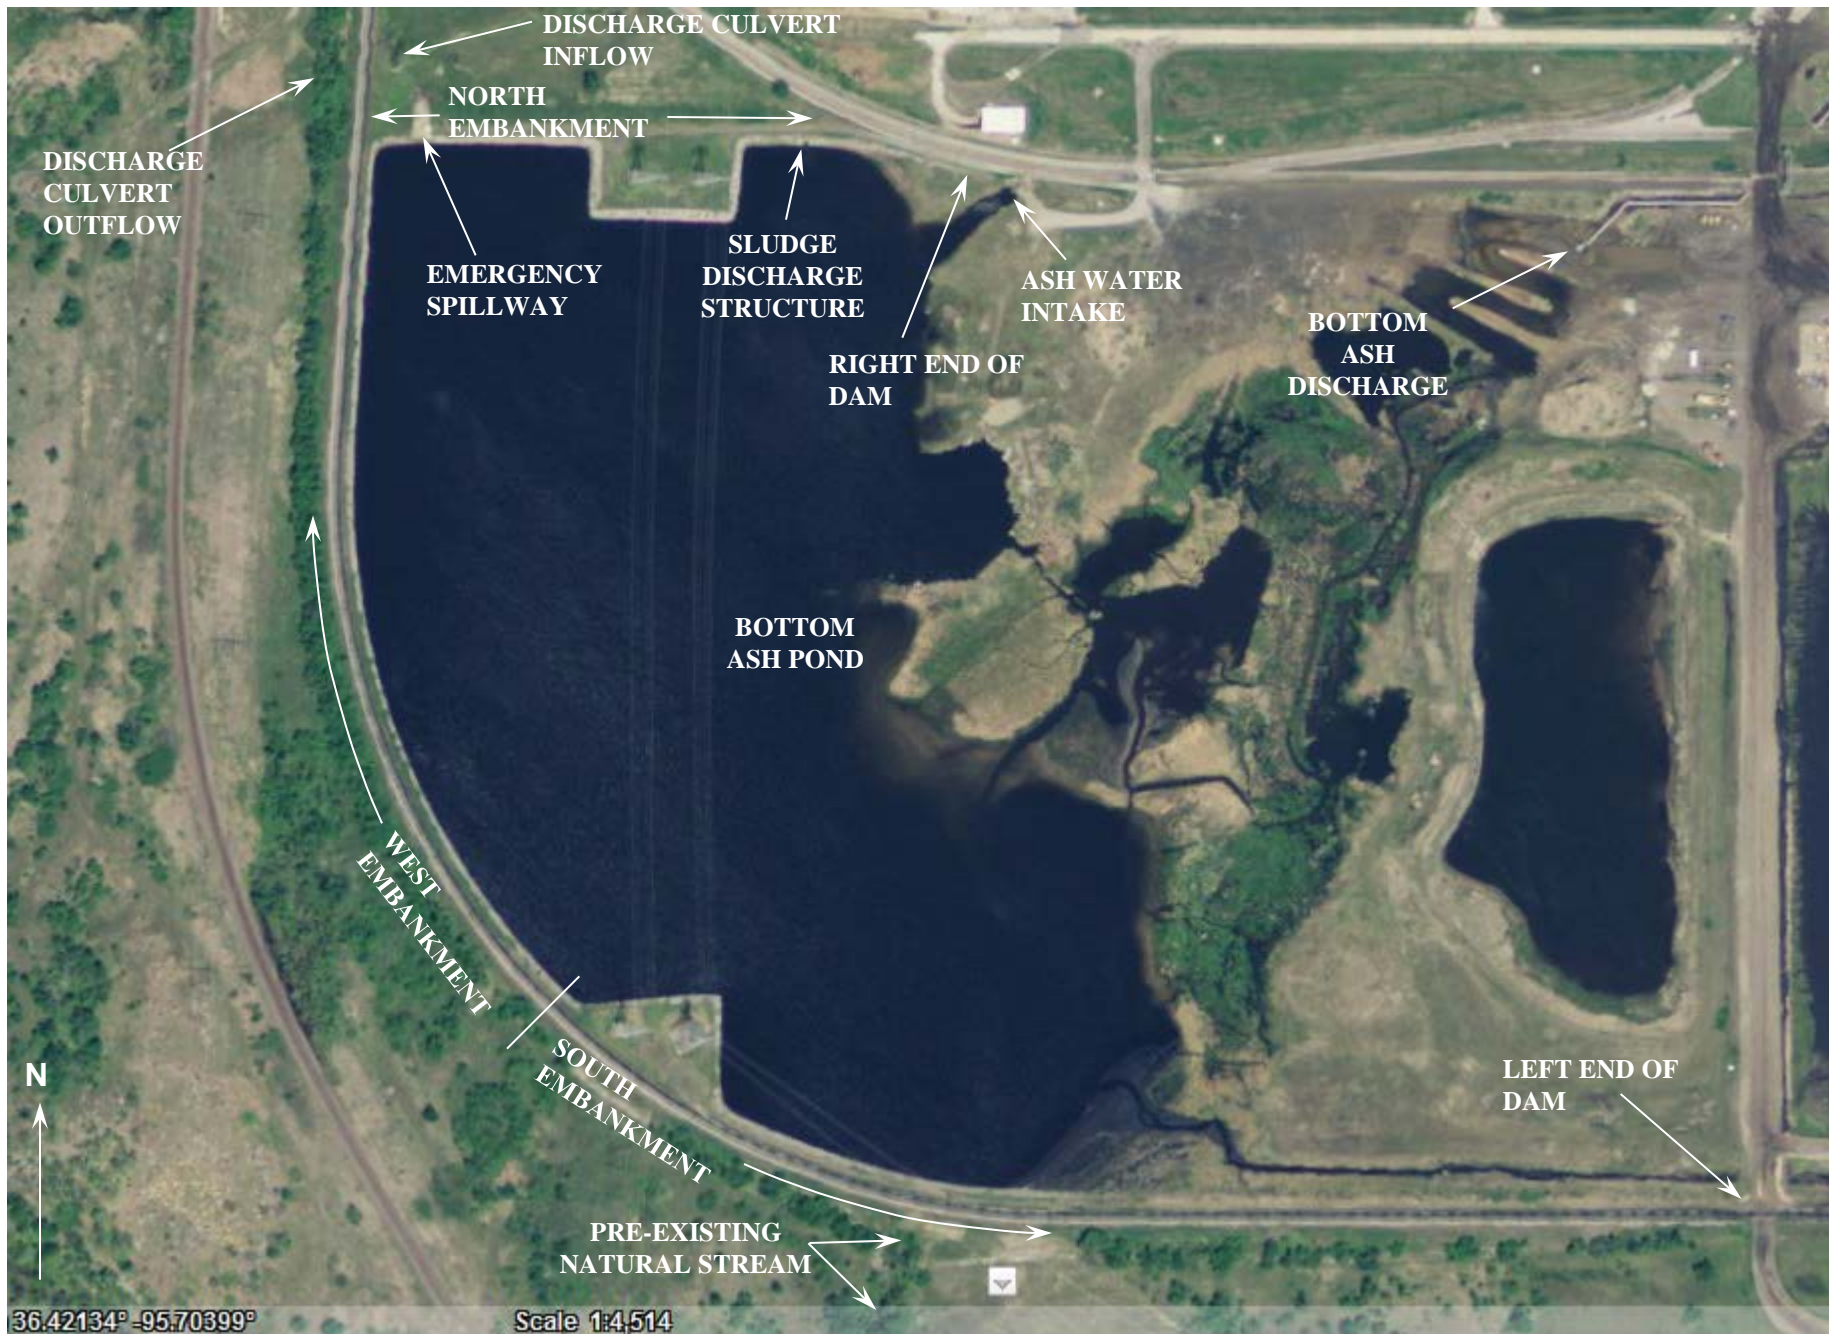
Figure 1. Satellite Image Of Bottom Ash Pond Dam, Features, And Appurtenances At Northeastern 3&4 Power Station.

Figure 1 provides a plan view, in the form of a satellite image, of the Bottom Ash Pond, the embankment structure or dam, pertinent dam features, and the dam's appurtenances. The dam is a 4,200-foot long cross-valley fill on an unnamed tributary to Fourmile Creek. The dam is roughly U-shaped and has been divided into north, west, and south embankments for reference in this inspection report.

There is no principal spillway at the bottom ash pond; water is typically recirculated back to the power plant for reuse. The auxiliary spillway at the bottom ash pond is a concrete overflow structure with a design crest elevation of 625.0 ft. Overflow from the spillway discharges to a low area and then flows through culverts under a railroad and off site. Figure 1 shows the spillway and discharge culvert locations.

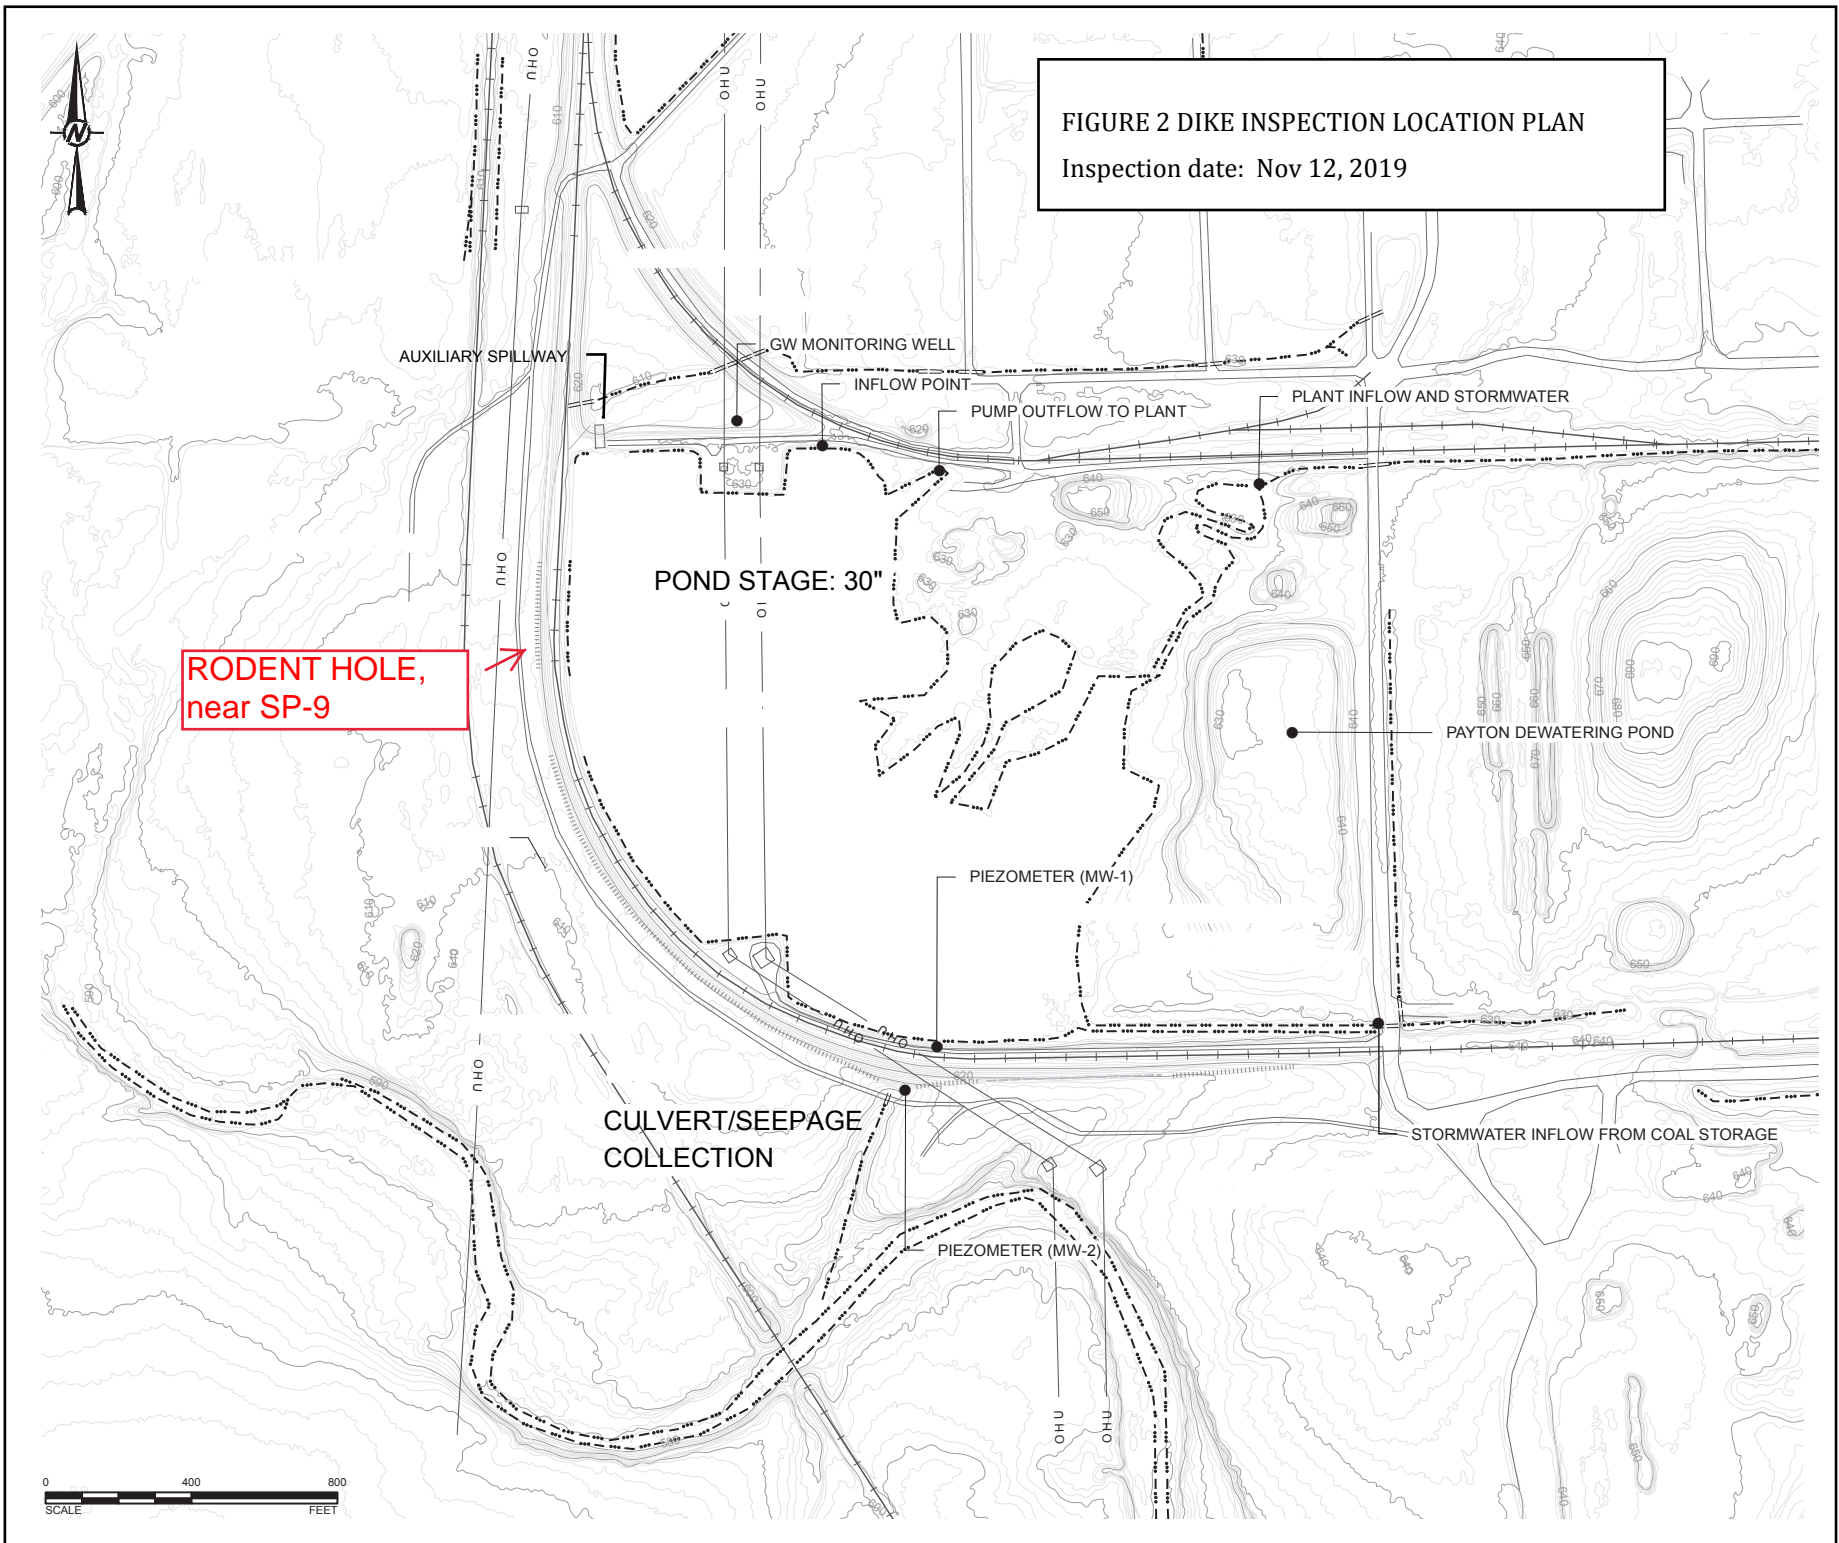
**FIGURE 2 DIKE INSPECTION LOCATION PLAN**  
Inspection date: Nov 12, 2019

There are two piezometers and a seepage collection pipe as part of the instrumentation for this facility. The locations of the instrumentations are shown on Figure 2. The maximum and minimum recorded readings of each piezometer since the previous annual inspection is shown in Table 1 below. The readings collected since the last inspection were all within their normal safe operating ranges. MW-01 is located on the crest of the dam and MW-02 is located at the toe of the dam. The water level in the pond ranged from elevation 624.5 – 622.3.

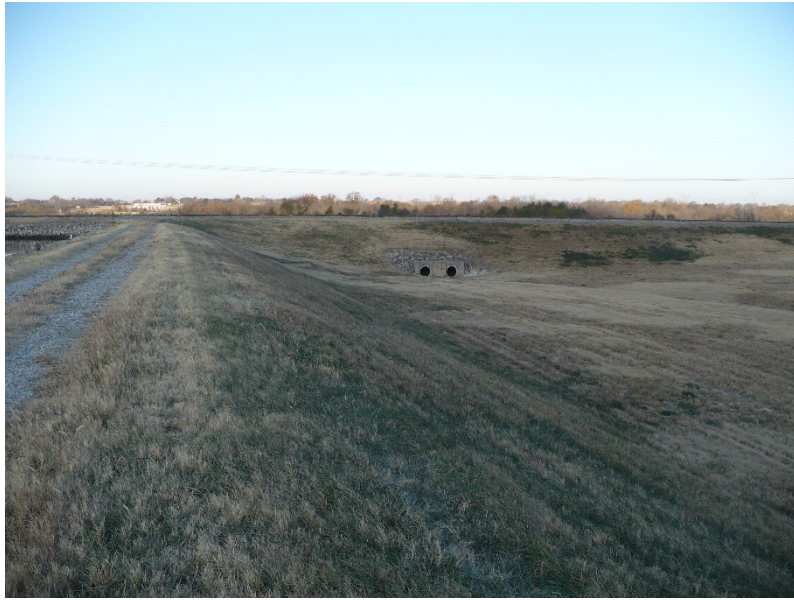
Photo #1 – exterior slope north dike– looking west

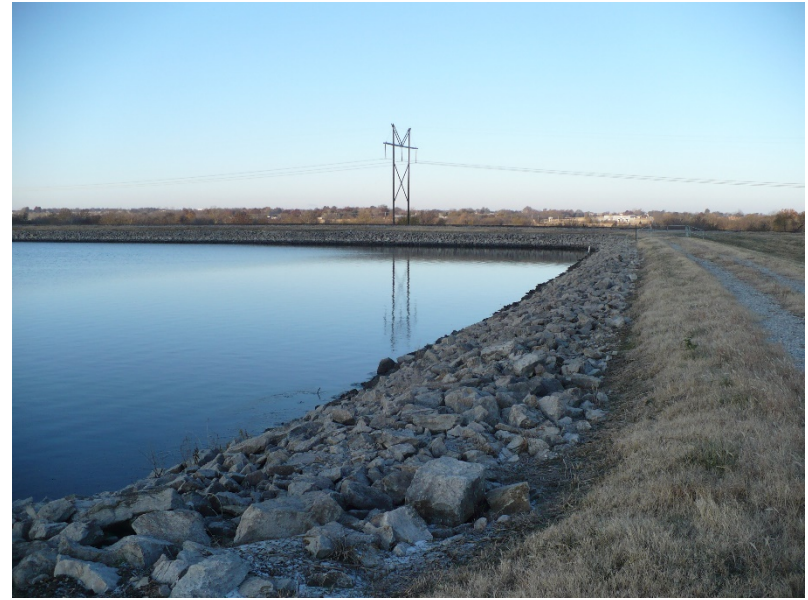
Photo #2 – interior slope of north dike-looking west

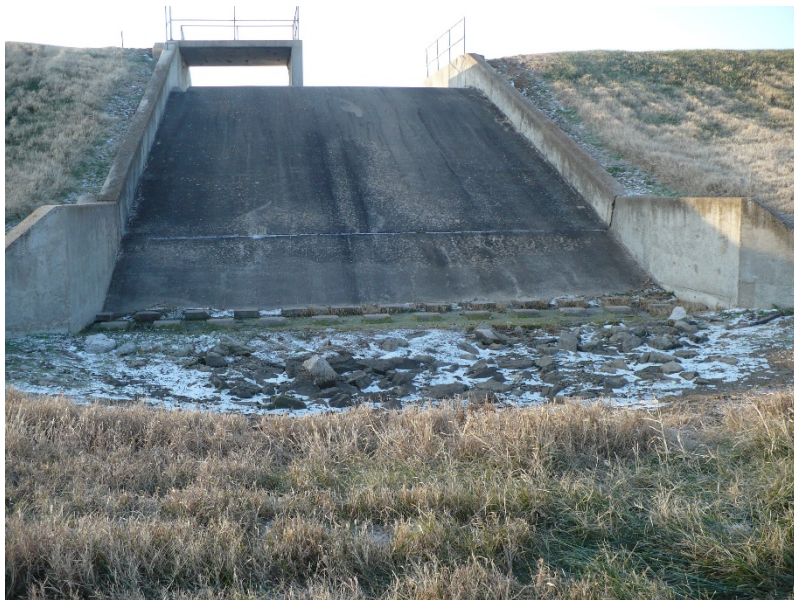
Photo #3 –spillway chute

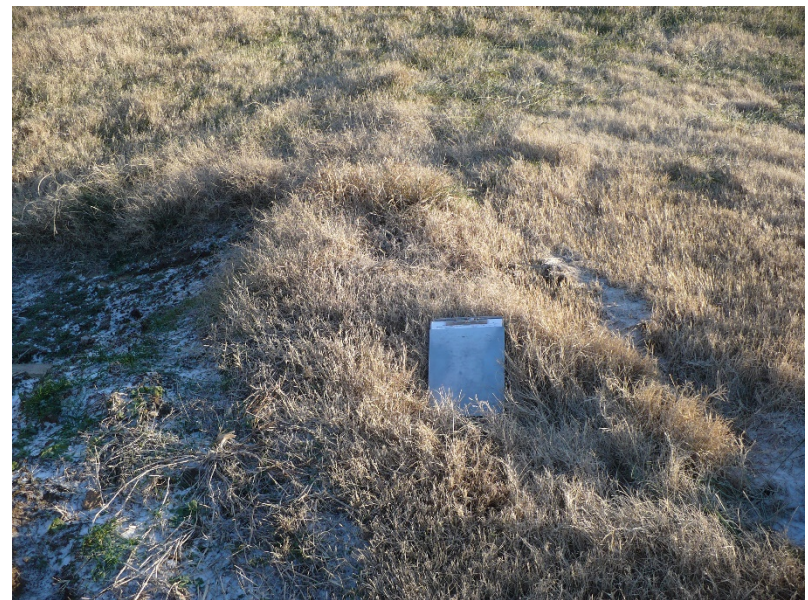
2. There were no signs of movement or misalignment along any of the construction joints except for the joint at the top of the chute. This occurred some time ago and the condition has remained stable based on past inspections. There was no seepage along the contacts between the concrete training walls and exterior slope of the embankment, nor at the end of the concrete chute.
3. The energy dissipater baffles at the toe of the spillway were clear of sediment and were in good condition.
4. The caulking at the concrete joints was in good condition.
5. There appeared to be a small depression about 12 inches in diameter at the toe of the spillway along the right training wall. There was good grass cover over the depression and no signs of animal activity. (photo 14)

Photo #4 – depression near right wall of spillway chute near the toe

- 1) Repair the depression near the toe of the auxiliary spillway.
- 2) Repair the observed rodent hole.

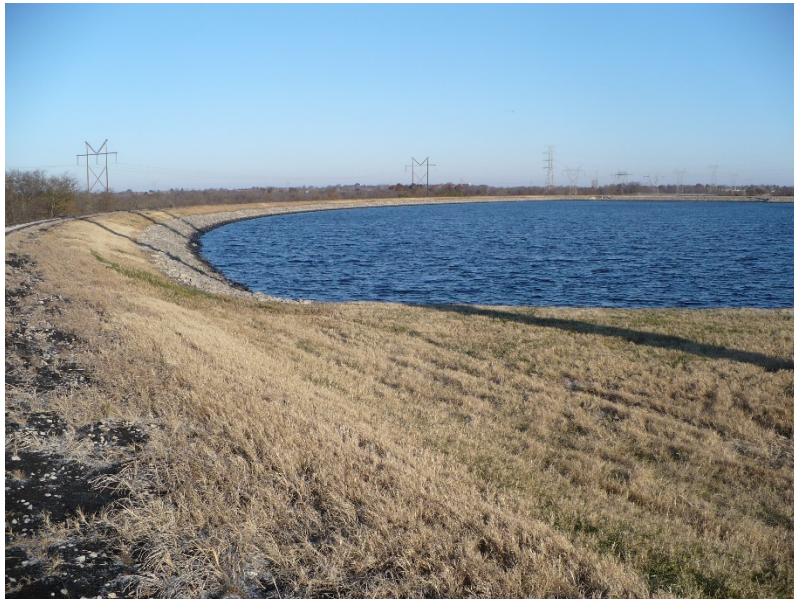
1. The interior slope of this embankment was in good condition. The riprap was free of any vegetation. (photo 5)
2. The area beyond the toe of the embankment has been well maintained to prevent heavy and/or woody vegetation within the regulatory 30-foot setback. The exterior slope is well vegetated and maintained (photo 9). There was no seepage noted along the toe of the West embankment.
3. The crest and railroad tracks do not show any signs of settlement or misalignment (photo 6). The tracks are inspected monthly by an independent company to ensure no misalignment or settlement.
4. A rodent hole was observed just above the riprap on the exterior slope near monitoring well SP-9 (see Location Map).

Photo #5 – interior slope of west dike

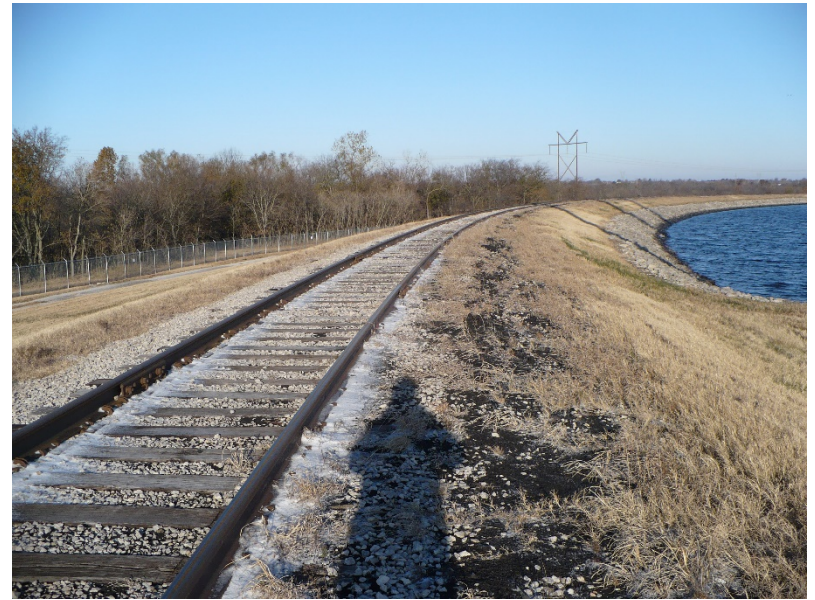
Photo #6 – crest of west dike

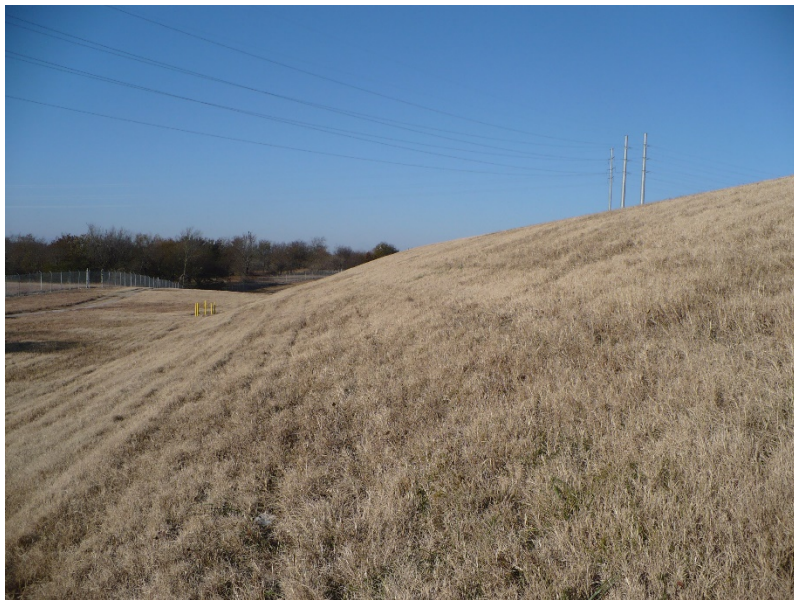
6. The exterior slope is well vegetated and maintained (photos 7&8). There was no observed seepage, wet or damp areas along the slope.
7. The seepage collection blanket appears to be functioning as designed. Seepage is directed to the low area below the embankment and is typically discharged through a pipe below an access drive. No seepage or moisture was observed at the outlet of the pipe (photos 11&12).

Photo #7 – exterior slope of south dike-looking west

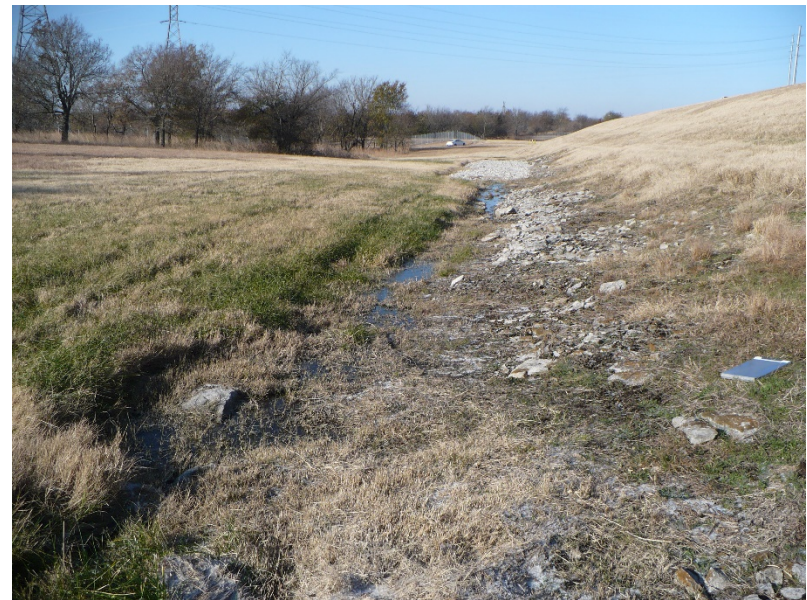
Photo #8 – toe of south dike-some ponded water in ditch

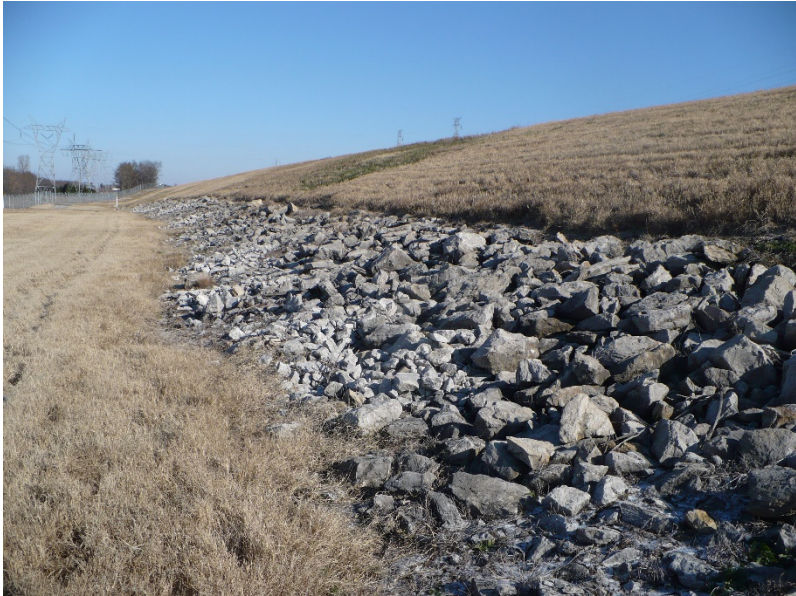
Photo #9 – exterior slope of west dike-looking north
