2019 ANNUAL DAM AND DIKE INSPECTION REPORT

BOTTOM ASH PONDS

**PIRKEY POWER PLANT
HALLSVILLE, TEXAS**

Dam & Dike Inspection Report ASH Ponds

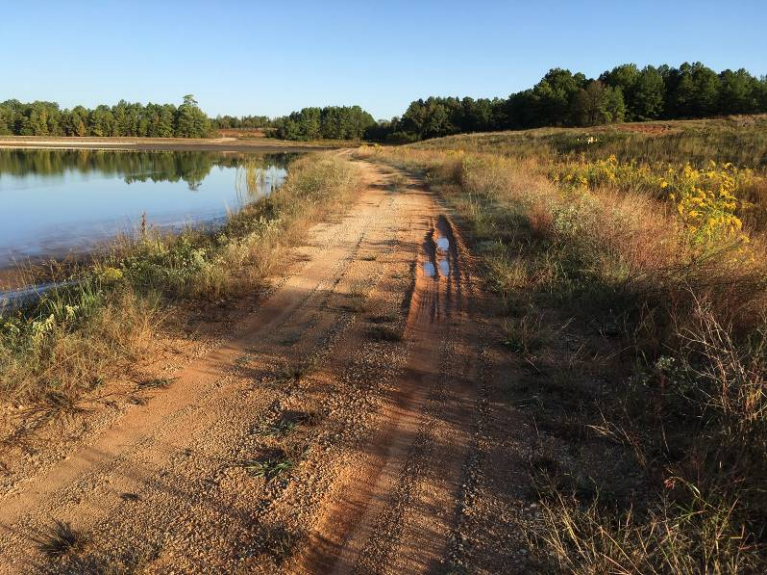
<p>Photo # 1</p>

1. Photographs No. 1 illustrates the crest area and interior slopes of the eastern side of the east bottom ash pond. The crest has signs of rutting from truck traffic and the vegetation on the interior slopes is overgrown. There were no other signs of settlement, misalignment and cracking observed.

- Overall, the slope conditions of the dam and levees are generally fair with the exception of some tire ruts caused from truck traffic and mowing activities. These areas overtime can lead to significant erosion and stability problems.
- Vegetation management for the facilities is considered satisfactory. However, some areas are overgrown and the vegetation needs to be maintained at least 25 feet from the toe of the embankments.

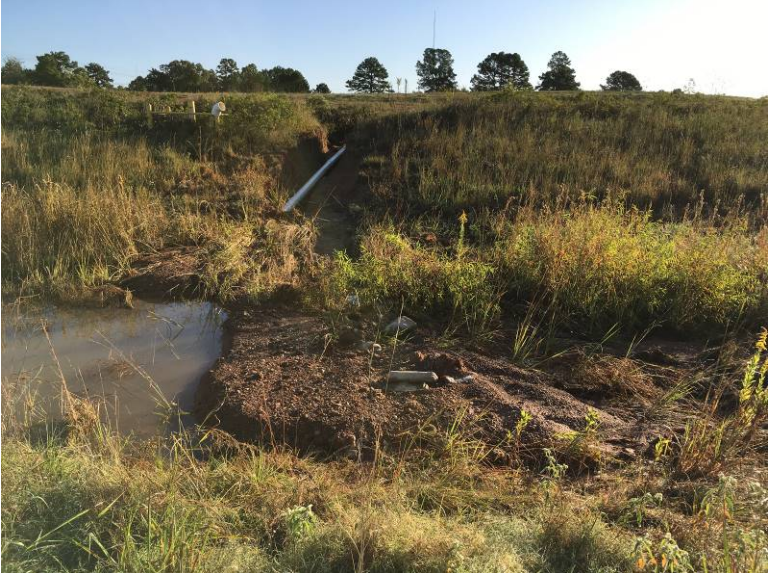
2. Photographs No. 2 illustrates the condition of the perimeter ditch on the east side of the pond. The perimeter ditch shows signs of a washout from a recent rain event. The sediment and vegetation buildup from the washout is causing standing water in the bottom of the ditch.

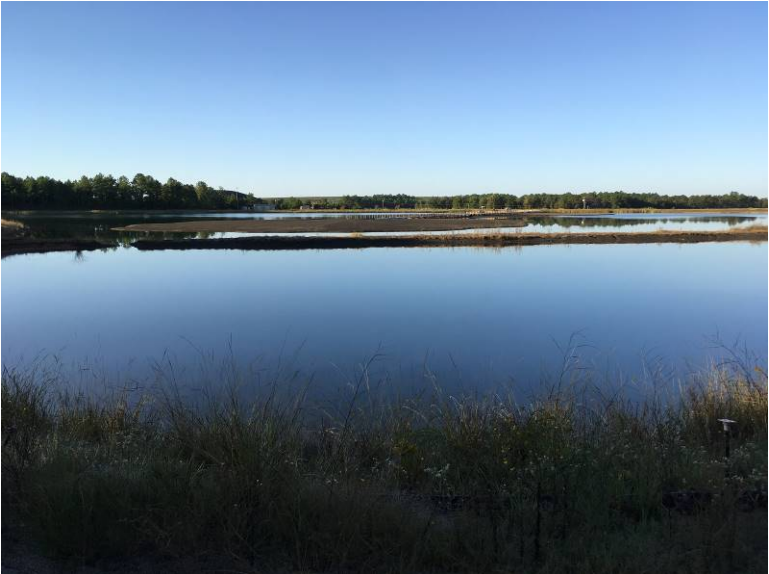
3. Photograph No. 3 shows the general condition of the interior area of the East Bottom Ash Pond. The east bottom ash pond was in service at the time of inspection.

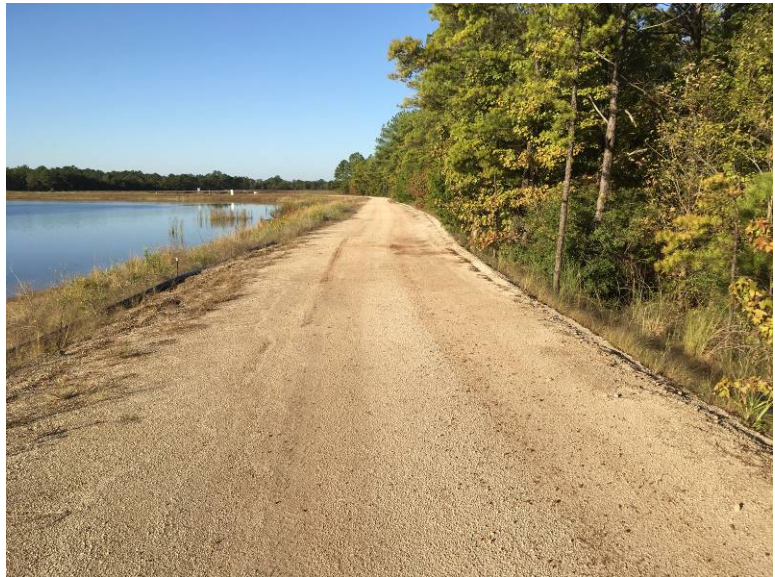
Photo # 4

4. Photograph No. 4 illustrates the typical condition of the crest area on the north side of the pond. In general, the crest area appeared to be in satisfactory condition with no signs of rutting, cracks or misalignment.

View of the East Bottom Ash Pond Crest Area. Crest Conditions area Satisfactory.

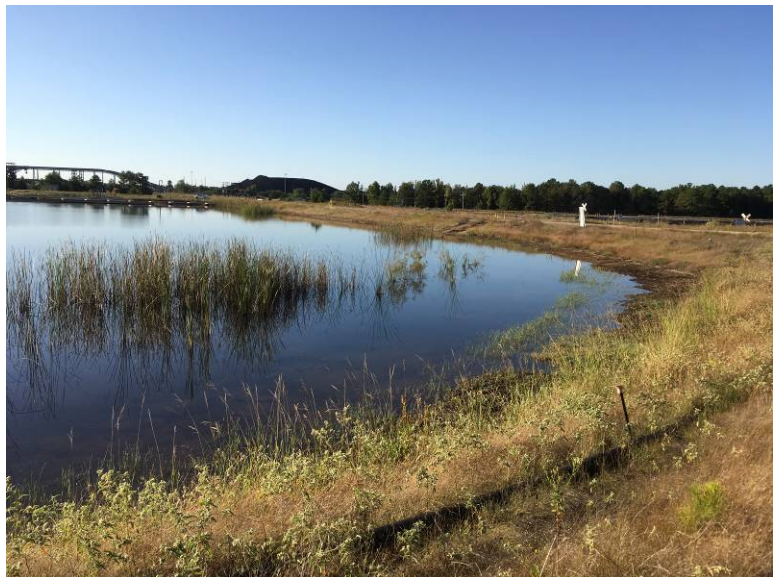
Photo # 5

5. Photographs No. 5 shows the general condition of the interior slopes of the east bottom ash pond. The slope appeared in satisfactory and stable condition. There were no signs of settlement, misalignment, sloughing or erosion.
6. The overflow discharge structure walkway, railings, metal decking, and visible concrete were found to be in satisfactory, functional condition. However, there was overgrown vegetation adjacent to the access platform. Photographs No. 6 illustrate the access stairs, metal walkway, metal deck, and concrete structure of the overflow discharge structure.

View of the East Bottom Ash Pond Interior Area and Slope Conditions. East Bottom Ash Pond is Currently In Service.

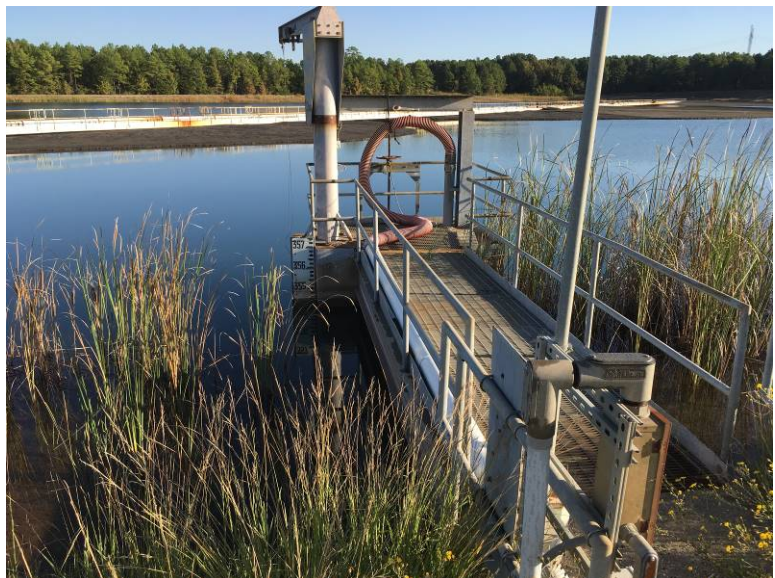
Photo # 6

View of the Discharge Structure at the East Bottom Ash Pond.

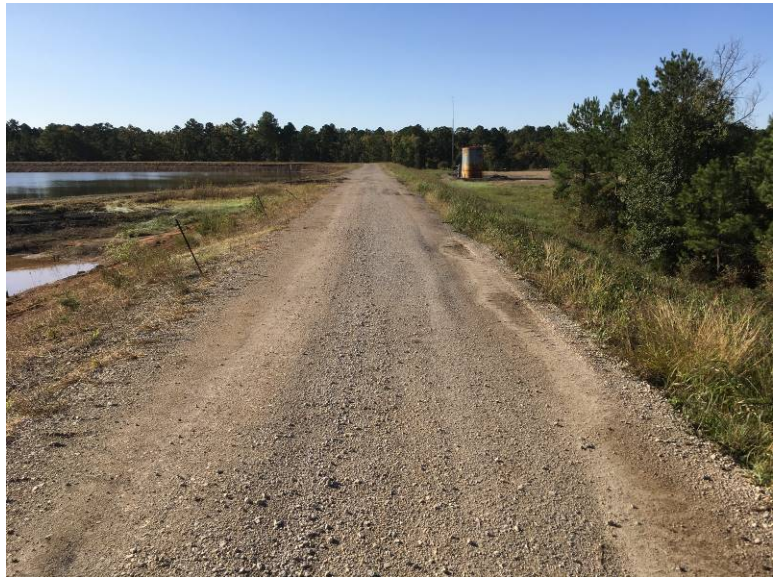
Photo # 7

7. Photographs No. 7 and 8 illustrate a typical overview of the dike crest. The crest appears to be in good and stable condition. There were no other signs of settlement, misalignment and cracking observed.

View of the West Bottom Ash Pond Crest Area. Crest Conditions are Satisfactory.

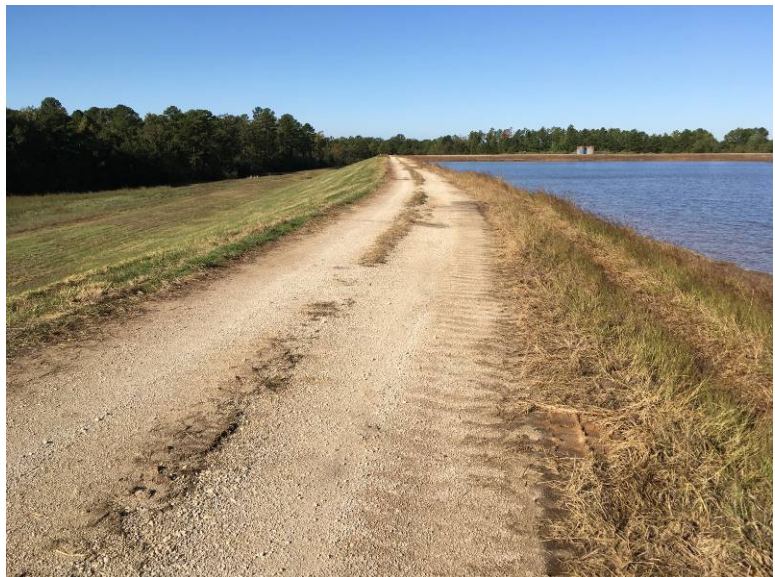
Photo # 8

View of the West Bottom Ash Pond Crest Area. Crest Conditions are Satisfactory.

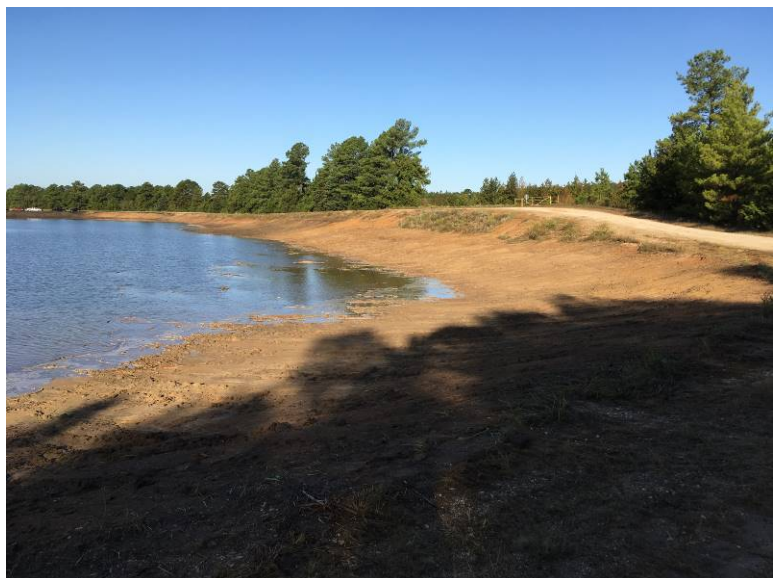
Photo # 9

8. Photographs No. 9 and 10 illustrate the condition of the interior slopes and vegetation management of the west bottom ash pond. The interior slopes and vegetation of the interior dikes appeared to be in satisfactory and stable condition.

View of the Interior Slope Conditions of the West Bottom Ash Pond.

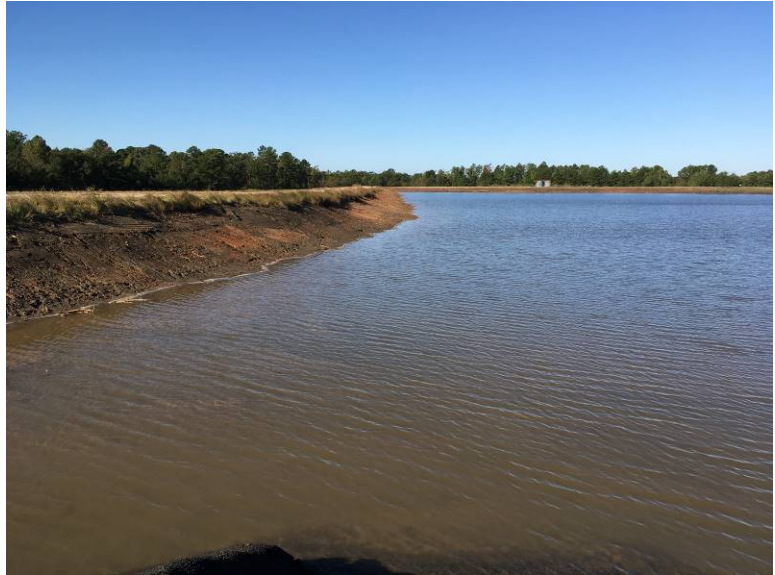
Photo # 10

View of the Interior Slope Conditions of the West Bottom Ash Pond. West Bottom Ash Pond is Currently Out of Service.

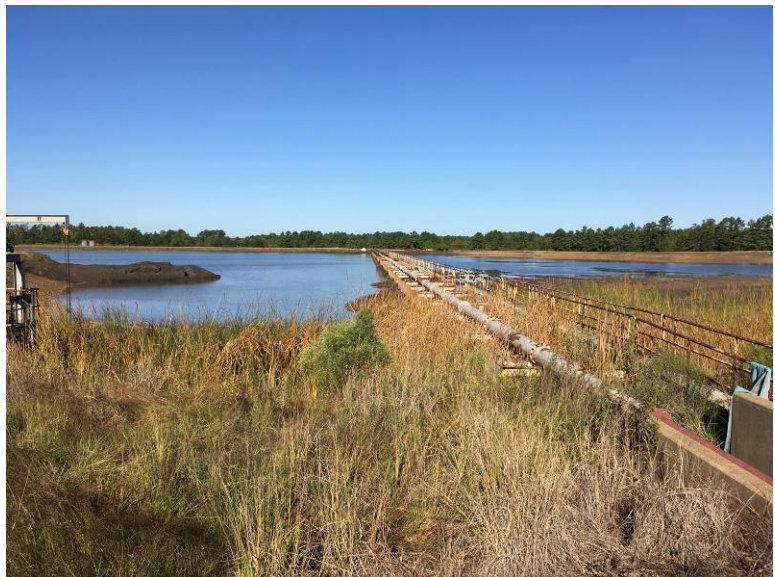
Photo # 11

9. Photograph No. 11 show the general condition of the interior area of the west bottom ash pond. There is some overgrown vegetation surrounding the sluicing pipe platform that extends out into center of the pond. The west bottom ash pond was out of service at the time of inspection.

View of the Sluicing Pipe Structure of the West Bottom Ash Pond.

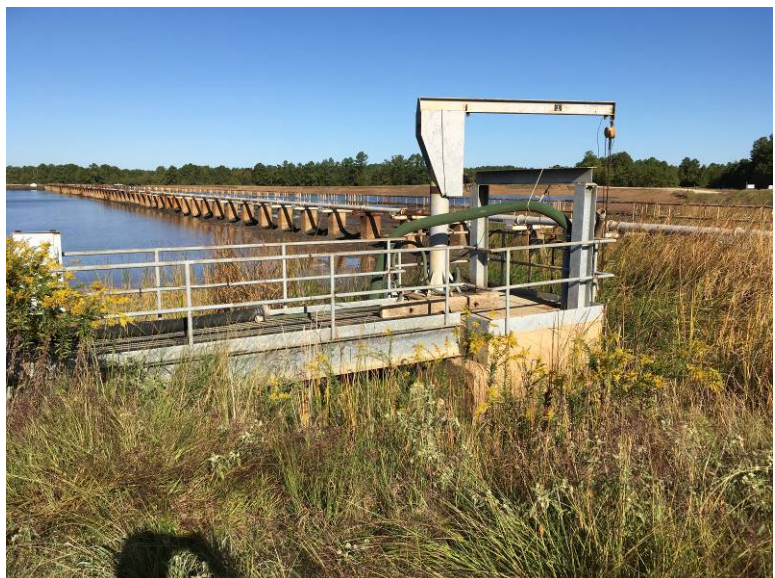
Photo # 12

10. The overflow discharge structure walkway, railings, metal decking, and visible concrete were found to be in satisfactory, functional condition. However, there was some overgrown vegetation adjacent to the access stairs. Photographs No. 12 illustrates the overgrown vegetation around the access metal walkway, metal deck, and concrete structure of the overflow discharge structure.

View of the Discharge Structure of the West Bottom Ash Pond.

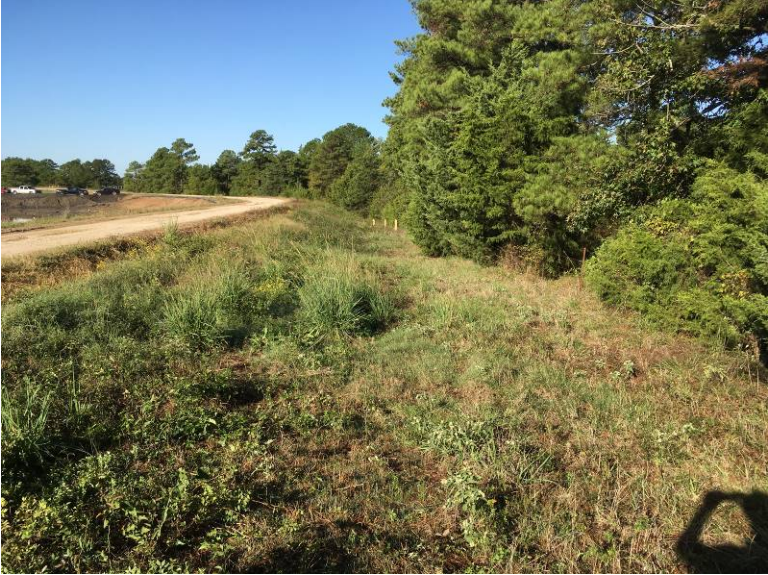
<p>Photo # 13</p>

11. Photographs No. 13, 14 and 16 shows the general condition of the exterior slope and toe areas of the west bottom ash pond. The slopes appeared in satisfactory and stable condition. There were no signs of wet areas, settlement, misalignment, sloughing or erosion. The north and west exterior slopes had overgrown vegetation.

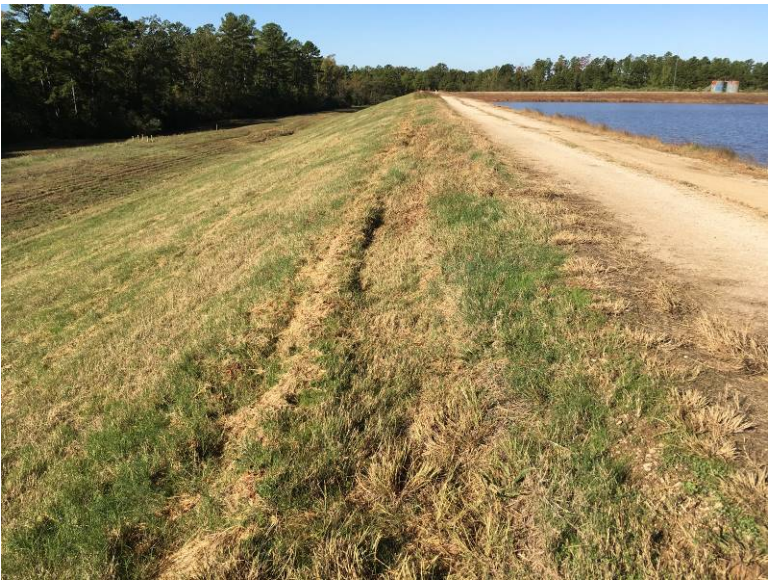
<p>Photo # 15</p>

12. Photograph No. 15 shows a significant tire rut on the upper south exterior slope near the crest. The tire rut is likely caused from recent mowing activities.

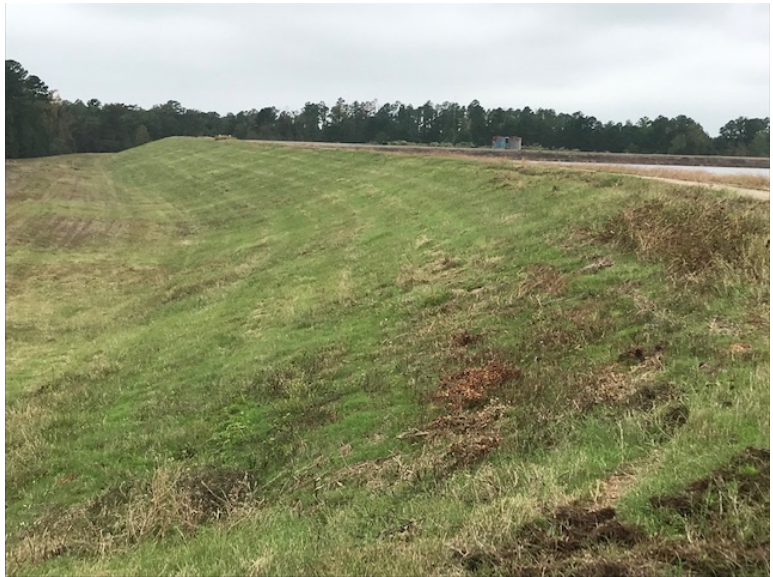
Photo # 16

View of the South Exterior Slope the West Bottom Ash Pond.

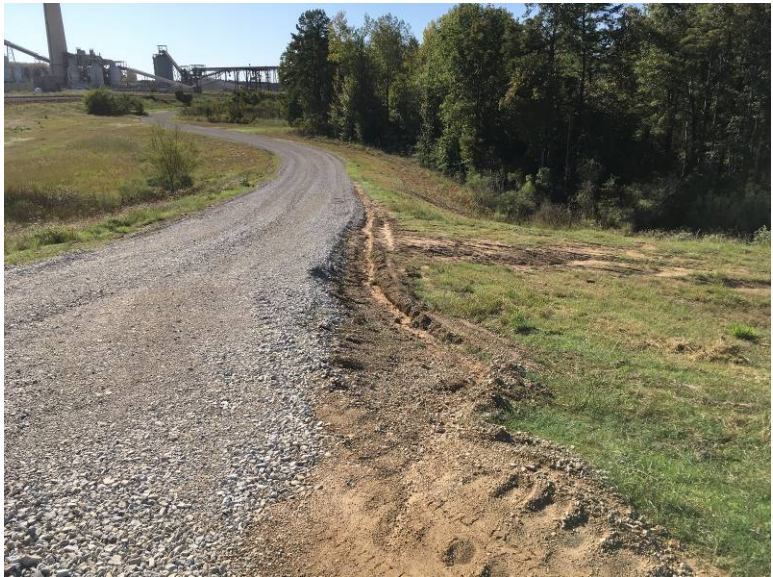
Photo # 17

13. Photograph No. 17 shows the development erosion formed along the edge of an access ramp on the southeast side of pond. There also are some minor erosion formed on another access ramp at the southwestern corner of the embankment. The erosion is taking place in

areas along these access ramps to the crest, but does not appear to be a detrimental condition to the integrity of the structure.

View of the Erosion Rills on the Access Ramp to the Crest Area on the Southeast corner of West Bottom Ash Pond.

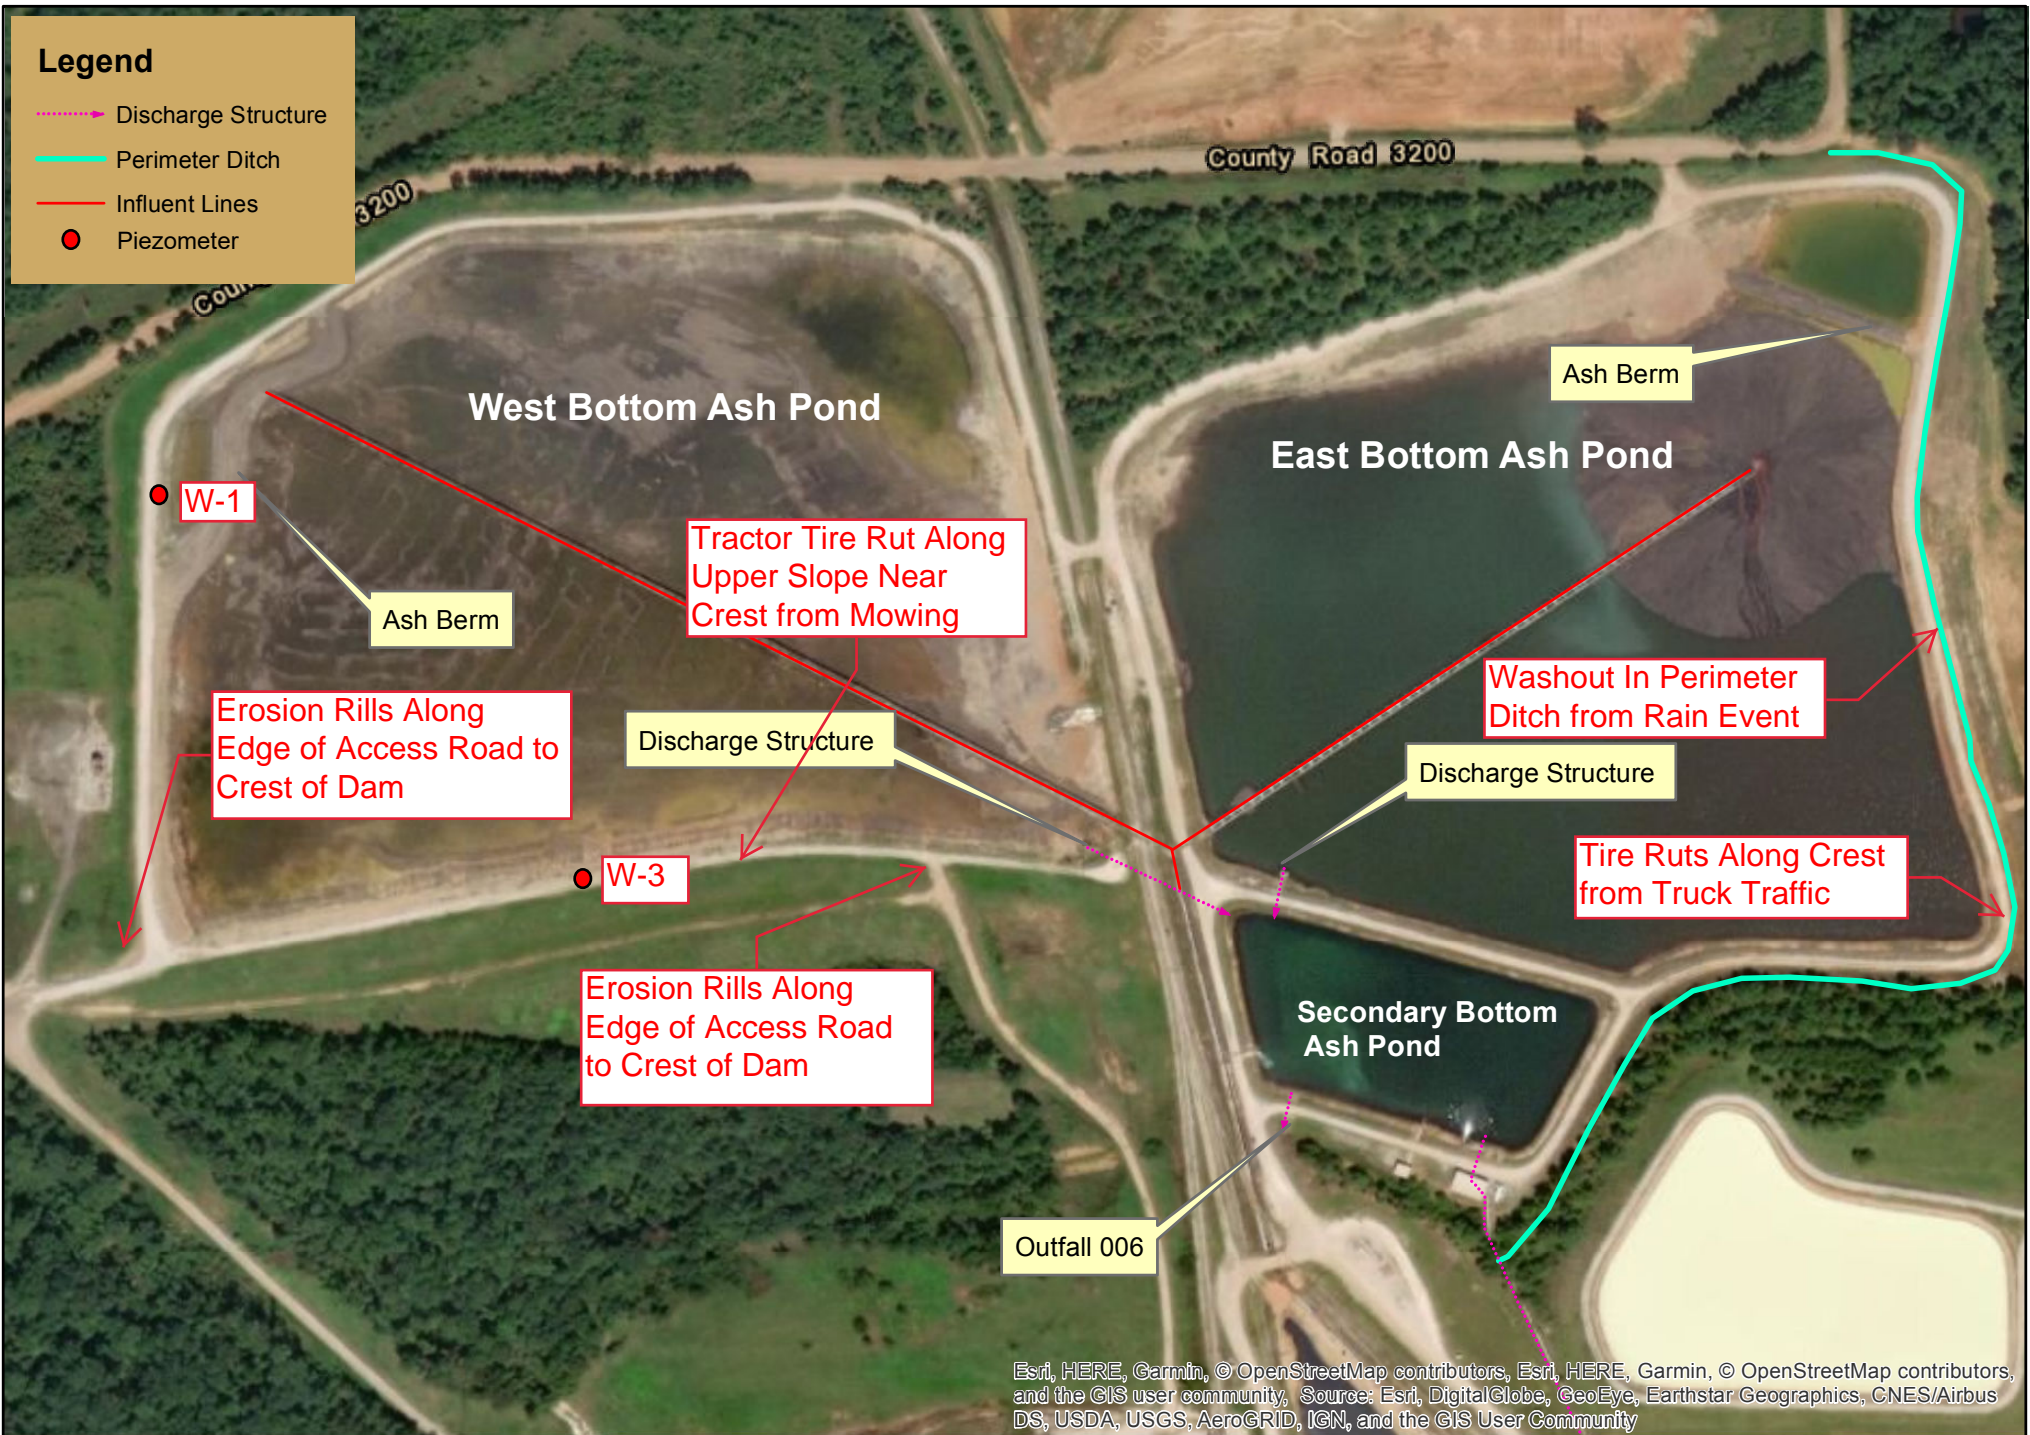
Site Map – CCR Ponds Complex

Erosion Rills Along Edge of Access Road to Crest of Dam

Tractor Tire Rut Along Upper Slope Near Crest from Mowing

Washout In Perimeter Ditch from Rain Event

Tire Ruts Along Crest from Truck Traffic
