# 2020 Annual Landfill Inspection Report

Northeastern Plant Landfill  
Public Service Company of Oklahoma  
Oologah, OK  
ODEQ Permit No. 3566010  
Document ID: GEVR-20-020

November 12, 2020  
Project No. 35207217

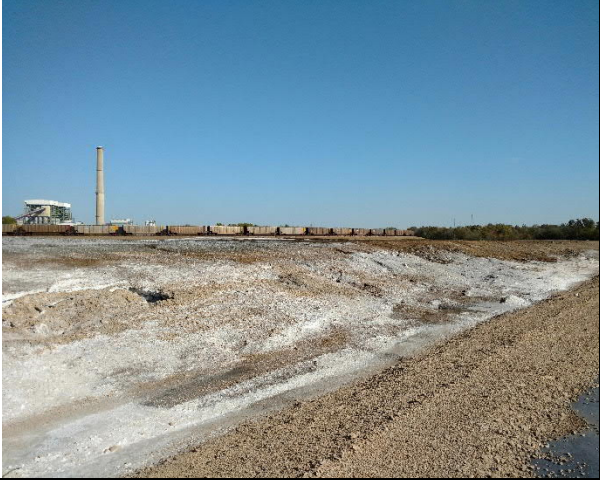
| Photos by F. Owen Carpenter | | | |
|---|--|--|--|
| 1.1<br>(112) | Looking north at active area – Cell 2 | From top of perimeter berm. | |

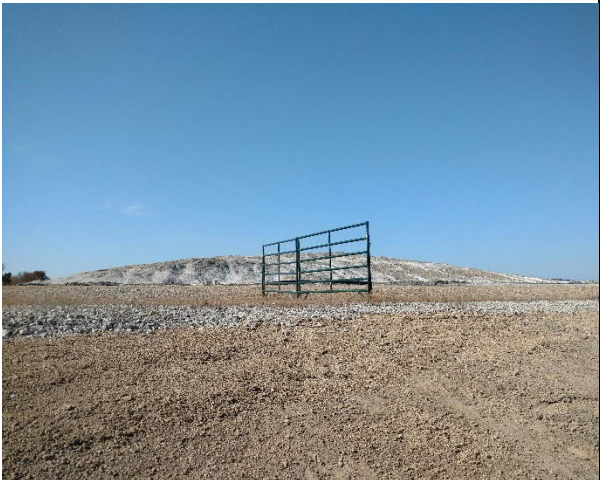
| Photos by F. Owen Carpenter | | | |
|---|--|--|--|
| 1.2<br>(115.5) | Looking west from leachate collection pond to Cell 2 waste in background | From near Cell 2 leachate collection pipe discharge into southeast corner of leachate collection pond. | |

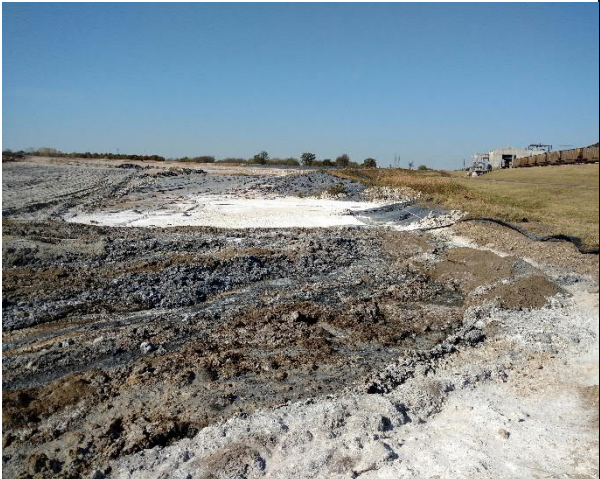
| Photos by F. Owen Carpenter | | | |
|---|--|--|--|
| 1.3<br>(116) | Looking southwest from leachate pond to Cell 1 | New waste has been placed in Cell 1 including side-gradient to up-gradient of the temporary weir. | |

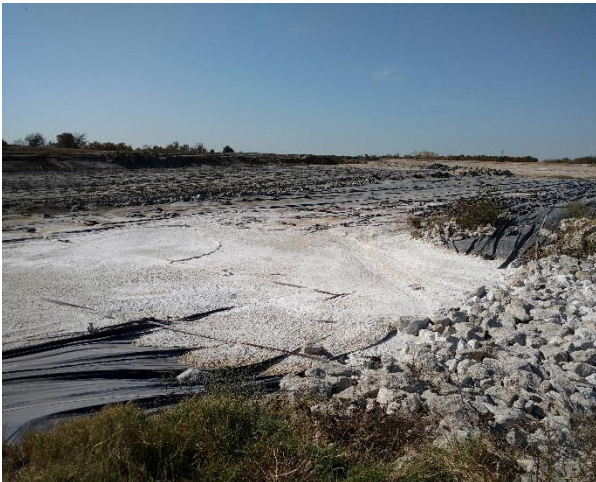
| <p>1.4<br/>(117)</p> | <p>Looking south over the lower end of Cell 1</p> | <p>New waste has been placed in Cell 1 including side-gradient to up-gradient of the temporary weir shown in foreground.</p> | |

- 1) The exterior slope of the north containment berm should be reseeded in denuded areas if required.
- 2) Place separation berm between Cell 1 new waste and lower end temporary weir (see Figure 1, location 1.4) or remove temporary weir per operations protocol.
- 3) Remove plastic debris from upstream culvert opening (near Figure 1, location 3.1)

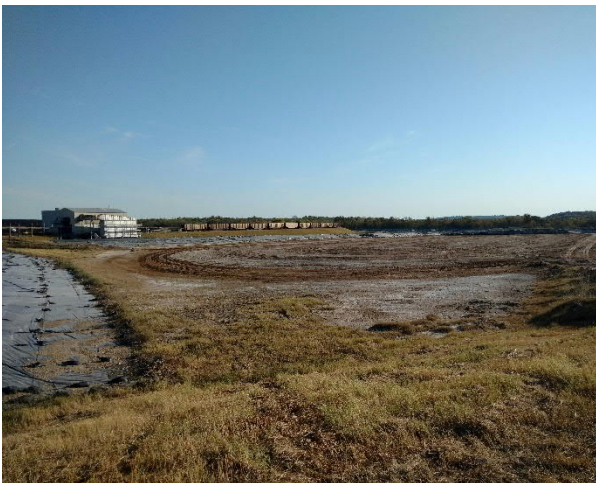
| <p>2.1<br/>(101)</p> | <p>Looking northeast over inactive up-gradient portions of Cell 1 on the right</p> | <p>Temporary rain blanket shown to the left. DuraSkrim rain blanket is a five-year+ exposure reinforced geomembrane in good condition. No photodegradation defects indicated on any observed rain blanket.</p> | |

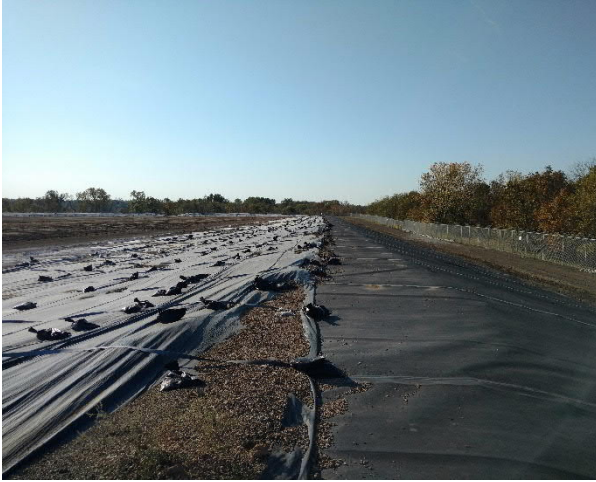
7. The west end of the landfill has exposed geomembrane as a cover over the slopes of the CCR material. No damage to the temporary cover was observed. (photo 2.2)

| <p>2.2<br/>(102)</p> | <p>Looking south along the perimeter berm. Inactive Cell 4 to the left</p> | <p>Shown from left to right – riverside berm in background, inactive Cells 3 &amp; 4, rain blanket to top of exposed geomembrane berm cover, perimeter road along southwest side, perimeter fencing.</p> | |

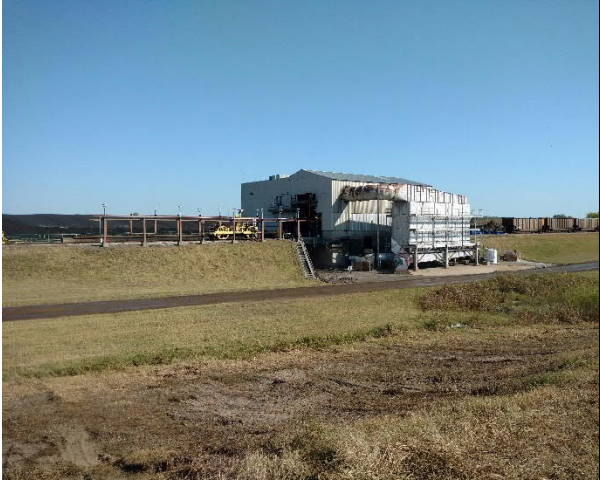
8. The exterior soil slopes of the north containment berm had recently been mowed and included occasional areas of denuded soils (photo 2.3).

| <p>2.3<br/>(121)</p> | <p>Looking northeast at north outer berm soil slope</p> | <p>North slope recently mowed. Occasional areas of soil exposure. Coal railcar building in background.</p> | |

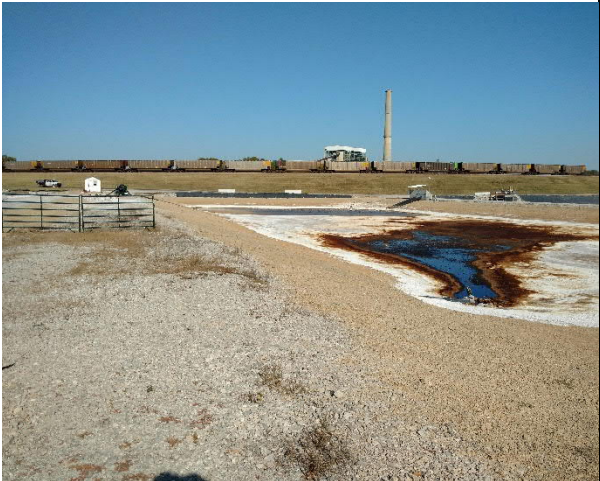
| <p>3.1<br/>(112.4)</p> | <p>Looking north into leachate collection pond near Cell 2 leachate collection pipe discharge</p> | <p>Leachate and Basin C pump stations in background.</p> | |

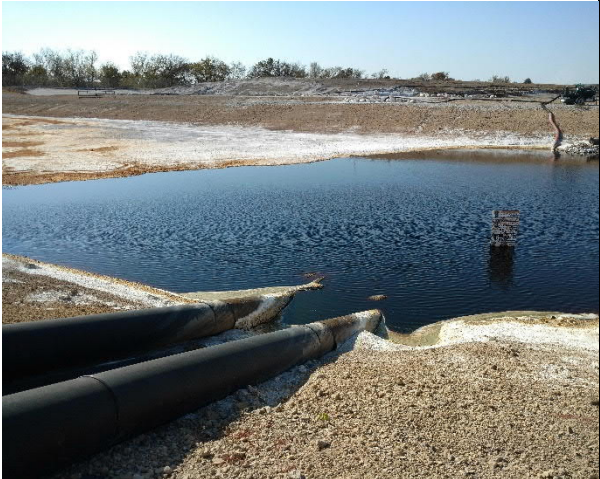
| <p>3.2<br/>(114.5)</p> | <p>Looking south into leachate collection pond near pump station</p> | <p>Shown are leachate collection riser pipes, pooled leachate, level gauge and Cell 2 waste in background.</p> | |

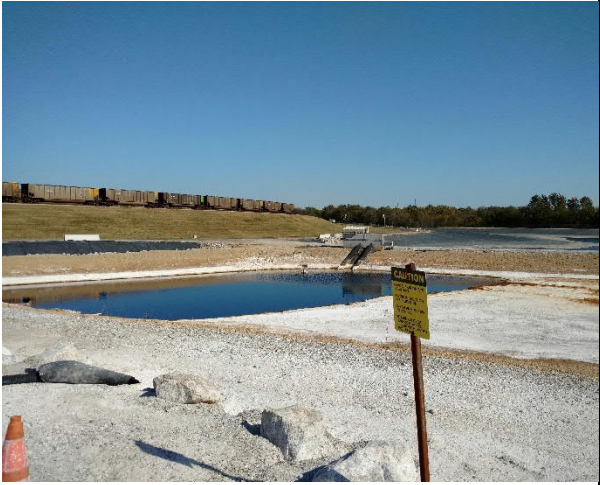
| <p>3.3<br/>(115)</p> | <p>Looking north into leachate collection pond near Cell 1 leachate collection pipe discharge</p> | <p>Leachate pump station and Basin C in background.</p> | |

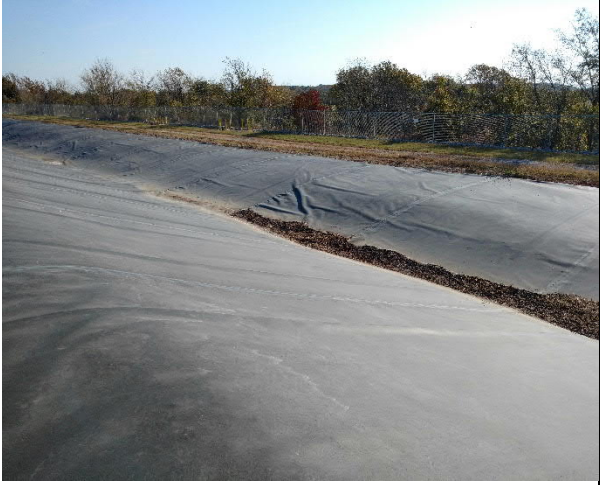
| <p>4.1<br/>(107)</p> | <p>Looking northeast at riverside lined berm and perimeter channel</p> | <p>Soil and vegetative debris in low area of drainage channel. Flow is to the left toward Basin C.</p> | |

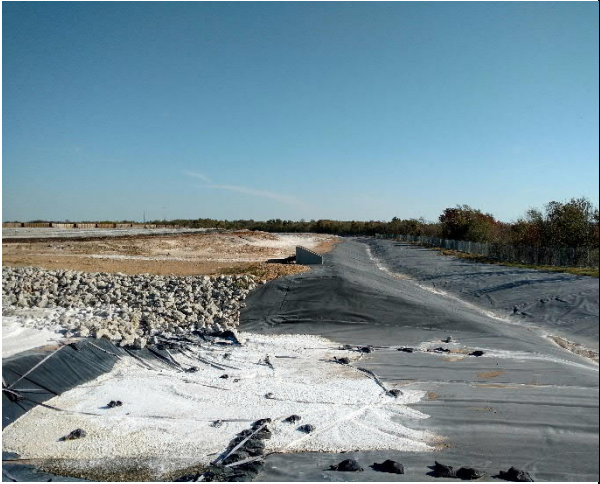
| <p>4.2<br/>(109)</p> | <p>Looking northeast along riverside berm and perimeter channel</p> | <p>Shown from left to right – temporary weir from Cell 3 into perimeter channel in foreground, Cell 2 waste in background, geomembrane lined perimeter berm and cleanout riser/headwall, lined perimeter drainage channel, perimeter access road, perimeter fencing, approximate 1:1 slope down to river.</p> | |

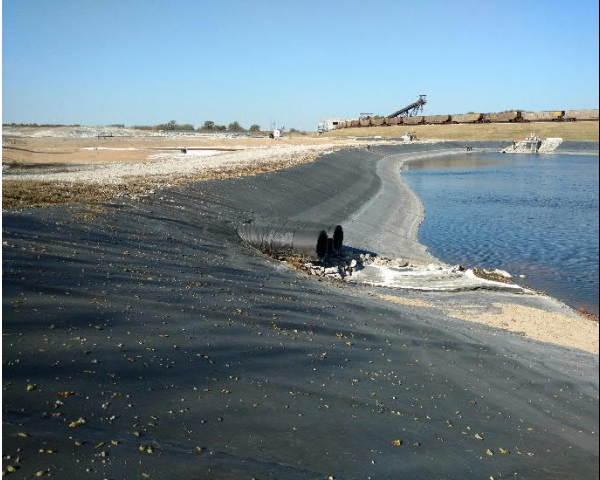
| <p>4.3<br/>(112.5)</p> | <p>Looking west along south side of Basin C (non-contact water) at southeast ditch discharge</p> | <p>Exposed geomembrane liner and HDPE stormwater discharge pipes with geomembrane boots. Basin C pump station in right background.</p> | |

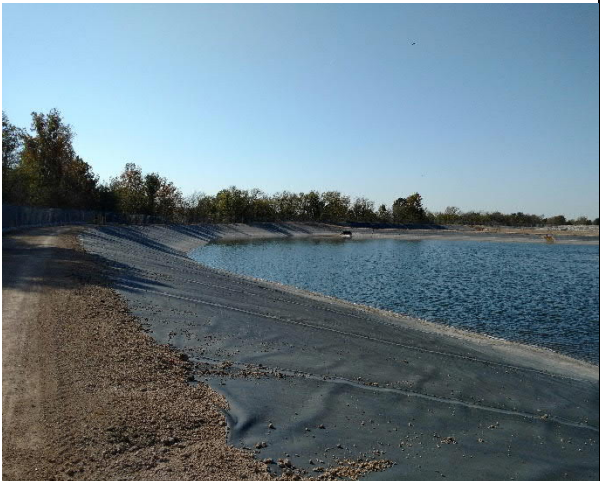
| <p>4.4<br/>(113)</p> | <p>Looking south along Basin C eastern (riverside) edge</p> | <p>Basin C showing exposed geomembrane liner and riverside perimeter road and fencing.</p> | |

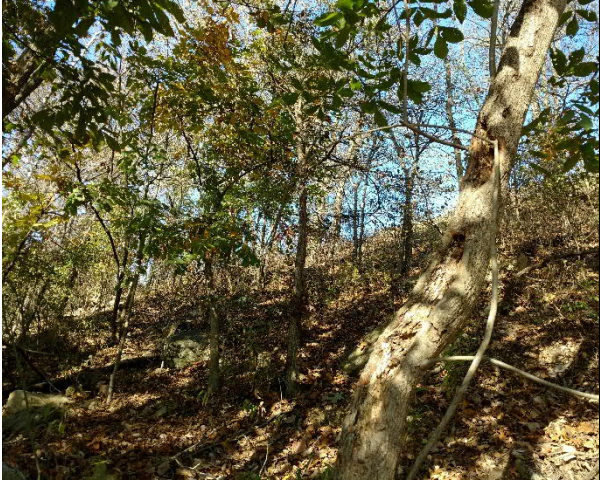
14. The crest of the perimeter dike was in good condition (photo 4.2). There were a few minor ruts in the surface of the perimeter access road aggregate surface.
15. The exterior slope of the dike is steep and heavily vegetated (photo 5.1). The natural riverbank slope below the dike is exposed rock.

| <p>5.1<br/>(100)</p> | <p>Looking west at steep (approximately 1:1) slope from riverside outside of perimeter fencing</p> | <p>Separation dike above the river is heavily vegetated and appeared stable as observed. The dike was visually inspected as available and no large-scale movement was indicated. Heavy vegetation and steep slopes do not allow for full observation of the area.</p> | |
