2021 Annual Dam and Dike Inspection Report

Bottom Ash Pond Complex

**John E. Amos Plant
Appalachian Power Co.
Putnam County, West Virginia**

Document Number: GERS-21-081

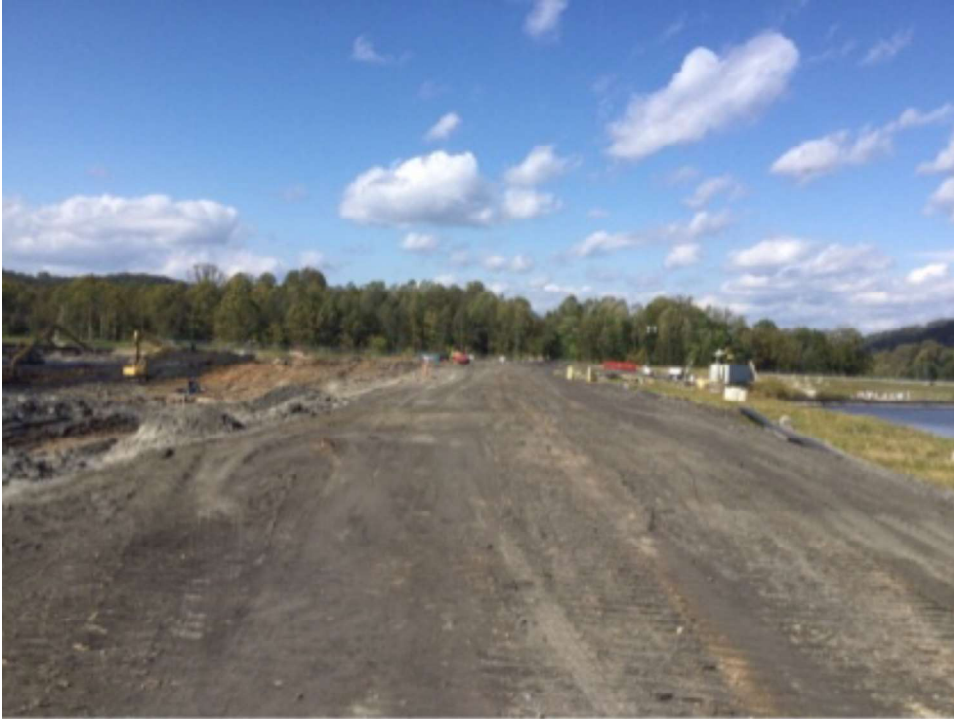
Notes: General condition of BAP 1A/1B splitter dike looking north.

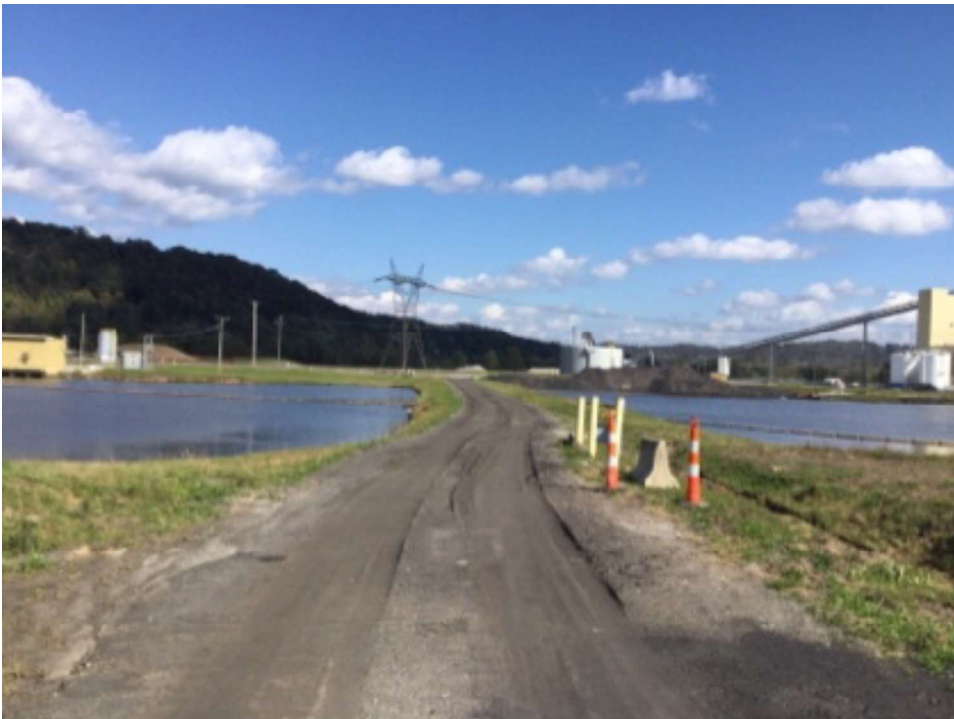
Notes: General condition of BAP1A/Reclaim Pond splitter dike looking east.

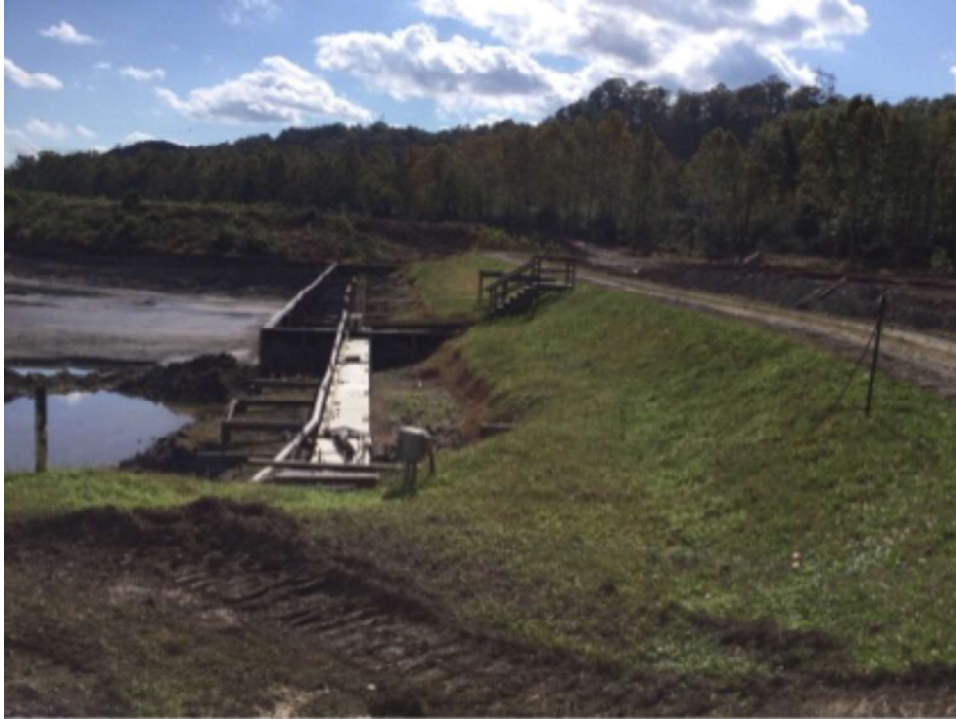
Notes: General condition of inboard slope of Northwest dike looking southwest. Note lowered pool in BAP 1B as part of closure operations.

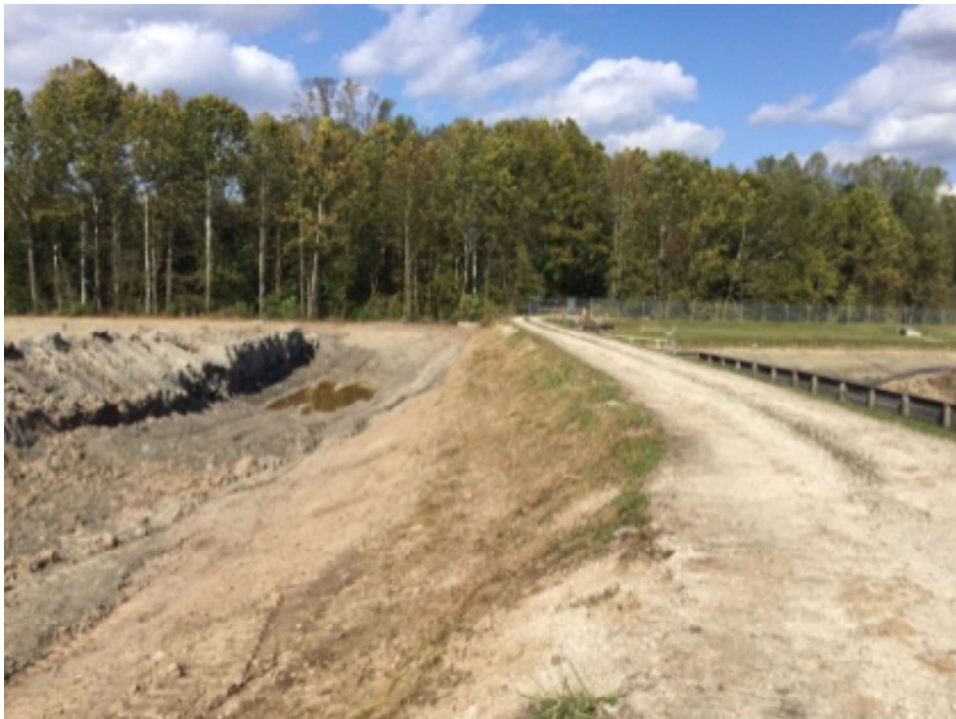
- The exterior slope of the dike at the northwest corner of BAP 1B vegetation removed as part of closure activities. Historic CCR material that was part of a historical configuration of the Bottom Ash Pond Complex is in the process of being removed.

Notes: General condition of Outboard slope of Northwest looking northeast. Note previous vegetation to the northwest removed as part of removing CCR material located between the north west dike and historical

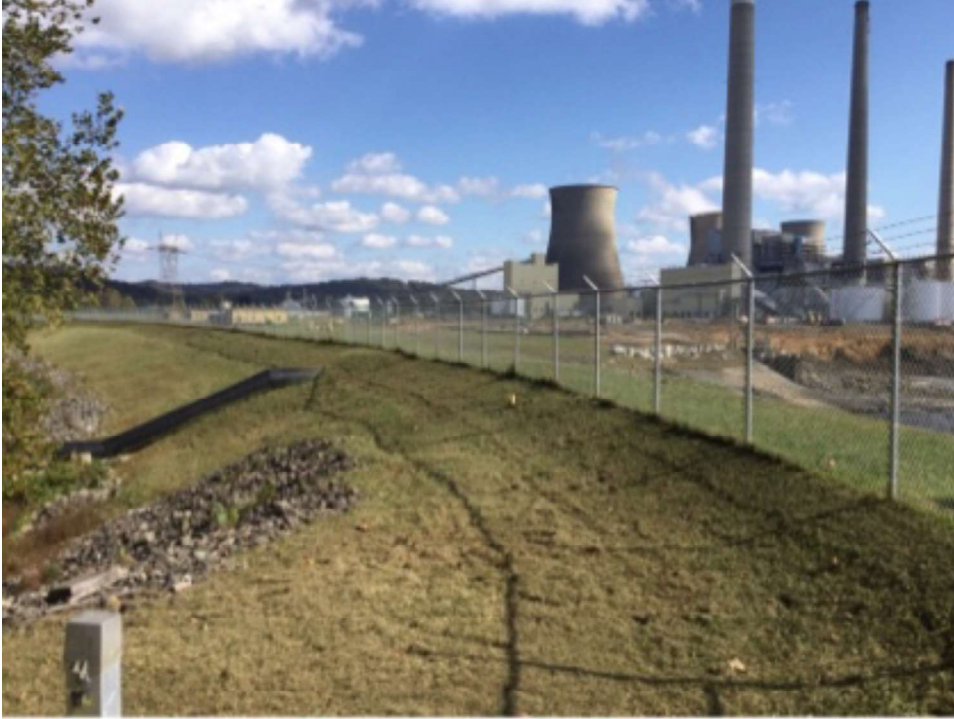
General condition of outboard slope of Main Dam looking east. The emergency outfall pipe from BAP 1B is visible in background.

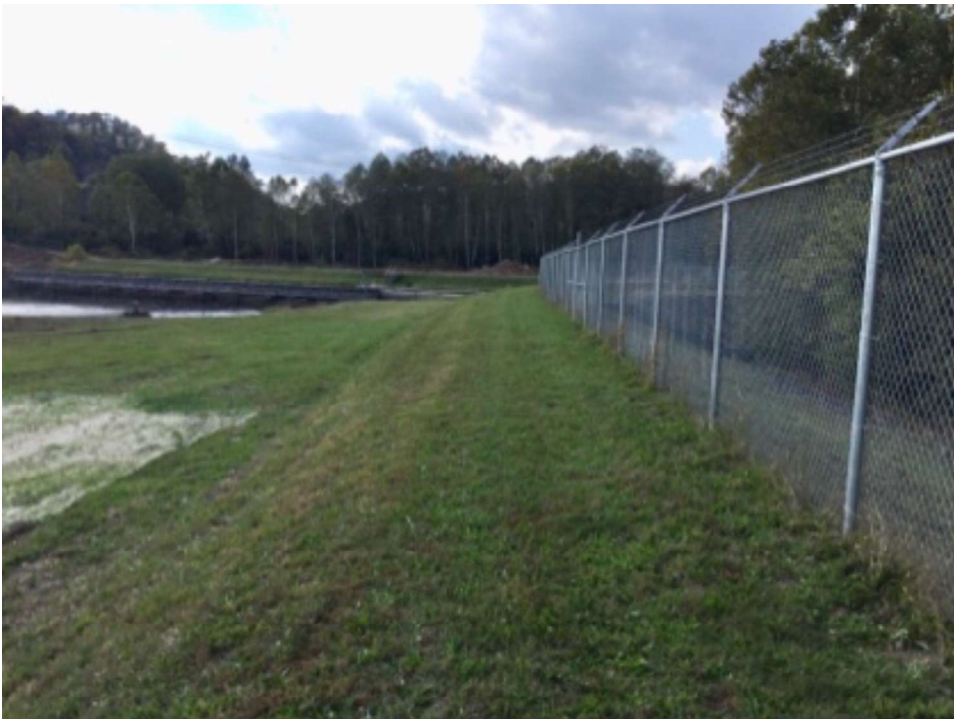
General condition of Main Dam crest in area of BAP 1B looking west

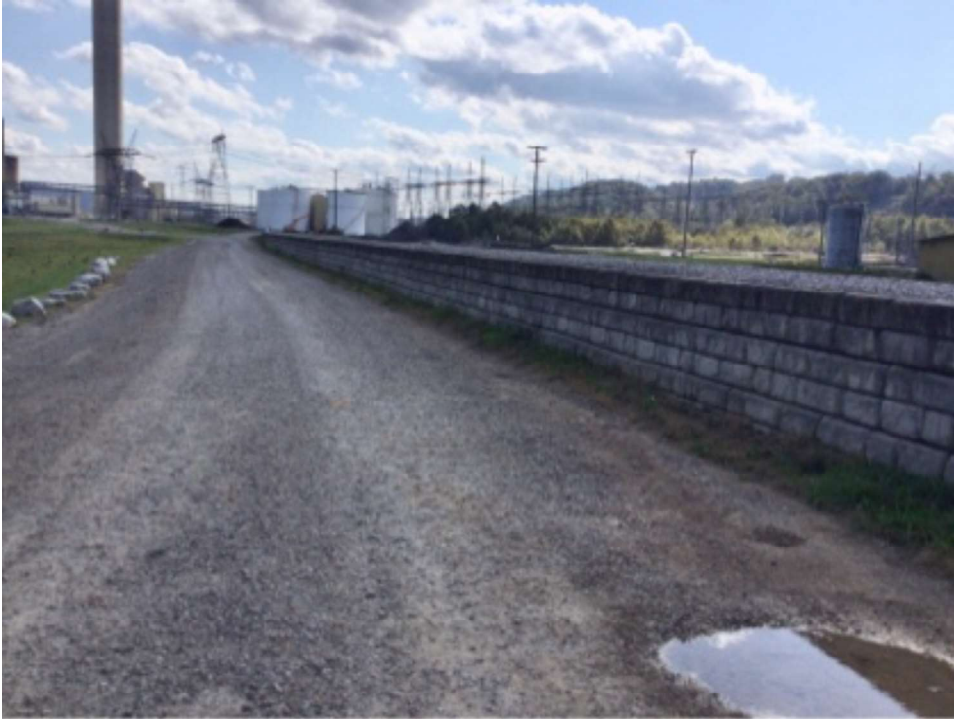
Notes: General condition of outboard side of stone wall along east side of Treatment (Clearwater) Pond.

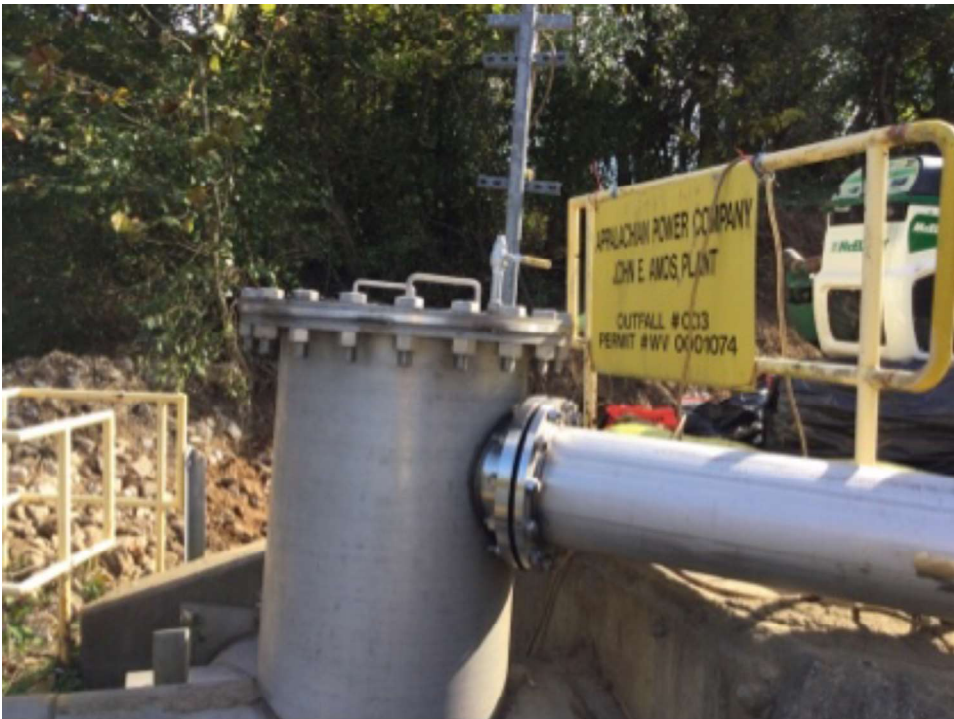
- The primary decant structure (outfall 003) was observed to be in excellent condition and no debris is entrained on trash rack that would impede discharge from the pond. No concrete spalling or other defects were observed at the upstream decant structure or the downstream headwall where the effluent discharges into the Kanawha River. Flow from the pond is discharged through the submerged diffuser ports.

Notes: General condition of 003 outfall at river bank before diffuser

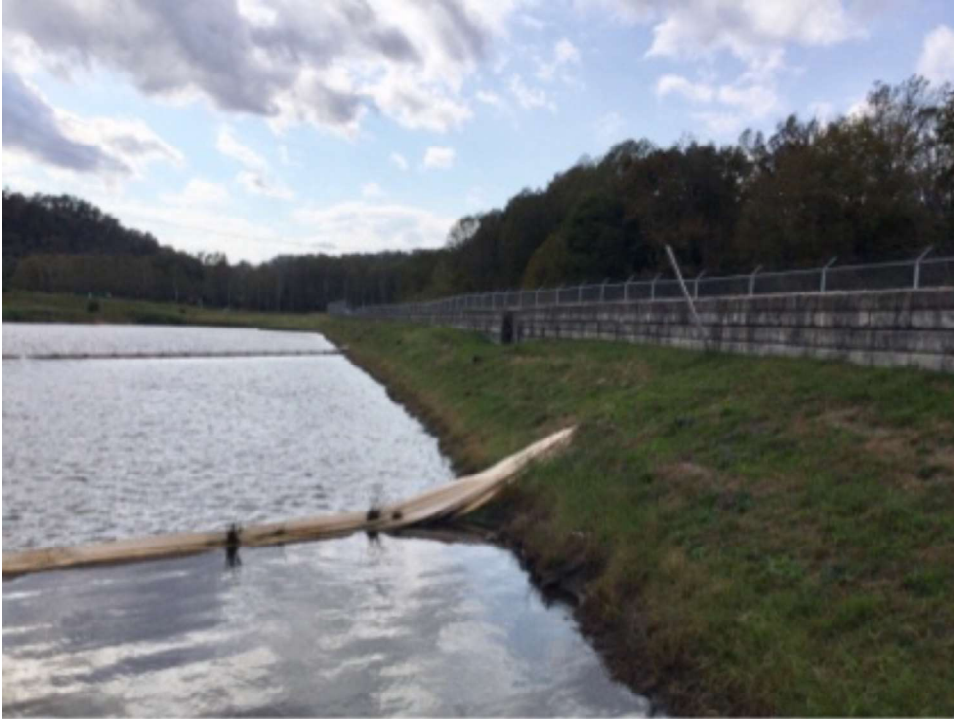
- The inboard slope of the Main Dam exhibited a good vegetative cover. There were no visual signs of misalignment, settlement, sloughing, erosion, or bulging that would indicate any instability within the dike. The primary decant skimmer structure was observed to be in an excellent condition.

Notes: General condition of inboard slope of Main Dam along Reclaim Pond

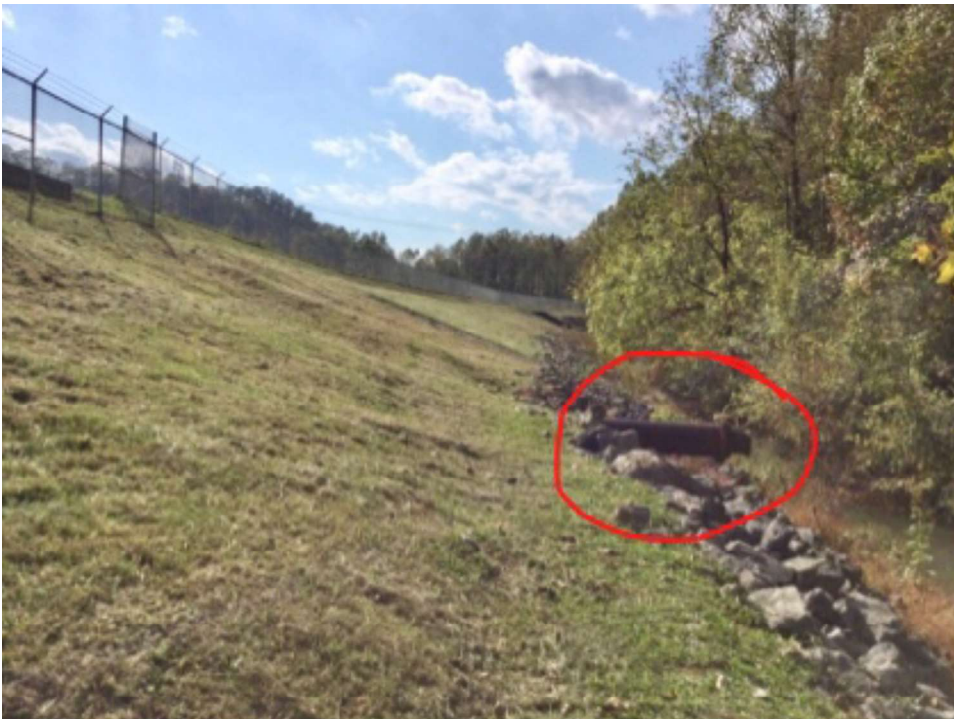
- No erosion or seepage was noted along the pipe that extends out from outboard slope of the Main Dam at the Reclaim pond. This pipe was permanently abandoned by welding a steel plate at the discharge end of the pipe.

Notes: General condition of outboard slope of Main Dam looking west. Note old discharge pipe near toe.

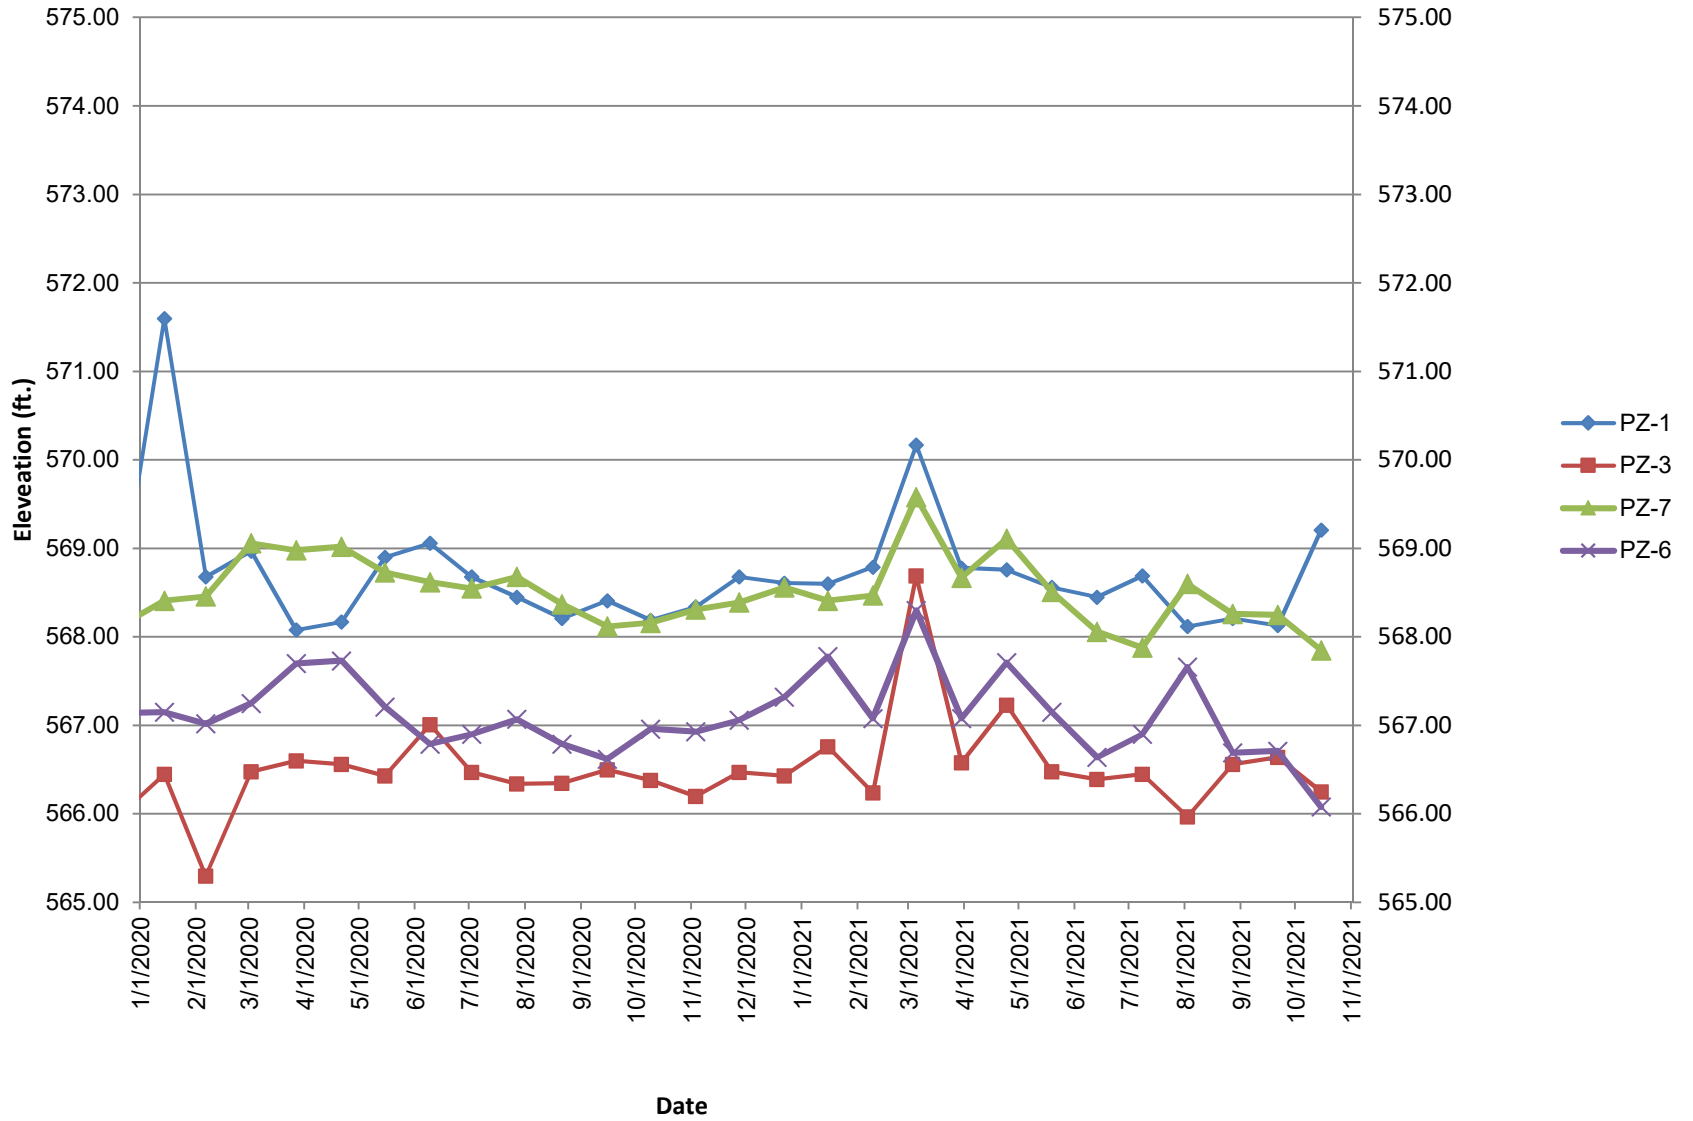
John E Amos Plant Piezometer Readings Bottom Ash Pond

The elevations of pond water levels and respective piezometer water levels have remained fairly constant with no adverse trends observed that would impair the structural stability of the perimeter dike. Piezometer hydrographs are contained in Attachment C.

1. Static water levels should continue to be measured on its current frequency for piezometers PZ-1, PZ-3, PZ-6 and PZ-7.
2. Monitor the Dam and dikes as during construction activities for movement or changes in conditions.
3. The pond pool stages should continue to be recorded on a periodic basis.
