2021 Annual Landfill Inspection Report

CCR Landfill

Flint Creek Plant

Document ID: GERS-21-014

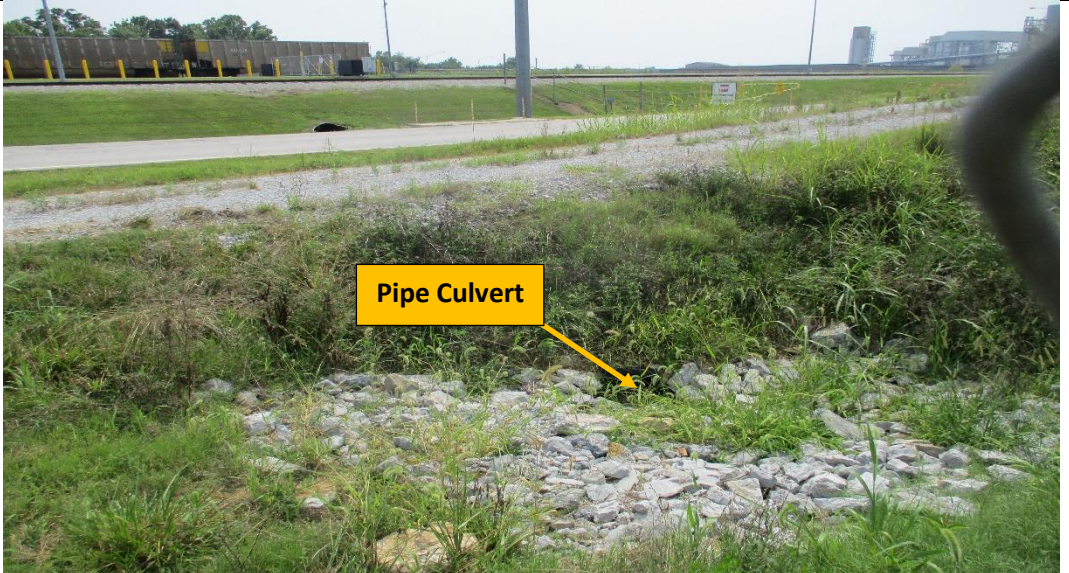
2. The drainage pipe culvert at the southwest corner (Photograph No. 4) appeared clear and was not obstructed. Slightly excessive vegetation was noticed around the pipe culvert.

| <p>PHOTO #4 The drainage ditch and a pipe culvert.</p> | <p>A photograph showing a drainage ditch filled with grey gravel. A yellow arrow points to a pipe culvert partially obscured by green grass. In the background, there is a paved road, utility poles, and industrial buildings under a clear sky.</p> |

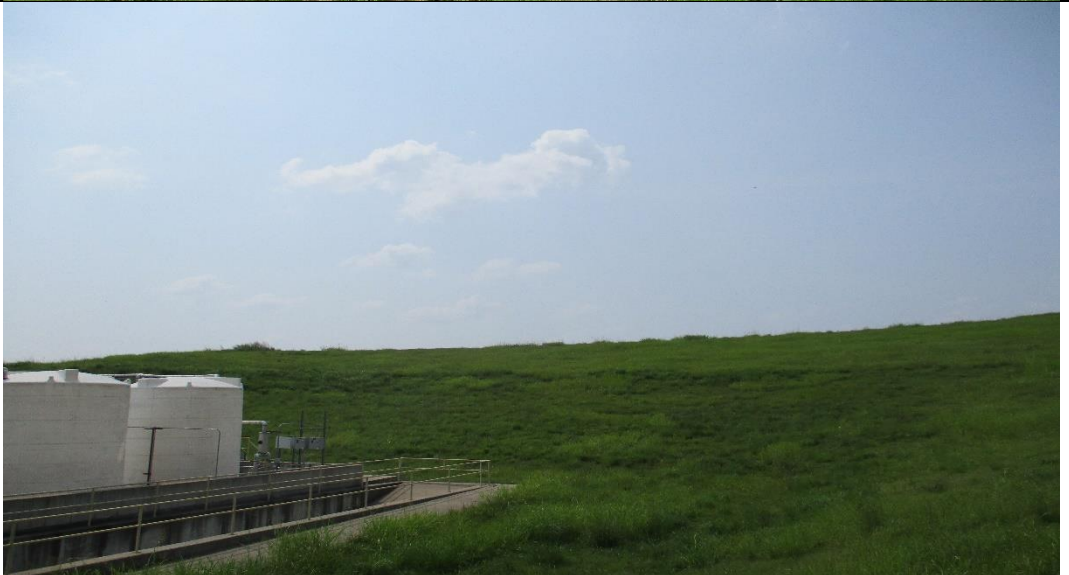
3. The southeast exterior slopes are fairly steep but appeared stable (Photograph No. 5). Typical condition of the eastern slope of closed landfill with clay cap is shown in Photograph No. 6. Overall, the slope was in good and stable condition. Slightly excessive vegetation growth and small bushes were present.

| <p>PHOTO #5 The southeast corner of the landfill outer slope.</p> | <p>A wide-angle photograph of a grassy landfill slope. In the lower-left foreground, there are two large, cylindrical concrete structures. The slope rises towards the right, and the sky is blue with scattered white clouds.</p> |

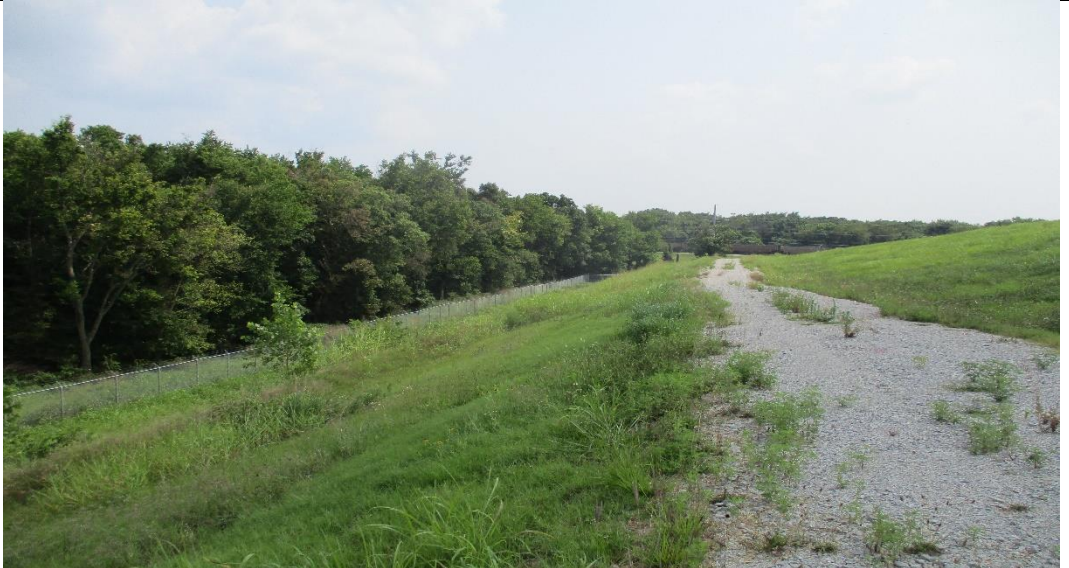
| <p>PHOTO #6 This photograph illustrates typical condition of the east slope.</p> | <p>A photograph showing a gravel-lined drainage ditch running along the edge of a grassy landfill slope. The slope is covered in green grass and some weeds. In the background, there is a dense line of green trees under a cloudy sky.</p> |

- 1) Excessive grass/vegetation should be mowed and this activity on regular basis at least 2-3 times during the year to facilitate inspections and keep woody vegetation to minimum.
- 2) As planned additional HDPE liner as a rainflap in the upper section of the slope at the leachate pond shall be installed. Geotextile fabric and the liner should be anchored at the crest of the dikes using the existing anchors bolts.
- 3) The exposed waste on the south side of the landfill shall be properly monitored and contained so that it does not spill over the berm. Any accumulation of the waste in the ditch should be immediately removed and placed in the landfill.

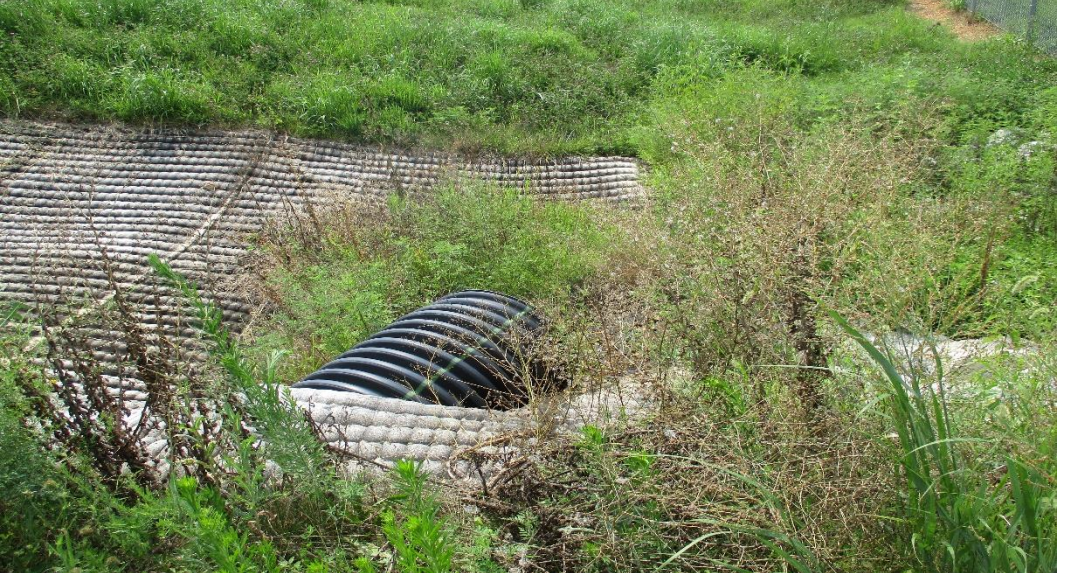
4. A fabriform drainage ditch and a pipe culvert is located at the northeast corner to the landfill (Photograph No. 7). The fabriform was in good condition and stable condition. Pipe culvert was free of obstruction and no standing water was noticed. Scattered excessive grown vegetation was found in this area.

| <p>PHOTO #7</p> <p>Fabriform line drainage ditch and pipe culvert.</p> | |

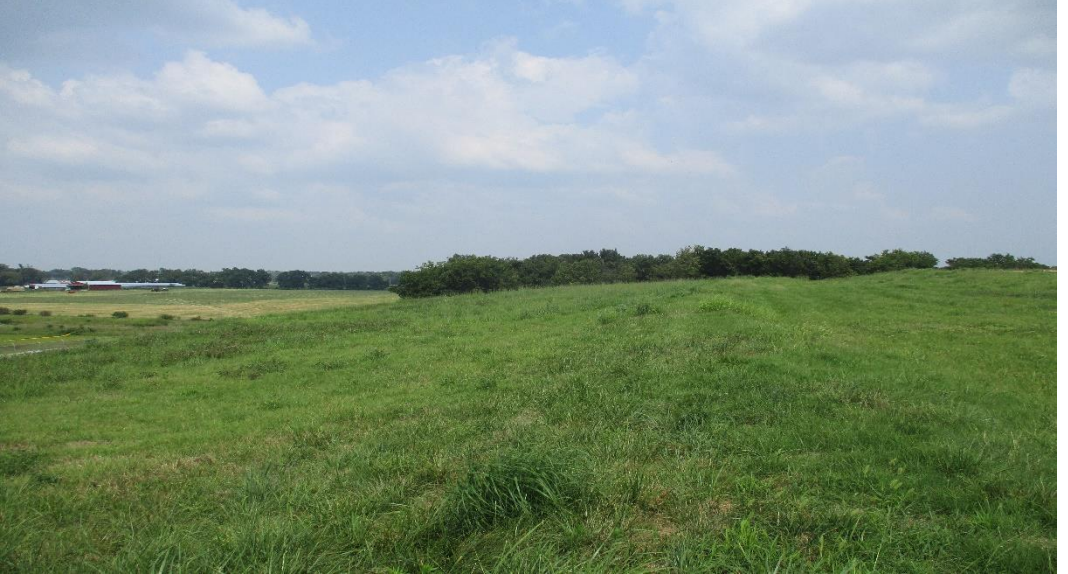
5. Typical condition of the north landfill slope that has final cover and certified is illustrated in Photograph No. 8. The condition of these slopes was good. There were no observed erosion gullies, sloughs, or other signs of movement of these areas. All areas had adequate vegetative cover. The vegetation is well established but the grass was slightly high. Fabriform letdown channel is located at the north slope (Photograph No. 9), appeared in good, stable, and functional condition.

| <p>PHOTO #8</p> <p>The north slope of the landfill.</p> | |

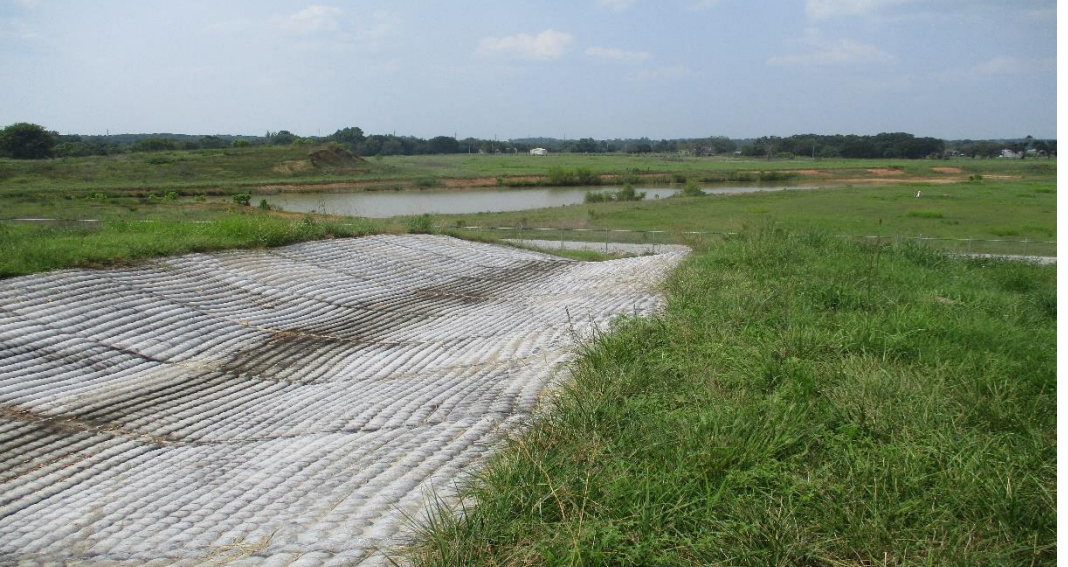
| <p>PHOTO #9</p> <p>Fabriform lined drainage channel.</p> | |

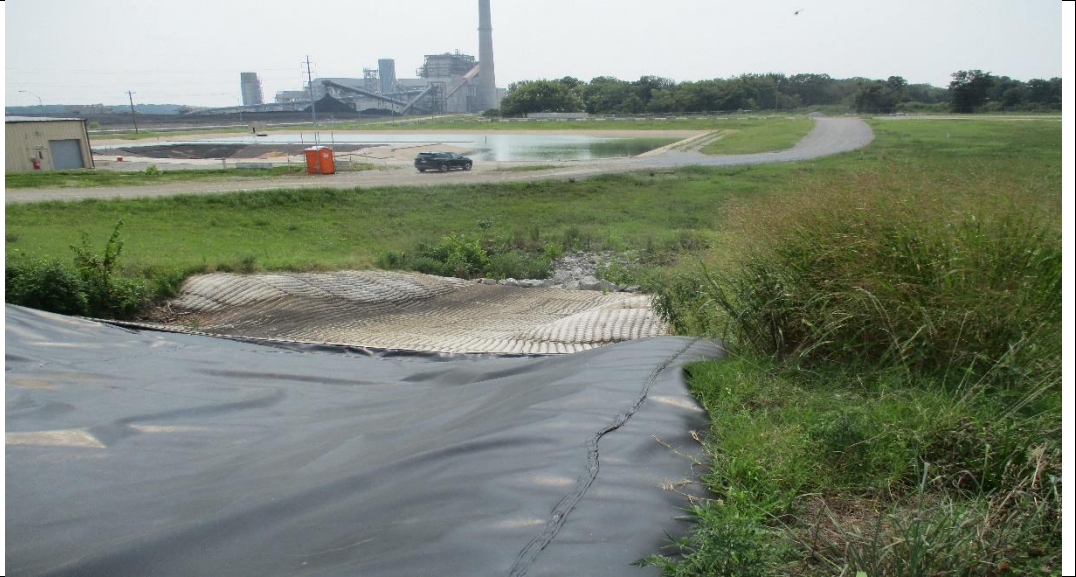
PHOTO #13

8. Photograph No, 13 illustrates stormwater ditch that conveys runoff from the landfill inactive area to the stormwater pond. The ditch partially lined by fabriform appeared in good functional condition as designed.

Drainage channel at the southwest corner of the intermediate liner area.

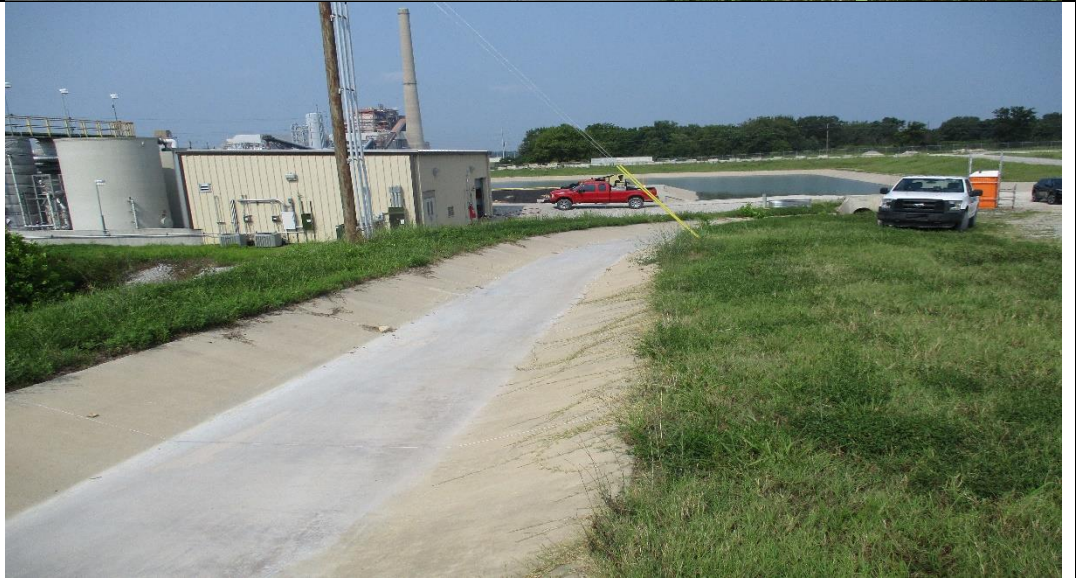
PHOTO #14

9. The north perimeter contact water ditch is illustrated in Photograph Nos. 14 and 15. The ditch was in good condition. Water was flowing through the pipe culvert to the contact water pond. The ditch is in good and stable condition, positive flow, and without any obstruction.

Contact water north concrete drainage ditch.

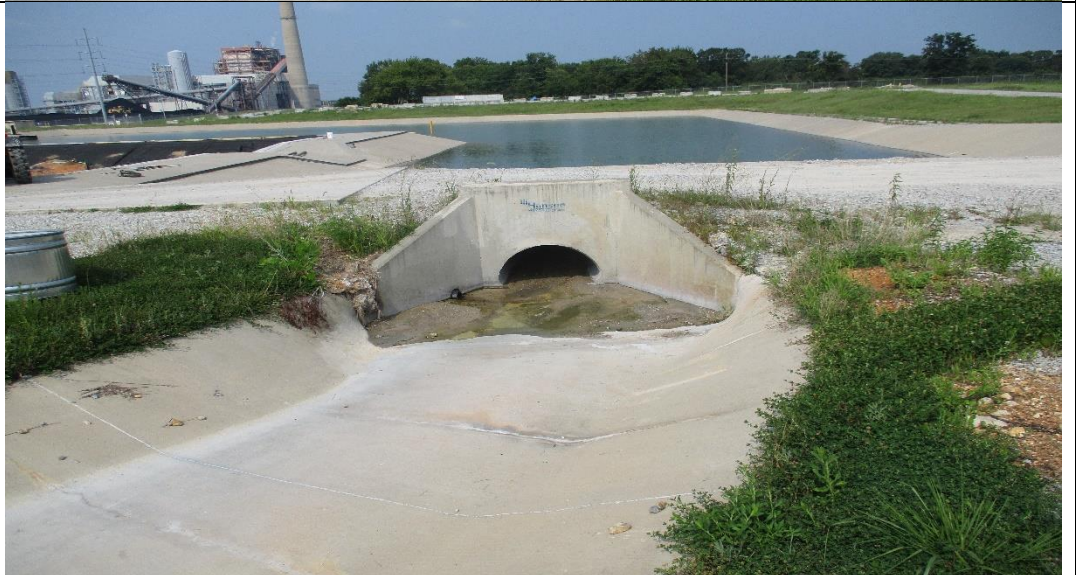
PHOTO #15

Drainage ditch pipe culvert to the contact water pond.

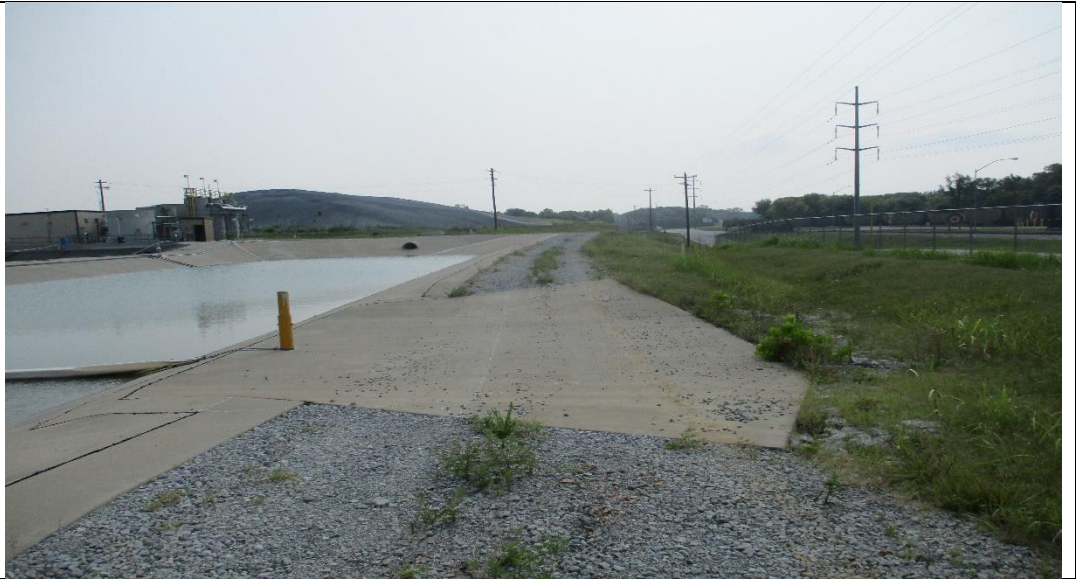
PHOTO #19

11. Photograph No. 18 illustrates overflow discharge pipe structure located in the southwest of the contact water pond. The structure appeared functioning as designed. Photograph No. 19 shows the emergency spillway located at the south dike. The emergency spillway was in good condition and appeared free from any obstruction to flow. Overall view of the contact water pond is illustrated in Photograph No. 20. The contact water pond dikes appeared in good and stable condition with good concrete cover. The pond appeared functioning as designed.

Emergency spillway
at the contact water
pond.

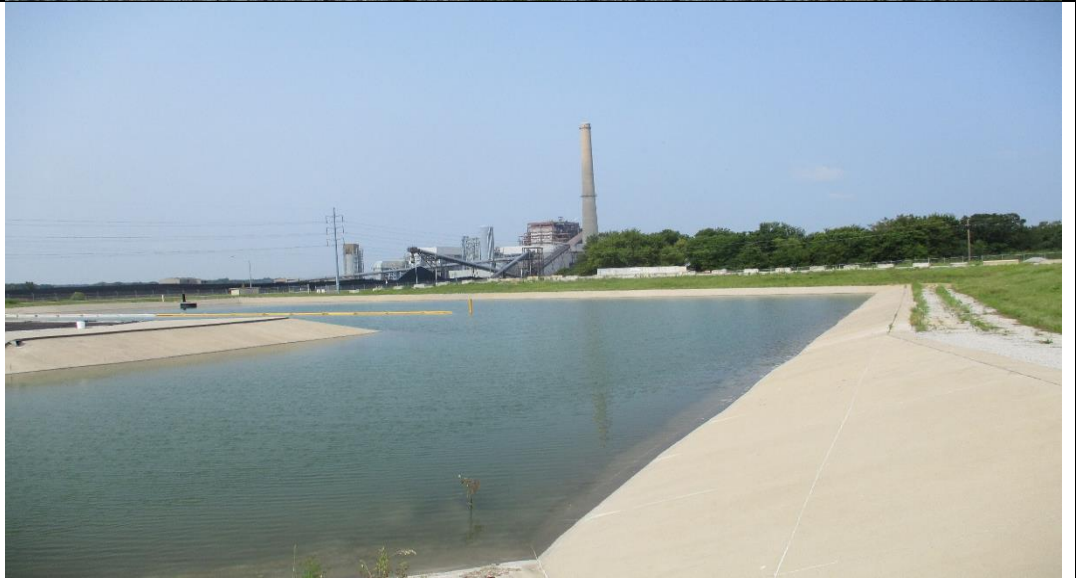
PHOTO #20

Overall view of the
contact water pond.

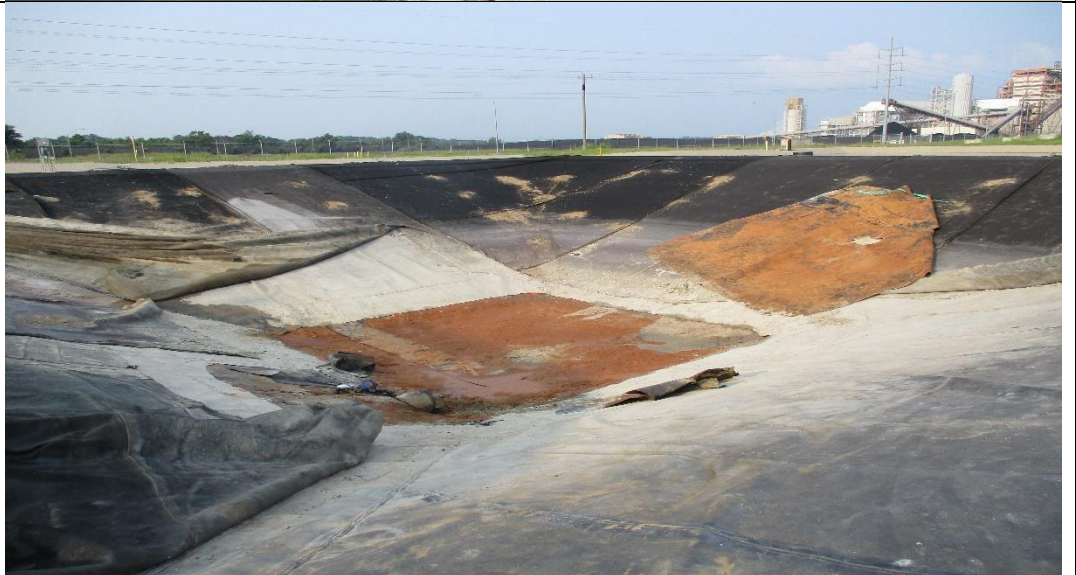
PHOTO #21

12. Leachate pond is shown in Photograph No. 21. Repair was performed at the leachate pond to remove trapped water under the bottom liner. Photograph No. 21 illustrates the geotextile fabric pulled aside and the bottom HDPE liner is cut out and the bottom clay liner is exposed. Photograph No. 22 shows repair work in progress around the leachate pipe. Photograph No. 23 illustrates completion of repair work and the geotextile fabric reinstalled on the top.

There was, however, a noted deficiency pertaining to the leachate pond discovered in January 2021. Water was present between the clay liner and HDPE liner in the bottom area of the leachate pond. The deficiency was addressed in August 2021 by repairing, removing, and replacing engineering components (clay liner, HDPE liner, geotextile, and leachate pipe boots) of the leachate pond in accordance with the permit design drawings and QAQC Plan.

Leachate pond
bottom liner
removed for repair.

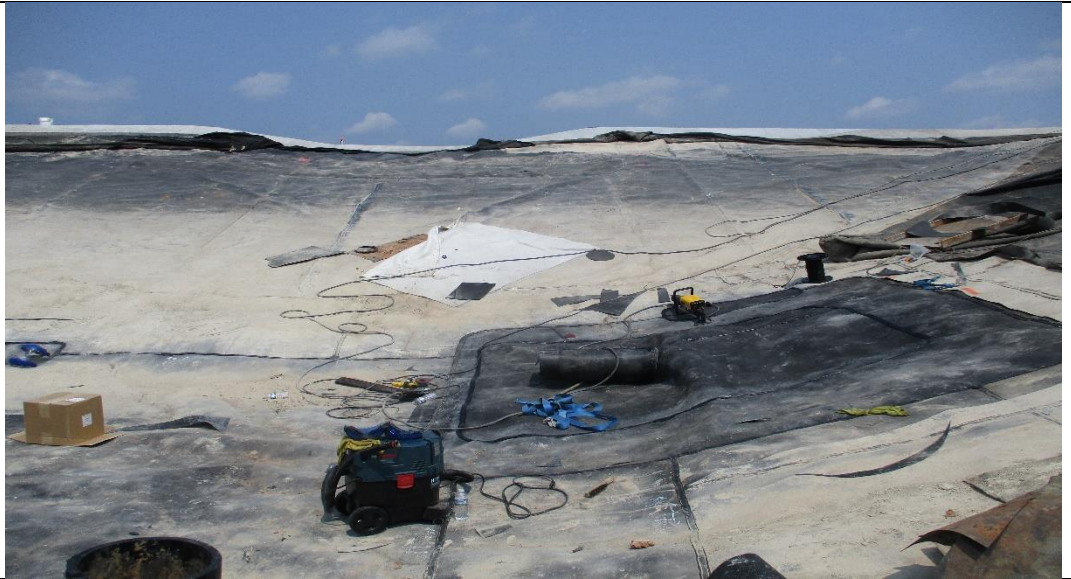
PHOTO #22

Leachate pond repair activities in progress.

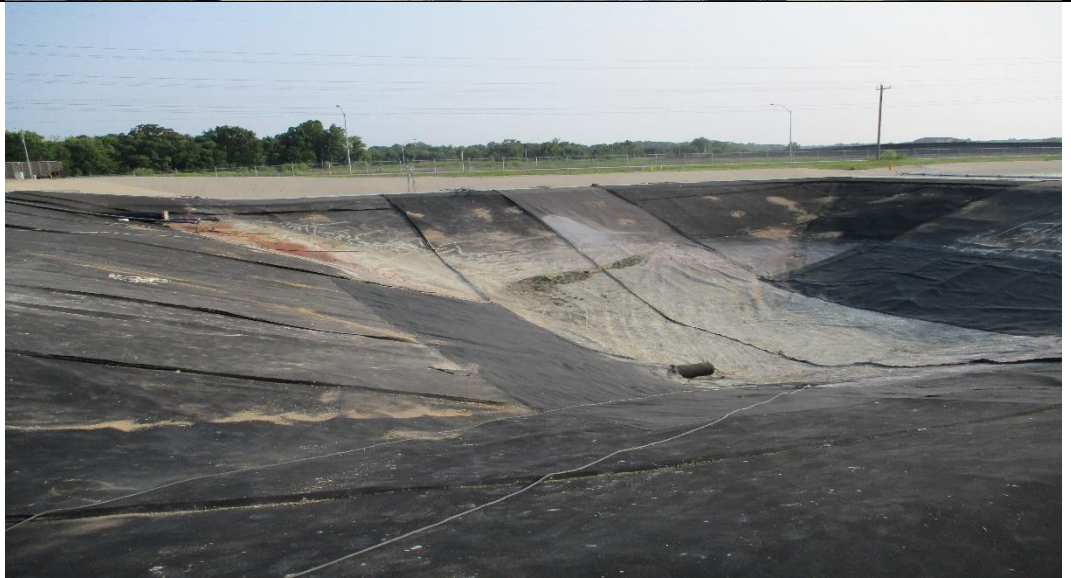
PHOTO #23

Leachate pond repair activities complete.

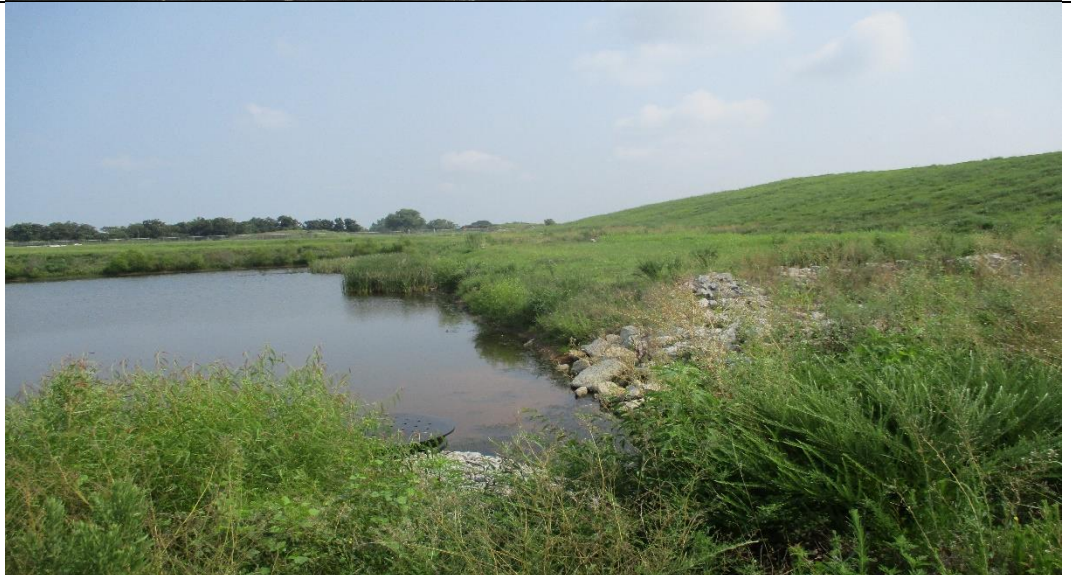
PHOTO #24

13. Photograph Nos. 24 and 25 shows the stormwater pond that is located to the northwest of the landfill. Incised slopes of the pond were stable but excessive vegetation was noticed. The overflow discharge pipe structure (Photograph No. 26) appeared to be in good and functional condition.

Stormwater pond (looking east slope).
