2021 ANNUAL DAM AND DIKE INSPECTION REPORT

CCR ASH PONDS

WELSH POWER PLANT
CASON, TEXAS

December, 2021

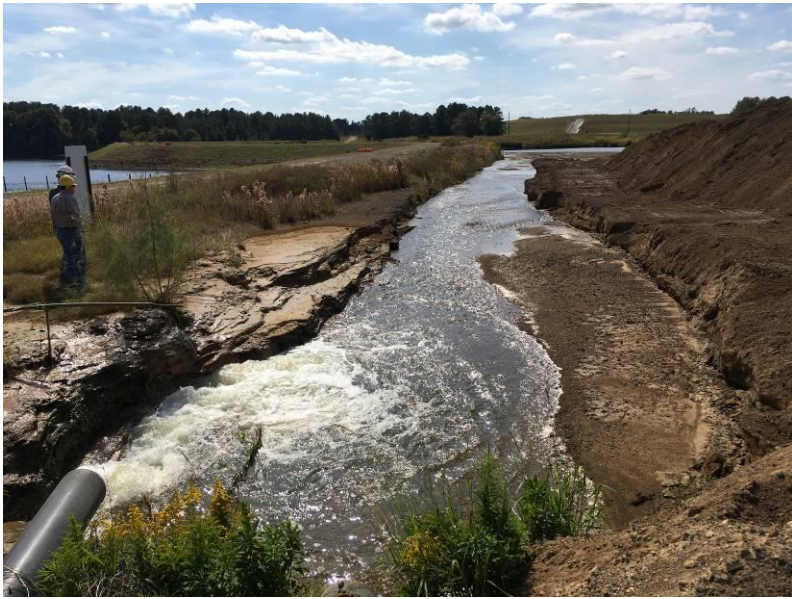
Photo # 1

- (i) Typical condition of the upstream slope, crest, and downstream slope is illustrated in Photographs No. 1-4. The dike appeared in satisfactory and stable condition. There were no signs of settlement, misalignment, sloughing or erosion. Slightly overgrown vegetation was noticed along the upstream slope and on the downstream slope near the rock rip rap. There was some minor damage of the downstream slope near the crest from mowing activities (Photograph No. 3)

Typical view of Primary Bottom Ash Pond upstream slope and interior conditions.

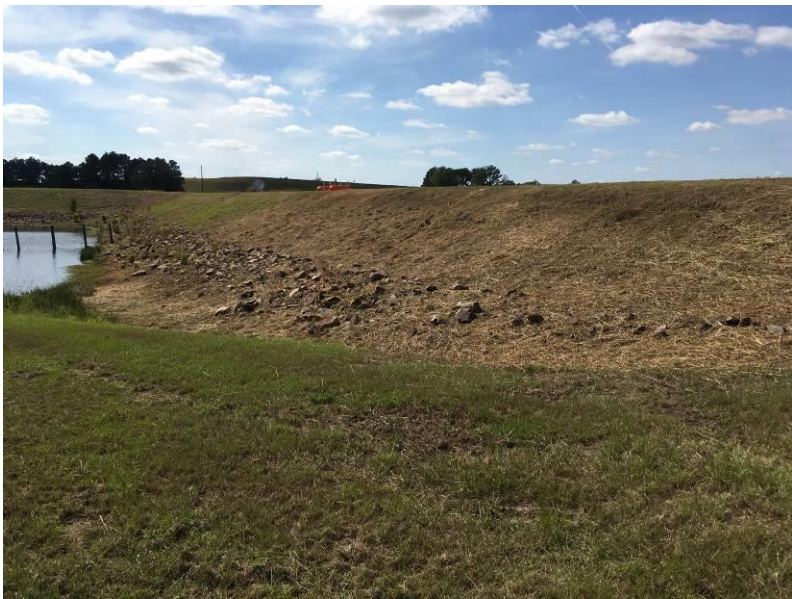
Photo # 2

Typical view of Primary Bottom Ash Pond downstream slope.

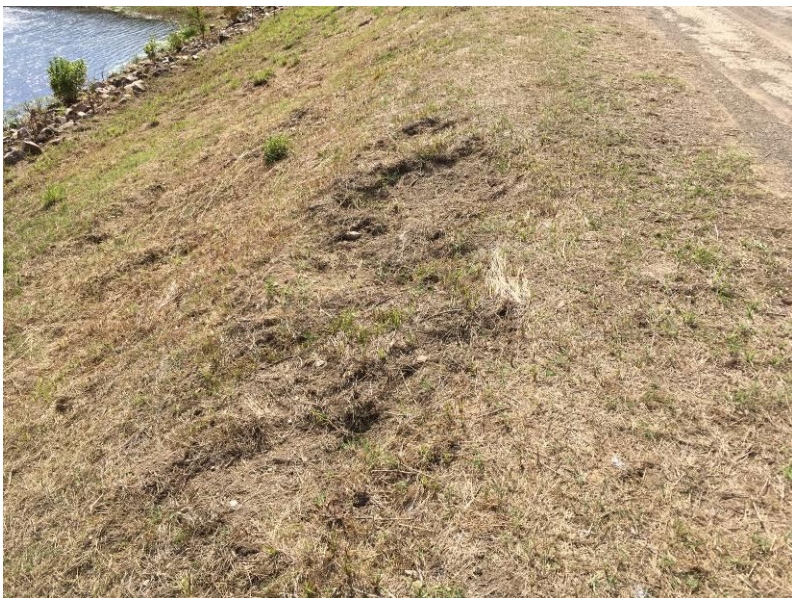
Photo # 3

View of disturbed areas from mowing activities on downstream slope near the crest.

- As noted all the excessive vegetation should be cut down and maintained consistently in order to control and properly manage it.
- The damaged slope area from mowing activities on the downstream slope of the primary ash storage pond should be repaired and seeded.
- The sediment buildup in the principal spillway basin area of the bottom ash storage pond should be cleaned out to promote un-obstructive flows through the basin area to the outlet pipe.

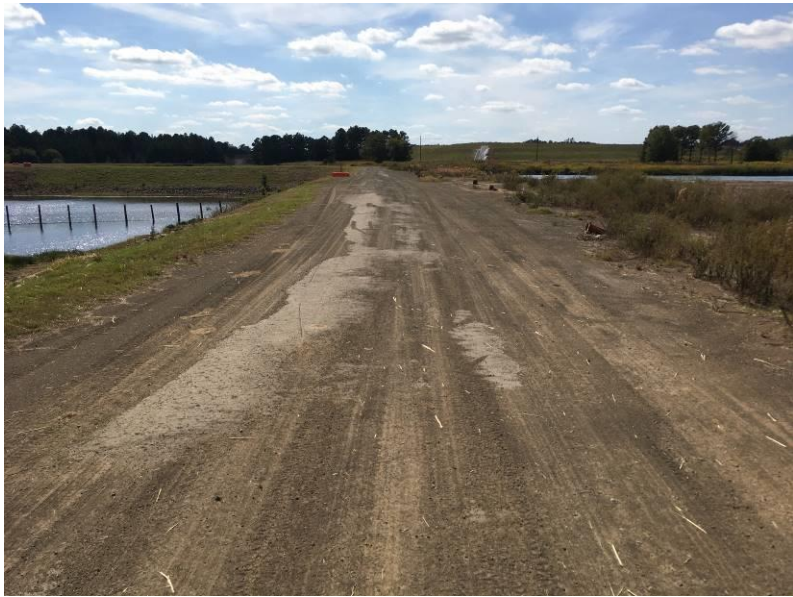
Photo # 4

Typical crest area of Primary Bottom Ash Pond.

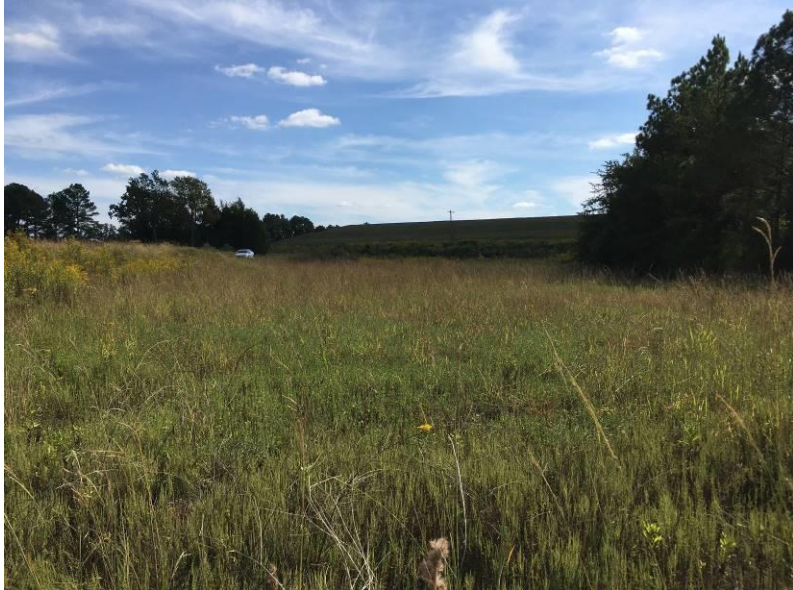
Photo # 5

- (iii) Photograph No. 5 illustrates the emergency spillway located towards the southeast section of the south dike. The emergency spillway appeared to be functioning as needed but was covered with overgrown vegetation preventing a full inspection of the area.

Emergency spillway channel of Primary Bottom Ash Pond.

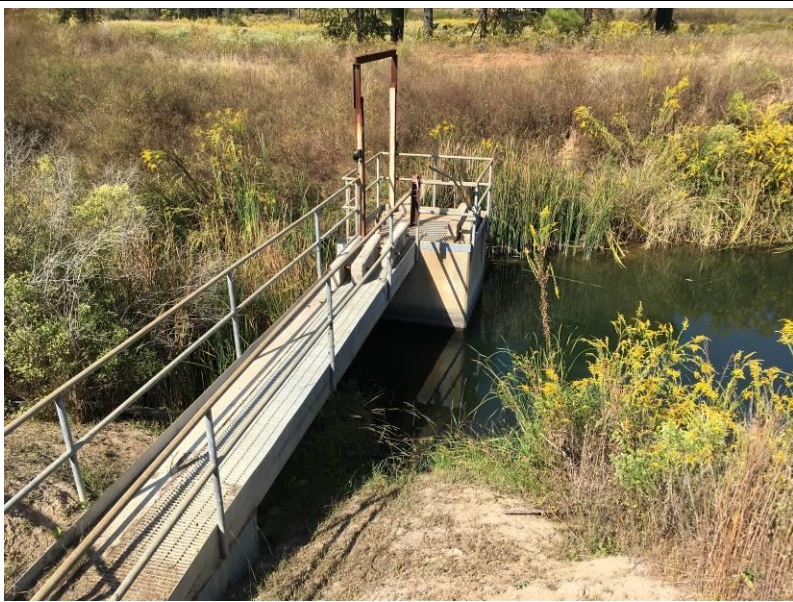
Photo # 6

- (iv) A canal is located at the south end of the pond. A typical view of the discharge canal concrete weir box is illustrated in Photograph No. 6. The canal conveys water from southwest corner of the ash pond to the Clearwater pond located at the west southeast end. The canal indicated positive drainage condition. Excessive vegetation was noticed along the banks of the canal.

View of the Primary Bottom Ash Pond discharge canal concrete weir box.

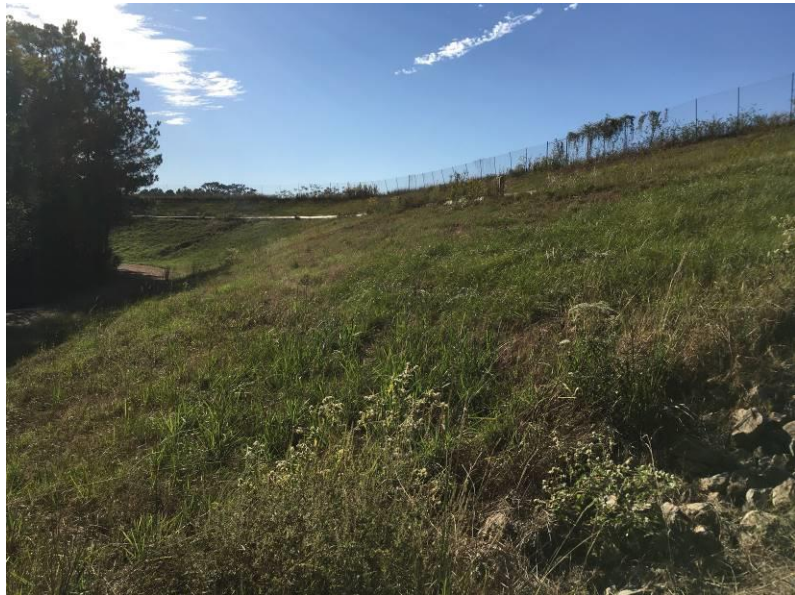
Photo # 7

- (i) The east portion of the downstream slope is illustrated in Photographs No. 7 and 8. Slightly overgrown vegetation was noticed on these slopes. The slope appeared in satisfactory and stable condition with no signs of settlement, misalignment, sloughing or erosion.

Bottom Ash Storage Pond (Winston Pond) looking at downstream slope conditions on east side.

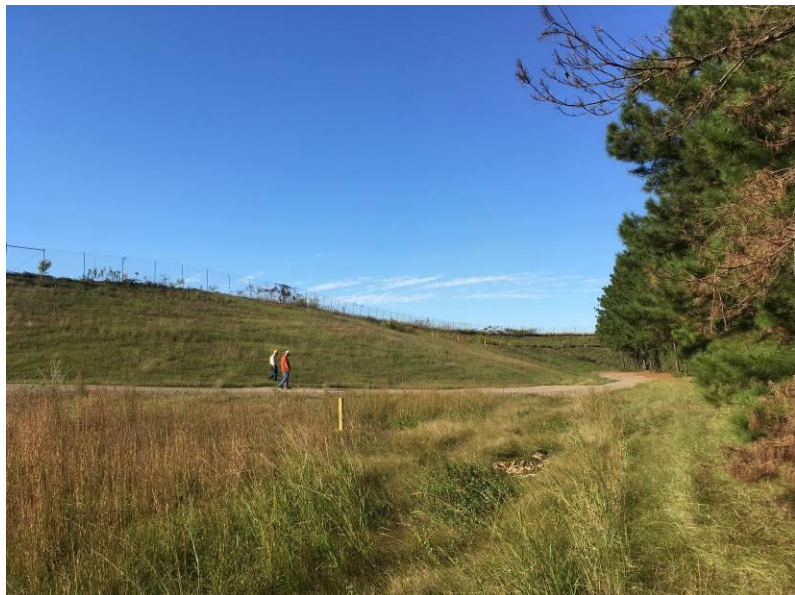
Photo # 8

Bottom Ash Storage Pond (Winston Pond) looking at downstream slope conditions on southeast side.

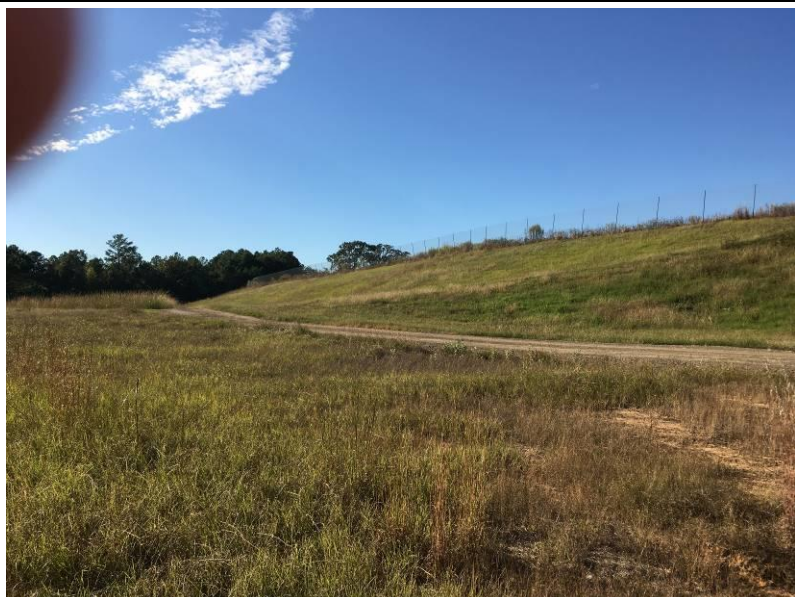
Photo # 9

- (ii) Photographs No. 9 and 10 illustrate the south downstream slope areas. The slopes appeared in satisfactory and stable condition with some minor overgrown vegetation. There were no signs of settlement, misalignment, sloughing or erosion.

Bottom Ash Storage Pond (Winston Pond) Looking at downstream slope conditions on south side.

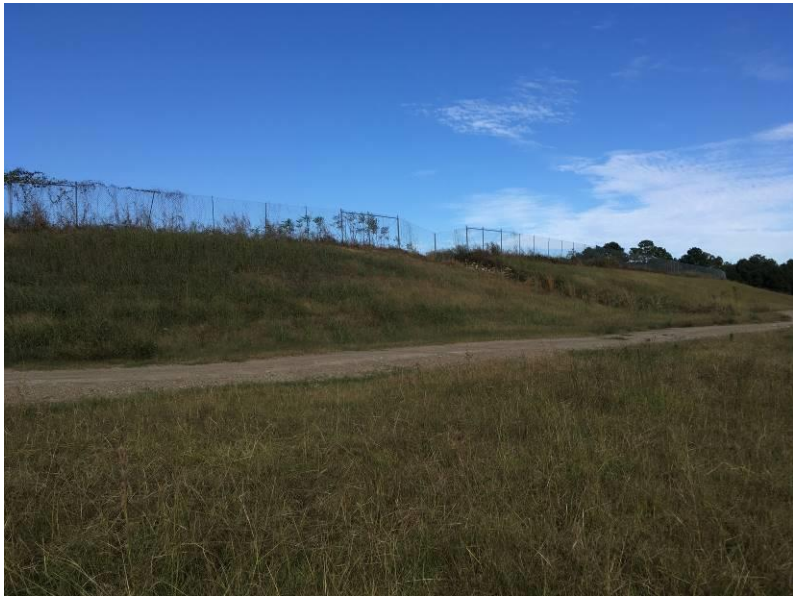
Photo # 10

Bottom Ash Storage Pond (Winston Pond) Looking at downstream slope conditions on southwest side.

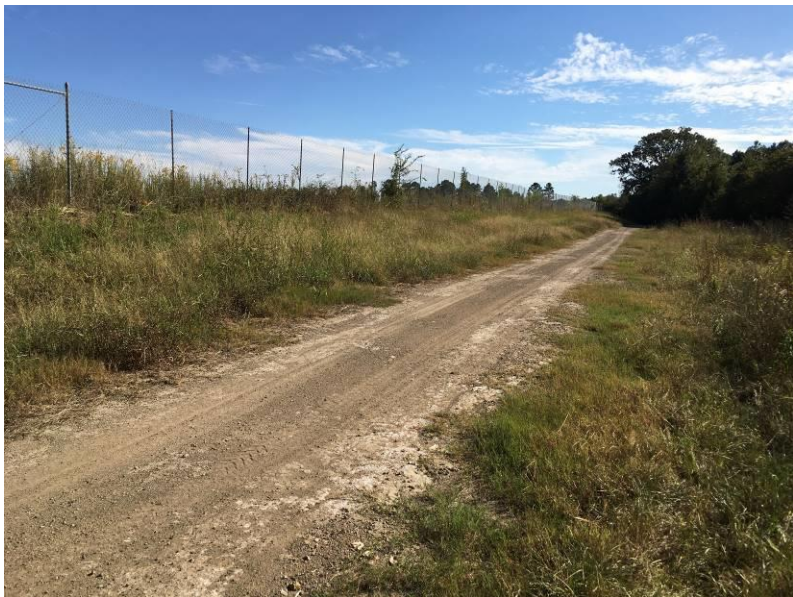
Photo # 11

- (iii) The northwest section of the west dike downstream slope is illustrated in Photograph No. 11. The slope appeared in satisfactory and stable condition with overgrown vegetation preventing a full inspection of the slopes. There were no signs of settlement, misalignment, sloughing or erosion.

Bottom Ash Storage Pond (Winston Pond) looking at downstream slope conditions on west side.

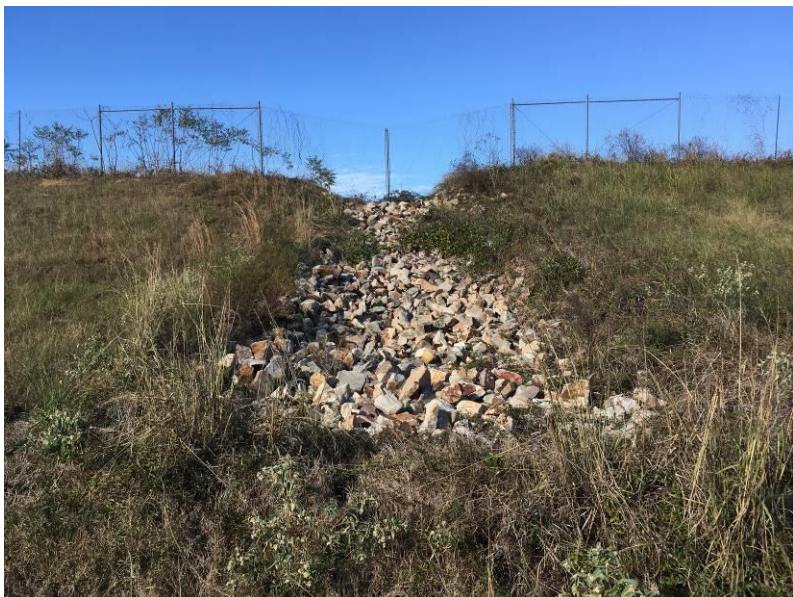
Photo # 12

- (iv) Photograph No. 12 illustrates the emergency spillway location at the southwest section of the south dike. The spillway riprap was in satisfactory condition with some vegetation near the edges of the rock rip rap.

Bottom Ash Storage Pond (Winston Pond) downstream slope looking at emergency spillway channel.

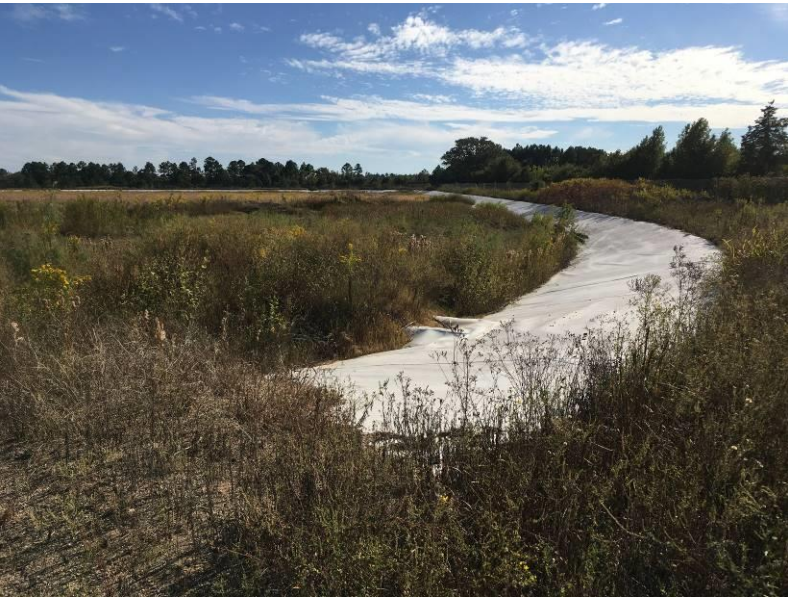
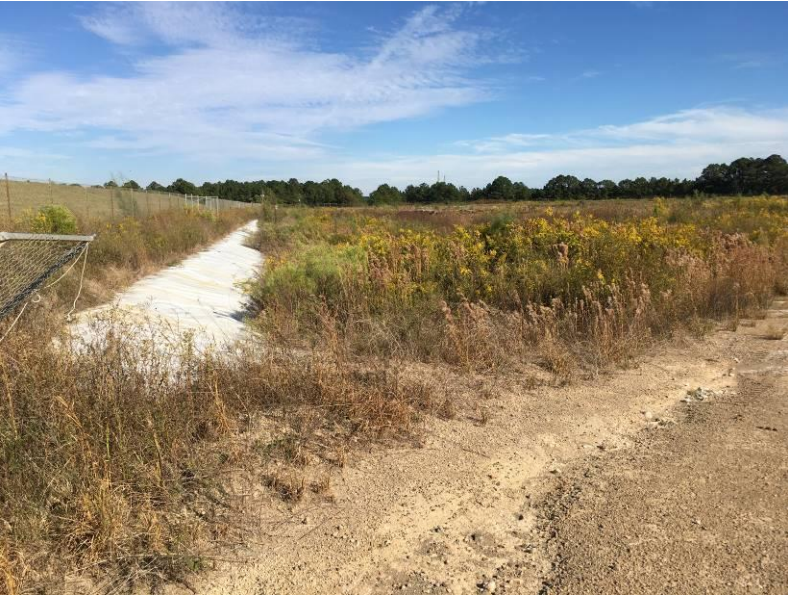
- (v) Photographs No. 13 and 14 illustrate the interior conditions, upstream slope and crest areas of the pond. The upstream slope appeared to be in good and stable condition and mostly buttress with ash. The geosynthetic liner appeared intact and in good condition. The crest appeared in good and stable condition. Overgrown vegetation was noticed throughout the interior of the pond and on the crest area.

Bottom Ash Storage Pond (Winston Pond) looking at typical interior conditions.

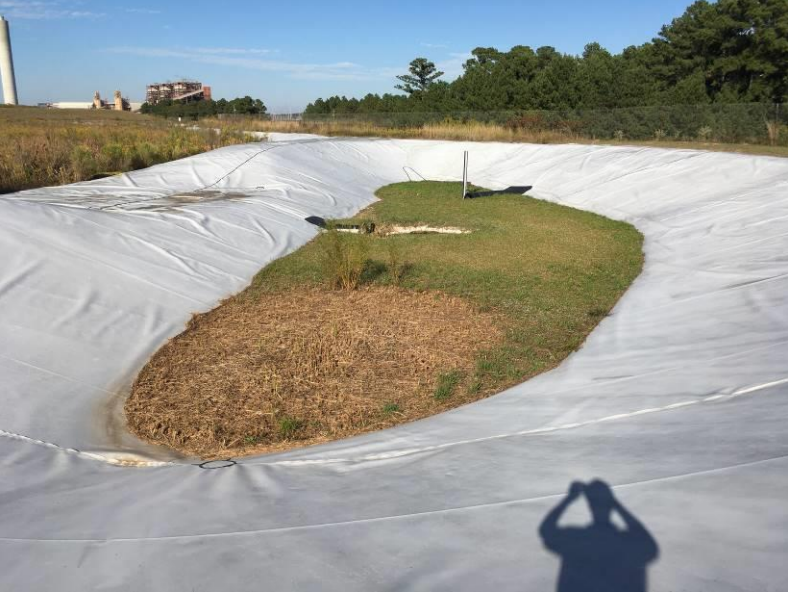
Photo # 15

- (vi) A small area within the pond is used as a control weir with a principal spillway inlet and outlet pipe located in southeast corner (Photograph No. 15). The principal spillway basin

was dry at the time of inspection with no flow through the inlet or outlet pipes. The basin is silted up with ash sediment to the flow line of the inlet and outlet pipes and could possibly restrict flows when passing water from the main pond through the basin to the outlet pipe.

Bottom Ash Storage Pond (Winston Pond) interior area looking at principal spillway outlet pipe and control weir at southeast corner.

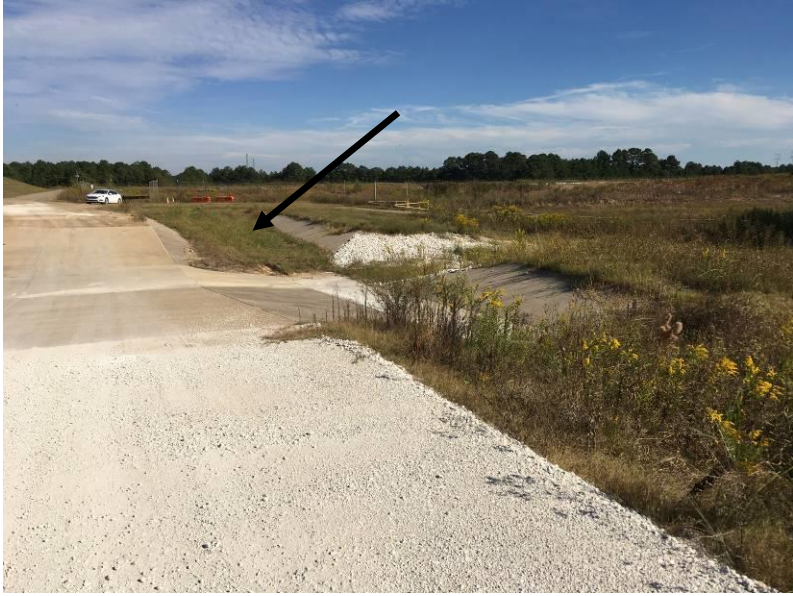
<p>Photo # 16</p>

- (vii) There are two pipe culverts located at the northwest corner of the pond that used to convey storm water from the landfill and surrounding areas into the pond. The storm water runoff channel and inlet pipes have been plugged to prevent storm water runoff from entering the pond (Photograph No. 16).

<p>Bottom Ash Storage Pond (Winston Pond) storm water runoff channel and inlet pipes have been plugged to prevent storm water runoff from entering the pond.</p>	
<p>Photo # 17</p>	
<p>Photo # 18</p>

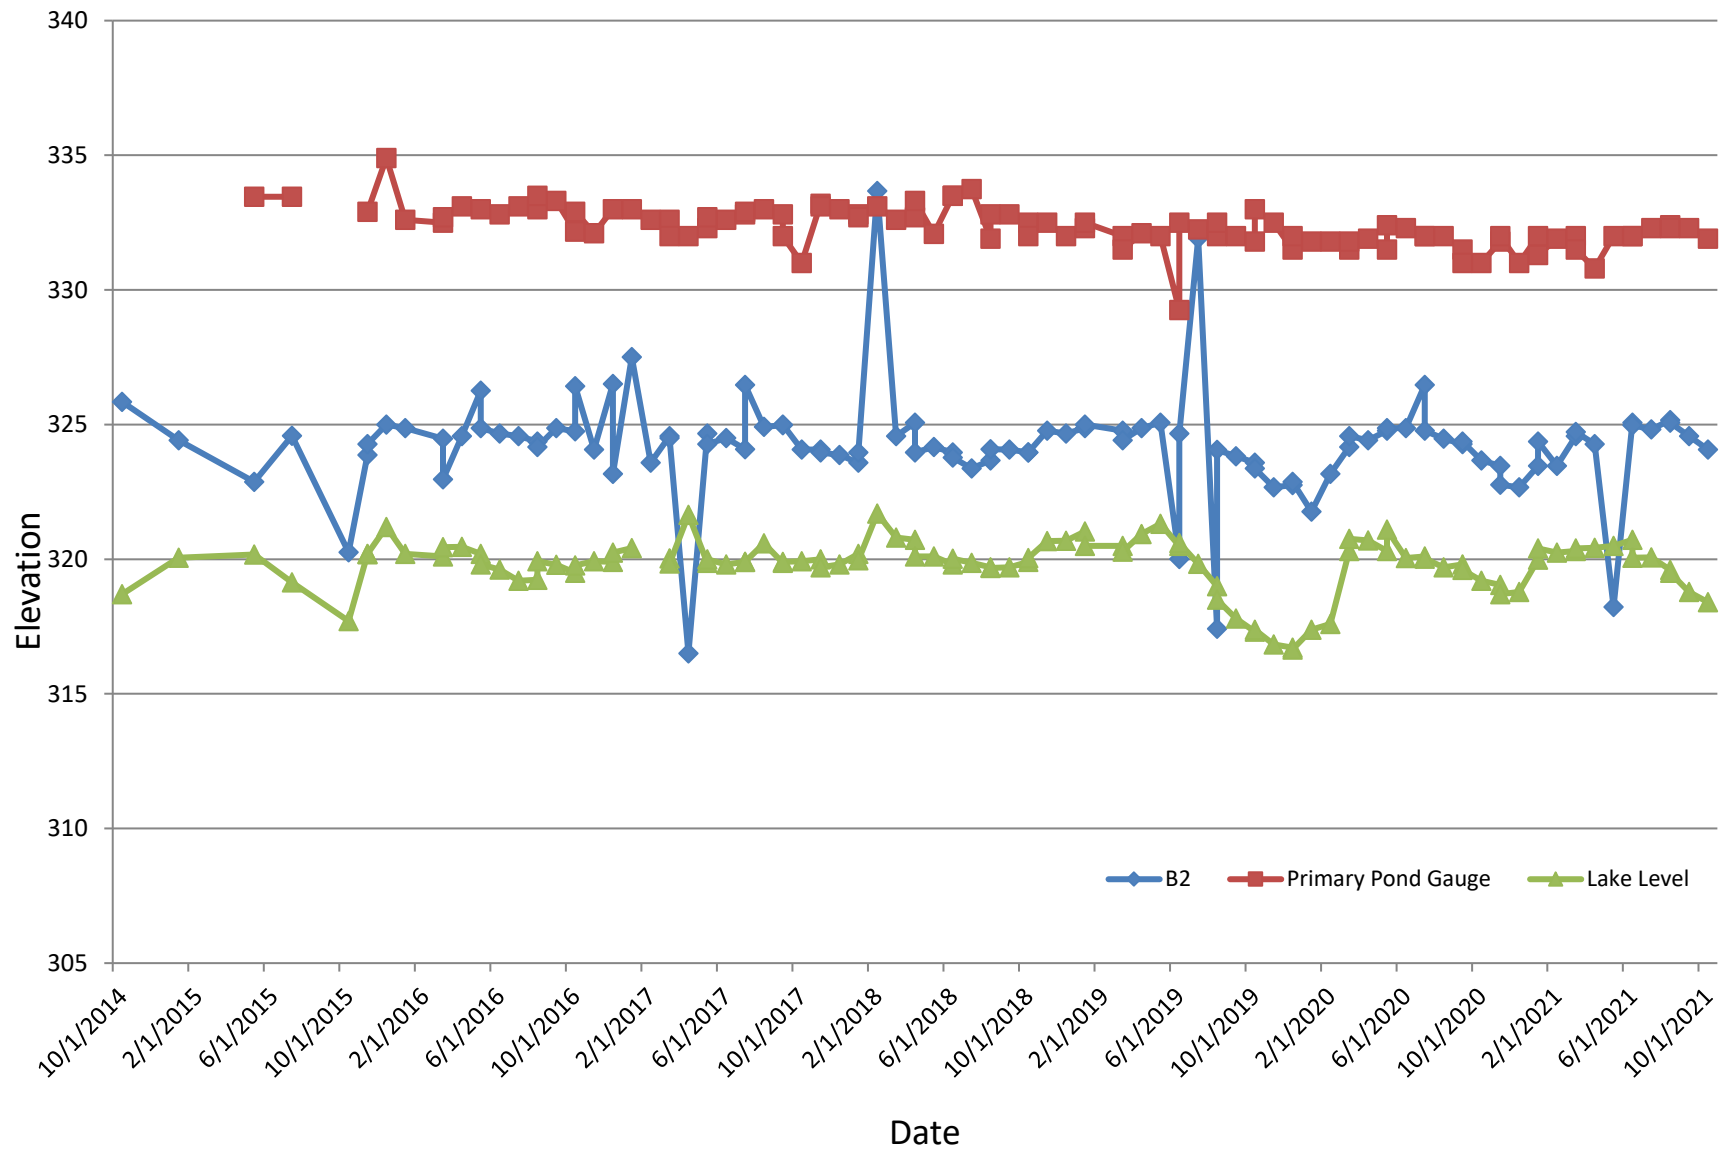
Figure 4B - Primary Pond Piezometer Readings

The monitoring instrumentation for the Primary Bottom Ash Pond consists of the one (1) active piezometer (B-2) located through the main embankment area. There is no monitoring instrumentation for the Bottom Ash Storage Pond (Winston Pond). The location of the instrumentation is shown in Attachment D, Figure 4A. The maximum and minimum readings of Piezometer B-2 since the last annual inspection, a time period of October 2020 to October 2021, were 325.07 ft msl and 318.22 ft msl, respectively. Piezometer B-2 levels appeared consistent from month to month, and reacted to the fluctuation in tail water levels (i.e. main lake). There was a recent dip in one of the monthly readings which is most likely due to an error. The results of the measurements of the piezometer is shown in Appendix D, Figure 4B.
