2022 Annual Landfill Inspection Report

Mitchell Plant

Wheeling Power Company

Document Number: GERS-22-027

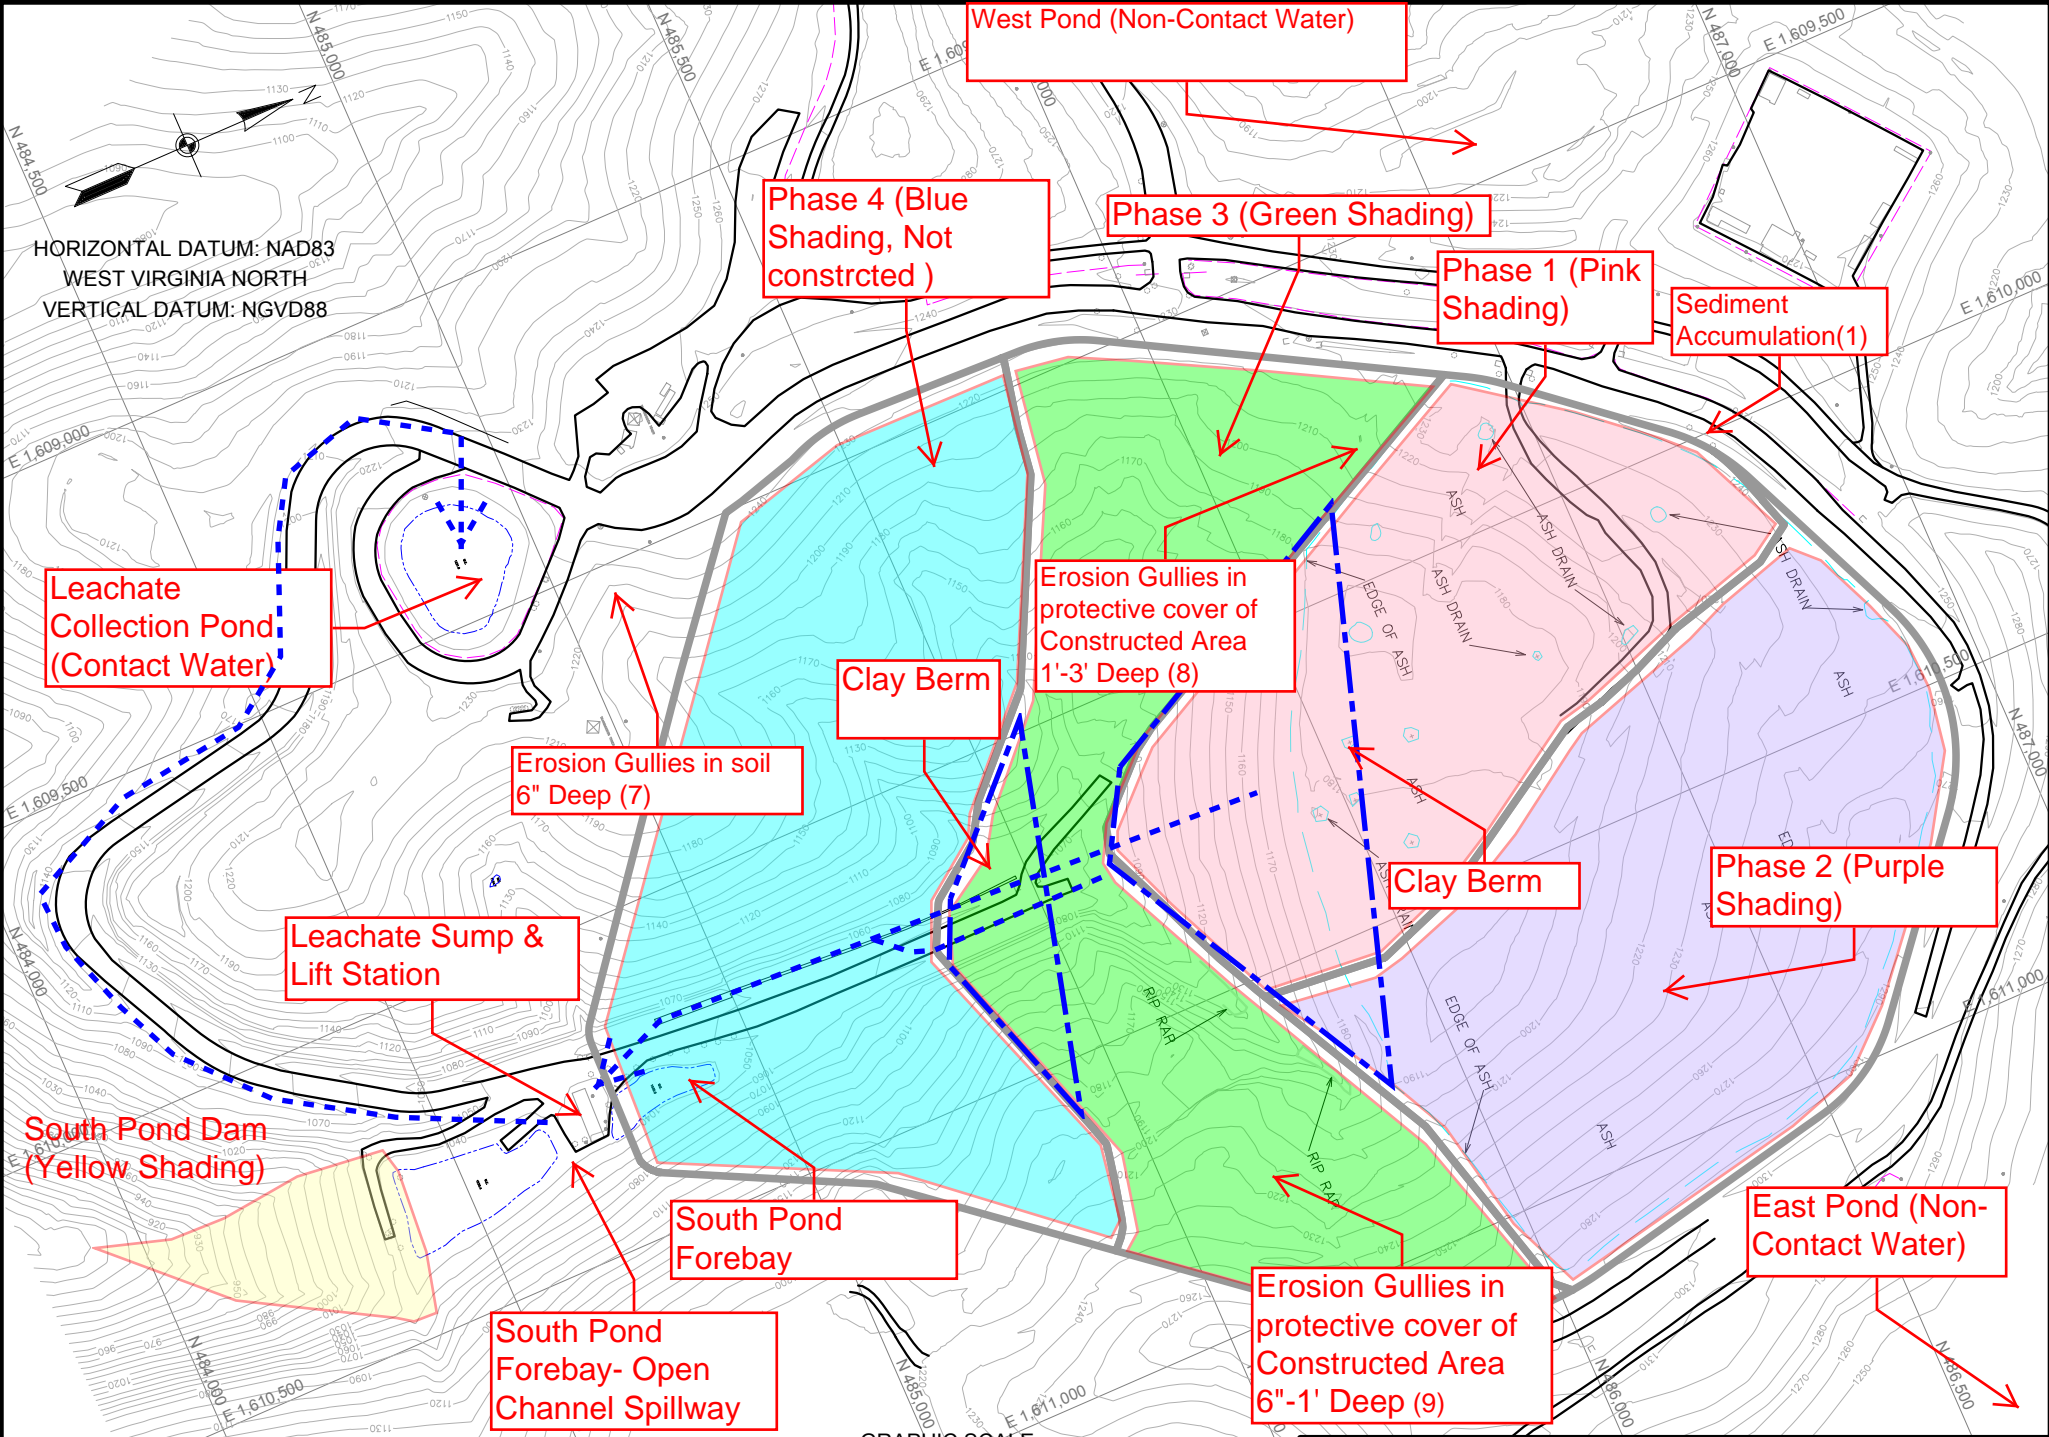
DRN BY: .	Landfill Inspection Location Map		
DATE: .	OHIO POWER COMPANY MITCHELL PLANT	WEST VIRGINIA	
SCALE: 1"=300'	LANDFILL FIGURE 1		AEP SERVICE CORP. 1 RIVERSIDE PLAZA COLUMBUS, OH 43215

Sediment Accumulation(1)

Erosion Gullies in protective cover of Constructed Area 1'-3' Deep (8)

Erosion Gullies in soil 6" Deep (7)

Erosion Gullies in protective cover of Constructed Area 6"-1' Deep (9)

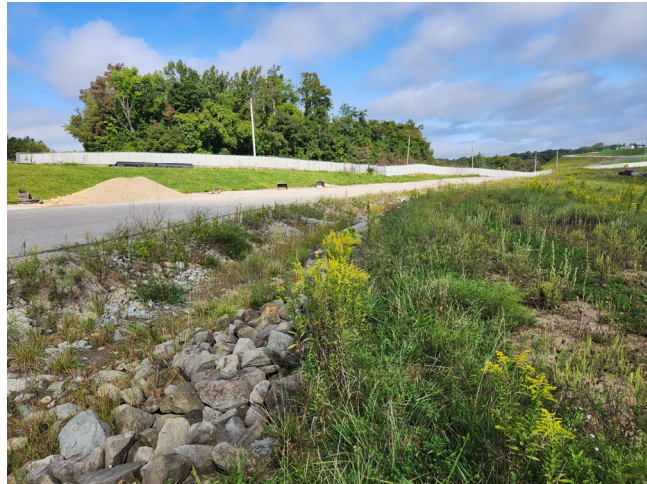
Photo No. 1

1. 6-inch-thick layer of the temporary cover was placed in the Phase 1 Area. The area is not actively receiving CCR material for disposal. There was no evidence of standing water, erosion, slope instabilities or uncontrolled seepage. Minor sediments collected in outer ditch north of phase 1 (Photographs 1 and 2).

Observation 1: Minor Sediment Accumulation

Location: Outer Ditch Phase 1

1. Periodically remove the vegetation growing in the riprap-lined areas on the upstream slope and downstream toe area of the south pond dam.
2. Periodically dress the slope surface in order to minimize the erosion of the bottom ash protective cover.
3. Continue to perform routine maintenance on the leachate pump system components and remove any debris accumulation (leaf litter, sticks, etc.) as necessary for proper operation of the pumping system.
4. Clean sediments in outer ditch phase 1

Recommendations: Clean ditch.

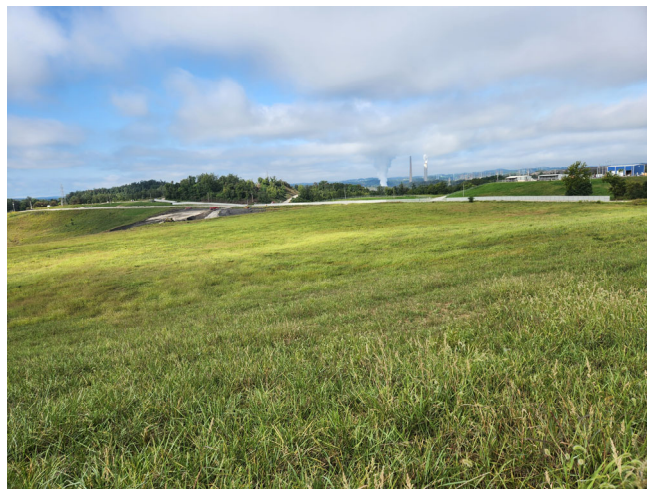
Photo No. 2

Observation 2: General Conditions: temporary soil cover

Location: Phase 1

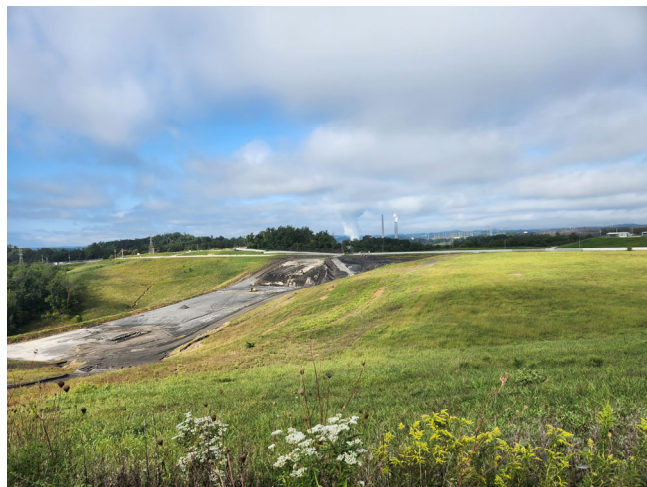
Photo No. 3

1. 6-inch-thick layer of the temporary cover was placed in the Phase 2 Area. The area is not actively receiving CCR material for disposal. There was no evidence of standing water, erosion, slope instabilities or uncontrolled seepage. Minor sediments collected in outer ditch north of phase 1 (Photograph 3 and 4)

Observation 3: General Conditions: temporary soil cover

Location Phase 2.

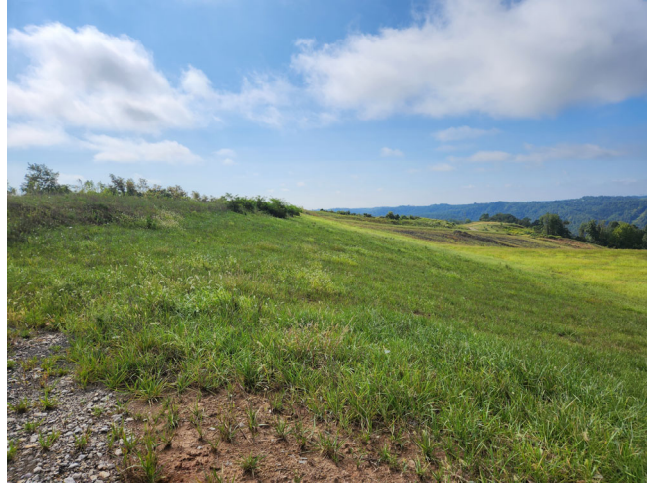
Photo No. 4

Observation 3: General Conditions:
temporary soil cover

Location Phase 2.

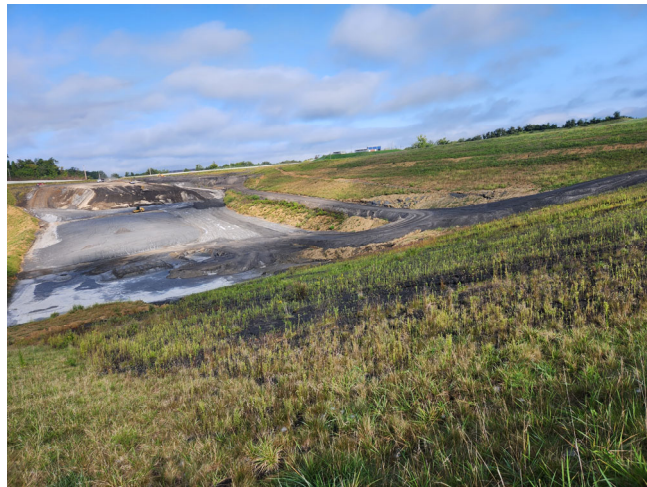
Photo No. 5

1. During the inspection, Phase 3 area was actively receiving CCR material for disposal. CCR material is dumped, spread out with a dozer and compacted with a smooth drummed roller. There was no evidence of standing water, slope instabilities or uncontrolled seepage. Few erosion gullies are present along the eastern slope and the western groin of the area within the protective bottom ash cover (Photographs 5 through 9).

Observation 4: General Conditions: Fly ash
placement in phase 3.

Location: Floor area of Phase 3.

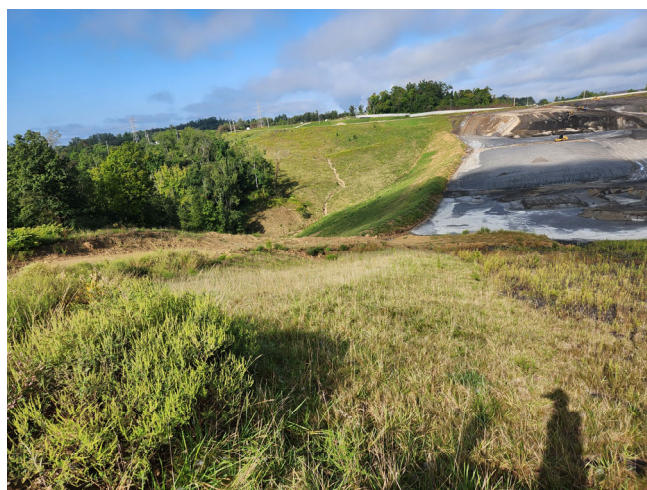
Photo No. 6

Observation 4: General Conditions

Location: left edge of east inboard slope
of Phase 3

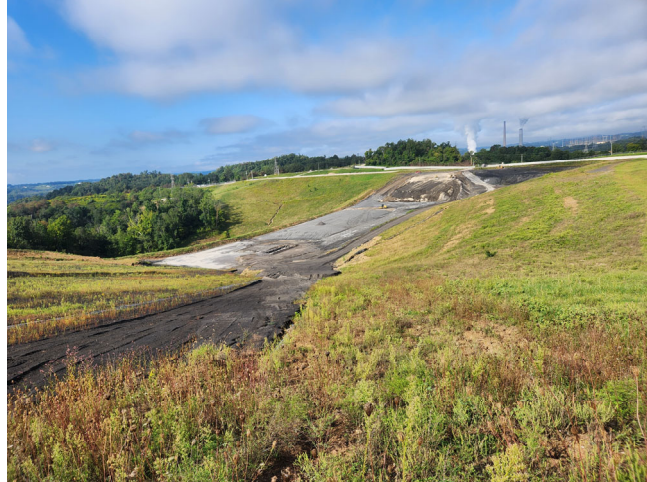
Photo No. 7

Observation 5: General Conditions

Location: Right edge of east inboard slope of Phase 3

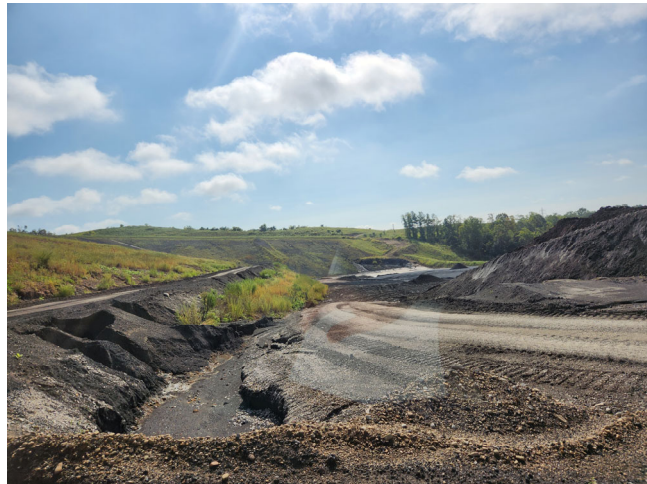
Photo No. 8

Observation 3: General Conditions:

Location: left edge of west inboard slope of Phase 3

Recommendations: dress the slope

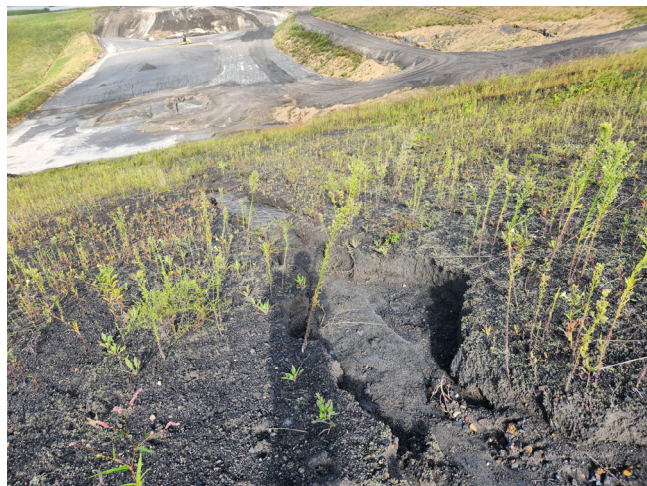
Photo No. 9

Observation 5: Erosion rills

Location: Center of east inboard slope of Phase 3

Recommendations: dress the slope

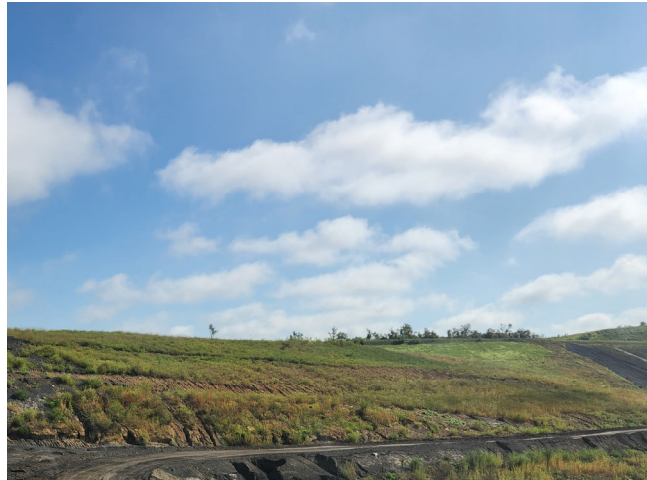
Photo No. 10

1. At the time of inspection, the clay berm south of phases 1 and 2 was recently mowed with good established grass cover. At some areas, the clay from phases 1 and 2 clay berm was harvested to be used in constructing the phase 3 Berm (photograph 10 and 11).
2. There was no evidence of uncontrolled leachate, slope instability or ponding water on the clay berms area.

Observation 7: Clay Berm

Location: Phase 1&2.

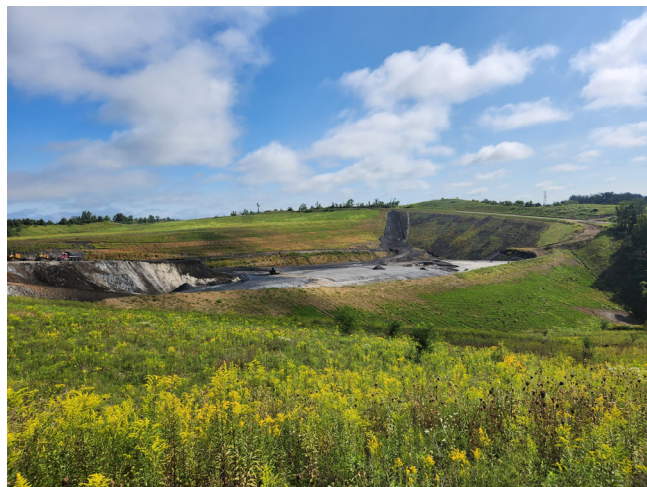
Photo No. 11

Observation 7: Clay Berm.

Location: Phase 3.
