2022 Annual Landfill Inspection Report

FGD Stackout Area

**H.W. Pirkey Plant
Southwestern Electric Power Company
Hallsville, Texas**

November, 2022

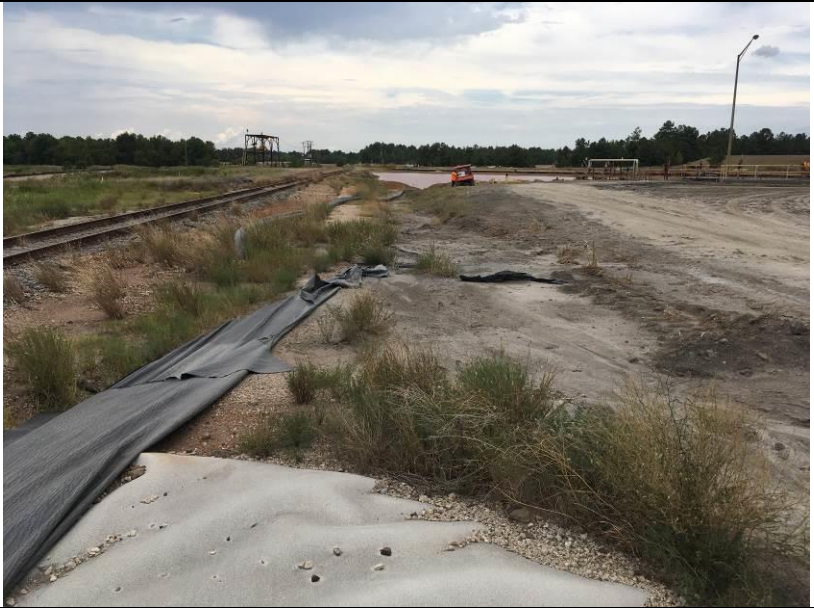
Photo # 1

View of the contact water drainage ditch located on the west side of Stackout Area.

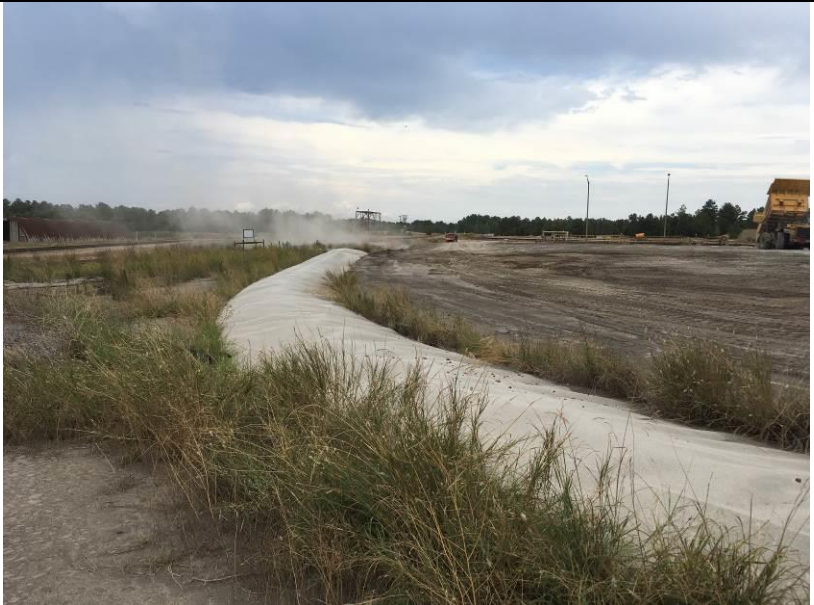
Photo # 2

1. In general, the gravel perimeter berm with a geomembrane cover appeared to be in good condition. There was no evidence of holes, air/water pockets, or other signs of distress noted on the geomembrane.

View of the western gravel berm with a geomembrane cover facing north.

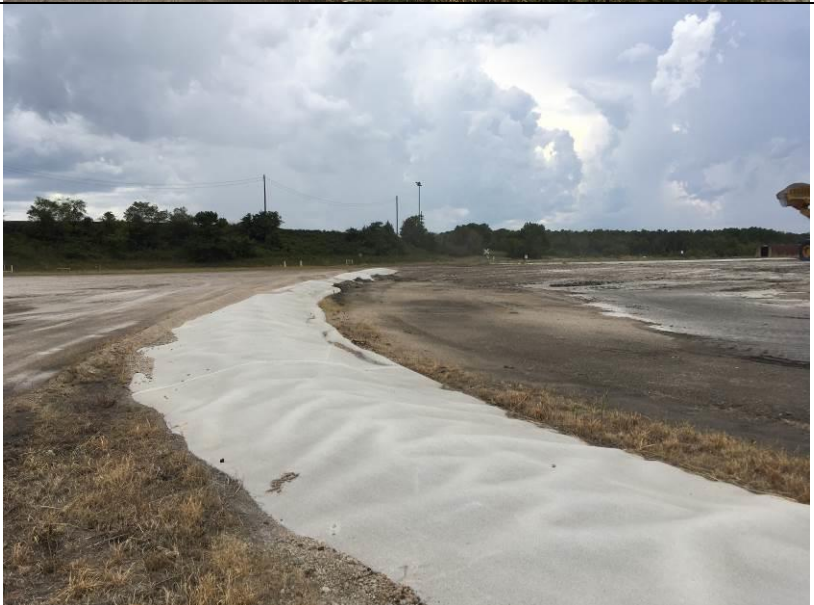
Photo # 3

View of the southern gravel berm with a geomembrane cover facing west.

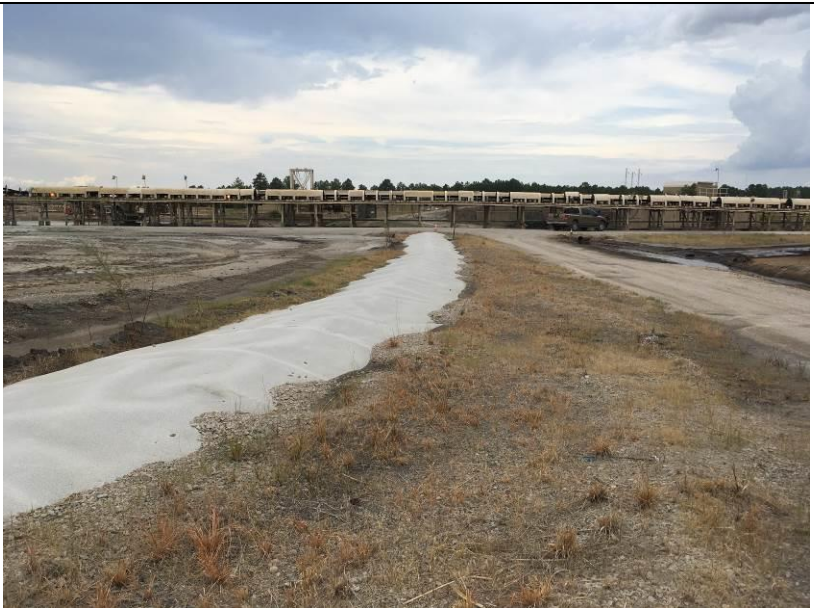
Photo # 4
View of the eastern gravel berm with a geomembrane cover facing north.

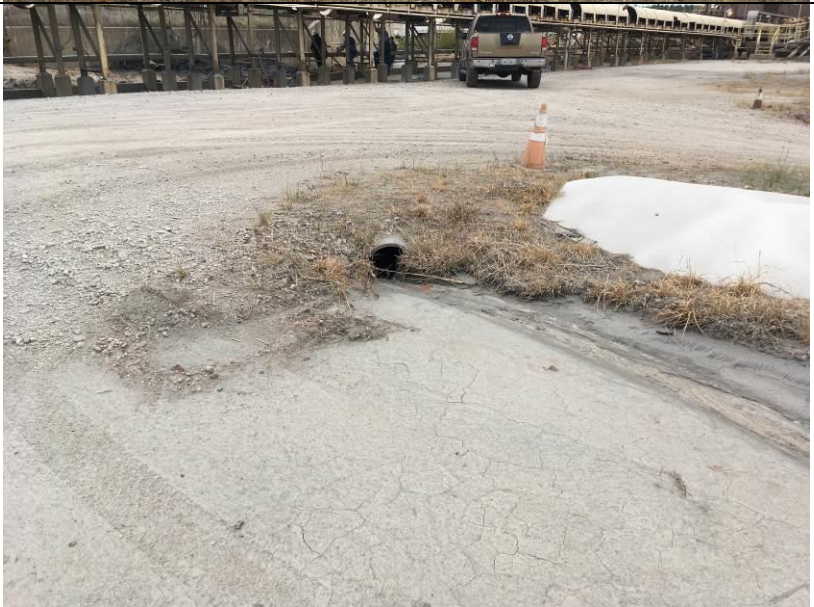
Photo # 5
View of the inlet culvert pipe that discharges water from the stackout area into the drainage ditch under the conveyor system.

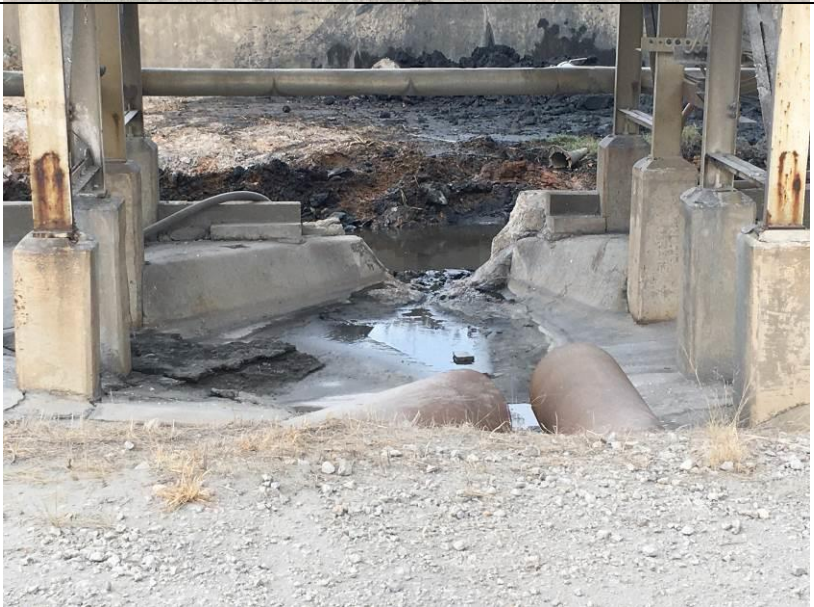
2. Surface water runoff from along the eastern perimeter berm is conveyed underneath an access road via a steel pipe culvert. Storm water from this culvert outlets onto a concrete slab with curb walls underneath the supports for the conveyor belt that supplies the radial arm stacker. A section of these curb wall has been notched out to allow surface water runoff to drain to the drainage ditch that feeds the Auxiliary Surge Pond. The steel culvert was not obstructed, but the area upstream of the culvert should be graded to maintain positive drainage to the culvert.

Photo # 6
View of the outlet area of the steel culverts under the conveyor system which feeds the radial arm stacker

- 1) The area upstream of the culvert that drains the eastern perimeter ditch should be graded to maintain positive drainage to the culvert.
- 2) The area upstream of the FGD Stackout pad that drains to the auxiliary surge pond should be graded to maintain positive drainage to the culvert.

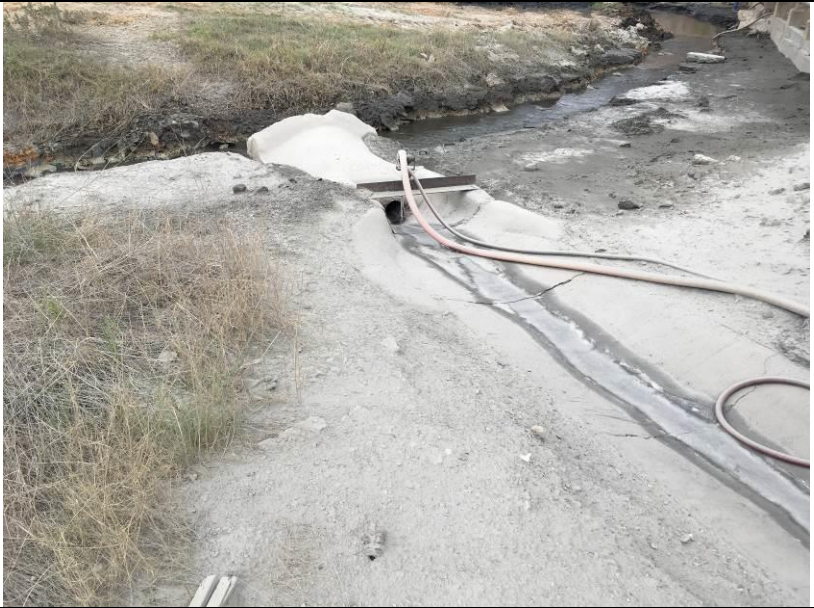
Photo # 7

View of the drainage culvert from the FGD Stackout Pad area that drains to the ditch which is located adjacent to the conveyor system on the north side.

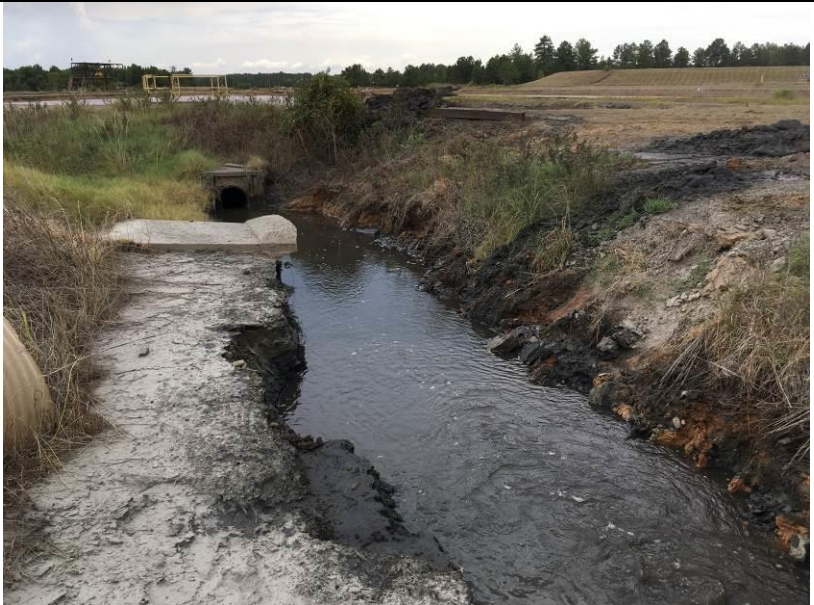
Photo # 8

3. An old railroad tie beam and other wood debris that were previously observed at the end of the north drainage ditch and up against the culvert that directs runoff into the auxiliary surge pond has been removed and cleared. This culvert is downstream of the notch in the curb mentioned above.

View of the drainage ditch culvert which directs runoff into the auxiliary surge pond. This culvert is downstream of the notch in the curb shown in Photo #6 and culvert shown in Photo #7.

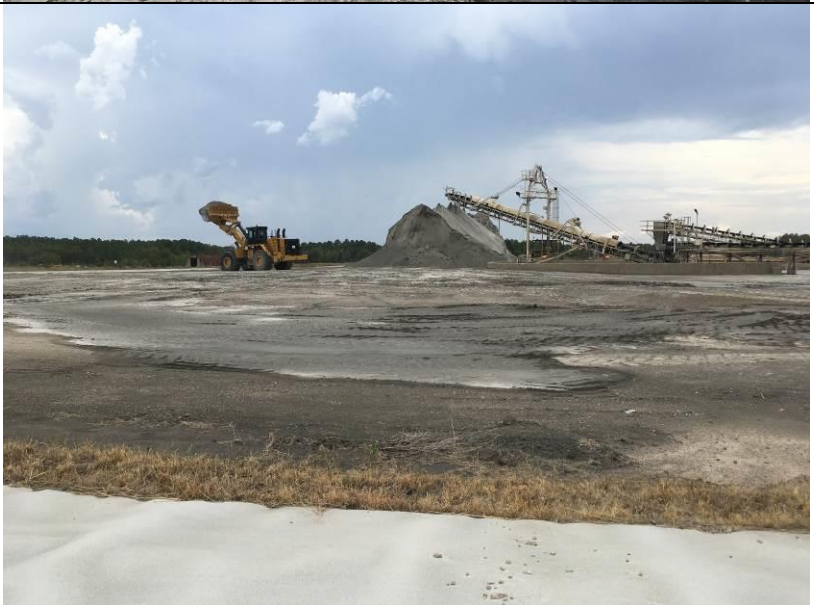
Photo # 9

View of the FGD Stackout Area with a pile of Gypsum on the pad.

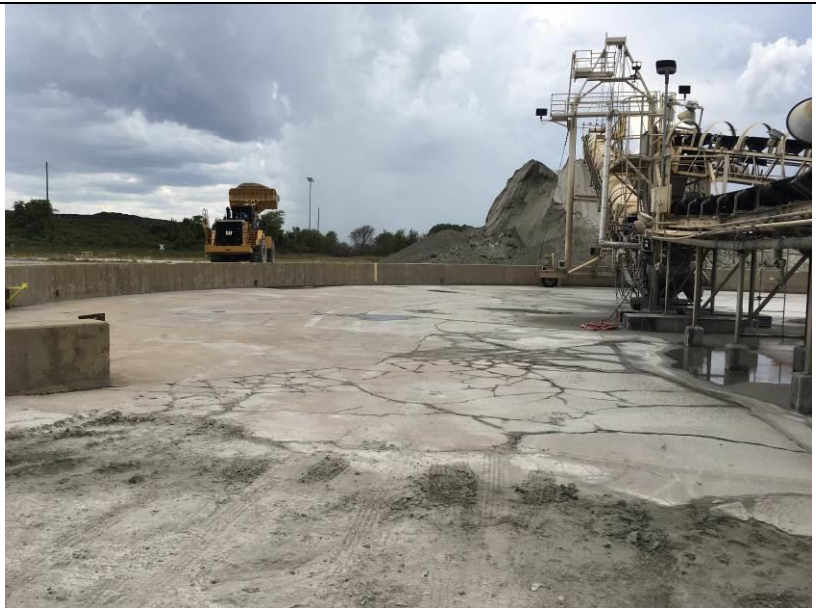
Photo # 10

View of the radial arm stacker that conveys gypsum to the stackout area.

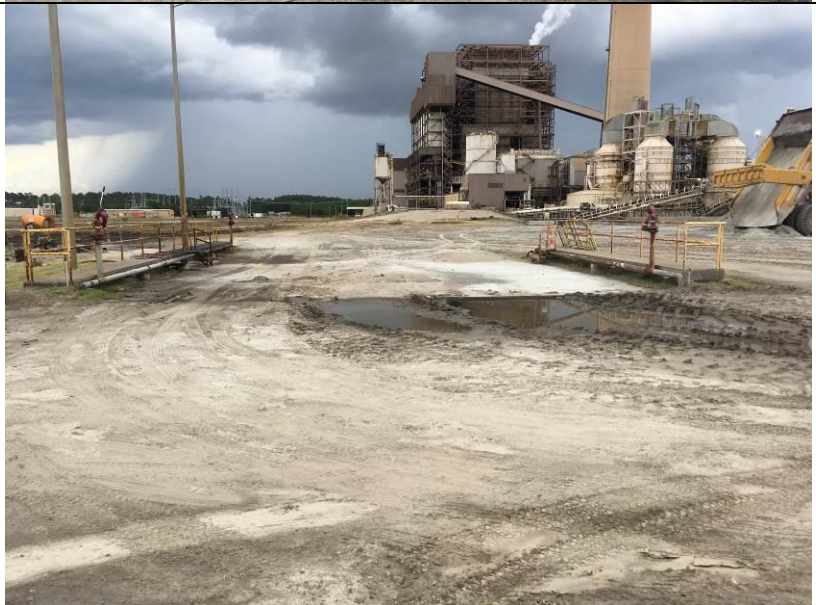
Photo # 11

View of the truck wash station to clean the dump trucks loading and hauling gypsum to the landfill.

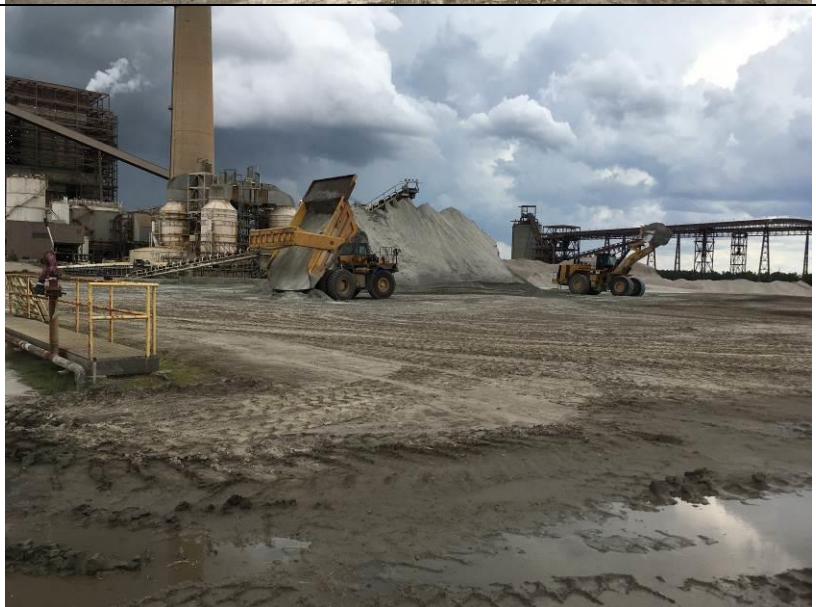
Photo # 12

View of the FGD Stackout Area on the north side adjacent to the truck wash out station.
