# 2022 Annual Landfill Inspection Report

**H.W. Pirkey Plant  
Southwestern Electric Power Company  
Hallsville, Texas**

**December 2022**

**Document ID: GERS-22-026**

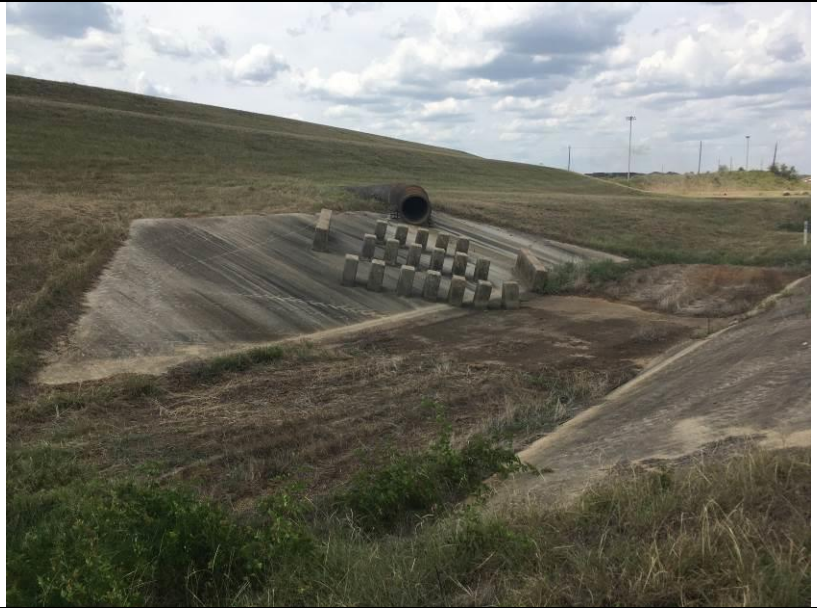
Photo # 1

4. Minor brush and some cattails were observed to be growing in the perimeter ditches and around the energy dissipater structures for the “let down” piping on the eastern edge of the landfill area.

View of the storm water let-down pipe on the east side of the landfill area.

- 2) Remove the brush and/or cattails growing around the outlets of the “let down” piping on the east side of the landfill. Establish grass cover on any disturbed areas.

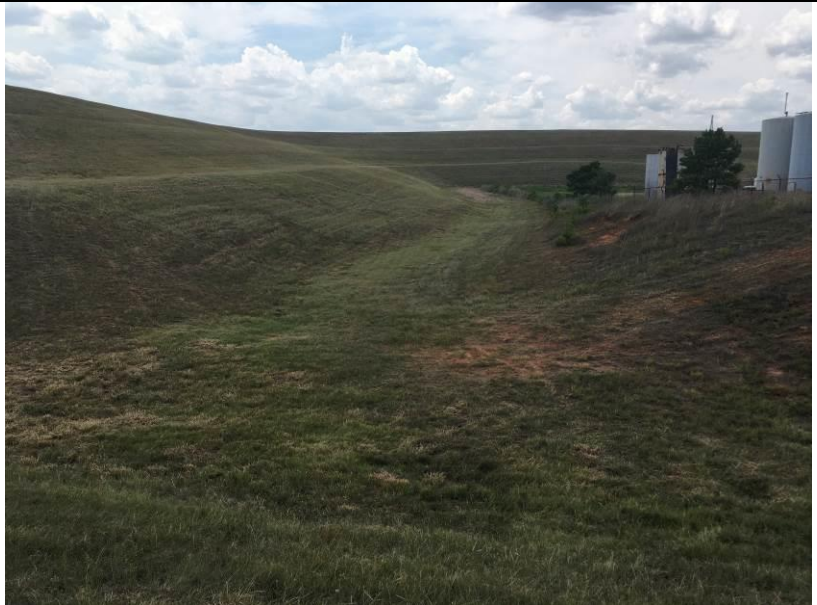
Photo # 2

View of the non-contact-water perimeter ditch and side slope conditions around the Mohan Well site on the east side of the landfill area.

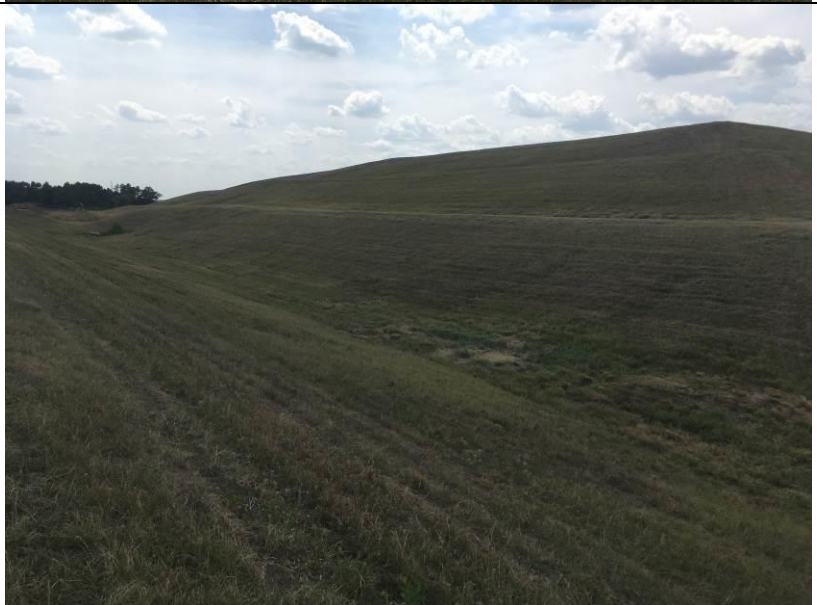
Photo # 3

View of the non-contact water perimeter ditch and side slope conditions on the east side of landfill area.

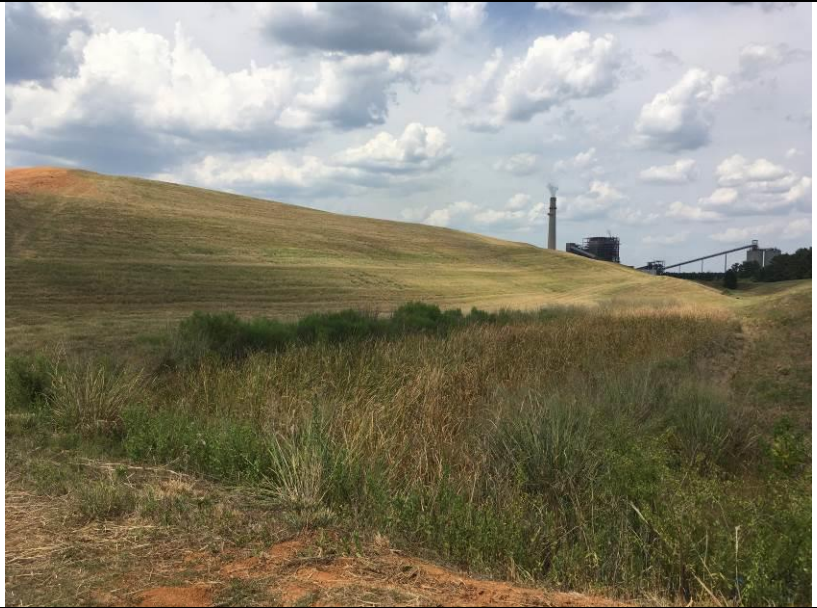
Photo # 4

View of the non-contact water perimeter ditch on the east side of landfill at the southeast corner of the 1993 cell.

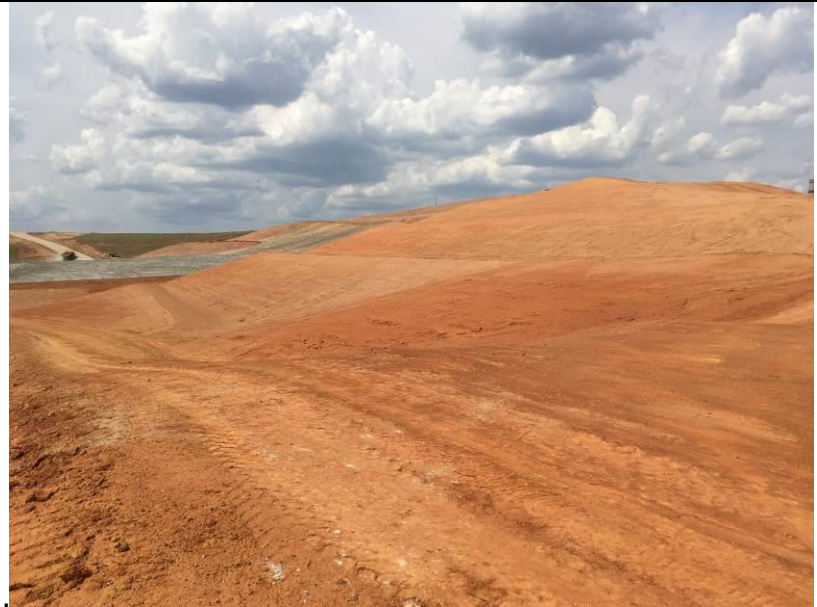
Photo # 5

View of the temporary soil cover over the south end of the 1993 cell. Area is being prepped for final cap and cover.

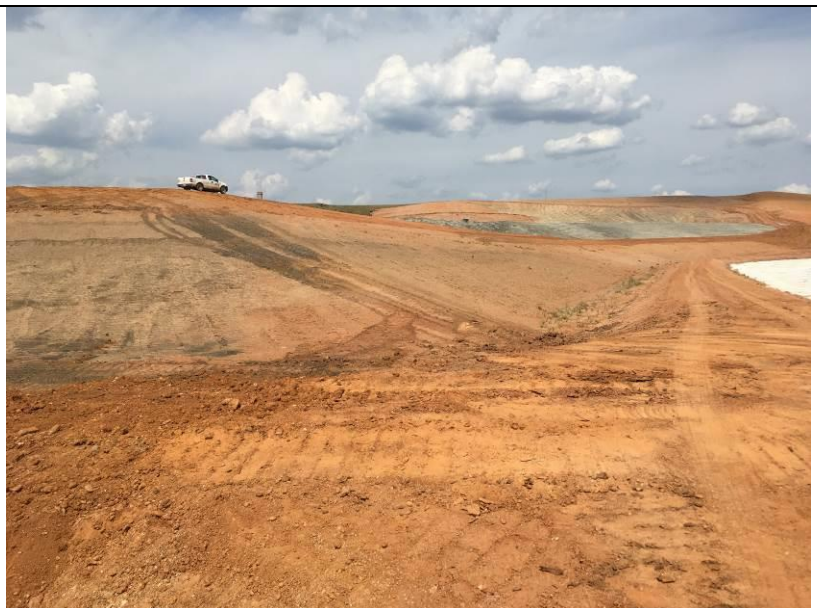
Photo # 6

7. A temporary soil cover consisting of a red clay material has been placed for an erosion protection measure on a portion of the side slopes of the 2012 cell. The soil cover has been seeded but most of the area still has no vegetative cover and there is some sediment buildup in the ditches. In addition to the soils cover, other adjacent areas of the 2012 cell, 1985 pond cell and 1993 cell have been covered with a temporary soil cover or interim soil cover in preparation for the installation of closure turf material. For areas that are not covered with closure turf material, the temporary soil cover will be seeded and mulched for erosion protection.

View of the temporary soil cover on the 2012 cell side slopes and the 1985 pond area. Need to establish vegetation to control erosion.

- 1) Repair the erosion rills, re-seed and mulch the temporary soil cover on the lower portion of the 2012 cell near the 1985 pond area on the south side.

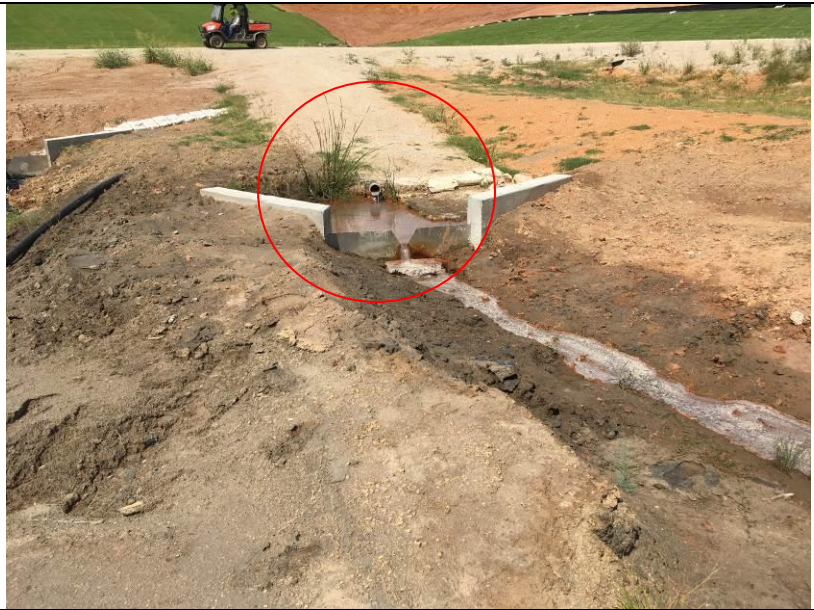
Photo # 7

View of the 12-inch diameter ground water interceptor pipe on south end of landfill. Discharge enters a pooling area fitted with a v-notch weir for measuring flow before entering the landfill pond.

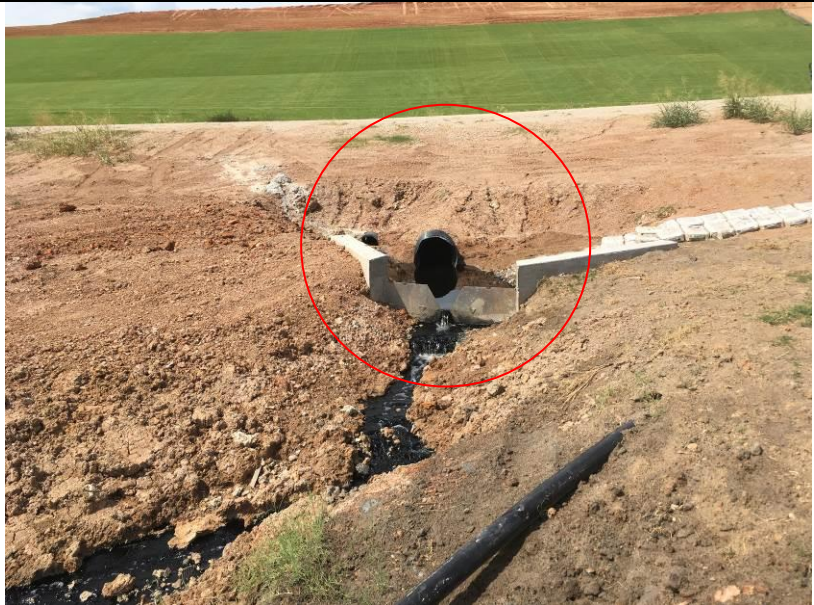
Photo # 8

View of the 24-inch diameter leachate pipe coming out of south end of landfill. Discharge enters a pooling area fitted with a v-notch weir for measuring flow before entering the landfill pond.

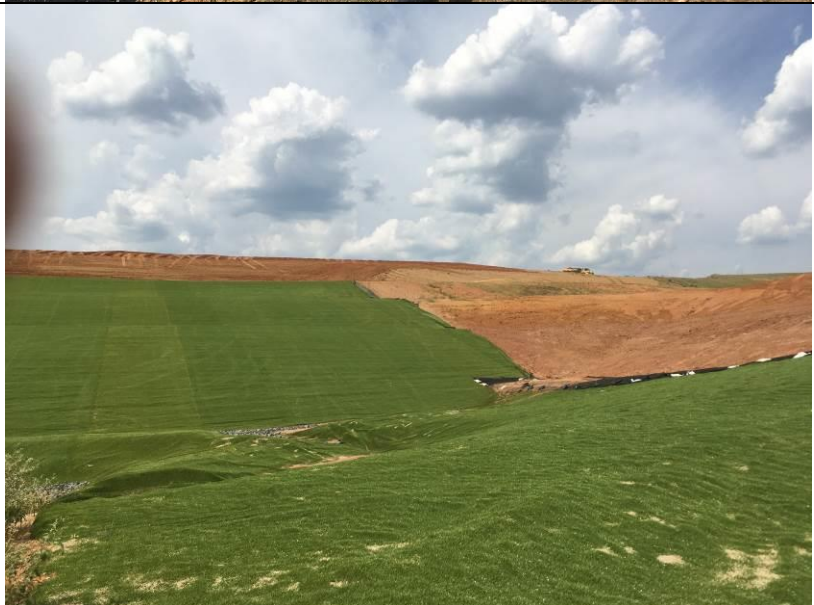
Photo # 9

View of the outside slopes of the 2015 cell area covered with closure turf material and the 2012 cell area covered with temporary soil cover.

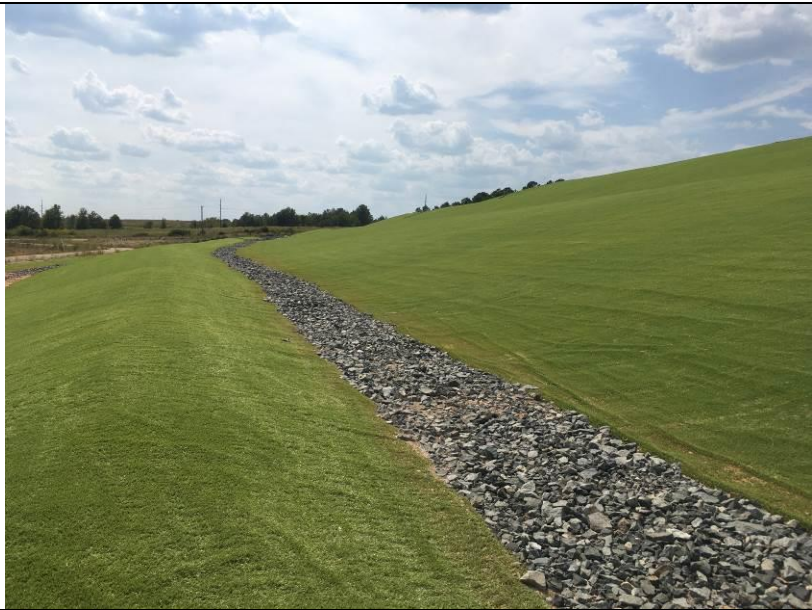
<p style="text-align: center;"><b>Photo # 10</b></p> <p>View of the 2015 cell outside slopes showing final cap and cover with a rock lined bench on the closure turf material.</p>

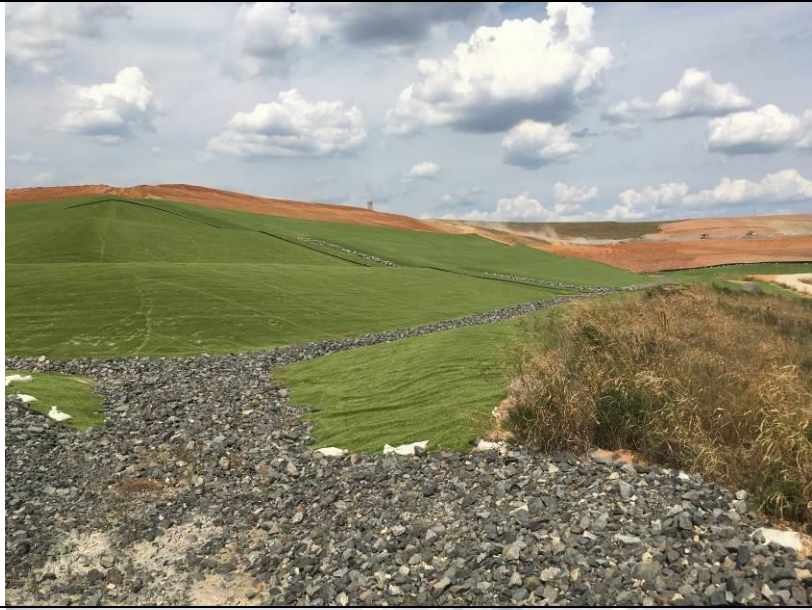
<p style="text-align: center;"><b>Photo # 11</b></p> <p>Landfill Cover - View of the closure turf material and the rock let down channels on the southwest corner of the 2015 cell area. Looking east.</p>

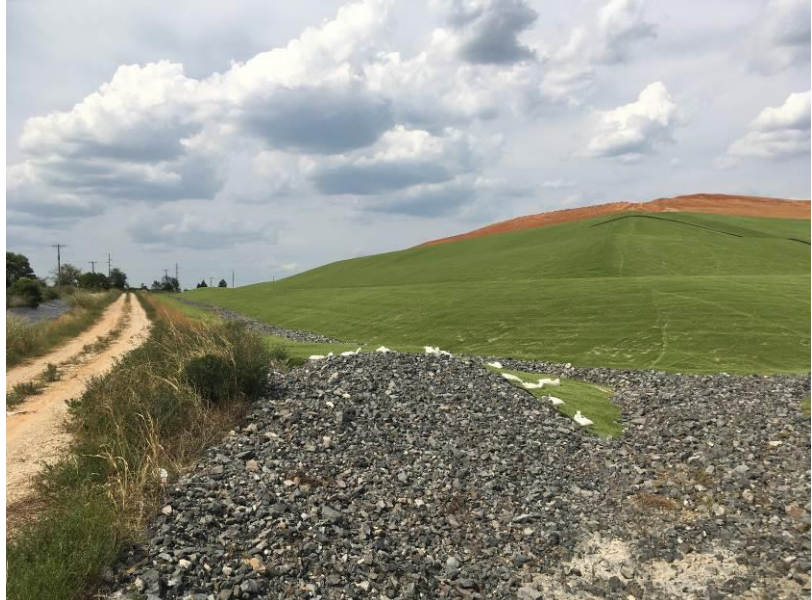
<p style="text-align: center;"><b>Photo # 12</b></p> <p>Landfill Cover - View of the closure turf material and the rock let down channels on the southwest corner of the 2015 cell area. Looking north.</p>

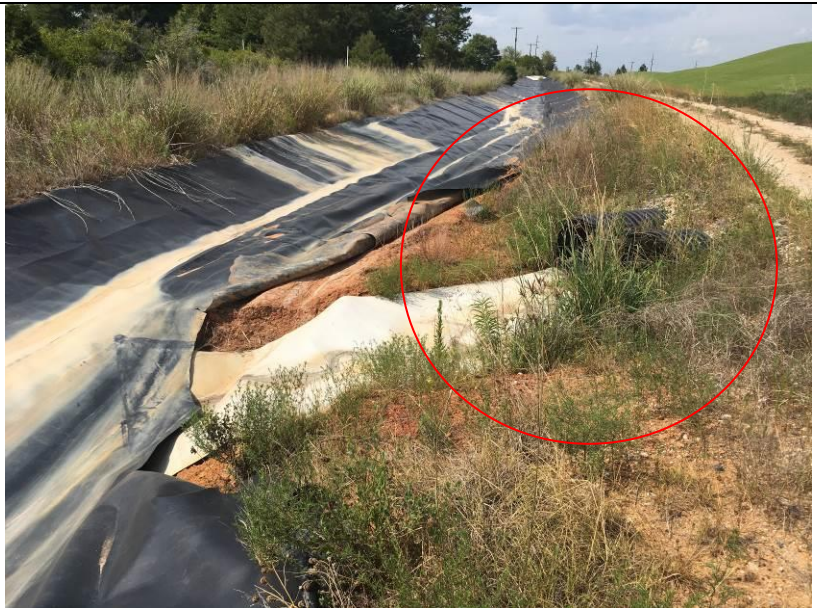
**Photo # 13**

16. A non-contact water ditch runs along the toe of the western edge of the landfill area and is lined with final Cap and Cover Closure Turf material. Runoff from the lower outside slope of the 2015 cell Closure Turf is collected into this ditch and then flows through a culvert located in the southwest corner of the landfill perimeter ditch and discharges onto the geomembrane lined non-contact water ditch that goes around the landfill pond. The non-contact water ditch geomembrane has been undermined from excessive flowing water from the culvert pipes.

View of the dual culverts on the southwest side of landfill that connect the landfill non-contact water from the southwest corner of the landfill to the non-contact water ditch on west side of landfill access road. The non-contact water ditch liner is damage from the flows of the culverts.

- 4) Repair the geomembrane liner in the non-contact water ditches on the west side of the landfill where culvert pipes have undermined the liner from excessive flows and pipe extensions have penetrated through the liner to enter the ditch.

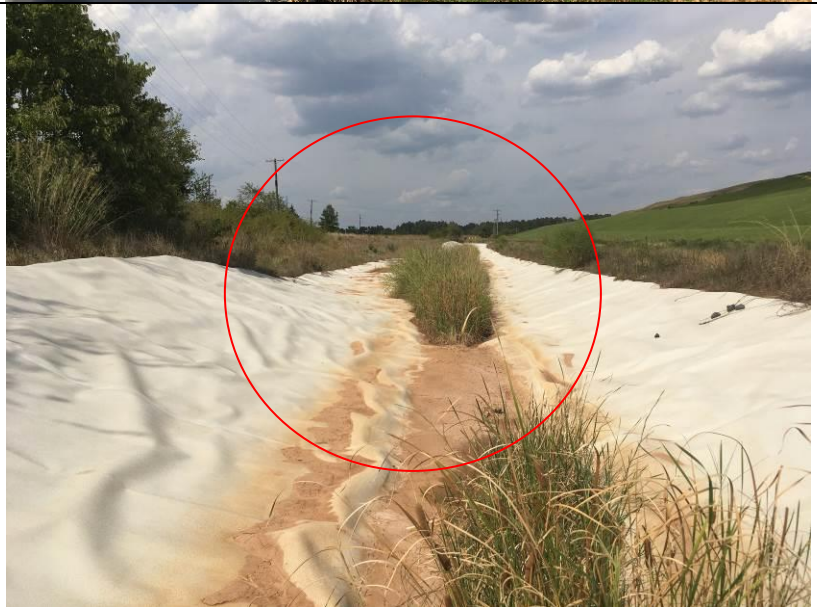
**Photo # 14**

18. A section of the non-contact water ditch has vegetation growing in it from sediment buildup on top of the liner and there are two other sections where the liner has been cut open to allow for the extension of other non-contact water pipes to enter the ditch. The liner needs repaired in these areas.

View of the non-contact water perimeter ditch on the west side of landfill. Vegetation is growing over liner material covered with silt.

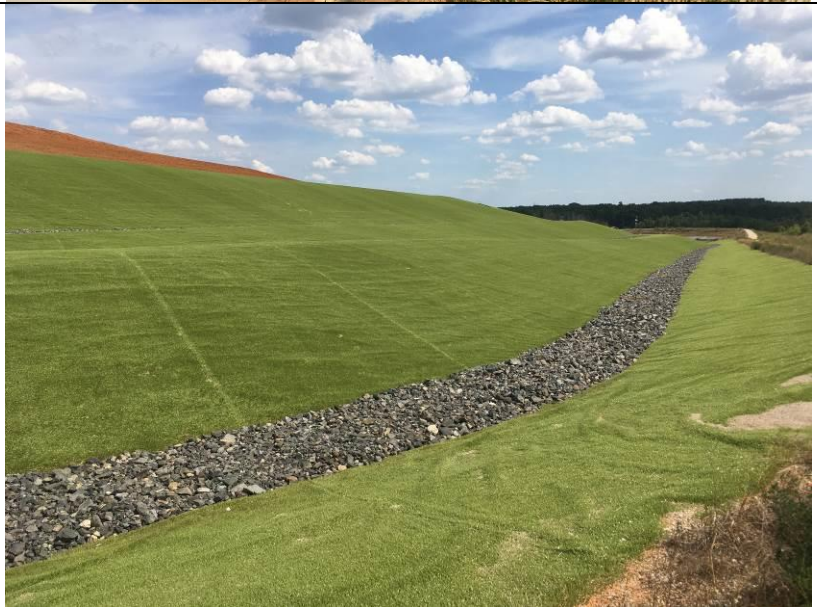
**Photo # 15**

Typical condition of the western slopes with closure turf material. Looking south.

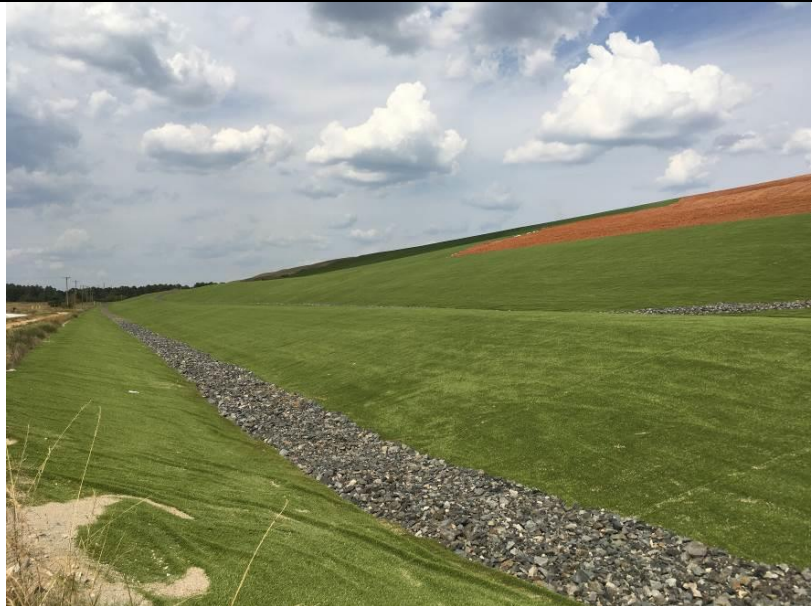
Photo # 16

Typical condition of the western slopes with closure turf material. Looking North.

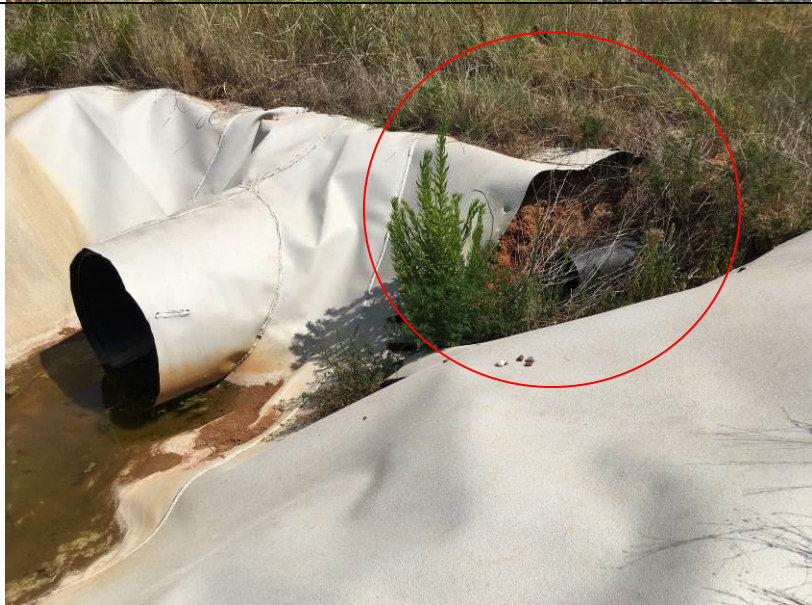
Photo # 17

17. Runoff from the 2005 Cell cap and cover is collected into a 36-inch-diameter conduit and this conduit discharges into the non-contact water ditch on the northern end of the west perimeter ditch area. The geomembrane liner is damaged from an extension of another non-contact water pipe into the ditch. An earthen berm armored with riprap material has been placed at the end of the non-contact water ditch to divert flow away from the toe area of the Landfill Runoff Storm Water Pond. Several small holes about 2 inches in diameter have been cut into the geomembrane to allow any trapped groundwater under the geomembrane to drain and prevent floating of the geomembrane liner.

View of the non-contact water ditch on the west side of the landfill that receives non-contact water runoff from the letdown culverts on top of the landfill and benches. The liner needs repaired where a non-contact water line enters the ditch.

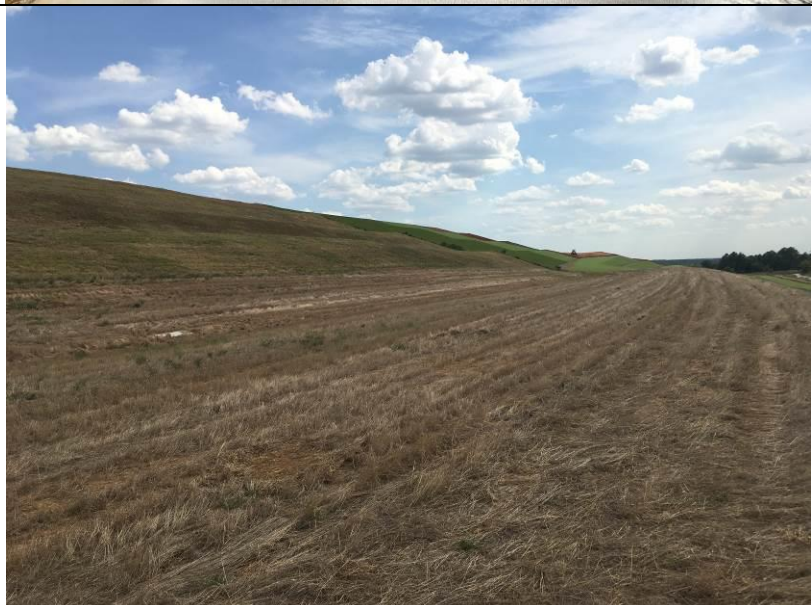
Photo # 18

View of the old haul road on west side of landfill that has been closed with final cap and cover.

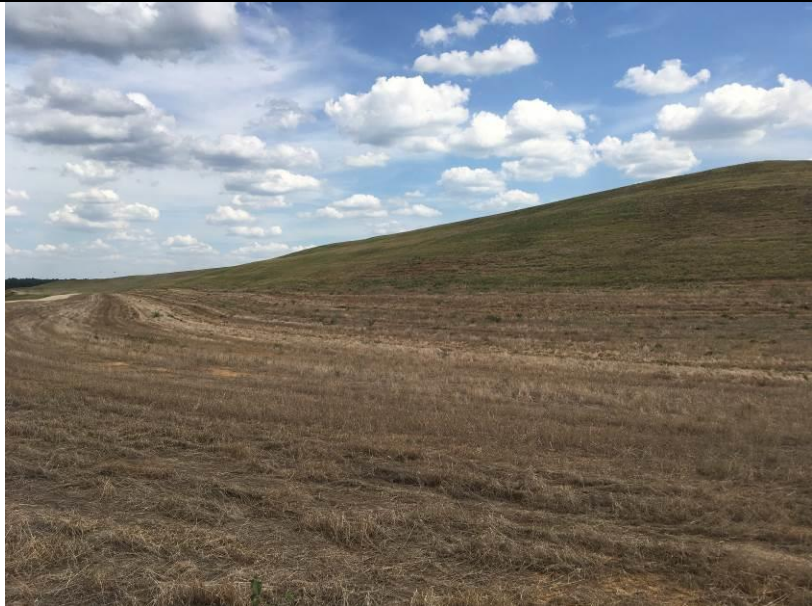
Photo # 19

View of the old haul road on north side of landfill that has been closed with final cap and cover.

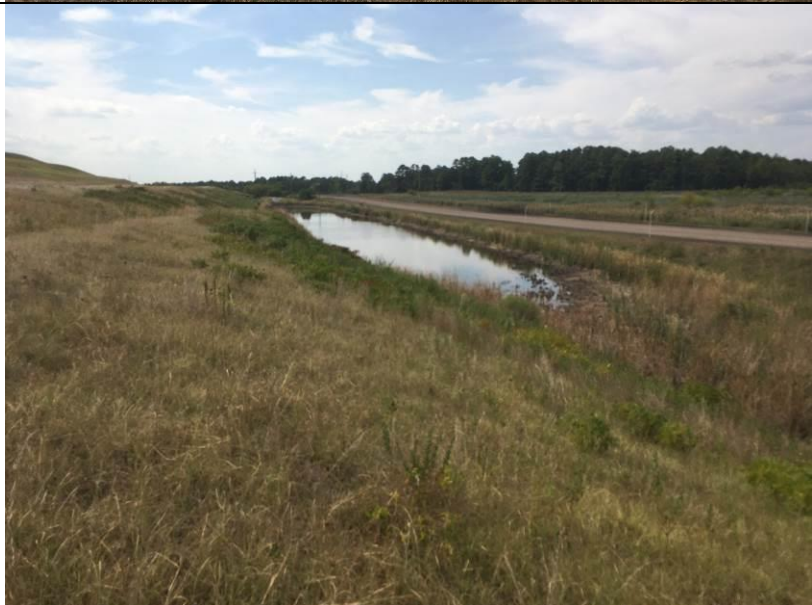
Photo # 20

5. There is ponded water in the downstream end of the perimeter ditch on the north side of the landfill. However, a pump and piping system has recently been installed to pump this water into non-contact water perimeter ditches on the west side of the landfill.

Typical condition of the northern slope areas below the old haul road. Notice the ponded water at the downstream end of the perimeter ditch.

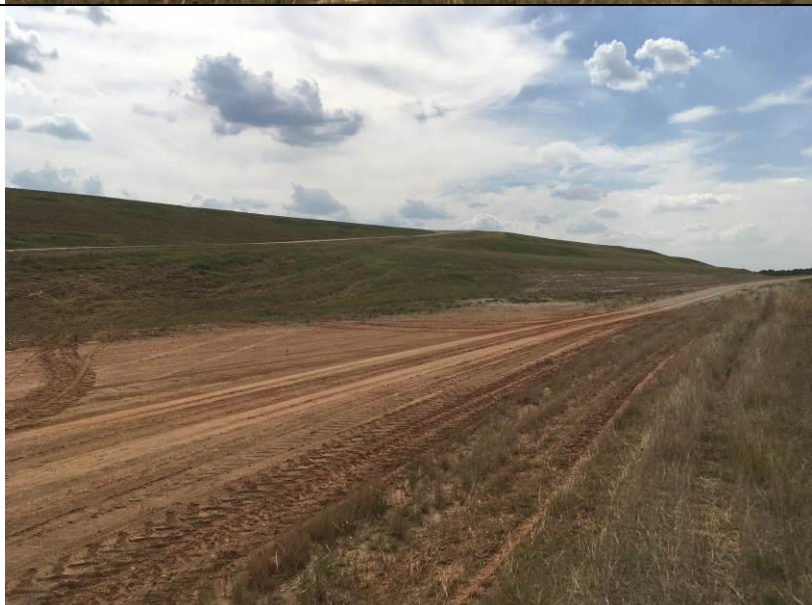
Photo # 21

Typical view of the side slopes for the new haul road established on the north end of the landfill. New haul road goes up over top of landfill instead of around the western side.

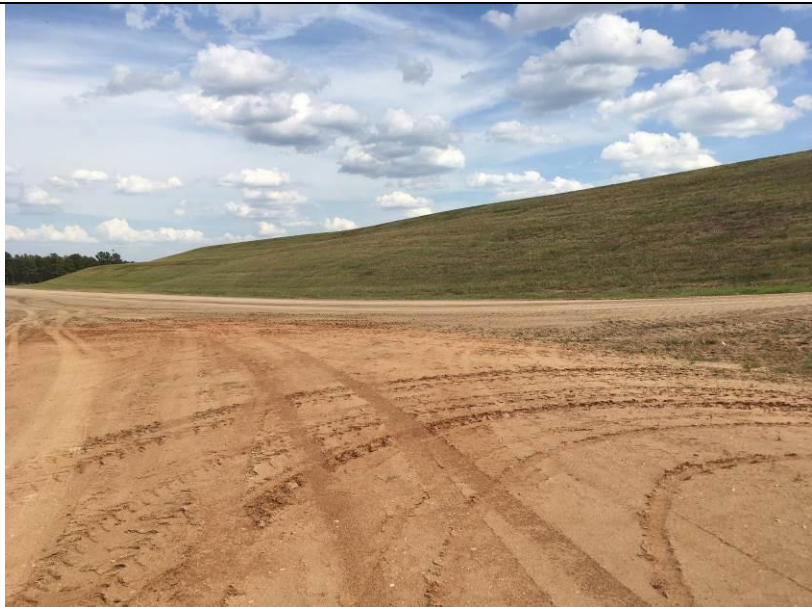
Photo # 22

Typical condition of the vegetative cover over the northern side slope areas.

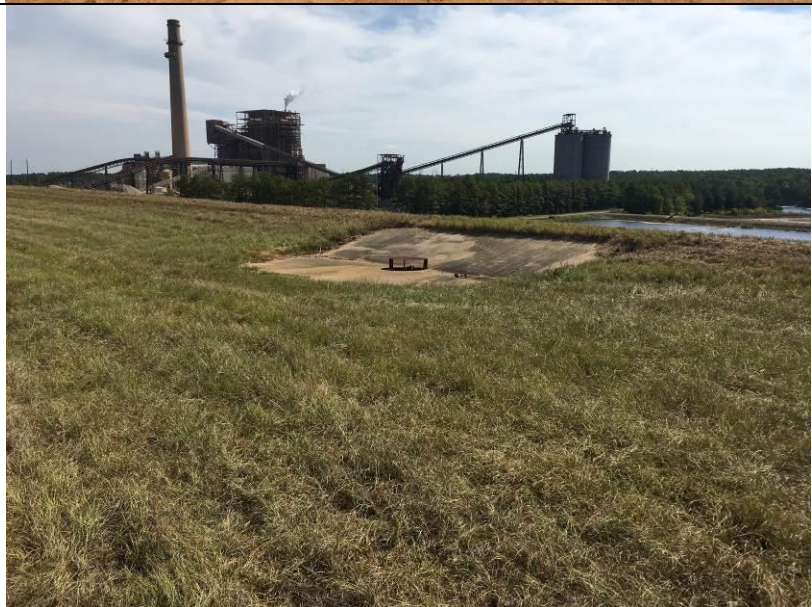
Photo # 23

Typical condition of the vegetative cover over the eastern and northern areas of the landfill cap. One of the letdowns catch basins.

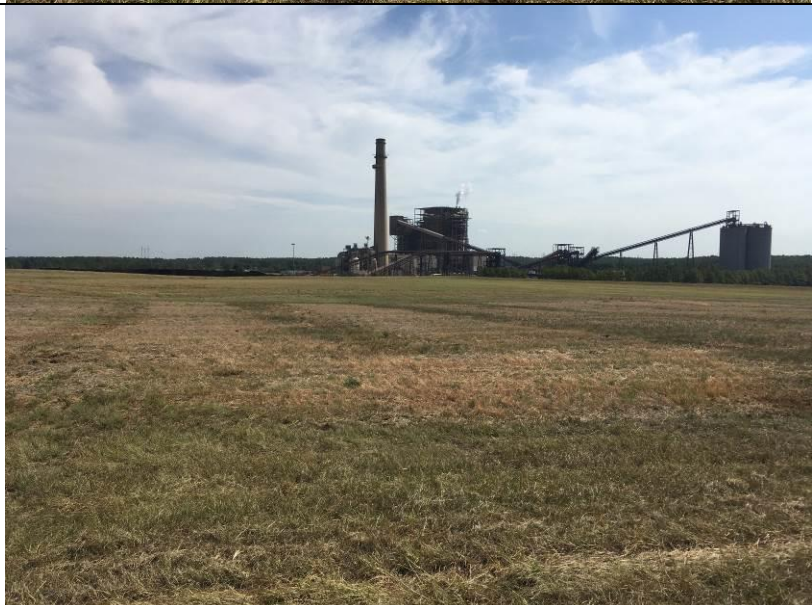
Photo # 24

View of final vegetative cover on the landfill central eastern areas.

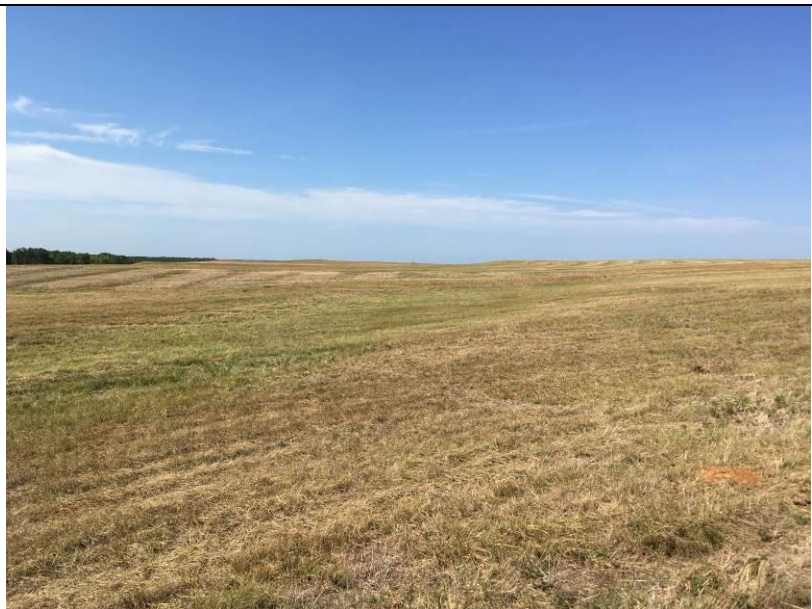
Photo # 25

Typical condition of the vegetative cover over the southern and eastern areas of the landfill cap.

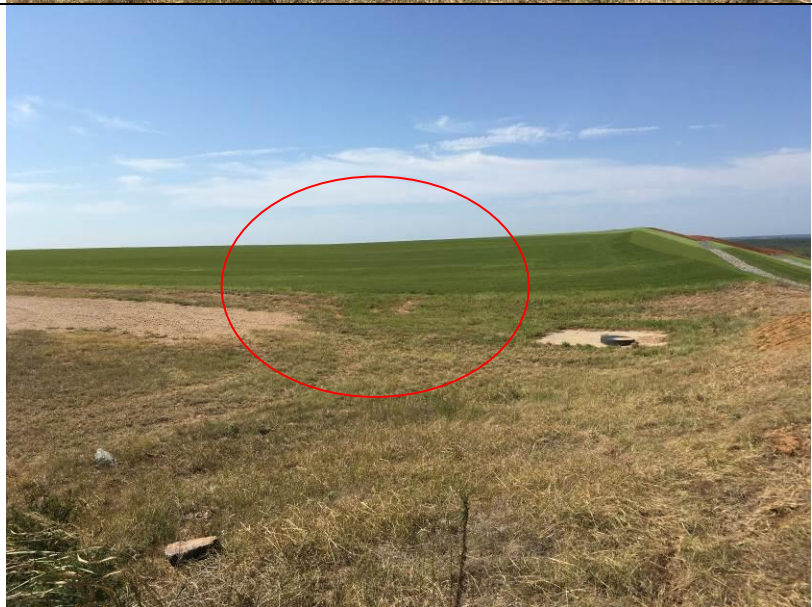
Photo # 26

View of final cover on the landfill central western areas. Notice the break between vegetative cover and closure turf material.

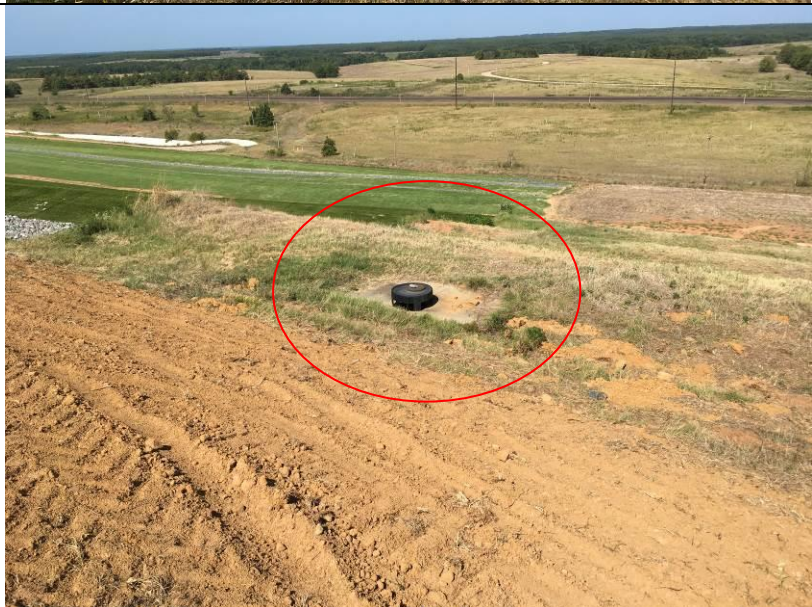
Photo # 27

Landfill Final cover benches. View of one of the letdowns catch basins inlets on top of one of the bench areas.

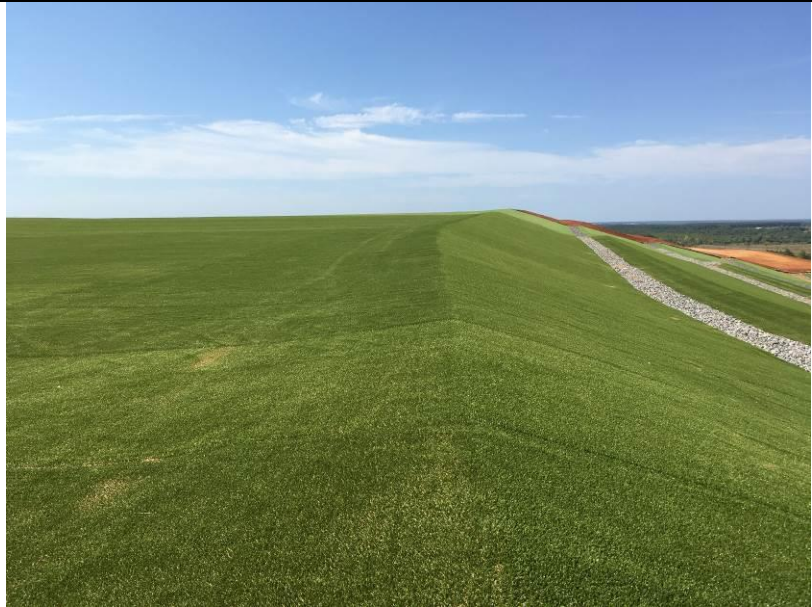
Photo # 28

View of the final cap closure turf material over the top of the 2015 cell. Looking south.

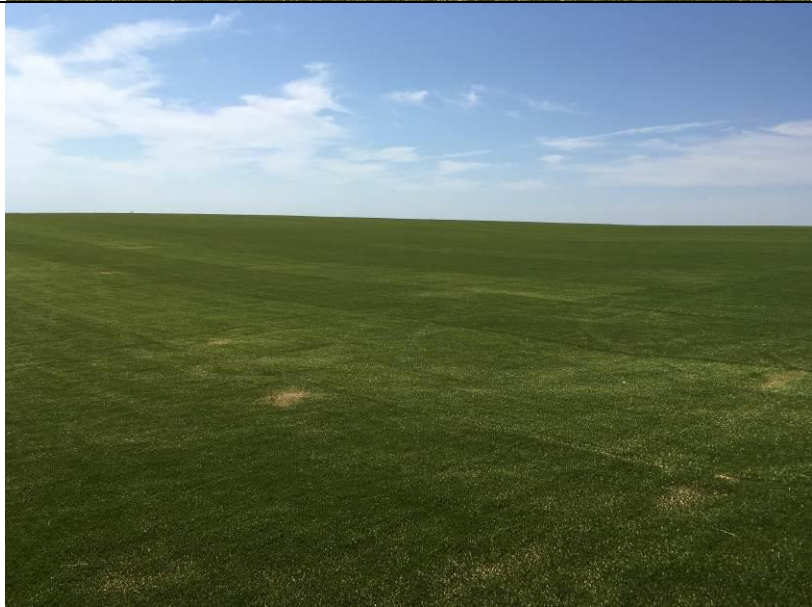
Photo # 29

View of the final cap closure turf material over the top of the 2015 cell. Looking Southeast.

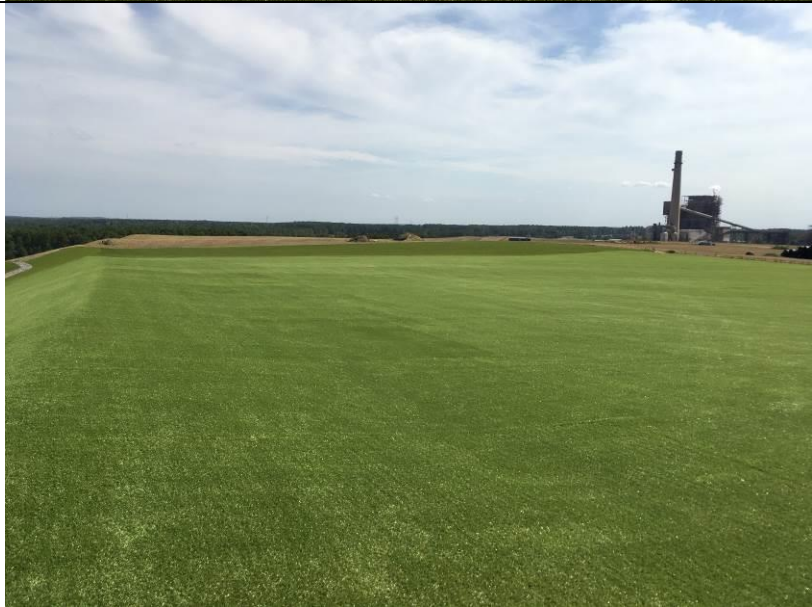
Photo # 30

View of the final cap closure turf material over the top of the 2015 cell. Looking north.

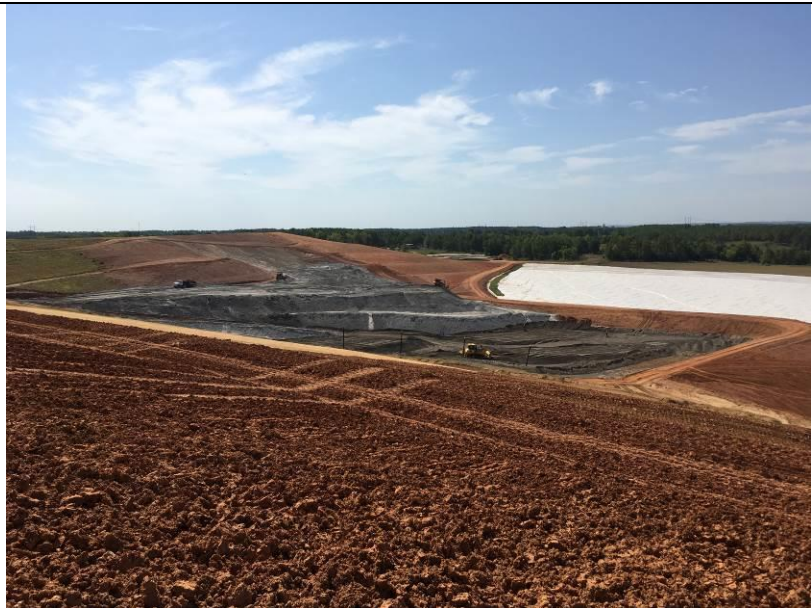
Photo # 31

View of the active material placement inside the 2018 cell looking south.

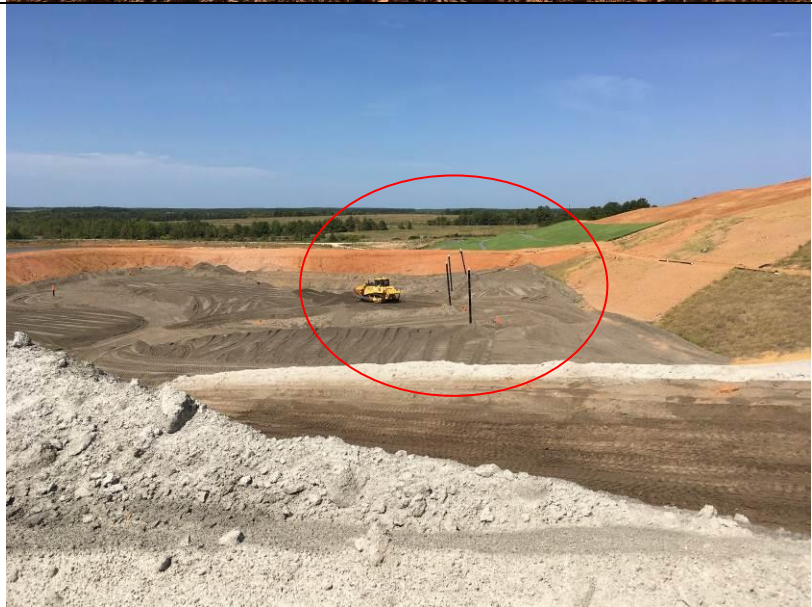
Photo # 32

View of the active material placement inside the 2018 cell looking west.

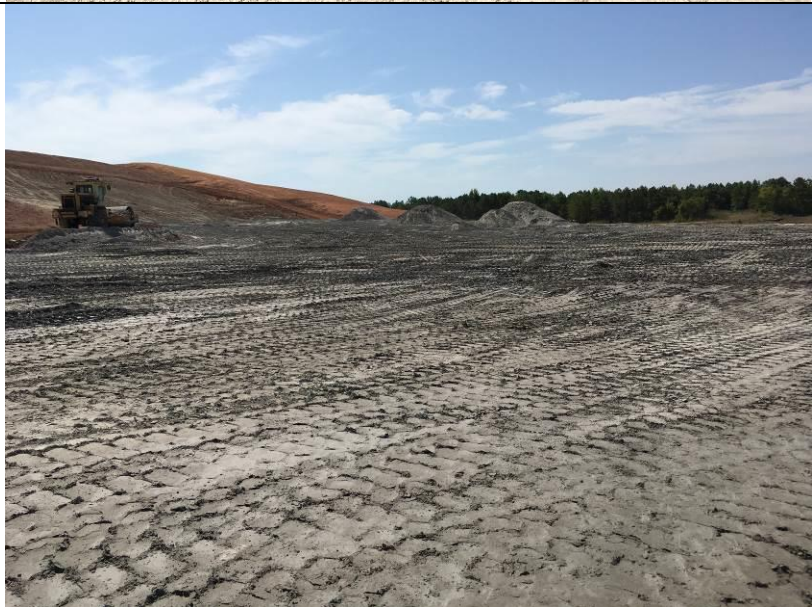
Photo # 33

View of the active material placement inside the 2018 cell looking south.
