# 2022 Annual Landfill Inspection Report

**Rockport Plant  
Indiana Michigan Power Company  
Rockport, Indiana**

**October 2022**

**Document ID: GERS-22-024**

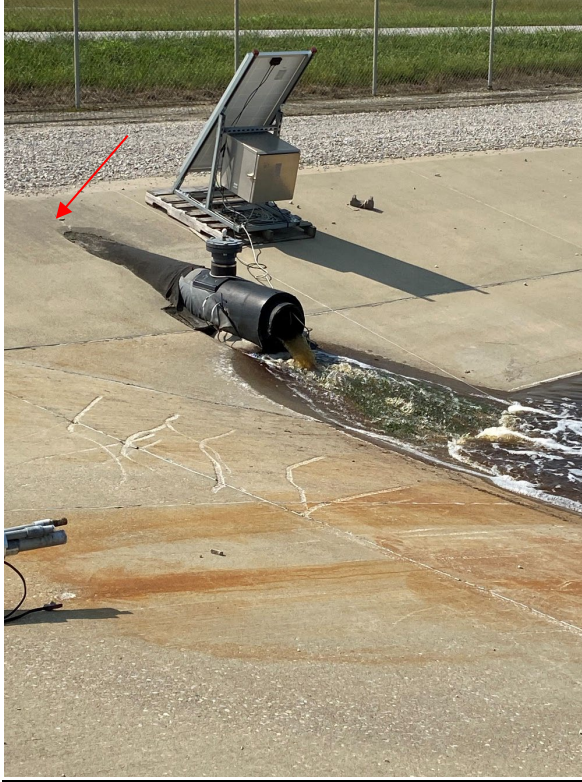
Photograph 1:

1. The North Pond was generally in good condition. At the time of the inspection both cells were filled and operating with about 5 feet of freeboard.
2. A small crack in the concrete liner of the West Pond was observed, and is located just above the leachate outlet pipes entering the pond from the south. There was about 3/8 inch vertical offset across this crack.

View of the leachate influent line at the west leachate pond. The crack in the concrete noted by the red arrow.

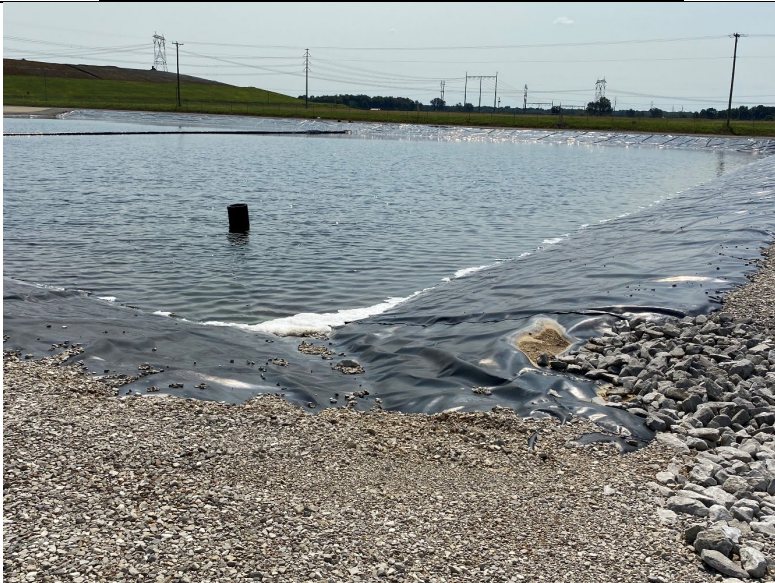
Photograph 2:

3. The West pond concrete lined portion was operating with about 4 feet of freeboard. The concrete lined section in general is in good condition with no signs of damage (except for small crack noted above).

View of the west leachate pond.

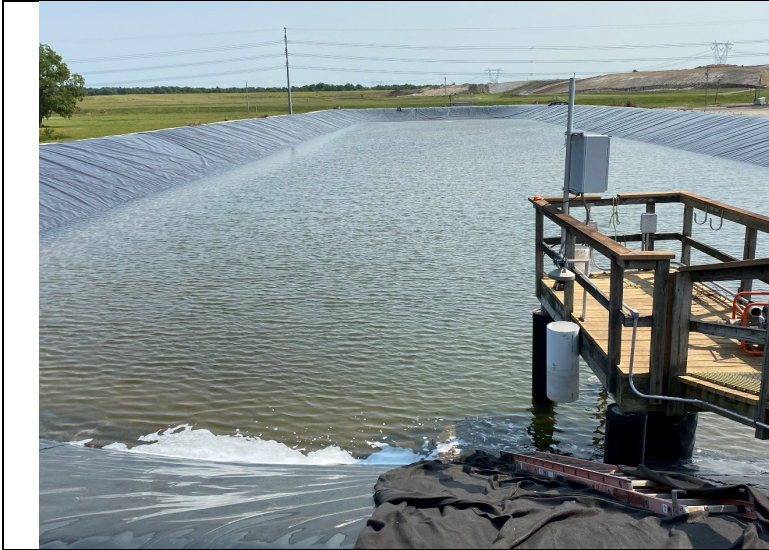
Photograph 3:

View of the discharge structure at leachate pond 002.

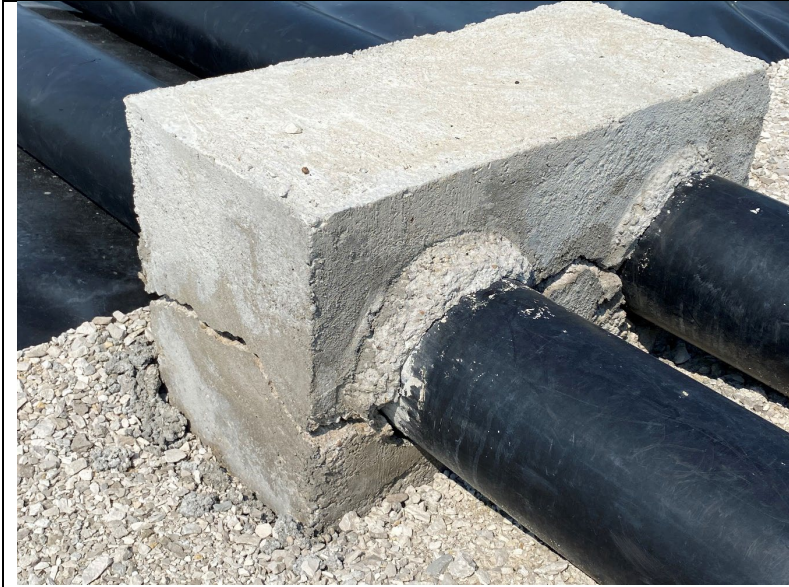
Photograph 4:

6. Cracks in the above grade concrete thrust blocks for the eastern influent lines into Pond 002 were observed.

View of a crack in the exposed thrust block on the east side of pond 002.

- 1) Monitor the interim berm seepage repair area for any signs of seepage.
- 2) Monitor the cracked thrust block on the leachate influent lines on the east side of pond 002 for any additional movement or distress.

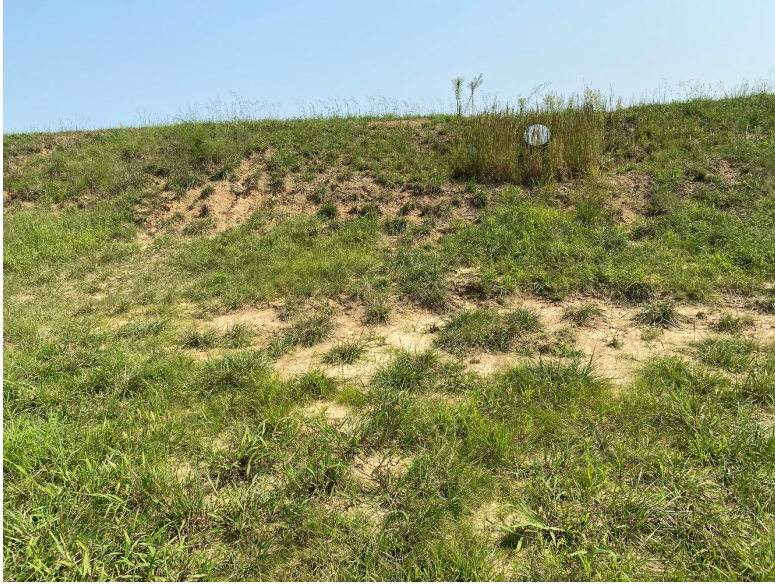
Photograph 5:

3. There was a small section on the exterior slope of the perimeter berm of Cell 7 that showed sparse vegetation with minor erosion.

View of some sparse grass cover and minor erosion on the exterior perimeter berm of Cell 7.

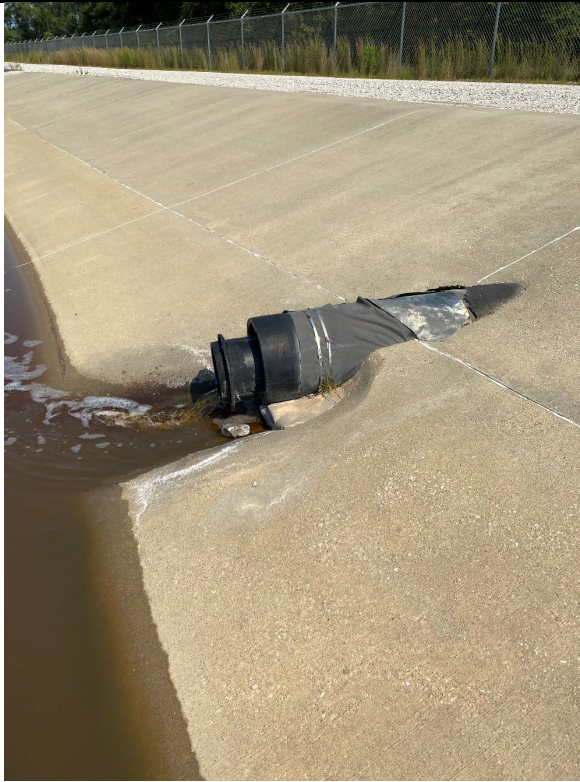
Photograph 6:

View of the leachate influent line into the north pond complex.

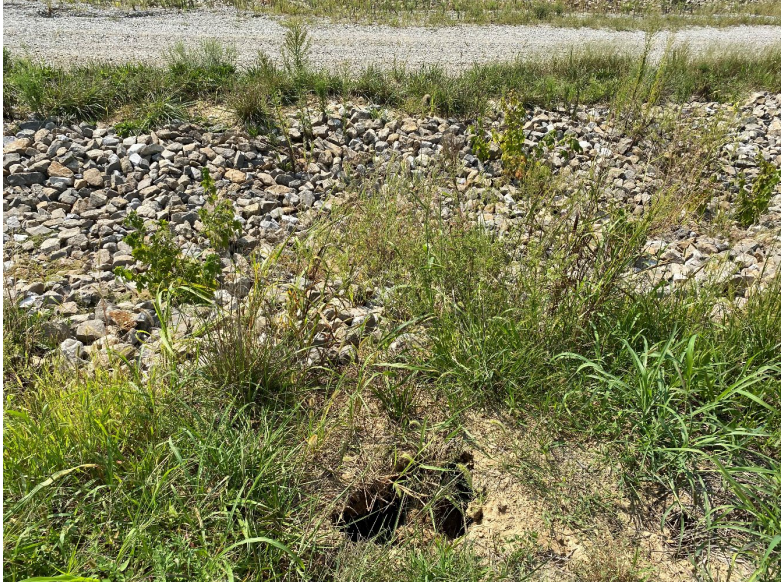
Photograph 7:

1. There was an area of erosion occurring on the northern edge of a riprap channel adjacent to the landfill access road. The erosion rill was about 2 feet deep. Rodent burrows were also found in this area.
2. The closed landfill area was observed to have a thick grass cover over the entire capped area that had recently been mowed. There were no signs of settlement, signs of movement or distress of the landfill area. The closed landfill area was in good condition and well maintained.

View of rodent burrow on the closed landfill section.

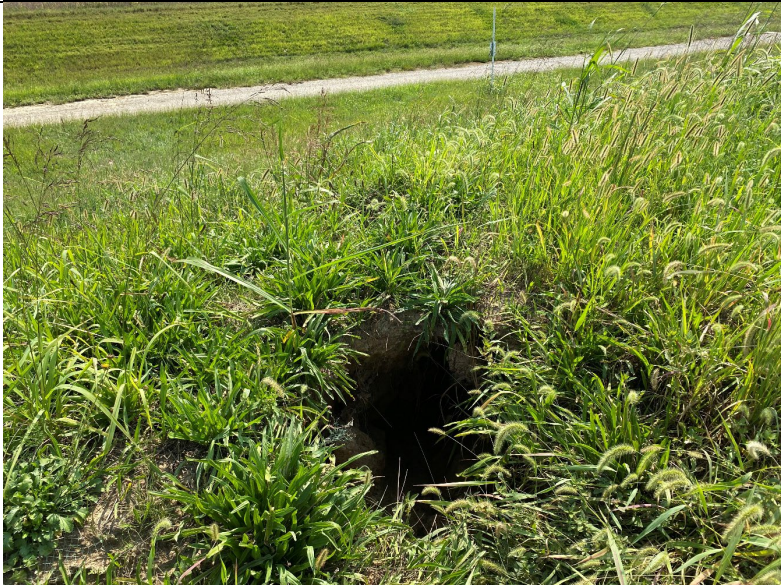
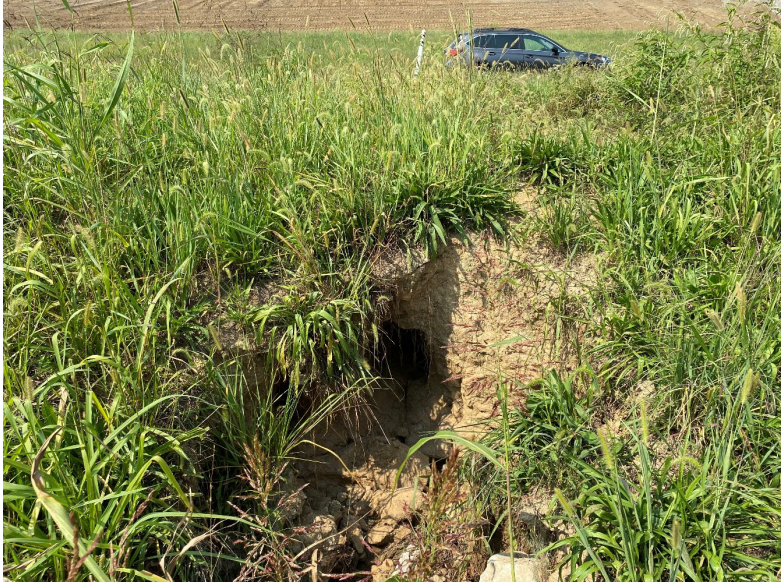
4. The surface of Cells 1B, 2 & 3 were being prepared to receive temporary soil cover.
5. An erosional feature near the edge of perimeter berm on the south side of Cell 2 was observed.

View of the erosional feature on the south side of Cell 2.

Another view of the erosional feature on the south side of Cell 2.

- 1) Improve the ash surface grades near the north side of Cell 1A so that contact water runoff is directed to the chimney drains.
- 2) Repair the peeling circular patch on the exposed liner in the north leachate pond.
- 3) Repair the erosion feature on the perimeter berm on the south side of Cell 2.
- 4) Remove the ash outside of the containment on the south side of Cell 2 and repair the grass cover.
- 5) Improve the grass cover in a small area on the exterior slope of perimeter berm of Cell 7.
- 6) Repair the erosion rill and rodent burrow noted adjacent to the riprap channel located on the closed landfill.
- 7) Install a suitable sealant in the crack in the concrete lined section of the west pond, located above the leachate discharge pipe.
- 8) Continue with plans to repair the small liner leaks in leachate pond 002.

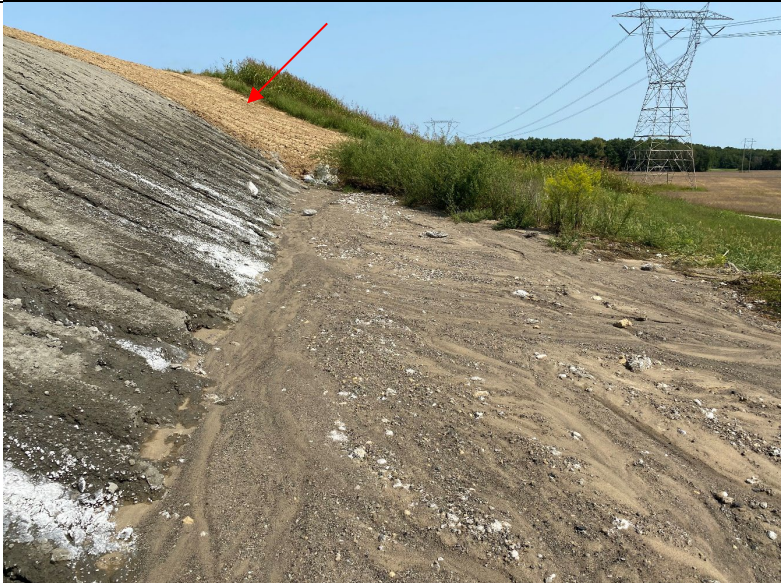
Photograph 10:

6. There was evidence of overtopping of the containment berm on the south side of Cell 2. A small ash delta was observed in the grass cover outside the containment berm. The limits of the ash delta were contained within the permitted landfill boundary. Erosion features inside the limits of the ash have already been repaired.

View of the containment berm on the south side of Cell 2. Notice the ash delta has overtopped the containment berm. The area noted by the red arrow was an erosion feature that was already repaired.

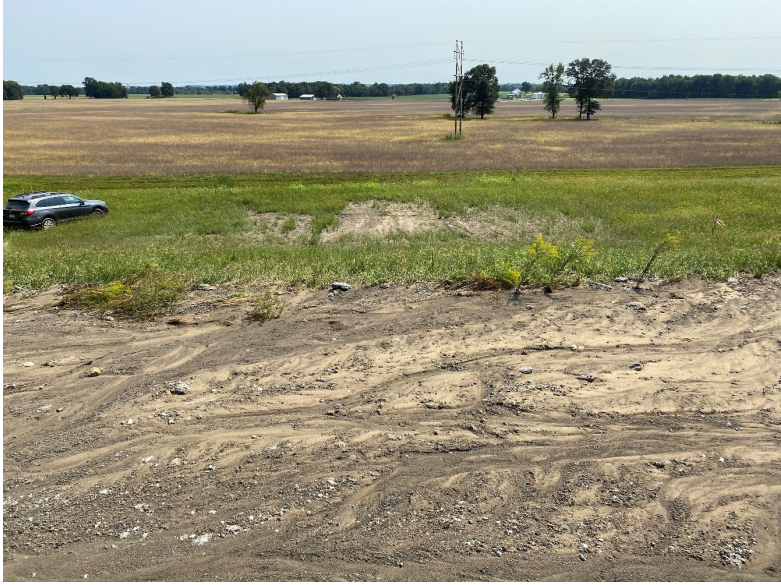
Photograph 11:  
View showing  
evidence of ash  
delta in the grass  
cover, but within  
the landfill  
boundary.

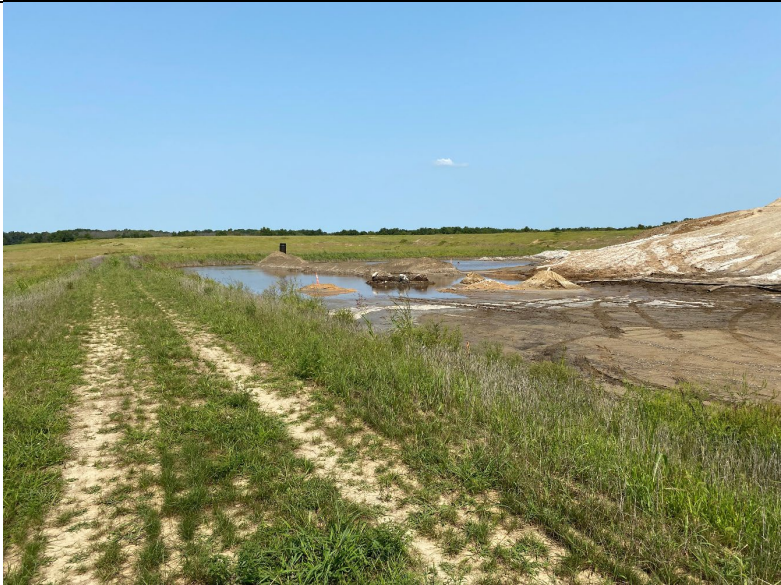
1. A 10-foot tall soil containment berm has been constructed along the northern edge of Cell 1A in 2021. Standing contact water was observed along the south side of the berm, between the berm and ash.

Photograph 12:  
View showing standing  
contact water between the  
soil berm and ash in Cell  
1A.

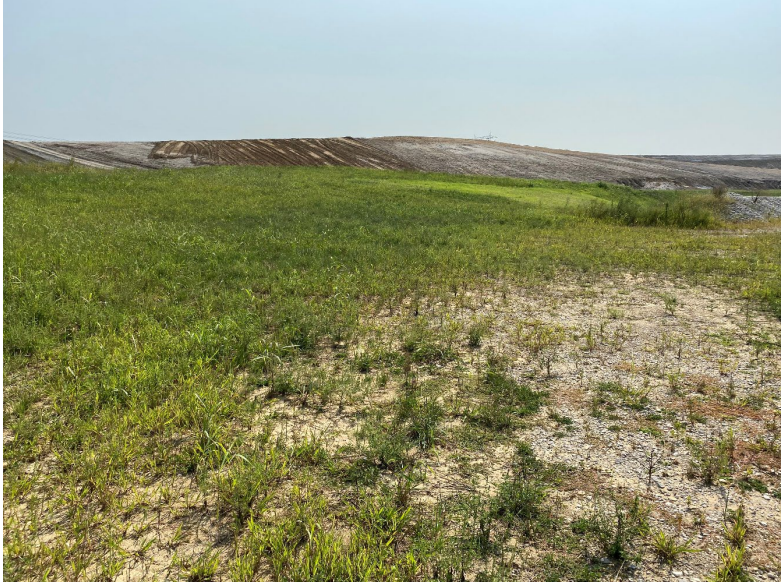
Photograph 13:

1. The inactive landfill cells 4B, 6 and 7 were in good condition. The vegetative cover was well established and in good condition.
2. Repairs to the intermediate berm were recently completed in 2021 a leachate seepage deficiency. Grass cover was well established and there were no signs of leachate seepage in this area.

View showing the leachate seepage outbreak area that was repaired in 2021.

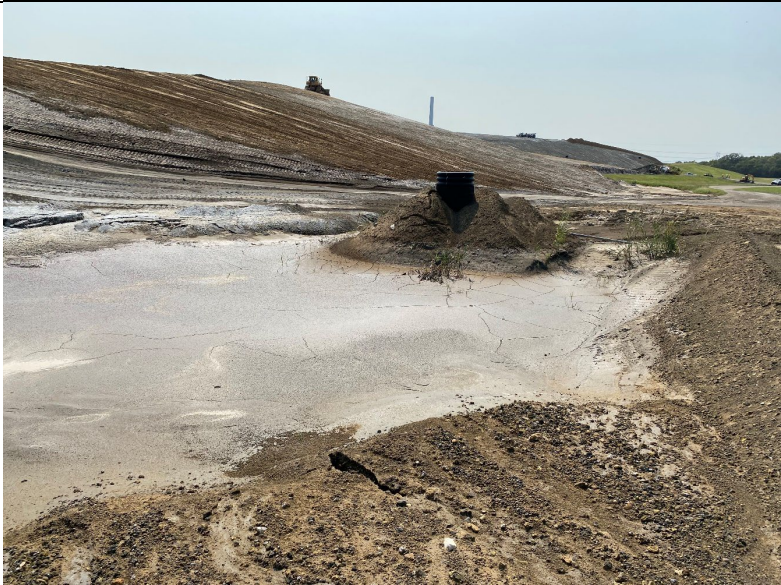
Photograph 14:

3. The chimney drains appear to be functioning as designed and there was some pooling of water around the drains and appeared to be related to topography/grade.

View of a chimney drain near Cell 1A.

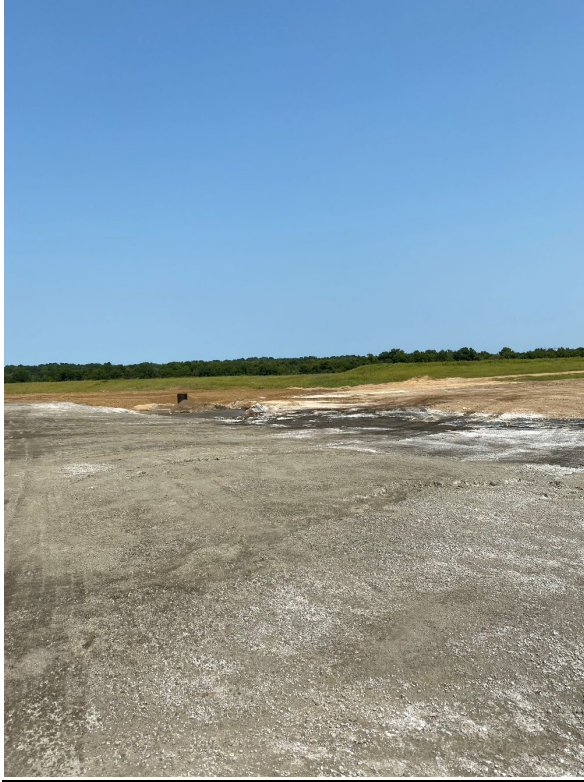
Photograph 15:

2. During the inspection, ash was being placed in the active disposal areas. Bottom ash from the cleanout of the East Bottom Ash Pond was drying out in areas of the active landfill. Soil from a 1-foot deep cut below the top of ash from the East Bottom Ash Pond was being placed to supplement near future temporary soil cover.

View of the active placement waste area.
