2022 Annual Dam and Dike Inspection Report

Bottom Ash Pond Complex

**Rockport Plant
Indiana Michigan Power Company
Rockport, Indiana**

Document ID: GERS-22-022

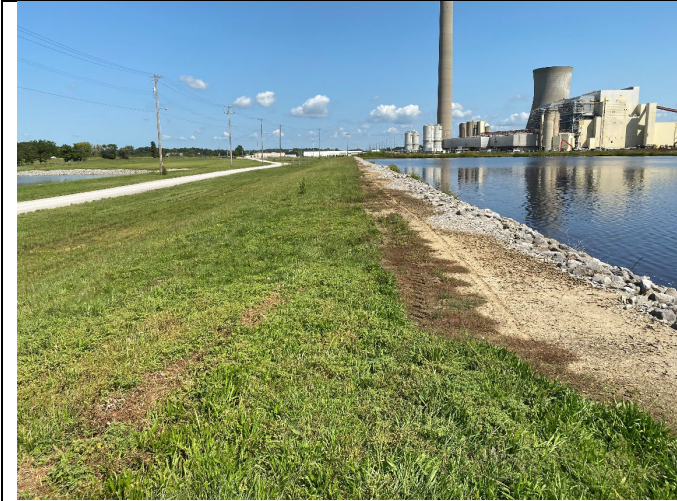
Photograph 1: #W

7. The crest of the west dike appeared in good and stable condition with no signs of distress such as settlement or ruts, and no erosion.
8. The primary discharge structure was in good condition and functioning properly. Flow was entering from all 3 sides of the box weir structure. The skimmer structure was in good condition. Vegetation is growing on the inside of the skimmer structure.

View of the crest of the west dike of the West Bottom Ash Pond.

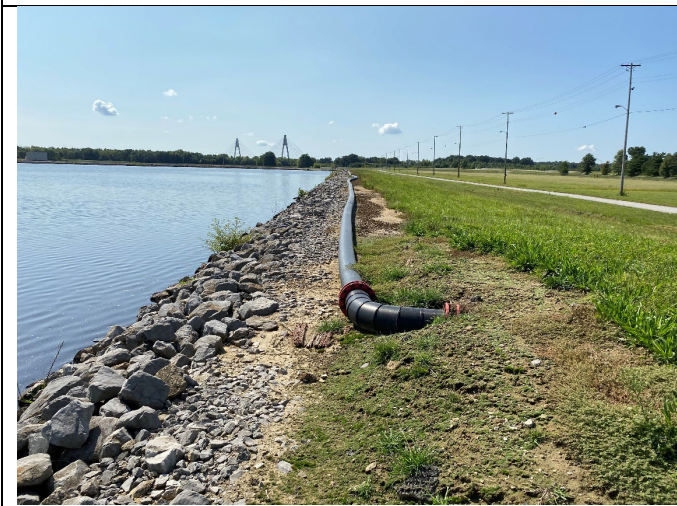
Photograph 2: #W

Another view of the crest of the dike of the West Bottom Ash Pond.

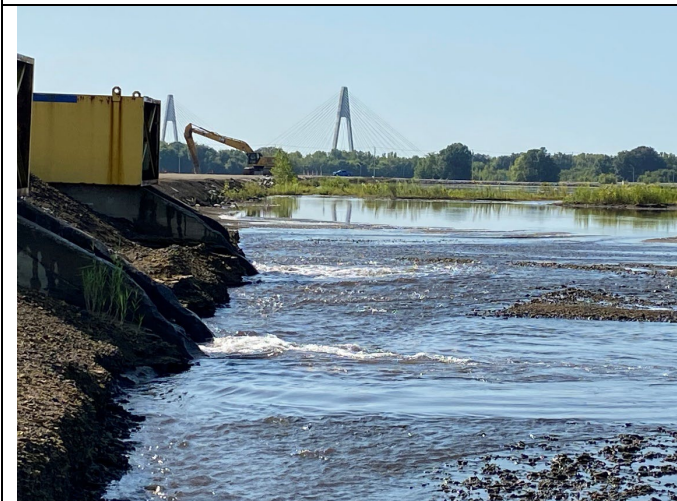
Photograph 3: #W

1. The WBAP was in operation during the time of the inspection. The diverter discharge structure was configured to allow all CCR flow to enter the WBAP. The concrete portion of the structure showed signs of wear but is in fair condition. The pool was at elevation 396 msl, which is at the maximum operating level.

View of the influent structure at the West Bottom Ash Pond.

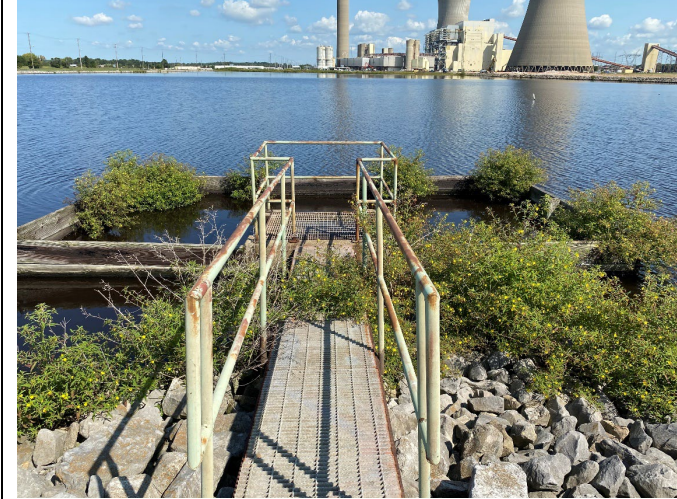
Photograph 4: #W

View of the inlet of primary discharge structure for the West Bottom Ash Pond.

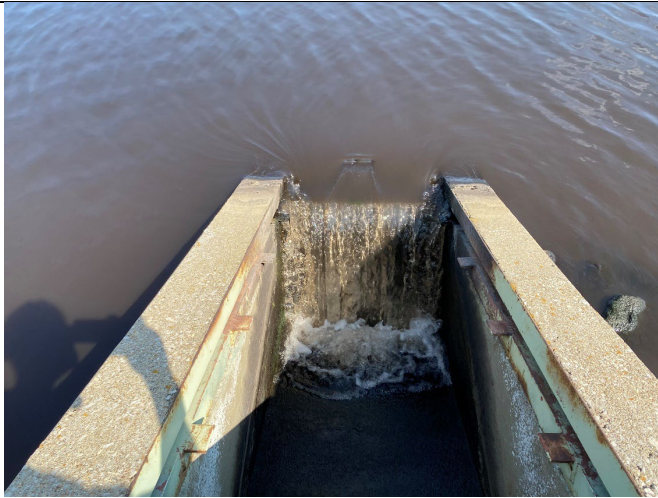
Photograph 5: #W

View of flows entering into the low level discharge structure of the West Bottom Ash Pond.

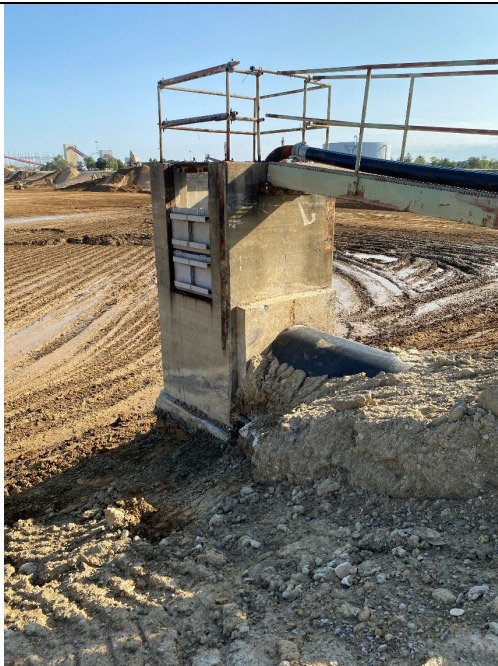
Photograph 6: #E

5. The low-level discharge structure has been permanently plugged with grout and partially demolished.
6. The primary discharge structure was in good condition and normally submerged components could be inspected. There were signs of corrosion noted along the stop log seals that are embedded in the concrete walls of the structure. The skimmer structure has been demolished.

View of the primary discharge structure for the East Bottom Ash Pond.

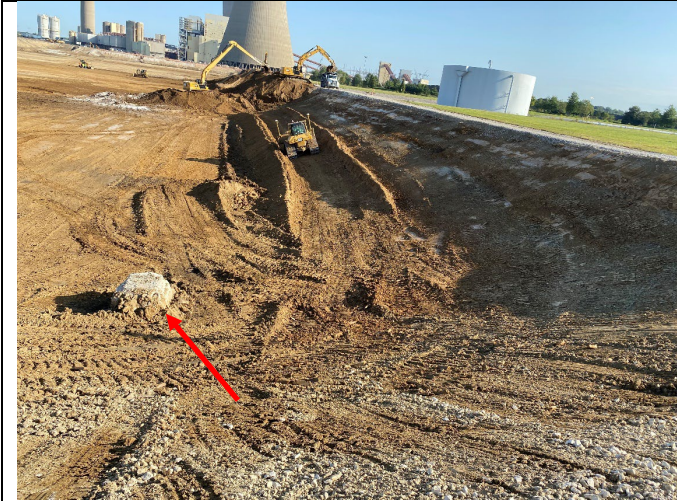
Photograph 7: #E

View the interior slope of the EBAP, the plugged and partially demolished low level discharge structure noted by the red arrow.

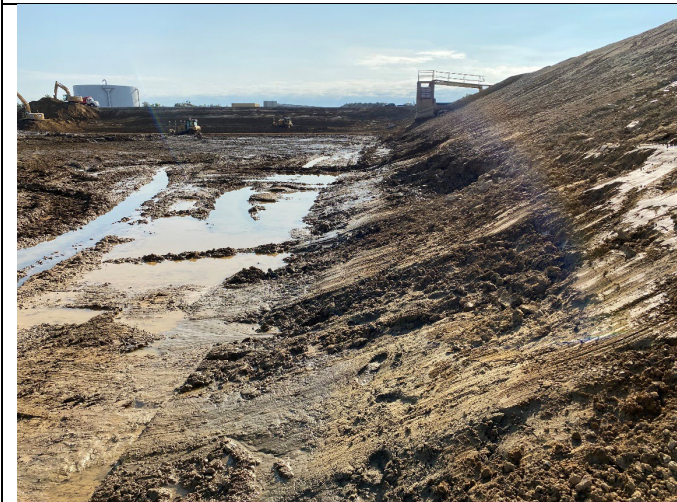
Photograph 8: #E

4. There was evidence of seepage though the splitter dike separating the East Bottom Ash Pond and East Waste Water Pond. The soils at the toe of the slope and across the southern quarter of the EBAP were soft and saturated. The seepage was diffused over a wide area, making flow rate estimates difficult.

View of the soft, wet areas at the toe of splitter dike separating the East Bottom Ash Pond and East Wastewater Pond.

- 2) Monitor the seepage at the toe splitter dike at the southern end of the EBAP, until this issue is addressed by the retrofit project.
- 3) Monitor the fiberglass pipe between the Reclaim Pond and the Clearwater Pond for signs of soil migration through the open joints.

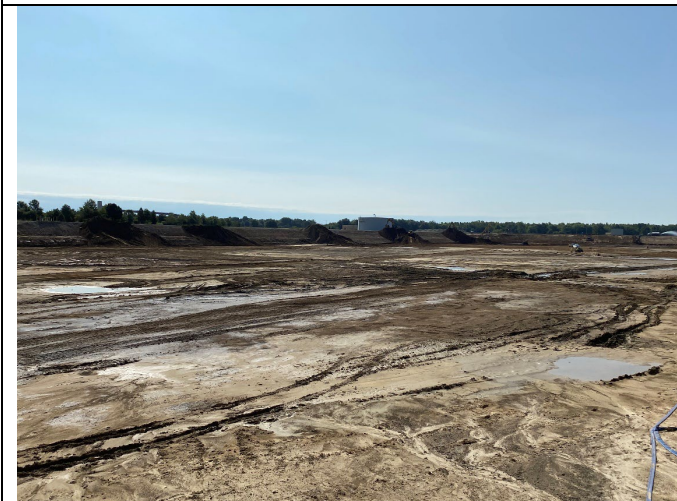
Photograph 9: #E

View of the pond bottom of the East Bottom Ash Pond.

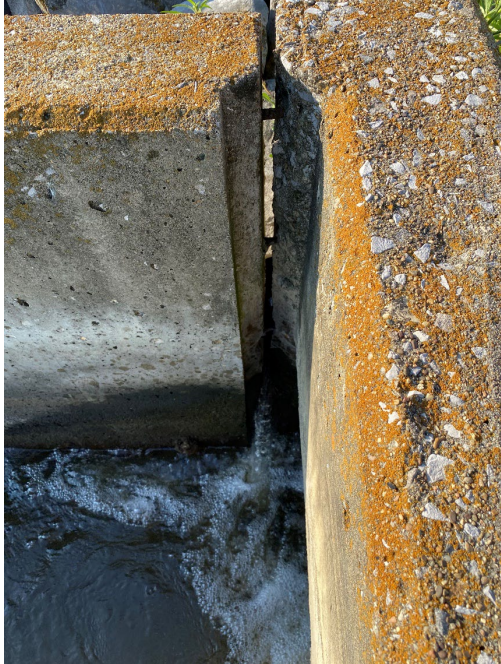
Photograph 10: #EW

6. The separation of the rectangular concrete weir channels in the EWWP does not appear to be any different from the conditions noted in previous inspection reports. During this inspection, a white line was marked at the joint to observe any additional movement.

View of the separated joint at the weir channel located inside the East Wastewater Pond

- 5) Monitor the offset joint at the discharge structure for the East Wastewater Pond. A permanent white reference line has been placed at the joint to identify any future movements.

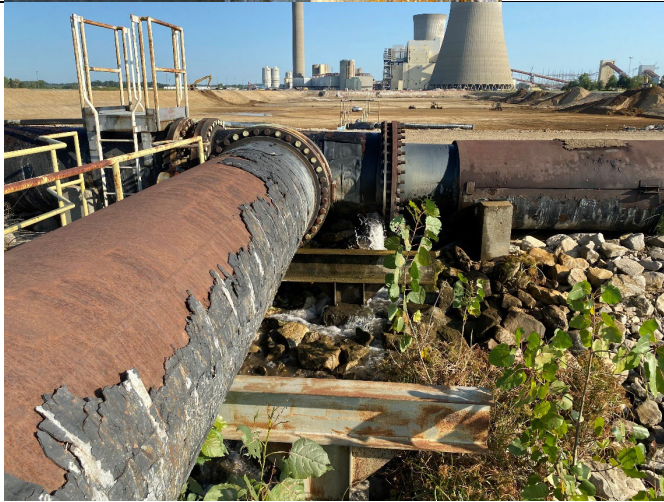
Photograph 11: #EW

3. The 42-inch-diameter header pipe running along the north side of the wastewater ponds was observed to have a leak near the outlet of the EBAP primary discharge structure. The leakage flows across the interior slope riprap and into the EWWP. The pond water in this immediate area of the EWWP did appear to have a slightly different coloration and could be sign that erosion is occurring due to the leaking header pipe. A sand delta appears to have accumulated within the pond where the flows from the leaking pipe enter into the pond.

View of the leaking 42-inch header pipe, flowing into the EWWP.

- 5) Repair the leaking header pipe running along the surface of the splitter dike between the wastewater pond and the bottom ash ponds.
- 6) Replace the lid to Manhole 13-F. Consider installing an open-grated lid at this manhole to allow surface drainage from the cropland area.

- 4) Monitor the interior slope of the East Wastewater Pond in the area of the leaking header pipe for signs of erosion. There are nearby discharge structures and walkway platforms that may complicate repairs to the interior slopes in this area.

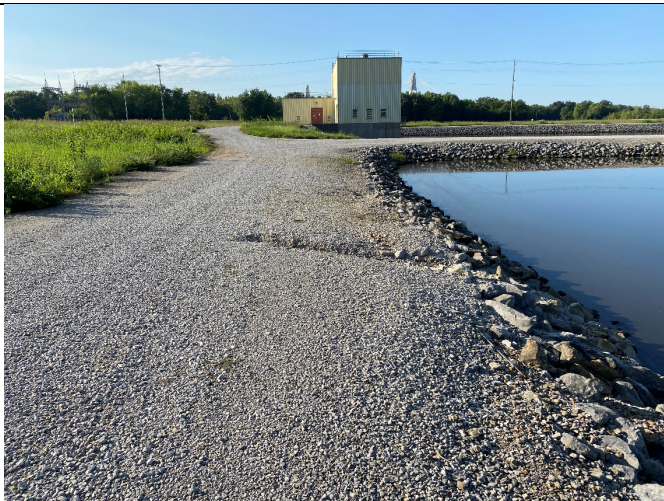
Photograph 12: #EW

7. The EWWP and WWWP are incised impoundments.
8. A 6-inch-deep erosion rill was observed in the crest of the East Waste Water Pond.

View of erosion rill on the crest of the East Wastewater Pond.

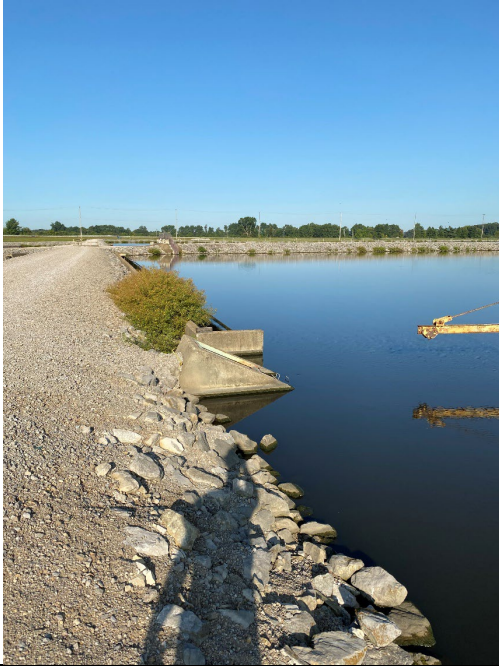
Photograph 13: #WW

View of the discharge structures in the West Wastewater Pond. Note the vegetation present by the skimmer structure.

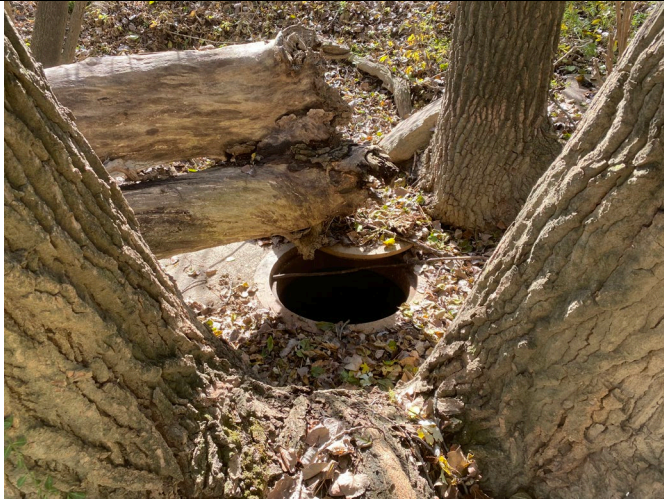
Photograph 14: #Clearwater

Manhole 13-F was found with the lid removed, and it appears the lid may have been removed by nearby farmer to provide surface drainage to cropland. This was found during the last inspection, and subsequently the manhole was closed by Rockport plant staff. However, the manhole has been removed once again.

View of the removed manhole lid at 13-F.

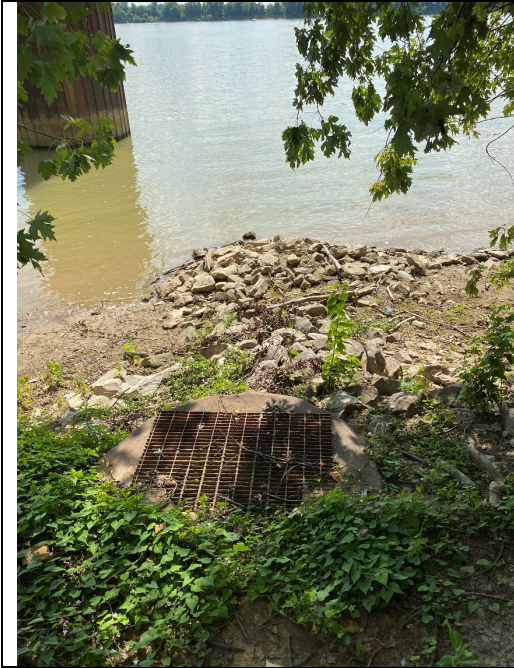
Photograph 15: #Clearwater

View of the final outlet for the pond complex into the Ohio River.

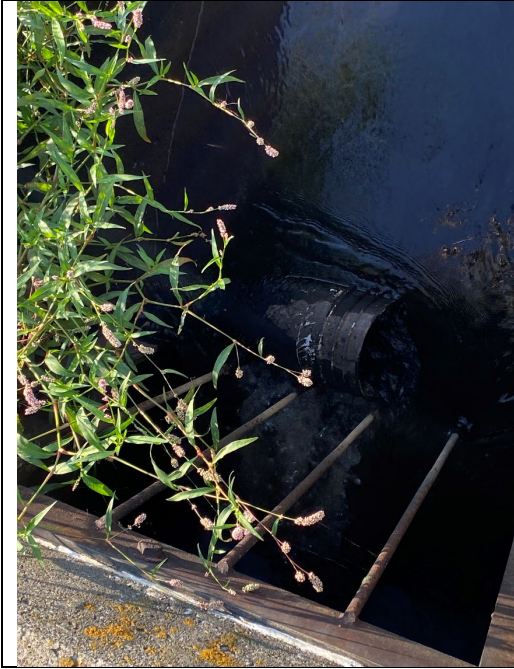
Photograph 16: #Clearwater

6. The outlet structure of the Clearwater Pond was in fair condition. A 5 bucket was observed to be trapped against the trash rack bars, slightly obstructed flows. The skimmer board and weir structure was in fair condition, however, several of the steel brackets were broken and few of the wood timbers are rotten. Some vegetation was growing inside the skimmer structure.

View of bucket trapped against the trash bars at the discharge structure of the Clearwater pond.

- 3) Repair the loose angle iron in diverter structure for the bottom ash ponds.
- 4) Remove the bucket from the trash bars at the Clearwater Pond Discharge structure.

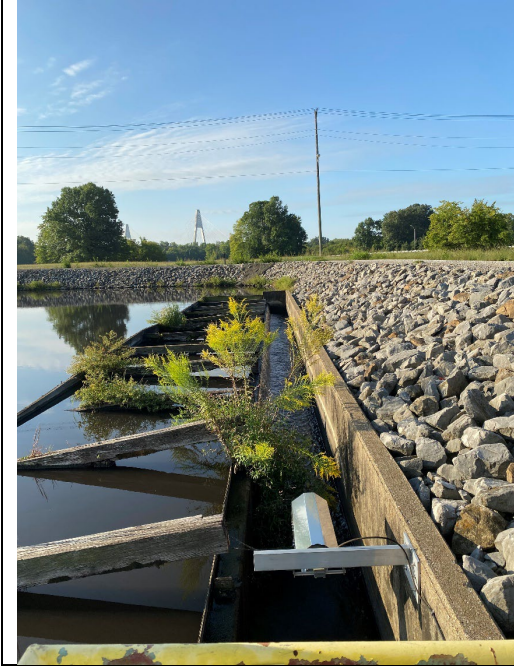
Photograph 17: #Clearwater

View of the skimmer structure of the Clearwater pond.

- 1) Continue with the vegetation maintenance & mowing efforts at the facility.
- 2) Consider repairing the deteriorated skimmer structure at the Clearwater Pond discharge structure.
