2023 Annual Dam and Dike Inspection Report

Bottom Ash Pond Complex

Mitchell Plant

Document ID: GERS-23-008

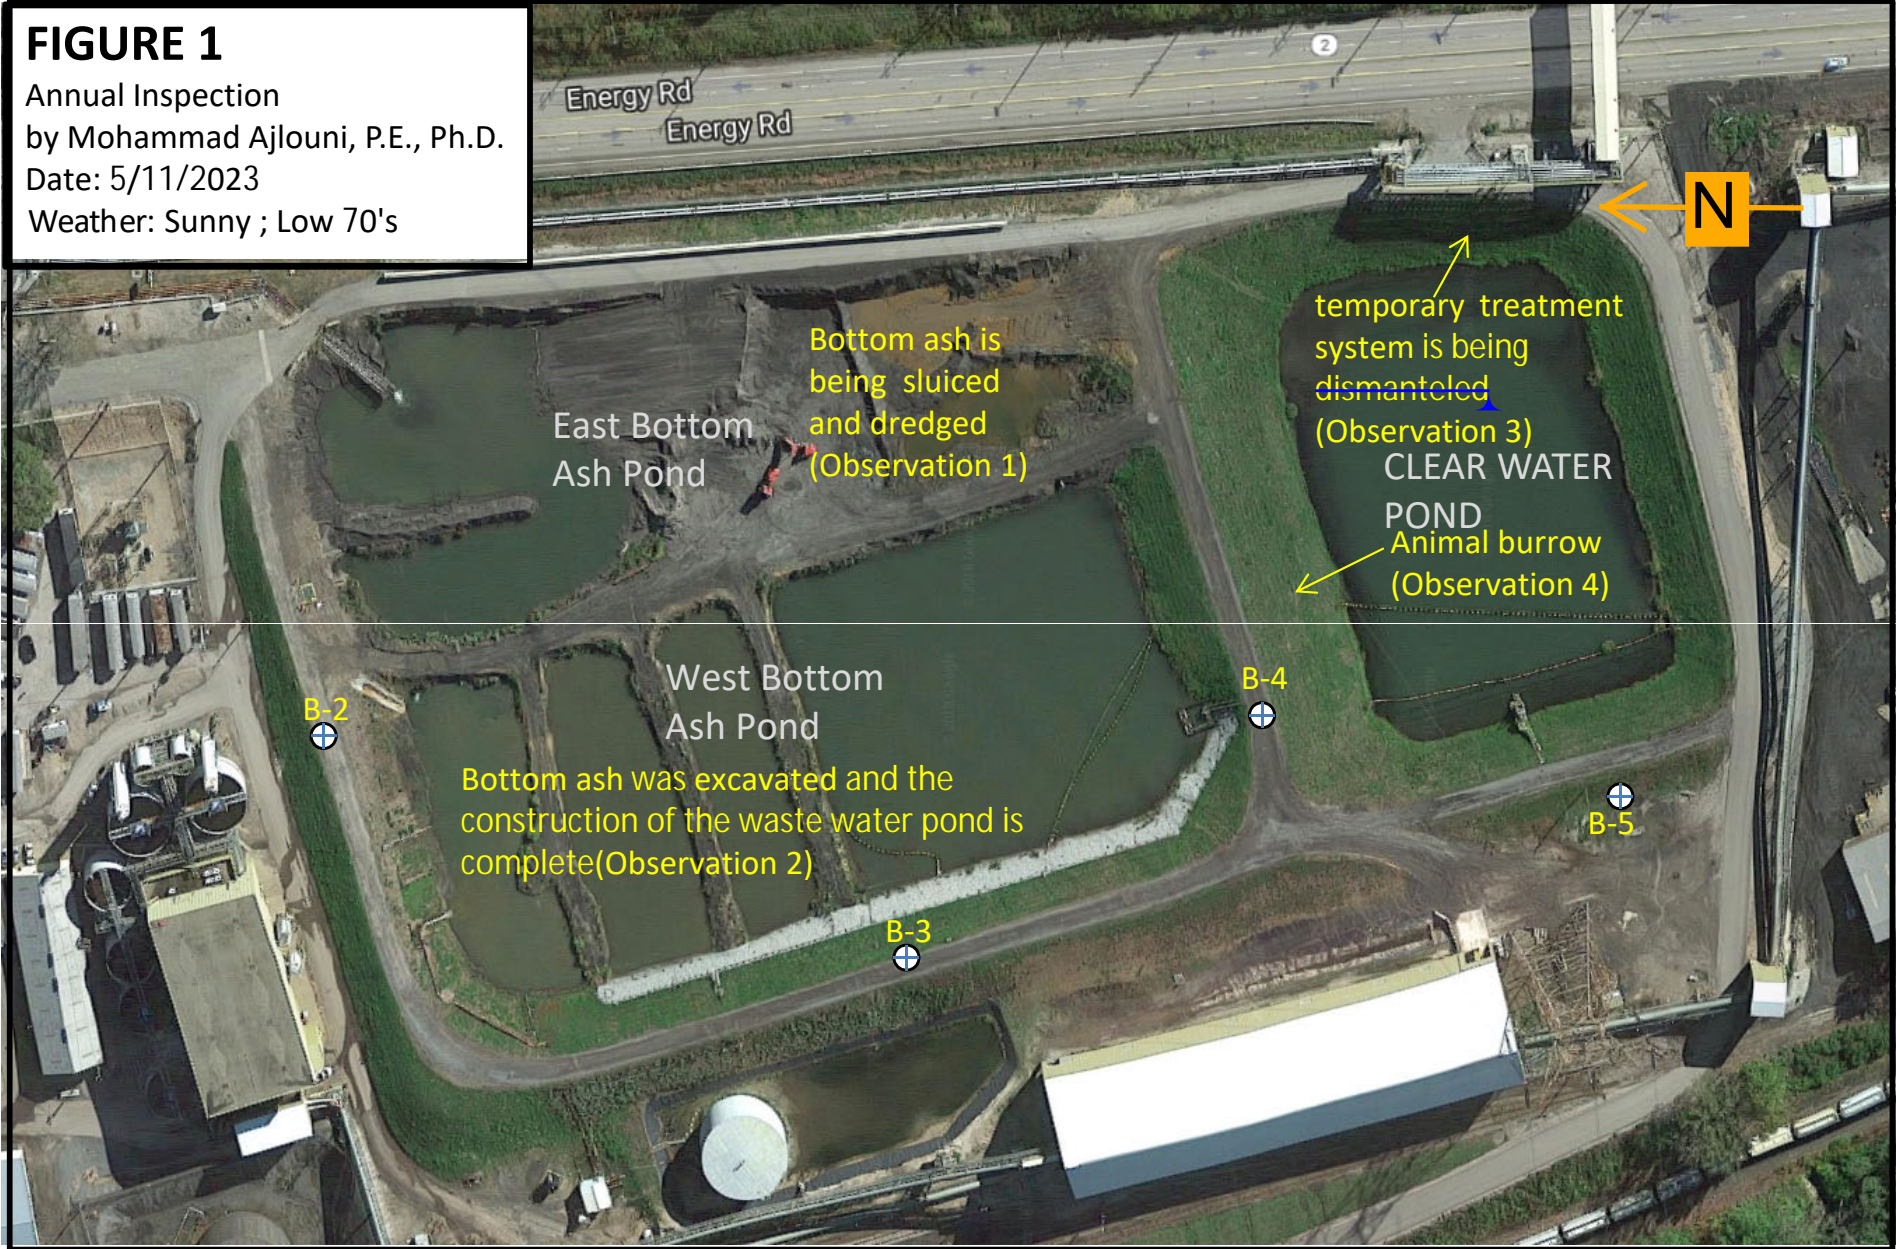
FIGURE 1

Overall, the facility is in good condition. The impoundment is functioning as intended with no signs of potential structural weakness or conditions which are disrupting to the safe operation of the impoundment. Inspection photos are included in Attachment A. Additional pictures taken during the inspection can be made available upon request. A map presenting locations of the inspection observations is included in

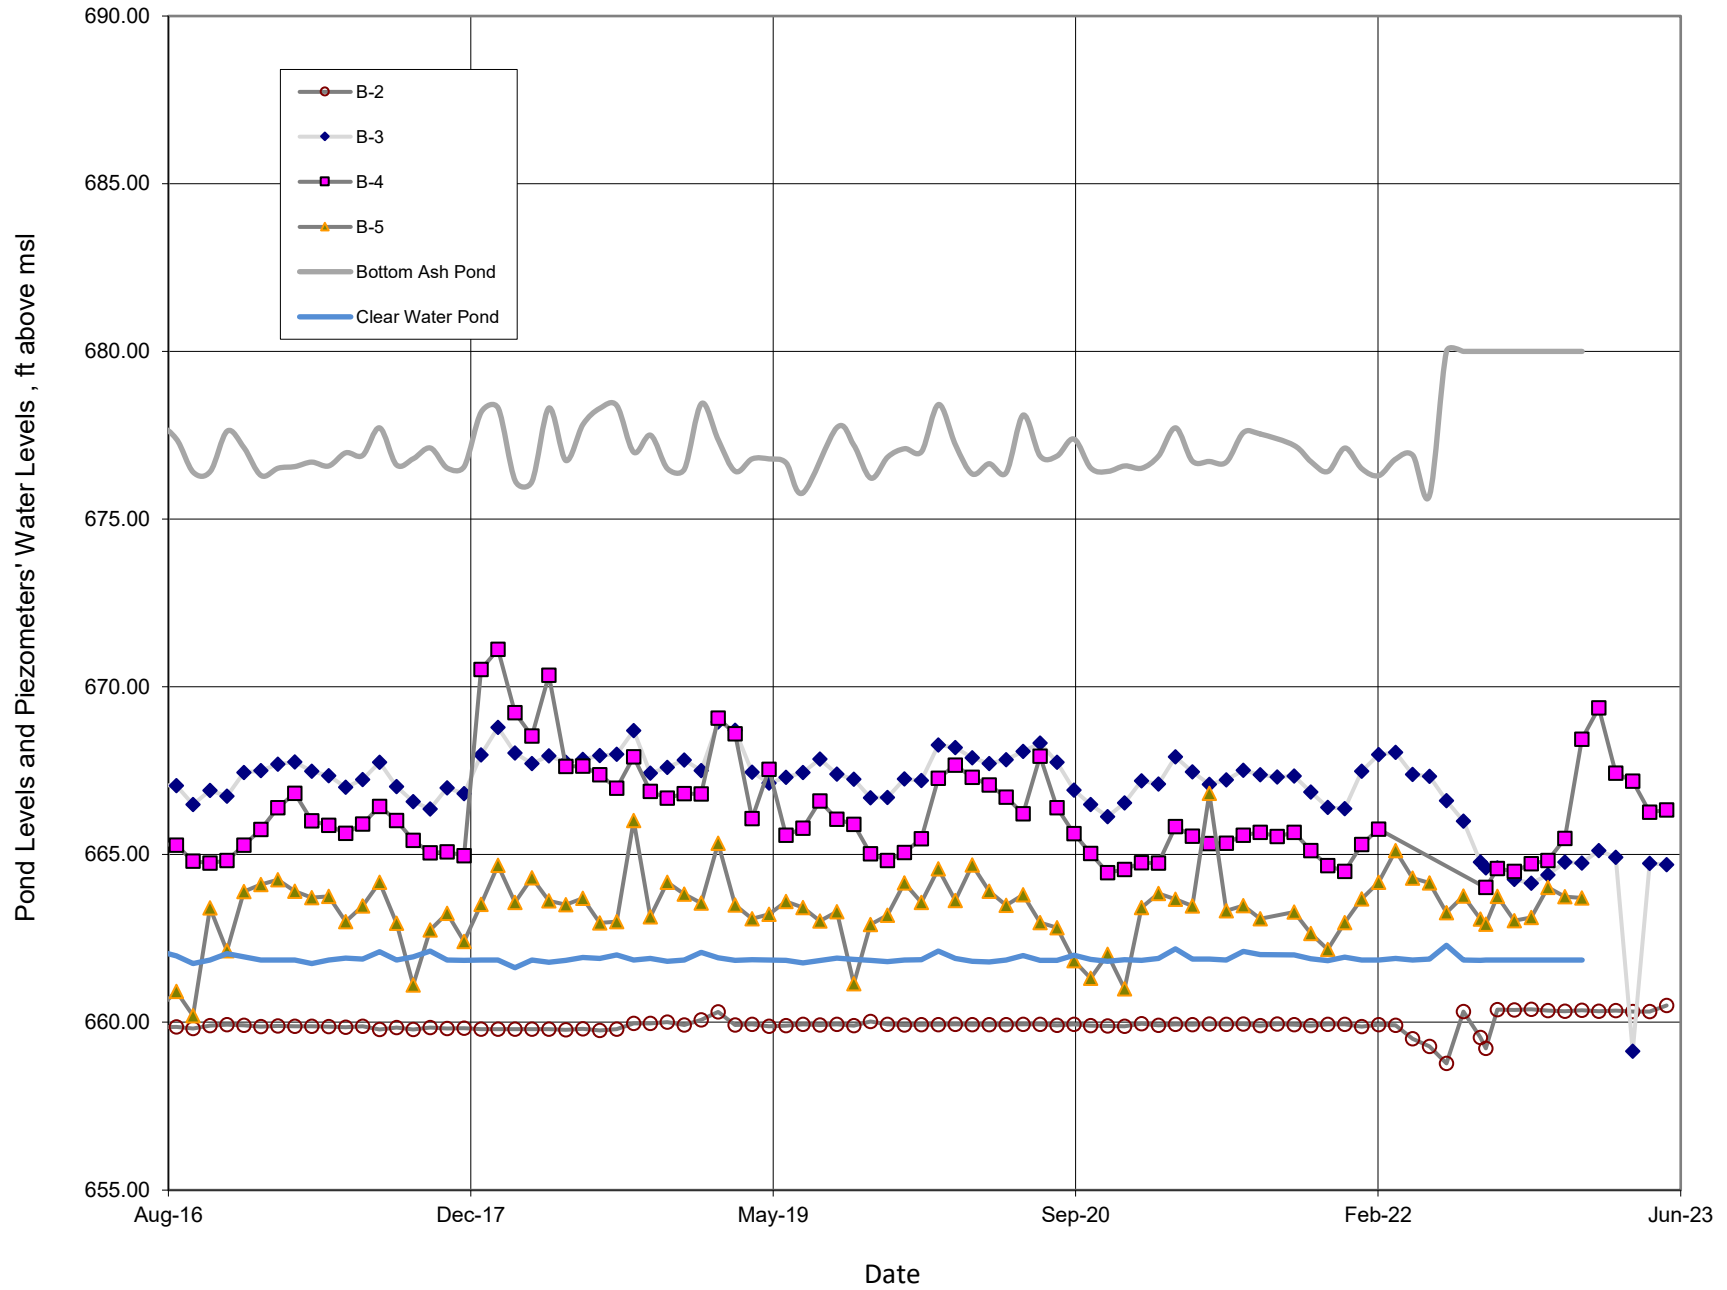
Figure 2 Bottom Ash Pond Complex Piezometers' & Ponds Level

Figure 2 presents the pond water levels as well as the piezometers water levels. Changes in piezometers levels does not appear to be affected by the bottom ash pond level because of the presence of the PVC liner.

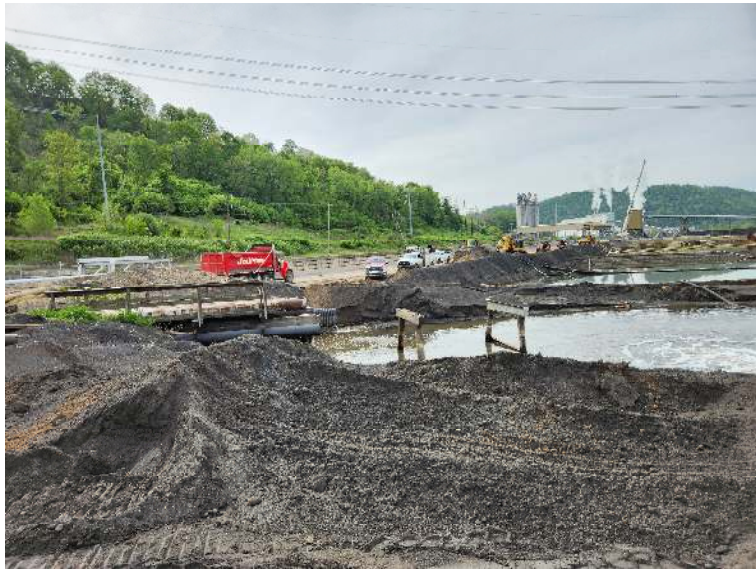
Photo No. 1

Observation 1: Construction Activities

Location: East inboard slope of the East section of Bottom Ash Pond looking south.

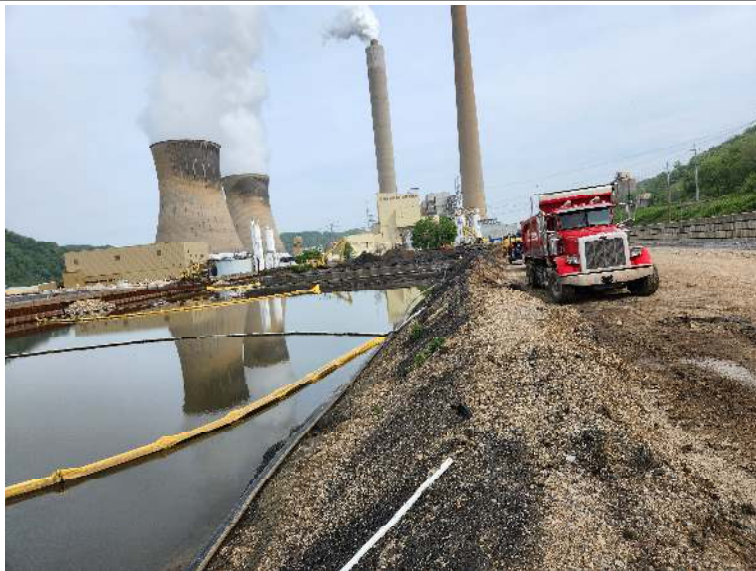
Photo No. 2

Observation 1: Construction Activities

Location: East inboard slope of the East section of Bottom Ash Pond looking north.

Bottom ash is being dredged

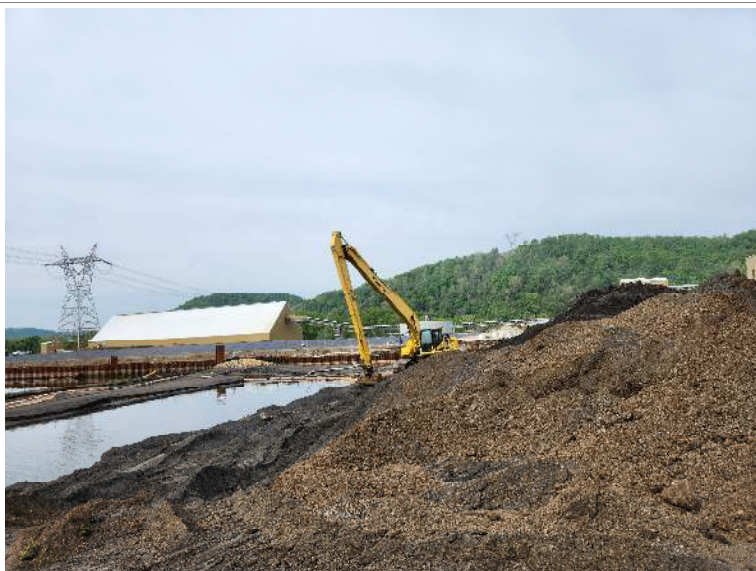
Photo No. 3

Observation 1: Construction Activities

Location: North inboard slope of the East section of Bottom Ash Pond looking west.

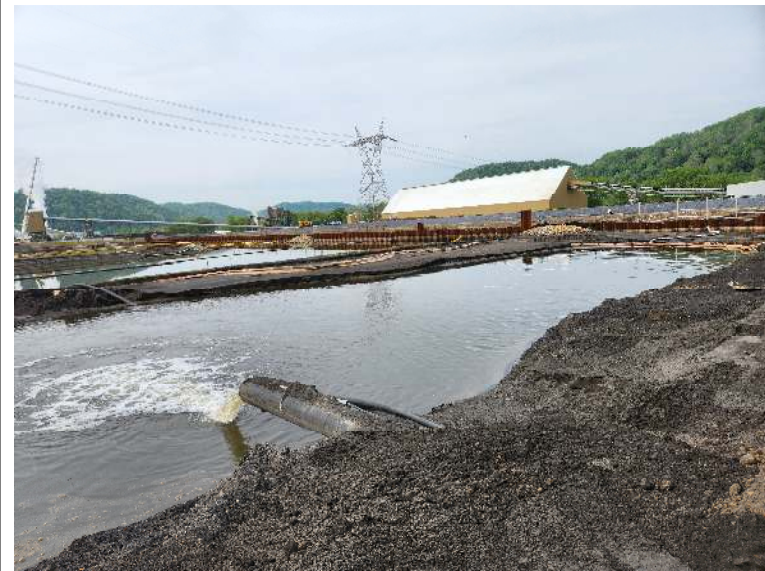
Photo No. 4

Observation 1: Construction Activities

Location: West inboard side of the East section of Bottom Ash Pond looking Southwest.

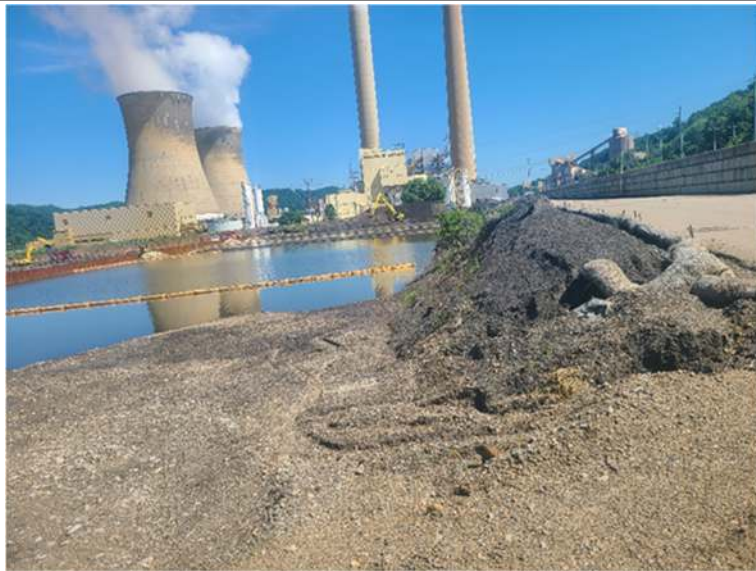
Photo No. 5

Observation 1: Construction Activities

Location: East inboard side of the East section of Bottom Ash Pond looking North.

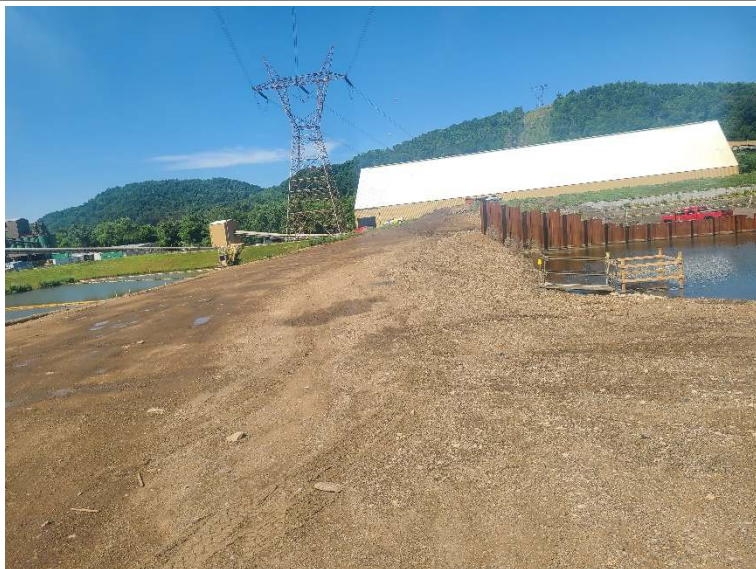
Photo No. 6

Observation 1: Construction Activities

Location: South inboard side of the East section of Bottom Ash Pond looking West.

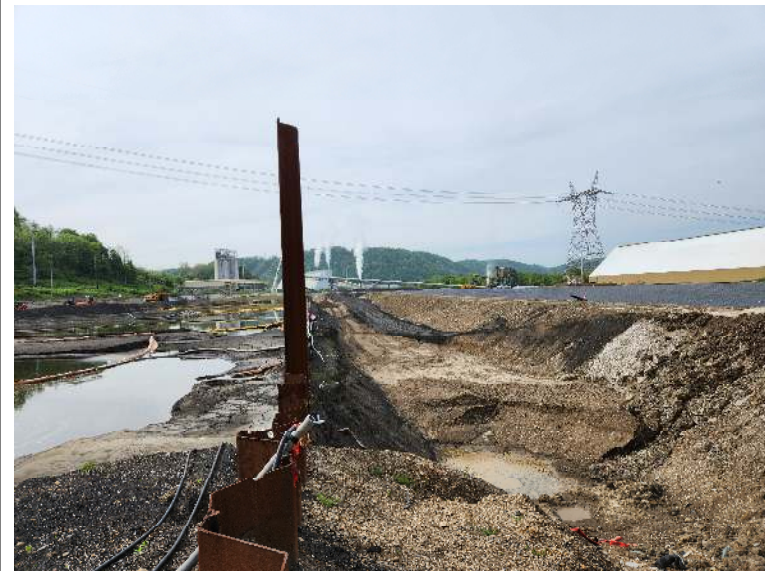
Photo No. 7

Observation 2: Construction Activities

Location: West inboard side of the West section of Bottom Ash Pond looking South.

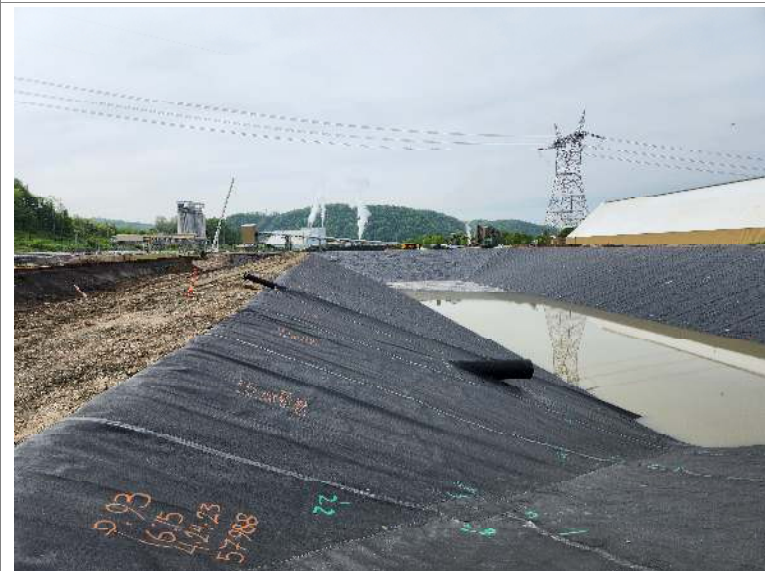
Photo No. 8

1. The Bottom Ash Pond was in service at the time of the inspection. Plant inflows were entering the pond along the northeast side. The pool was at an elevation of 680 which is around its normal operating level. Construction activities related to the bottom ash pond repurposing included splitting the BAP into east and west segments by installing sheet pile along the central part of the pond from the north to the south directions.
2. The east portion of the pond is used for dewatering and removal of sluiced bottom ash. The dewatering activities were not observed to impact the structure or stability of the dam and the impounding area of the pond appeared in good condition (Photos 1 through 7).
3. The construction of the west portion of the pond was completed and awaiting approval. (Photos 8 through 10).
4. There were no seepage or wet areas observed along the embankment.

Observation 2: Construction Activities

Location: West section of Bottom Ash Pond looking South.

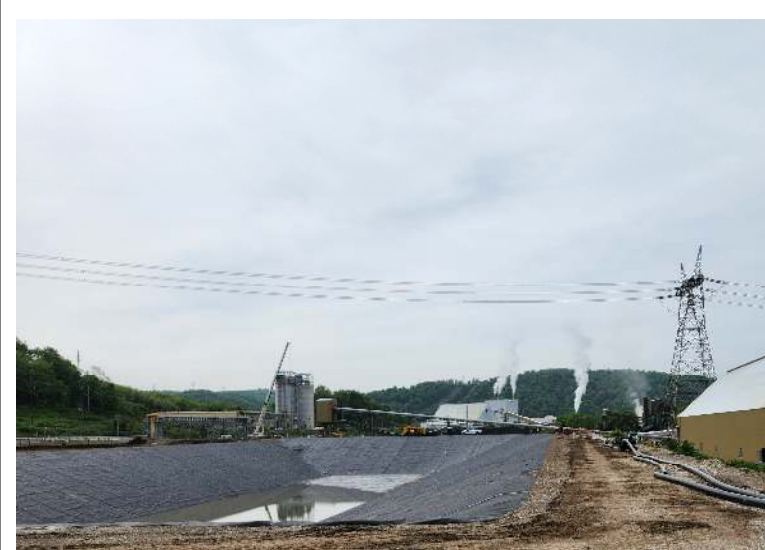
Photo No. 9

Observation 2: Construction Activities

Location: West inboard side of the West section of Bottom Ash Pond looking South.

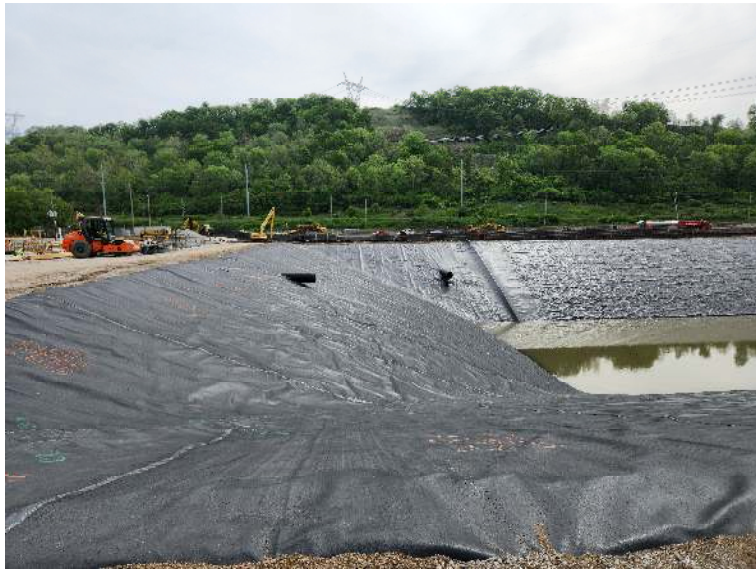
Photo No. 10

Observation 2: Construction Activities

Location: West inboard side of the West section of Bottom Ash Pond looking South.

Bottom Ash excavation

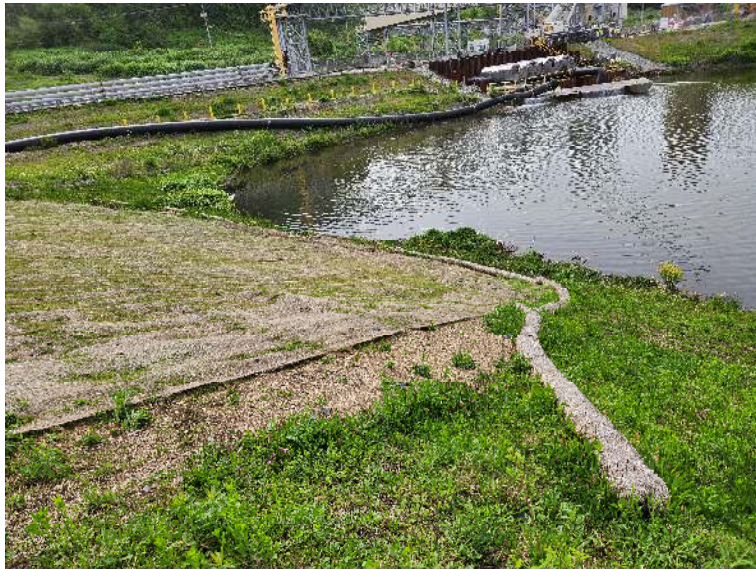
Photo No. 11

1. The Clear Water Pond was in good operating condition during the time of the inspection. Inflows from the East side of BAP enter the pond through the newly constructed temporary treatment system and the flow appeared to be unobstructed (Observation 3, Photos 11 through 13).

Observation 3: Construction Activities

Location: Clear Water Pond looking East.

Installed temporary water treatment Structure is being dismantled

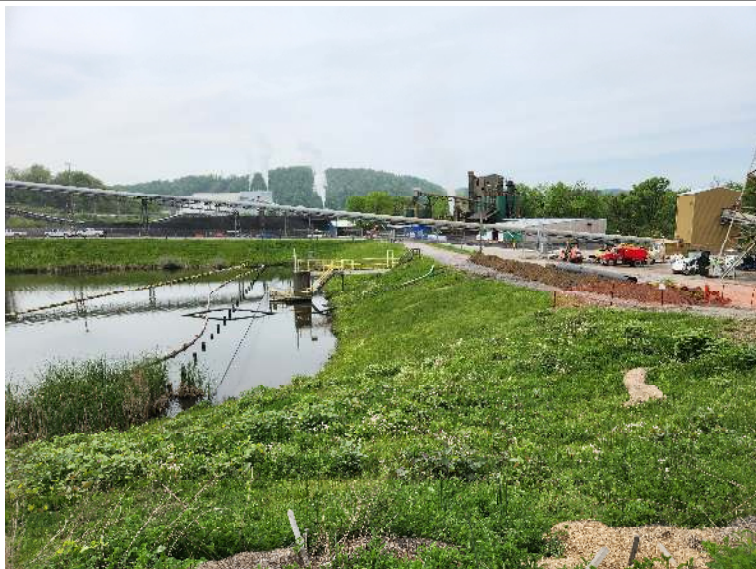
Photo No. 12

Observation 3: Construction Activities

Location: Clear Water Pond west Inboard dike.

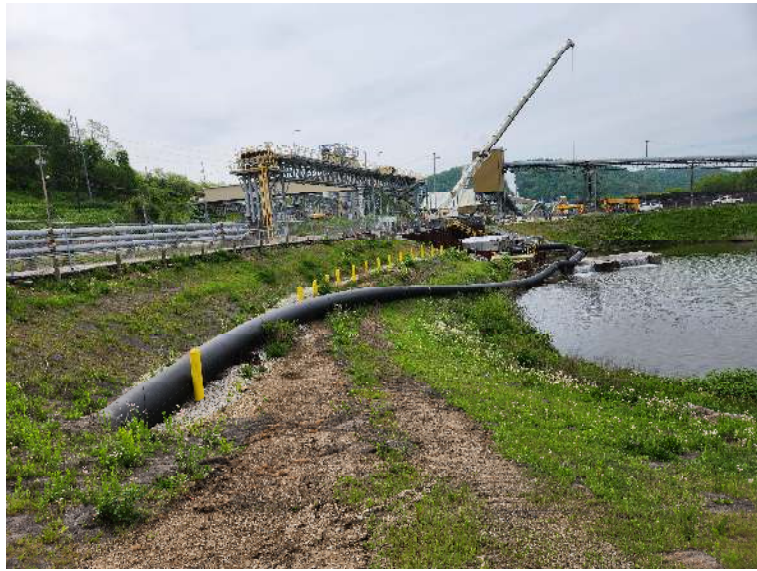
Photo No. 13

Observation 3: Construction Activities

Location: East inboard side of the Clear Water Pond looking South.

temporary treatment system is being bypassed.

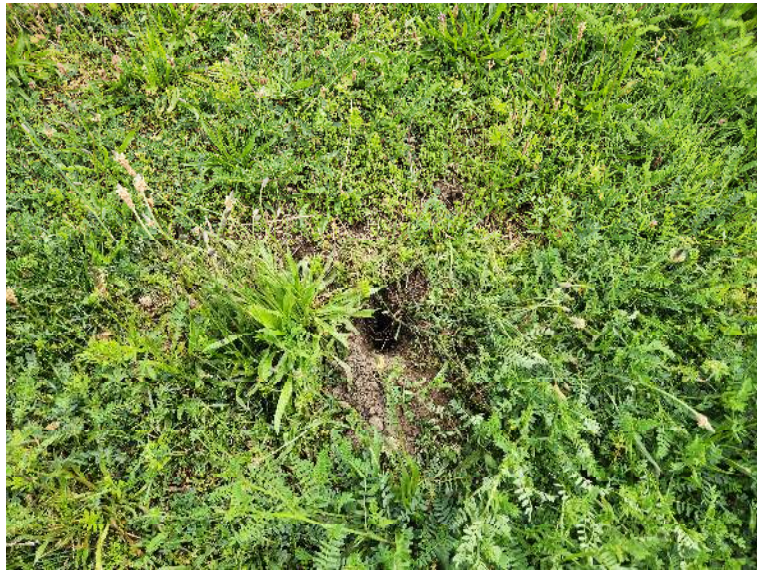
Photo No. 14

2. The interior slopes showed no signs of distress such as sloughing or bulges. The grass was recently mowed before the inspection. One animal burrow was observed during this inspection along the north interior dikes (Observation 4, Photo 14).

Observation 4: Burrow Hole.

Location: North inboard slope of Clear Water Pond

- 1) Repair animal burrows along the north slope of the interior dike of the clear water pond (Observation 4).

Recommendations: Repair by fill in with soil.
