2023 Annual Landfill Inspection Report

**Rockport Plant
Indiana Michigan Power Company
Rockport, Indiana**

Document ID: GERS-23-022

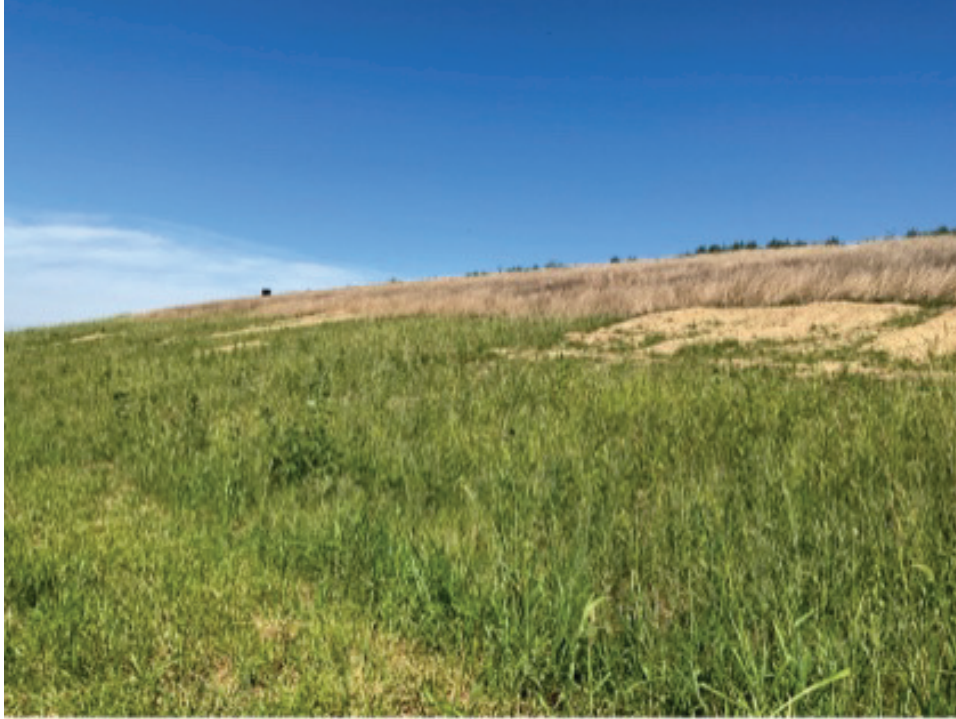
Notes: Erosion repair areas on upper part of south slope of Cell 2 temporary cover

1. Several areas of erosion or poor vegetation were noted in the temporary cover over Cells 1B, 2, & 3. Continue monitoring and repairing these areas.
2. Install a suitable sealant in the crack in the concrete lined section of the west pond, located above the leachate discharge pipe.

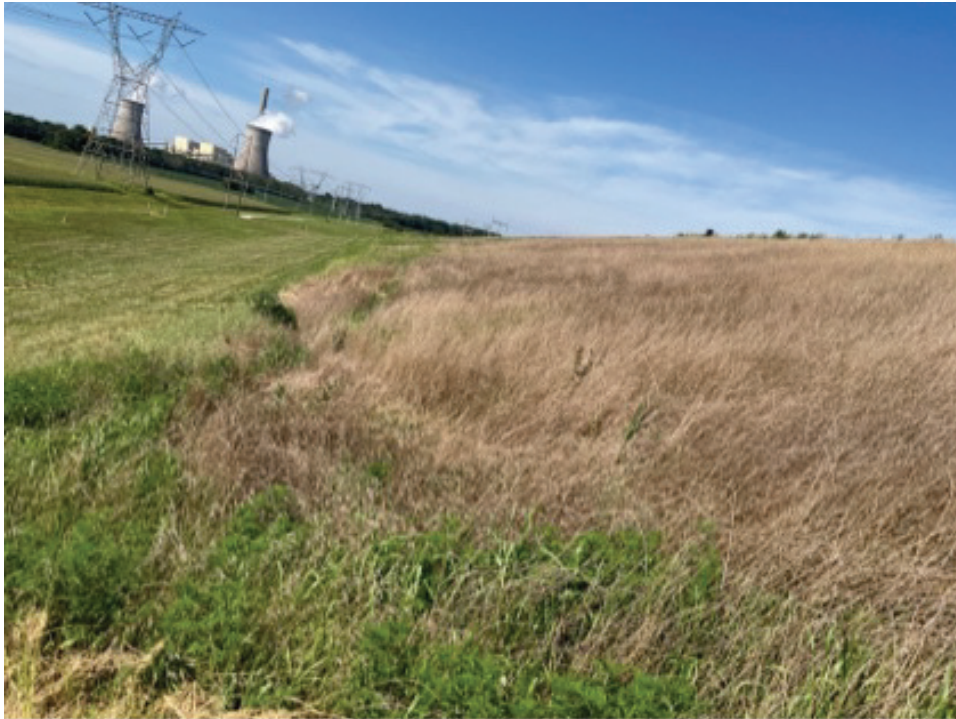
Notes: General condition of temporary cover on cell 1B south slope

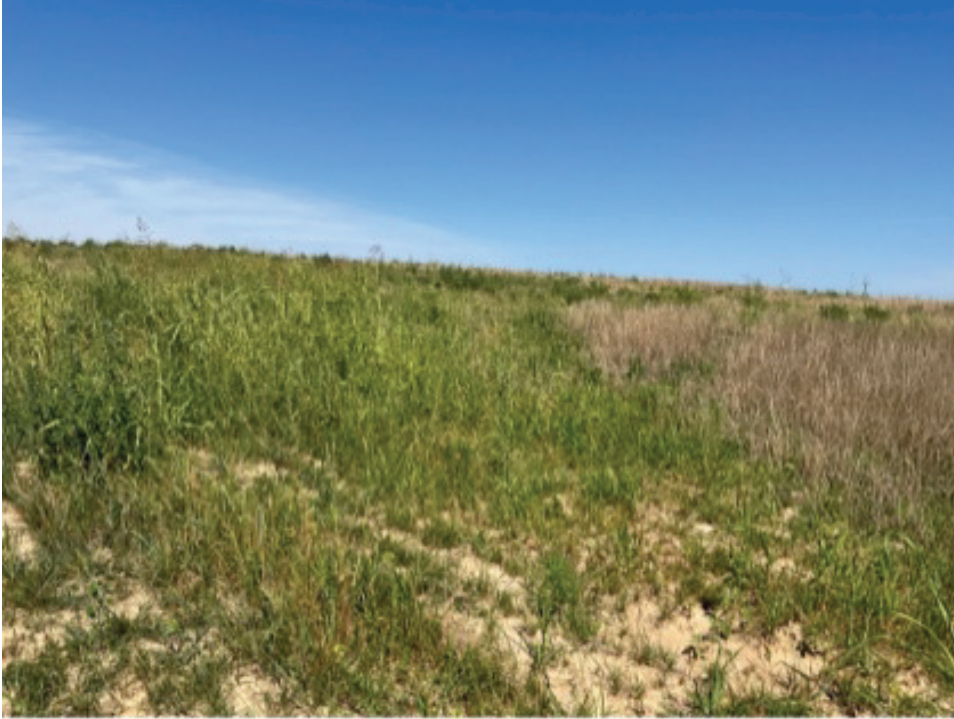
Notes: General condition of cell 1B temporary cover on upper area. Area recently seeded and Grass still high to allow vegetation to establish

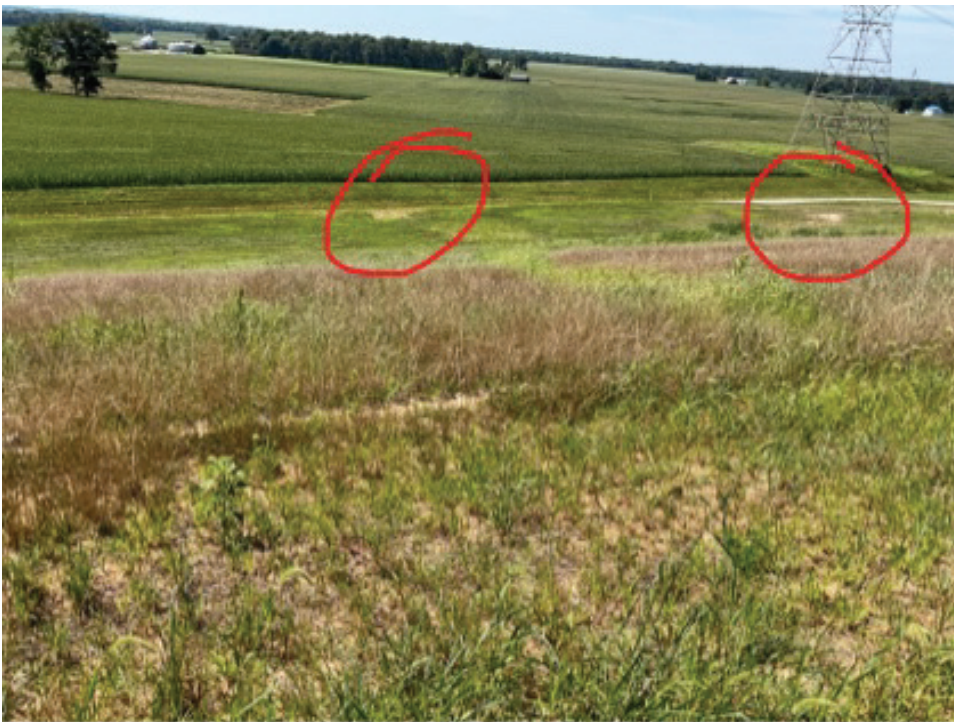
Notes: General condition of cell 2 south slope. Note spots with limited vegetation on the surface of the lower berm.

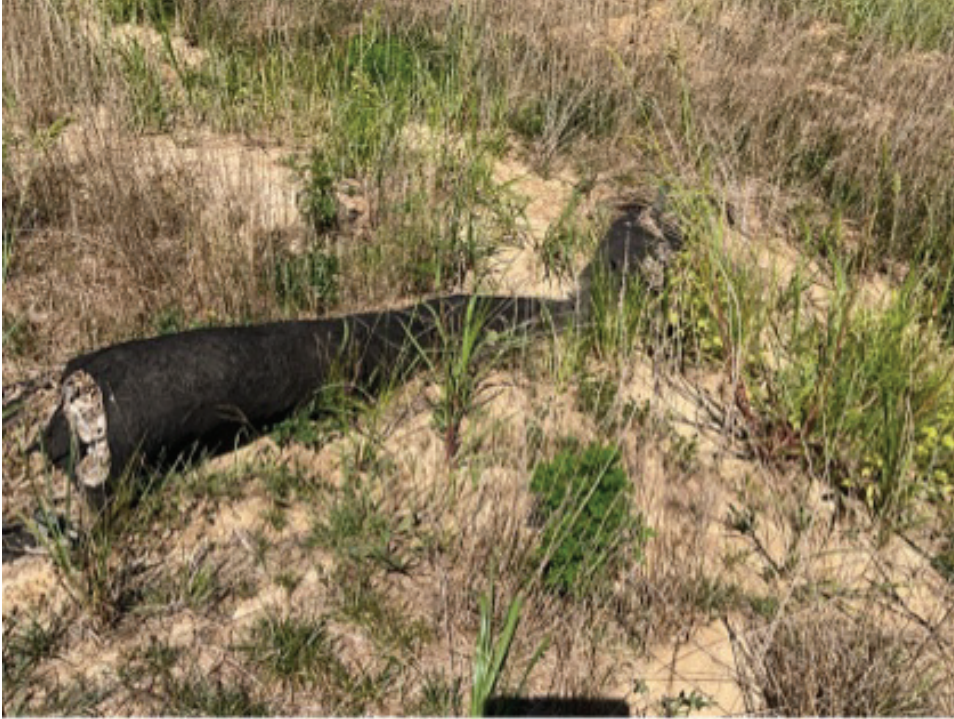
Notes: Erosion around mulch log on temporary cover in cell 2

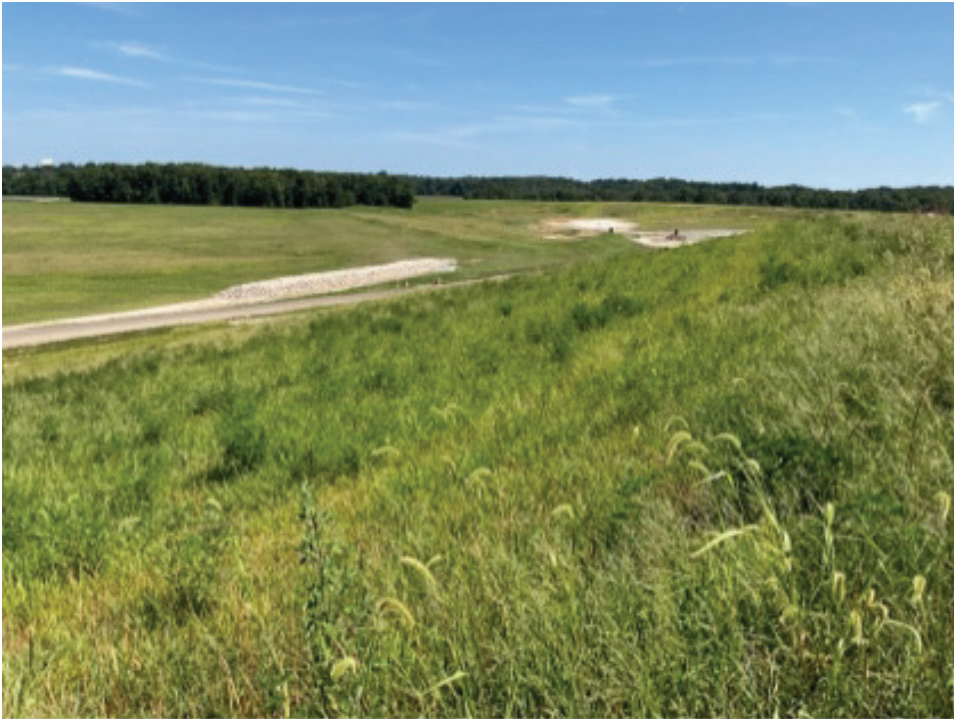
Notes: General condition of temporary cover on north slope of cells 1B & 2.

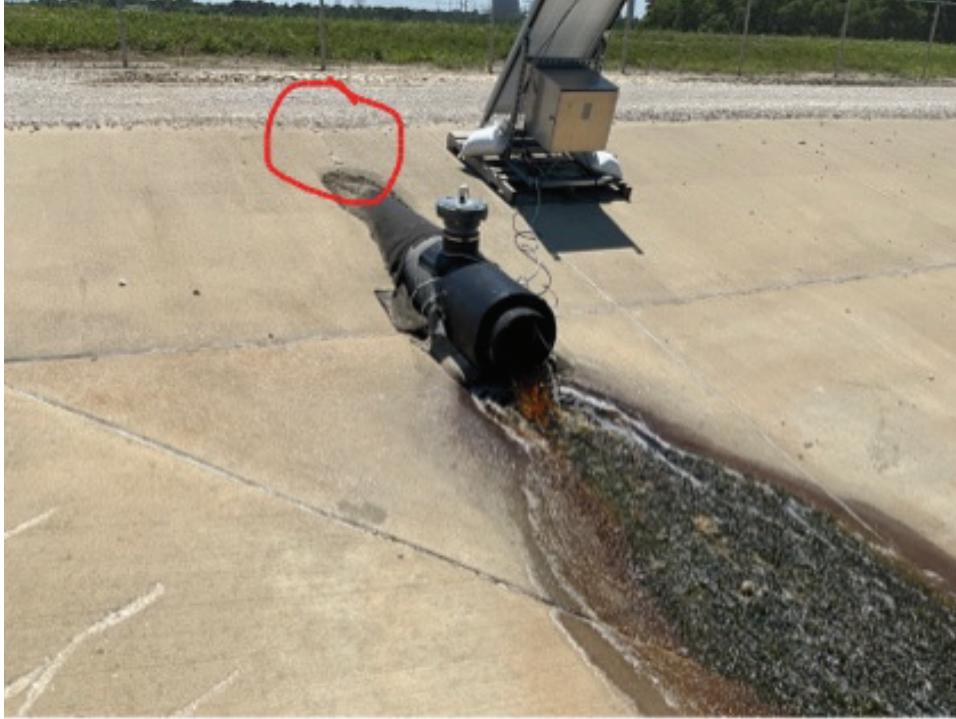
1. The small crack in the concrete liner of the West Pond previously reported was located just above the leachate outlet pipes entering the pond from the south. There appears to be no change in width of the crack from the 2022 inspection.

Notes: West leachate settling pond inlet. Note crack in concrete above pipe. Appears similar to previous inspections

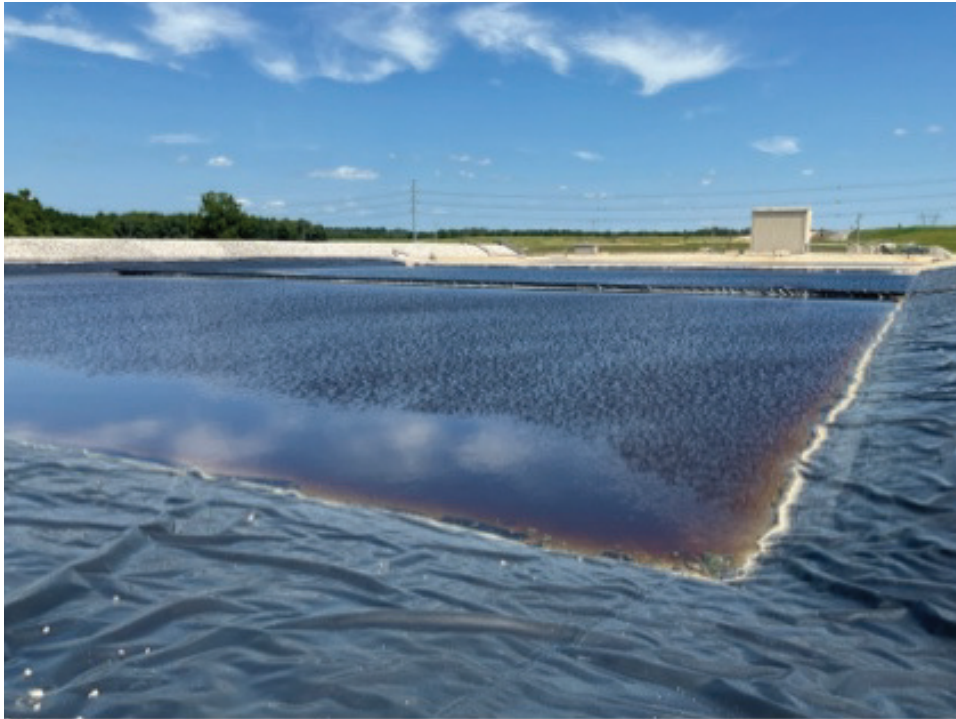
Notes: General condition of west leachate pond
