# 2023 ANNUAL DAM AND DIKE INSPECTION REPORT

CCR BOTTOM ASH STORAGE POND

WELSH POWER PLANT  
CASON, TEXAS

September 2023

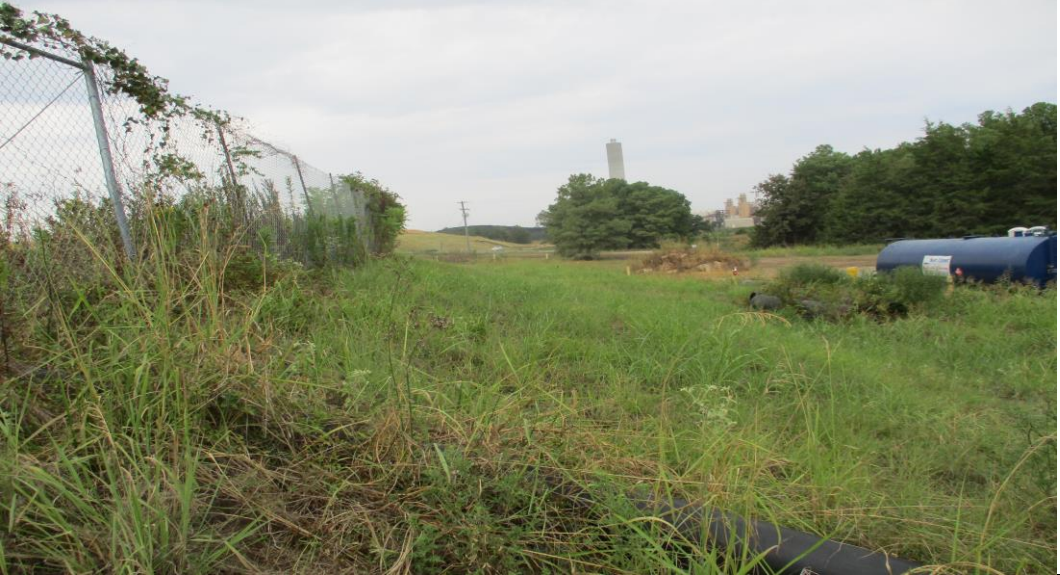
- (i) The eastern portion of the downstream slope is illustrated in Photographs No. 1-4. The slope appeared in satisfactory and stable condition with no signs of settlement, misalignment, sloughing or erosion. Slightly overgrown vegetation was noticed on the uppermost section of the slope.

<p>Photograph No. 1</p> <p>View of the upper section of the downstream slope of the east dike (looking north).</p>

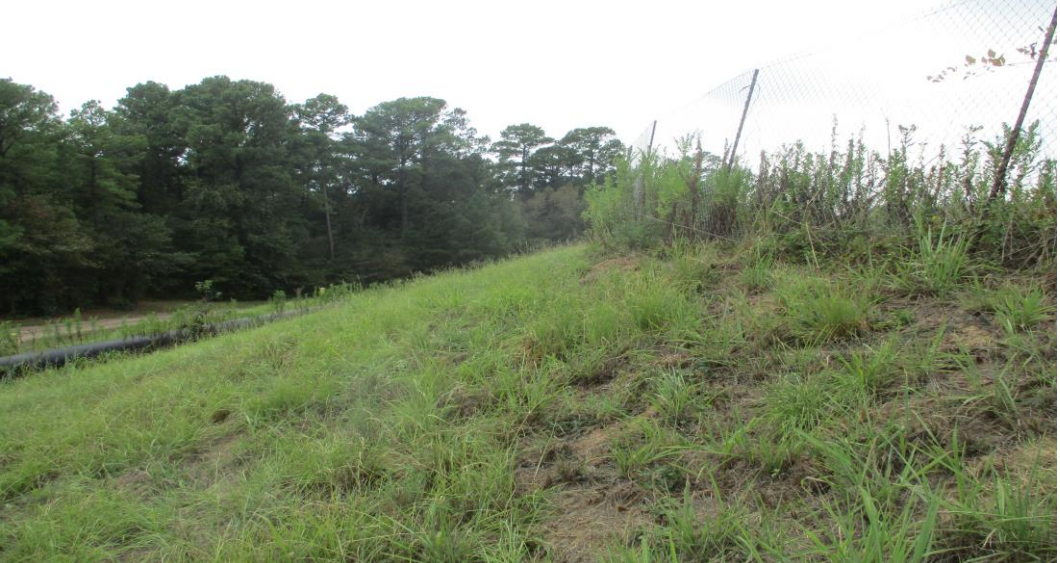
A photograph showing the upper section of the downstream slope of the east dike. The foreground is dominated by tall, green grasses. A chain-link fence runs along the top of the slope. In the background, there are trees, a utility pole, and a blue cylindrical tank.
<p>Photograph No. 2</p> <p>View of the upper section of the downstream slope of the east dike (looking south).</p>

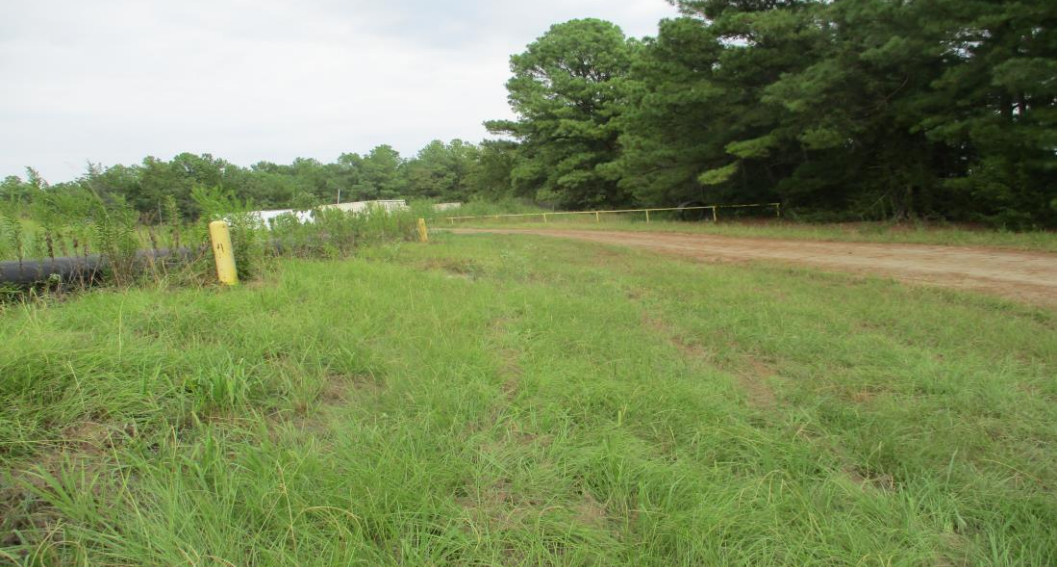
A photograph showing the upper section of the downstream slope of the east dike from a different angle. The slope is covered in green grass. A chain-link fence is visible on the right side. The background shows a dense line of trees.
<p>Photograph No. 3</p> <p>View of the lower section of the downstream slope of the east dike (looking north).</p>

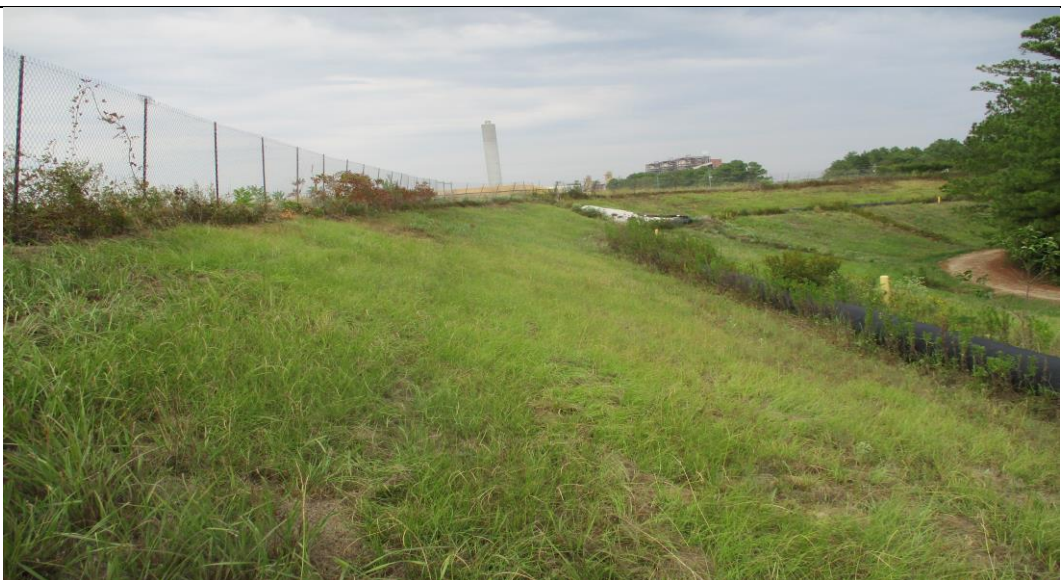
Photograph No. 4  
Overall view of the  
east dike downstream  
slope.

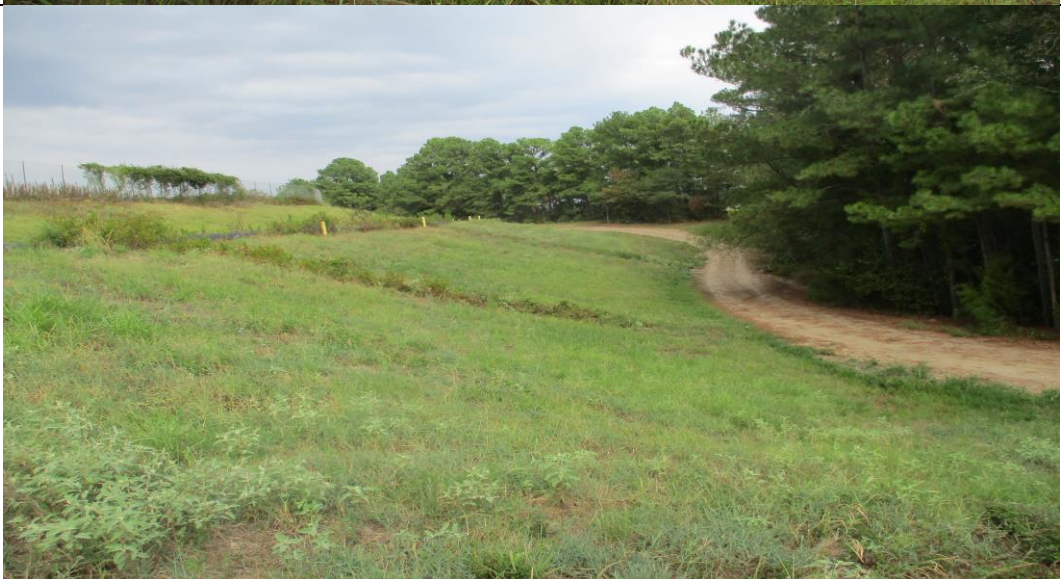
Photograph No. 5

- (ii) Photographs No. 5 and 6 illustrate the south and southeast downstream slope areas. Overall, the downstream slopes appeared in satisfactory and stable condition with some minor overgrown vegetation in the spillway ripped channels. There were no signs of settlement, misalignment, sloughing or erosion.

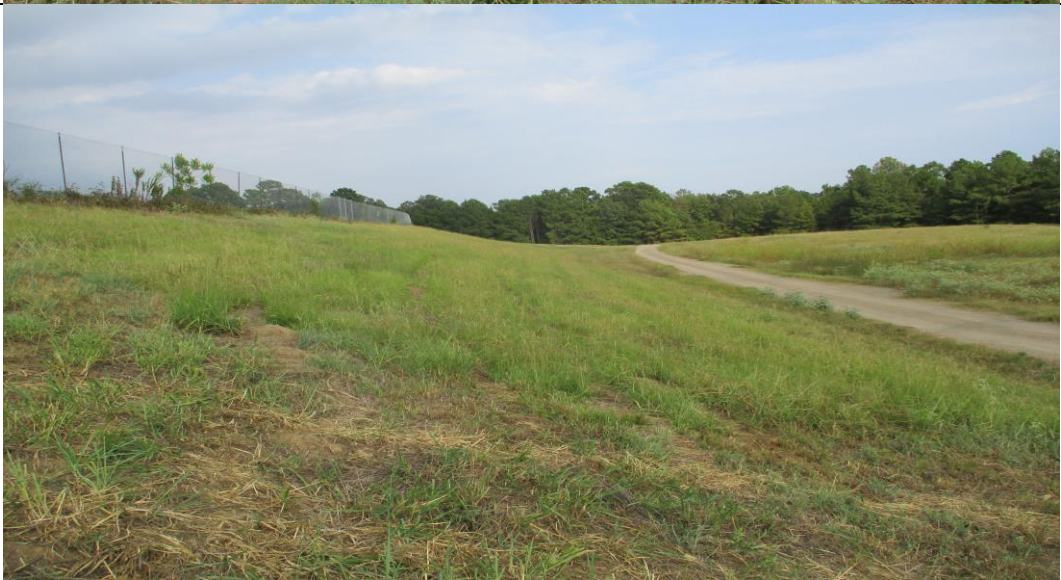
Photograph No. 6  
Southeast  
downstream slope.

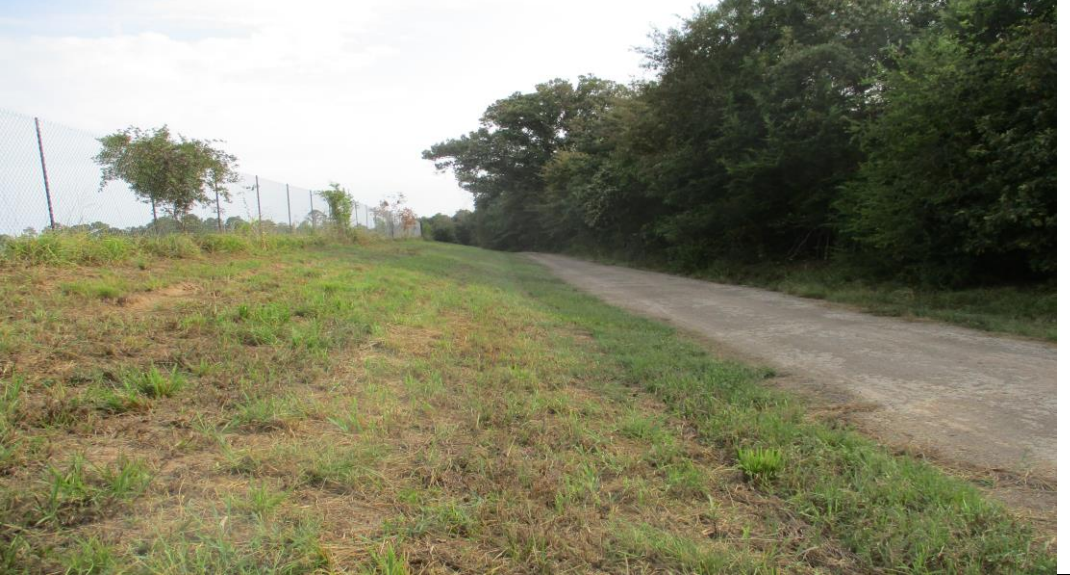
- (iii) The west dike downstream slope and access road is illustrated in Photographs No. 7-9. The slope appeared in satisfactory and stable condition with minor erosion in the northern section of the dike (Photograph No. 9). There were no signs of settlement, misalignment, sloughing or erosion. Overall, the dike appeared in good condition and the setback distance was adequate without any trees within 25 feet of the dike.

<p>Photograph No. 7 Downstream west slope (looking south).</p>

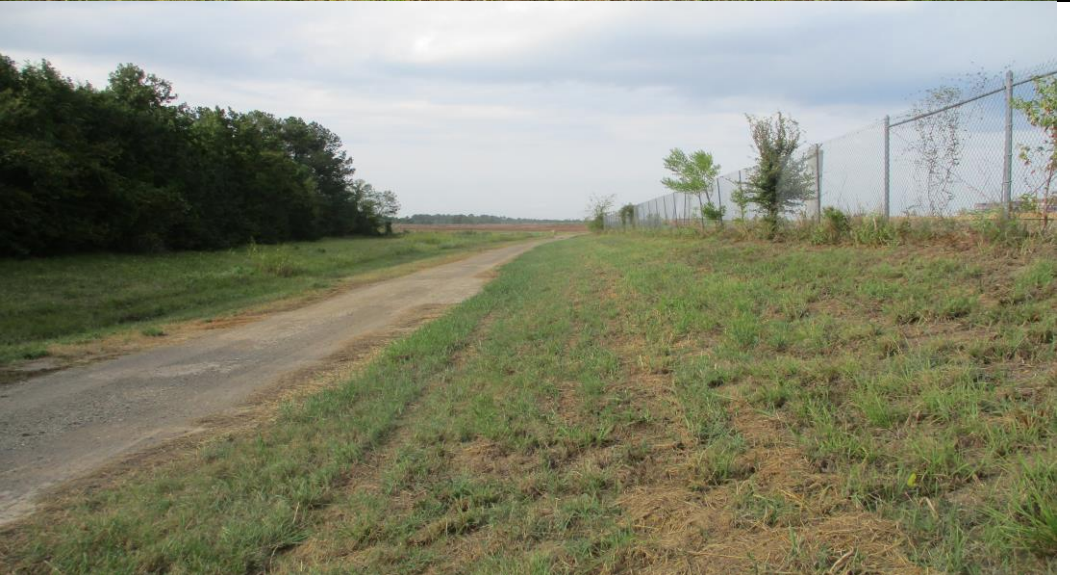
A photograph showing a dirt road on the right side of a grassy slope. The slope is covered in green and brown grass. In the background, there is a chain-link fence and some trees under a cloudy sky.
<p>Photograph No. 8 Downstream west slope (looking north).</p>

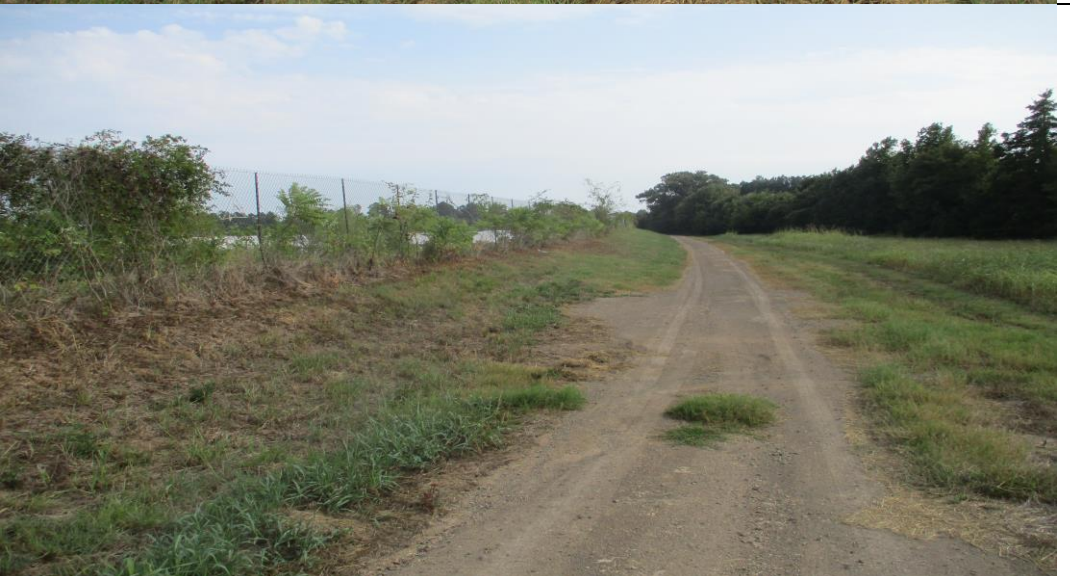
A photograph showing a dirt road on the left side of a grassy slope. The slope is covered in green and brown grass. In the background, there is a chain-link fence and some trees under a cloudy sky.
<p>Photograph No. 9 Access road adjacent to the west dike.</p>

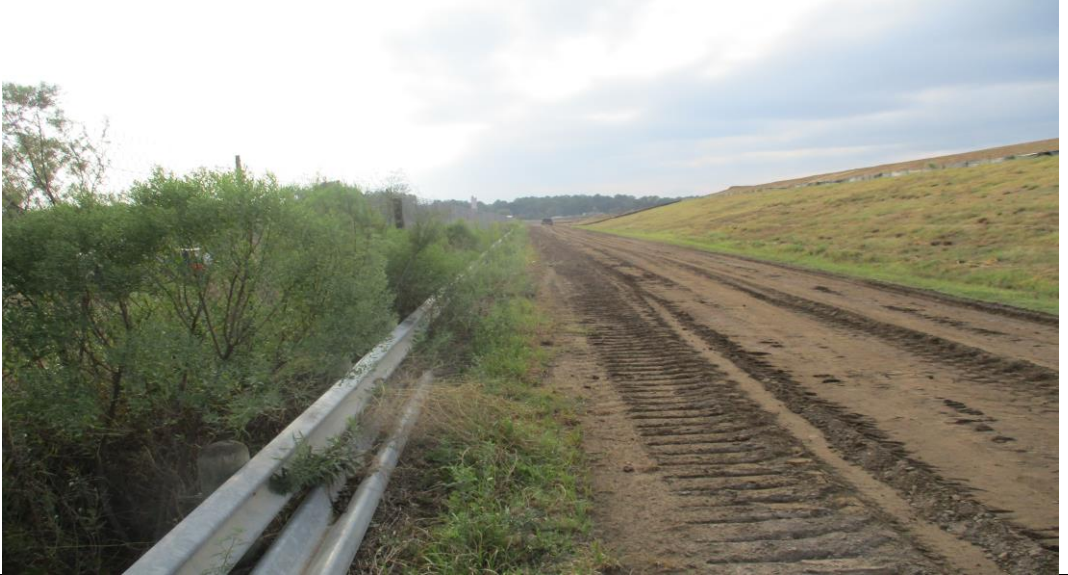
- (iv) Typical condition of the north dike is illustrated in Photograph No. 10. This dike also used as an access road and also located adjacent to the landfill. Some minor rutting of the access road was noticed due to the construction vehicular traffic. Excessive vegetation was noticed along this dike section.

<p>Photograph No. 10 Typical condition of the north dike.</p>

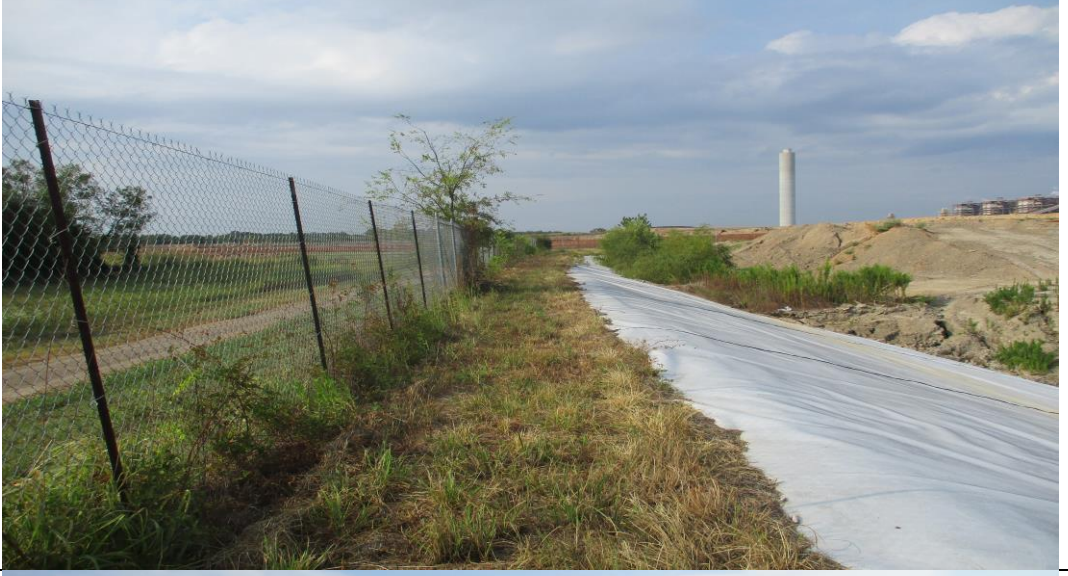
- (v) Typical interior slope of the west dike is illustrated in Photographs No. 11 and 12. The interior slope and the liner is still intact and in good condition with the pond closure activities.

<p>Photograph No. 11 Typical condition of the interior slope (looking north).</p>

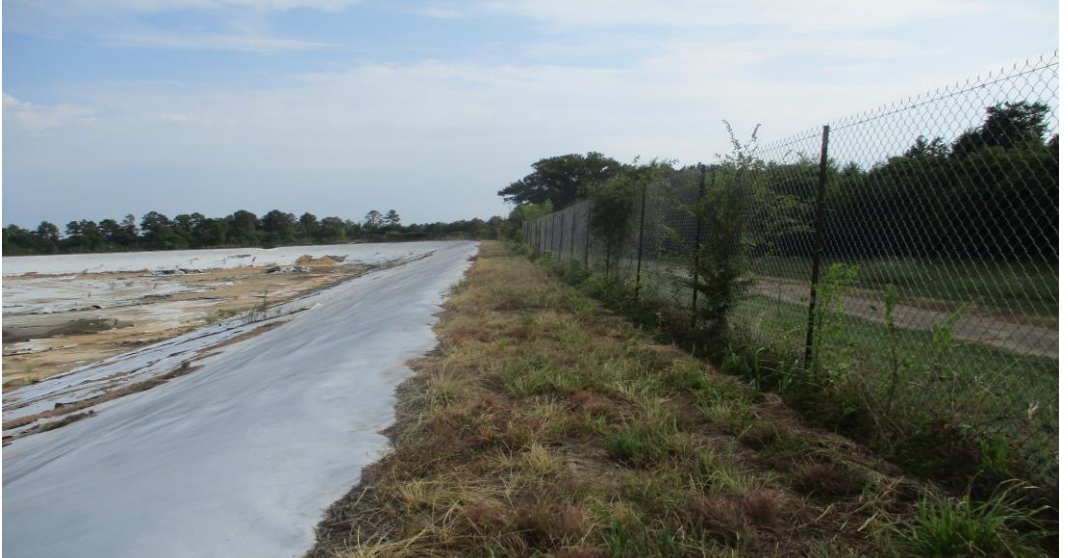
<p>Photograph No. 12 Typical condition of the interior slope (looking south).</p>

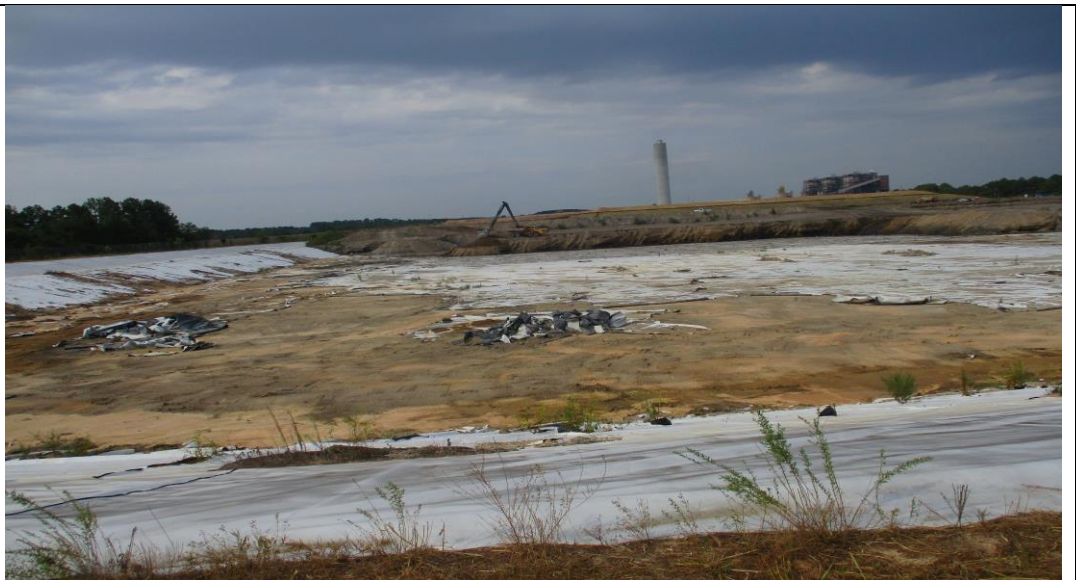
- (vi) The interior of the pond is illustrated in Photographs No. 13 and 14. Most of the CCR materials had been removed and the remaining CCR materials is in the process of being removed. The service spillway (Photograph No. 14) is removed due to the closure by

Photograph No. 13  
Pond interior  
illustrating excavation  
of CCR materials.

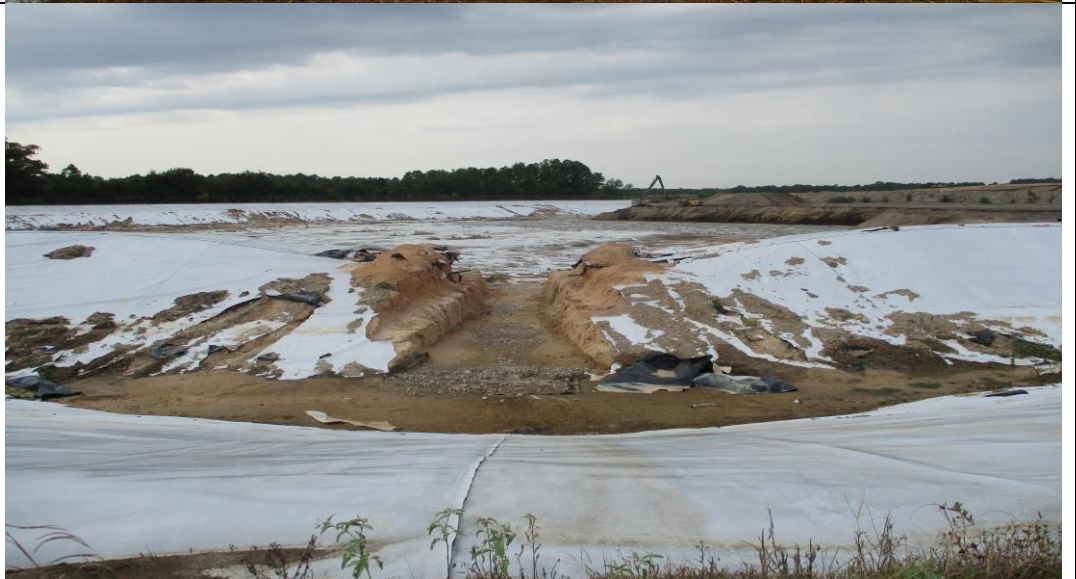
removal of the pond.

Photograph No. 14  
Interior area service  
spillway removed.
