2023 ANNUAL CCR LANDFILL INSPECTION REPORT

Ash Landfill

**Welsh Plant
American Electric Power Service Corporation
(SWEPCO)
Cason, Texas**

Document ID: GERS-23-024

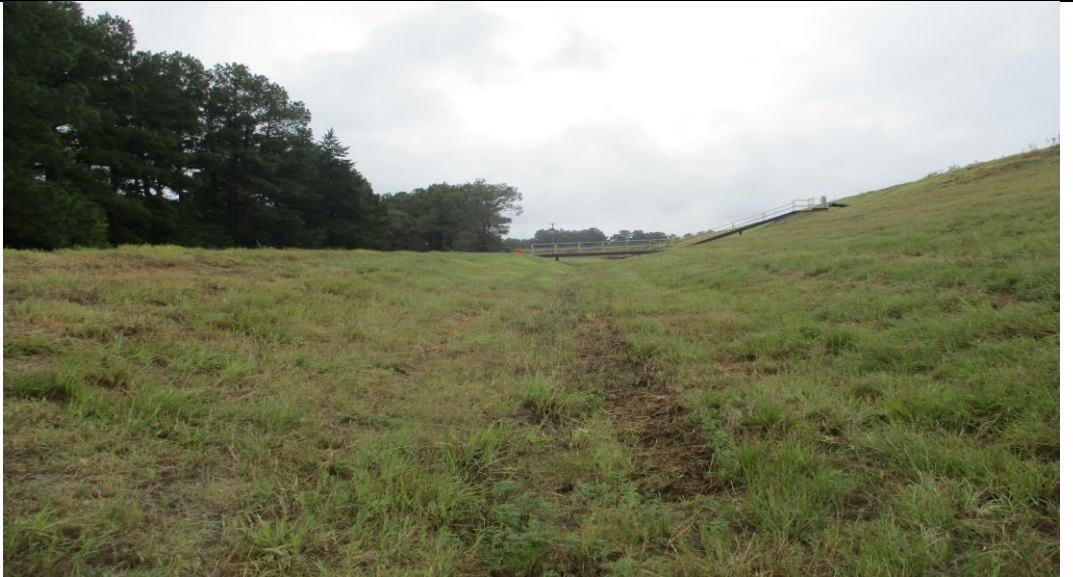
1. The east slope of the landfill and the toe ditch is illustrated in Photograph Nos. 1 and 2. The slope appeared in satisfactory condition with no signs of seepage, significant erosion, or sloughing. Photograph No. 3 illustrates the HDPE lined letdown channel in the northeast corner of the landfill. The channel appeared to be in satisfactory and functional condition. The bottom section of the letdown channel is lined with concrete with energy dissipater blocks to slow water down before it enters the perimeter ditch. The letdown, toe ditch, and the pipe culverts are functioning as designed. The perimeter soil berm (Photograph No. 4) was recently constructed to control the contact water of the Landfill appeared in good and stable condition. Overall view of the placed CCR material at the Landfill is illustrated in Photograph No. 5 appeared to be stable without any standing water or significant erosion.

Photograph No. 1
View of the eastern
slope (looking south).

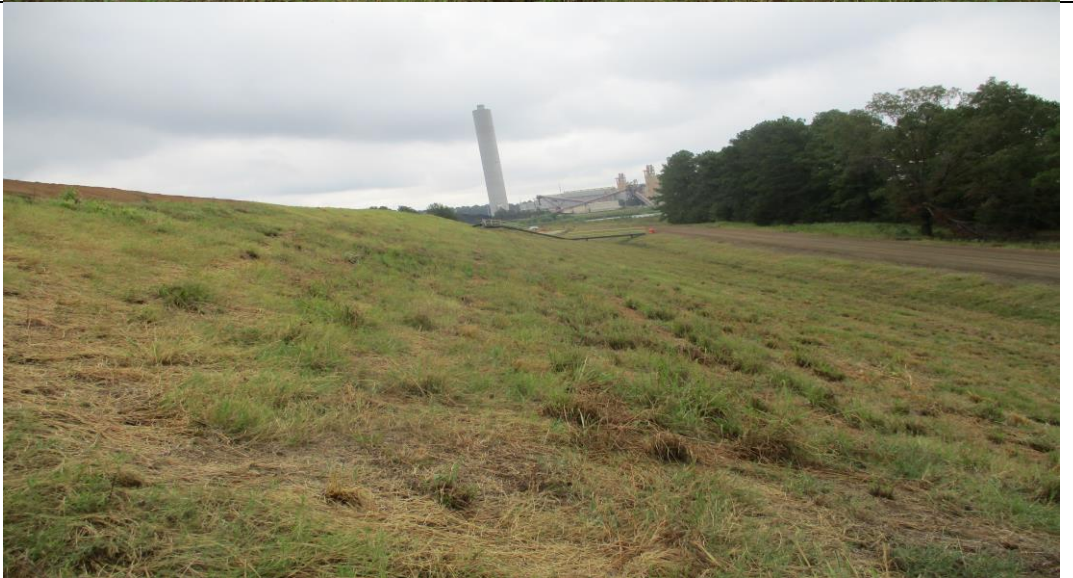
Photograph No. 2
View of the eastern
slope (looking north).

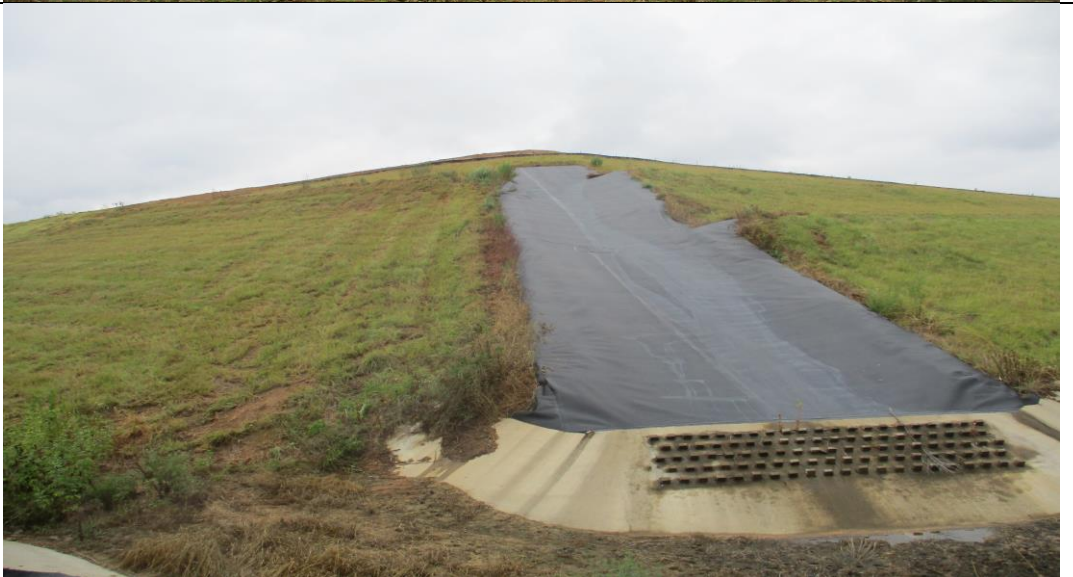
Photograph No. 3
View of the northeast
corner let down to the
ditch.

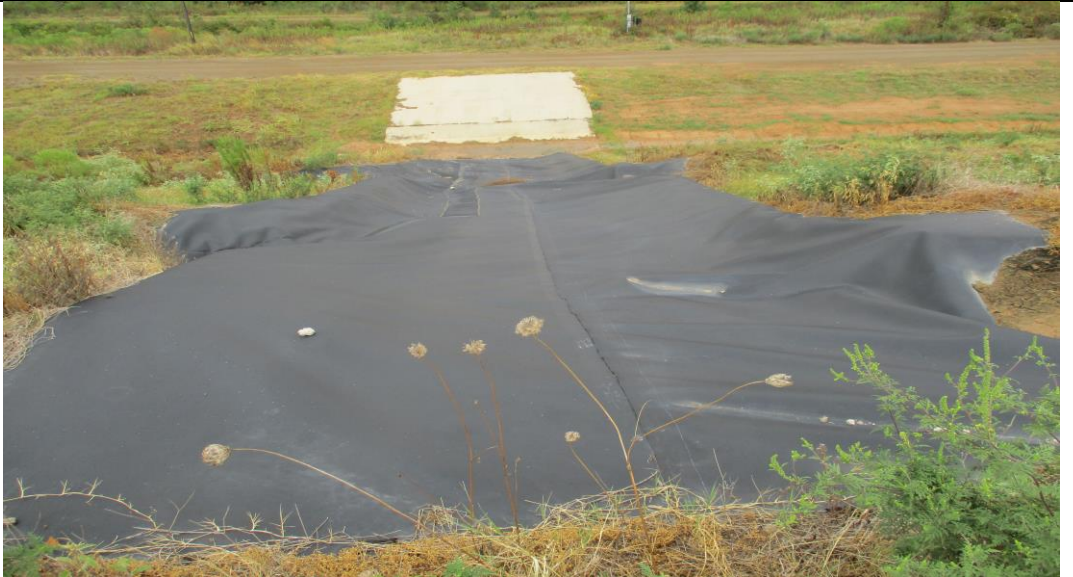
2. Photograph No. 6 illustrate the perimeter soil berm at the north slope of the Landfill. The berm appeared in good and stable condition. Photographs No. 7-9 illustrates the outer slopes, northern let down channel and perimeter ditch on the north side of the landfill. Most of the slopes appeared in satisfactory condition with no signs of seepage,

Photograph No. 7
View of the northern slope central let down channel.

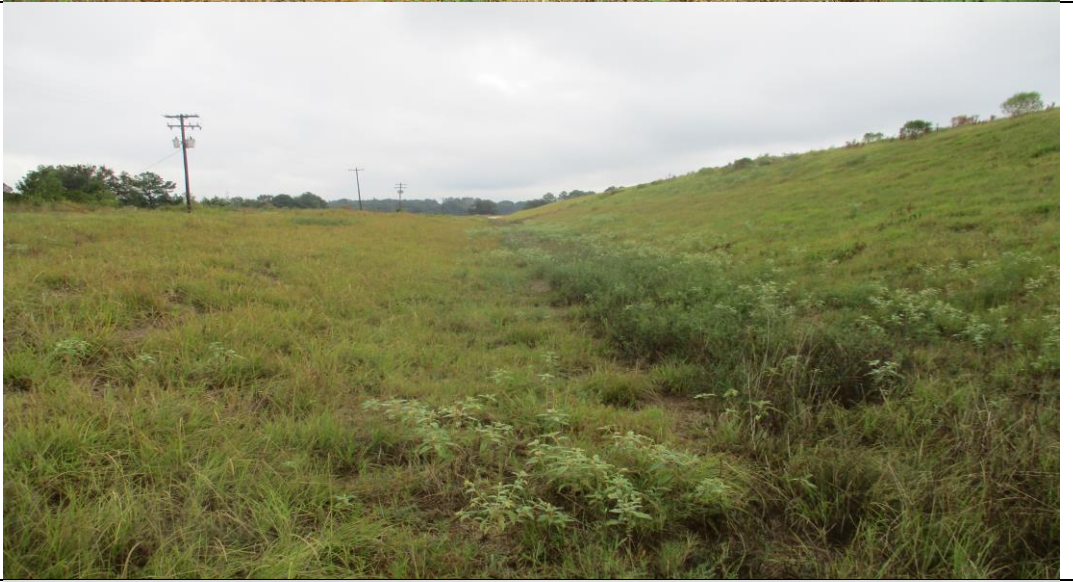
Photograph No. 8
Overall view of the north slope and the toe ditch (looking east).

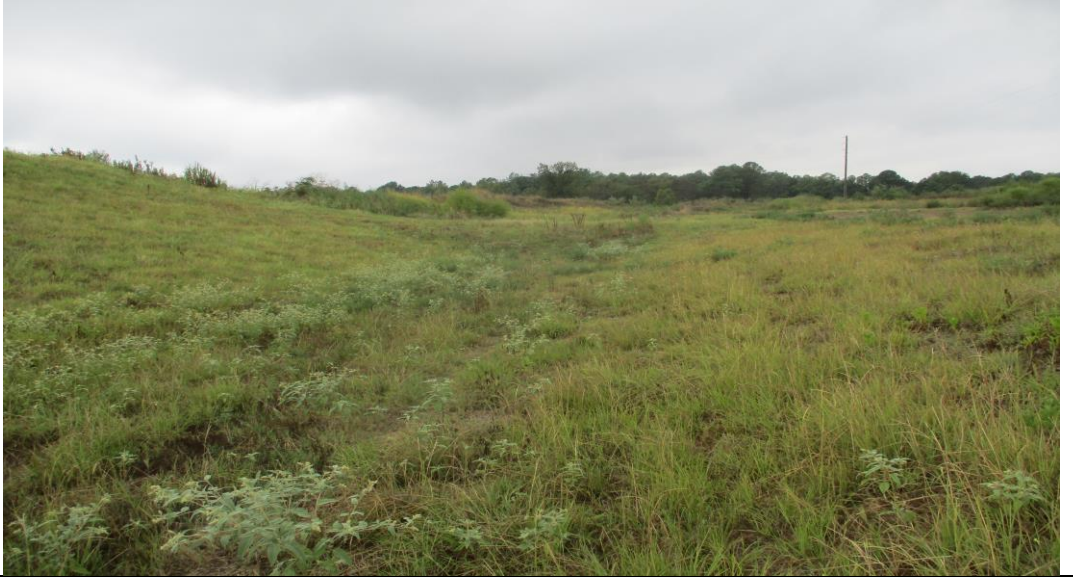
Photograph No. 9
North slope looking west.

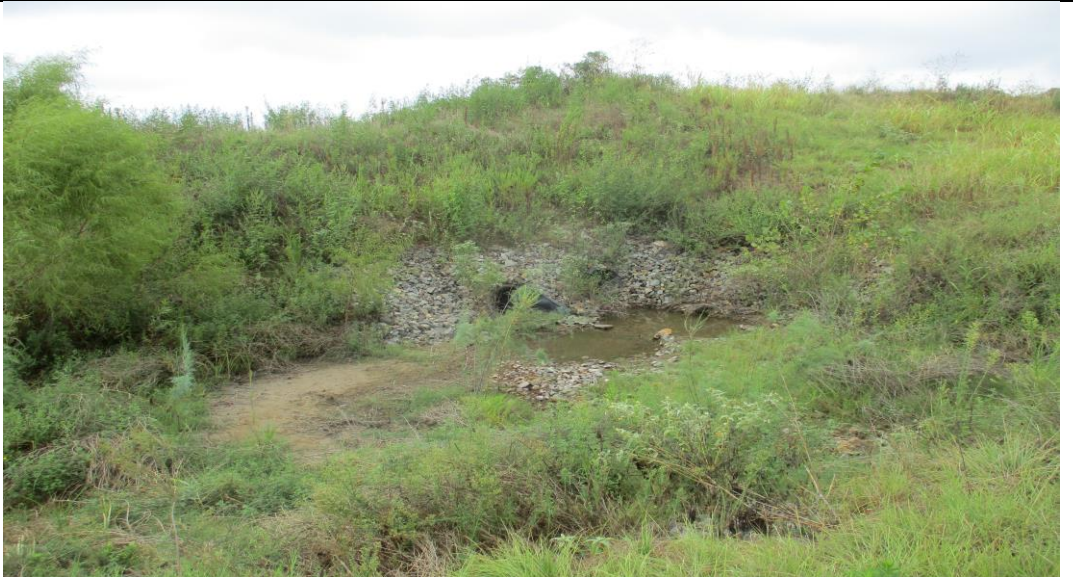
significant erosion, or sloughing. Vegetation cover is satisfactory except for some sparse overgrown areas adjacent to the west toe area at the pipe culverts (Photograph No. 10). The perimeter ditch on the north side was mostly dry at the time of inspection and appeared to have positive flow.

Photograph No. 10
Landfill runoff pipe
culvert in the
northwest area of the
landfill.

- 1 Vegetation growth on the newly capped and covered slopes (South, East and North) is satisfactory, but some northwest areas had either sparse vegetation that needs to be re-seeded or overgrown vegetation that needs to be mowed.
- 2 The inner and outer slopes of the western berm are in poor, but functioning condition. Since this area is primarily an ash processing area, little ash is stacked up against the berm. The west berm will have to be re-built and the slope vegetation cleared and maintained before any active disposal operations can occur in the western end of the Landfill.
- 3 The sump pumps should be reset after all the pumps resume normal function as before to make sure that the no excessive standing water is accumulated at the base of the Landfill.

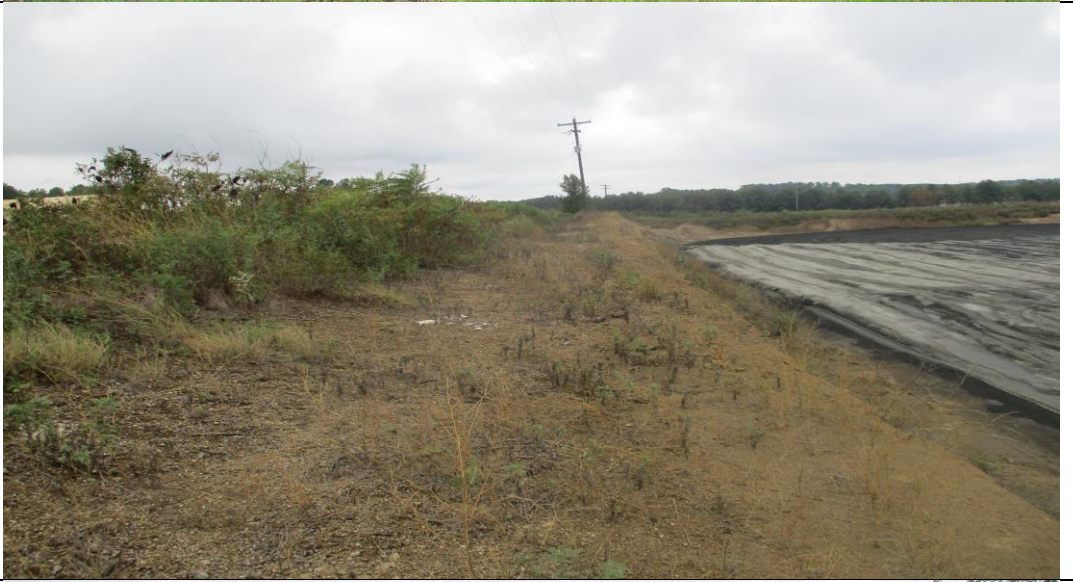
3. The west side berm is illustrated in Photographs No. 11-13. The outer slopes of the western berm of the landfill are partially constructed of temporary soil cover and CCR material and have overgrown vegetation on the cover. Photograph No. 13 illustrates the condition of the exterior slope and toe ditch. The outer slopes appeared to be in poor, but functioning condition. The toe ditch is covered with overgrown vegetation. The western 1/3 of the landfill area is primarily utilized for the processing for beneficial use and sales of CCR materials. At the time of inspection, the area was being used for ash processing (Photograph No. 14). This area is maintained and CCR materials are contained within the boundary of the Landfill and the drainage control was good.

Photograph No. 11
View of the west dike
interior southern
section (looking
north).

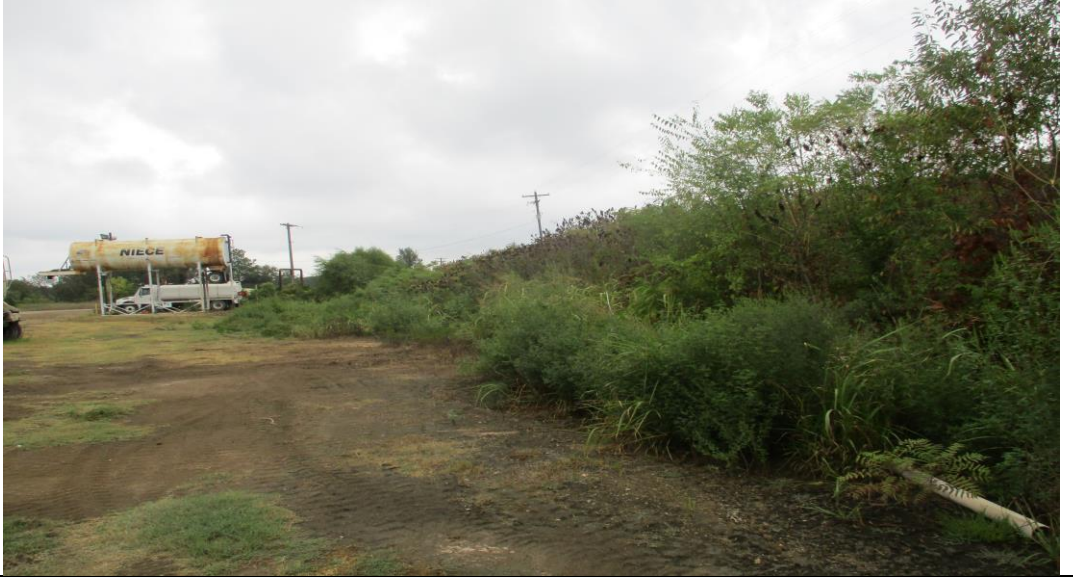
Photograph No. 12
Typical view of the
west dike exterior slope
(looking north).

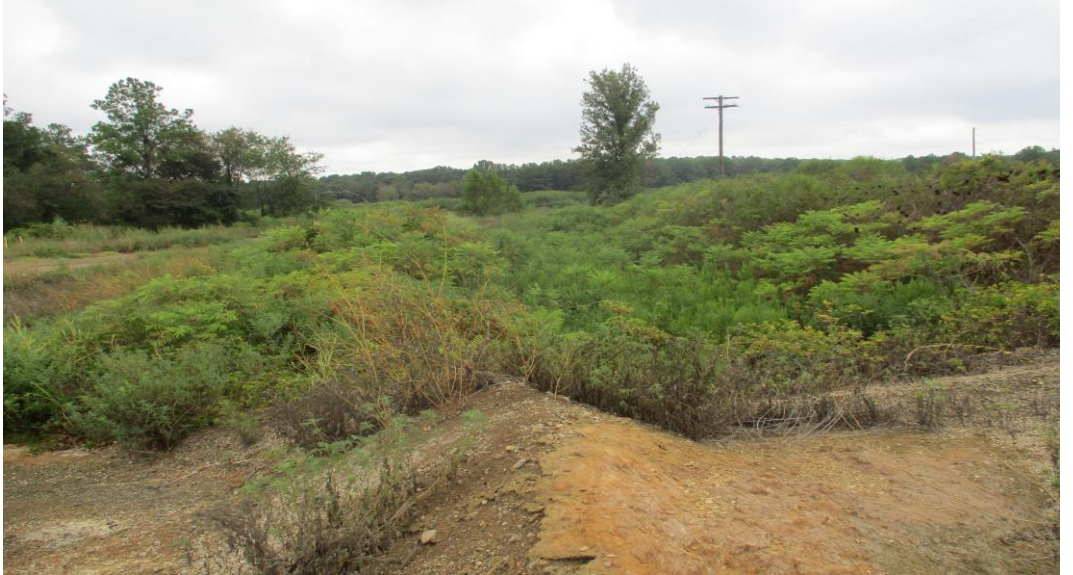
<p>Photograph No. 13 West dike northern section (looking north).</p>

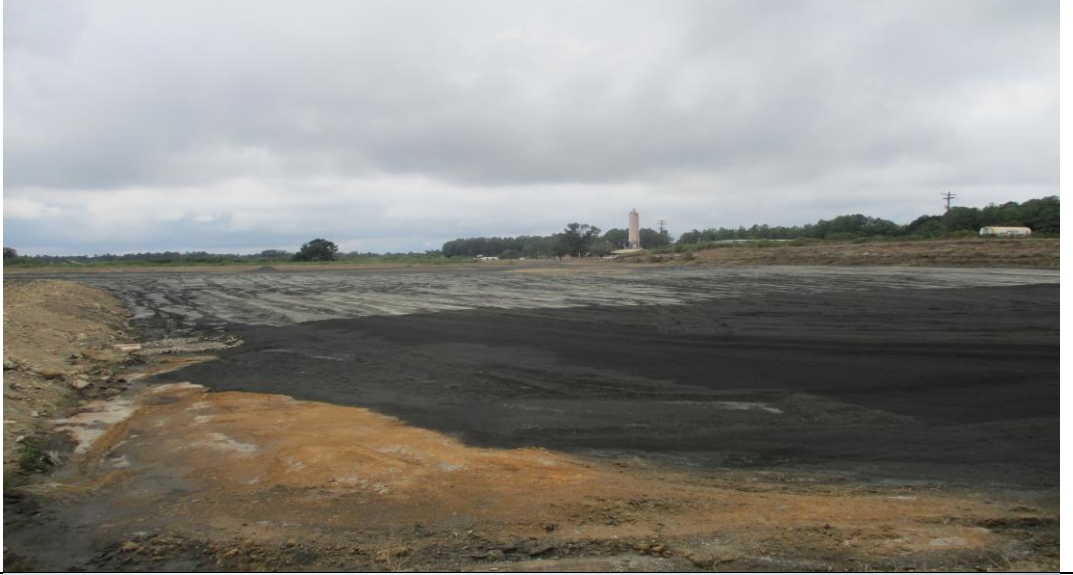
<p>Photograph No. 14 Overall view of the west interior area of the landfill.</p>

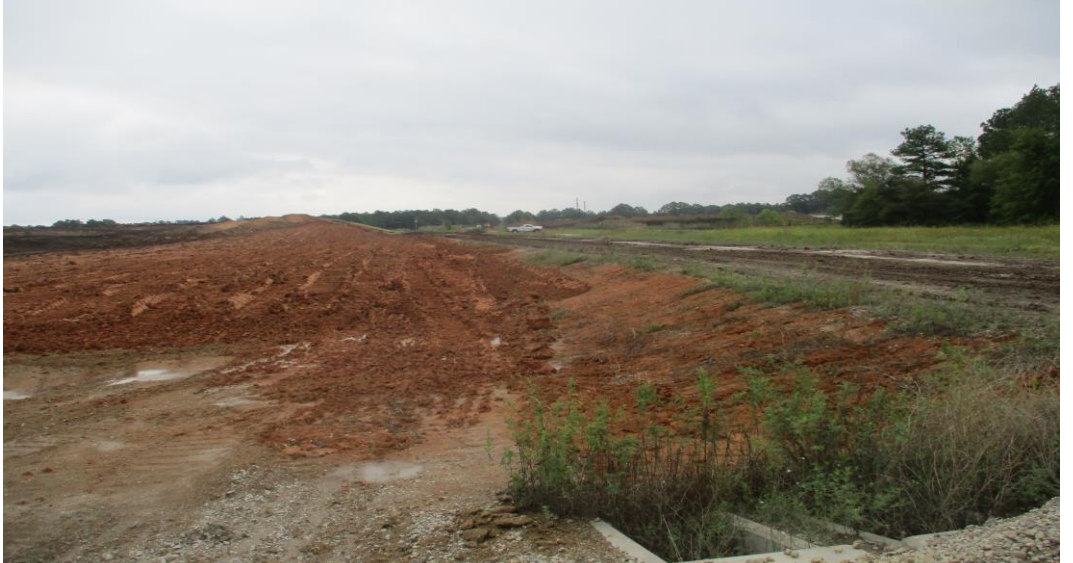
4. The low water crossing previously constructed of reinforced concrete was filled in temporarily to protect it during construction of the stability soil berm on the south side (Photograph No. 15). The stability berm and perimeter berm at the south side of the Landfill were under construction at the time of inspection. The existing section of the south slope and the toe ditch were functioning as designed and in good, stable condition (Photographs No. 16 and 17).

<p>Photograph No. 15 South perimeter berm (looking east).</p>

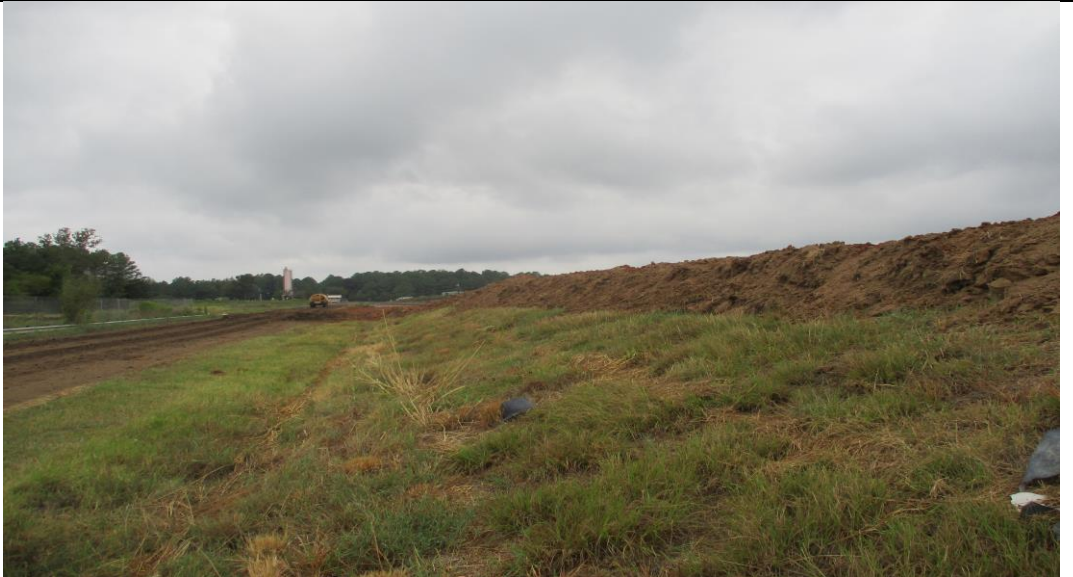
Photograph No. 16
South slope of the landfill (looking west).

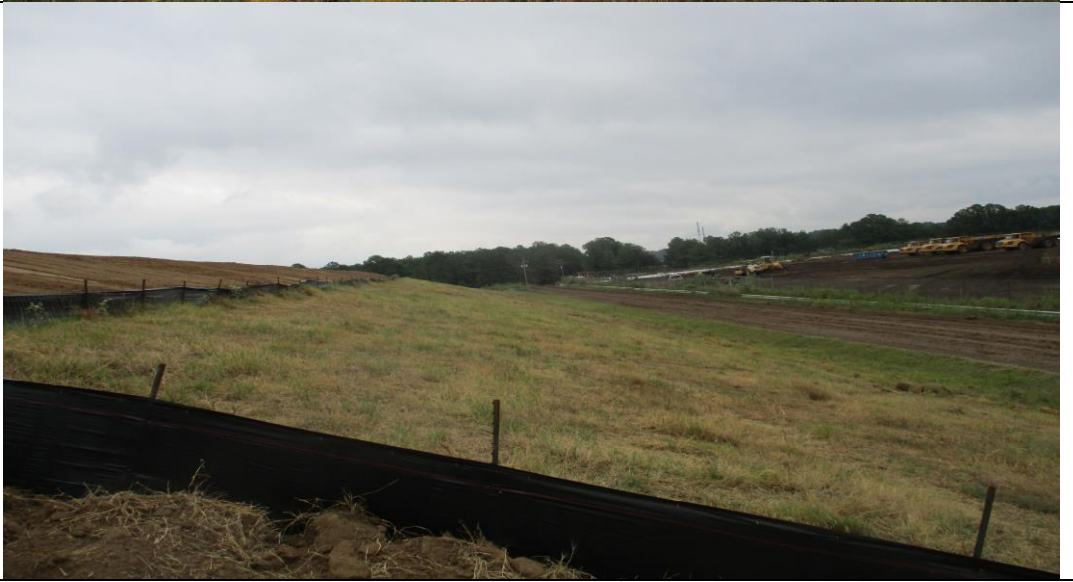
Photograph No. 17
South slope of the landfill (looking east).
