**MT LBR Landfill Deficiency Corrective Measure Report
for
Area 3 Slip**

**Appalachian Power Company
Little Broad Run Landfill
Mountaineer Plant
New Haven, WV**

August 2020

Document ID: GERS-20-021

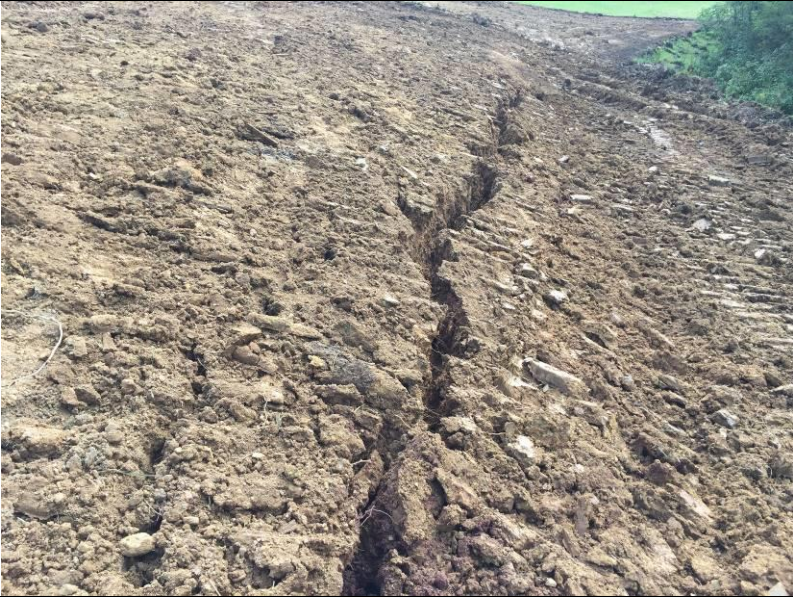
<p>Photo # 1</p>

The deficiency was first identified on April 5, 2017 during a 7-day landfill operational inspection. Plant personnel noted that the soil cover had slipped in Area 3. There was cracking near the top and bulging near the bottom of the exterior slope located in Area 3. There was no sign of exposed ash. The area was put under monitoring and a repair plan was initiated. The area was monitored over the next several months while an investigation and repair plan was developed. The area was monitored daily until a final repair plan was developed and repair work began in September of 2018. The repair work was completed on December 19, 2018.

<p>This photograph illustrates longitudinal crack along the Area 3 west slope.</p>	
<p>Photo # 2</p>

After a complete investigation and slope stability analysis, and evaluating several options for a repair, it was decided that the best option was to regrade the slope and improve the surface drainage features. Final construction drawings were developed and repair work began in September 2018. An execution plan and revised construction drawings were developed in October 2018 due to field conditions encountered during construction. The Area 3 Slip Repair work was complete on December 19, 2018.

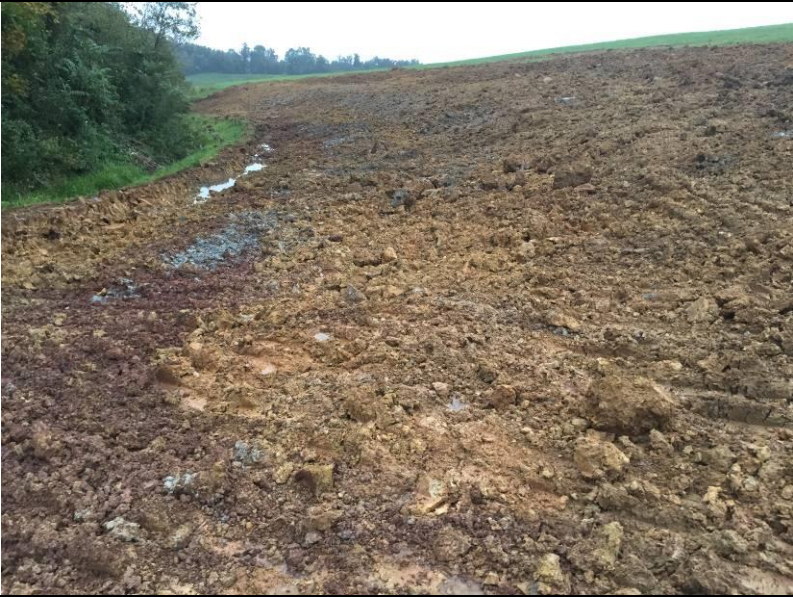
<p>Typical condition of the Area 3 slope after clearing and grubbing all vegetation.</p>	
<p>Photo # 3</p>

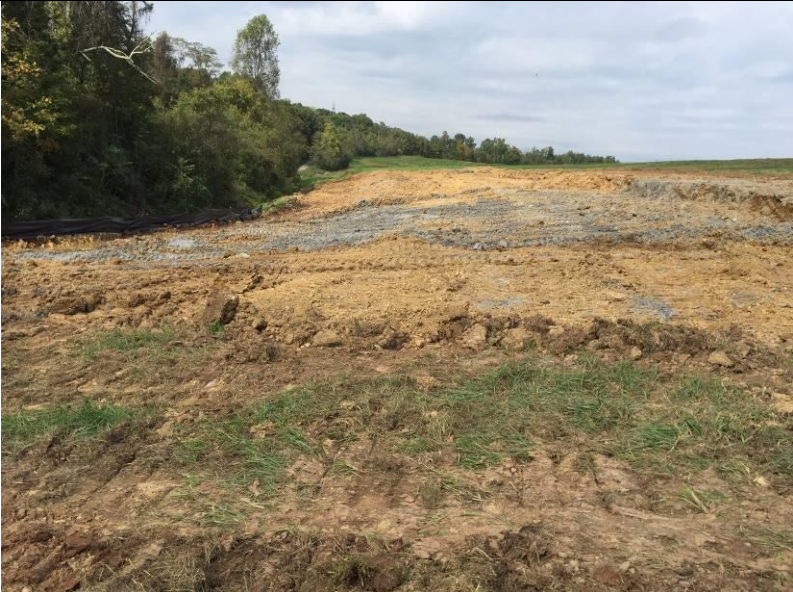
<p>Typical condition of the Area 3 west slope after stripping all soil cover.</p>

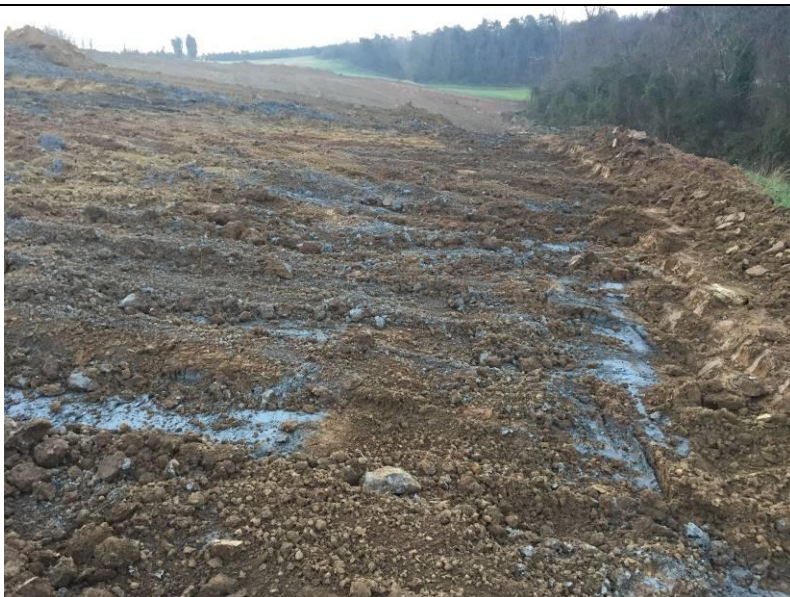
Photo # 4

Typical condition of the Area 3 west slope after stripping all soil cover.

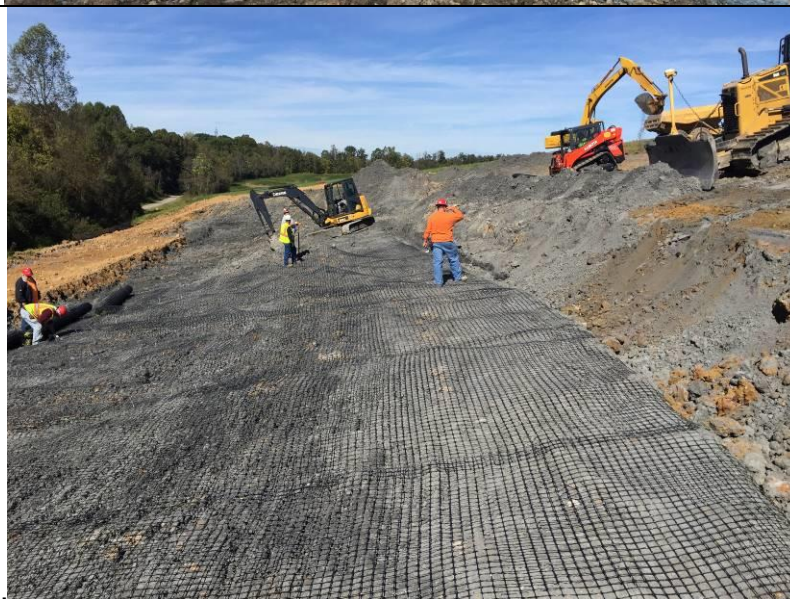
Photo # 5

Typical condition of the Area 3 west slope during slope cut back and geo-grid placement.

The overall slope conditions of Area 3 slope are stable. The slope cut back with geo-grid placement and re-grading the slope to a 3:1 has made the western slope of Area 3 stable. There have been no sign of cracks, slips or bulges during the 7-day inspection since the repair work was completed. The corrective measures taken to address the Area 3 slip at the Mountaineer LBR Landfill were implemented on April 5, 2017 and completed on December 19, 2018. The deficiency for the Mountaineer LBR Landfill Area 3 slip repair has been resolved in accordance with 40 CFR 257.

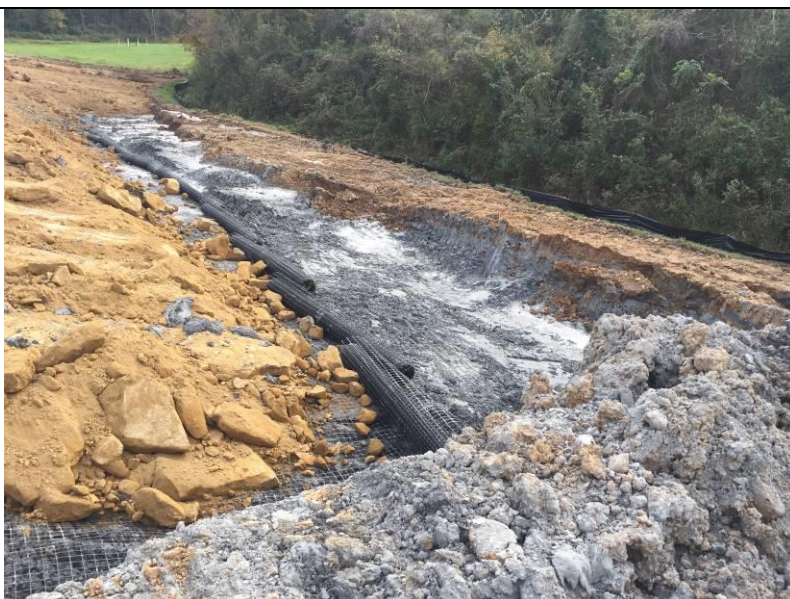
Photo # 6

Typical condition of the Area 3 west slope during slope cut back and geo-grid placement.

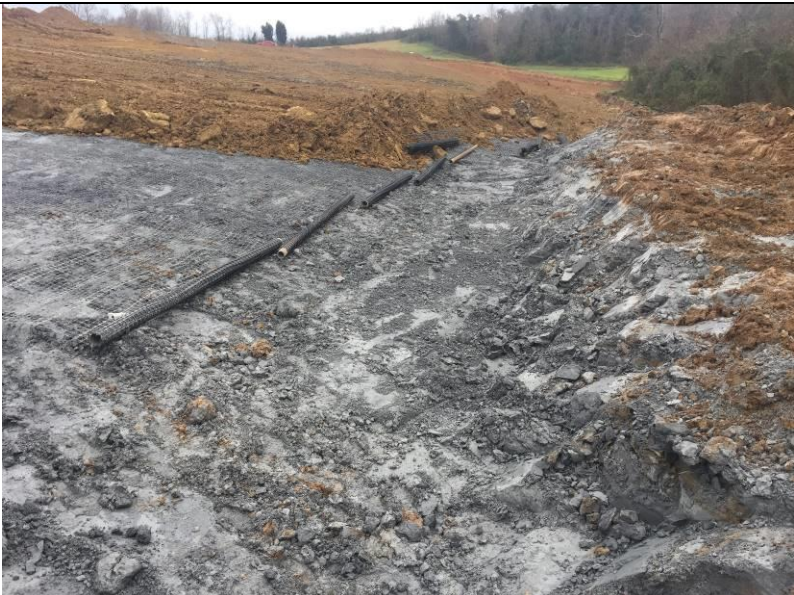
Photo # 7

Typical condition of the Area 3 west slope during slope cut back and geo-grid placement.

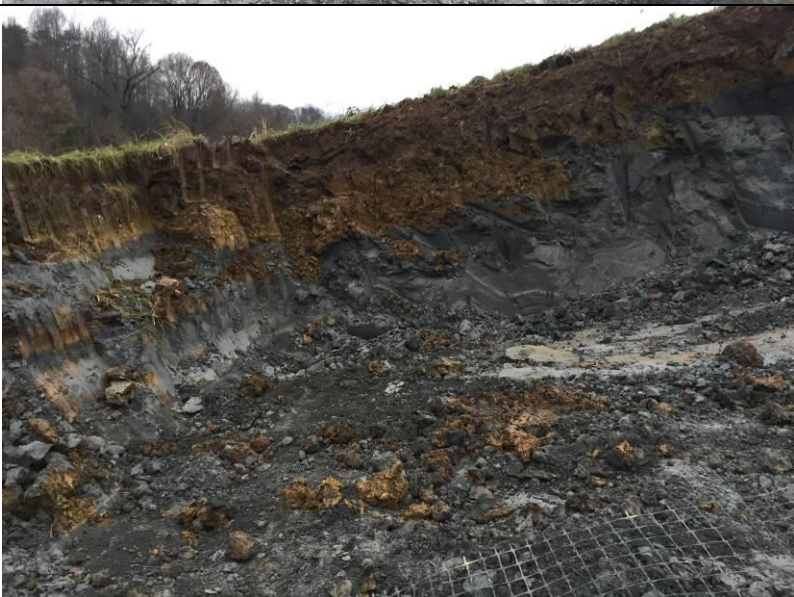
Photo # 8

Typical condition of the Area 3 west slope during slope cut back and geo-grid placement.

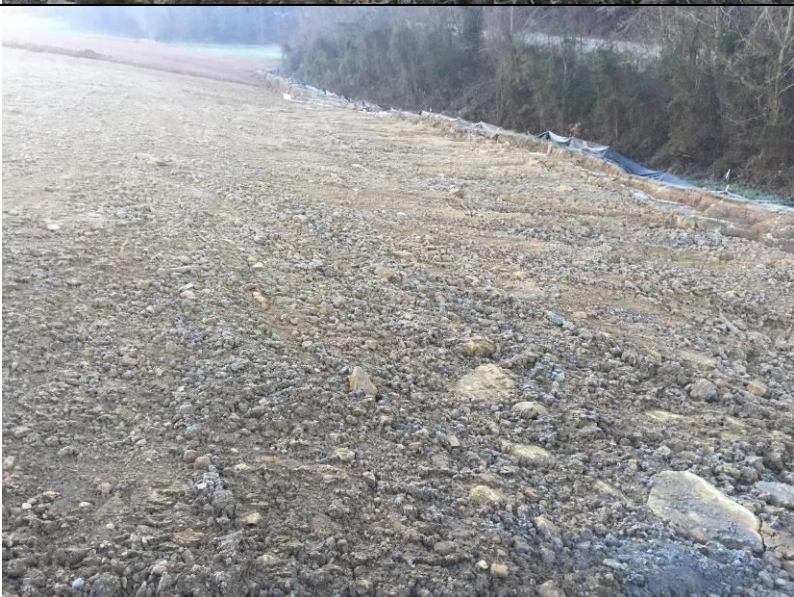
Photo # 9

Overview of Area 3 west during final grading cover.

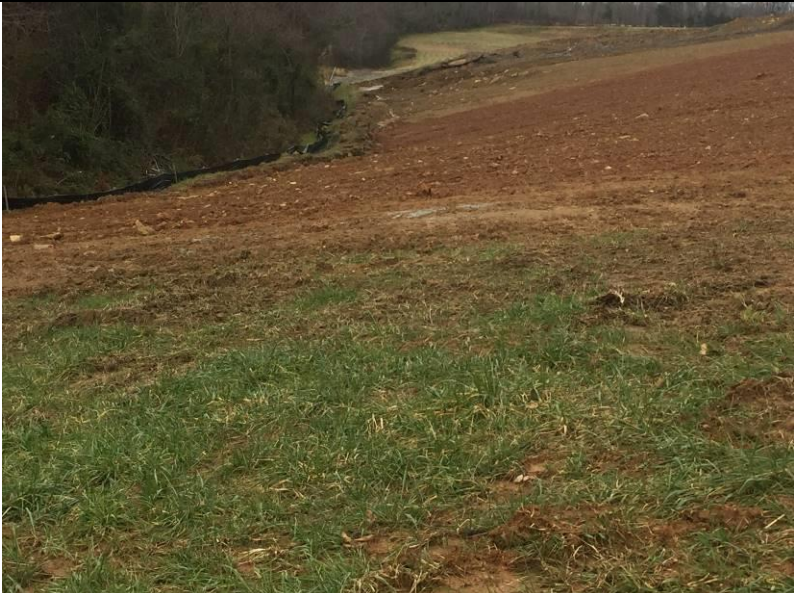
Photo # 10

Overall view of Area 3 west slope during final grading.

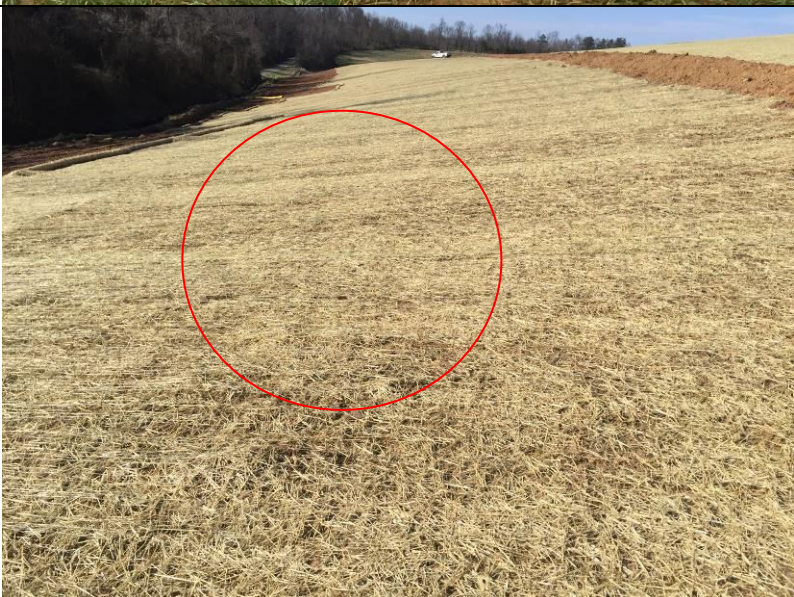
Photo # 11

Overall view of Area 3 west slope during final seeding and mulching.

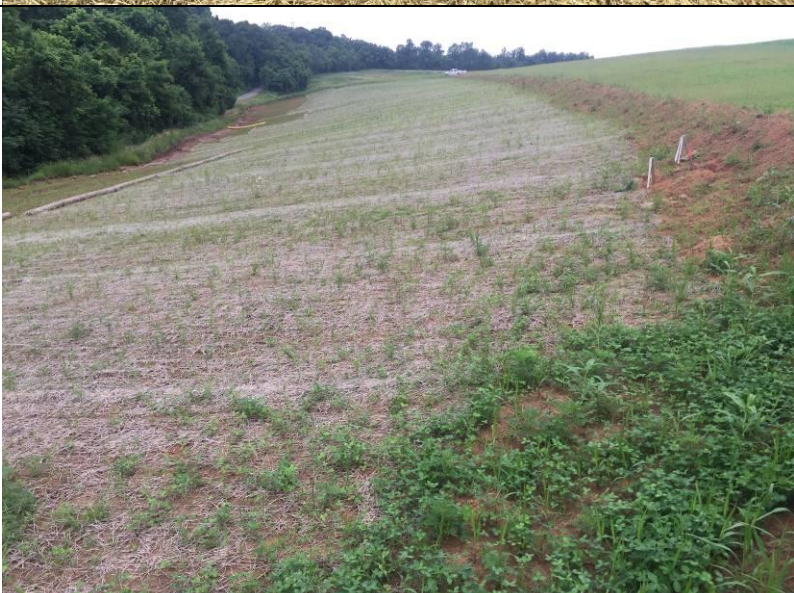
Photo # 12

Overall view of Area 3 west slope during initial vegetation growth on final cover.
