2020 Annual Dam and Dike Inspection Report

Bottom Ash Pond Complex

**Rockport Plant
Indiana Michigan Power Company
Rockport, Indiana**

Document ID: GERS-20-024

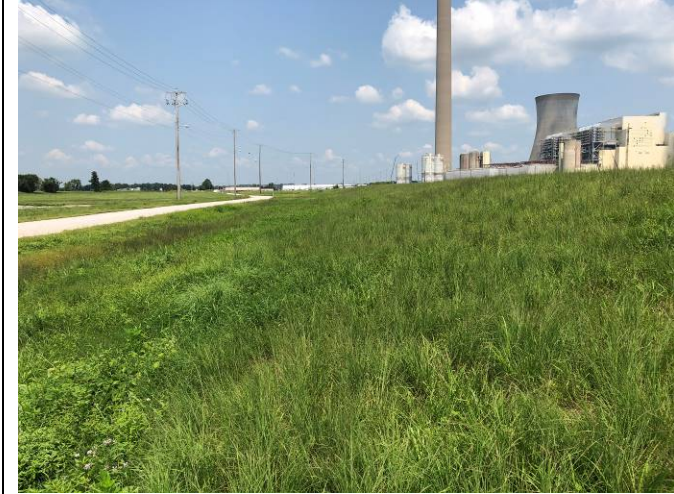
Photograph 1: #W

5. The outboard slope of the WBAP was in good condition. There were no signs of movement or misalignment, sloughing or bulges. The inspection was conducted prior to mowing, but the vegetation was not excessively high and was mowed the day after the inspection.

View of the embankment dike of the west bottom ash pond, looking north.

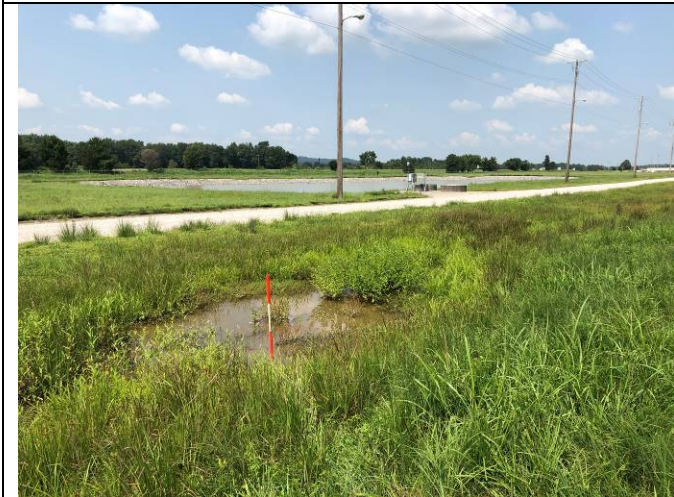
Photograph 2: #W

6. There were no seepage or wet areas observed on the embankment. However, there was an area of standing water noted beyond the downstream toe; no signs of flowing water were observed. This area was investigated and appears to be the result of the flat topography surrounding the bottom ash complex.

View of standing water noted beyond to the toe of the embankment dike of the west bottom ash pond.

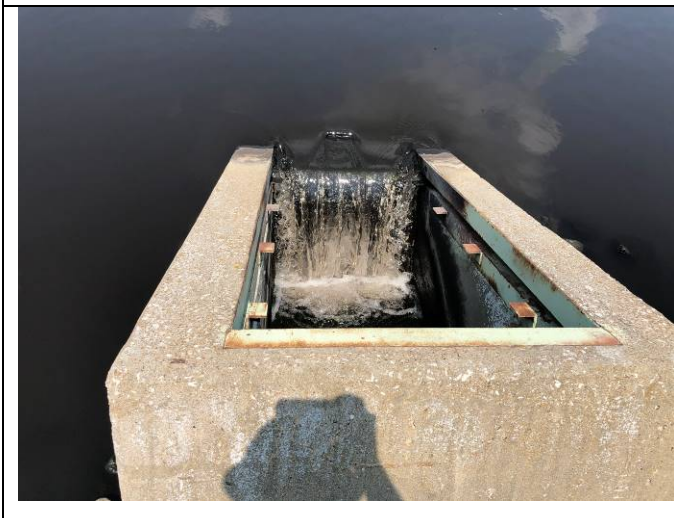
Photograph 3: #W

7. The crest of the west dike appeared in good and stable condition with no signs of distress such as settlement or ruts, and no erosion.
8. Flow was discharging into the low-level drain structure. While this structure is typically used for draining the pond, it appears to be functioning as part of the primary discharge for the pond. The structure appeared in good condition. Flow was unobstructed.

View of the low-level discharge structure at the west bottom ash pond.

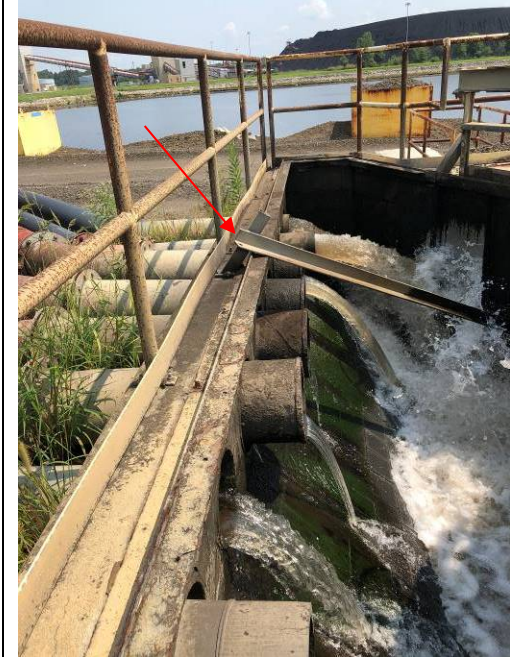
Photograph 4: #W

2. A piece of angle iron has been installed at the diverter structure to reinforce the slide gate seal to the East Bottom Ash Pond at the diverter discharge structure. This angle iron was observed to be loose, due a concrete expansion anchor that has pulled out.

View of the bottom ash sluice lines discharging into the diverter structure. The red arrow notes the loose angle iron.

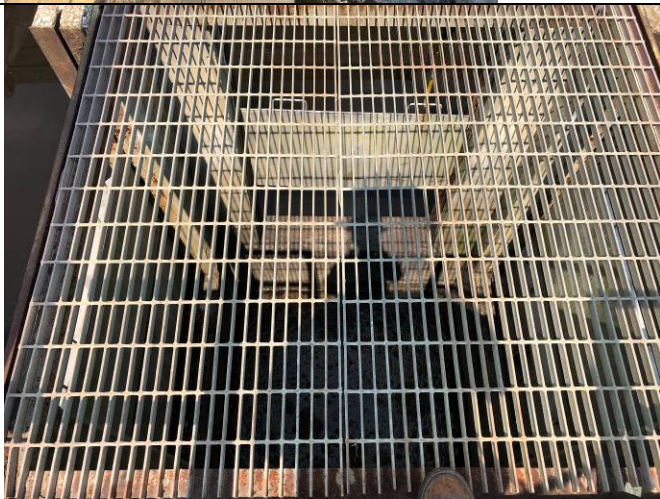
Photograph 5: #E

7. The primary discharge structure was in good condition and functioning properly. The water level was about 10 inches below the concrete sill that the stoplogs rest upon. The stoplogs were removed on all 3 sides of the box weir structure. The skimmer structure was in good condition.
8. The access road located at the crest of the pond appeared in good and stable condition with no signs of distress such as settlement, cracking or ruts.
9. There are scattered areas on the interior side slopes where vegetation is starting to grow.

View of the primary discharge structure of the east bottom ash pond. The water level was about 10 inches below the concrete sill.

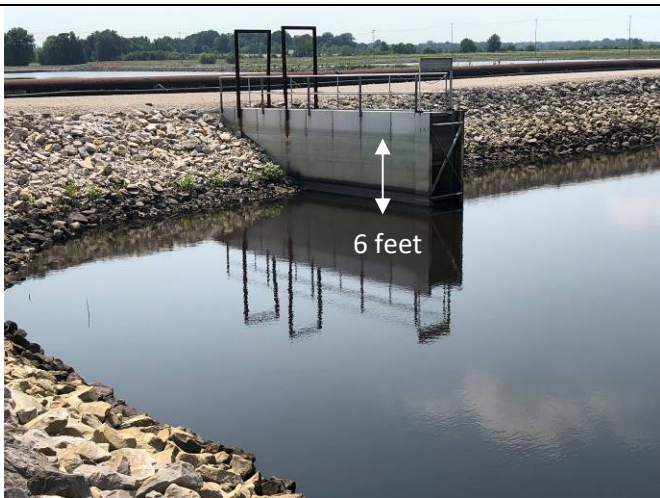
Photograph 6: #E

6. The low-level discharge structure was reported to have become plugged and is non-functioning. The low-level discharge structure has been used in the past to periodically drain water to facilitate bottom ash removal. This is not considered a deficiency because the primary discharge structure is suitable for conveying flows from storm events.

View of the low level Discharge structure. The water level was about 6 feet below the normal operating pool mark.

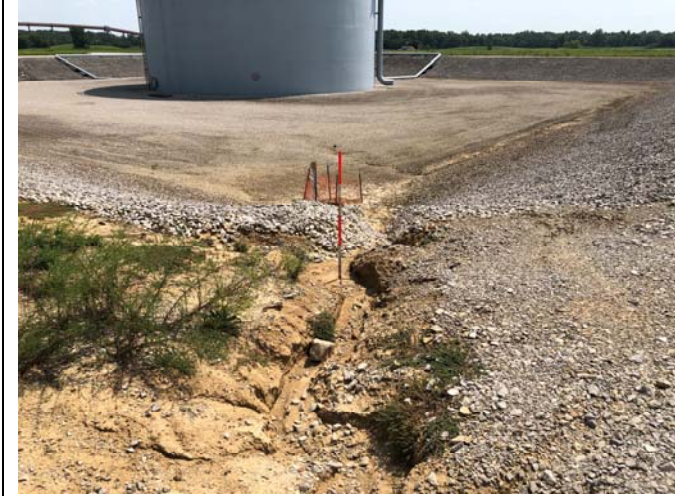
5. The portion of diked embankment adjacent to the metal cleaning tank containment area had an erosion rill in the groin between the metal cleaning tank containment and the east bottom ash pond. This portion of the embankment was otherwise in good condition. There are two pipes that are used to pump storm water from the containment area into the EBAP and they appeared to be functioning properly.

Photograph 7: View of erosion rill on the northern groin between the metal cleaning tank containment dike and the east bottom ash pond dike.

- 1) Eliminate vegetation growth within the scattered riprap areas using appropriate herbicide. Eliminate/ remove vegetation growth from within Clearwater pond discharge structure and the west bottom ash pond skimmer structure.
- 2) Replace rotten wood logs and deteriorated steel brackets at the skimmer at the Clearwater pond outlet structure.
- 3) Repair the loose angle iron in diverter structure for the bottom ash ponds.
- 4) Consider installing an open grated manhole cover at manhole 13-F to allow surface drainage in the cropland area.
- 5) Repair the erosion gully in the groin of the metal cleaning tank containment area and the west bottom ash pond.

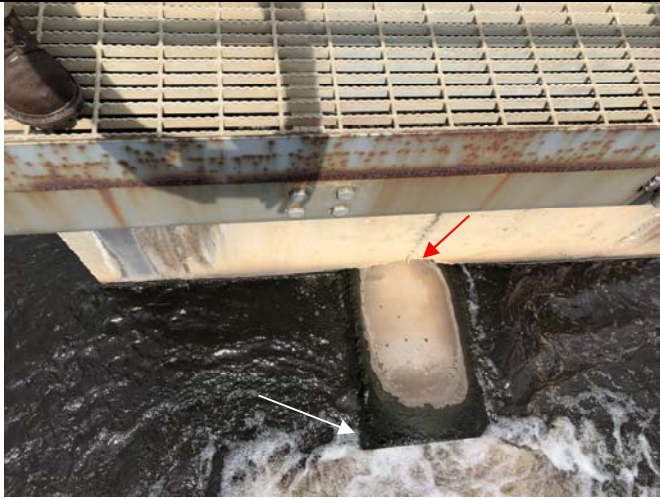
Photograph 8: #WW

1. Wastewater flows were entering both the EWWP and WWWP at the northern end of each pond. The pool elevation of the WWWP was 389.0. The pool elevation of the EWWP was 389.0.
2. The interior slopes of the EWWP and WWWP Ponds were in good condition. The riprap showed no signs of deterioration or weathering. Some minor areas with patches of vegetation were observed.
3. At the outlet of the WBAP discharge structure (coming from the WBAP into the WWWP), some deterioration was observed at the horizontal pipe/concrete wall interface. Minor deflections

estimated at 0.5 inches were observed at the mostly submerged pipe, as water flowed through the pipe.

View of the discharge entering into the west wastewater pond from the west bottom ash pond. Concrete deterioration was noted at the joint between the pipe and concrete wall. Deflections were observed at the end of the pipe, noted by the white arrow.

- 1) Monitor the deterioration of pipe penetration and deflection of the horizontal outlet pipe at the outlet of the west bottom ash pond structure, flowing into the west wastewater pond for further deterioration or excessive movement.
- 2) It is recommended to perform a camera inspection/investigation of the corrugated metal conduit for outfall 001. This is based on the presence of a sinkhole around manhole 13-A, the potential for tree roots to have entered into the pipe, the age of the pipe, manholes which have shifted out of level, and the overall importance of this conduit to the pond complex.

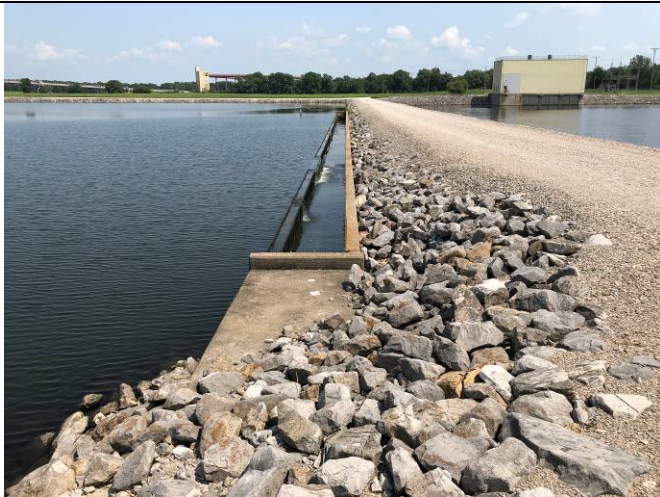
Photograph 9: #WW

4. The spillway structures in the EWWP and the WWWP were in good condition. There were no obstructions at either structures and they appear to be functioning properly. Flow over the weir in the EWWP and WWWP was smooth. The water discharged into the distribution structure where the flow was directed to the Reclaim Pond.
5. The separation of the rectangular concrete weir channels in both ponds does not appear to be any different from the conditions noted in previous inspection reports.
6. The EWWP and WWWP are incised impoundments. The crests of the ponds were well maintained with no signs of settlement or depressions.

View of the primary discharge structure for the east wastewater pond.

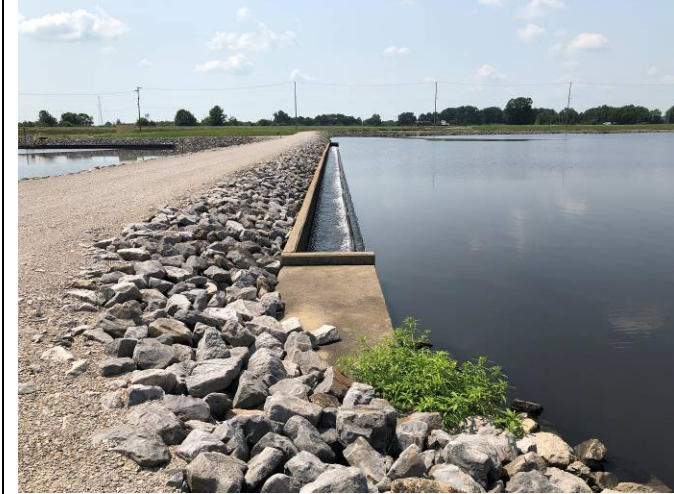
Photograph 10: #WW

View of the discharge structure for the west wastewater pond.

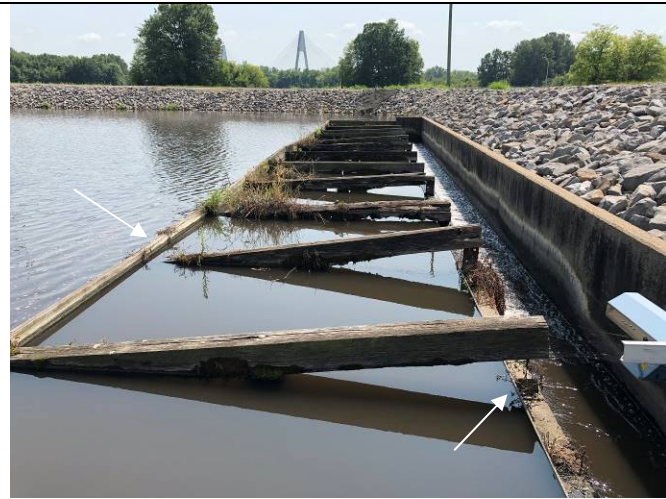
Photograph 11: #Clearwater

6. The outlet structure of the Clearwater Pond was in fair condition with no obstructions. The skimmer board and weir structure was in fair condition, however, several of the steel brackets were broken and few of the wood timbers are rotten. Some vegetation was growing at the entrance to the weir structure.

View of the skimmer at the Clearwater pond discharge. Notice the vegetation, deteriorated timbers and broken metal brackets.

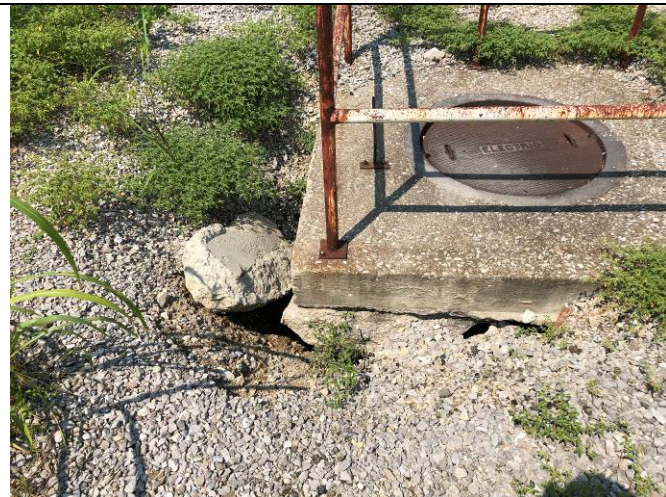
Photograph 12: #Clearwater

8. A small sinkhole feature was observed at manhole 13-A, which provides access to the corrugated metal pipe conduit for outfall 001. A tape measure was inserted into the sinkhole, measuring a depth of roughly 26 inches. Based on discussions with plant personnel, this manhole has experienced concrete deterioration and been repaired in the past.

View of the sinkhole found at the southwest corner of manhole CB-13A

AEP Engineering will coordinate this item with the plant to determine feasible options and timelines for stopping the flow of water into this conduit to facilitate the inspection. It is anticipated that this work will occur over a week of or so, as the flow of water out of the pond complex can only be shut off for small windows of time without overfilling the ponds.

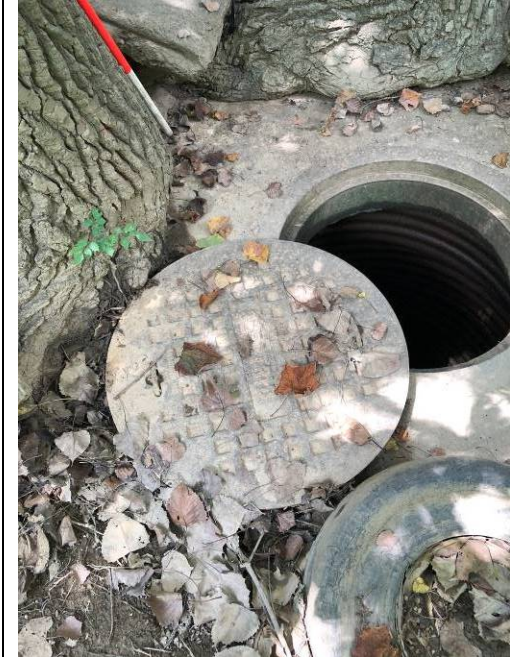
Photograph 13: #Clearwater

Manhole 13-F was found with the lid removed, and it appears the lid may have been removed by nearby farmer to provide surface drainage to cropland.

View of the open manhole found at CB-13F

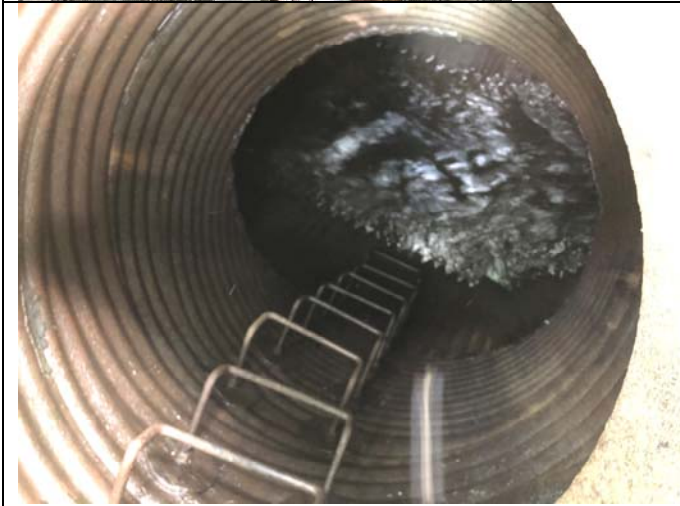
Photograph 14: #Clearwater

View inside the manhole at CB-13F, notice the flowing water and minimal corrosion on the visible areas.

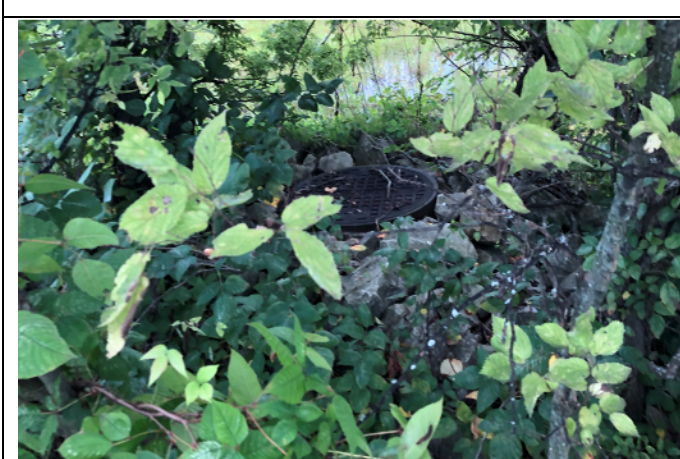
Photograph 15: #Clearwater

Further, additional manholes were located and inspected for similar problems. Some trees and brush were present around four of the manholes. Several of the manholes were observed to be not level. The location of the manholes were marked with pink survey ribbon to make them easier to locate.

View of CB-13C, notice the trees/brush around the manhole, which has also shifted out of level.
