# 2021 ANNUAL DAM AND DIKE INSPECTION REPORT

**BOTTOM ASH PONDS**

**PIRKEY POWER PLANT  
HALLSVILLE, TEXAS**

Document Number: GERS-21-031

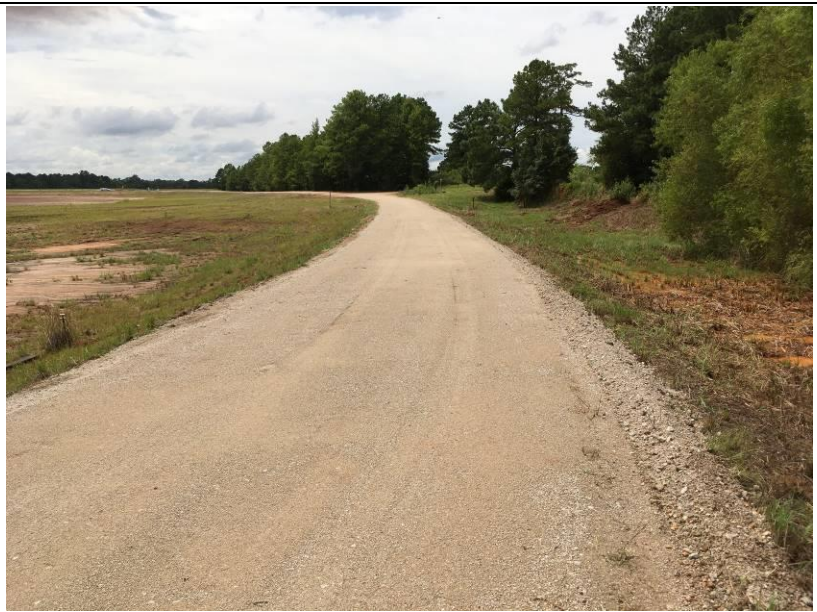
Photo # 4

4. Photograph No. 4 illustrates the typical condition of the crest on the north side of the pond. The crest has signs of rutting from truck traffic. There were no other signs of settlement, misalignment and cracking.

- Overall, the crest and slope conditions of the dam and levees are generally fair with the exception of some minor tire ruts caused from truck traffic and mowing activities. These areas overtime can lead to significant erosion and stability problems.
- Vegetation management for the facilities is considered satisfactory. However, some areas are overgrown and the vegetation should be maintained to promote adequate growth and aid in inspection activities.
- There was standing water observed in the perimeter ditches along the east and south side of the pond. The perimeter ditch flow lines are relatively flat but they do maintain positive flow. However, overgrown cattails and tire ruts from mowing activities have develop isolated areas of standing water along the ditch.

View of the East Bottom Ash Pond Crest. Crest Conditions are Satisfactory with Some Minor Tire Ruts.

- Overall, the crest and slope conditions of the dam and levees are generally fair with the exception of some minor tire ruts caused from truck traffic and mowing activities. The tire rut areas should be repaired/regraded as part of regular maintenance activities. These areas overtime can lead to significant erosion and stability problems.
- Vegetation management for the facilities is considered satisfactory. However, some areas are overgrown and the vegetation should be maintained to promote adequate growth and aid in inspection activities.
- The perimeter ditches should be maintained for overgrown vegetation and damage from mowing activities should be repaired in a timely manner to promote positive flow along the ditches.

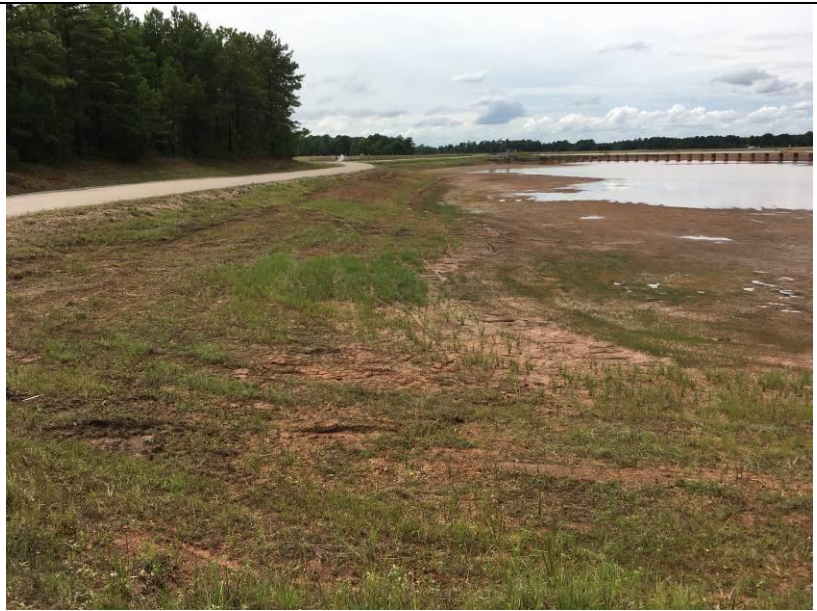
Photo # 5

5. Photographs No. 5 and No. 6 shows the general condition of the interior slopes of the east bottom ash pond. The slope appeared in satisfactory and stable condition. There were no signs of settlement, misalignment, sloughing or erosion.

View of the East Bottom Ash Pond Interior Area and Slope Conditions. East Bottom Ash Pond is Currently Out of Service.

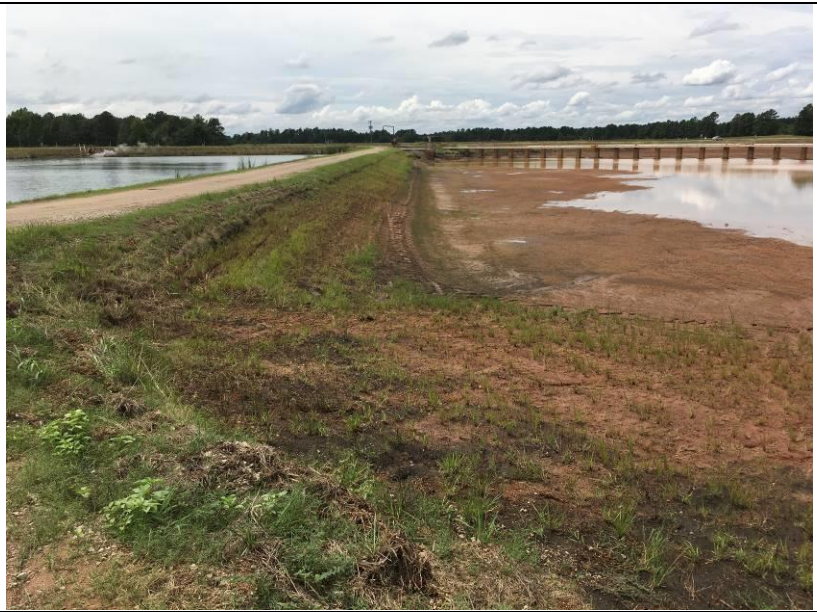
Photo # 6

View of the East Bottom Ash Pond Interior Area and Slope Conditions. East Bottom Ash Pond is Currently Out of Service.

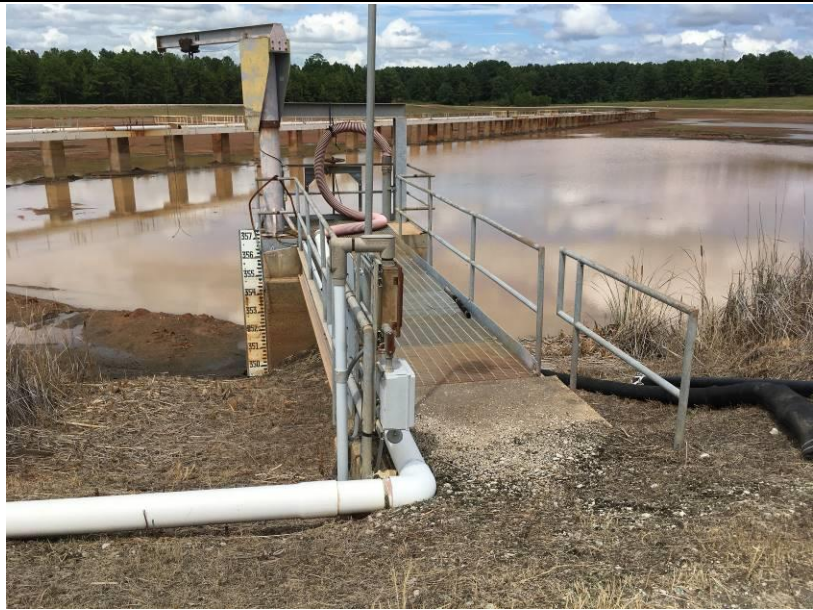
Photo # 7

6. The overflow discharge structure walkway, railings, metal decking, and visible concrete were found to be in satisfactory, functional condition. Photographs No. 7 illustrate the access stairs, metal walkway, metal deck, and concrete structure of the overflow discharge structure.

View of the Discharge Structure at the East Bottom Ash Pond.

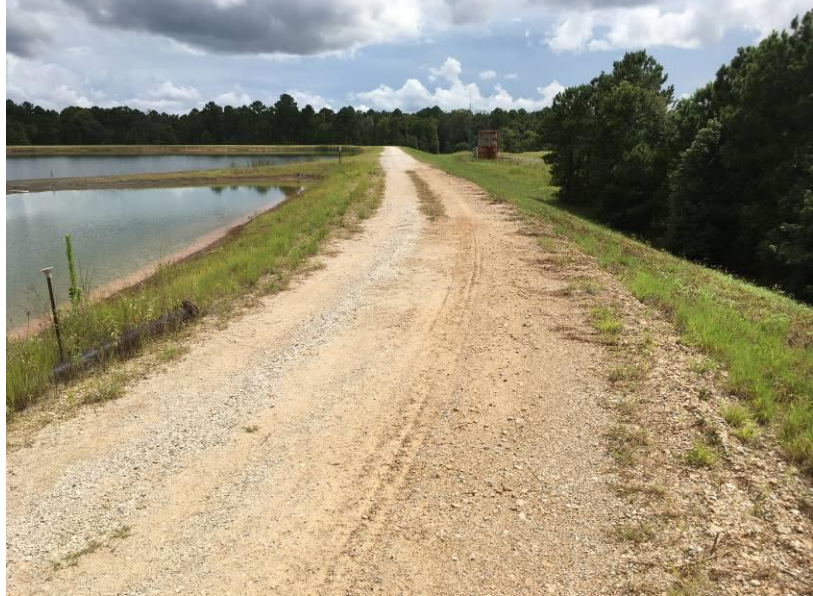
Photo # 8

7. Photographs No. 8 and 9 illustrate a typical overview of the dike crest. The crest appears to be in good and stable condition. Minor rutting from truck traffic was observed during the inspection. There were no other signs of settlement, misalignment and cracking observed.

View of the West Bottom Ash Pond Crest. Crest Conditions are Satisfactory with Some Minor Tire Ruts.

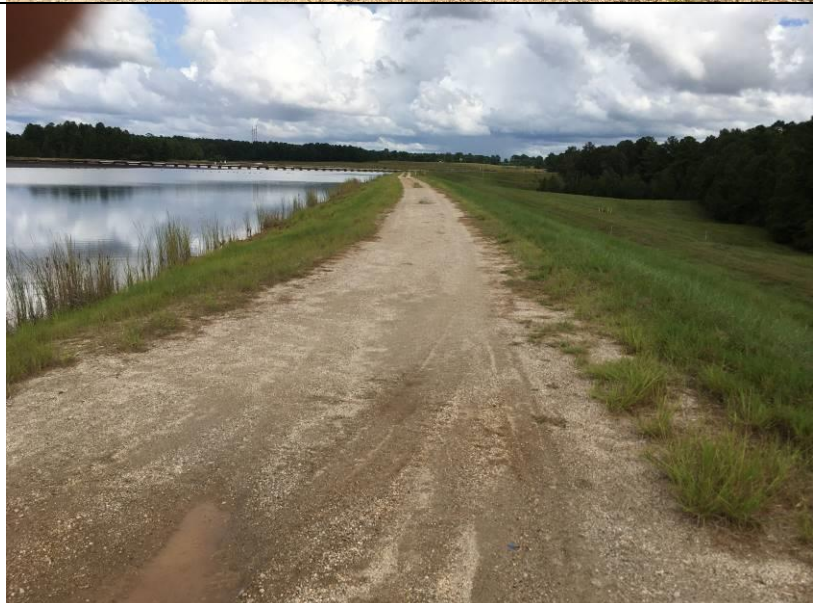
Photo # 9

View of the West Bottom Ash Pond Crest. Crest Conditions are Satisfactory with a Some Minor Tire Ruts.

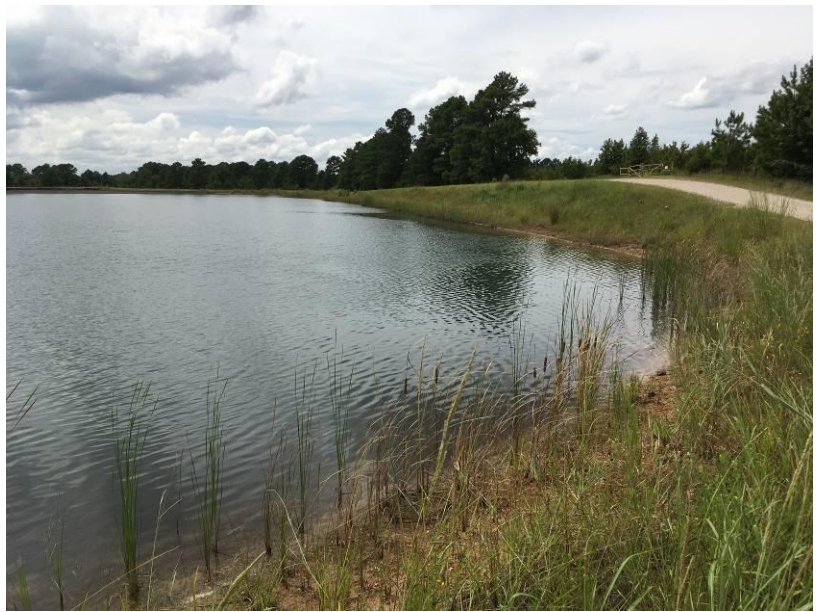
Photo # 10

8. Photographs No. 10 and 11 illustrate the condition of the interior slopes and vegetation management of the west bottom ash pond. The interior slopes appeared to be in satisfactory and stable condition. The vegetation appears to be overgrown near the water line.

View of the Interior Slope  
Conditions of the West Bottom  
Ash Pond. West Bottom Ash  
Pond is Currently In Service.  
Vegetation is slightly  
Overgrown near the Waterline.

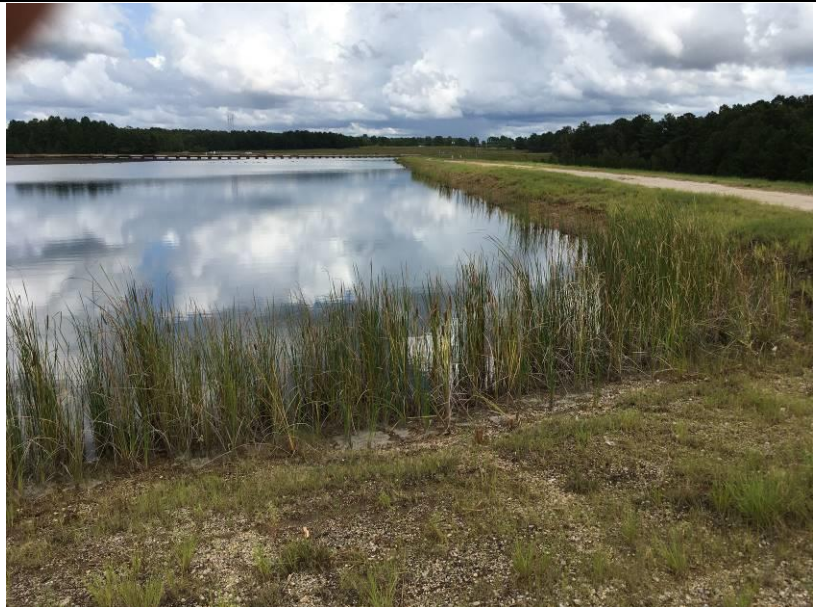
Photo # 11

View of the Interior Slope  
Conditions of the West Bottom  
Ash Pond. West Bottom Ash  
Pond is Currently In Service.  
Vegetation is slightly  
Overgrown near the Waterline.

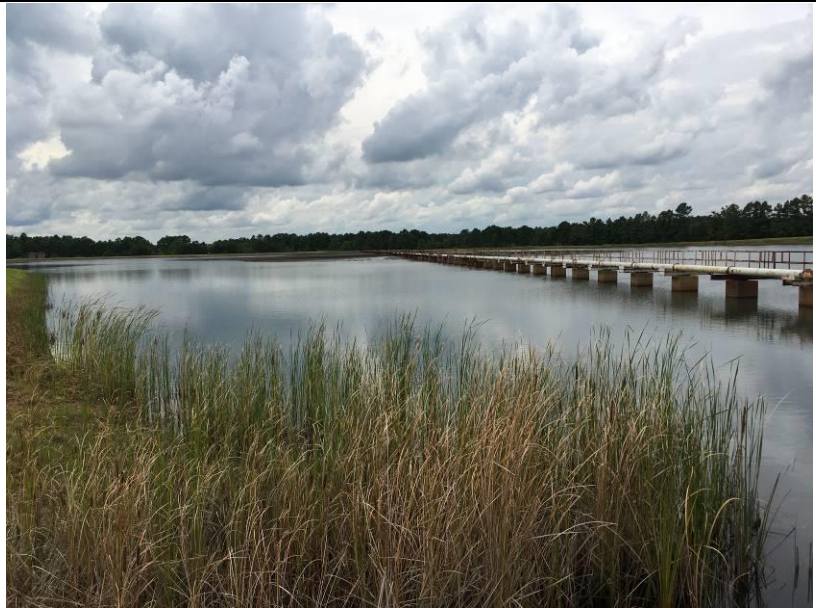
Photo # 12

9. Photograph No. 12 show the general condition of the interior area of the west bottom ash pond and the sluicing pipe platform that extends out into center of the pond. Both the pond interior and the pipe platform structure appeared to be in satisfactory condition. The west bottom ash pond was in service at the time of inspection.

View of the Sluicing Pipe  
Structure of the West Bottom  
Ash Pond.

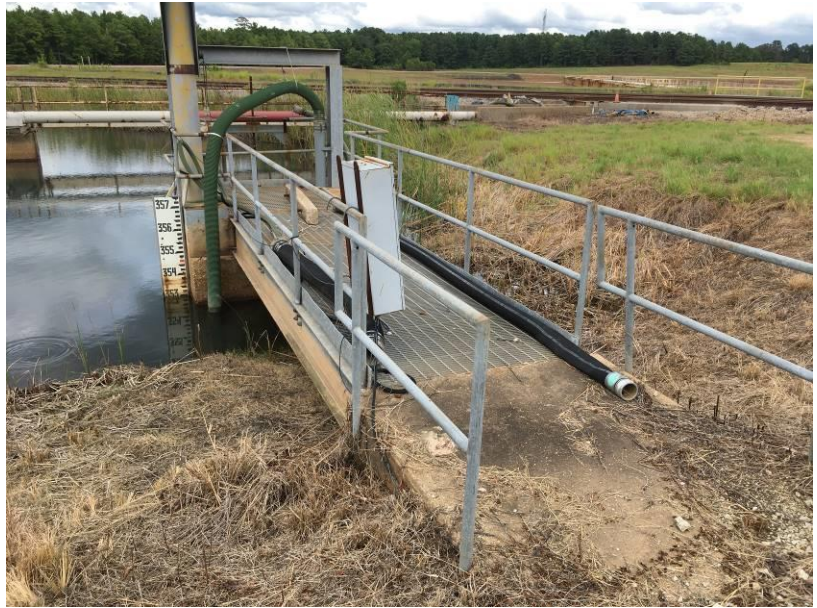
Photo # 13

10. The overflow discharge structure walkway, railings, metal decking, and visible concrete were found to be in satisfactory, functional condition. Photographs No. 13 illustrates the access metal walkway, metal deck, and concrete structure of the overflow discharge structure.

View of the Discharge Structure of the West Bottom Ash Pond.

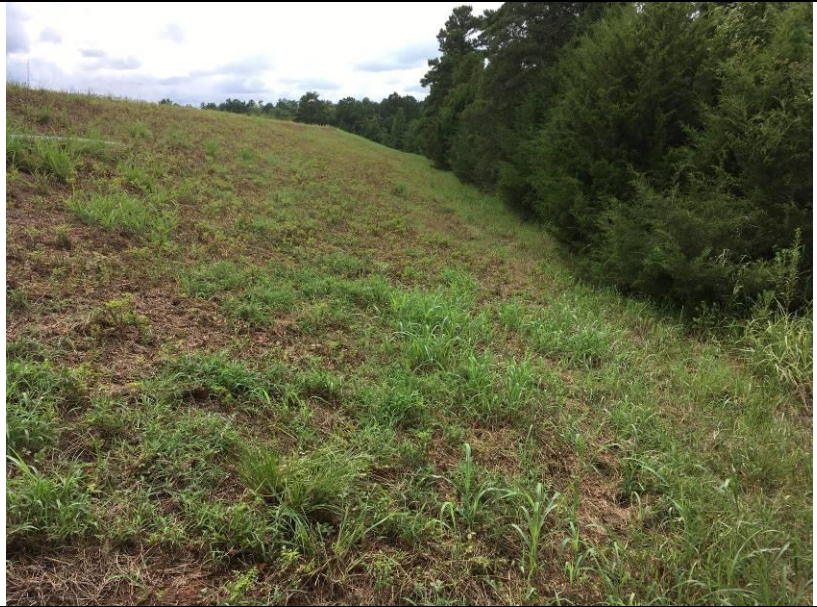
Photo # 14

11. Photographs No. 14, 15 and 16 shows the general condition of the exterior slope and toe areas of the west bottom ash pond. The slopes appeared in satisfactory and stable condition. There were no signs of wet areas, settlement, misalignment, sloughing or erosion. The south slope has some standing water in tire ruts at the toe of the slope.
12. Photograph No. 17 shows the general condition of the southern slope near the east end of the pond. The toe area appear to be wet and there is overgrown vegetation near the culvert that passes under the access road to the dam.
13. Photograph No. 18 shows the condition of the access ramp on the southeast side of pond. In general, the access ramp appears to be in satisfactory conditions with no signs of rutting, cracking, misalignment or erosion.

View of the North Exterior Slope of the West Bottom Ash Pond. Slope Vegetation is Well Managed.

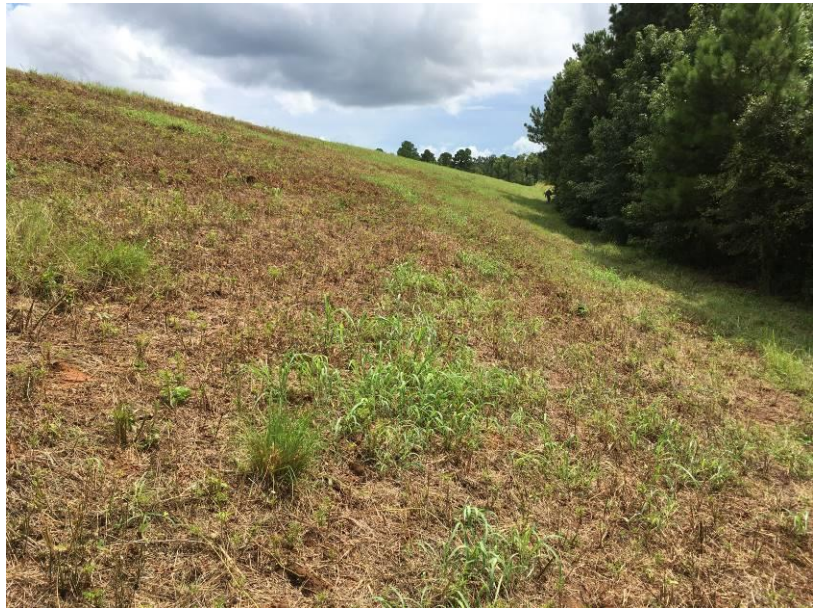
Photo # 15

View of the West Exterior Slope of the West Bottom Ash Pond. Slope Vegetation is Well Managed.

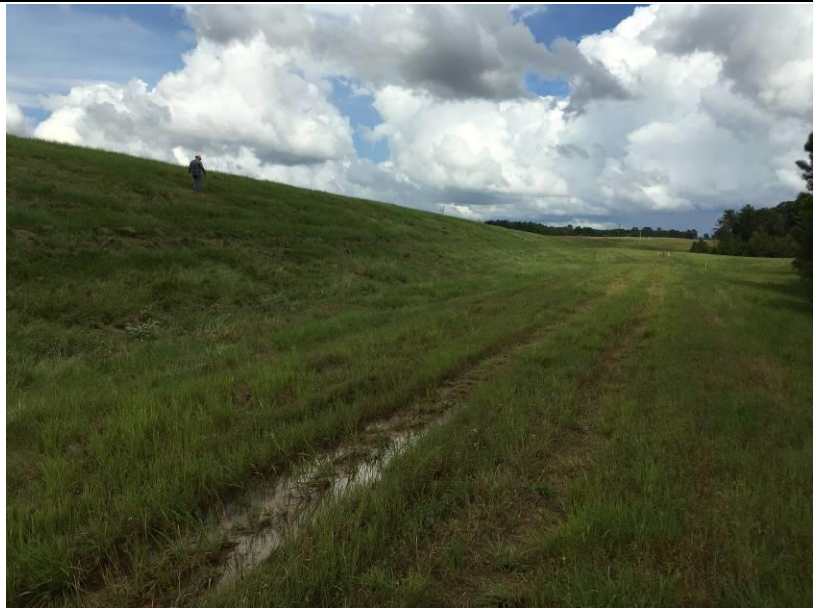
Photo # 16

View of the South Exterior Slope the West Bottom Ash Pond. Slope Vegetation is Well Managed. Notice standing Water in tire Ruts.

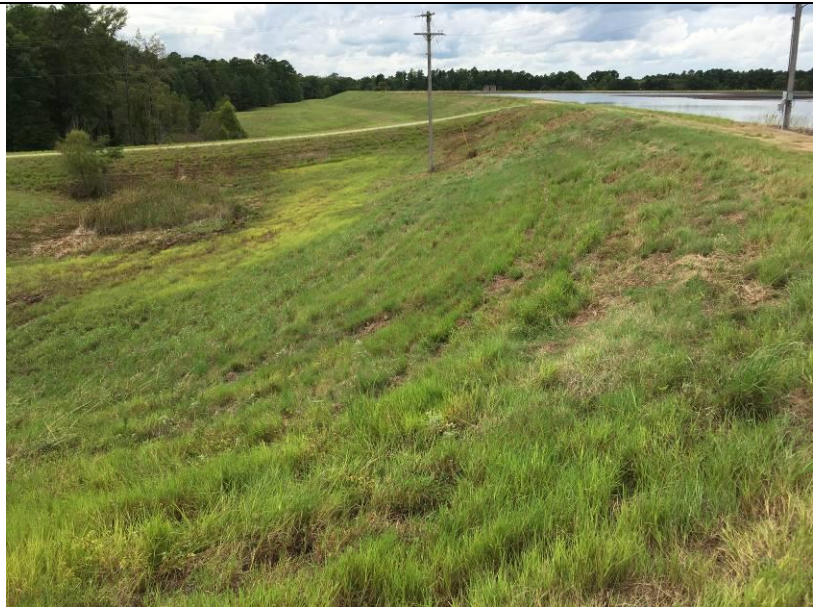
Photo # 17

View of the South Exterior Slope of the West Bottom Ash Pond. Lower Section Has Overgrown Vegetation Near Culvert Pipe.

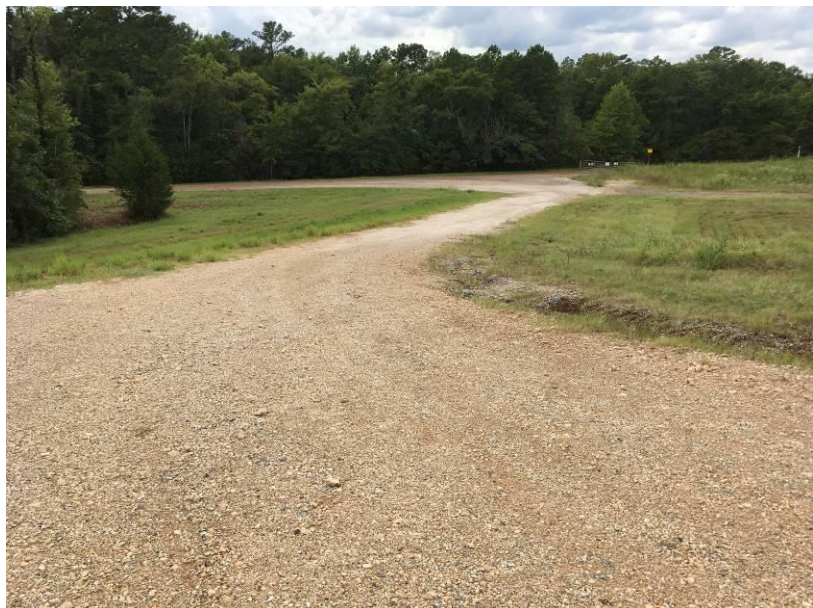
Photo # 18

View of the Access Ramp to the Crest Area on the Southeast corner of West Bottom Ash Pond. Access Road in Satisfactory Condition.
