# **2021 Annual Landfill Inspection Report**

**CCR Landfill**

**Turk Power Plant  
Southwestern Electric Power Company  
Fulton, Arkansas**

**Document ID: GERS-21-068**

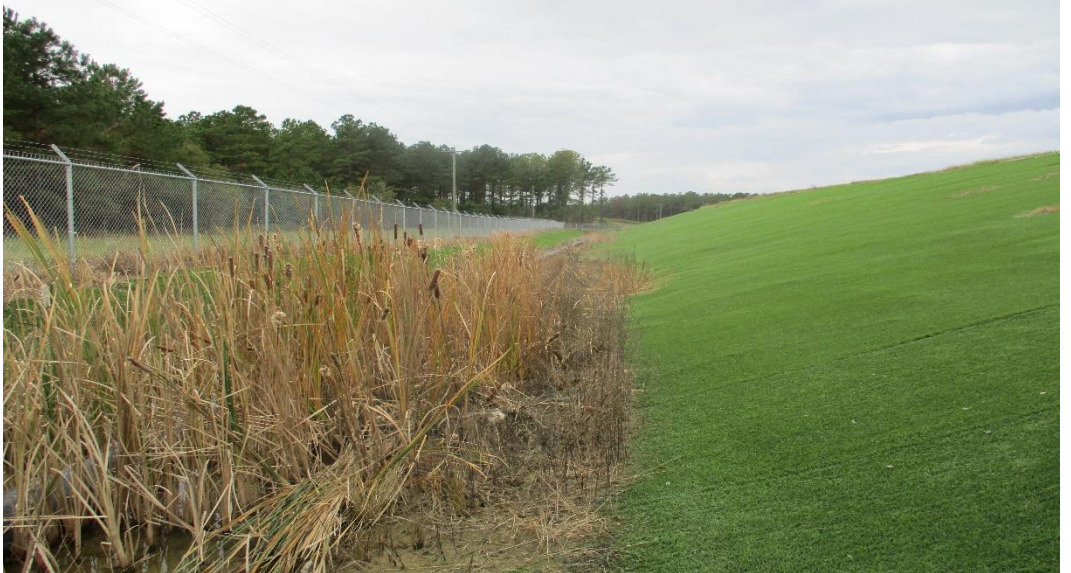
<p>Photograph No. 4 South side toe ditch (looking west).</p>

2. A perimeter berm with a toe ditch was constructed for the landfill to support the landfill and control runoff from the landfill. The south perimeter berm is shown in Photographs No. 3 and 4. The slope of the berm consists of artificial turf (alternate to the natural grass cover) and appeared in good and stable condition. Few isolated spots indicated weeds protruding through the artificial turf. It appears that some of the sand that was placed as ballast over the artificial turf may have washed down into the toe ditch. The eastern section of the toe ditch exhibited overgrown vegetation in the ditch bottom, while the western section was in good shape without excessive vegetation.

- (i) All the overgrown vegetation should be cleared or cut down carefully as not to disturb the artificial turf from the ditch and restored to its design condition.
- (ii) Minor rutting at the south perimeter haul road should be repaired by regrading and keeping up regular maintenance in future. Erosion control berm can be added at the bottom of the temporary channel in order to minimize future erosion.
- (iii) General vegetation control should be maintained at the leachate pond and storm-water pond, particularly around the outlet pipes. Temporary cover at the landfill should be re-seeded and/or maintained.

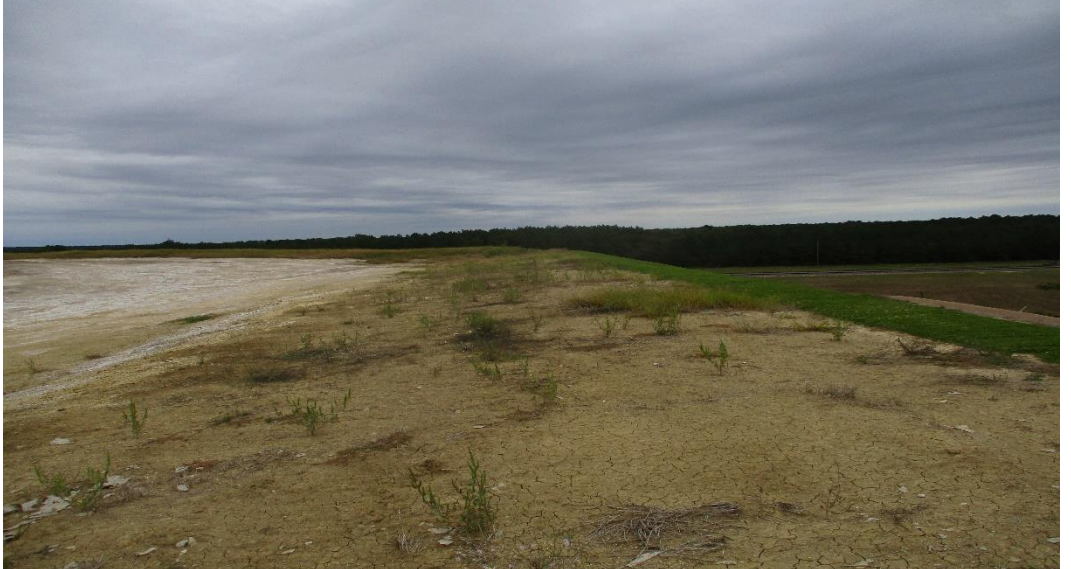
4. Photograph No. 6 illustrates area of Cell 1 and closure turf anchored on the top. Overall the anchor trench is intact in-place and Cell 1 surface is properly graded without any ponding or erosion issues.

A photograph showing a toe ditch filled with tall, dry, brown reeds or grasses. To the right of the ditch is a well-maintained green lawn that slopes upwards. In the background, a chain-link fence runs parallel to the ditch, with a line of trees behind it under a cloudy sky.
<p>Photograph No. 5 South side closure turf test pad (looking east).</p>	  A wide-angle photograph of a large, sloping area covered in green grass. A long, narrow strip of light-colored gravel or crushed stone runs diagonally across the slope. The sky is overcast and grey.
<p>Photograph No. 6 Cell 1 top area.</p>

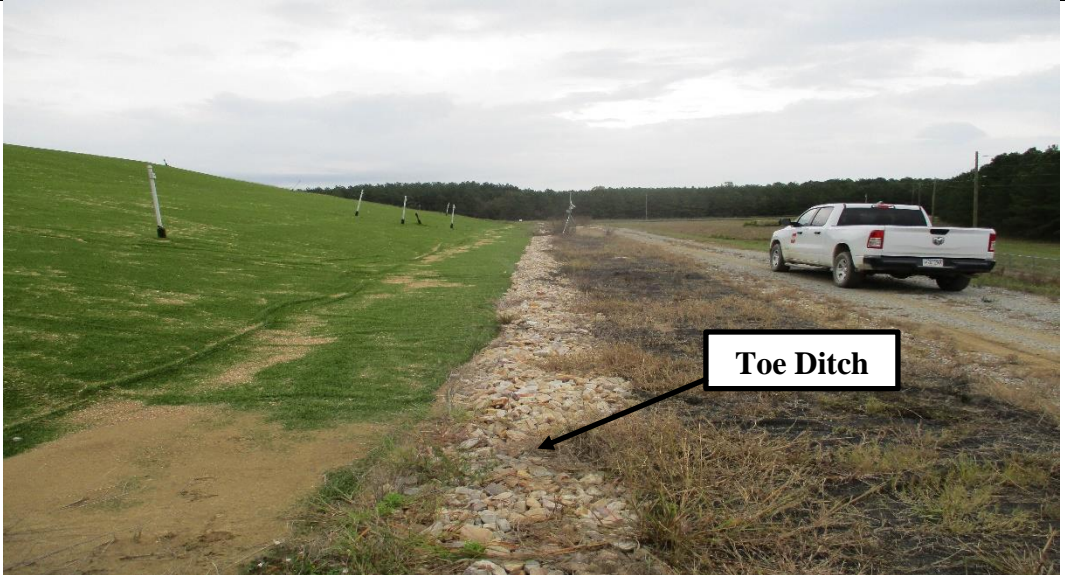
<p>Photograph No. 7 Cell 1 south side toe ditch (looking east).</p>

5. Photograph No. 7 illustrates closure turf, toe ditch, and access perimeter road. The toe ditch was recently constructed for runoff control. The ditch is functioning as designed and the access road was in good condition without any sign of settlement, misalignment, or significant erosion.

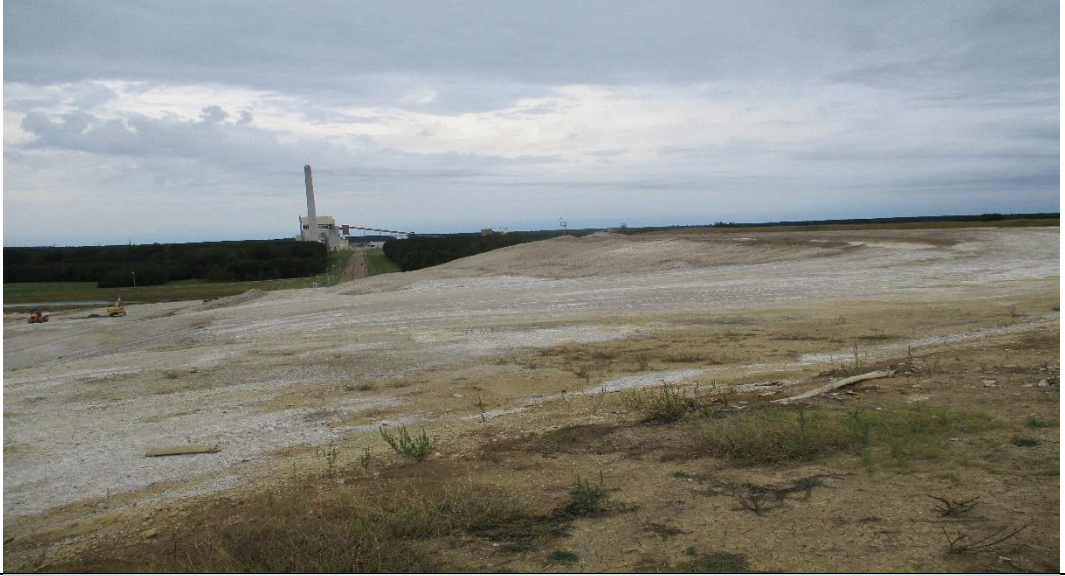
6. Overall condition of the landfill Cell 1 is illustrated in Photograph Nos. 8-10. Photograph No. 8 was taken from top of Cell 1 looking down towards Cell 2 and Photograph No. 9 is illustrating east side of Cell 1. Existing landfill Cell 1 was in good and stable condition with no sign of instability, water ponding or significant erosion of the interim slopes. The east side slope soil cover is temporary cover. Minor bare areas with sparse vegetation (Photograph No. 10) were observed on the east slope.

<p>Toe Ditch</p>
<p>Photograph No. 8 Cell 1 west slope.</p>

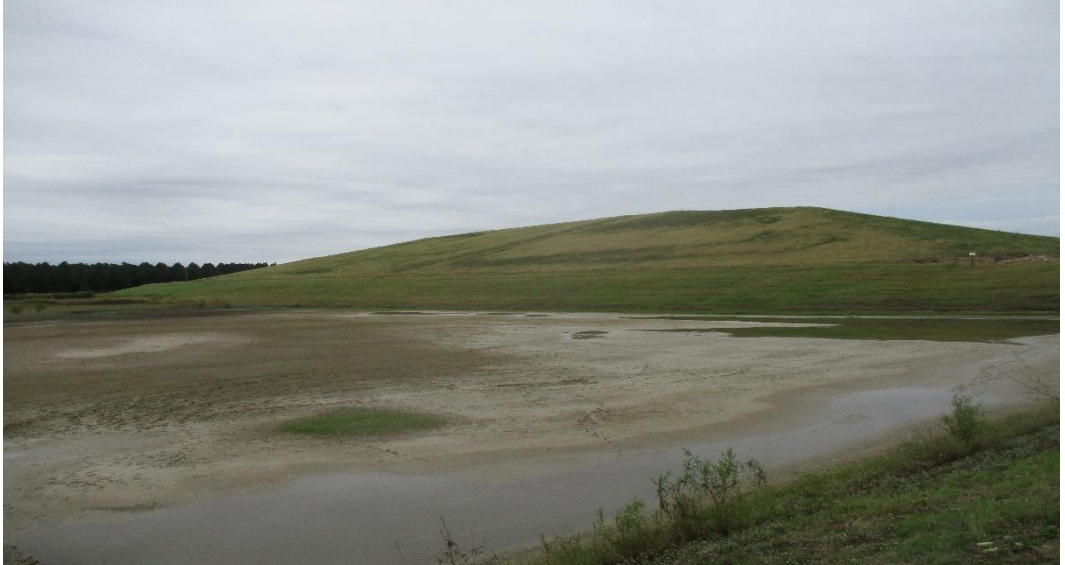
<p>Photograph No. 9 Overall view of Cell 1 east slope.</p>

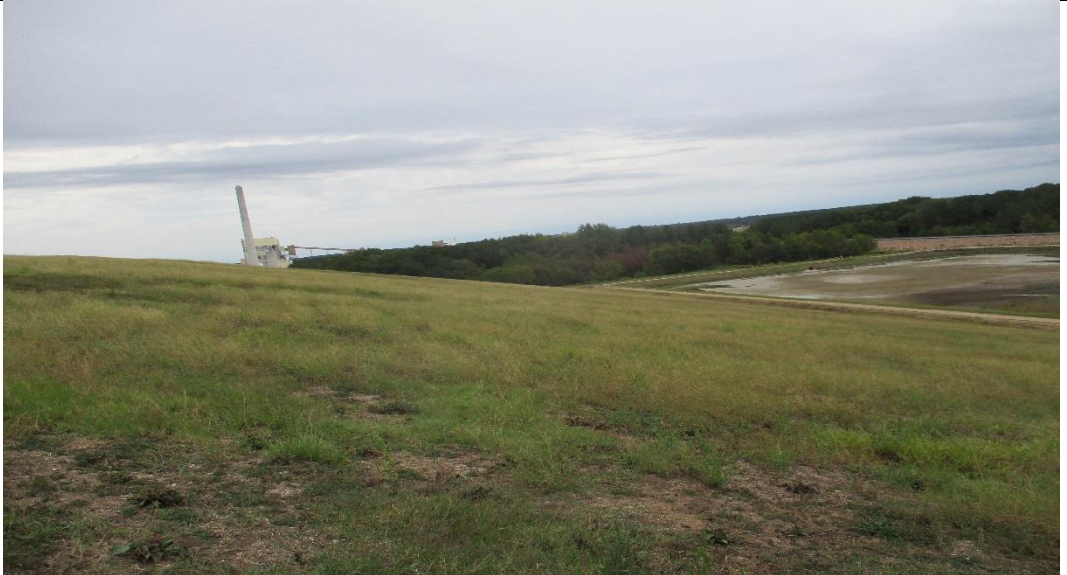
<p>Photograph No. 10 Cell 1 east slope (looking north).</p>

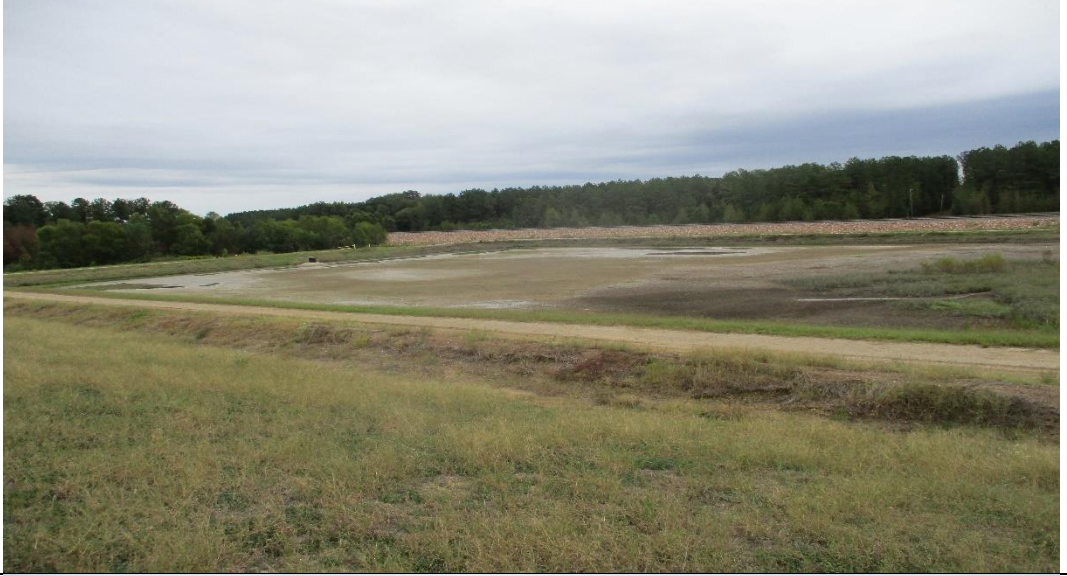
7. Typical perimeter berm is illustrated in Photograph Nos. 11 and 12. Overall, the berm was functioning well and in good condition. The perimeter access road appeared in good condition without any signs of settlement, instability, misalignment, or significant erosion.

A wide-angle photograph showing a grassy slope leading up to a large, flat, brownish area in the distance. A tall, thin structure is visible on the horizon under a cloudy sky.
<p>Photograph No. 11 East side berm (stormwater pond in the background).</p>

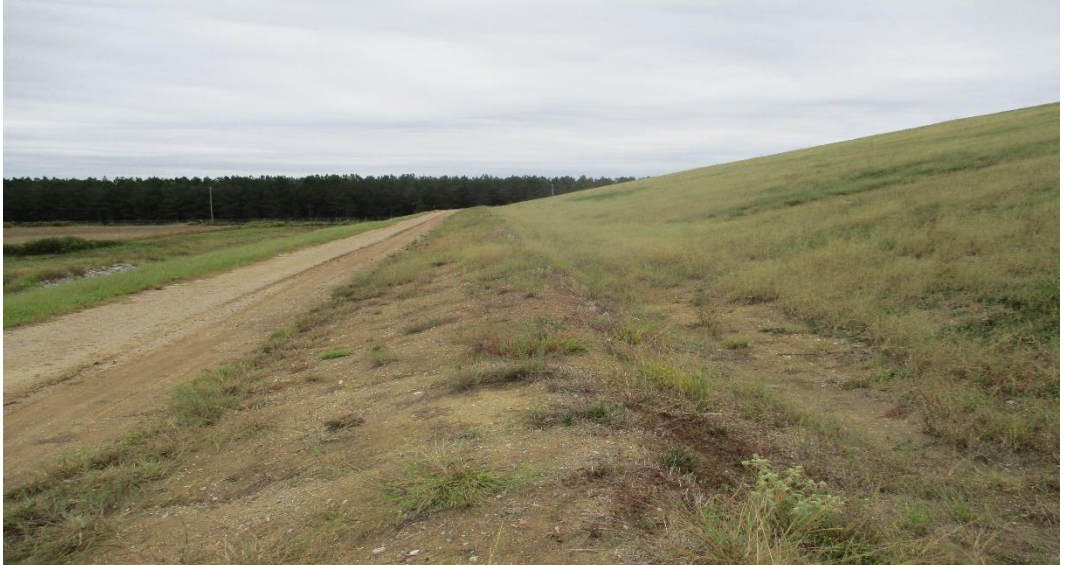
A photograph of a grassy area with a dirt path leading towards a large, flat, brownish area in the background. A line of trees is visible in the distance under a cloudy sky.
<p>Photograph No. 12 East side slope, berm, and access road (looking south).</p>

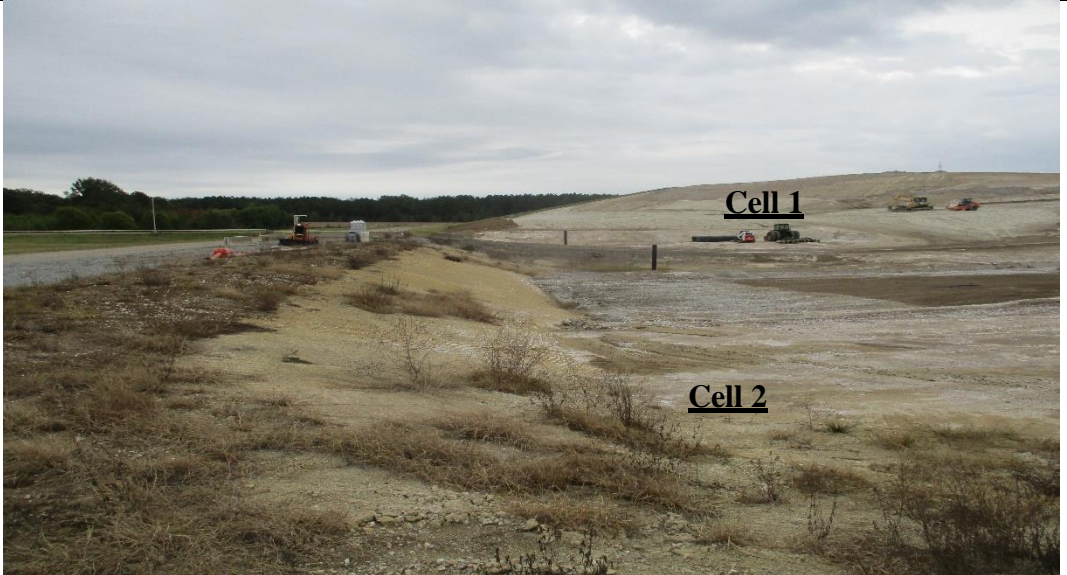
9. Photograph Nos. 15-17 illustrate Cell 2, Cell 1 is also in the background (Photograph No. 16). Cell 2 is currently active waste disposal area and Cell 1 is used as support by filling in waste and to tie the grades to the Cell 1 slope. Both cells appeared in good and stable condition. Perimeter road appeared in good and stable condition and surface runoff and contact water was properly maintained per the design.

10. Photograph No. 16. The berm with the haul road appeared in good and stable condition.

<p>Photograph No. 16 Cell 2 (looking east).</p>

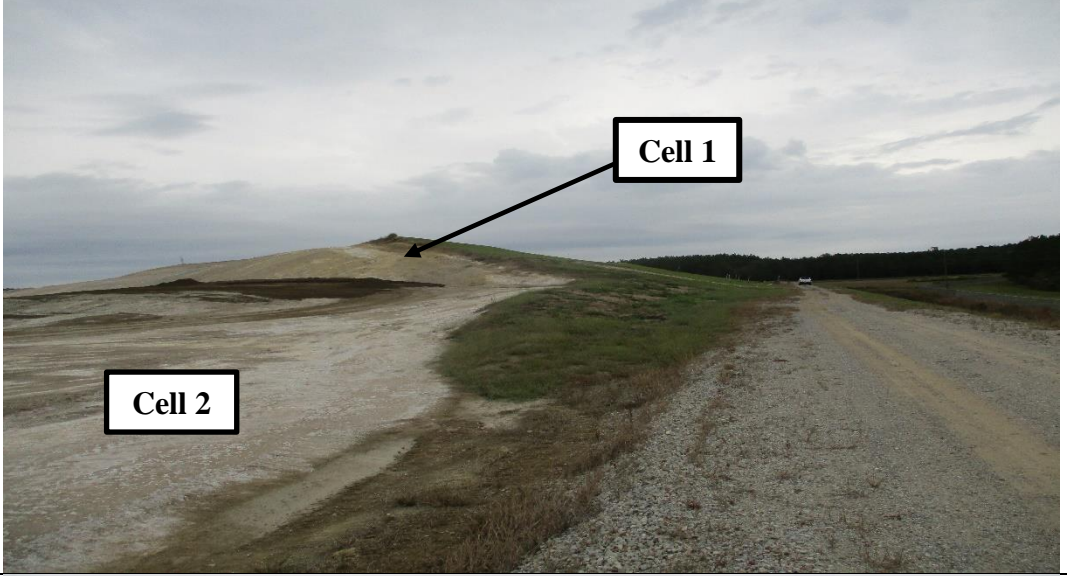
<p>This photograph shows a wide view of the landfill cells. In the foreground, there is a dirt path with sparse, dry vegetation. To the right, a large, flat, brownish area is labeled "Cell 2". In the background, a higher, rounded mound is labeled "Cell 1". Several pieces of heavy machinery, including excavators and trucks, are visible on the surface of Cell 1. The sky is overcast with grey clouds.</p>
<p>Photograph No. 17 Cell 2 and Cell 1 (looking east).</p>

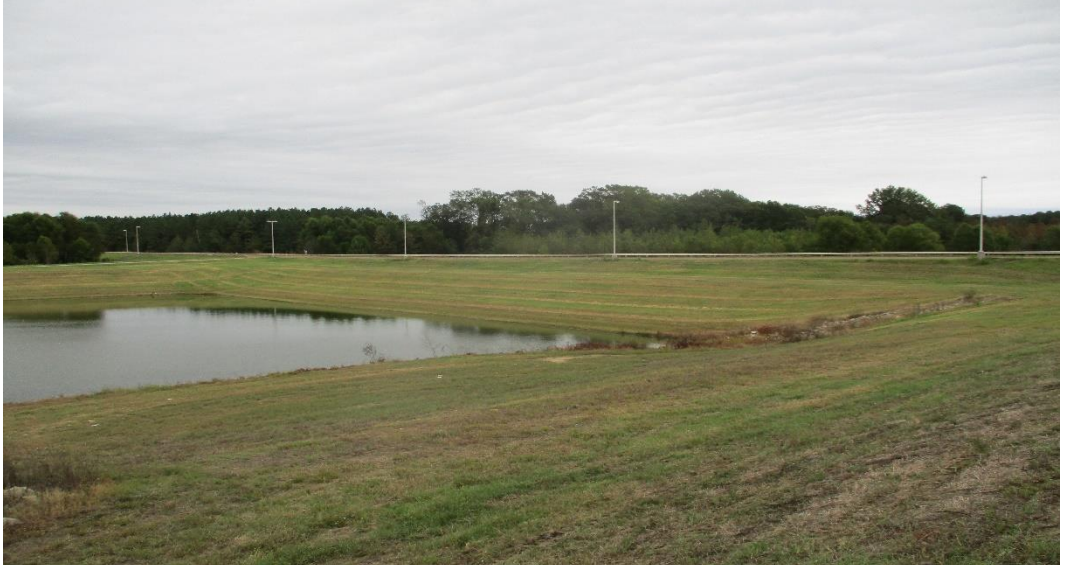
11. Overall, typical interior view of the leachate pond is illustrated in Photograph No. 18. The vegetative cover on the interior slopes (north, south, and east) appeared in good and controlled condition.

<p>This photograph shows a dirt road leading towards the landfill cells. On the left side of the road, a mound of earth is labeled "Cell 2". On the right side, a higher mound is labeled "Cell 1" with an arrow pointing to it. The ground is a mix of dirt and gravel. The sky is cloudy.</p>
<p>Photograph No. 18 Overall view of the leachate collection pond interior (looking northeast).</p>
