2021 ANNUAL CCR LANDFILL INSPECTION REPORT

Ash Landfill

**Welsh Plant
American Electric Power Service Corporation
(SWEPCO)
Cason, Texas**

Document Number: GERS-21-075

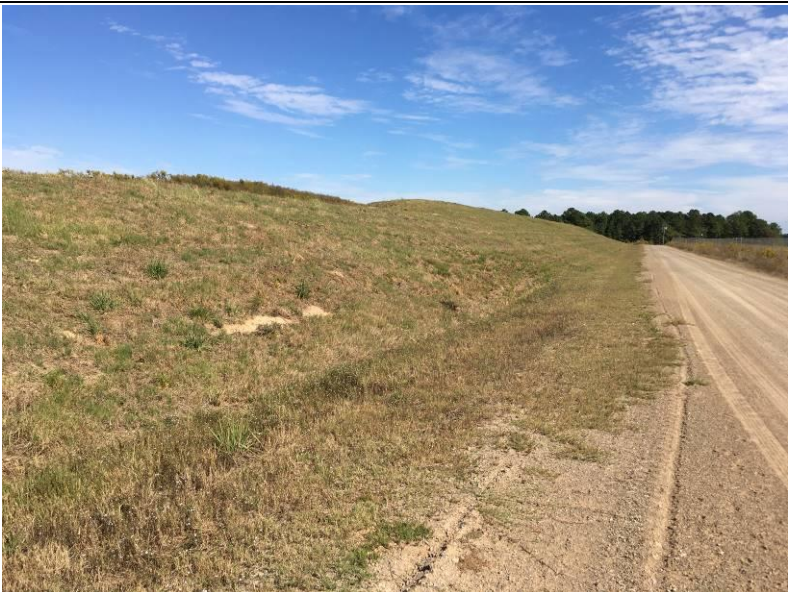
Photo # 1

1. The south slope of the landfill and the toe ditch is illustrated in Photograph No. 1. The slope appeared in satisfactory condition with no signs of seepage, erosion, or sloughing. The toe ditch at the time of inspection appeared mostly dry. An area of the top of slope indicated hog rutting activity (Photograph No. 2).

View of the Southern Berm Outside Slope Looking East.

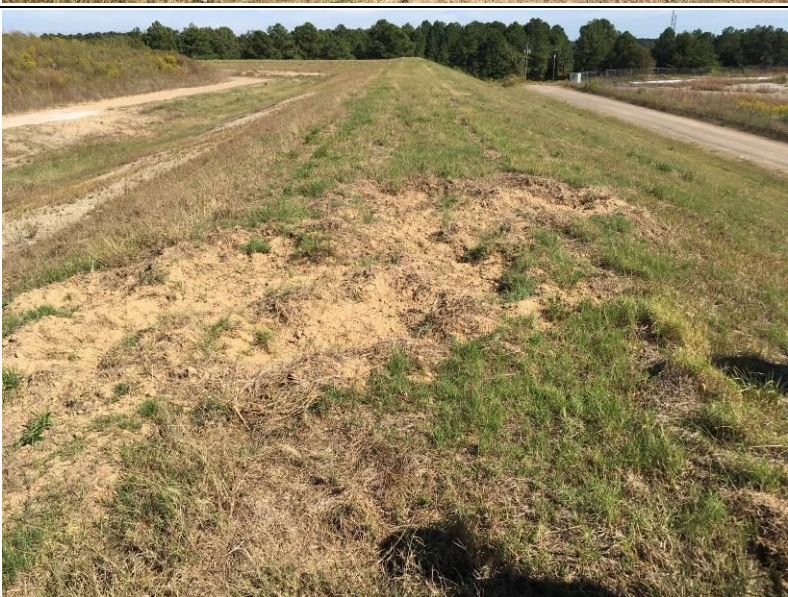
Photo # 2

View of the Southern Berm Top of Slope looking East. Notice Hog Rutting Activity.

- 1 The outside slope areas damaged by hog activity on the southern and eastern slopes should be repaired.
- 2 Positive drainage shall be maintained over the landfill and in the perimeter ditches. The low spot in the east side perimeter ditch should be graded and fill in to maintain positive drainage.

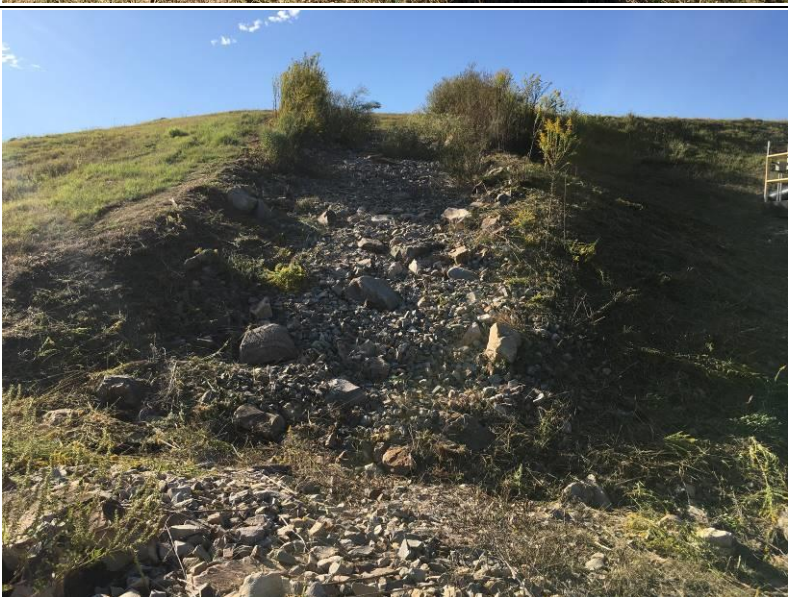
Photo # 3

2. Photograph No. 3 illustrates the southeast corner of the landfill where the riprap lined letdown channel is located. The channel appeared in satisfactory and functional condition. There was some overgrown brush and woody vegetation protruding through the rock lined channel.

View of the Southeast Berm Let Down Channel. Notice Some Overgrown Vegetation in Rocks.

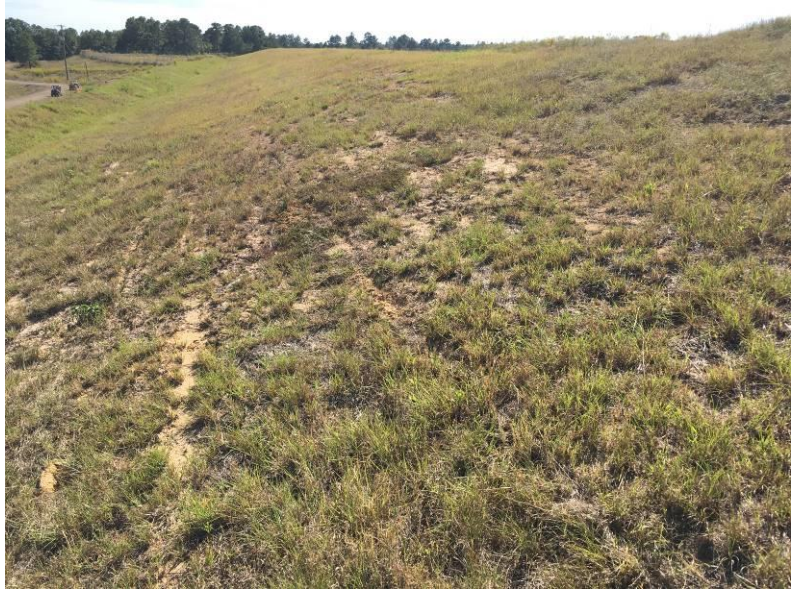
Photo # 4

3. The east slope of the landfill and the toe ditch is illustrated in Photographs No. 4 - 7. The slope appeared in satisfactory condition with no signs of seepage, erosion, or sloughing. The toe ditch at the time of inspection appeared mostly dry. The perimeter ditch below the access walkway on the northern end was bare from vegetation indicating that there had been standing water (Photograph No. 5) in this section of the ditch. Hog rutting activity was noticed on the mid slope near the access walkway on the northern end (Photograph No. 6). The perimeter ditch on the north end showed signs of head cutting activity from erosion (Photograph No. 7).

View of the Eastern Berm
Outside Slope Looking South.

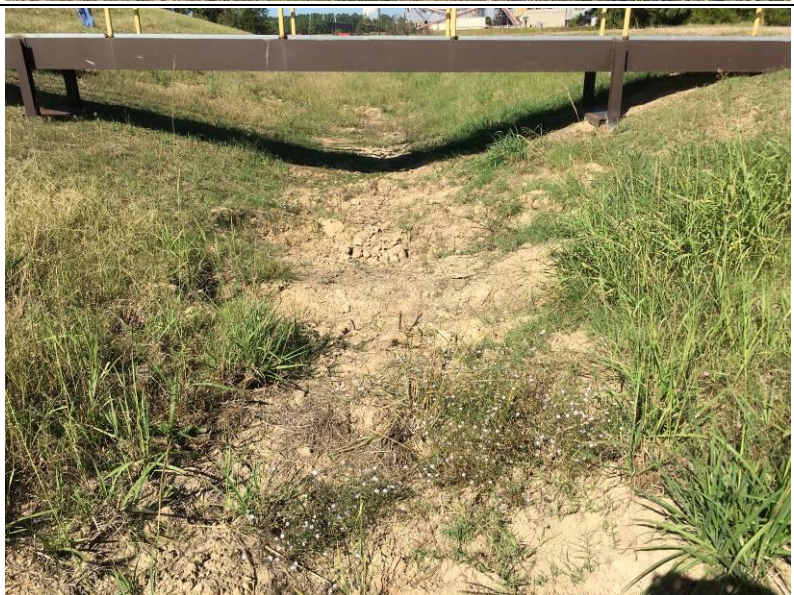
Photo # 5

View of the Eastern Berm
Perimeter Ditch. This Section of
Ditch is Flat and Holds Water
After Storm Events.

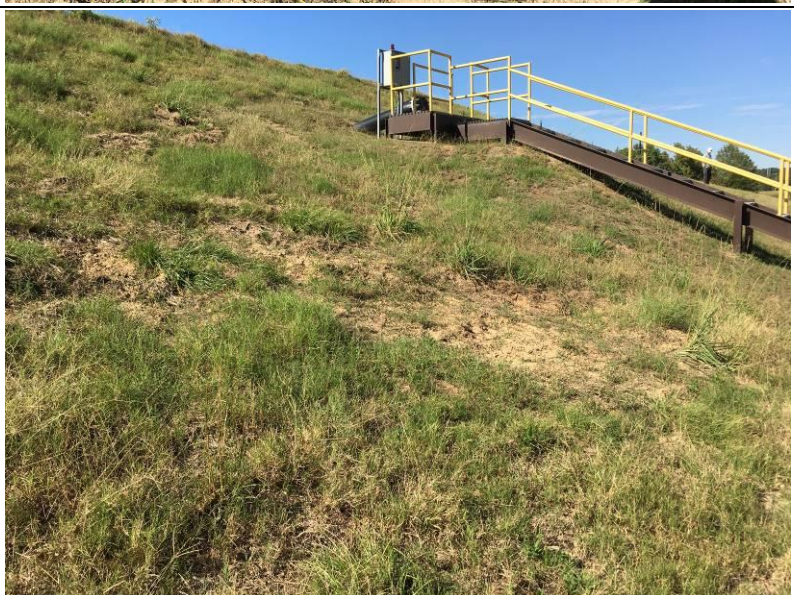
Photo # 6

View of the Eastern Berm
Outside Slope Conditions. Notice
Hog Rutting Activity.

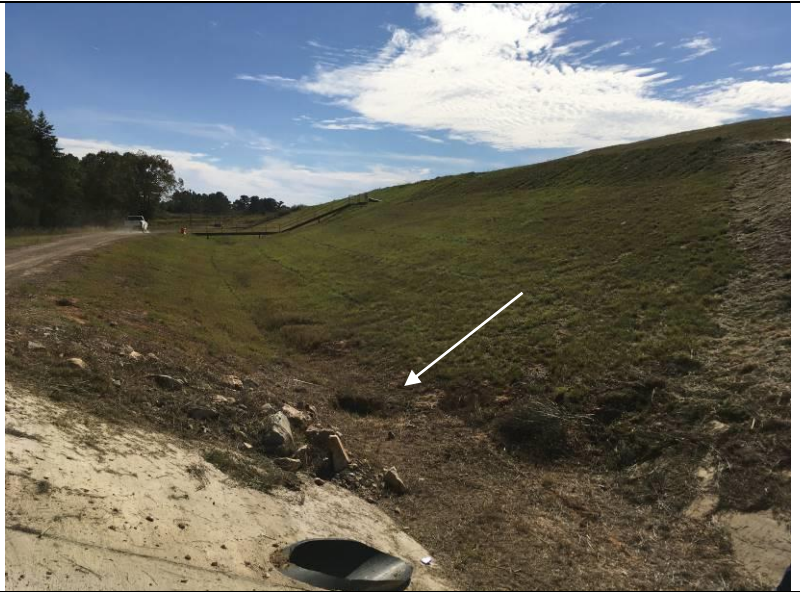
Photo # 7

View of the Eastern Berm Outside Slope and Perimeter Ditch. Notice Head Cutting in Center of Ditch From Flowing Water.

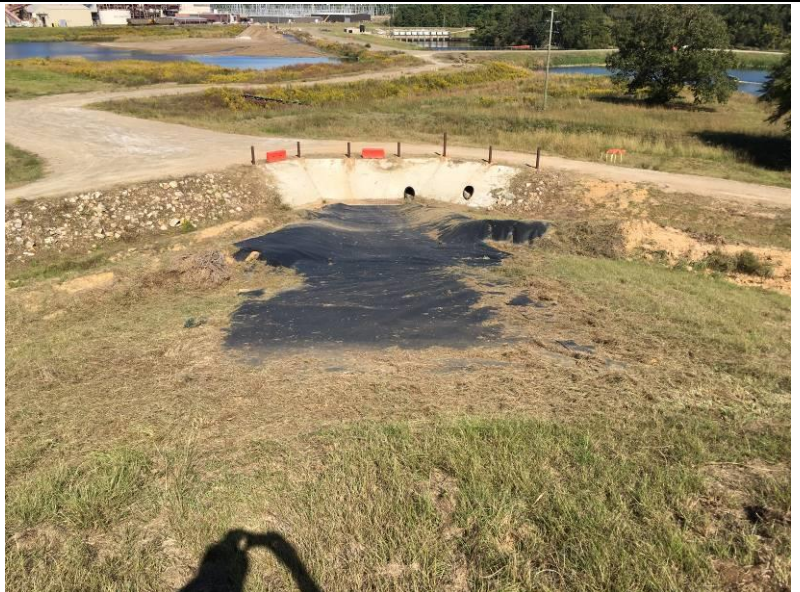
Photo # 8

4. Photograph No. 8 illustrates the HDPE lined letdown channel in the northeast corner of the landfill. The channel appeared to be in satisfactory and functional condition, however there was a small tear in the liner near the anchor trench about midway up the slope (Photograph No. 10). The bottom section of the letdown channel is lined with concrete with energy dissipater blocks to slow water down before it enters the perimeter ditch. There is sediment buildup in the bottom of the ditch near the inlets to the 30 and 36 inch pipes (Photograph No. 9).

View of the Northeast Corner Berm Let Down Ditch.

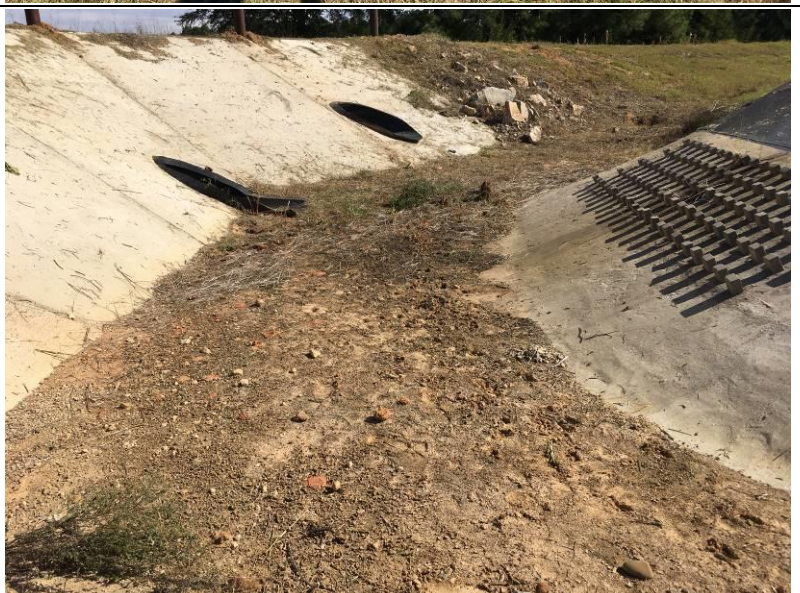
Photo # 9

View of the 30 and 36 inch Storm Water Pipes Located in Northeast Corner of Landfill Perimeter Ditch. Notice Sediment Buildup in Ditch and In Front of Pipe Inlets.

- 3 The HDPE liner on the northeast corner let down channel should be repaired to prevent erosion and additional damage to the adjacent area.
- 4 The sediment build up in the northeast corner perimeter ditch near the 30 and 36 inch pipes needs to be cleared to prevent any pipe flow blockage from additional sediment build up.

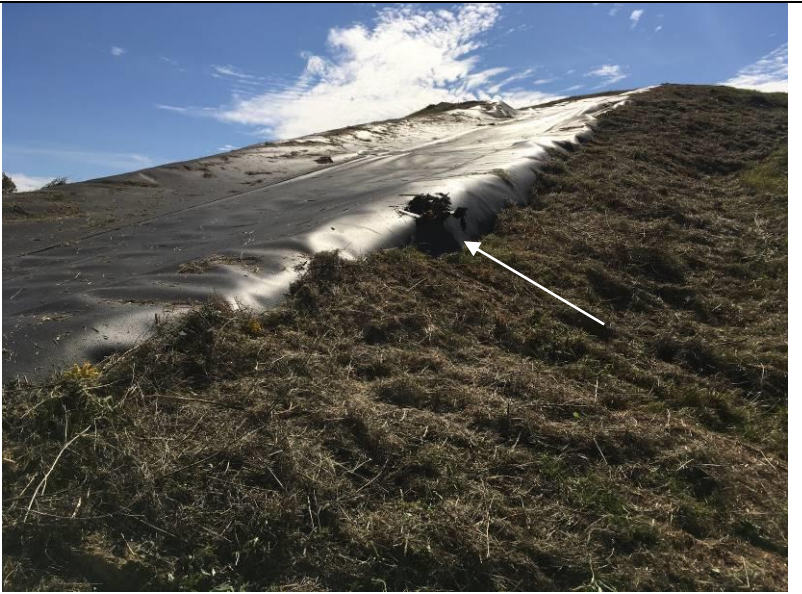
Photo # 10

View of the Northeast Corner Bern Let Down Ditch. Notice the Tear in the HDPE geomembrane.

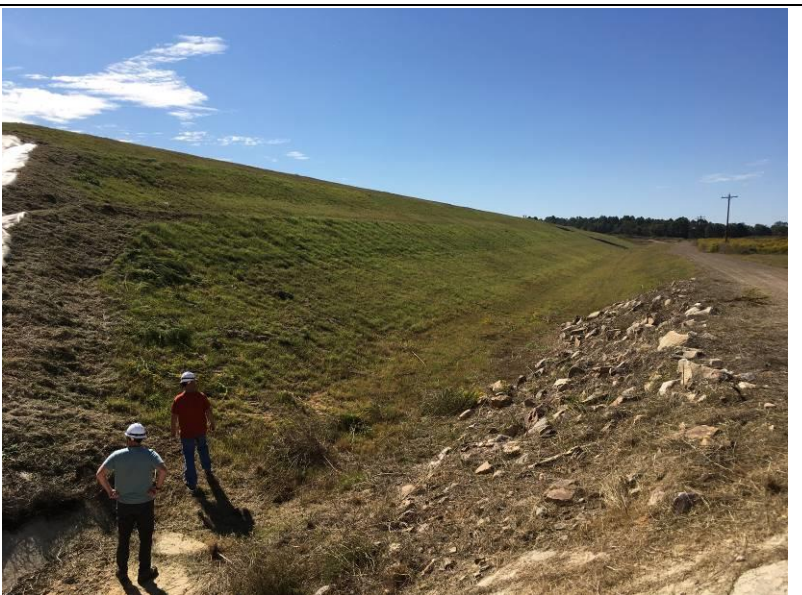
Photo # 11

5. Photographs No. 11 – 16 illustrates the outer slopes, northern let down channel and perimeter ditch on the north side of the landfill. Most of the slopes appeared in satisfactory condition with no signs of seepage, erosion, or sloughing. Vegetation cover is satisfactory except for a few sparse areas located just west of the northern let down channel (Photograph No. 13 and 14). The west end of the northern berm is in poor condition with overgrown vegetation (Photograph No. 15). Photograph No. 17 shows the view of culvert #2 located in the northwest corner of the landfill. The culvert basin area is in satisfactory condition with some minor overgrown vegetation on the slopes.

View of the Northern Berm Outside Slope Conditions Looking West.

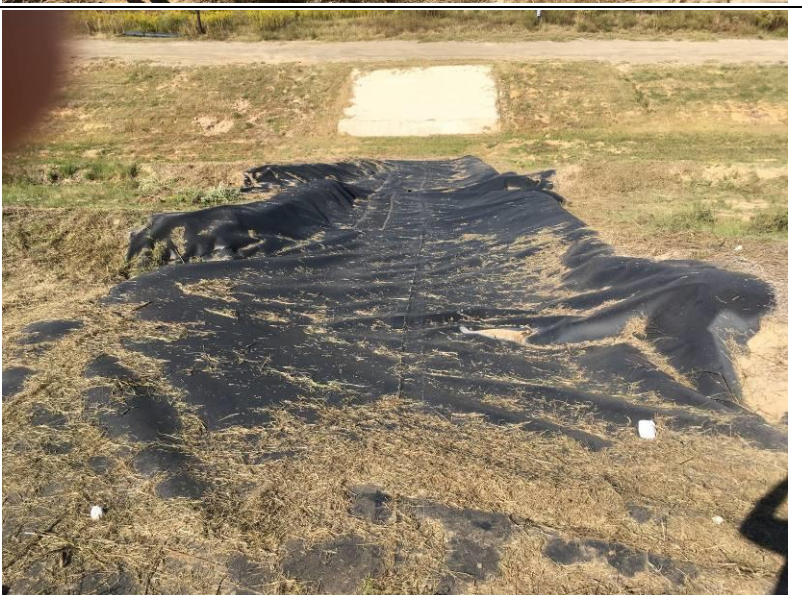
Photo # 12

View of the Northern Berm Central Let Down Channel.

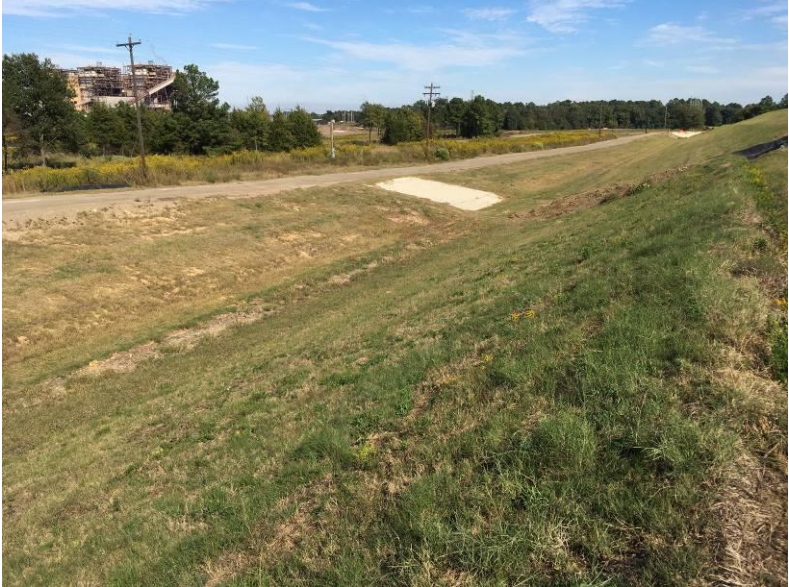
Photo # 13

Typical View of the Northern Berm and Perimeter Ditch Slope Conditions Looking East. Notice the Areas of Sparse Vegetation.

- 5 Vegetation growth on the newly capped and covered slopes (South, East and North) is satisfactory, but some areas had either sparse vegetation that needs to be re-seeded or overgrown vegetation that needs to be maintained. There were a few areas of vegetation growth on the inside of the landfill needs to maintained as well (culvert #2).

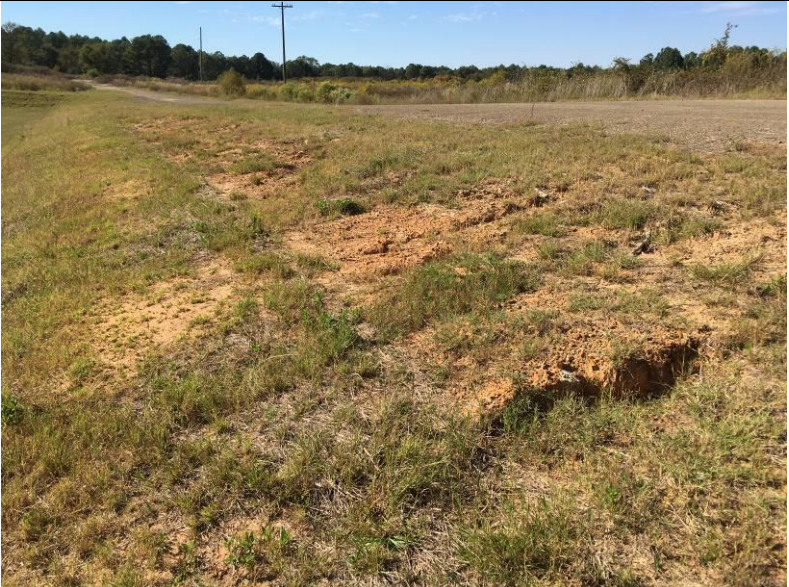
Photo # 14

View of the Central Area of the Northern Berm Perimeter Ditch Conditions. Notice the Area of Sparse Vegetation.

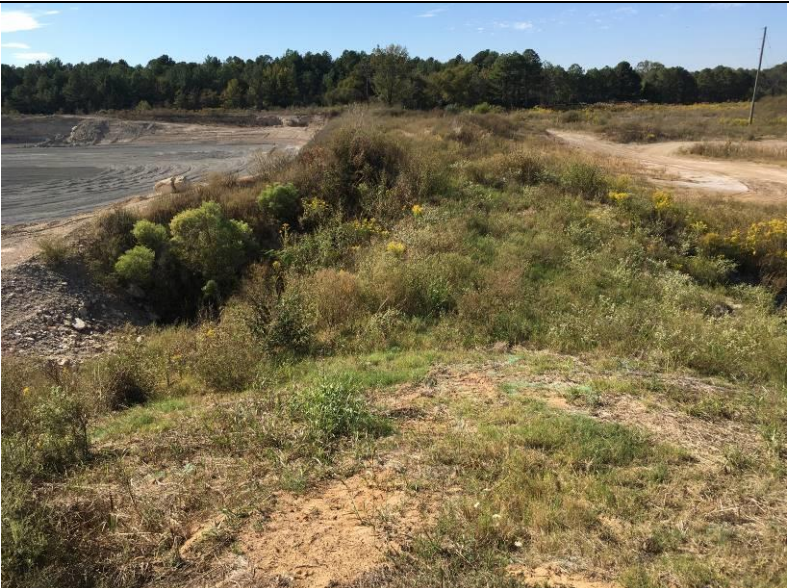
Photo # 15

View of the West End of the Northern Berm. Notice Vegetation is Overgrown and Berm is in Poor Condition.

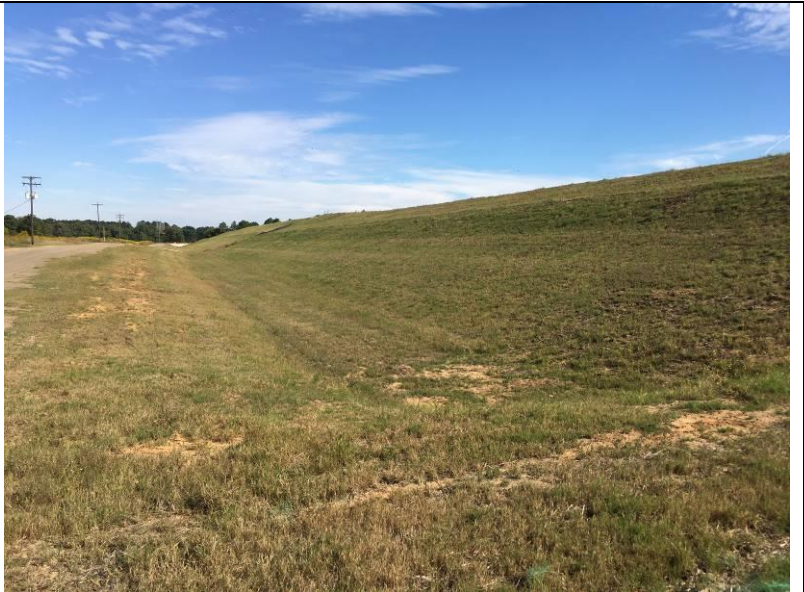
Photo # 16

Typical View of the West End Northern Berm Outside Slope Conditions Looking East.

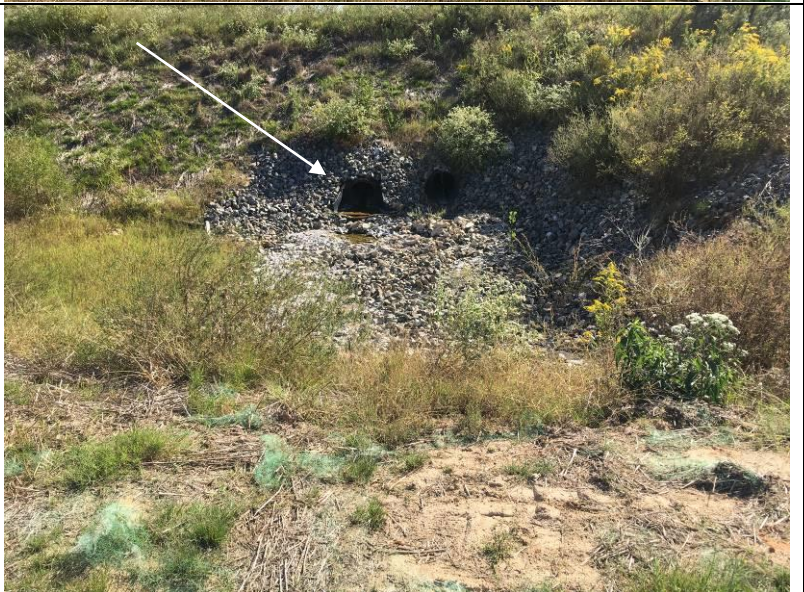
Photo # 17

View of Culvert #2 Outlet Pipe. Located on the Outside Slope in the Northwest corner of the Northern Berm.

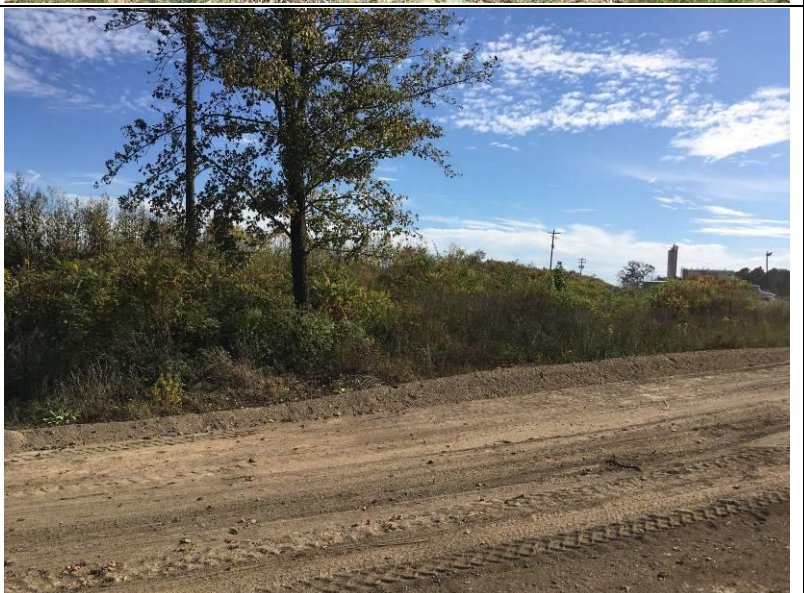
Photo # 18

6. The outer slopes of the western berm of the landfill are partially constructed of temporary soil cover and CCR material and have overgrown vegetation on the cover. Photographs No. 18 illustrates the condition of the exterior slope and toe ditch. The outer slopes appeared to be in poor, but functioning condition with no signs of seepage, erosion or sloughing. However, excessive vegetation and tree growth was noticed on the slope and in the toe ditch.

View of the Western Berm Outside Slope Conditions. Notice the Overgrown Vegetation and Mature Tree on the Slope Areas.

- 6 The inner and outer slopes of the western berm are in poor, but functioning condition. Since this area is primarily an ash processing area, little ash is stacked up against the berm. The west berm will have to be re-built and the slope vegetation cleared and maintained before any active disposal operations can occur in the western end of the landfill.

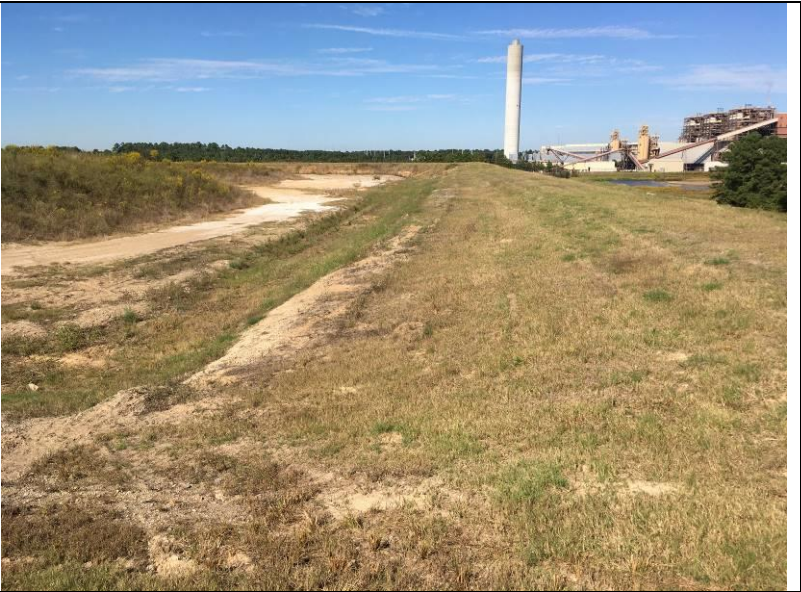
Photo # 19

7. During the inspection the active disposal area (eastern 2/3 area) was being used for waste placement. The inside perimeter ditches and leachate collection sump drains were functioning as designed and there was no ponding of water in the disposal areas (Photographs No. 19 through 21). All of the storm water inside the landfill is directed to a diversion ditch which leads to a detention basin before it exits the landfill through Pipe Culvert #2 located in the ash processing area (Photographs No. 22 – 24). There is some overgrown vegetation near Pipe Culvert #2 that needs maintenance and clearing.

View of the South Interior Perimeter Ditch for the Active Disposal Area Located on the East Side of Landfill.

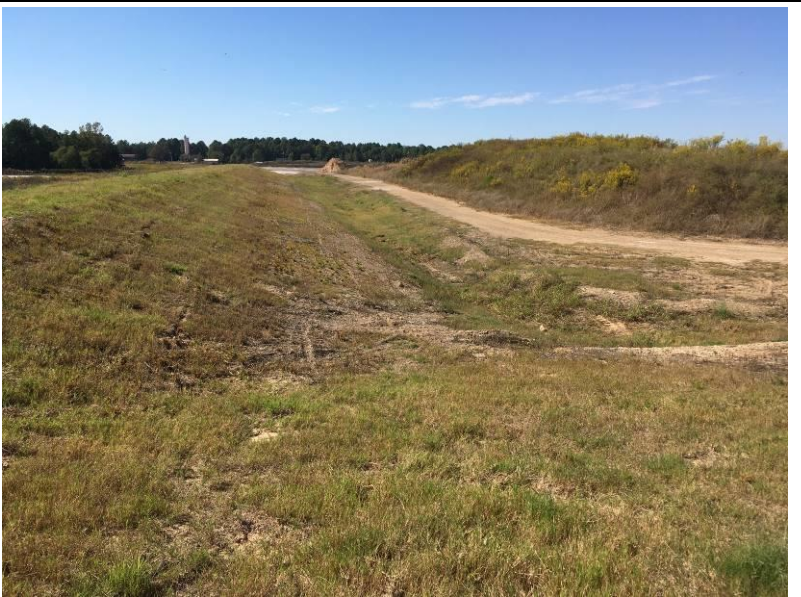
Photo # 20

View of the East Interior Perimeter Ditch for the Active Disposal Area Located on the East Side of Landfill.

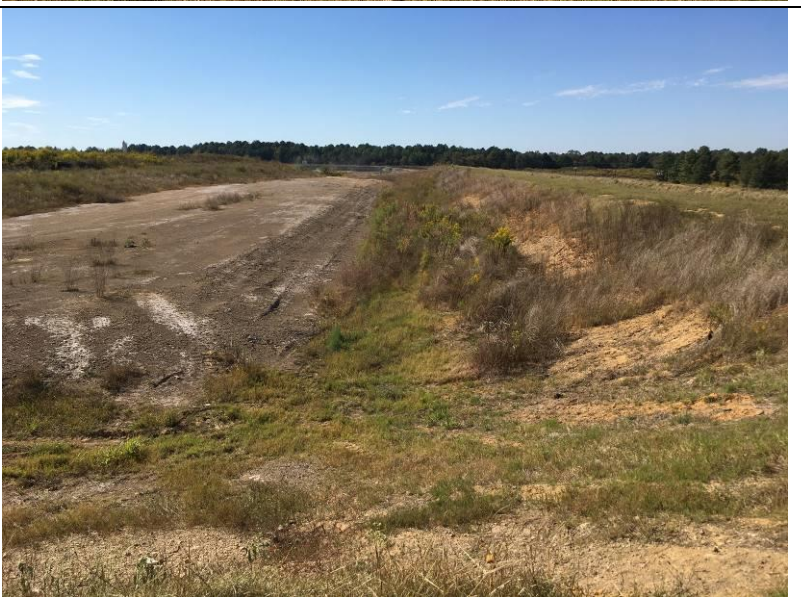
Photo # 21

View of the North Interior Perimeter Ditch for the Active Disposal Area Located on the East Side of Landfill.

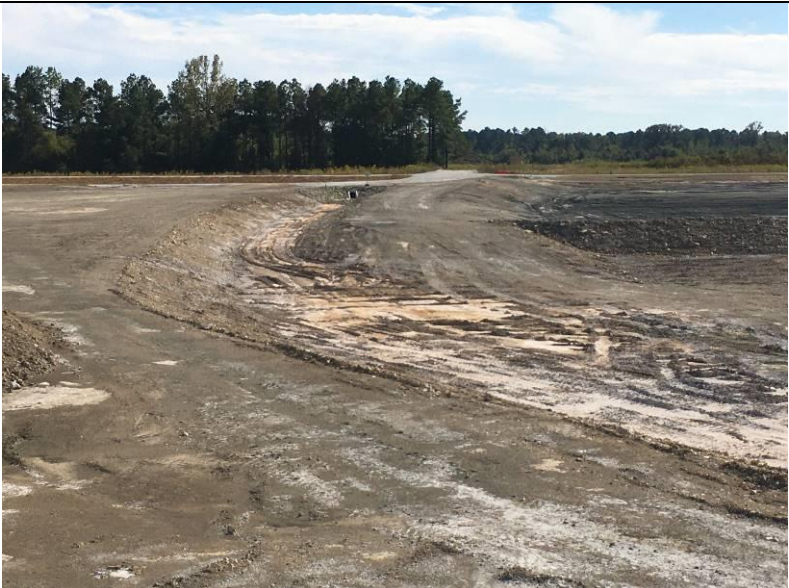
Photo # 22

View of the Active Disposal Area Storm Water Diversion Ditch Located in the Middle Section of the Landfill.

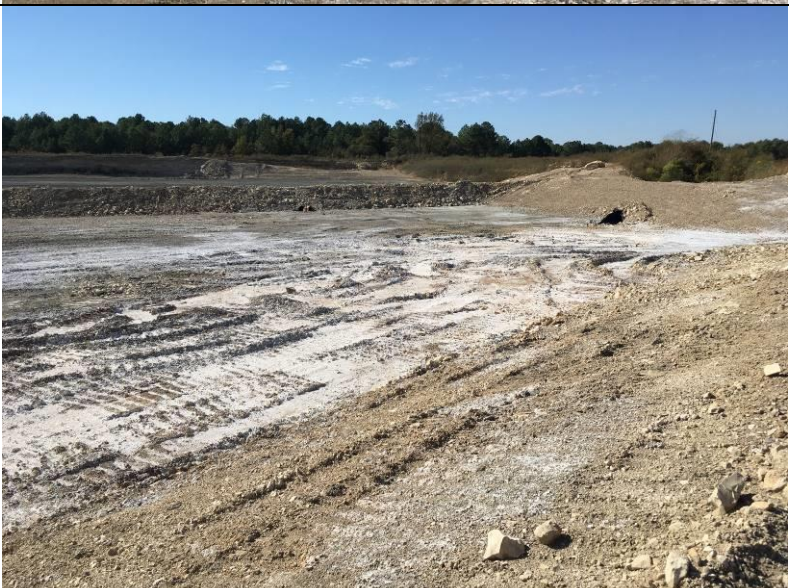
Photo # 23

View of the Active Disposal Area Storm Water Detention Area Located in the Middle Section of Landfill.

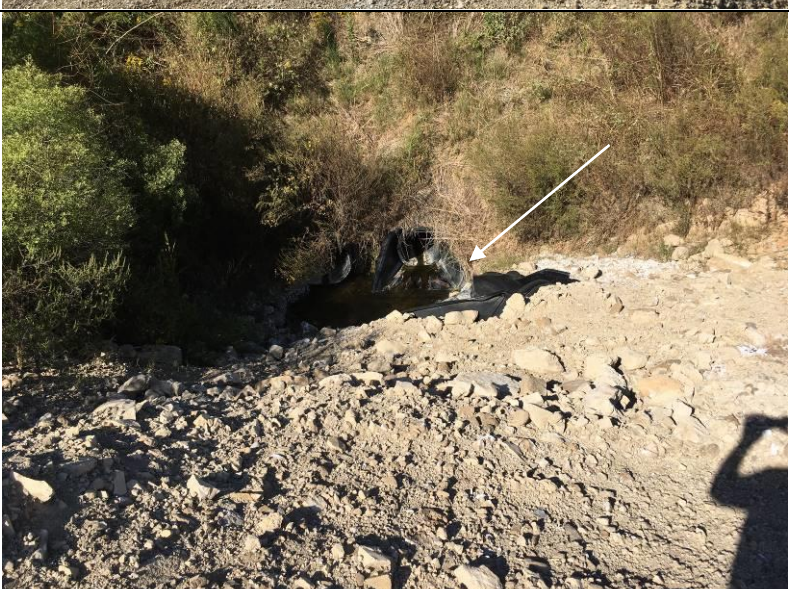
Photo # 24

View of Culvert #2 Pipe From Inside the Landfill Ash Processing Area.

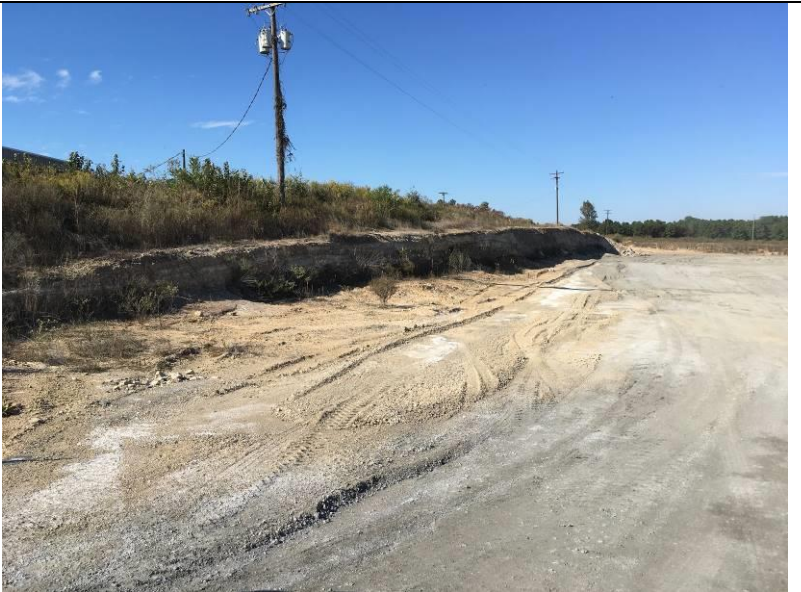
Photo # 25

8. The western 1/3 of the landfill area is primarily utilized for the processing for beneficial use and sales of CCR materials. At the time of inspection the area was being used for ash processing. The areas are bound on the north and west sides by berms constructed out of soil and ash and have a temporary cover system. The area is bound on the south by a series of perimeter ditches, driveways and culverts to collect the storm water runoff

View of the Interior Western Berm of the Ash Processing Area. Looking North.

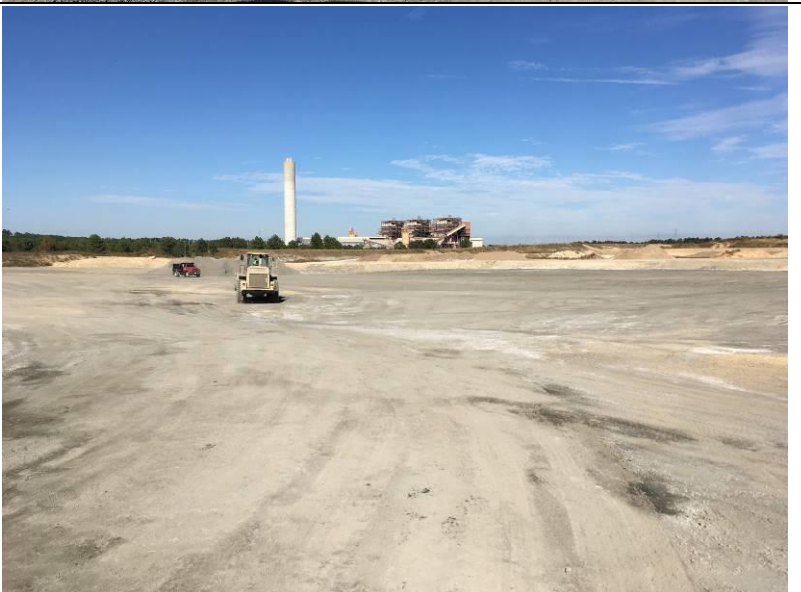
Photo # 26

View of the Ash Processing Area Typical Conditions. Looking East.

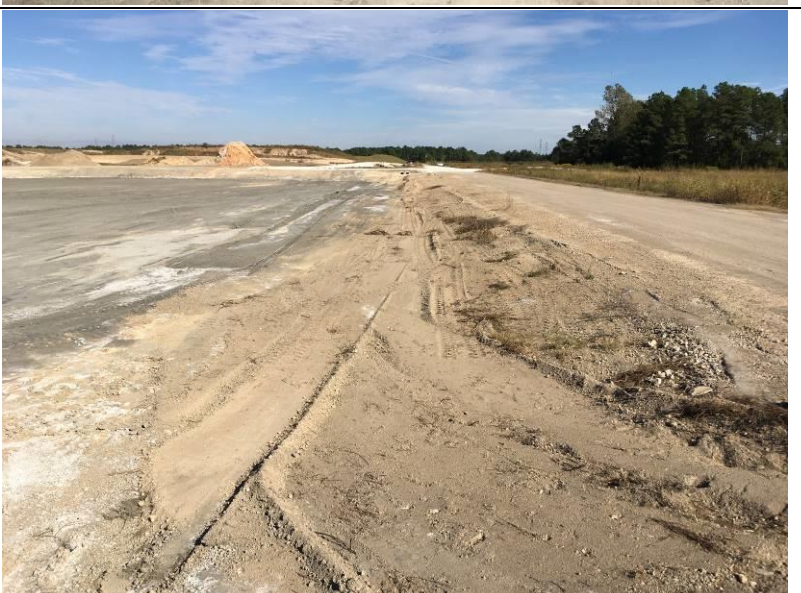
Photo # 27

View of the South Interior Perimeter Ditch Located Along the Ash Processing Area.

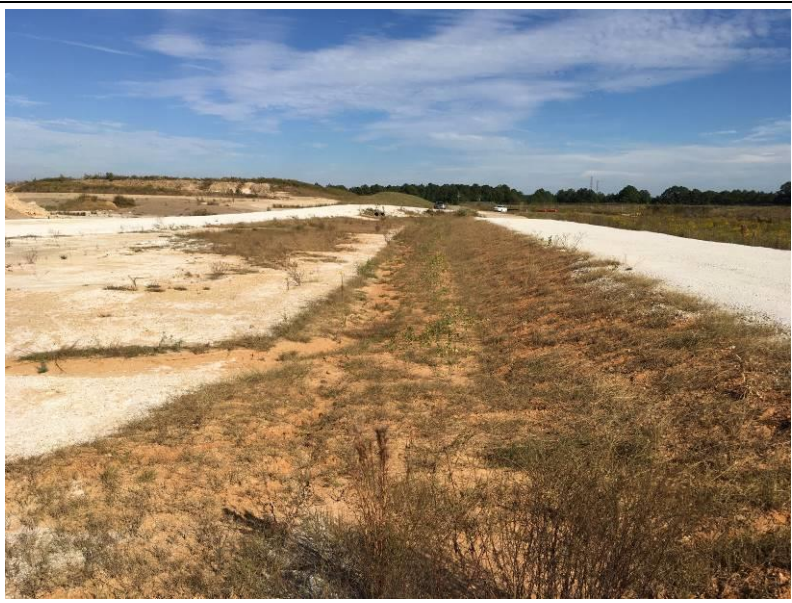
Photo # 28

View of the South Interior Perimeter Ditch Along the Mid-Section of the Landfill.

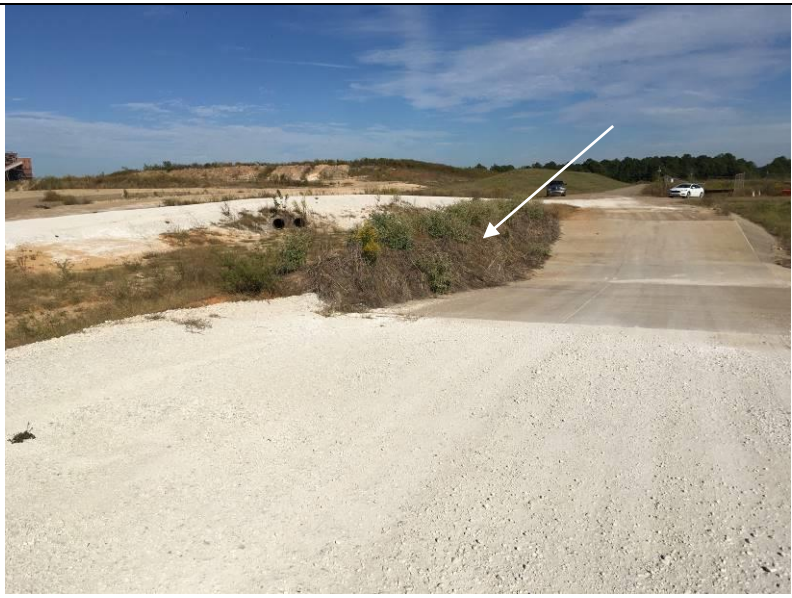
Photo # 29

9. The low water crossing is constructed of reinforced concrete pavement and was in good and functional condition at the time of inspection (Photograph No. 29). Typically, storm water runoff from the active disposal areas used to be directed towards the western end of the disposal area where it is channeled into a low water crossing on the south side that flows into the Bottom Ash Storage Pond. However, since the notice of intent to close the Bottom Ash Storage Pond (April 6, 2021), a clay soil berm has been placed inside the landfill to prevent contact storm water from entering the low water crossing structure. In addition, the south side access road ditch has been plugged with a clay soil berm to prevent non-contact storm water from the access road, low water crossing and the access road ditch from entering the Bottom Ash Storage Pond (Photograph No. 30).

View of the Low Water Crossing Located on South Side of Landfill Active Disposal Area. A Soil Berm has Been Placed Along the Interior of the Landfill to Divert Contact Storm Water Away from the Low Water Crossing.

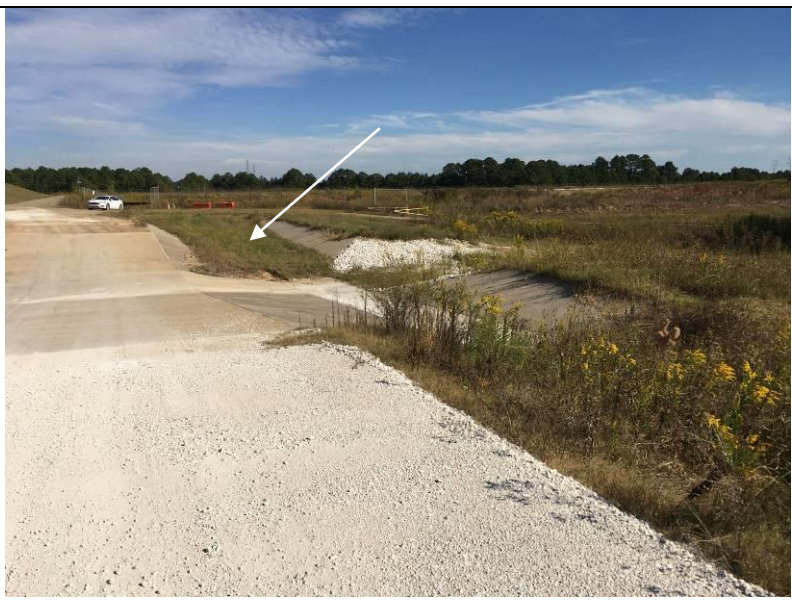
Photo # 30

View of the South Side Low Water Crossing and Access Road Ditch Looking East. The Access Road Ditch Been Plugged with Soil to Prevent Non-Contact Storm Water From the Low Water Crossing and Access Road Ditch from Entering the Bottom Ash Storage Pond.
