2022 Annual Landfill Inspection Report

CCR Landfill

Flint Creek Plant

Inspection Date: July 20, 2022

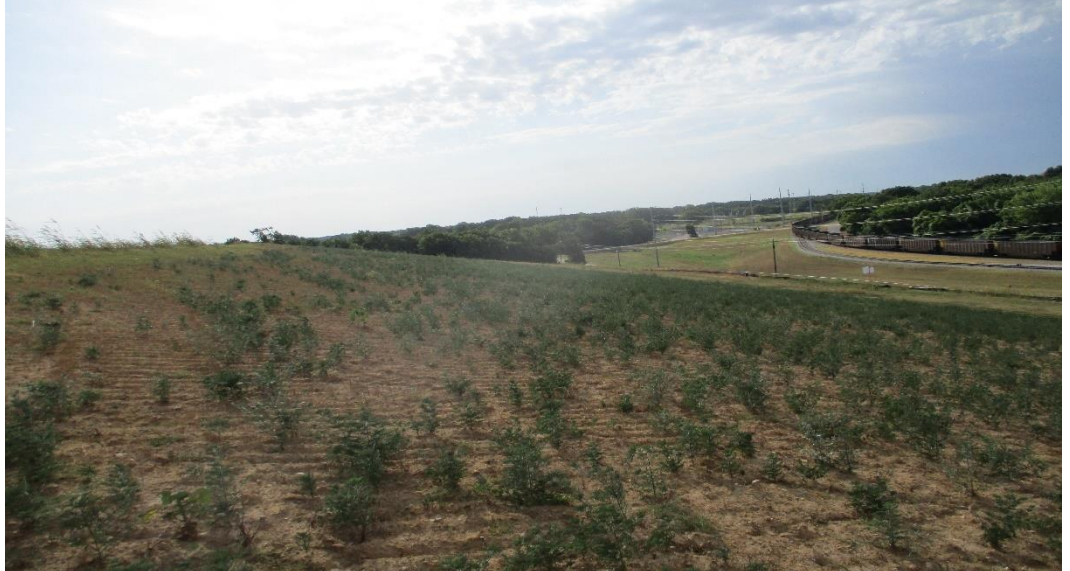
1. The lower section of the south slope and the drainage ditch (Photograph Nos. 1 and 2) at the toe appeared in good and stable condition. The toe ditch appeared to have positive drainage. The soil cover exhibited lack of grass and undesired weed growth (Photographs Nos. 3 and 4). Few minor erosion gullies were noticed at the lower section of the south slope (Photograph No. 3).

<p>PHOTO #4</p> <p>South slope intermediate cover.</p>

- 2) Minor erosion gullies at the south slope of the Landfill should be repaired.
- 3) CCR waste placement should be properly contained within the Landfill areas and contact water should be conveyed via interior temporary ditches and/or piping system as designed.

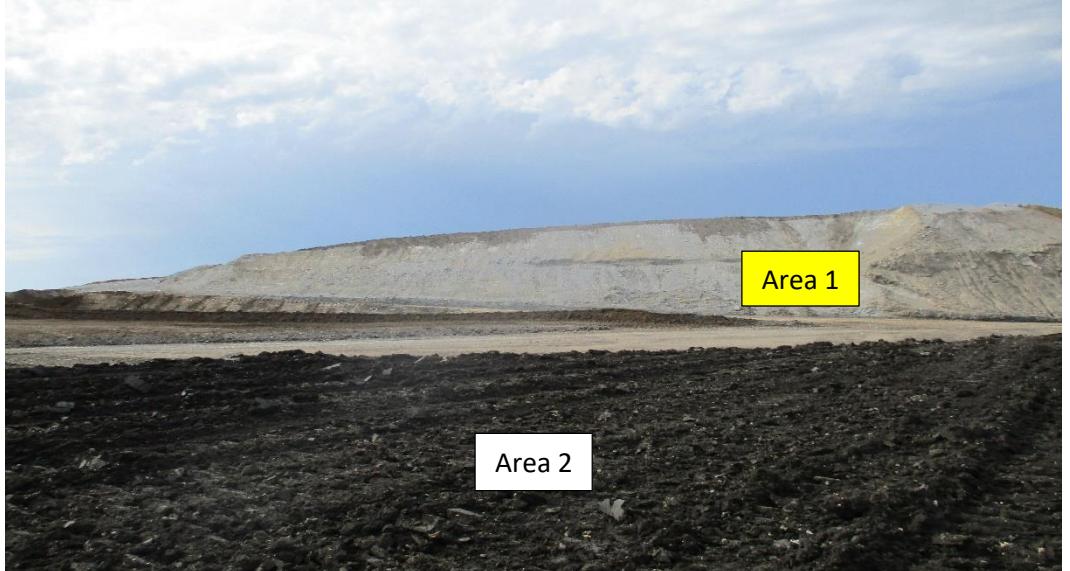
2. At present Area 1 and Area 2 of the Landfill are active and receiving CCR waste. Area 1 is getting close to its disposal capacity (Photograph No. 5). There was no ponding of water in the active areas. The material in the active areas is separated from the inactive areas by a low splitter berm all within the waste limits. There was no erosion of the CCR material in the active area and the interim slopes were safe for the operational activities. Intermediate (temporary) soil cover is placed at the south slope of Area 1. Stormwater runoff from this area is directed into the contact water pond via the concrete lined ditches.

<p>PHOTO #5</p> <p>Active areas of the landfill Area 1 and Area 2 (looking south).</p>

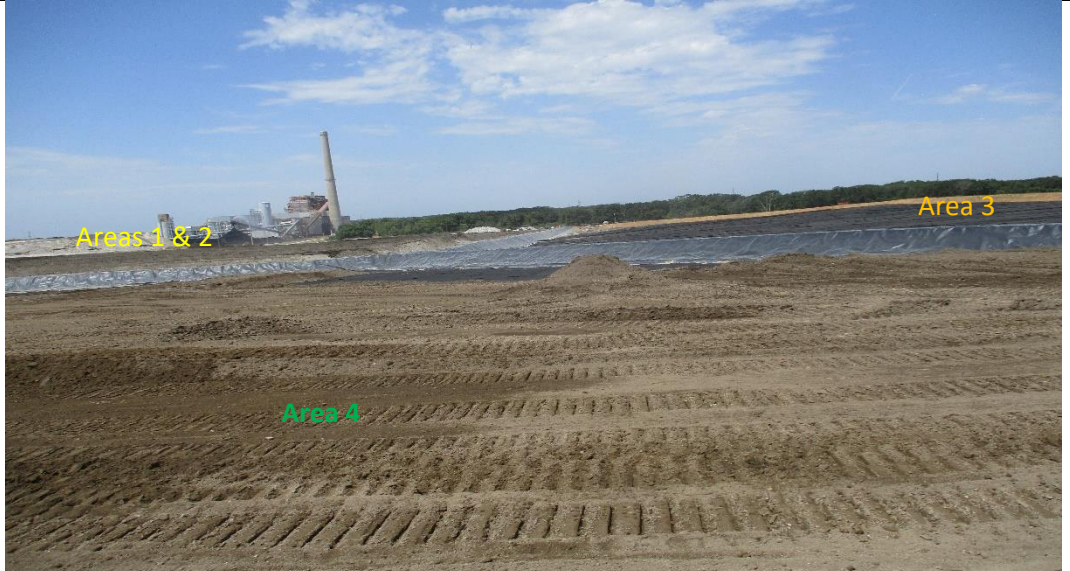
3. Photograph No. 6 illustrates the active and inactive areas of the Landfill. Protective cover is currently placed in inactive area (Areas 3 and 4) of the Landfill. Contact and non-contact water are properly managed and conveyed to appropriate ponds. The drainage system and interim slopes are maintained properly to avoid any ponding or overflow condition.

<p>PHOTO #6</p> <p>Landfill Areas 1-4 (looking west).</p>

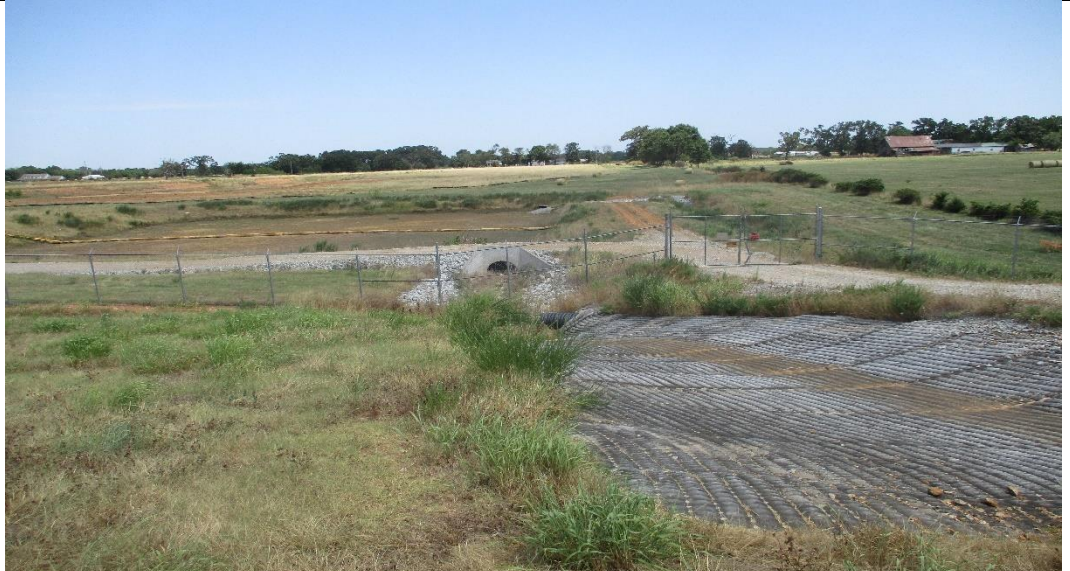
9. A fabriform drainage ditch and a pipe culvert is located at the northeast corner of the Landfill (Photograph No. 15). The fabriform was in good and stable condition. Pipe culvert was free of obstruction and no standing water was noticed. Scattered excessive grown vegetation was found in this area.

<p>PHOTO #13</p> <p>North slope of the landfill and toe ditch (looking east).</p>	 
<p>PHOTO #14</p> <p>Overall view of the north slope.</p>	 
<p>PHOTO #15</p> <p>Northeast corner illustrating fabriform channel.</p>

- 1) Excessive grass/vegetation should be mowed on a regular basis at least 2-3 times during the year to facilitate inspections and keep woody vegetation to minimum. Any trees at or around the slopes should be removed.

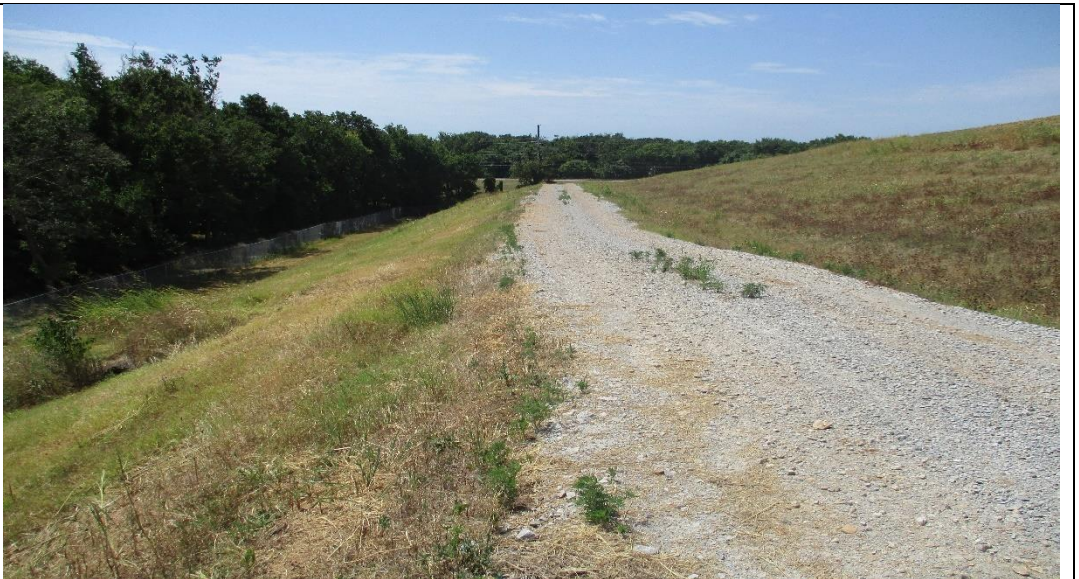
10. Photograph No. 16 illustrate the east slope of the Landfill and access road. The lower section of the slope downstream of the access road is steeper than the upper slope section. The slope appeared to be in good and stable condition. Excessive vegetation was observed along lower section of the slope.

<p>PHOTO #16</p> <p>East slope of the landfill.</p>

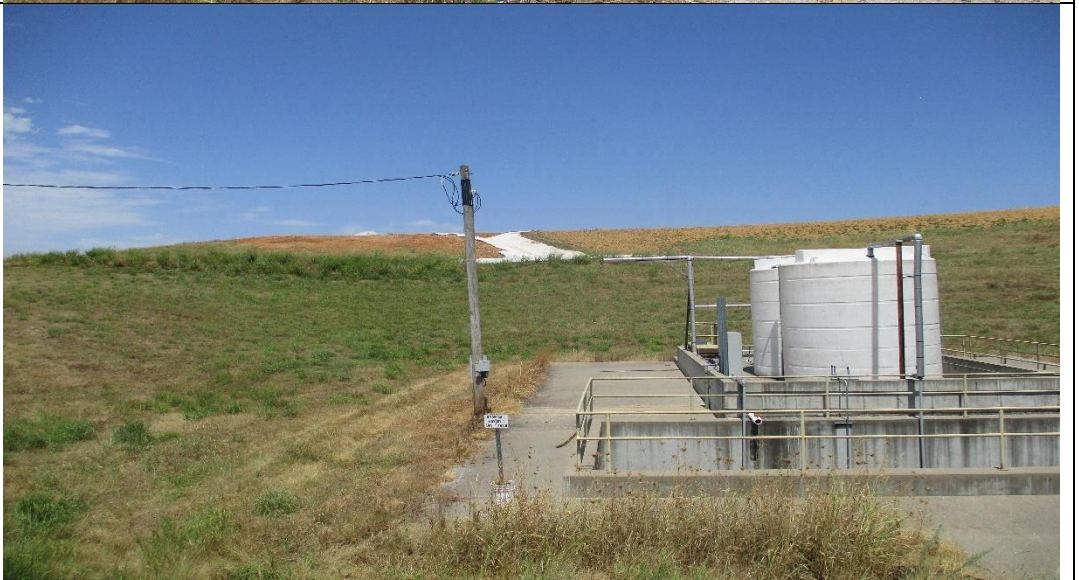
11. The southeast exterior slopes of the Landfill area illustrated in Photograph No. 17. Previously installed leachate collection tanks for treatment are located in this area of the Landfill. These tanks are not used at present. Also, a new fabriform letdown was installed for the construction of the Landfill Areas 3 and 4. Overall, the condition of the slope was in good and stable condition. Slightly overgrown vegetation was noticed in the lower section of the slope.

A wide-angle photograph showing a gravel-lined path or channel running along the east slope of a landfill. The slope is covered in dry, yellowish-brown grass and some green weeds. In the background, there is a dense line of green trees under a clear blue sky.
<p>PHOTO #17</p> <p>Southeast slope of the landfill and recently installed fabriform channel.</p>

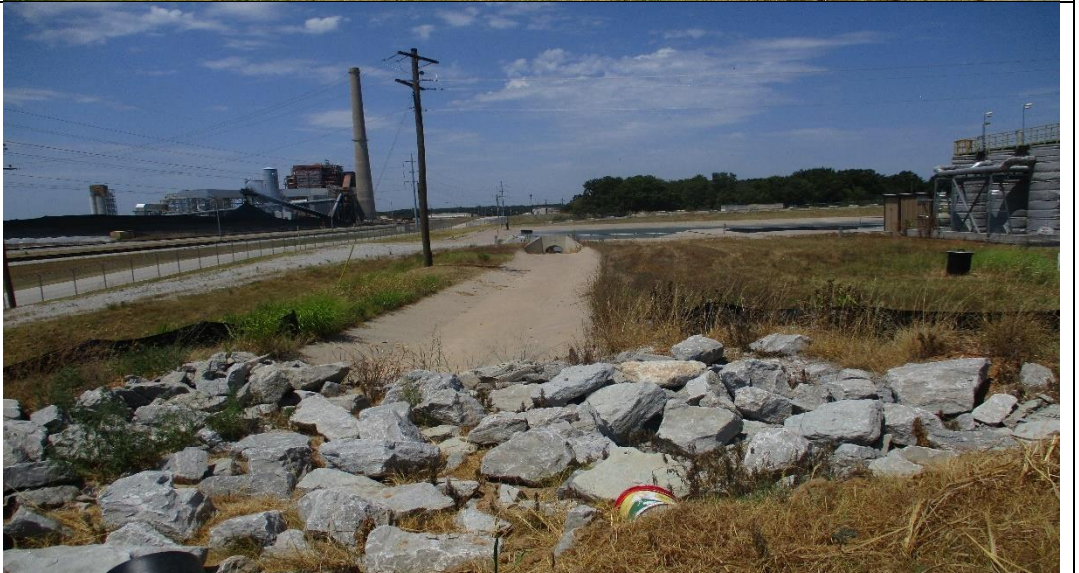
12. The south perimeter contact water concrete lined channel and outlet end of the pipe culvert are illustrated in Photograph Nos. 18 and 19. The channel was clear of debris and in good condition. The channel appeared in good and stable condition, no standing water was noticed and no obstruction to flow. The north perimeter contact water channel is illustrated in Photograph No. 20. The channel appeared in good and stable condition. Water was flowing through the pipe culvert to the contact water pond (Photograph No. 21). Minor accumulation of solids was noticed at the outlet end of the pipe in the pond (Photograph No. 22).

A photograph showing a concrete fabriform channel in the foreground, leading towards a large, cylindrical metal tank. The channel is situated on a grassy slope. In the background, there is a utility pole and a clear blue sky.
<p>PHOTO #18</p> <p>South contact water concrete lined channel.</p>

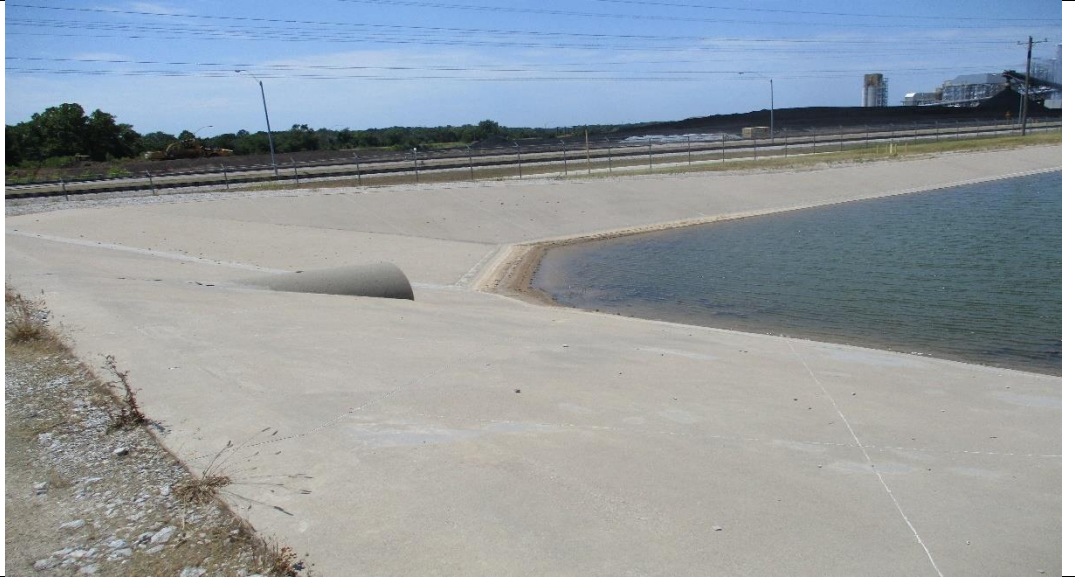
PHOTO #19

Discharge pipe of the south contact water channel.

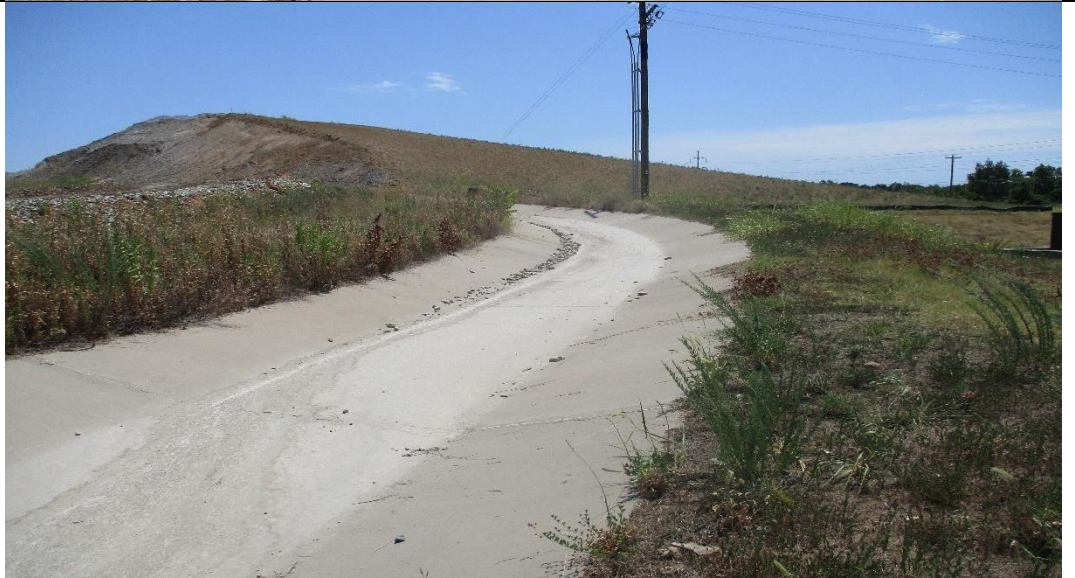
PHOTO #20

North contact water concrete lined channel.

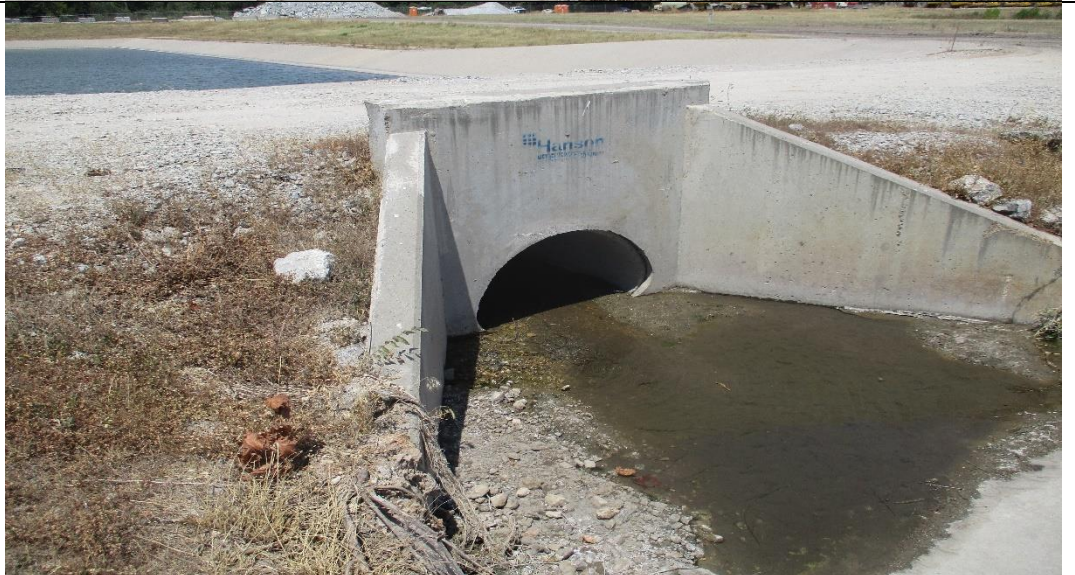
PHOTO #21

North contact water channel pipe inlet end.

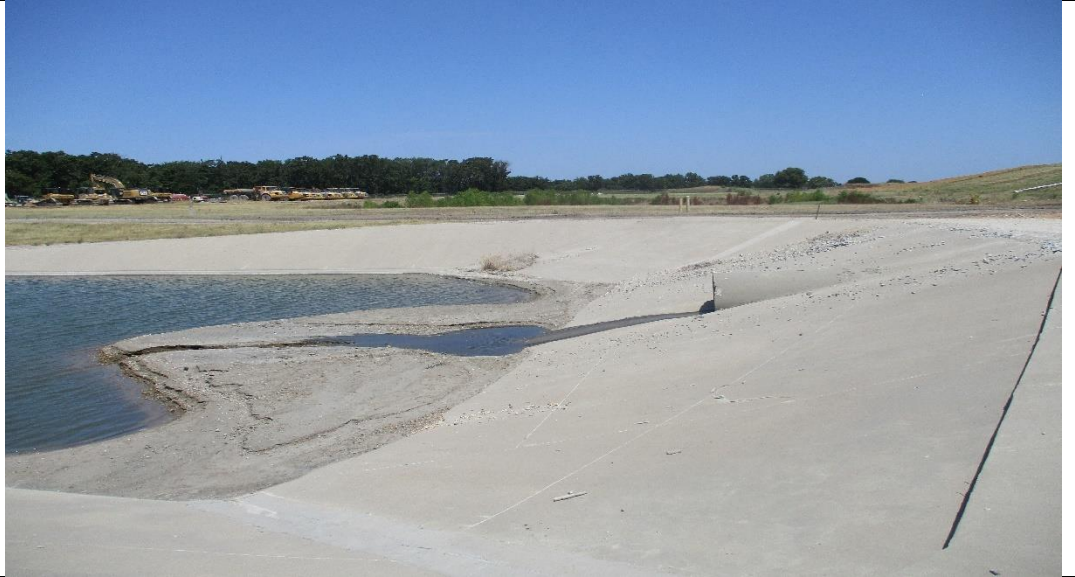
PHOTO #22

North contact water channel pipe outlet end at the pond.

- 4) The interim slope of the waste should be properly maintained safely (3H:1V) as more waste is placed.
- 5) The accumulation of ash at the north contact water collection pipe at the pond should be either controlled or removed from the pond on a regular basis.

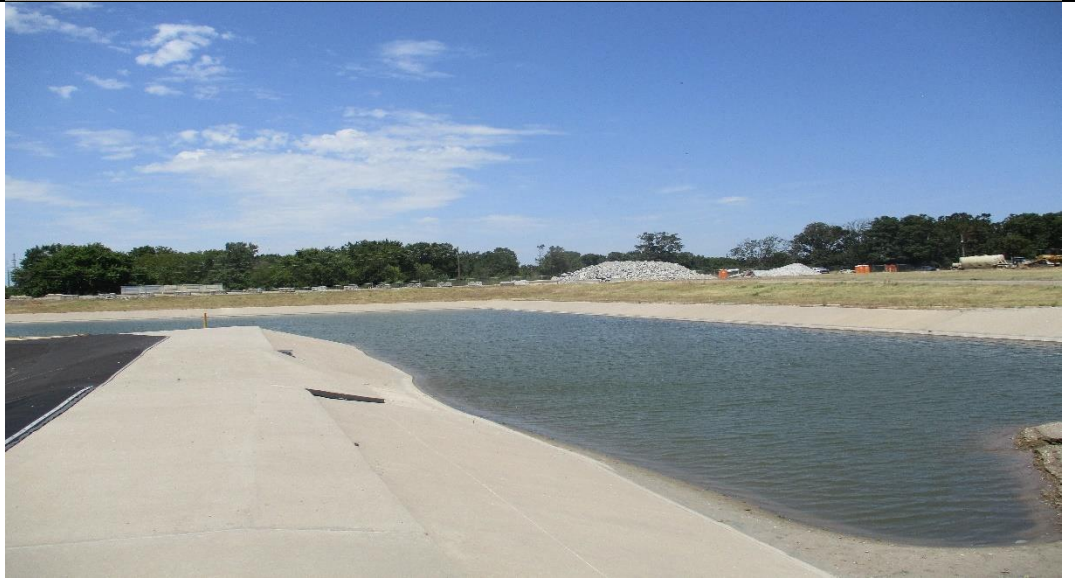
PHOTO #23

13. Overall view of the contact water pond is illustrated in Photograph No. 23. The contact water pond dikes appeared in good and stable condition with good concrete cover. The pond appeared functioning as designed.

Overall view of the contact water pond.

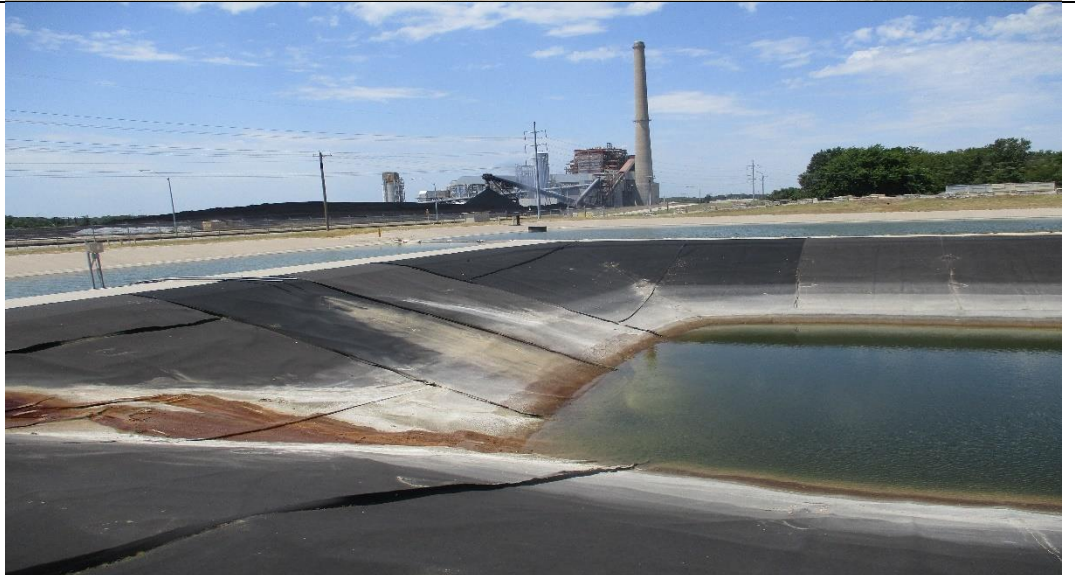
PHOTO #24

14. Overall view of the leachate pond is shown in Photograph No. 24. Repairs were performed at the leachate pond in 2021 to remove trapped water under the bottom liner. Leachate pond is functioning as designed after repairs were performed and no unusual condition in the pond components were observed.
15. Photograph Nos. 25 and 26 depicts the stormwater pond and riprap channel conveyance channel. At the time of the inspection, the stormwater had no water and the pond bottom was visible. Excessive bushes and small trees around the pond slopes and within the riprap channel were noticed. It appeared that the stormwater pond is in good and functional condition.

Overall view of the leachate pond.

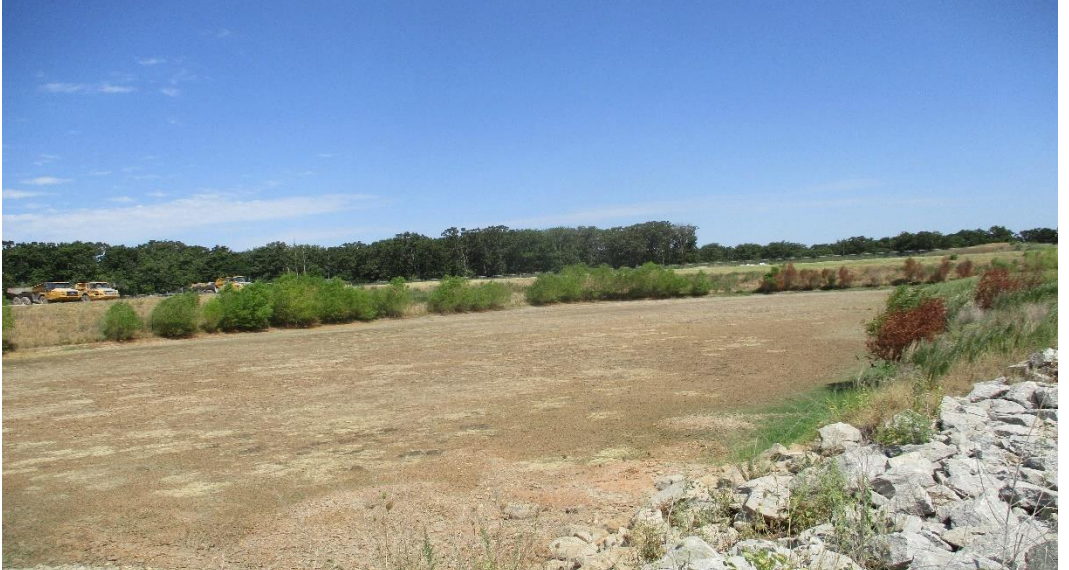
<p>PHOTO #25</p> <p>Overall view of the Storm water pond (looking north).</p>

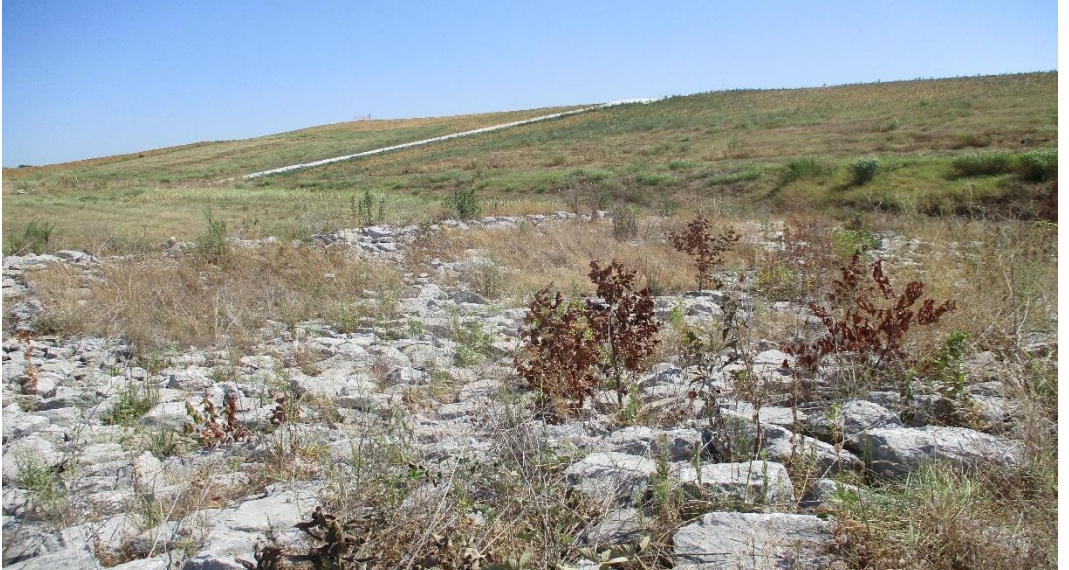
A wide-angle photograph showing a large, flat, brownish field, likely a storm water pond, under a clear blue sky. In the background, there is a line of trees and some yellow construction equipment. The foreground is dominated by a rocky, riprap-lined area with sparse vegetation.
<p>PHOTO #26</p> <p>Riprap lined channel to the storm water pond.</p>
