2022 Annual Dam and Dike Inspection Report

Primary Bottom Ash Dam

Flint Creek Plant

Inspection Date: July 21, 2022

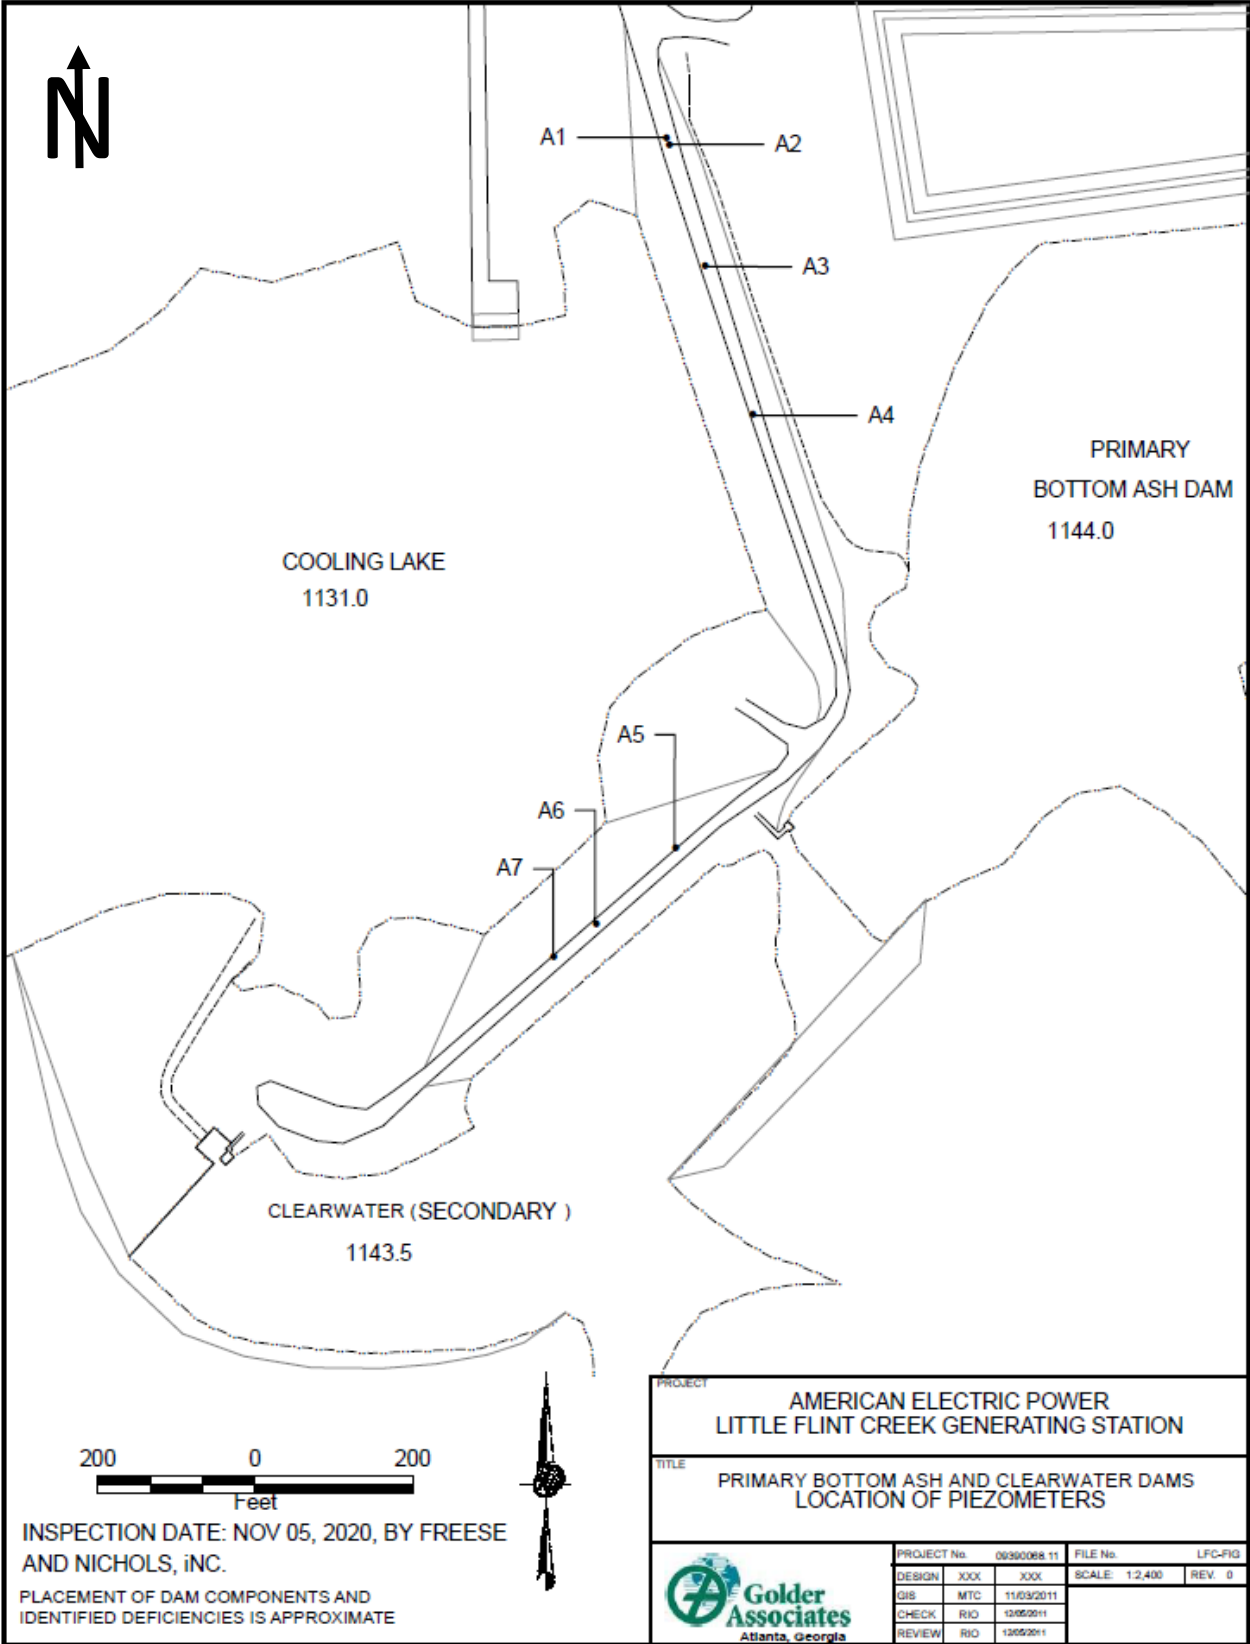
Figure 2 – Piezometer Location Map
Primary Bottom Ash Dam
Flint Creek Plant, Gentry, AR

There are four piezometers located along the crest of the dam as shown on Figure 2. These are the only instrumentation related to this facility. A review of readings since the last inspection and historical readings (2017-2022) indicate the levels are consistent and respond to the fluctuation of the cooling lake level. The piezometers are more influenced by the level of the cooling lake than the elevation of the Primary Bottom Ash Pond. A spike was noticed in all the piezometers in May 2022 reading which were consistent with the fluctuation in the lake level. The trend in the historical data between the piezometers reading, lake level, and pond levels are consistent. Table 1 lists the maximum piezometer reading since the last annual inspection.

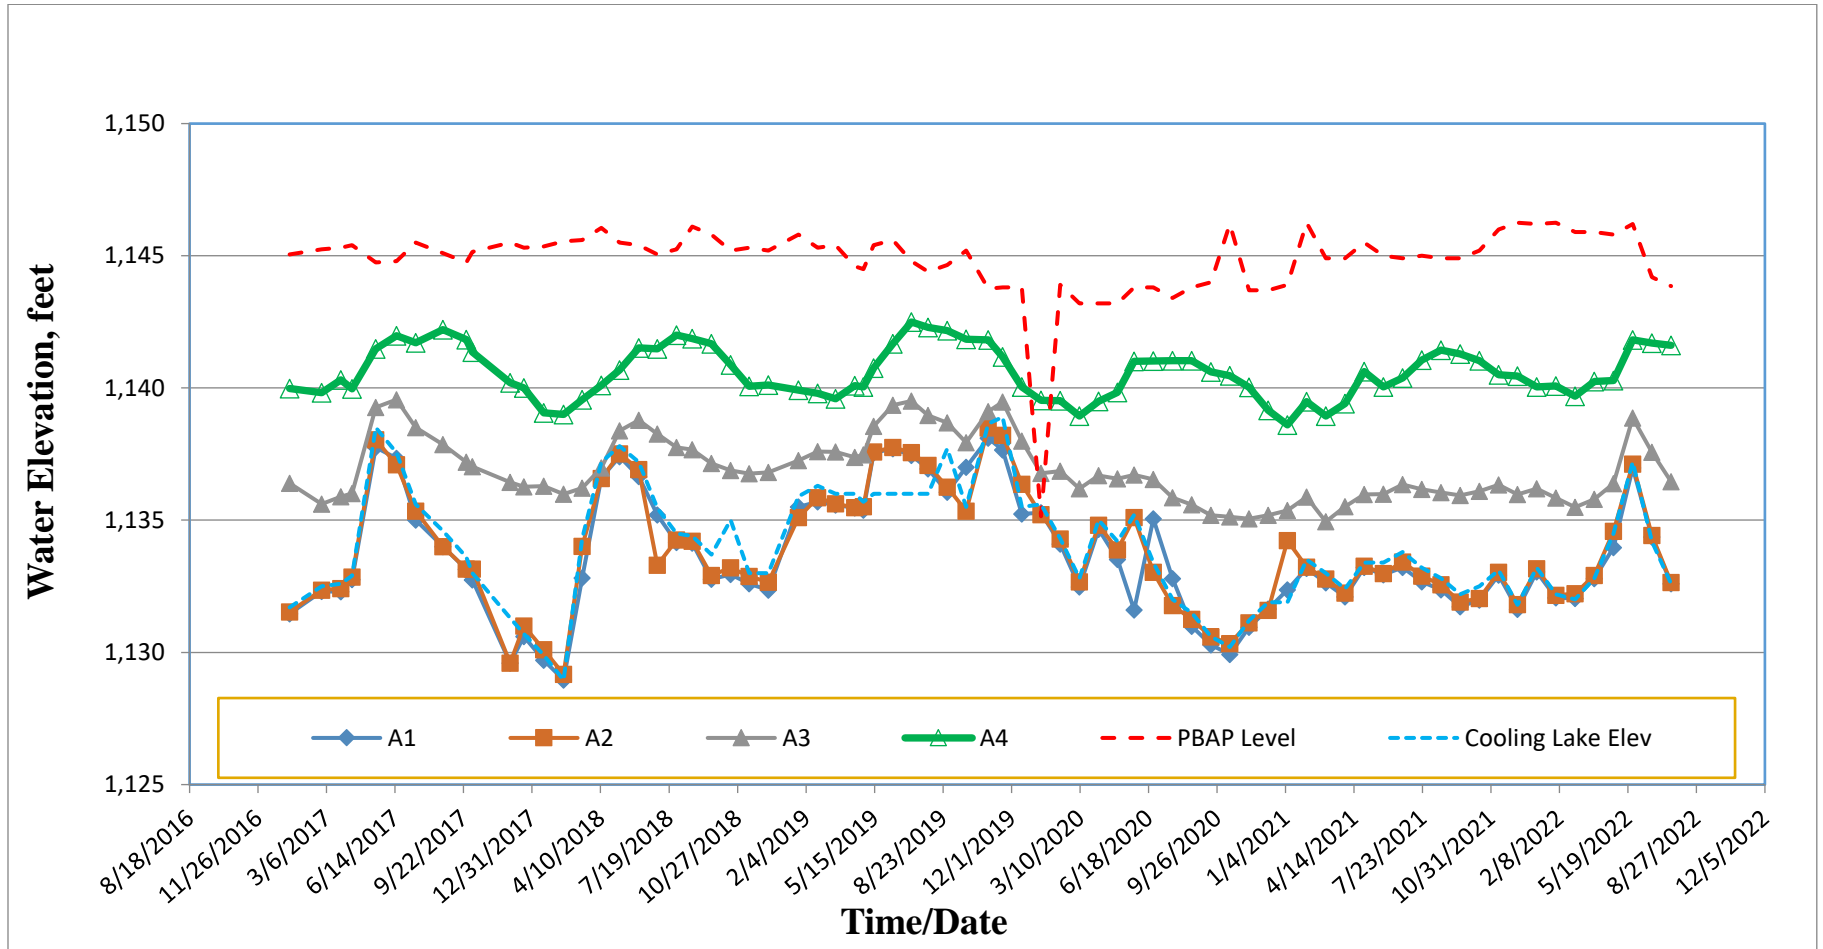
Figure 3 – Historical Piezometer Data Plot
Primary Bottom Ash Dam
Flint Creek Plant, Gentry, AR

Figure 3 is a historical plot of the piezometer readings over the past several years.

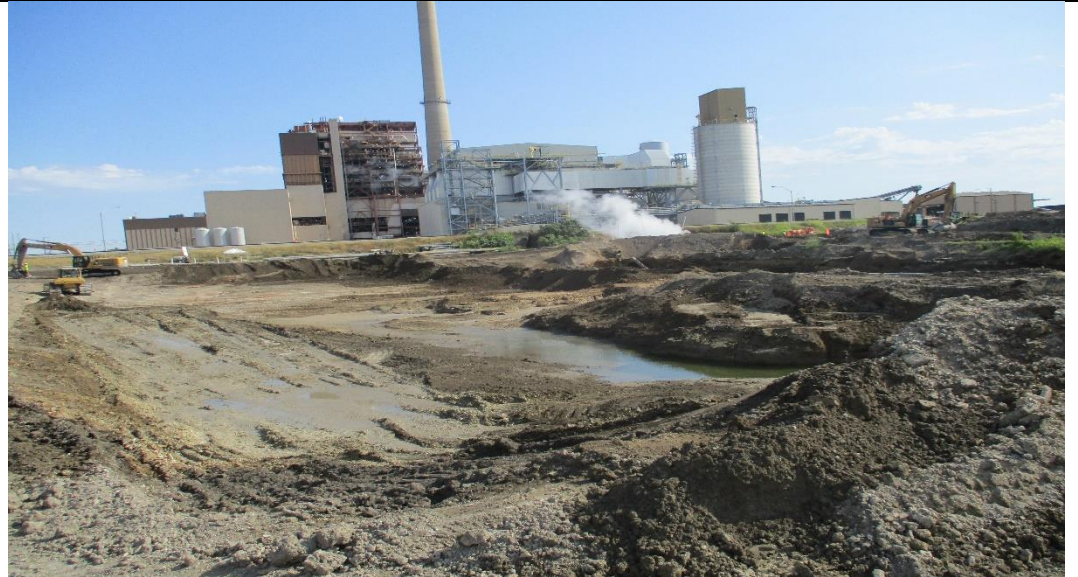
PHOTO #4

- (ii) Photograph No. 4 and 5 illustrates the north half of the pond where currently bottom ash from the pond is temporarily stockpiled, dewatered, and dried prior to placement at the landfill. It appears that this area is well maintained with these activities in progress.

CCR removal activities in the northeast dredge area.

- Continue the vegetation control plan of mowing and spraying.
- Continue maintaining the temporary stockpile and dredge cell/rim ditches for the removal activities of bottom ash so that it is contained within the limited area.
- Avoid any encroachment and overtopping of the dam with bottom ash stockpile.

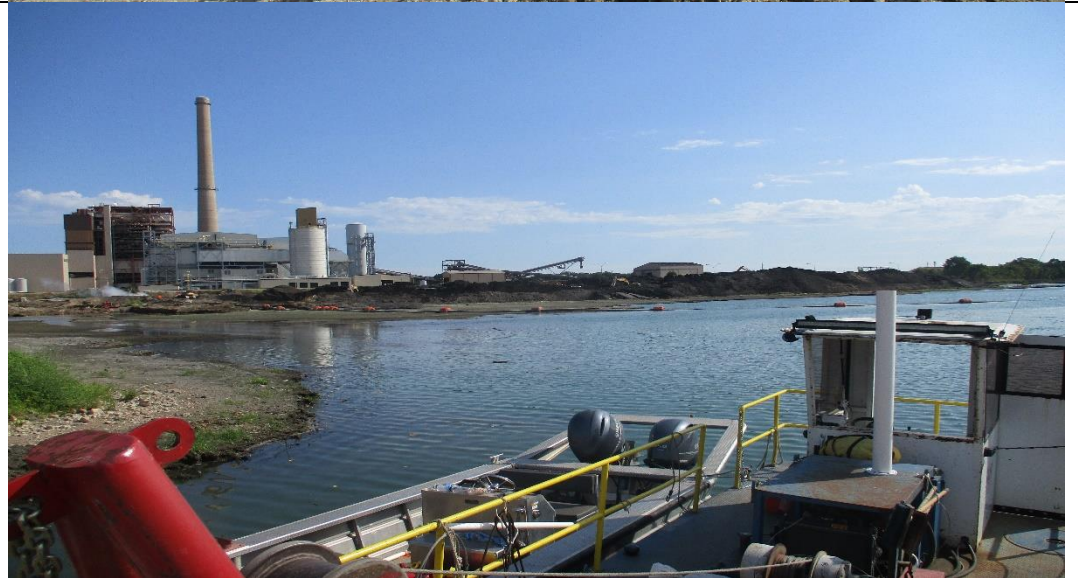
PHOTO #5

Overall view of CCR removal activities.

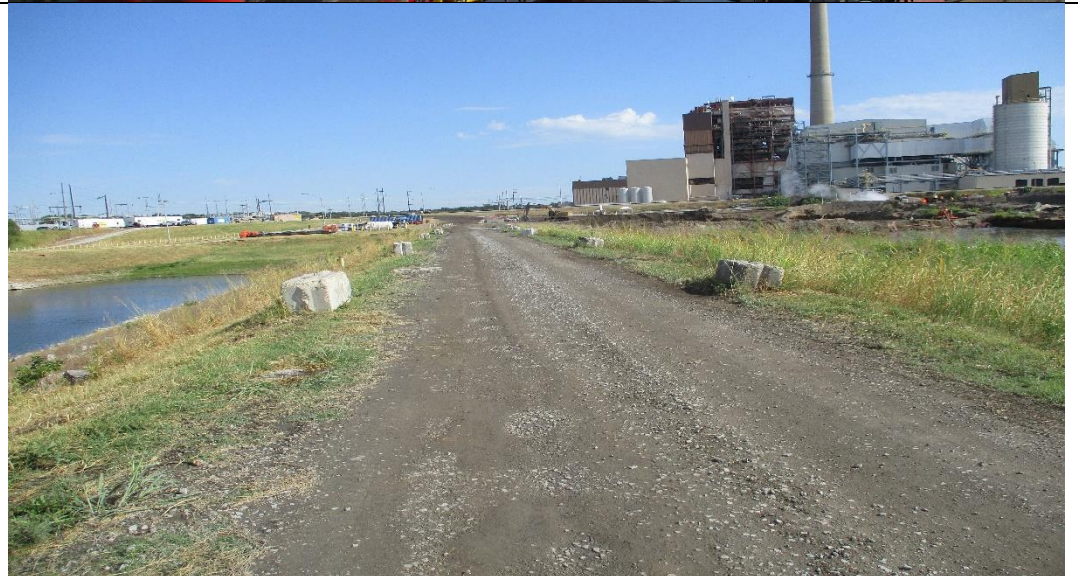
PHOTO #6

- (iii) Photograph No. 6 illustrate crest of the dam. The crest surface of the dam is composed of hard-packed earth topped with bottom ash. Crest is also used by vehicular traffic to access the monitoring instrumentation and at present for the pond closure work. The crest is in generally good condition with no evidence of misalignment, settlement, or cracking. Some minor rutting along the crest was noted due to the vehicle traffic.

Crest of the dam (looking north).

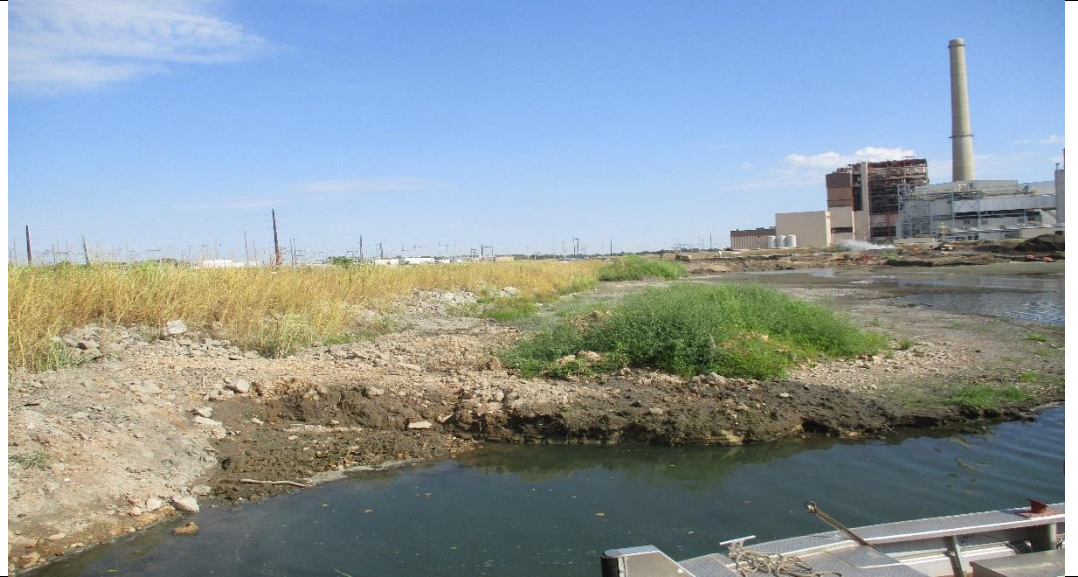
PHOTO #7

- (iv) Photograph Nos. 7 and 8 illustrates the condition of the upstream slope. Most of the larger trees and vegetation noticed in the 2021 inspection were cleared from the upstream slope. The upstream slope of the primary dam was observed to be in satisfactory condition. The interface of the upstream slope and ash limits was visible and stable.

Upstream slope at the south end of the dike (looking north).

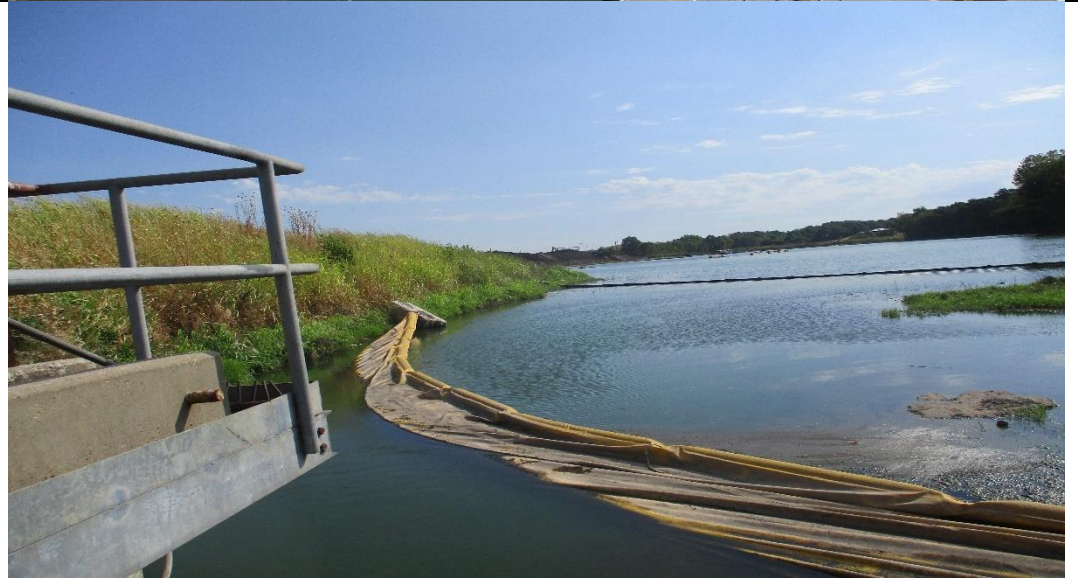
PHOTO #8

Upstream slope south end near the overflow discharge structure.

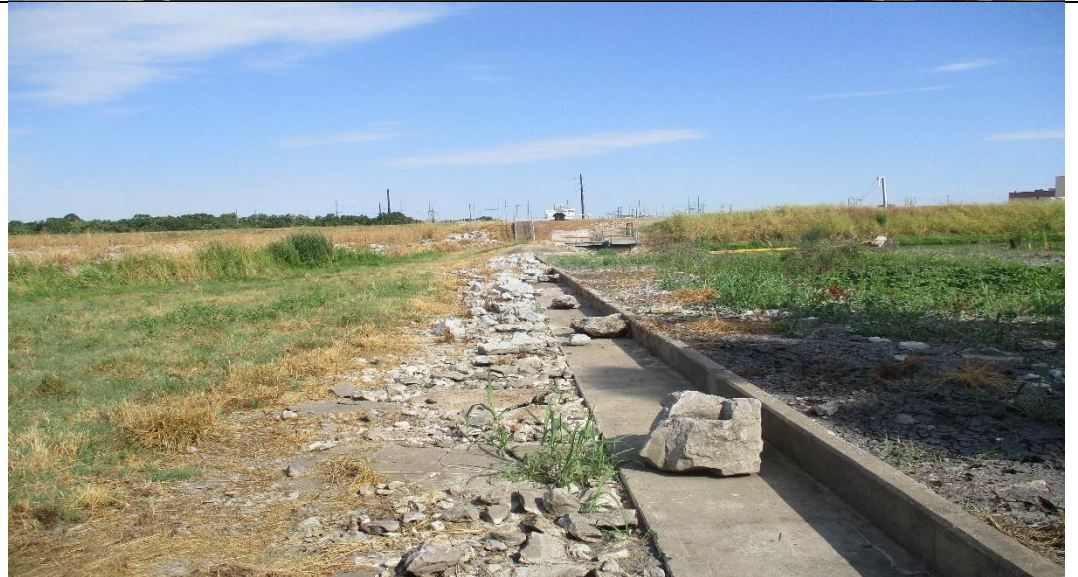
PHOTO #9

- (v) The emergency spillway (Photograph Nos. 9-11) is an incised channel in natural ground with a concrete weir control section, 1 ft. in height, across the channel width. The spillway was in generally good condition at the time of inspection. The spillway appeared to be generally stable. Vegetation control in this natural ground area is good. Hairline cracks were noticed along the concrete spillway and at the buttress to the north of the spillway.

Emergency spillway concrete sill (looking north).

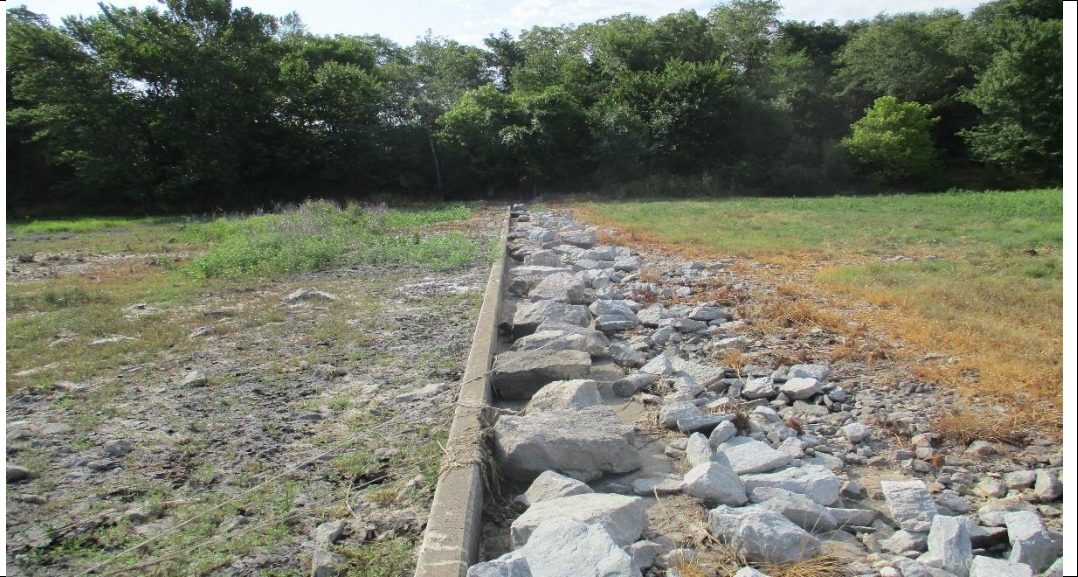
PHOTO #10
Emergency spillway
concrete sill (looking
south).

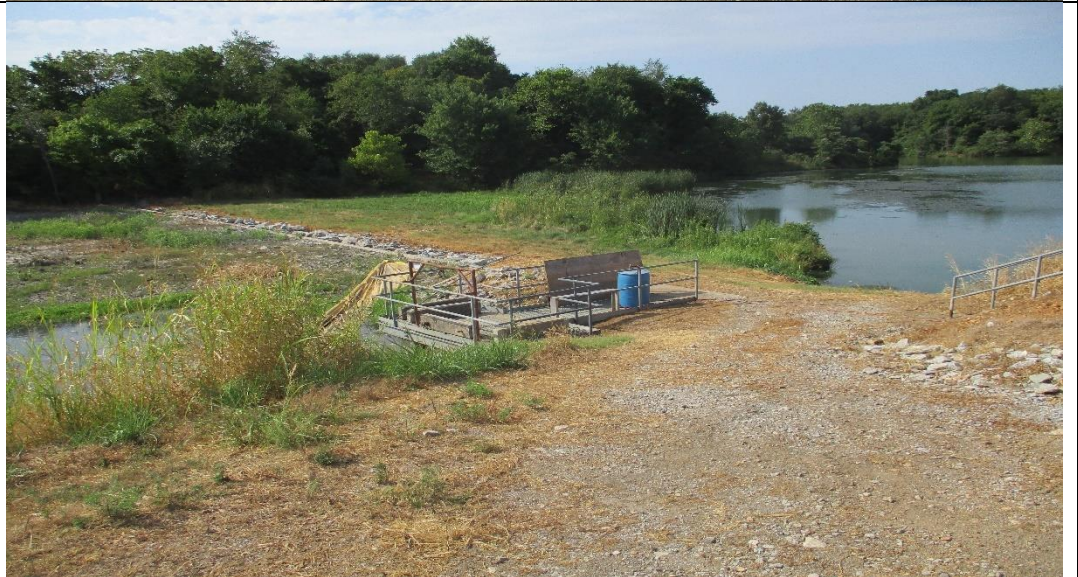
- (vi) Photograph No. 12 illustrates the principal spillway (overflow discharge structure). The principal spillway for the pond is a concrete drop-inlet structure with stop logs used to control the pool elevation. The spillway was in generally fair condition. Flow through the principal spillway was unobstructed (Photograph No. 13).

PHOTO #12
Overflow discharge
structure.

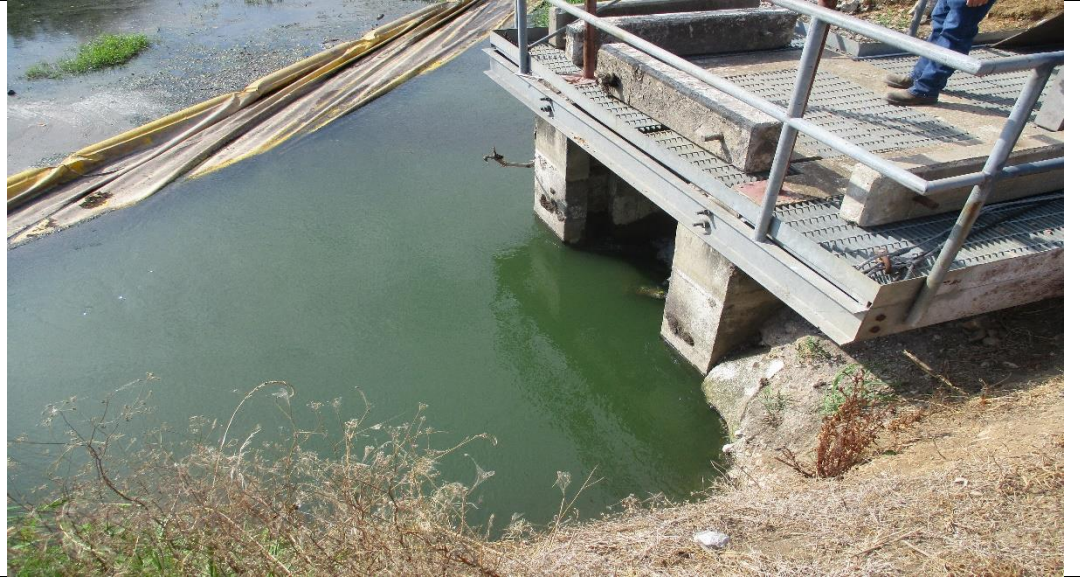
PHOTO #13

Interior of the overflow discharge structure.

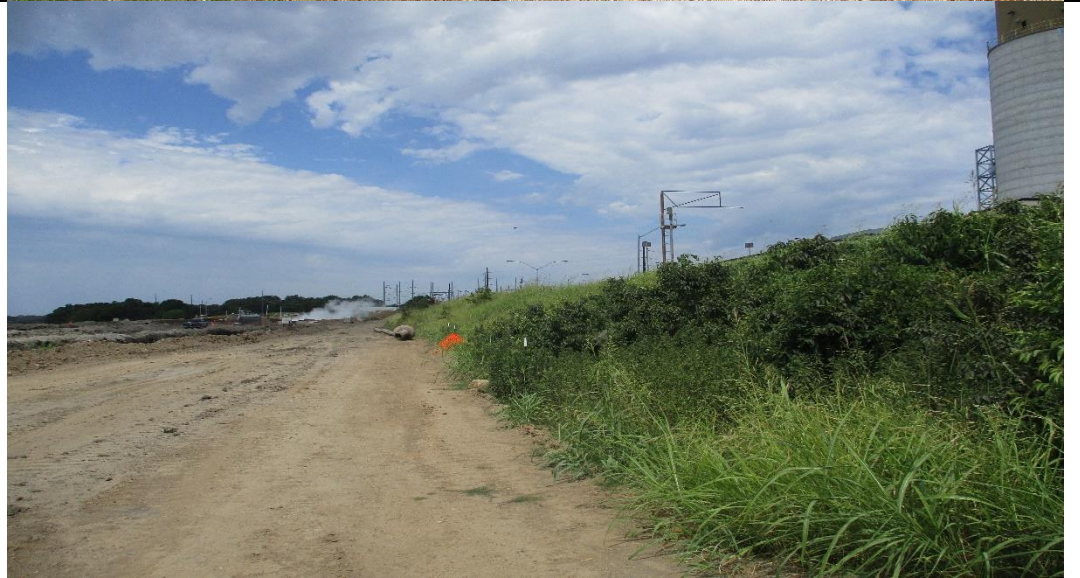
PHOTO #14

- (vii) Photograph Nos. 14 and 15 illustrates upstream slope of the north dike. North dike crest also supports the railroad loop of the coal-yard. The west section of the dike is covered with the dredge cell and most of the slope is covered with the bottom ash buttress/access road. The exposed upper section of the slope is covered with excessive vegetation, but the slope is in stable condition.

North dike upstream slope (west section).

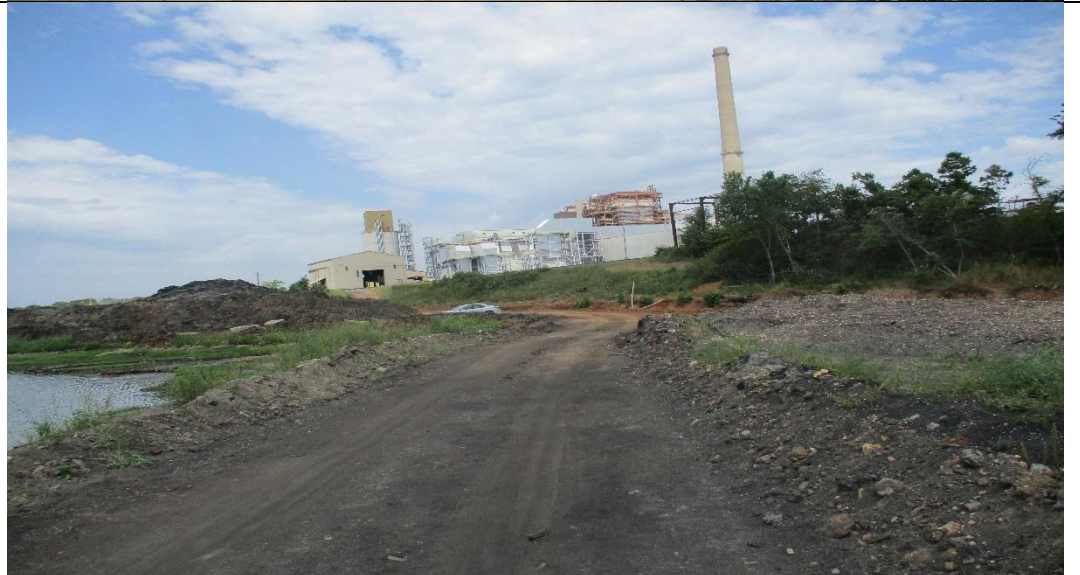
PHOTO #15

Another view of the upstream slope (east section).
