# **2022 Annual Landfill Inspection Report**

**CCR Landfill**

**Turk Power Plant  
Southwestern Electric Power Company  
Fulton, Arkansas**

**Document Number:** GERS-22-031

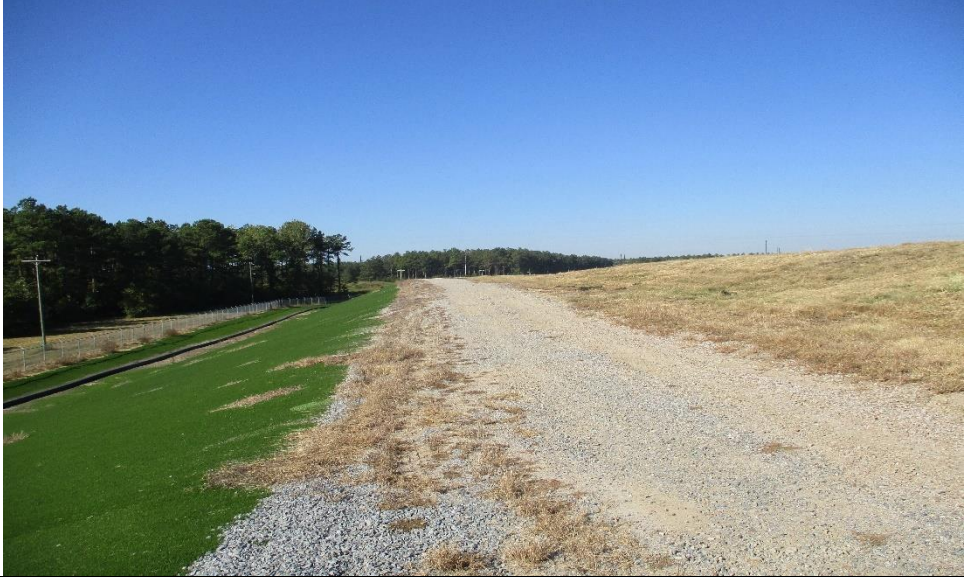
1. Photographs No. 1 and 2 illustrate south perimeter berm and toe ditch. The berm and ditch were constructed for the landfill to support the landfill and control runoff from the landfill. The slope of the berm consists of artificial turf (alternate to the natural grass

cover) and appeared in good and stable condition. Few isolated spots indicated weeds protruding through the artificial turf. It appears that some of the sand that was placed as ballast over the artificial turf may have washed down into the toe ditch. The ditch appeared in good condition with positive flow and free from overgrown vegetation.

<p><b>Photograph No. 1</b> South side of the landfill, support berm, and storm water ditch (looking west).</p>

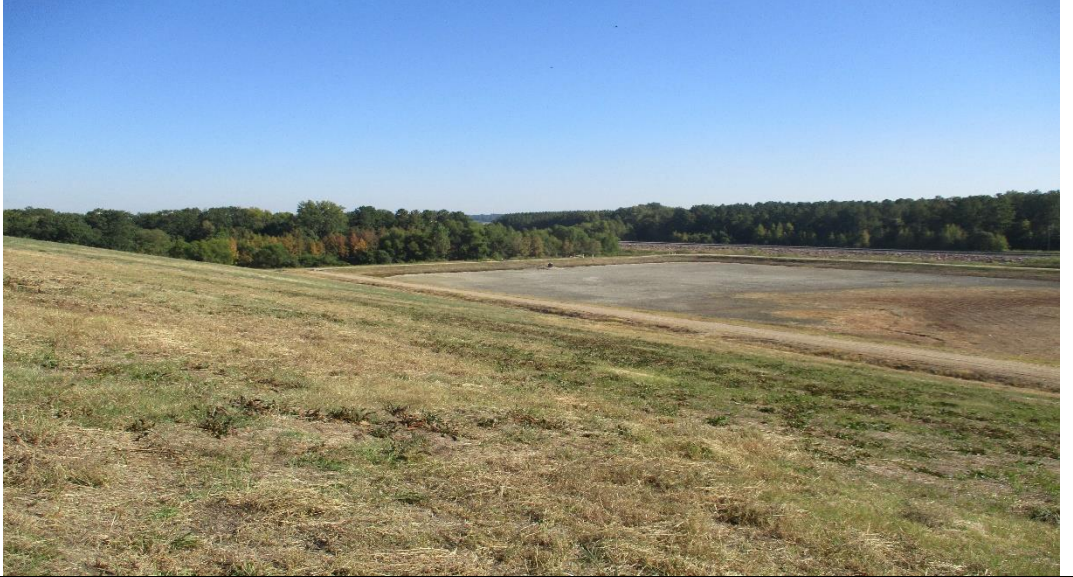
4. Typical condition of the landfill slope of Cell 1 is illustrated in Photograph No. 7. The east and south slope are covered with temporary soil cover. The north slope is partially covered with temporary cover and work is in progress to cover the remaining north slope. The north slope appeared in good and stable condition without any significant erosion or instability. The east and north slope indicated intermittent bare areas (Photograph No. 8).

<p><b>Photograph No. 7</b> Typical slope of the landfill.</p>

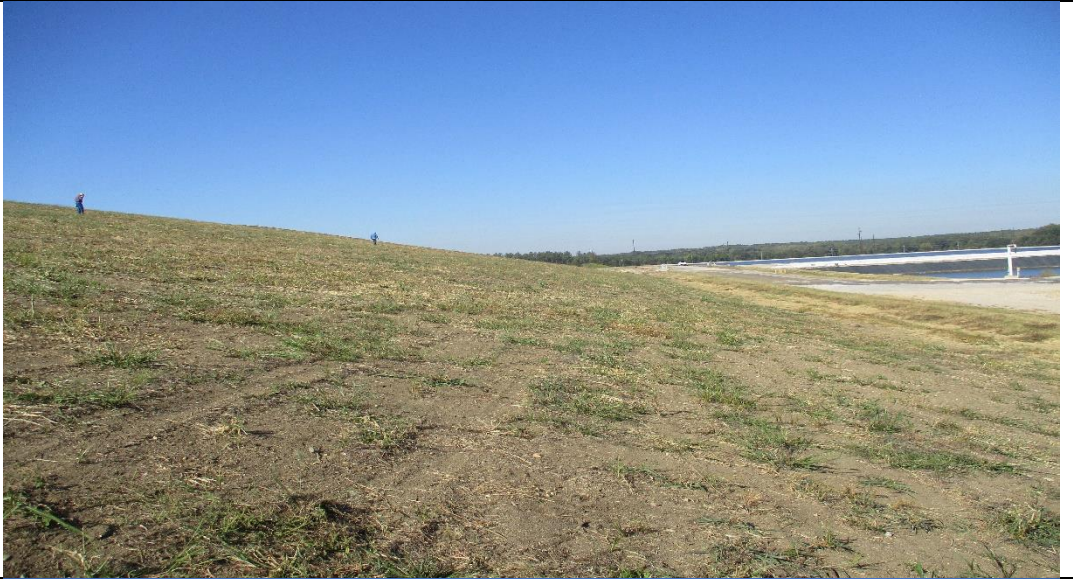
A wide-angle photograph showing a large, grassy slope of a landfill. The slope is covered in dry, yellowish-brown grass and some green patches. In the background, there is a line of trees and a clear blue sky.
<p><b>Photograph No. 8</b> Closeup of the temporary soil cover.</p>

- (i) General vegetation control should be maintained at the leachate pond and storm-water pond, particularly around the outlet pipes. Debris around the pipes should be removed for leachate pipes to operate properly. Temporary cover at the landfill should be re-seeded and/or maintained.

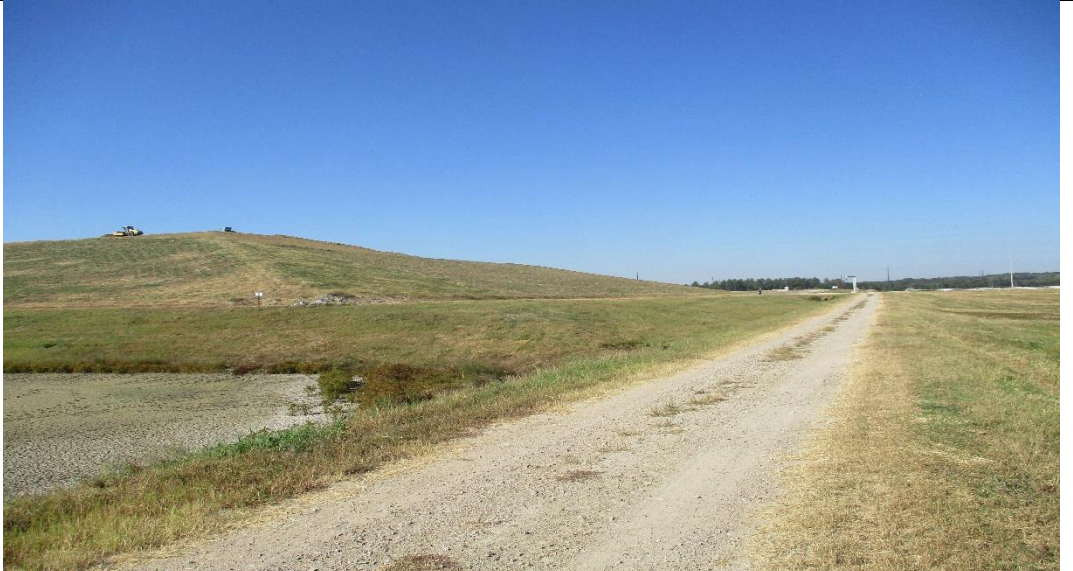
5. The perimeter access road appeared in good condition without any signs of settlement, instability, misalignment, or significant erosion. Typical condition of the perimeter access road is illustrated in Photograph No. 9.

A close-up photograph of the temporary soil cover on the landfill slope. The ground is a mix of dark brown soil and sparse, dry grass. Two small figures of people are visible on the slope in the distance, providing a sense of scale.
<p><b>Photograph No. 9</b> Typical condition of the perimeter road.</p>

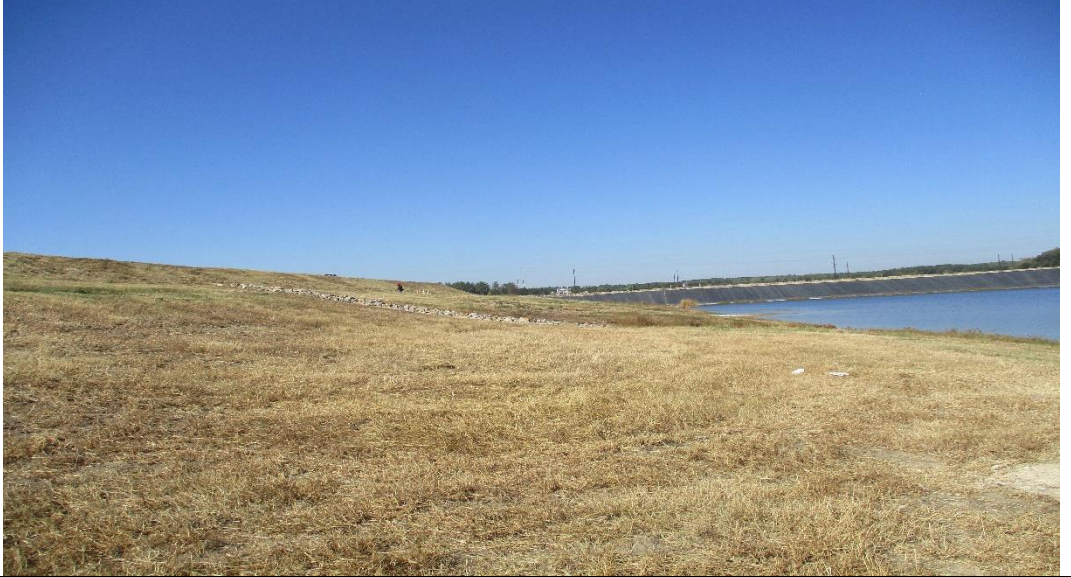
6. Overall, typical interior view of the leachate pond is illustrated in Photographs No. 10 and 11. The vegetative cover on the interior slopes (north, south, and east) appeared in good and controlled condition.

<p><b>Photograph No. 10</b> The south interior slope of the leachate pond.</p>

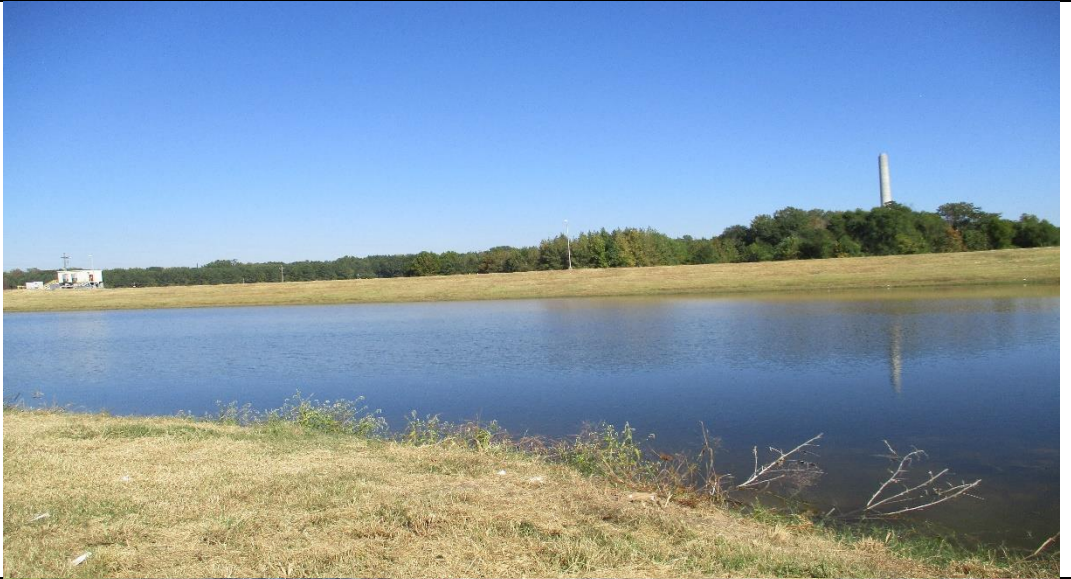
<p><b>Photograph No. 11</b> Overall view of the leachate collection pond interior slope.</p>

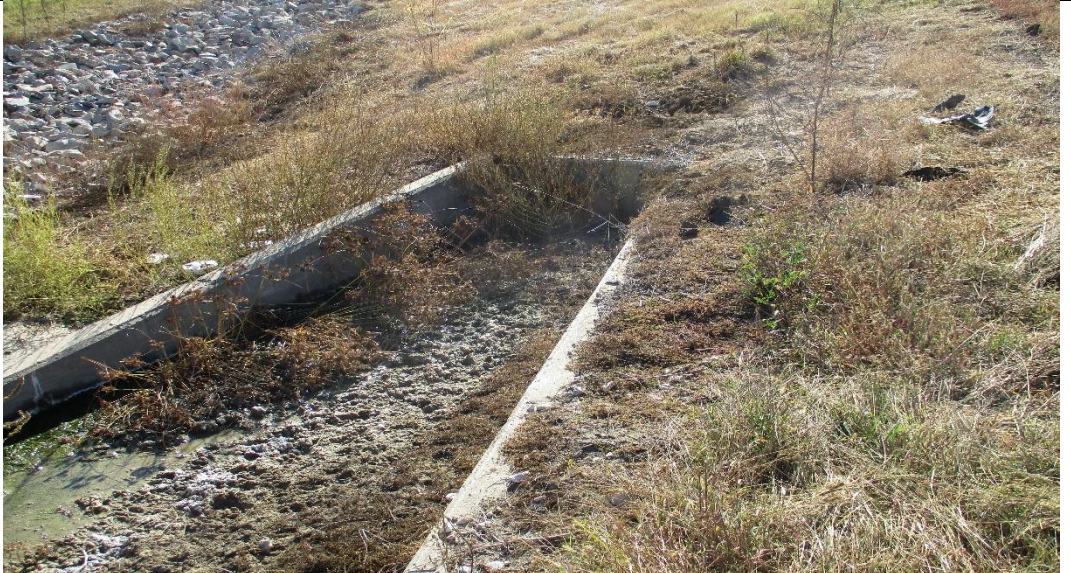
7. There are three leachate drainpipes (southeast, center, and southwest) on the south slope of the leachate pond. Leachate enters the pond from the Cell 1 leachate collection system through a pipe at the southeast corner of the pond (Photograph No.12). Leachate was draining from the pipe at the time of the inspection, but the drain pipe cover appeared to be covered with obstruction by debris and vegetation (Photograph Nos. 12 and 13).

<p><b>Photograph No. 12</b> Southeast corner leachate pipe.</p>

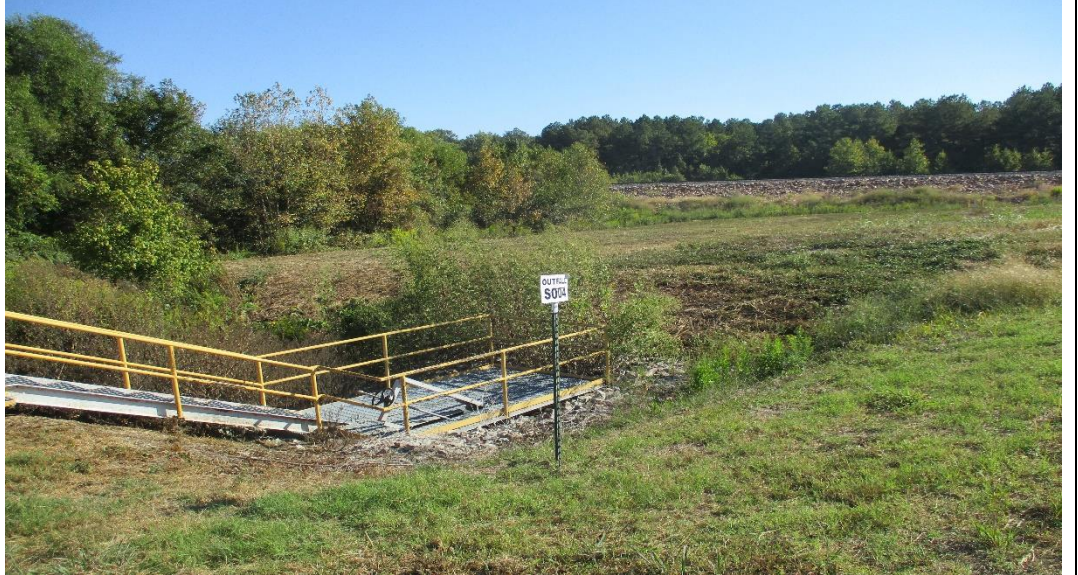
**Photograph No. 16**

9. The storm water pond is located to the east of the landfill and receives non-contact storm water run-off from areas outside the active Cells of the landfill. The pond appeared dry and the bottom was visible (Photograph No. 15). Overall, the pond appeared in good and functional condition.
10. The outlet of the overflow pipe structure of the storm-water pond is illustrated in Photograph No. 16. The overflow pipe structure appeared in good condition. No water

was flowing at the time of inspection from the outlet pipe. The outlet pipe area exhibited excessive vegetation that should be cleared as part of maintenance activities.

Overflow discharge structure.

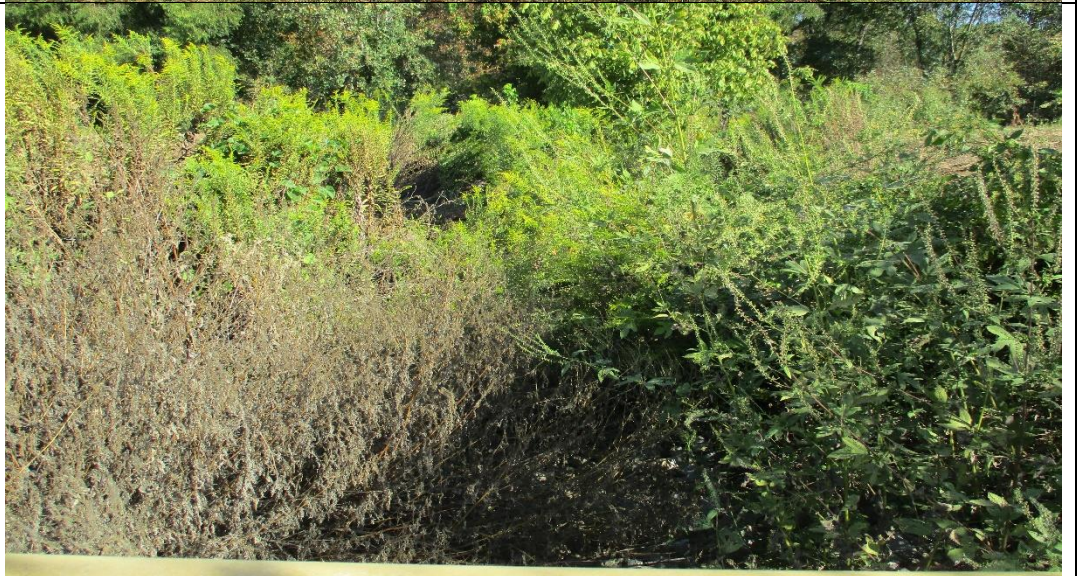
**Photograph No. 17**

Excessive vegetation.
