# **2023 Dam and Dike Inspection Report**

**Bottom Ash Pond**

**Northeastern 3&4 Plant  
Public Service Company of Oklahoma  
Oologah, OK**

**Document ID: GERS-23-049**

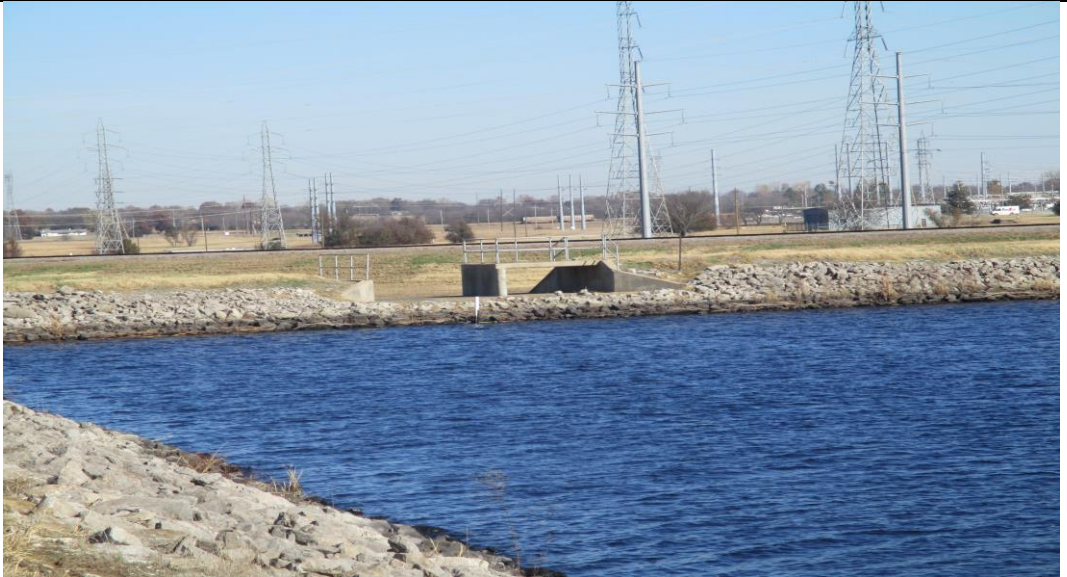
1. Photograph No. 1 illustrates the auxiliary spillway located at the northwest corner of the pond. Overall, the spillway appeared to be in good and functional condition as designed without any obstruction to flow. There were no signs of movement, settlement, or misalignment of the spillway. There were no signs of seepage along the contacts between the concrete training walls and downstream slope or at the end of the concrete chute.

<p>Photograph No. 1 Upstream slope and auxiliary spillway (looking north).</p>

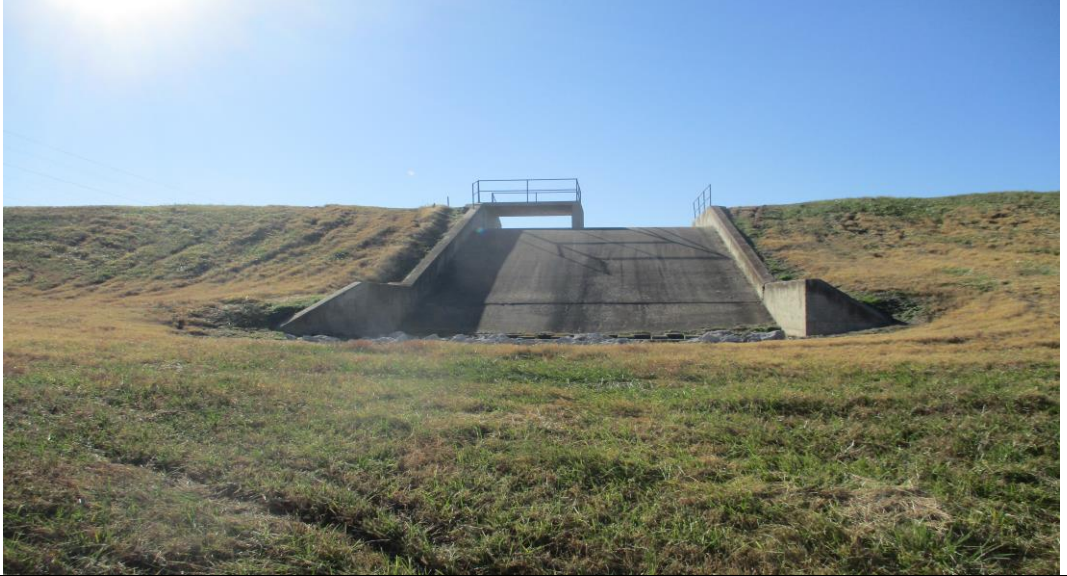
2. The energy dissipater baffles (Photograph No. 2) at the toe of the spillway were clear of sediment and were in good condition. The drainage pipe culverts downstream of the spillway appeared clear of obstruction, dry, and in good functional condition.

A wide-angle photograph showing the upstream slope of the ash pond. In the foreground, there is a rocky embankment leading down to a body of blue water. In the middle ground, a concrete auxiliary spillway structure is visible. The background features a flat landscape with several high-voltage power line towers under a clear blue sky.
<p>Photograph No. 2 Auxiliary spillway of the ash pond.</p>

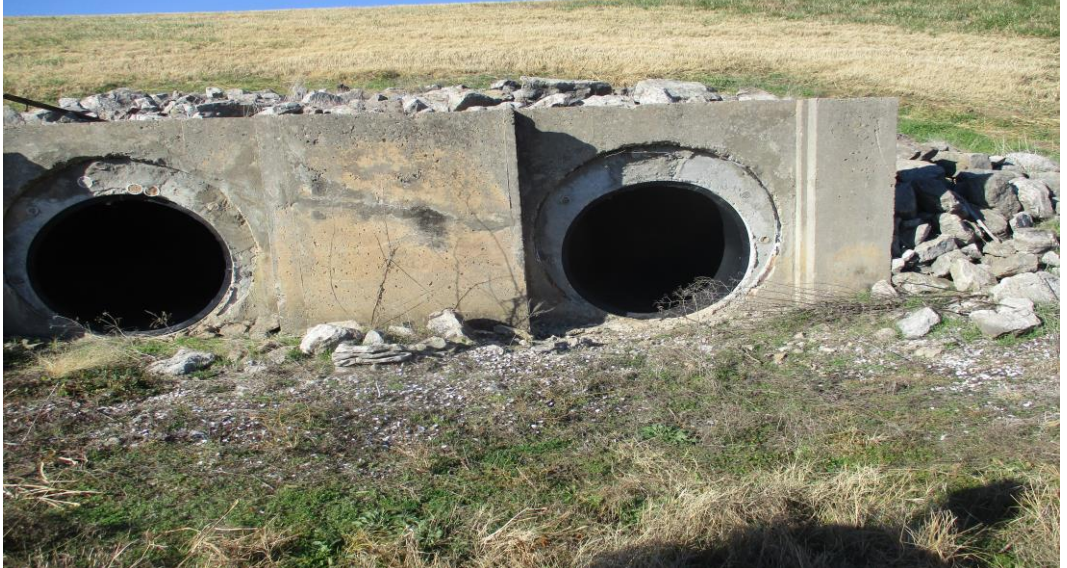
3. The pipe culverts located downstream of the spillway (Photograph No. 3) appeared in good condition and clear from any obstruction.
4. Typical condition of the crest and downstream slope of the northwest dike section was well vegetated. The grass along the exterior slope was recently mowed. There were no signs of sloughing or other slope movement observed at this dike section (Photographs No. 4 and 5).

A photograph of the auxiliary spillway structure, which is a concrete trapezoidal structure with a flat top. It is situated on a grassy slope. A metal walkway with railings runs along the top edge of the spillway. The surrounding area is covered in green and brown grass.
<p>Photograph No. 3 Culvert pipes.</p>

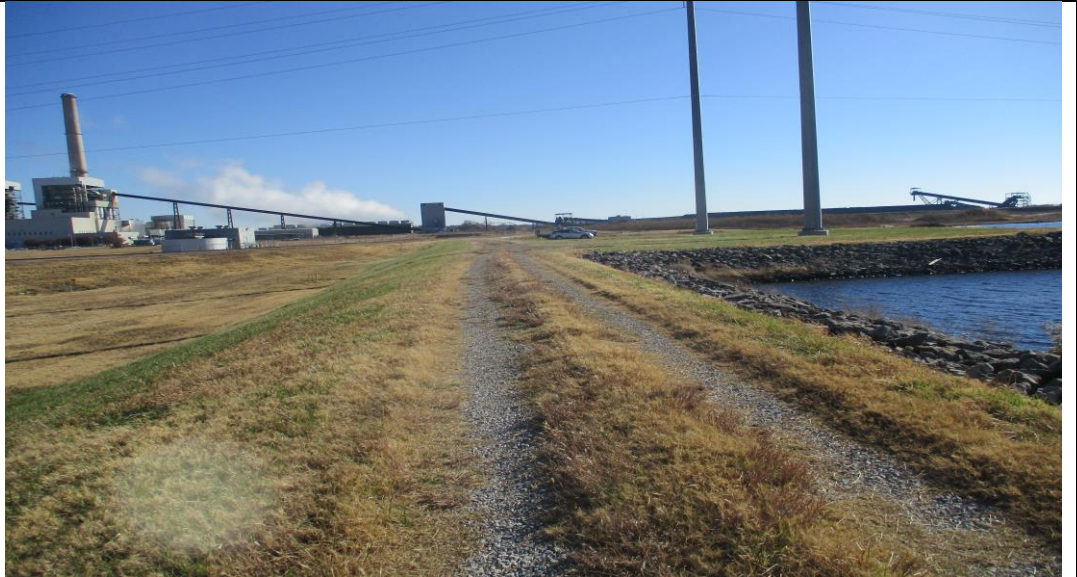
Photograph No. 4  
Typical condition of the crest of the northwest dike section (looking east).

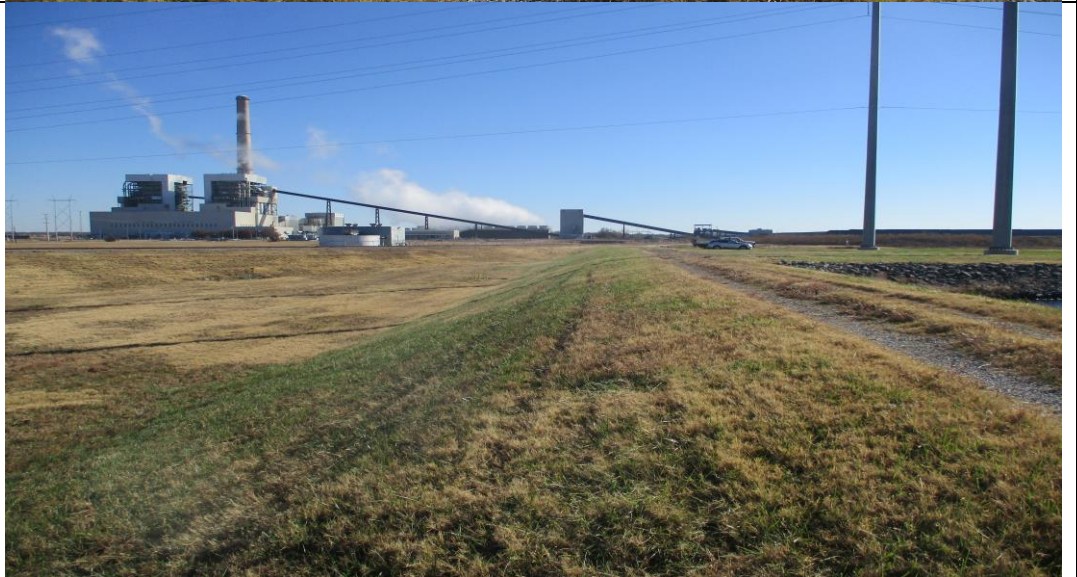
Photograph No. 5  
Downstream slope of the northwest dike section.

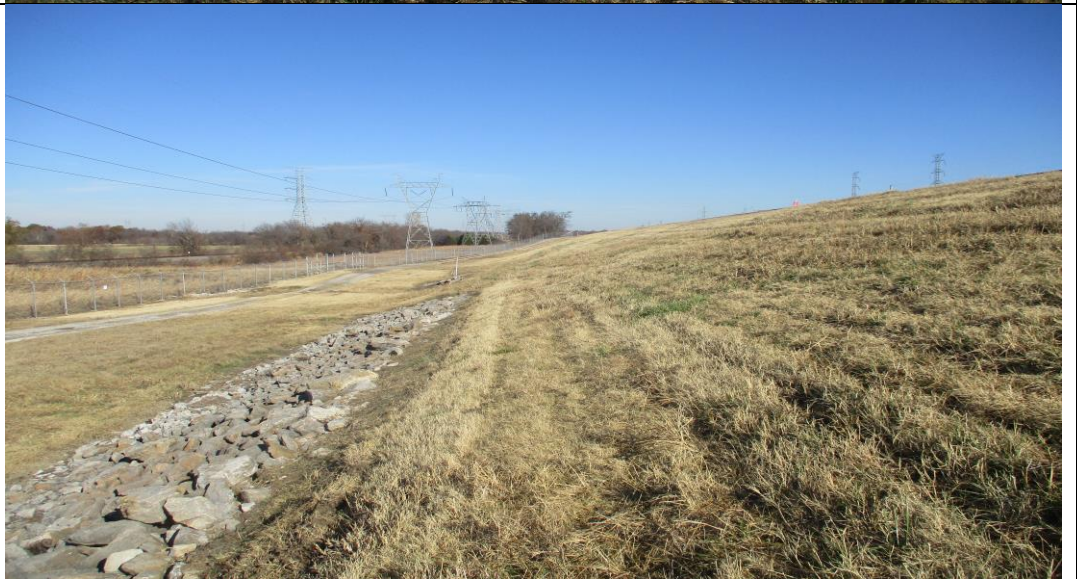
5. The downstream slope (Photographs No. 6-9) was well vegetated and maintained in a controlled manner. There was no observed seepage, wet, or damp areas along the slope. The area about 30-feet beyond the toe of the dike is well maintained and free from overgrown trees. There were no signs of sloughing, settlement, animal holes, or other deficiencies. The toe drainage blanket appeared in good and intact condition. No seepage was observed at the time of inspection.

Photograph No. 6  
Downstream slope toe drain (looking north).

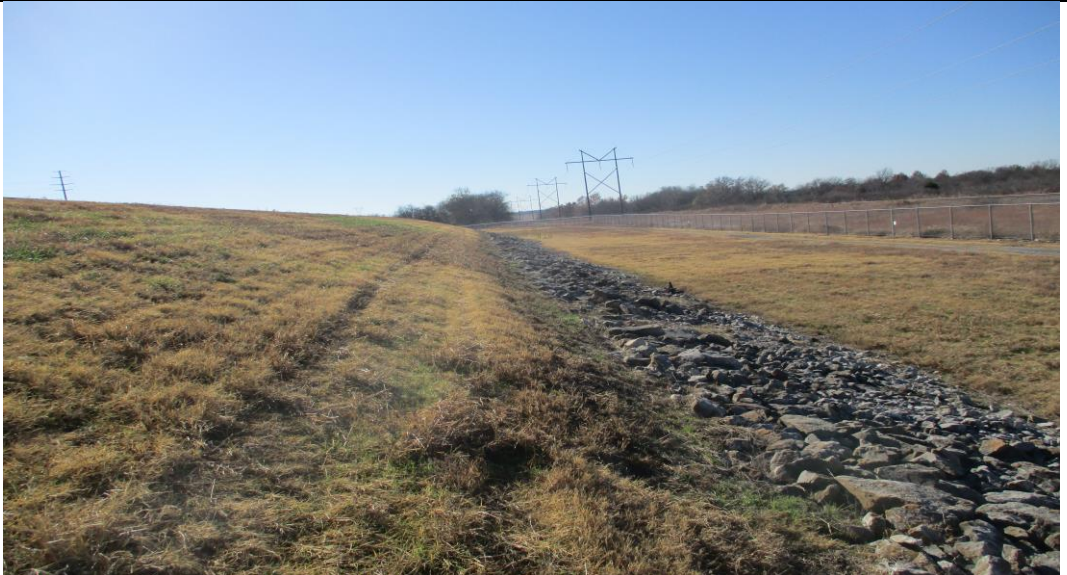
<p>Photograph No. 7</p> <p>View of the downstream slope and toe drain (looking south).</p>

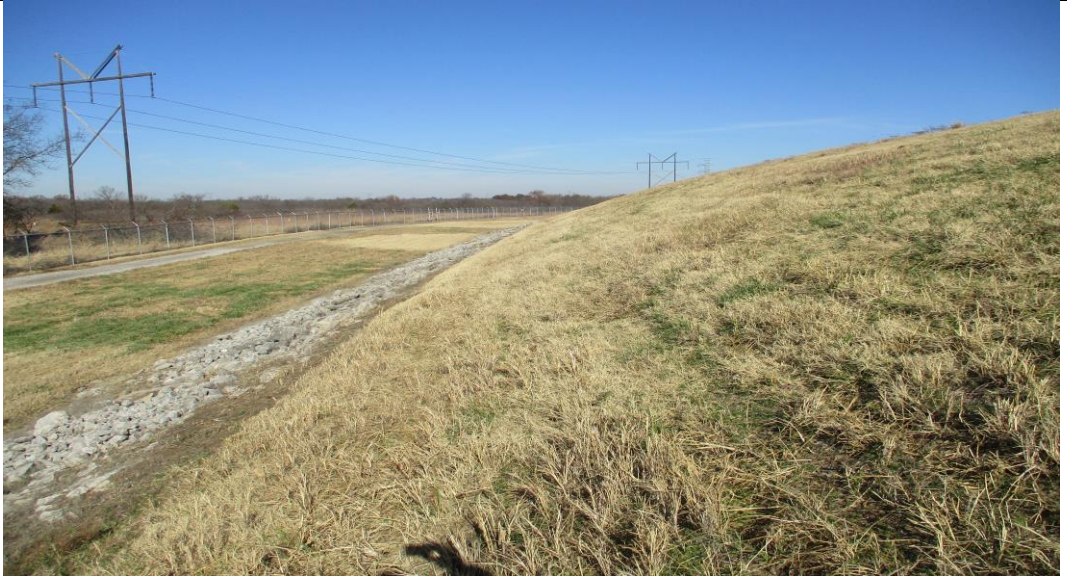
A photograph showing a wide, grassy downstream slope of a dam or dike. A stone toe drain runs along the base of the slope, extending into the distance. In the background, there are several high-voltage power line towers under a clear blue sky.
<p>Photograph No. 8</p> <p>Toe drain another section.</p>

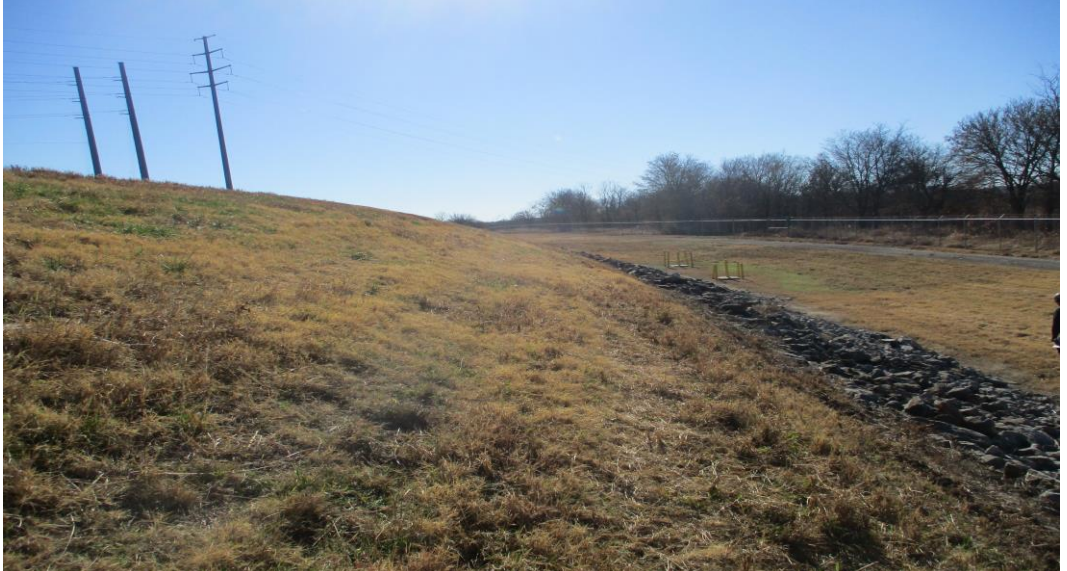
A photograph showing a different section of the stone toe drain. The drain is a narrow channel of stones running along the edge of a grassy slope. A road and power line towers are visible in the background.
<p>Photograph No. 9</p> <p>Downstream slope (south section).</p>

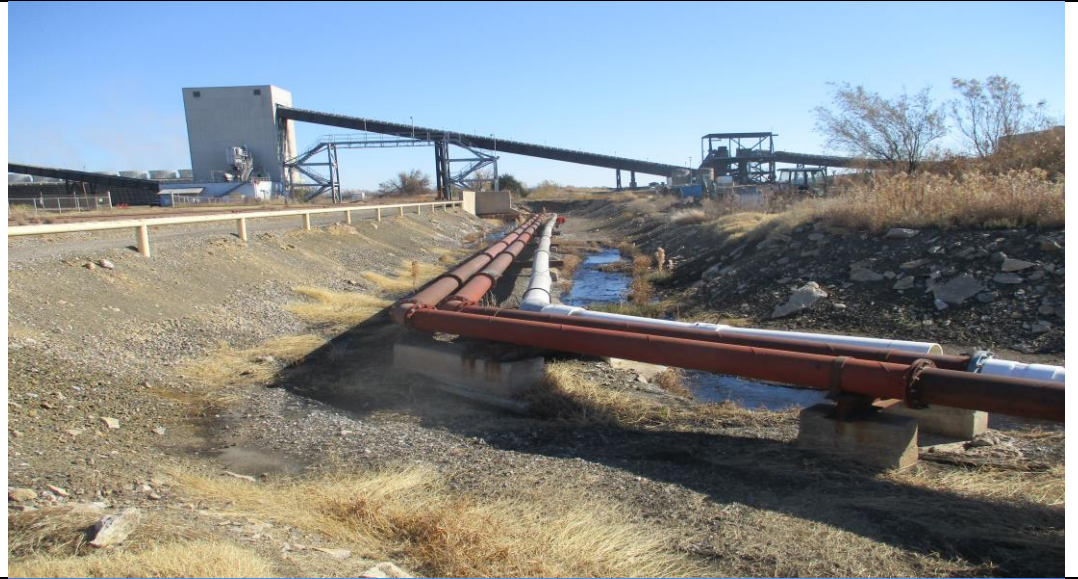
8. Ash and waste water sluice pipes are illustrated in Photograph Nos. 15 and 16. The sluice pipes are located in the mid-section of the north dike. Overall, the sluice pipes are functioning as intended. The outlet end support of the pipe may need additional support to the existing arrangement. All the pipe support should be inspected for undermining of pipe support footings.

Photograph No. 16  
Sluice pipes support.

- 1) Continue to monitor sluice pipe support footing and subgrade for any undermining or potential unstable condition.

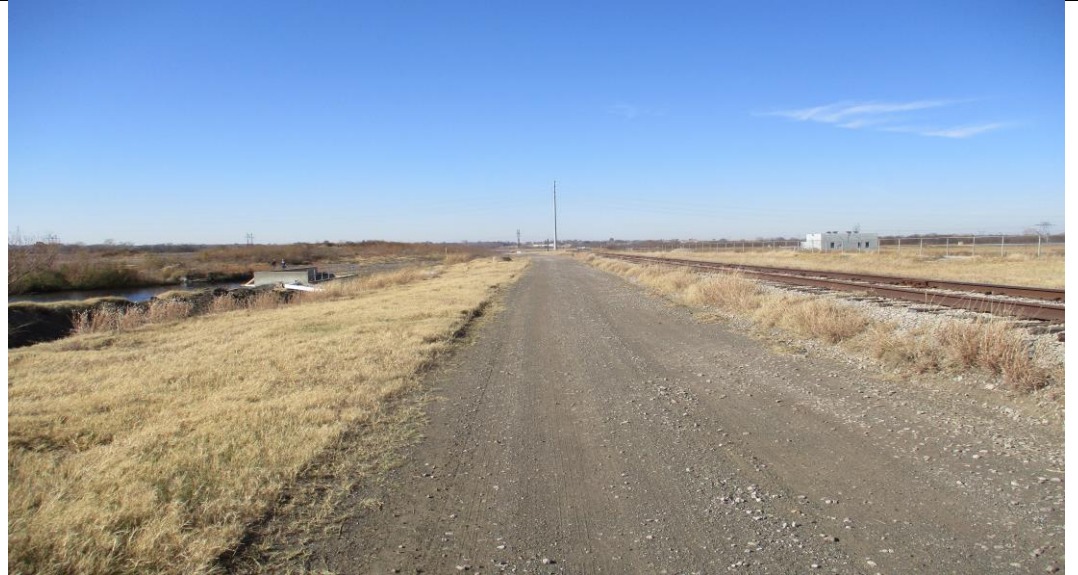
9. Photographs No. 17 and 18 illustrate the crest and upstream of the northeast section of the dike. The crest appeared in good and stable condition with no significant settlement, misalignment, or noticeable sign of distress. The interior slopes show no signs of significant sloughing or bulges. The riprap protection section along the slope was in good condition and no significant grassy vegetation was noticed within the riprap.

Photograph No. 17  
North dike crest (looking west).

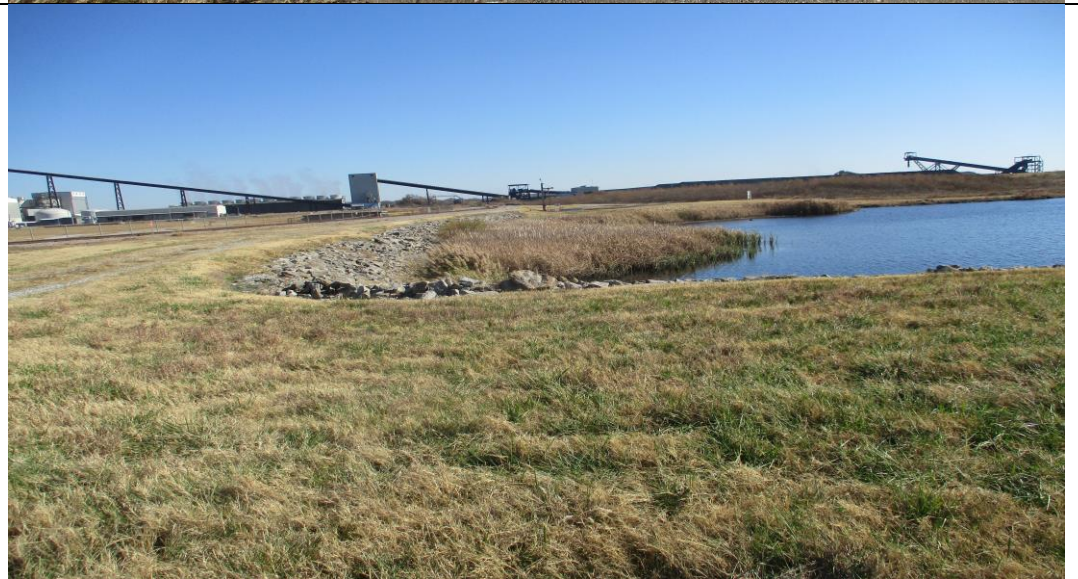
Photograph No. 18  
Upstream slope of the northeast dike section.
