# **2023 Annual Landfill Inspection Report**

**CCR Landfill**

**Turk Power Plant  
Southwestern Electric Power Company  
Fulton, Arkansas**

**Document ID: GERS-23-036**

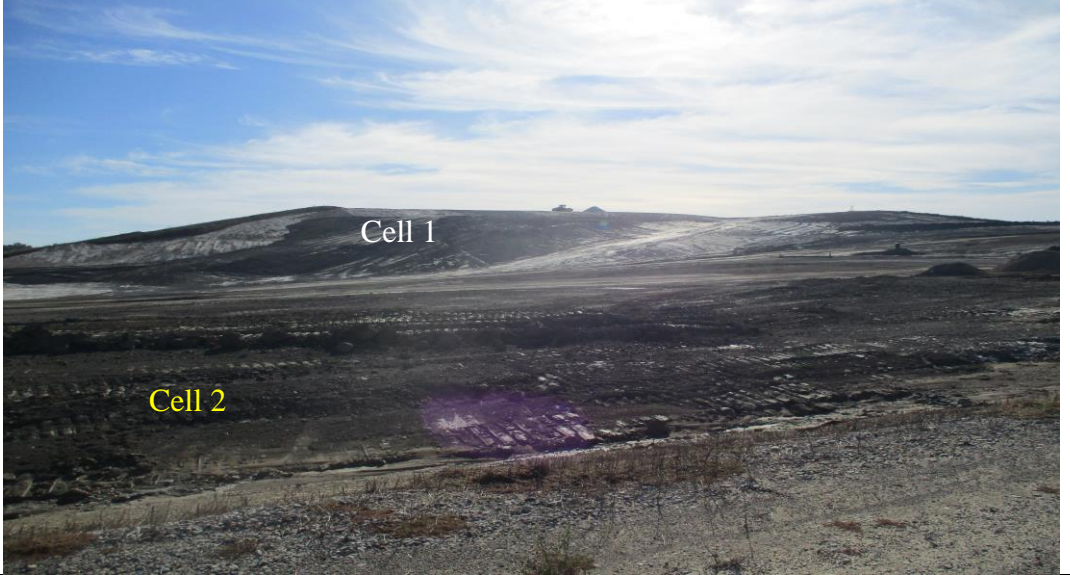
1. Overall condition of the landfill Cell 1 and Cell 2 are illustrated in Photographs No. 1-5. Photograph No. 1 was taken from the access road illustrating Cell 1 in the background completed to the maximum fill grades and Cell 2 in the foreground. Cell 2 fill has reached close to the elevation of the perimeter road with the CCR material. Cell 2 fill area

appeared in good condition and no significant erosion or water pond was observed.

<p>Photograph No. 1 Active Cell 2 (looking east).</p>

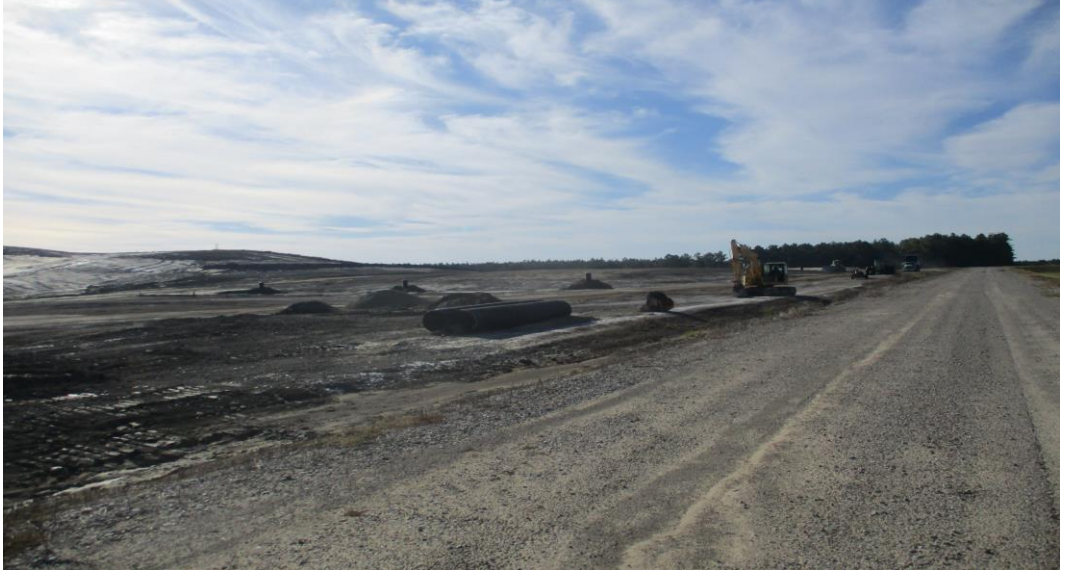
Inactive landfill Cell 1 (Photographs No. 3 and 4) was in good and stable condition with no sign of instability, water ponding or significant erosion. The temporary access road to the west (Photograph No. 2) and landfill perimeter road to the south appeared in good condition.

<p>Photograph No. 2 Access road to the west of Cell 2.</p>

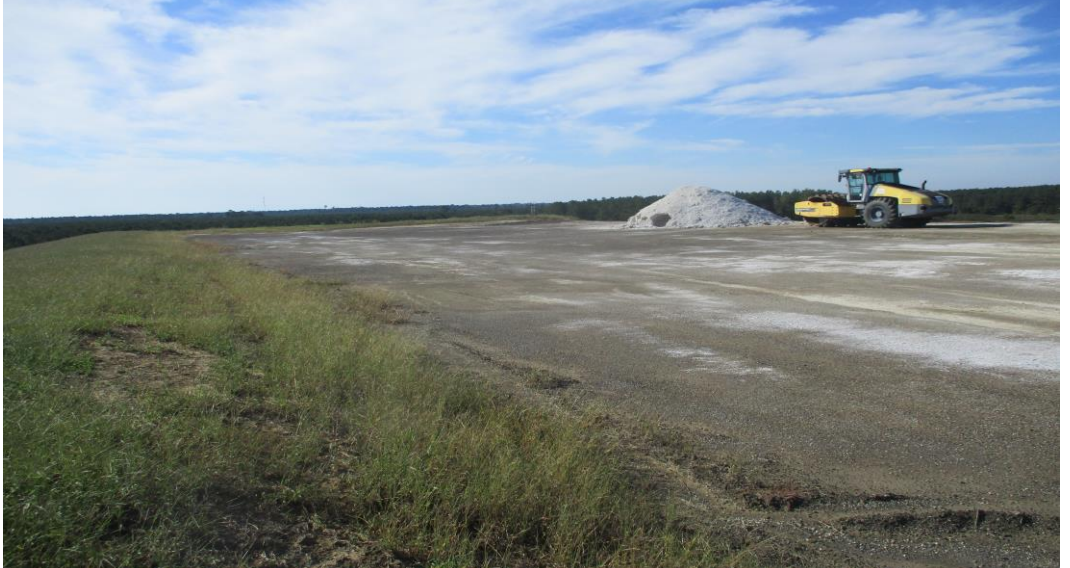
<p>Photograph No. 3 Cell 1 along the slope.</p>

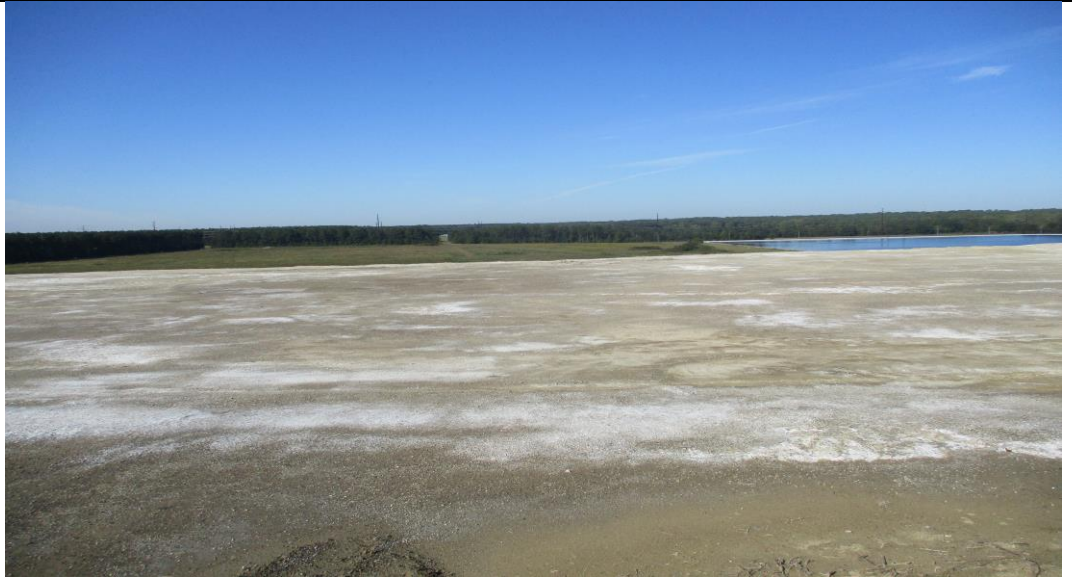
Photograph No. 4  
Top of Cell 1.

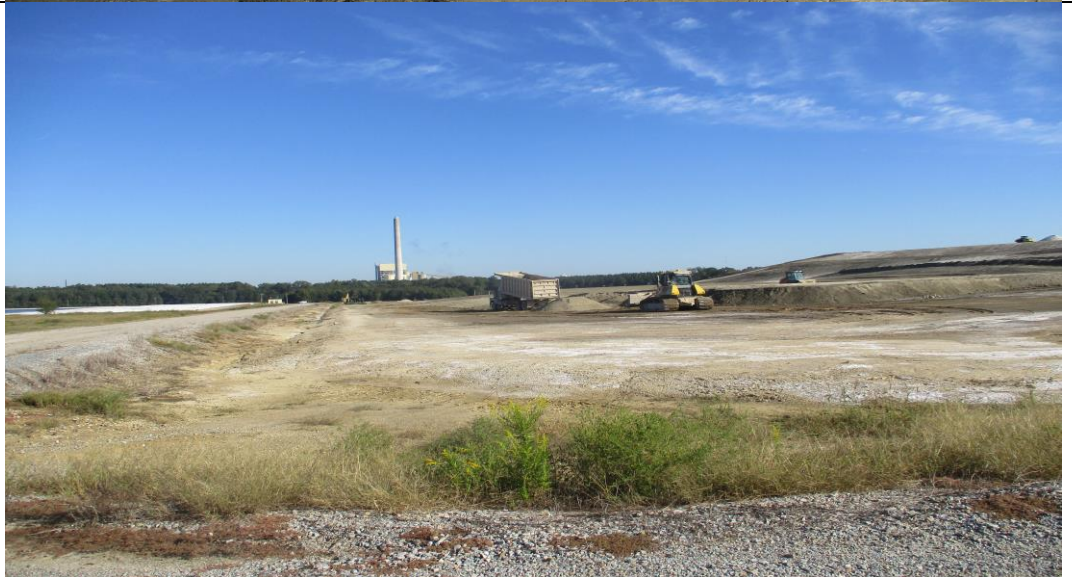
Photograph No. 5  
Active Cell 2 (looking north).

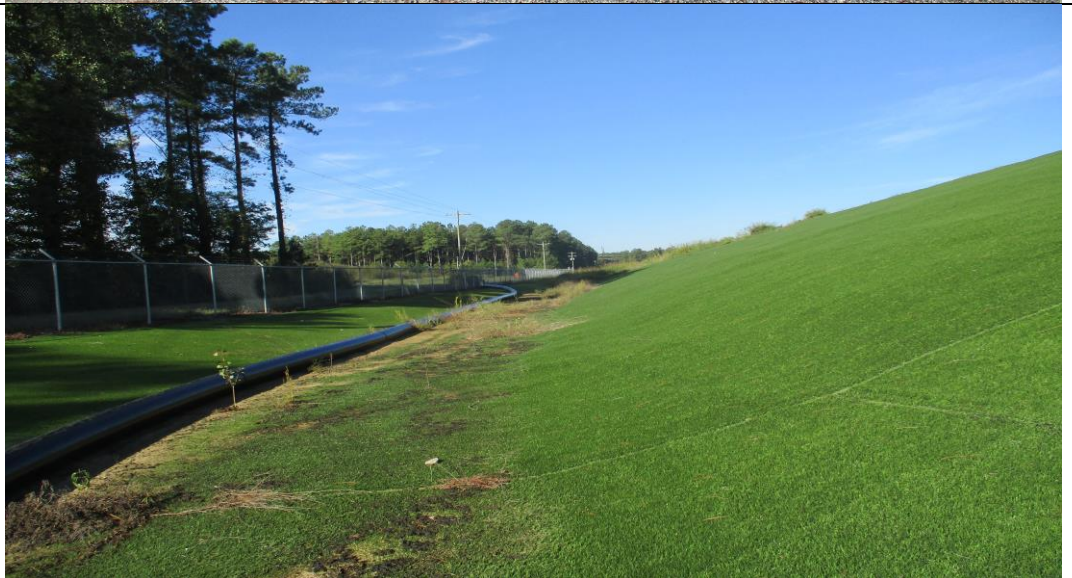
2. Photographs No. 6-10 illustrate south and east perimeter berm and toe ditch. The berm and ditch were constructed for the landfill to support the landfill and control runoff from the landfill. The south slope of the berm consists of artificial turf (alternate to the natural grass cover) and appeared in good and stable condition. Few isolated spots indicated weeds protruding through the artificial turf. Overall, the closure turf cover and toe ditch are functioning as designed. An area at the southeast corner (Photographs No. 7 and 8) appears to have some water ponding. Minor overgrown vegetation was noticed at the end of ditch to the stormwater pond (Photograph No. 10). Overall, the toe ditch and the berm is functioning as designed.

Photograph No. 6  
Landfill support berm and storm water ditch (looking west).

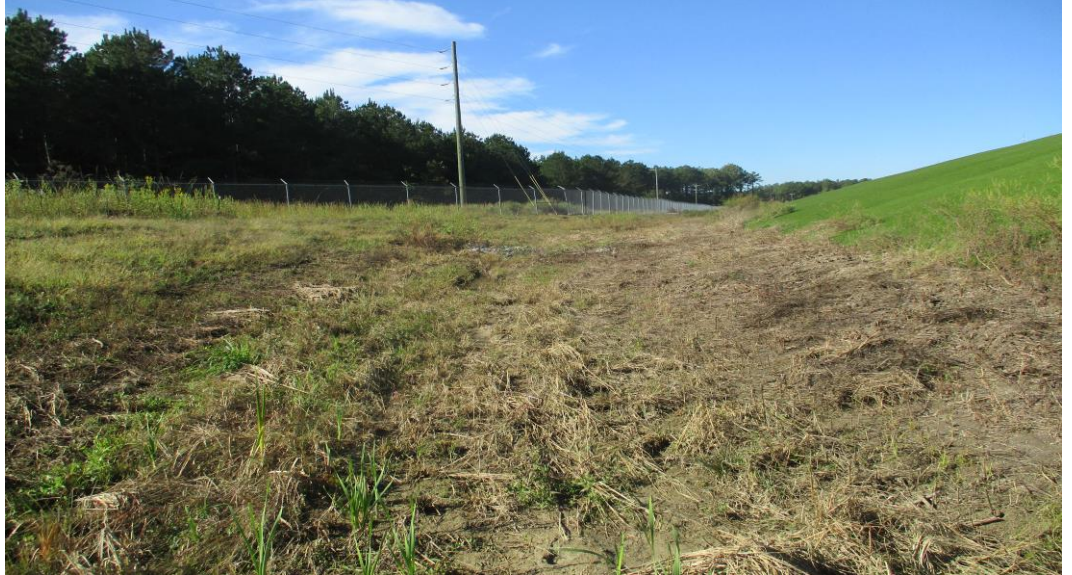
Photograph No. 7  
Toe ditch (looking west).

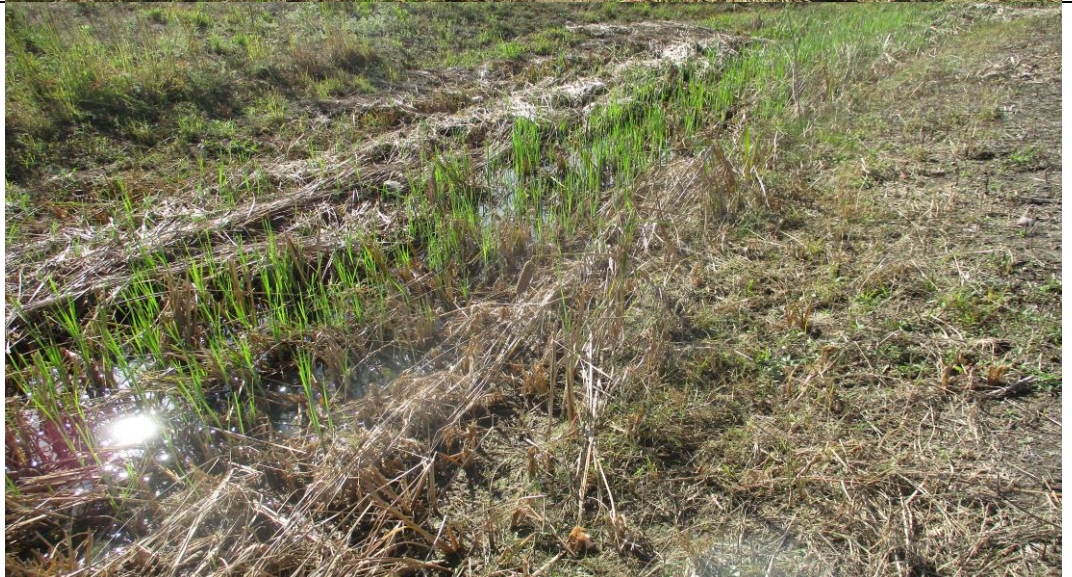
Photograph No. 8  
Toe ditch southeast corner.

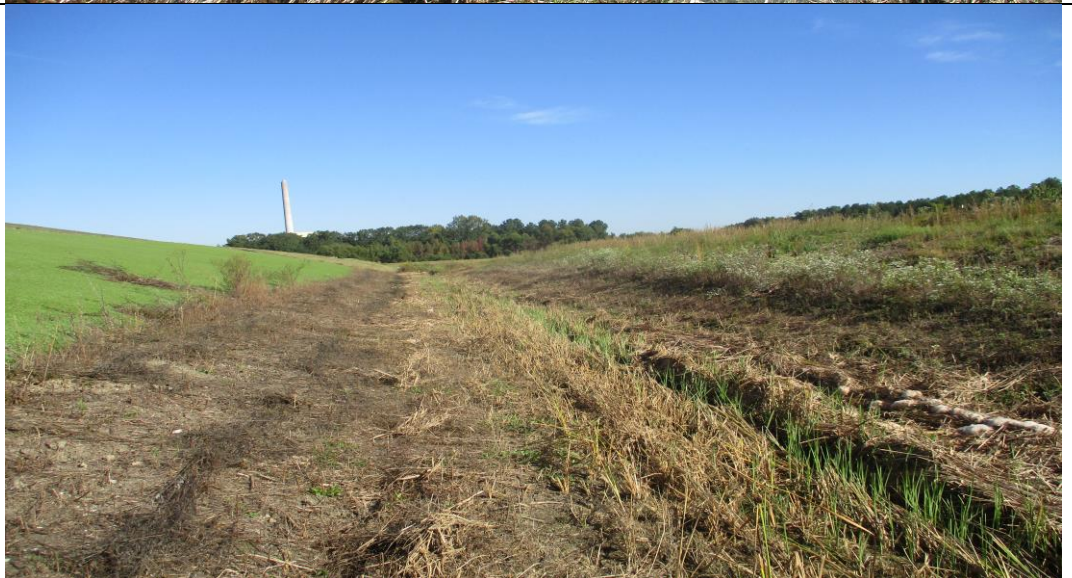
Photograph No. 9  
Toe ditch east side (looking north).

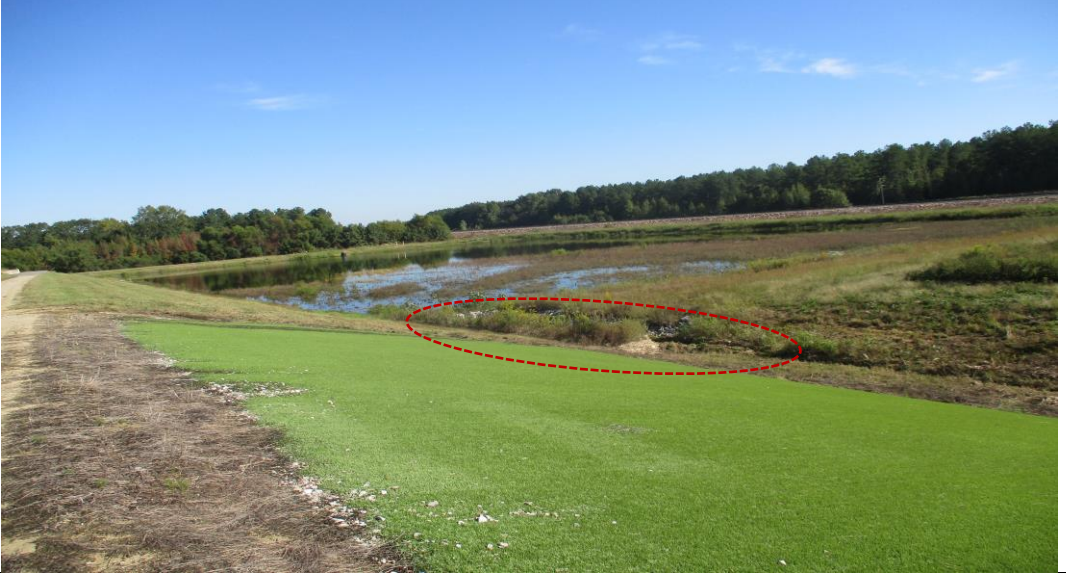
<p>Photograph No. 10</p> <p>Toe ditch letdown to the stormwater pond illustrating minor overgrown vegetation.</p>

- (i) General vegetation control should be maintained at the toe ditch, leachate pond and storm-water pond, particularly around the outlet pipes and interior slopes.
- (ii) The settlement at the catch basin pipe culverts should be backfilled until there is no noticeable settlement.

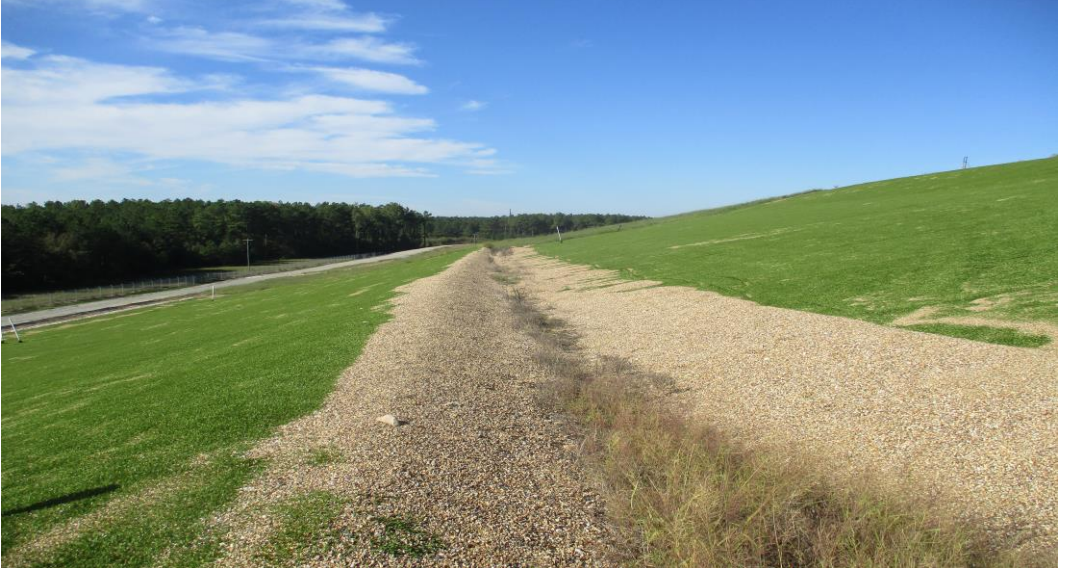
3. A test pad using closure turf for the permanent cover system installation was completed in October 2019 at the southeast slope of the landfill (Photographs No. 11 and 12). The test pad was under inspection and monitoring through 2023. Test pad is currently review by the ADEQ after completion of testing and monitoring phase. The closure turf cover system is designed to be in compliance with the CCR rules. Photograph No. 11 illustrate an intermediate bench and ditch for runoff control. The test pad, bench, and ditch of the cover system appeared in good, intact, and in stable condition.

<p>Photograph No. 11</p> <p>Closure turf test pad intermediate bench (looking west).</p>

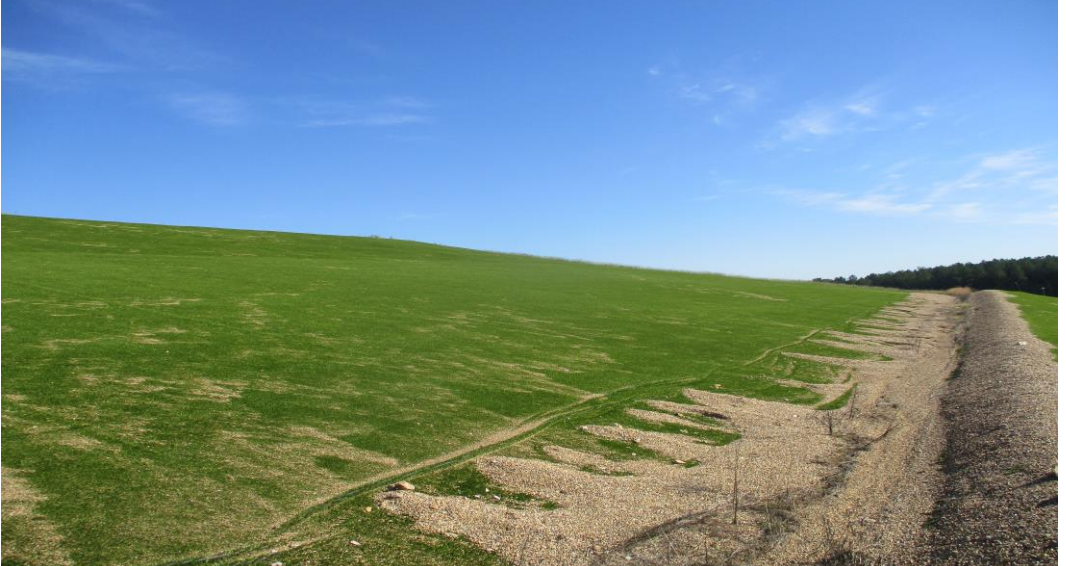
<p>Photograph No. 12</p> <p>Closure turf test pad above the intermediate bench.</p>

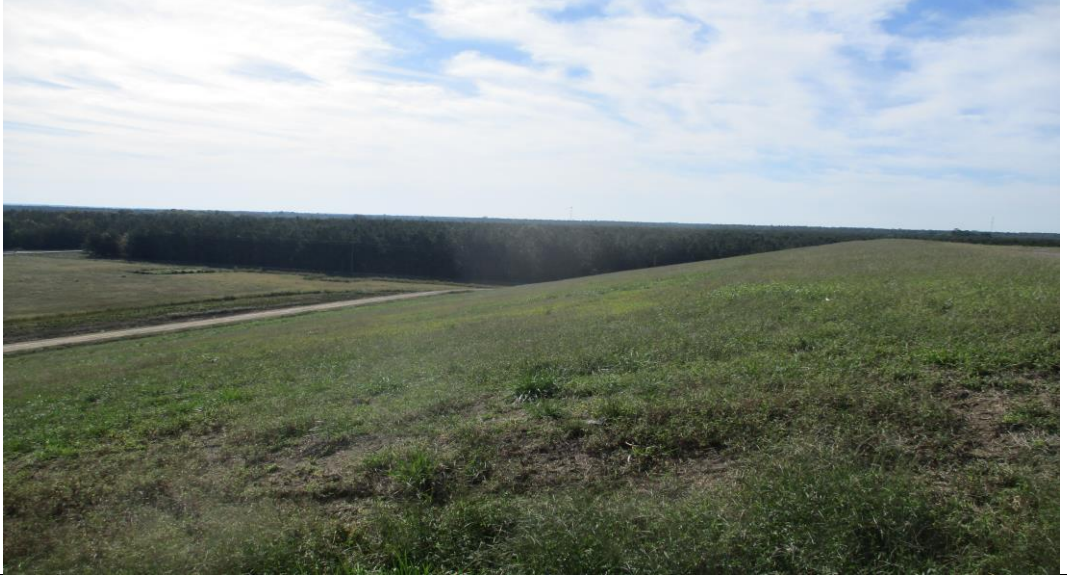
4. Typical condition of the landfill slope of inactive Cell 1 is illustrated in Photographs No. 13-15. The north, south, and east slopes are covered with temporary soil cover. All the slopes are covered with temporary grass cover and appeared in good and stable condition without any significant erosion or instability. The north slope was completed last year and started to show grass growth (Photograph No. 15).

<p>Photograph No. 13 East slope (looking south).</p>

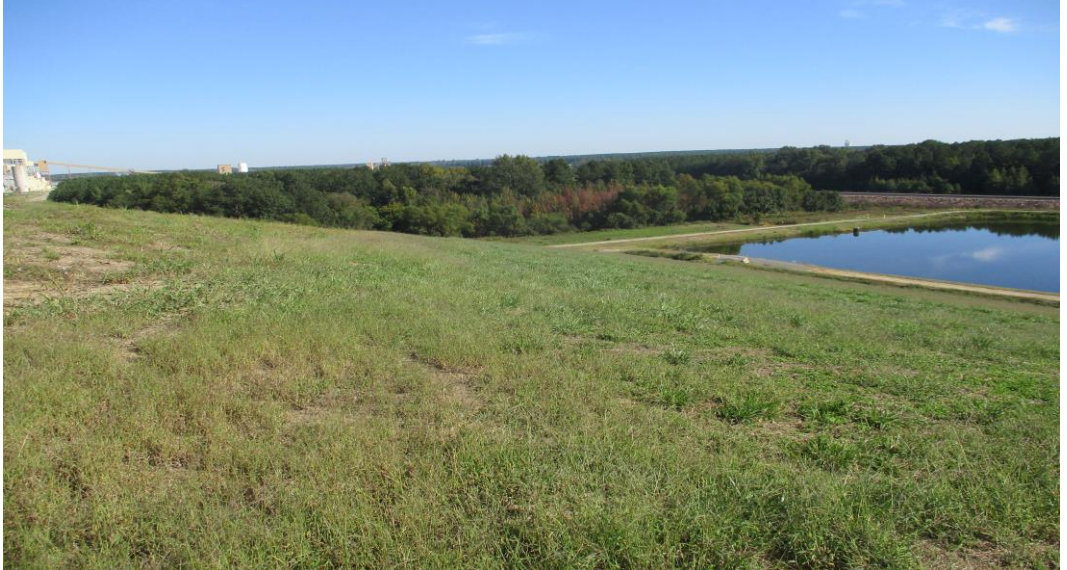
<p>Photograph No. 14 East slope (looking north).</p>

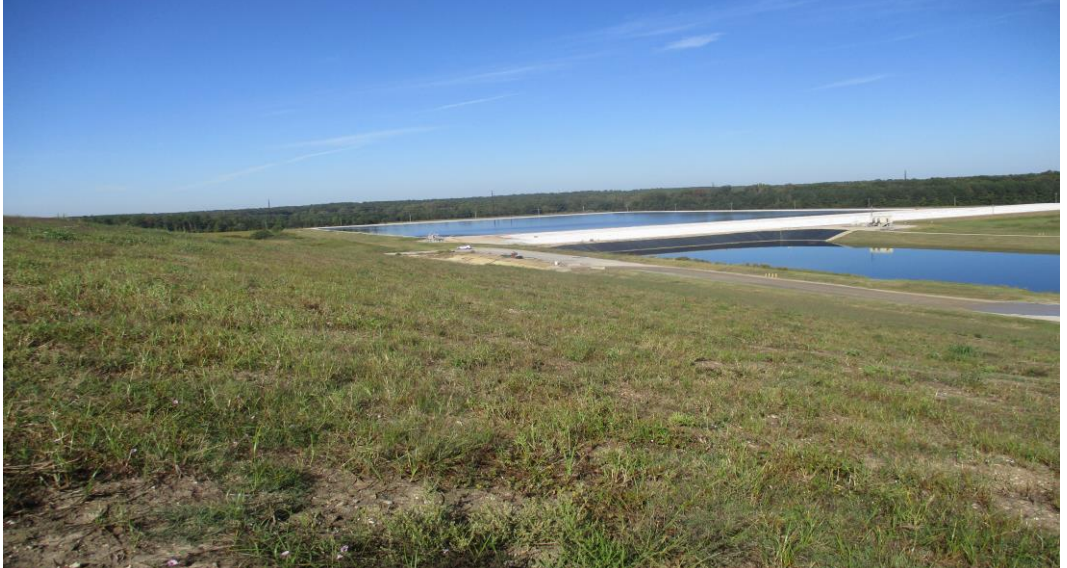
<p>Photograph No. 15 North slope of the landfill.</p>

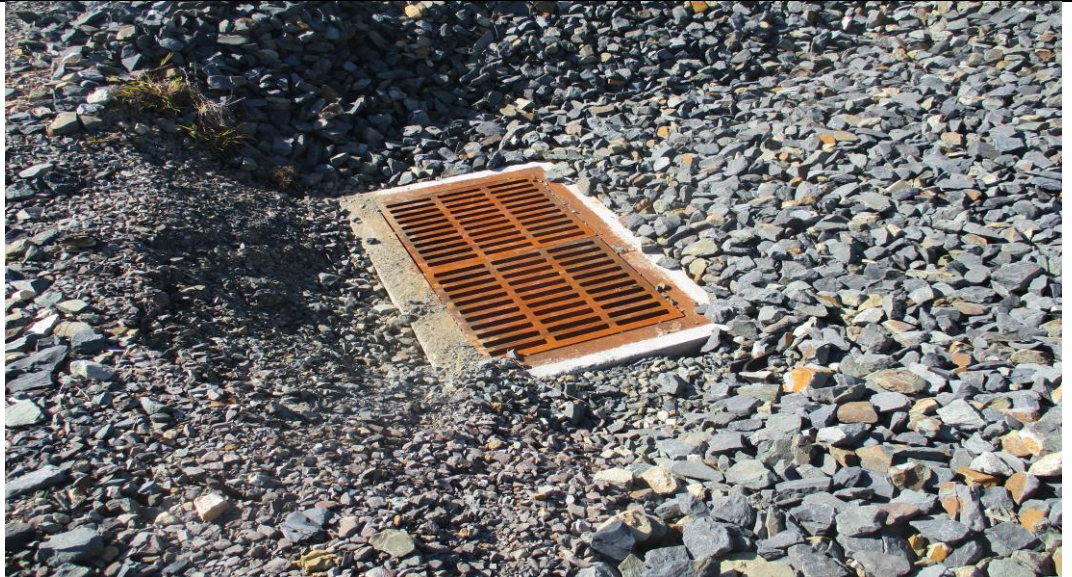
5. A new catch basin is added in the northeast corner of the landfill at the end of the perimeter ditch (Photograph No. 16). Two pipe culverts are extended from the catch basin to the stormwater pond under the perimeter road. The fill has settled (Photograph No. 17) at the road section above the pipe culverts.

Photograph No. 16  
A new stormwater catch basin installed at the northeast corner.

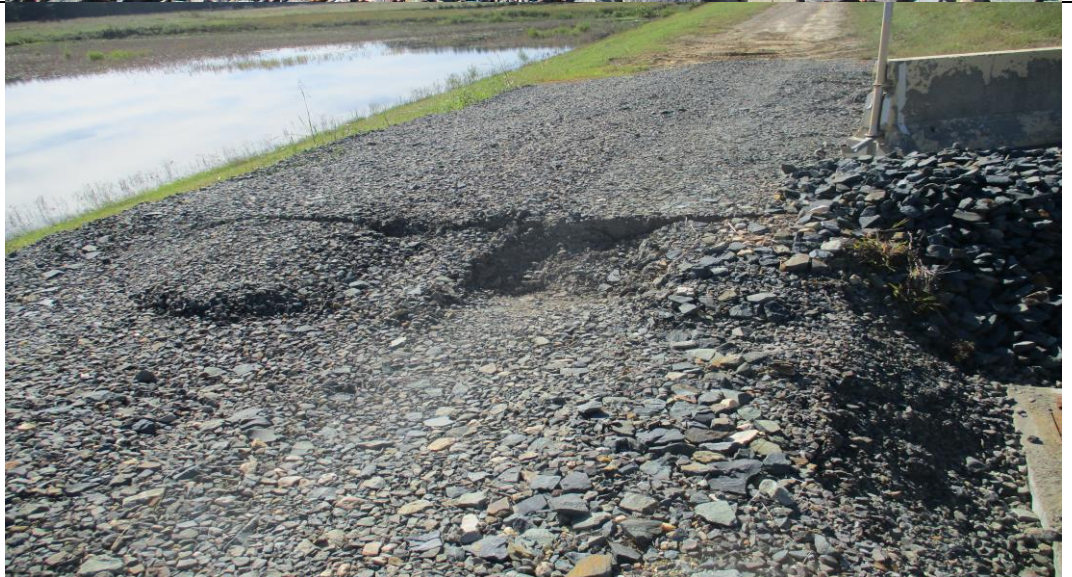
Photograph No. 17  
Settlement notices of the catch basin pipe under the access road.

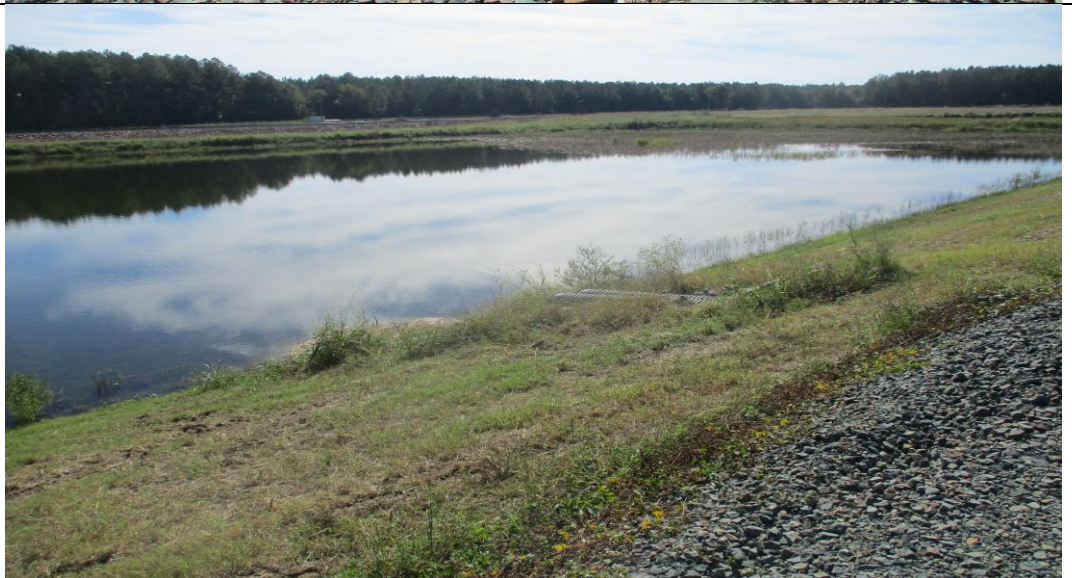
6. The storm water pond is located to the east of the landfill and receives non-contact storm water run-off from the slopes of Cell 1 covered with temporary cover and areas outside the landfill. The pond appeared in good functional condition with some overgrown vegetation along the interior slopes (Photographs No. 18 and 19).

Photograph No. 18  
Interior of the stormwater pond.

- (i) In general, the landfill is functioning as intended. The landfill areas (Cell 1 and Cell 2) are in good and stable condition.
- (ii) The storm water ditches and the perimeter haul road are in good functional condition. The recently installed catch basin in the northeast corner is functioning as designed. The settlement along the pipe culverts should be backfilled until there is not settlement.
- (iii) Previously observed excessive vegetation in the south ditch at the toe of the support berm was cleared. An area in the southeast corner appeared to be soft and may need some additional repair.
- (iv) Overall, the leachate pond is in good and stable condition including the west slope repair. The storm-water pond is functioning as designed and adequately handling the runoff water. Excessive vegetation should be cleared from the interior slopes of the pond and outfall area.

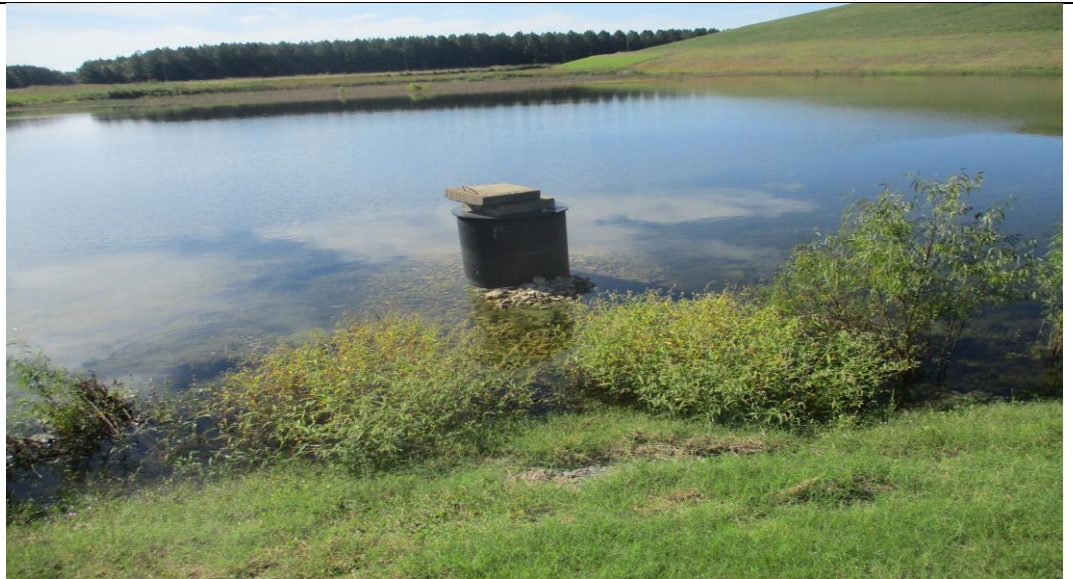
Photograph No. 19  
Overflow discharge pipe.

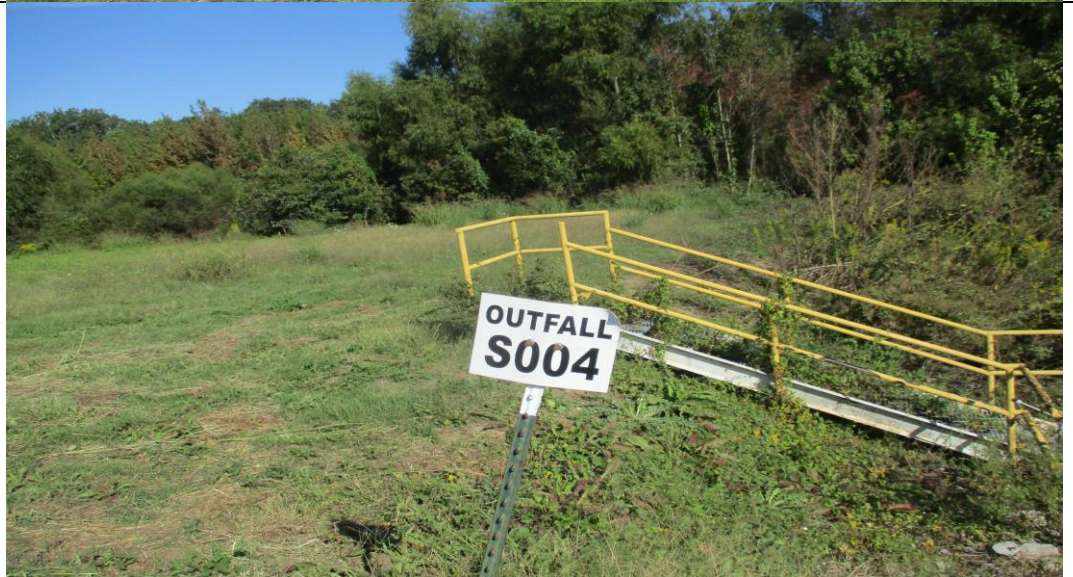
7. The outlet of the overflow pipe structure of the storm-water pond is illustrated in Photograph No. 20. The overflow pipe structure appeared in good condition. Water was flowing at the time of inspection from the outlet pipe. The outlet pipe area exhibited excessive vegetation that should be cleared as part of maintenance activities.

Photograph No. 20  
Overflow discharge structure.

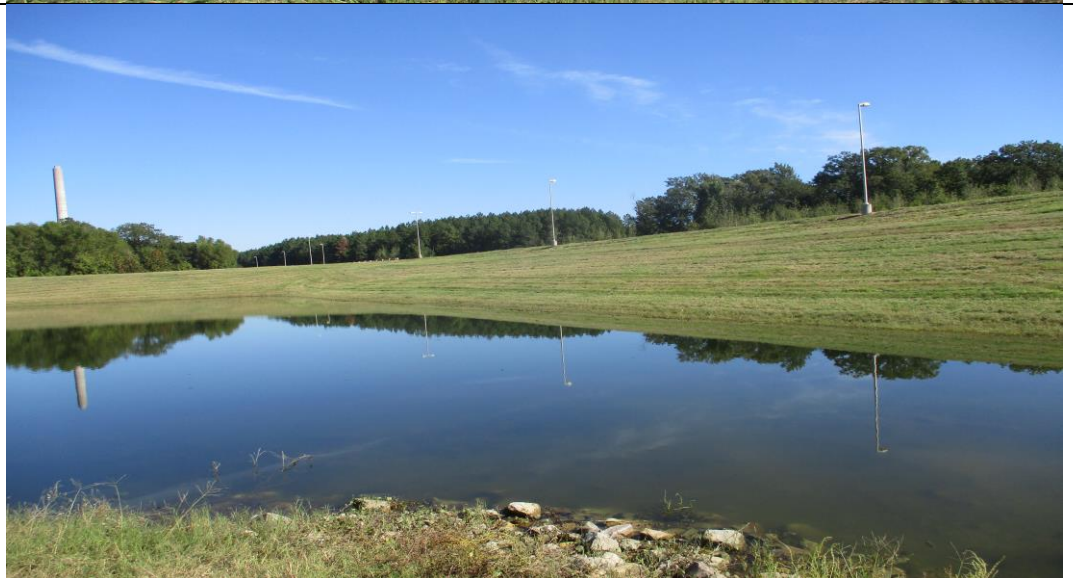
8. Overall, typical interior view of the leachate pond is illustrated in Photograph No. 21. The vegetative cover on the interior slopes (north, south, and east) appeared in good and controlled condition.

Photograph No. 21  
Typical condition of the leachate pond interior.

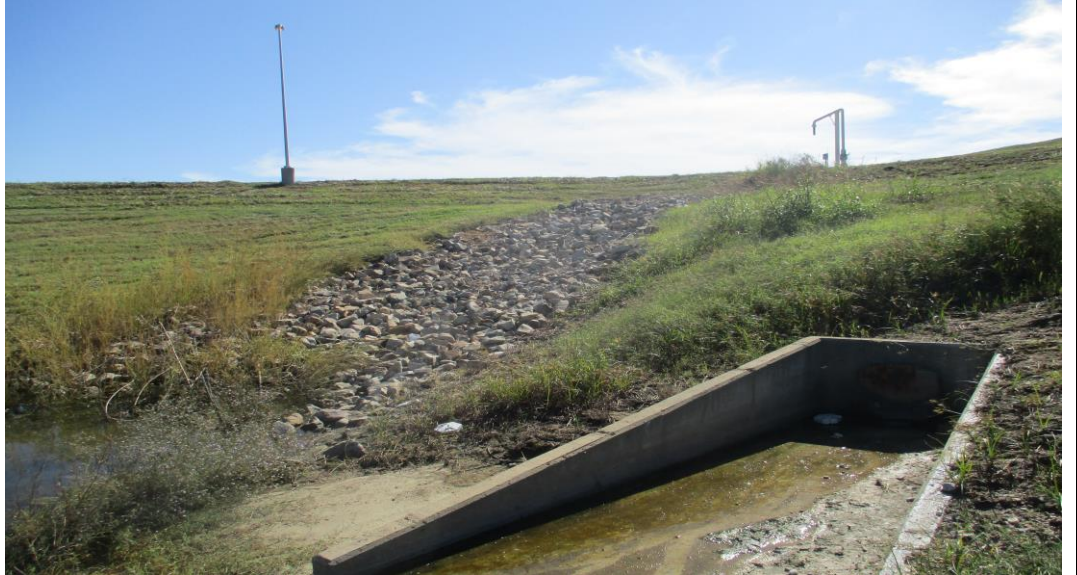
9. There are three leachate drainpipes (southeast, center, and southwest) on the south slope of the leachate pond. Leachate enters the pond from the Cell 1 and Cell 2 leachate collection system through a pipe at the southeast corner and center of the pond south slope (Photographs No.22 and 23). Leachate was draining from the pipe and in functional condition at the time of the inspection.

Photograph No. 22  
Cell 1 leachate pipe outlet.

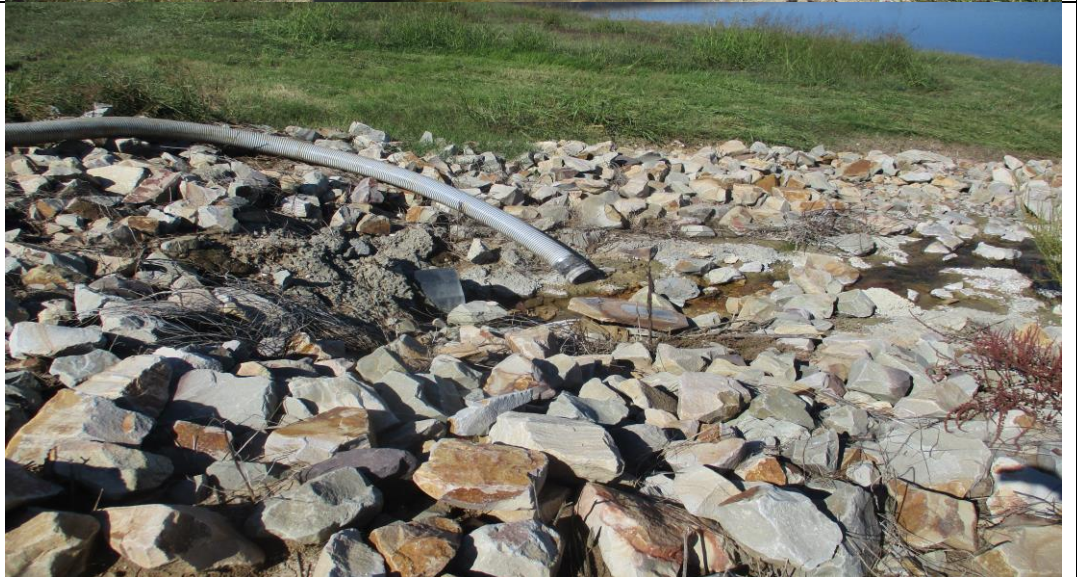
Photograph No. 23  
Cell 2 leachate pipe outlet.

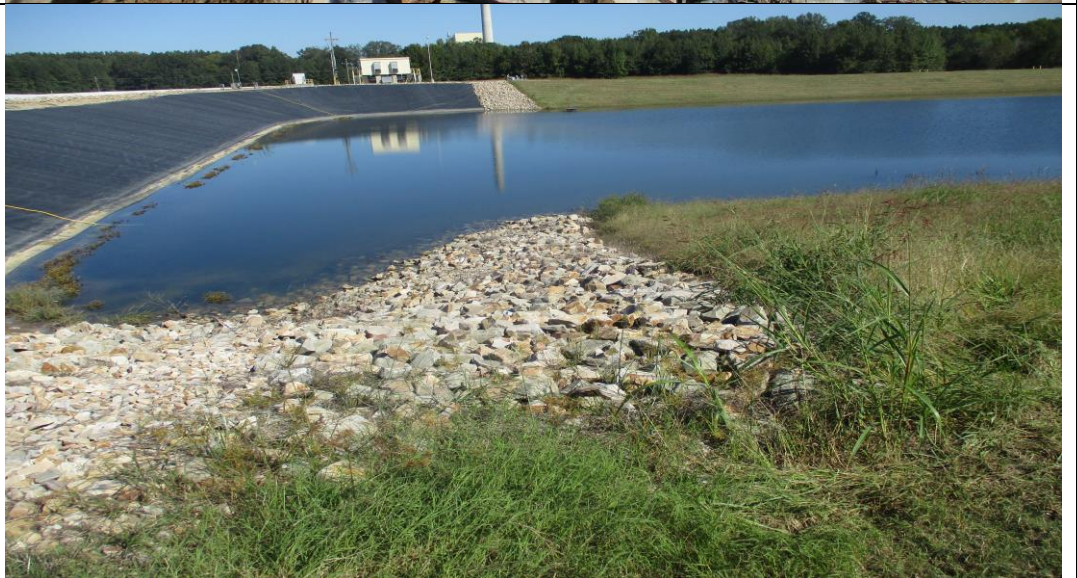
10. Photograph No. 24 illustrates the west slope of the pond. This slope was repaired a few years ago by replacing vegetative cover with a geosynthetic liner. The liner appeared in good condition without any damage or displacement. The slope appeared in good and stable condition without any sign of failure.

Photograph No. 24  
West interior slope.
