2023 Annual Landfill Inspection Report

FGD Stackout Area

**H.W. Pirkey Plant
Southwestern Electric Power Company
Hallsville, Texas**

Document ID: GERS-23-041

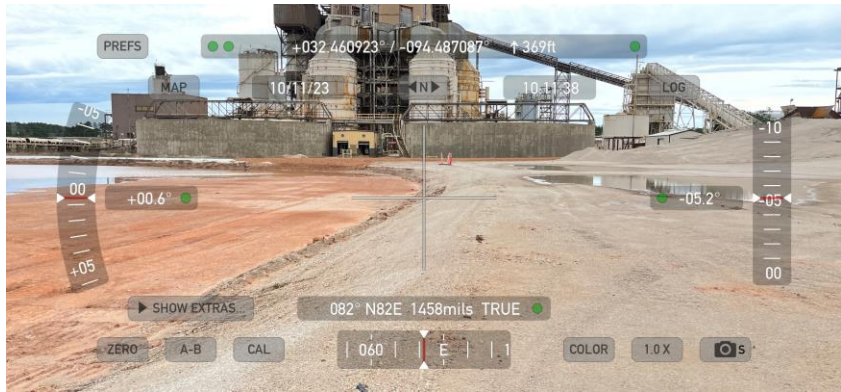
Photo # 1
 View of the eastern perimeter berm, minor ponding was noticed (looking northeast).

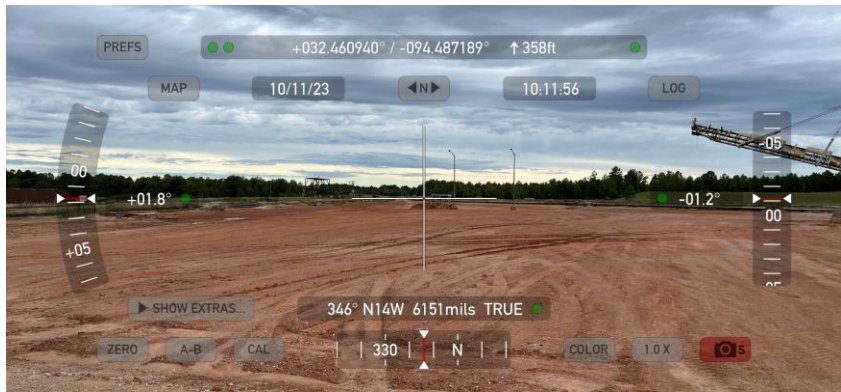
Photo # 2
 View of the FGD Stackout Pad (looking northwest).

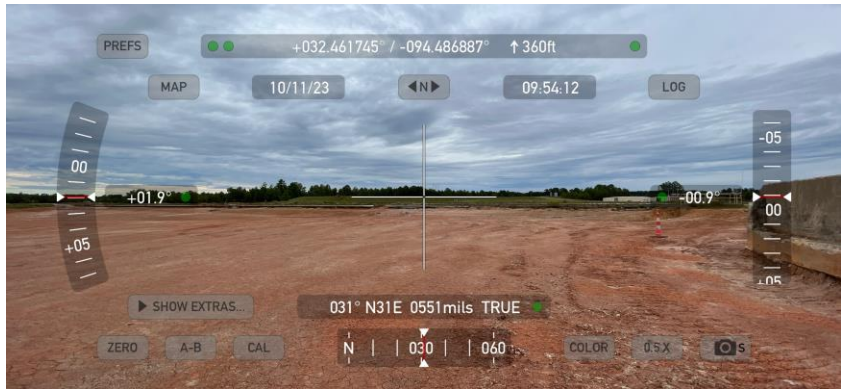
Photo # 3
 View of the FGD Stackout Pad (looking northeast).

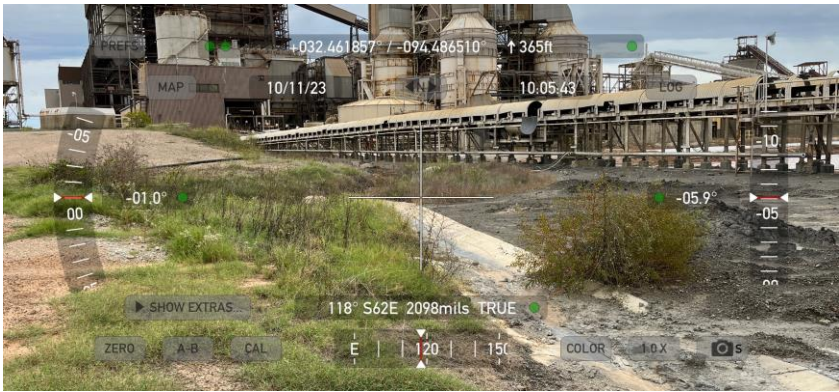
Photo # 4

View of the FGD Stackout area with remnant of Gypsum on the pad (looking southeast).

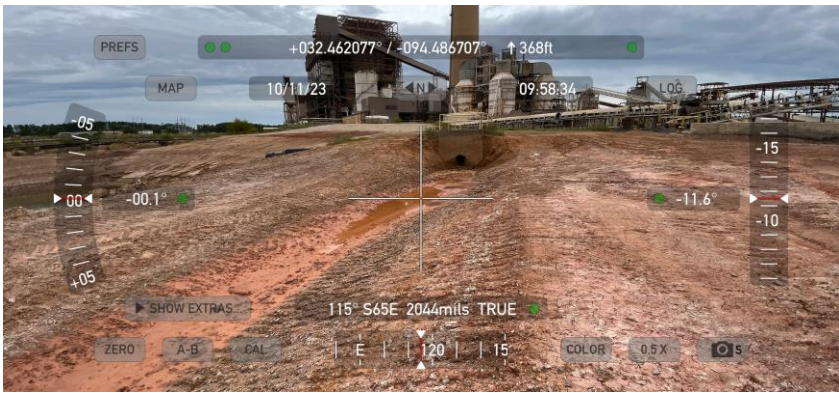
Photo # 5

View of the drainage outlet (north of stackout pad).

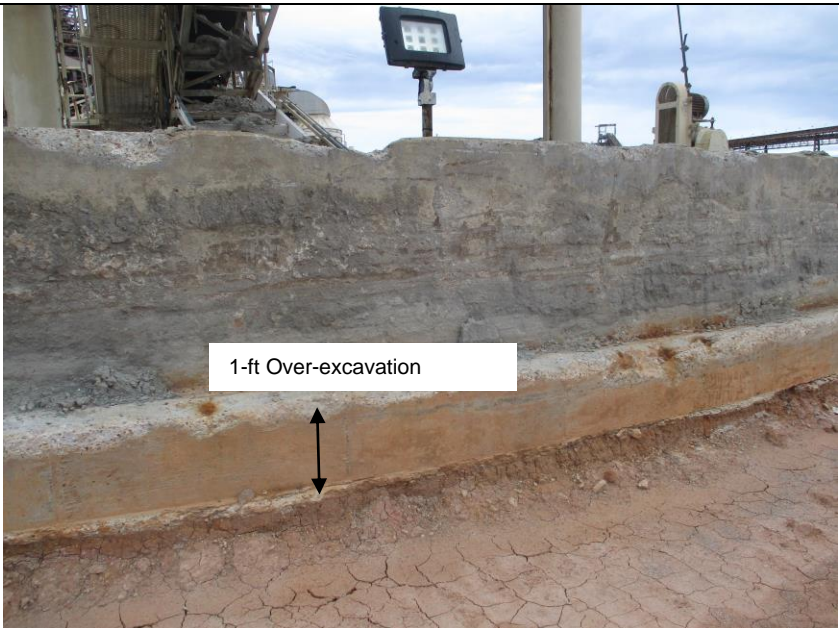
Photo # 6

View of exposed ring beam foundation of radial arm stacker pad after over-excitation of native soil.

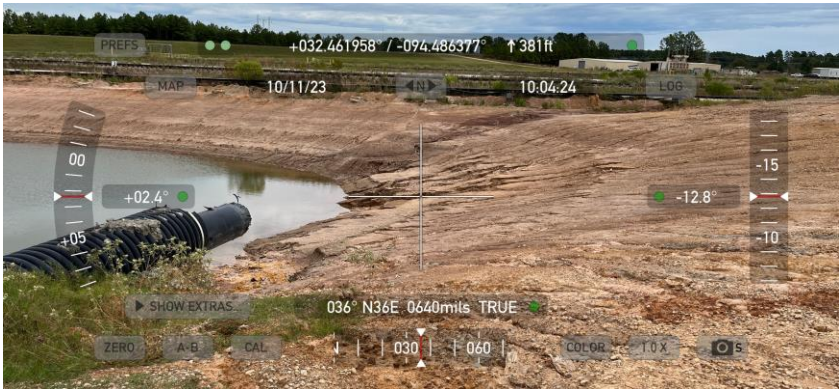
Photo # 7

4. Erosion was observed where the FGD Stackout Pad surface area drains into the Auxiliary Surge Pond. This area should be graded to maintain positive drainage and to prevent excessive erosion.

Observed erosion rills near Auxiliary Surge Pond (looking northeast).

- 1) Continue with the regular maintenance of the area with repair of significant erosion rills that have formed from the stackout pad to the Auxiliary Surge Pond.

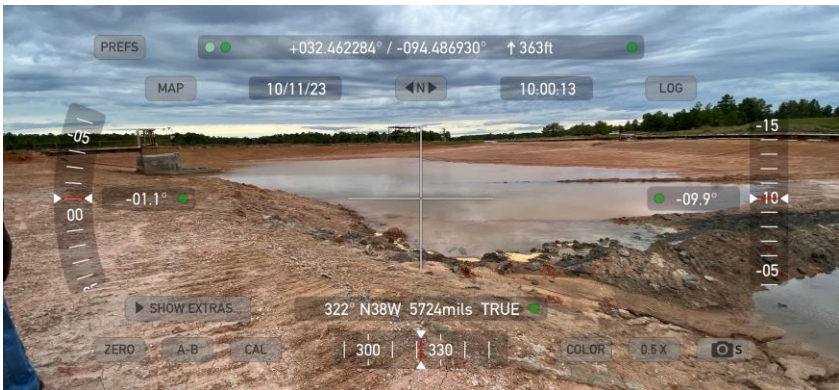
Photo # 8

Observed erosion rills near Surge Pond (looking northwest).

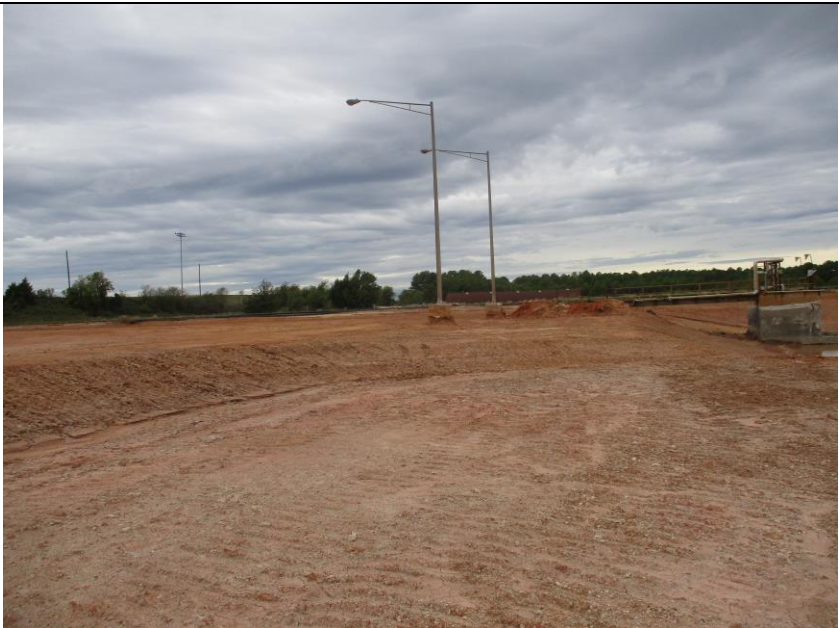
Photo # 9

View of the FGD Stackout Area with a pile of Gypsum on the pad (looking northwest).
