2021 Annual Landfill Inspection Report

Amos FGD Landfill

**John E. Amos Plant
Appalachian Power Company
Putnam County, West Virginia**

Document ID: GERS-21-083

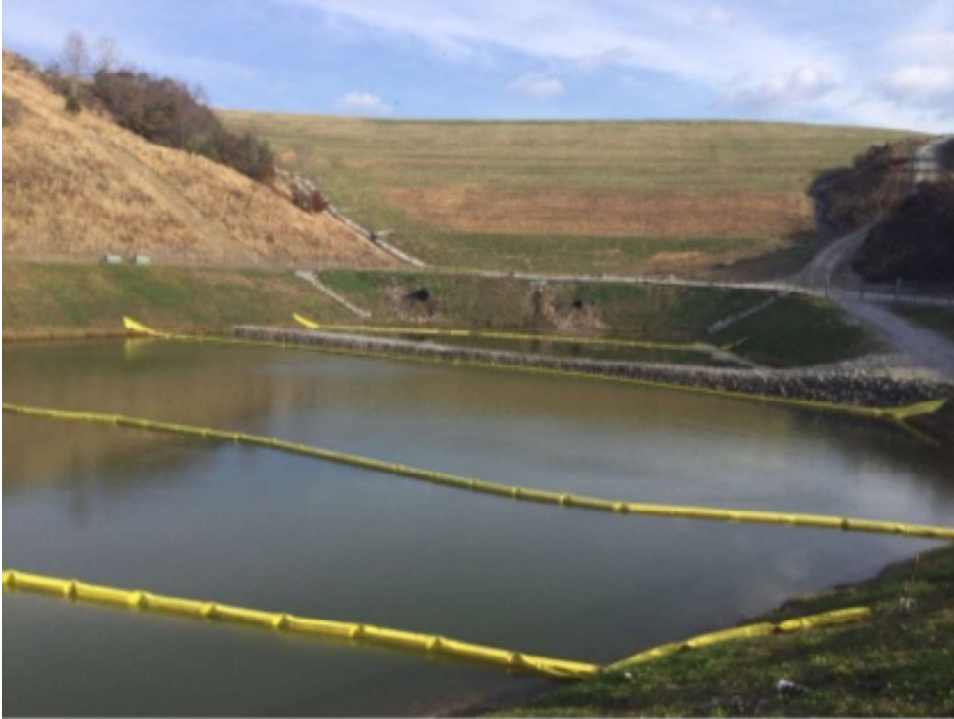
Photo #: 1

Notes: General condition of south valley sediment pond looking northeast

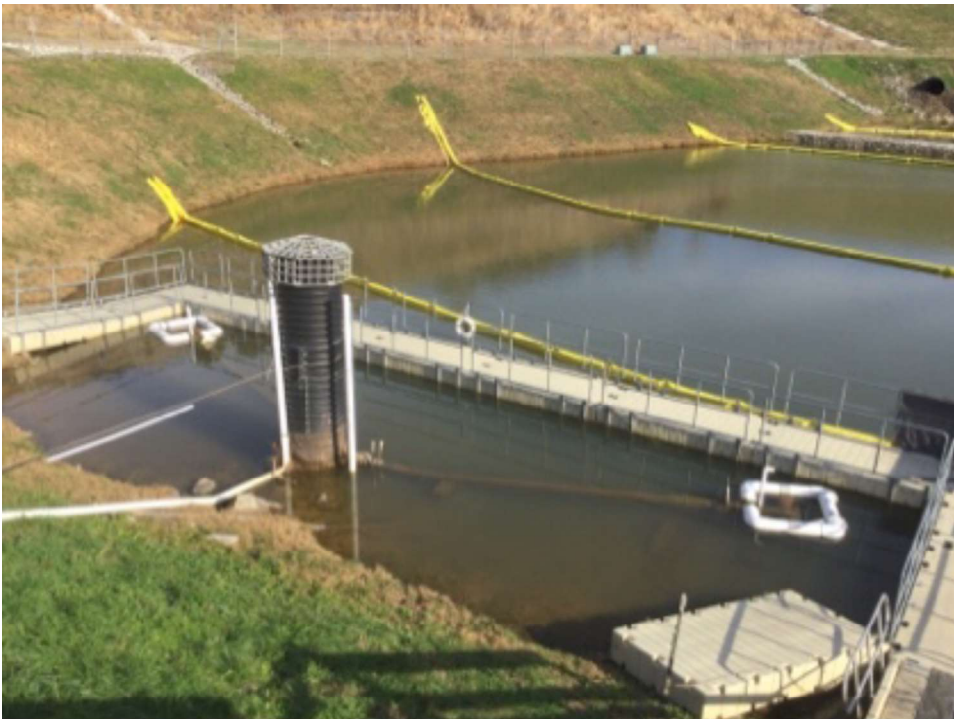
Photo #: 2

11. The small erosion rill noted upstream of the emergency overflow at the South Valley Sediment pond in the 2020 inspection has been repaired with the placement of riprap.
12. The section of the floating platform to access the principal spillway for the South Valley Sediment Pond has a damaged handrail.
13. The Plateau Sediment Collection Pond was in good condition appeared to be functioning as designed.

Notes: General condition of south valley sediment pond discharge structure looking northeast.

- 5) Monitor the floating platform for accessing the skimmers for the principal spillway for the south valley sediment collection pond for additional distress or unsafe conditions for people walking out to the principal spillway.

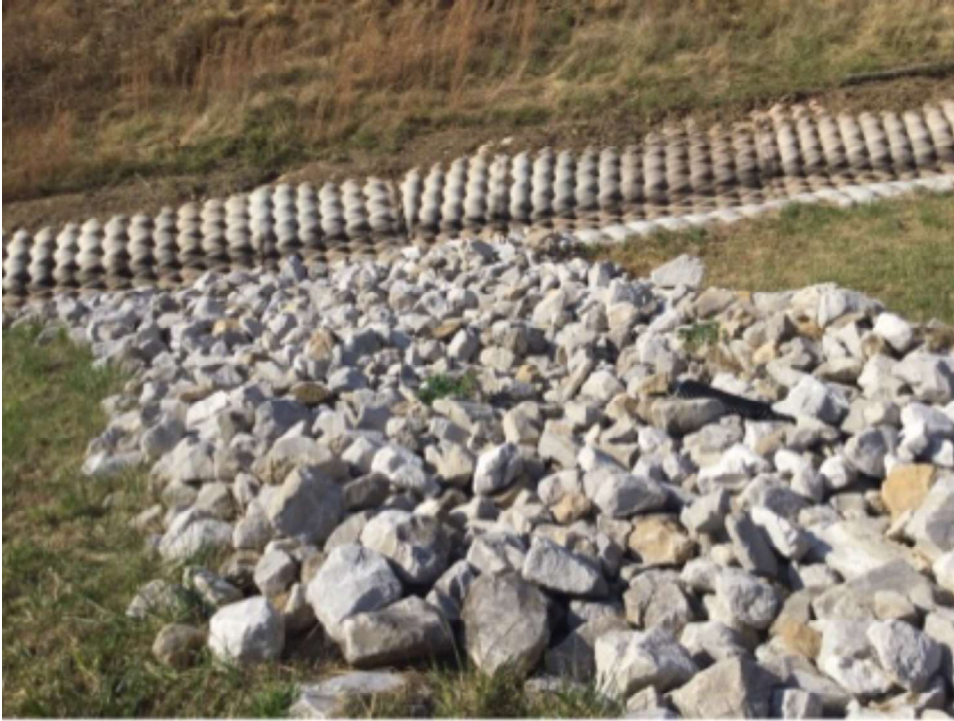
Photo #: 11

Notes: General condition of bench drain to north perimeter channel on final cover.

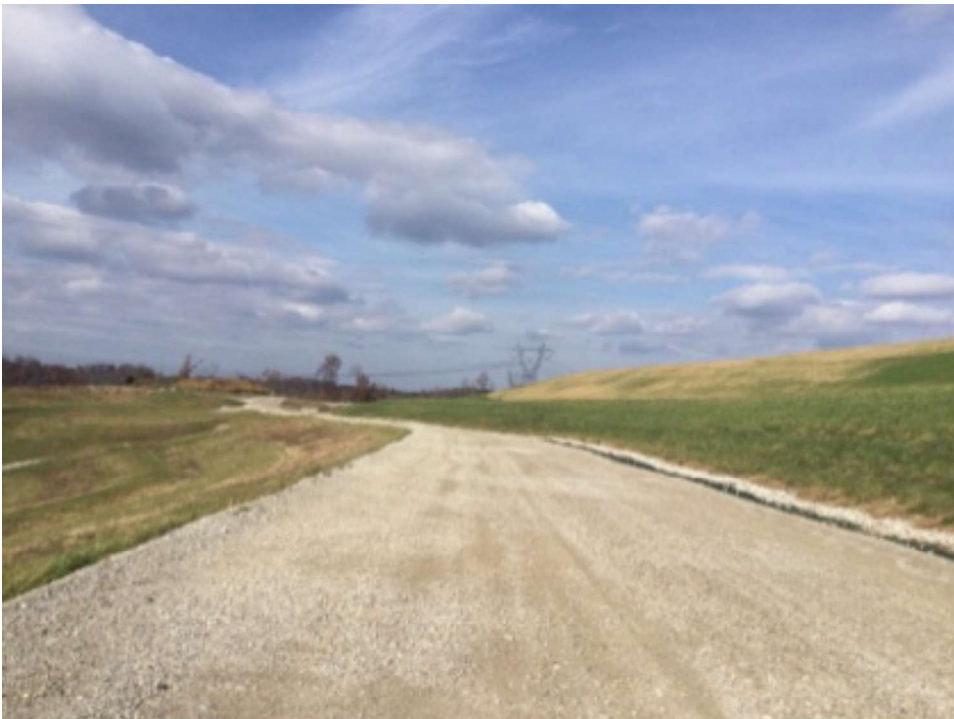
Photo #: 12

Notes: General condition of 930 bench road looking northwest

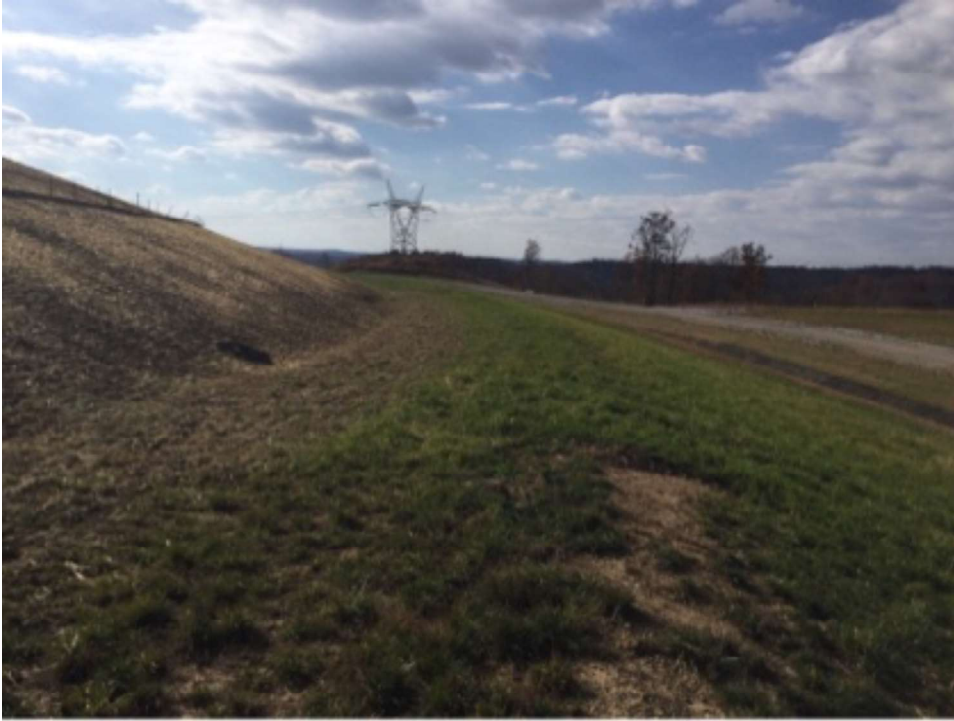
Photo #: 15

Notes: General condition from 950 bench looking south. Final cover and perimeter channel to the right, established temporary cover straight

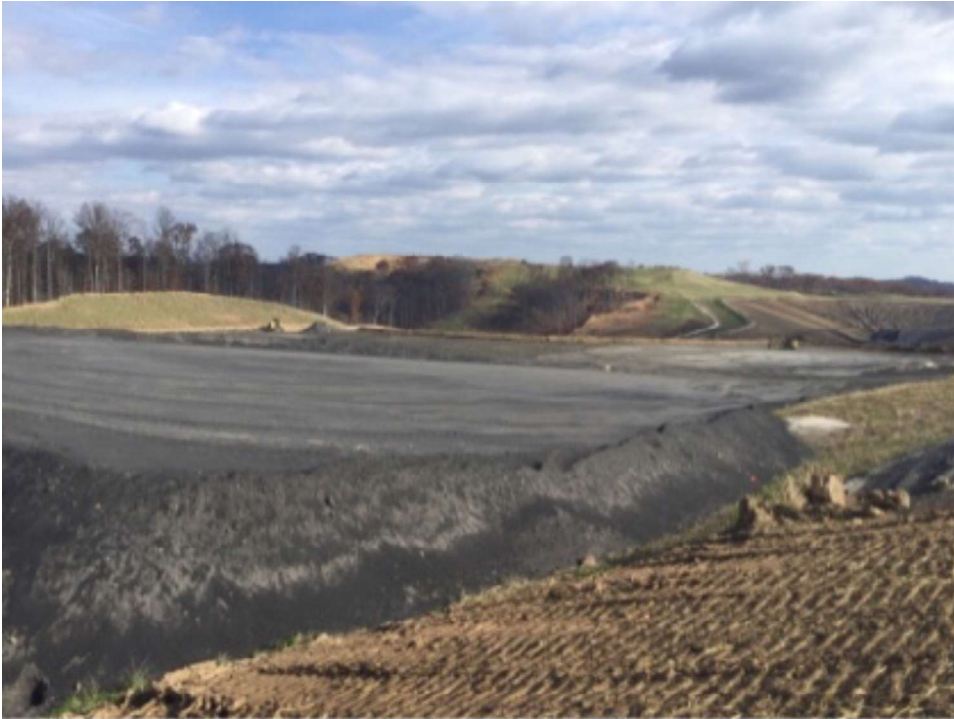
Photo #: 16

Notes: General condition of waste placement in the west side of Sequence 4 looking northeast

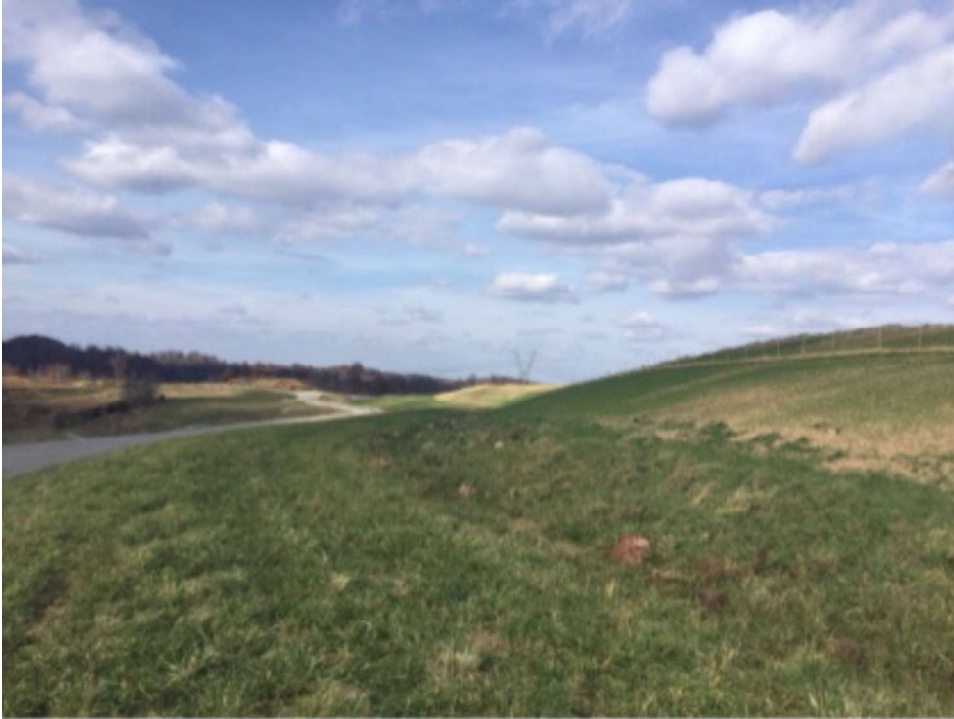
Photo #: 19

Notes: General condition of temporary cover along 950 bench

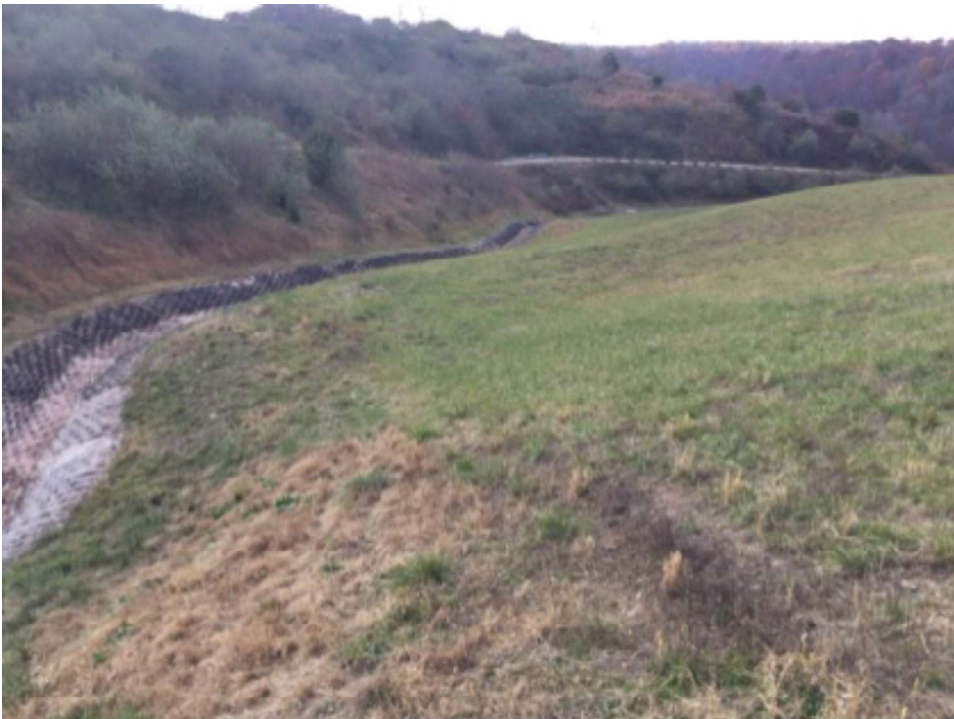
Photo #: 20

Notes: General condition of south perimeter channel looking west from below 930 bench road

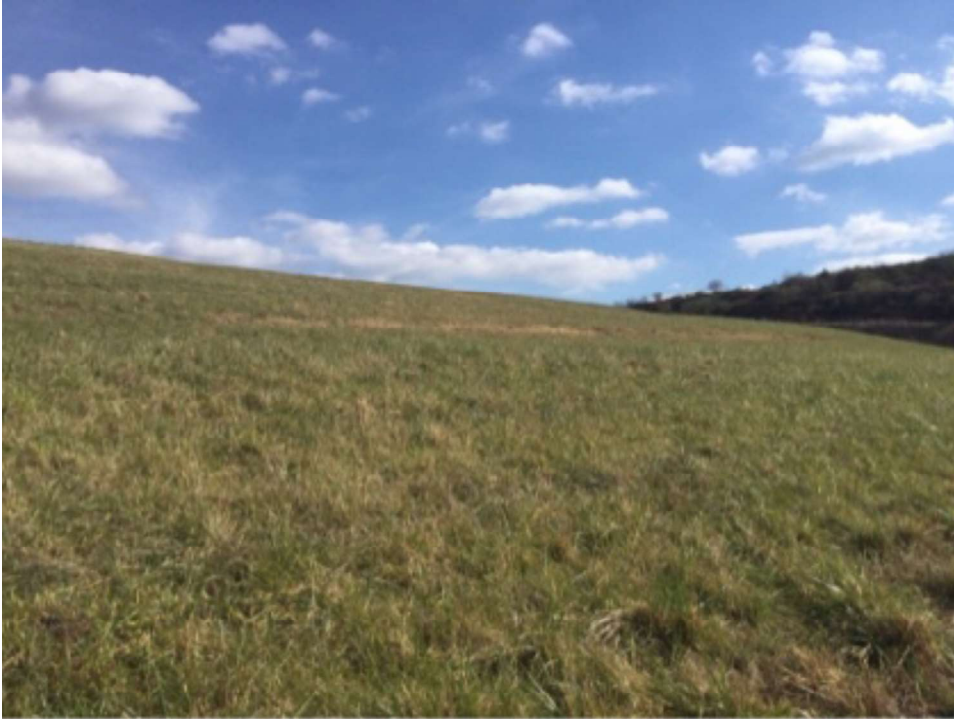
Photo #: 21

Notes: General condition of final cover looking east

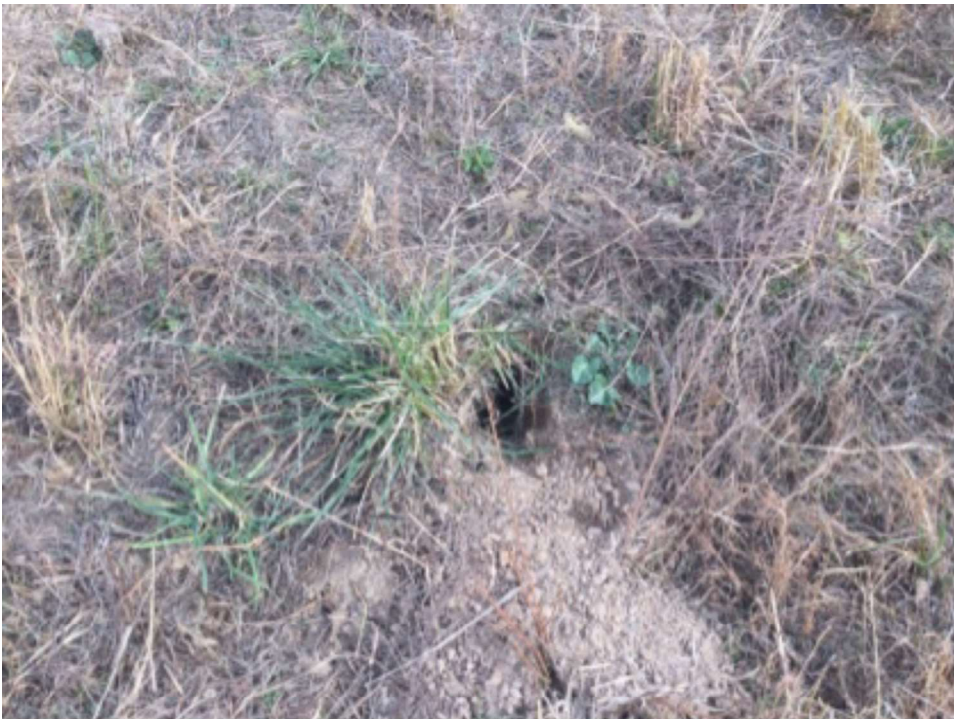
Photo #: 22

5. The final cover construction on the southwest slope of the South Valley is complete and dense grass cover vegetation is established. There were no signs of erosion or instabilities observed.
6. The final cover soil drain pipe outlets exposed in the fabric-formed concrete ditch were in good condition with no signs of obstructions or problems.
7. An active animal borrow was noted in the final cover along the south west side. The animal borrow was filled the day of the inspection.

Notes: Active animal borrow in final cover above 4th bench near south perimeter.

- 3) Continue routine mowing of final and temporary covers to ensure proper vegetative growth.
- 4) Address issues like animal burrows and erosion rills as they are found.

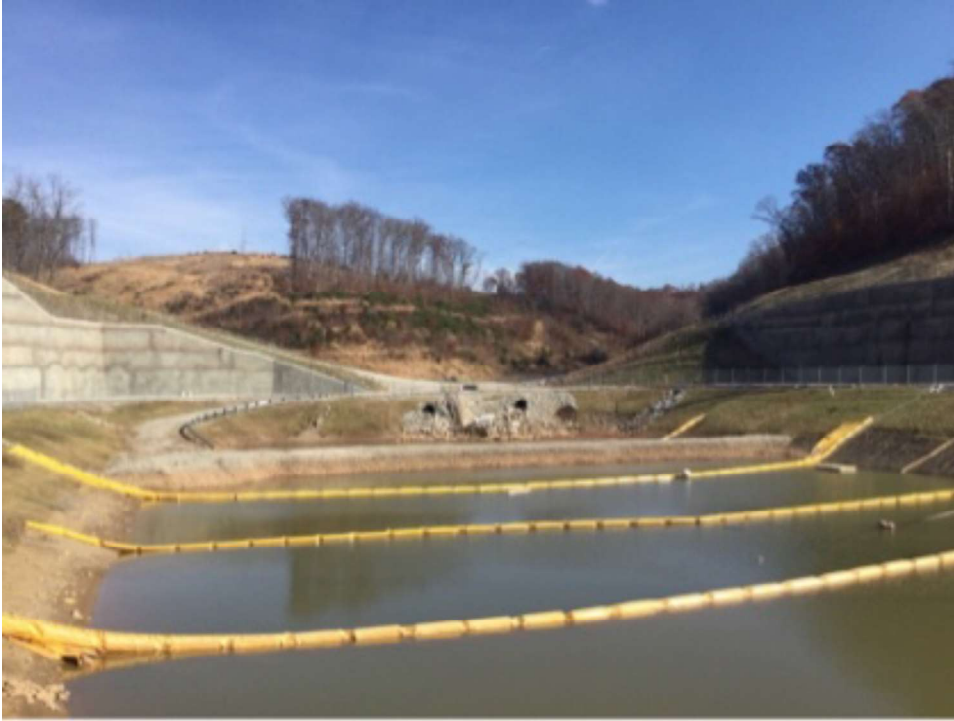
Photo #: 29

Notes: General condition of North Valley Sedimentation Pond looking east.

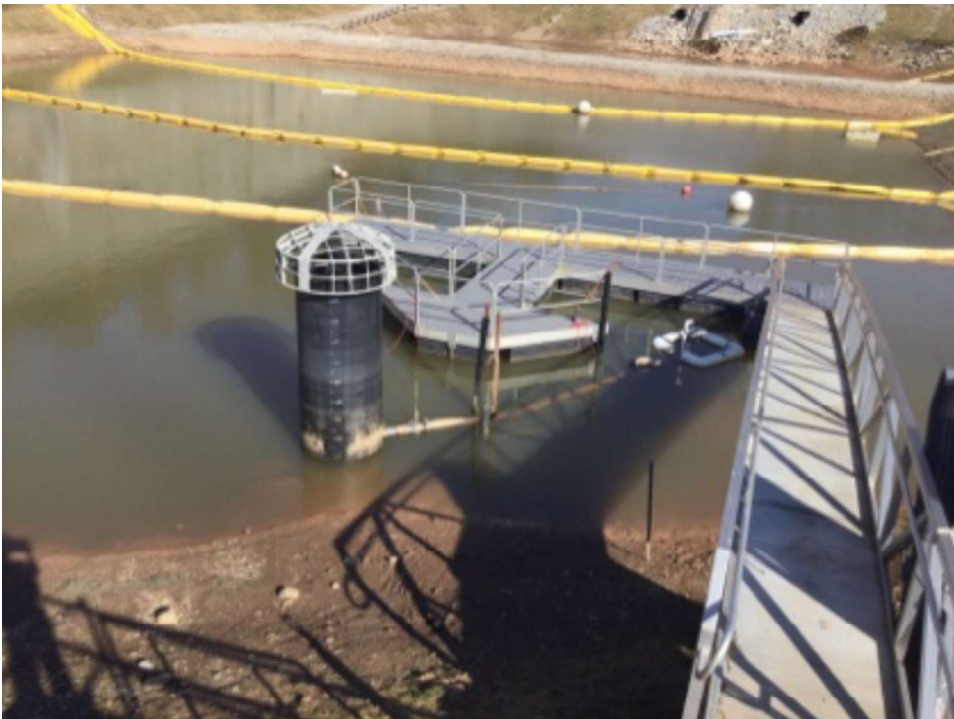
Photo #: 30

Notes: General condition of outlet structure and walkway for North Valley Sediment Pond.

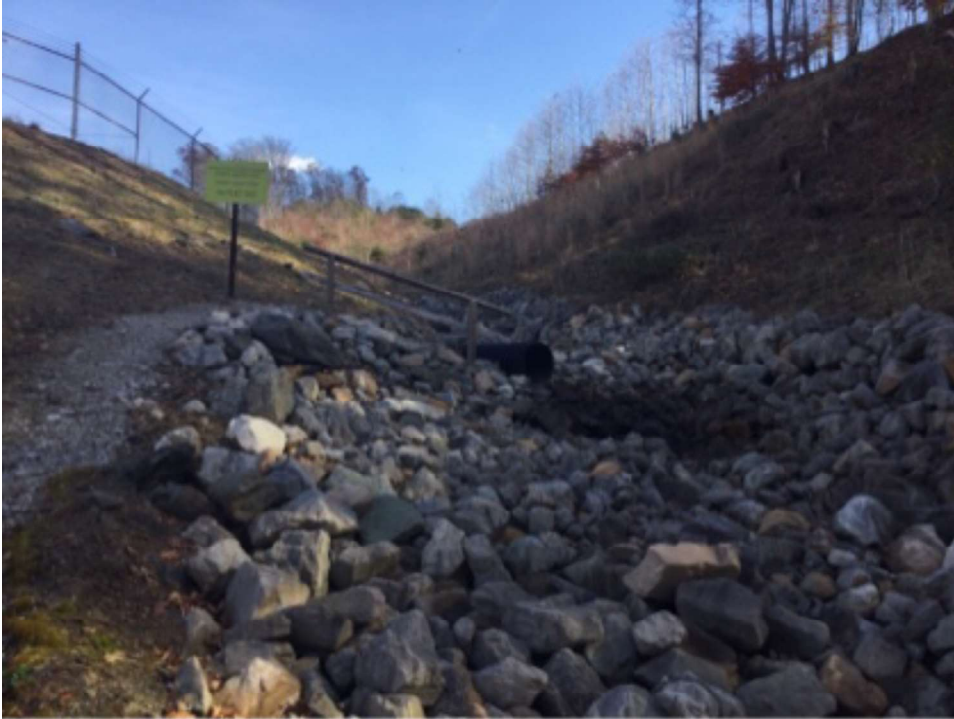
Photo #: 33

Notes: General condition of North Valley Sedimentation Pond discharge pipe.

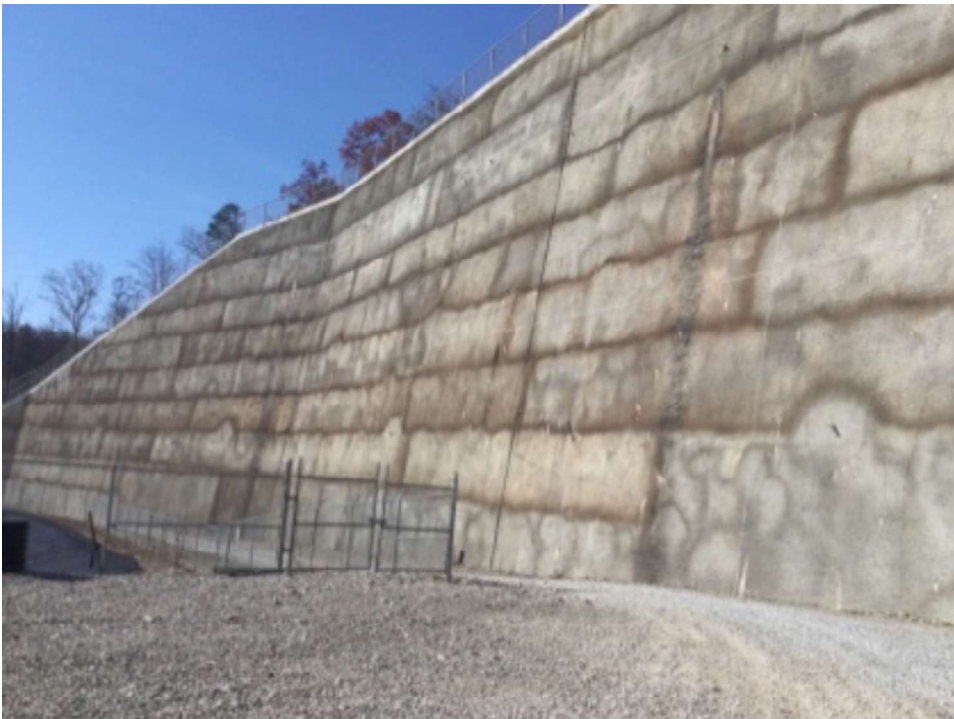
Photo #: 34

14. Based on ground review of the both soil nail walls in the North Valley both appeared to be in good condition with no visible displacement, spalling or damage observed.

Notes: General condition of North soil nail wall in North Valley.
