**2021 DAM AND DIKE INSPECTION REPORT
BOTTOM ASH COMPLEX
(Facility ID #05307)**

GERS-21-019

**APPALACHIAN POWER COMPANY
MOUNTAINEER PLANT
NEW HAVEN, WEST VIRGINIA**

DAM & DIKE INSPECTION REPORT
Mountaineer Bottom Ash Complex
(Facility ID #05307)

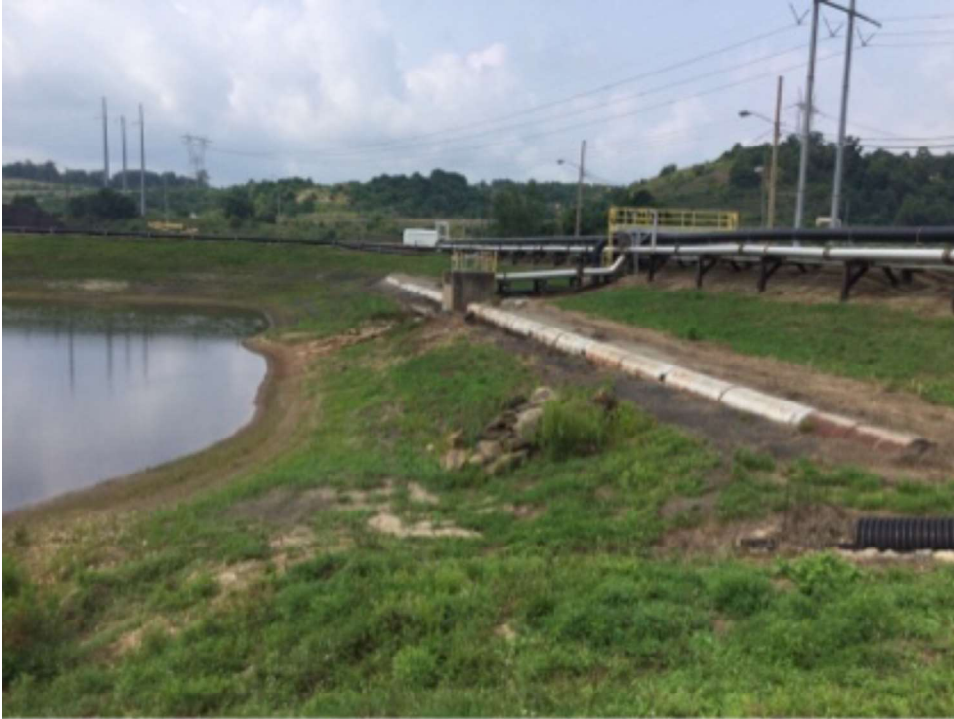
Photo #: 29

Notes: General condition of interior slope of North Dike in East BAP looking west. Discharge structure visible.

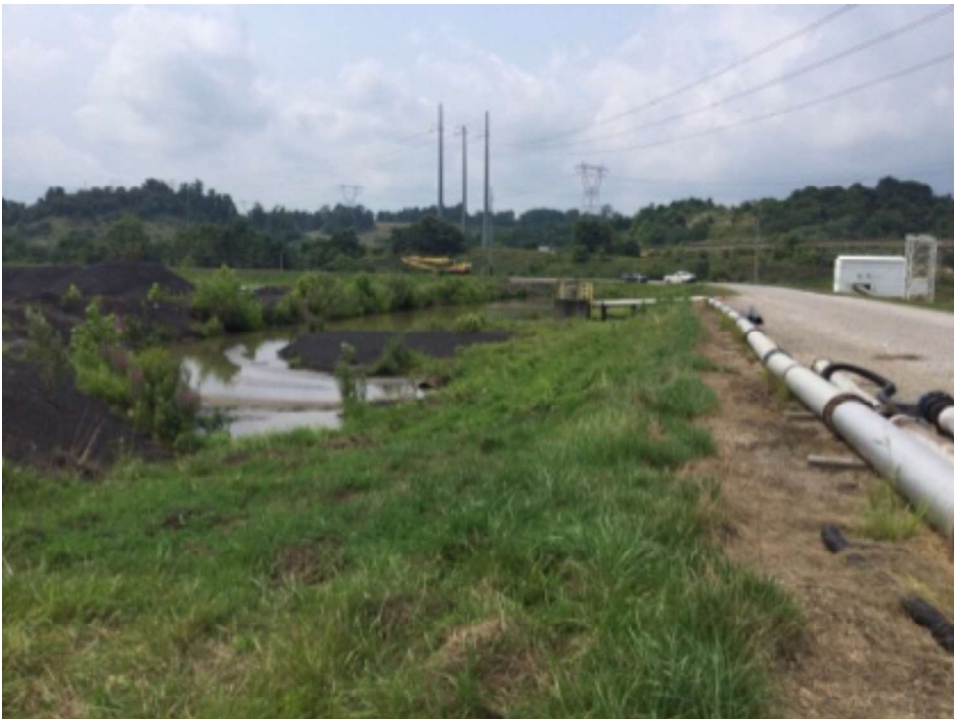
Photo #: 30

Notes: General condition of interior slope and crest of the North Dike at West BAP

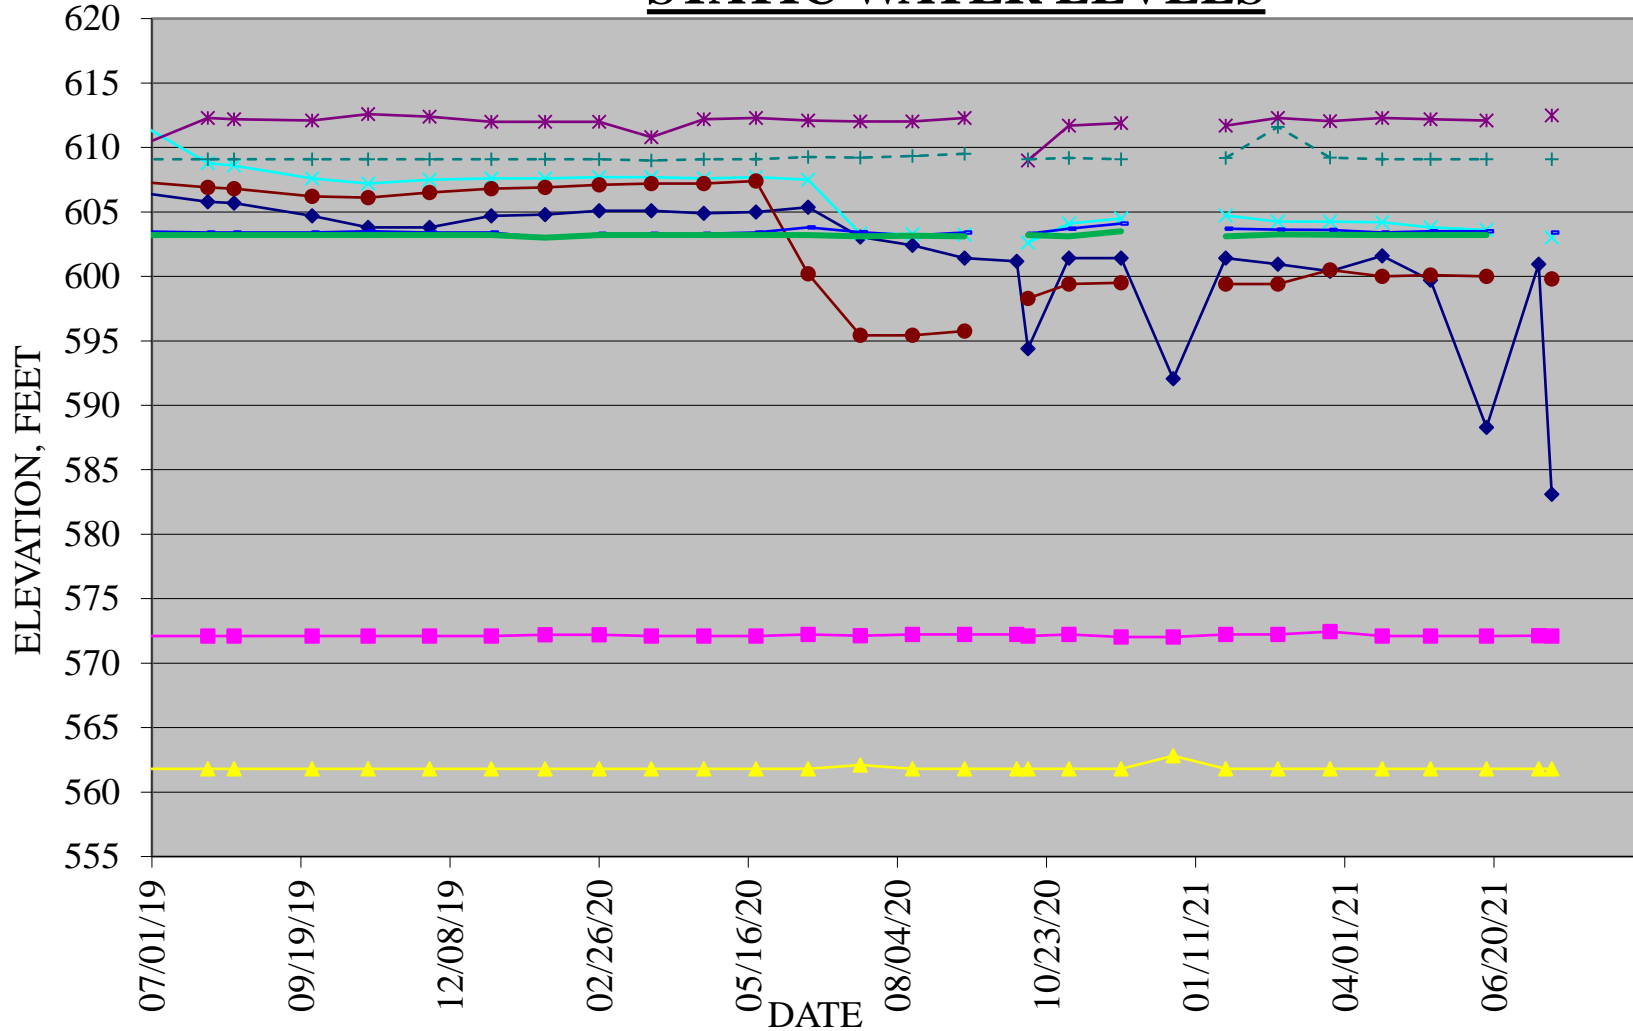
FIGURE 5 - MOUNTAINEER BOTTOM ASH COMPLEX
STATIC WATER LEVELS

Piezometers PZ-09-04 and PZ-09-05 indicate no changes in the static water levels from 2018 to present. This is probably due to the piezometers being installed above the static water table in the area. Based on well installation logs, piezometers PZ-09-04 and PZ-09-05 were installed and developed as dry wells. Even after initial well development,

the water injected into the wells dissipated and the piezometer have remained dry. Piezometer PZ-09-03, which is located at the crest of EBAP has indicated fluctuations in the water level over the years. This fluctuation is consistent with the water level changes in the EBAP and is a reflection of the phreatic surface in the embankment materials. Even though the EBAP is out of service, the plant will periodically send process waters to the EBAP affecting the water levels.

(iii) Piezometer PZ-09-03 shall be flushed and continue to be used in monitoring and the data be reviewed for further corrective action.
