# **2022 Annual Landfill Inspection Report**

**Northeastern Power Plant  
Public Service Company of Oklahoma  
Oologah, OK**

**September 2022**

**Document ID: GERS-22-020**

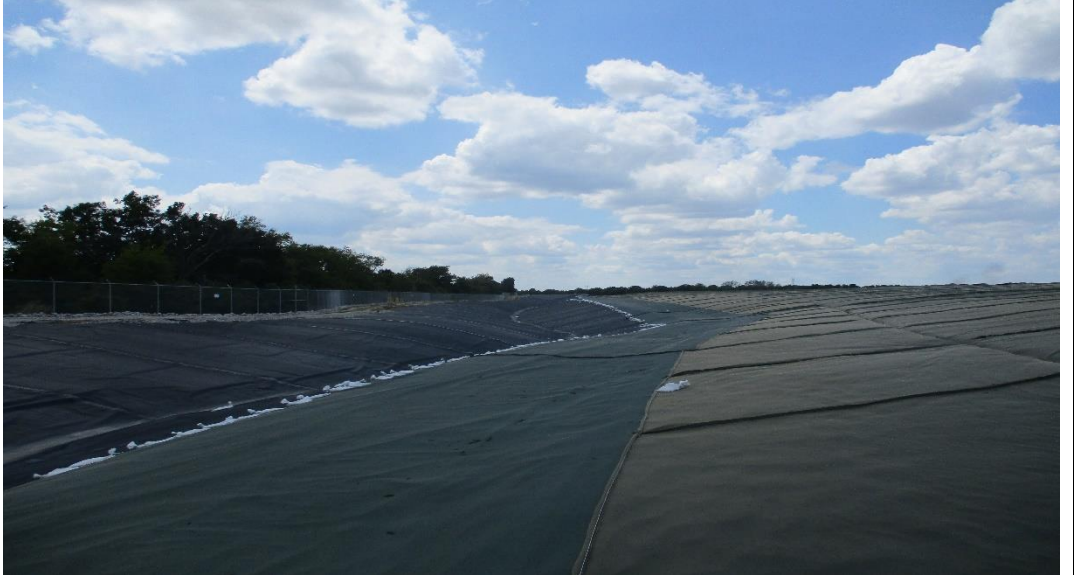
1. Photograph No. 1 illustrates Cell 2 surface of the inactive disposal areas covered with temporary geomembrane (rainflap) and wind defender. The wind defender was repaired due to the tears at the seams (Photograph No. 2). The overall condition of Cell 2 area appeared good.
2. Cell 3 area is illustrated in Photograph No. 3. This area is also covered with the rainflap and wind defender. The containment berm and the geomembrane lined perimeter ditch are illustrated in Photograph No. 4. There were no observations of erosion or other unsatisfactory conditions of the Cell 3 areas. The perimeter berm and ditch are

<p>Photograph No. 1 Cell 2 area with rainflap and wind defender (looking southwest).</p>

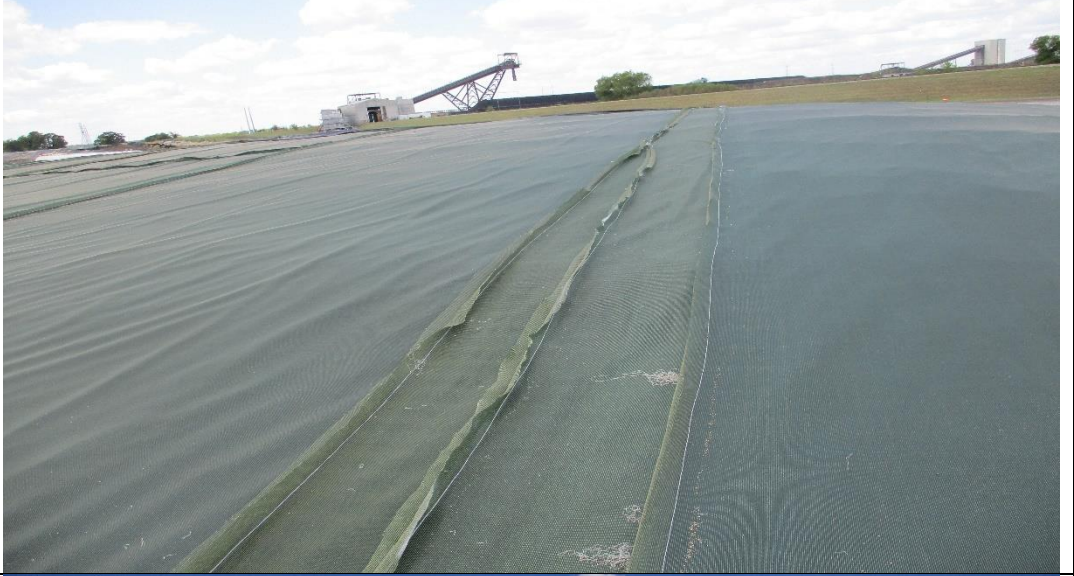
A wide-angle photograph of a landfill cell covered in dark green geomembrane. A long, narrow strip of white material, likely a wind defender or rainflap, runs across the middle of the cell. The sky is blue with scattered white clouds. A chain-link fence and trees are visible in the background.
<p>Photograph No. 2 Cell 2 area wind defender repair work.</p>

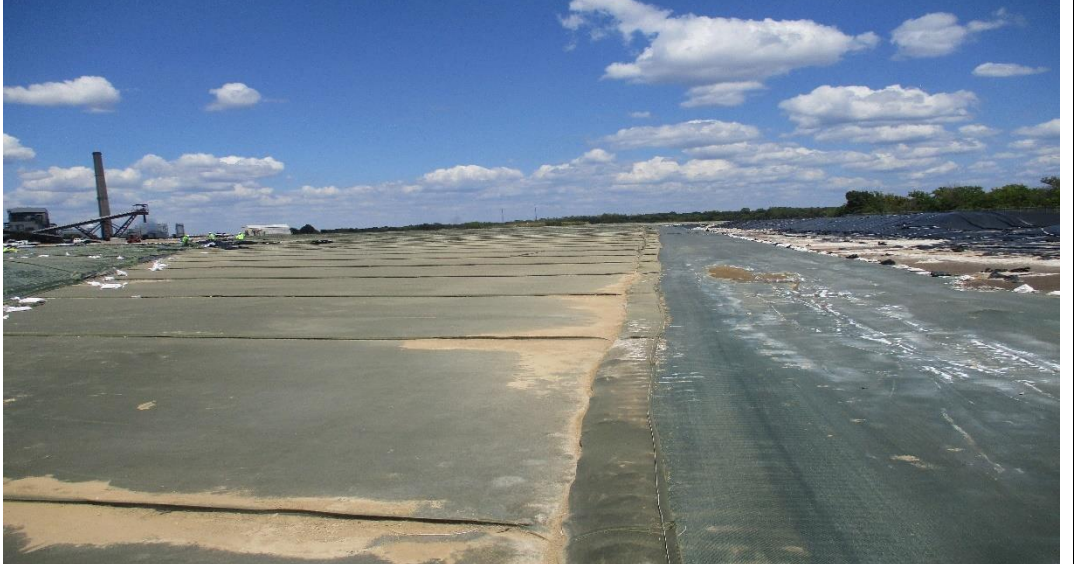
A close-up photograph of the geomembrane surface. A section of the dark green material is being repaired or replaced, showing a lighter, textured area. In the background, industrial structures and a conveyor belt are visible under a cloudy sky.
<p>Photograph No. 3 Cell 3 rainflap and wind defender installed.</p>

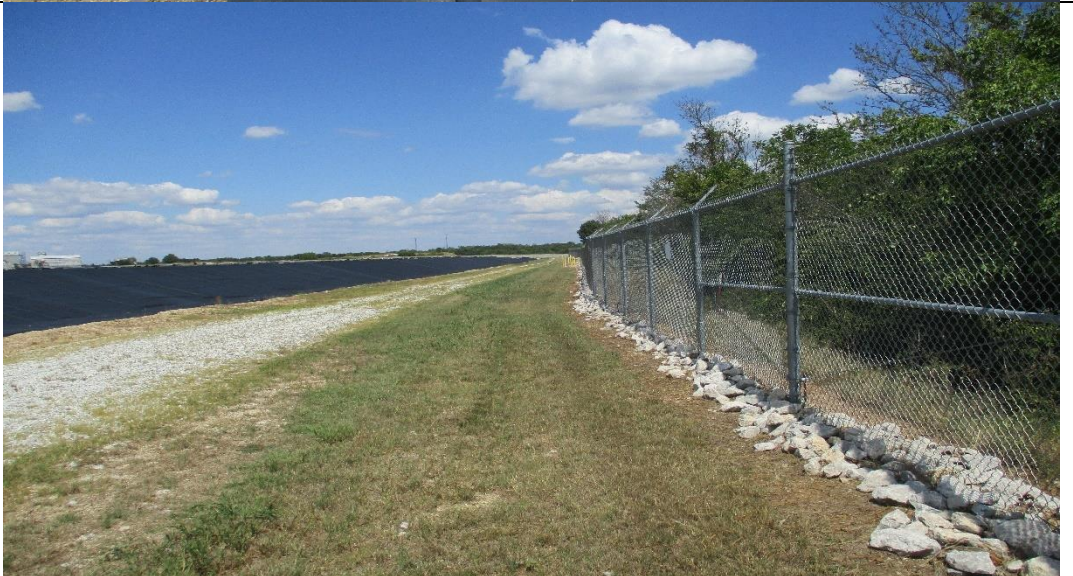
3. The exterior south slope and access perimeter road (Photograph Nos. 5 and 6) appeared in good and stable condition. The slope adjacent to the river is very steep and observation of the slope from the chain link fence indicated the slope was heavily vegetated with mature trees and small bushes. The access road appeared in good condition without any signs of settlement, misalignment, or excessive erosion.

<p>Photograph No. 4 Cell 3 and perimeter berm (looking northeast).</p>	  A wide-angle photograph showing a long, narrow landfill cell covered in black plastic liner. The cell is bordered by a gravel berm on the left. The background shows a clear blue sky with scattered white clouds and some distant trees.
<p>Photograph No. 5 Access road adjacent Cell 3 (looking northeast).</p>

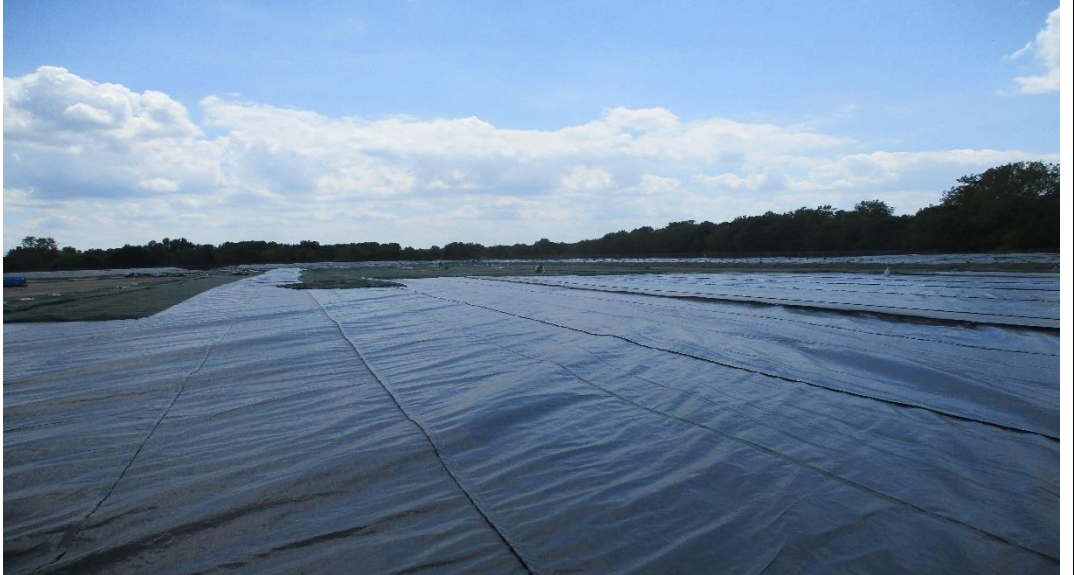
4. At the time of inspection, installation of rainflap and wind defender was being performed in the landfill area (Cell 4). Photograph No. 7 depicts the installation work in progress. The access road adjacent to Cell 4 is illustrated in Photograph No. 8. The road was in good condition with no sign of misalignment, settlement, or excessive erosion. The perimeter ditch was functioning as designed and the liner was intact and in good condition. The exterior slope adjacent to the Cell 4 appeared in good and stable condition.

<p>Photograph No. 7 Cell 4 area rainflap and wind defender installation.</p>

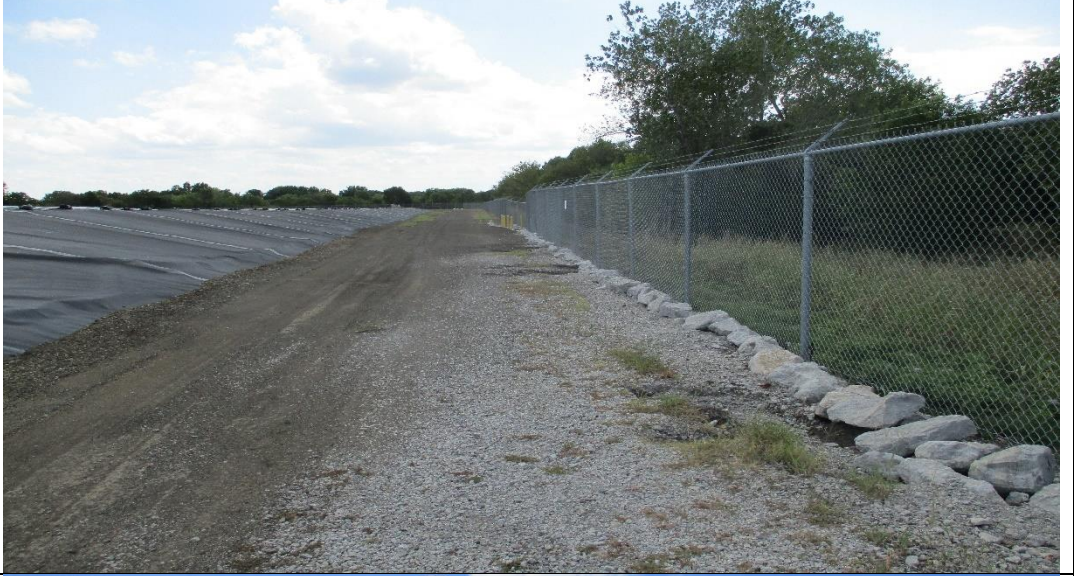
A wide-angle photograph showing a large area of a landfill cell covered with a dark, heavy-duty plastic liner. The liner is laid out in long, parallel strips, creating a grid-like pattern. The sky is blue with scattered white clouds. In the background, there is a line of trees.
<p>Photograph No. 8 Cell 4 berm and access road.</p>

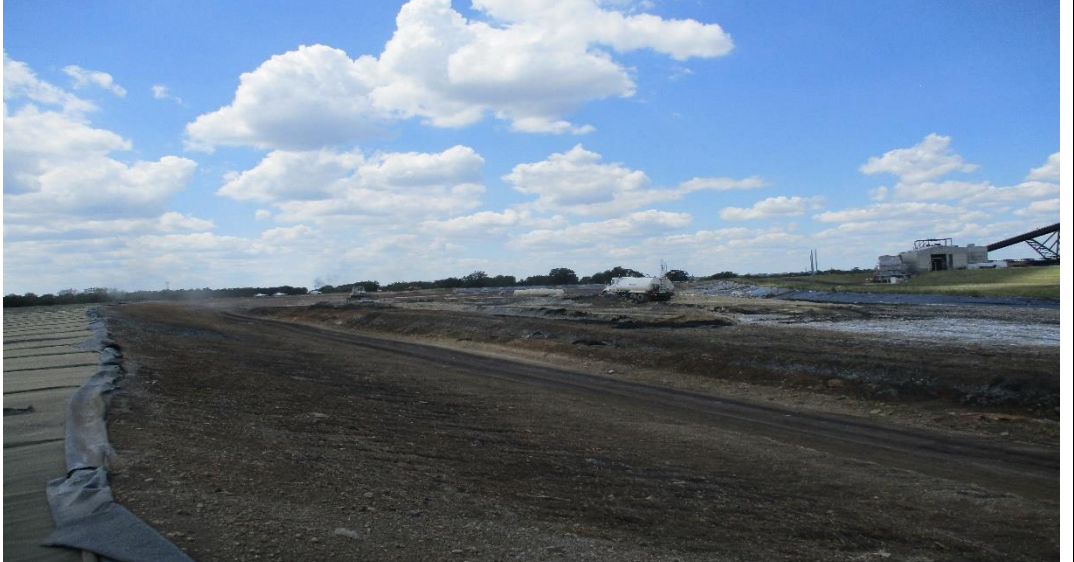
5. Photograph No. 9 illustrate typical condition of Cell 1 which is currently the active landfill disposal area. The surface appeared graded and free of ponding water. Temporary grades are maintained to direct runoff to the perimeter ditch.
6. Cell 1 area is located adjacent to Cell 2 and the interim grades are slightly at a lower level (Photograph No. 10). There was no erosion, minor ponding of water with no instability noticed throughout the area.

A photograph of a gravel access road running alongside a landfill cell. The road is bordered by a chain-link fence on the right side, which is supported by a concrete or stone berm. The landfill cell is visible on the left side of the road. The sky is blue with white clouds.
<p>Photograph No. 9 Cell 1 surface graded (looking northwest).</p>

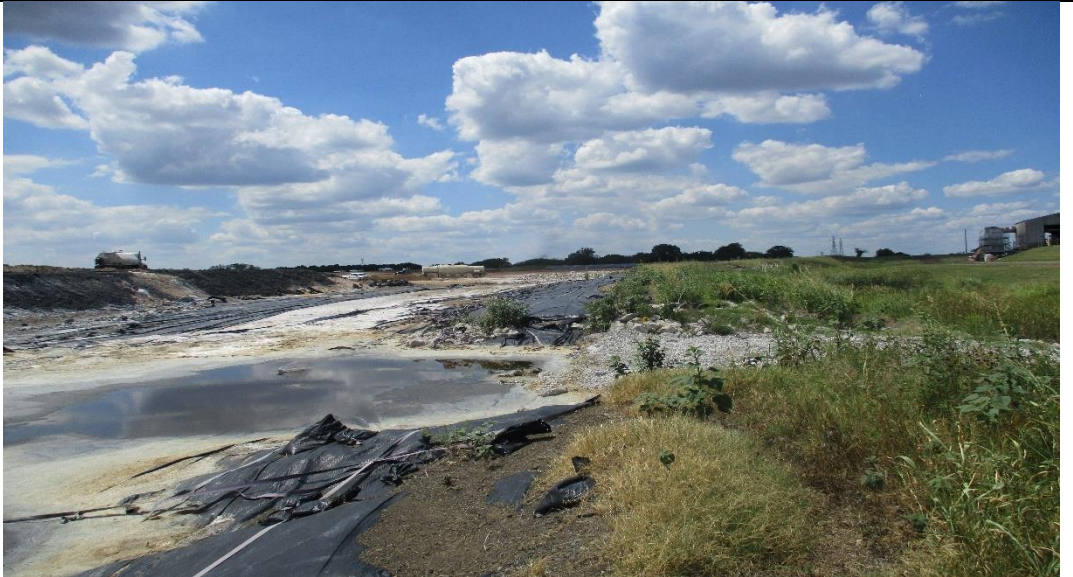
Photograph No. 10  
Cell 1 surface graded  
(looking west).

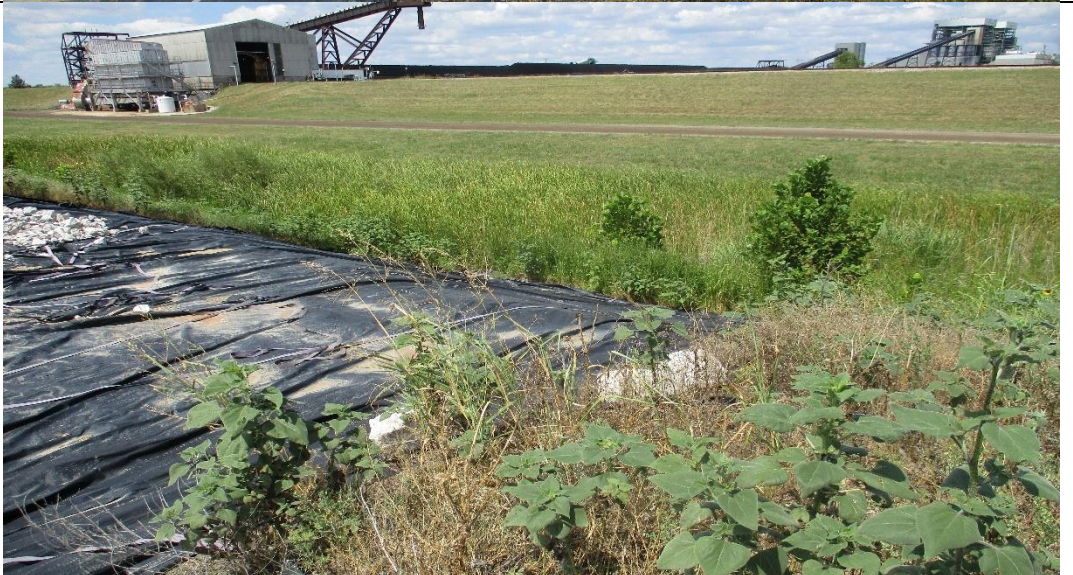
7. Overall, the perimeter ditches were in good condition and functioning as designed. The ditches are currently lined with geomembrane. There were some local areas of very shallow ponding due to either minor sediment or small wrinkles in the geomembrane. The north ditch adjacent to Cell 1 landfill area (Photograph No. 11) exhibited excessive vegetation but appeared to have positive water flow toward the pipe culvert.
8. The north and south perimeter ditches at the eastern, downstream end of the landfill consists of pipe box culverts (Photographs Nos. 12 and 13). These pipe box culverts

Photograph No. 11  
Cell 1 area runoff  
perimeter water ditch  
(looking northwest).

- 1) Clear excessive vegetation from the exterior slope and the north side ditch.
- 2) The subgrade of the south ditch at the box culvert apron should be backfilled to match the slope and/or extend the geomembrane liner over to the apron.

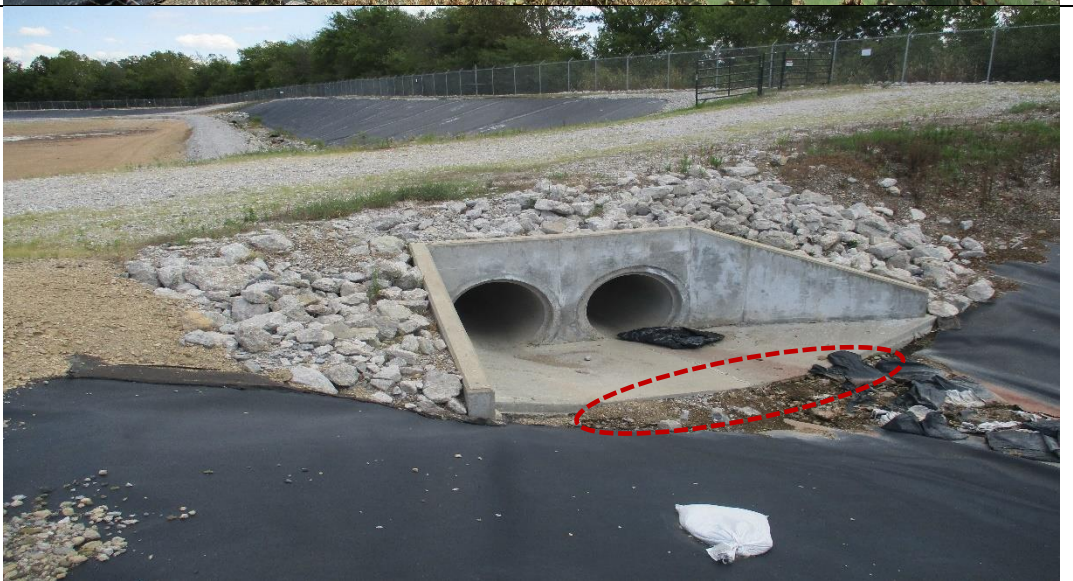
were clear of any debris and indicated no obstruction to flow. The south box culvert pipes (Photograph No. 12) indicated slightly lower level in the ditch compared to the concrete apron slab of the box culvert.

- 1) In general, the landfill is functioning as intended. All areas of the facility are maintained and in good condition.
- 2) The Plant is performing regular maintenance and inspections as required.
- 3) Installation of the temporary geomembrane (rainflap) and wind defender in the landfill areas (Cell 2, 3, and 4) is complete in order to prevent infiltration for better management of the leachate generation.
- 4) Repair work recommended in the 2021 inspection report of the leachate pond dikes was completed.
- 5) The north side drainage ditch at the east end have excessive vegetation.
- 6) The south ditch subgrade at the box culvert apron location (Photograph No. 12) should be at or higher than apron elevation.

Photograph No. 12  
South side perimeter  
runoff ditch and pipe  
culvert inlet.

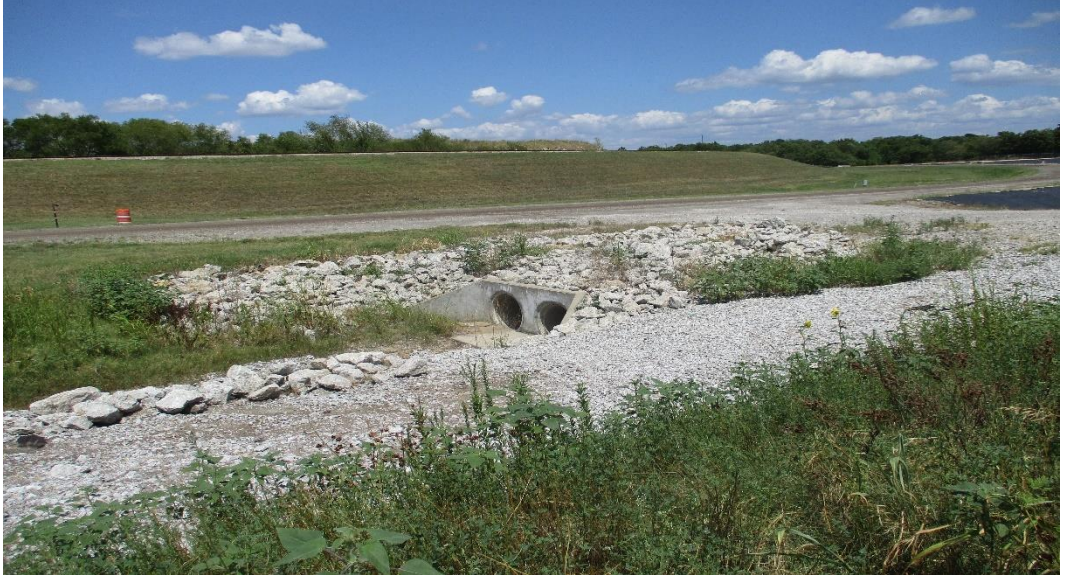
<p>Photograph No. 13 North side perimeter runoff ditch and pipe culvert inlet.</p>

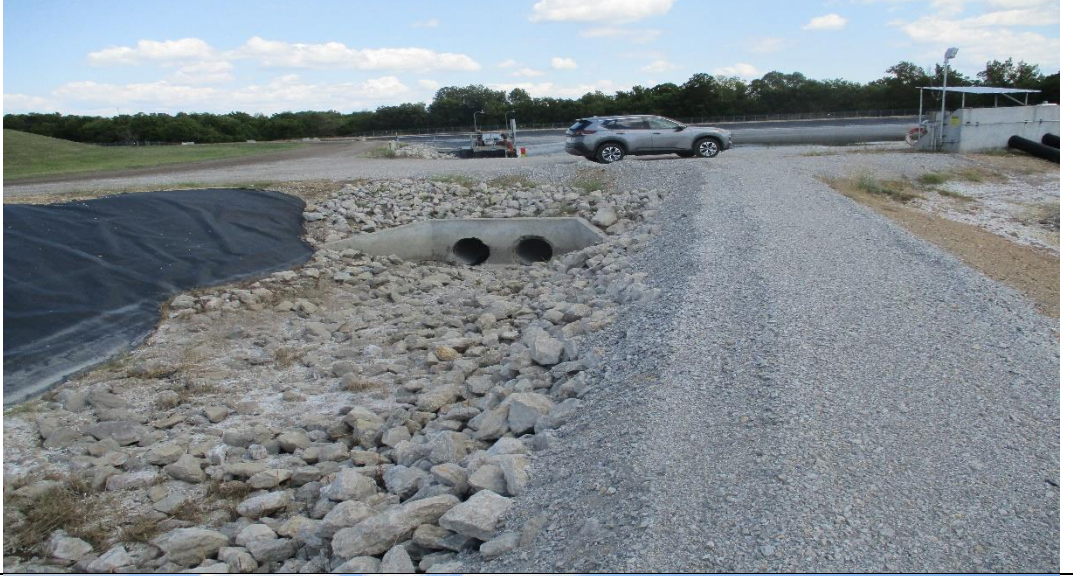
9. The north and south conveyance channel are illustrated in Photograph Nos. 14-17). Also illustrated is the crest of the dikes adjacent to the channels. The crest were repaired and appeared in good and stable condition. The runoff channel and pipe culverts appeared in good and functional condition.
10. Typical condition of the dike, interior slope, and pond bottom is illustrated in Photograph No. 18. The interior slope of the pond was in fair condition with minor erosion (Photograph No. 19) at the west dike slope. The pond was partly dry to the south end and appeared to have minimal amount of leachate water.
11. The splitter dike between the leachate pond and Basin C is illustrated in Photograph No. 20. The splitter dike appeared in good and stable condition without any settlement or misalignment.

A photograph showing a concrete pipe culvert inlet with two circular openings, partially buried in a bed of light-colored gravel. The culvert is situated in a runoff ditch. The background features a grassy embankment under a blue sky with scattered white clouds.
<p>Photograph No. 14 Leachate pond north side perimeter runoff channel and pipe culvert outlet (looking east).</p>

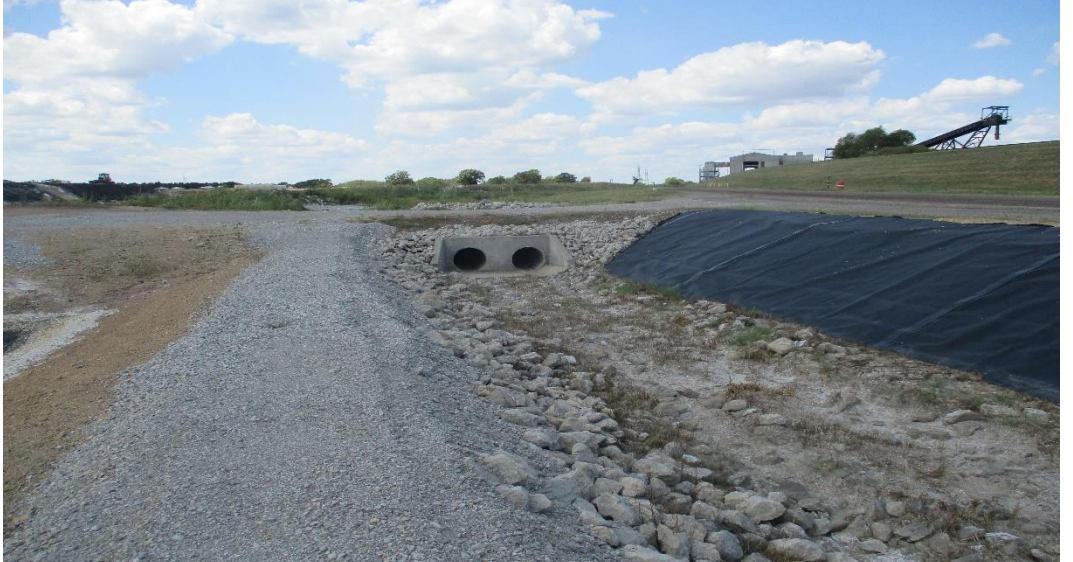
A photograph showing a concrete pipe culvert outlet with two circular openings, surrounded by a bed of light-colored gravel. To the left of the culvert is a black geomembrane liner. In the background, a silver SUV is parked on a gravel area, and a white building is visible under a blue sky with scattered white clouds.
<p>Photograph No. 15 Leachate pond north side perimeter runoff channel and pipe culvert outlet (looking west).</p>

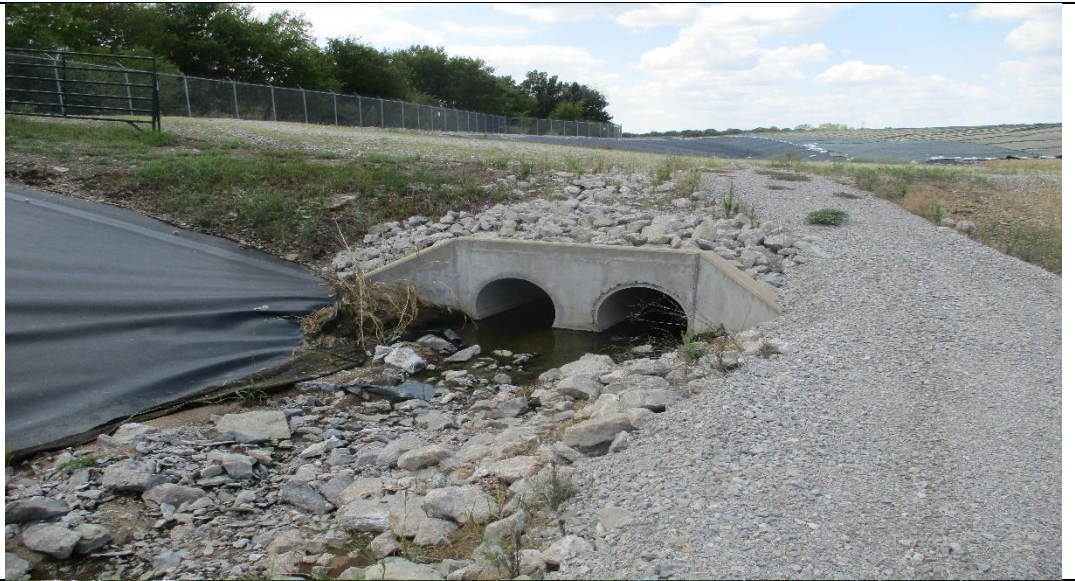
Photograph No. 16  
Leachate pond south side perimeter runoff channel and pipe culvert outlet (looking west).

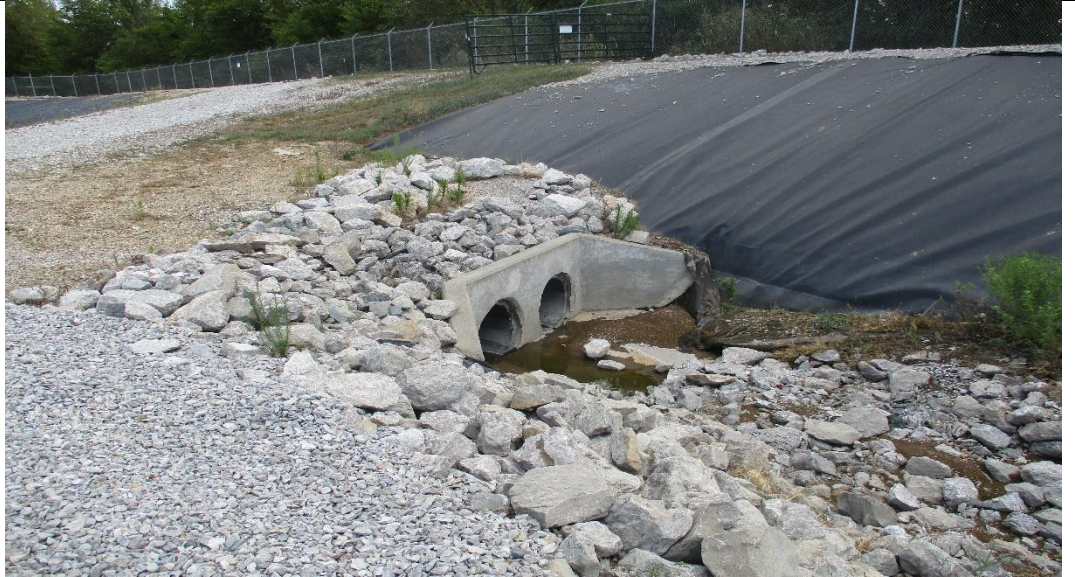
Photograph No. 17  
Leachate pond south side perimeter runoff channel and pipe culvert outlet (looking east).

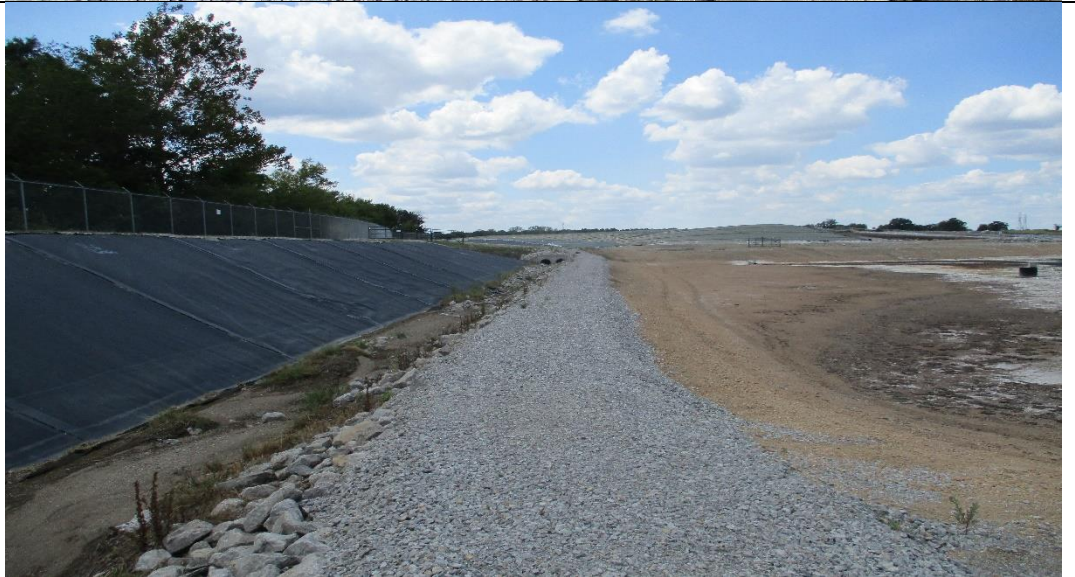
Photograph No. 18  
Contact water ditch.

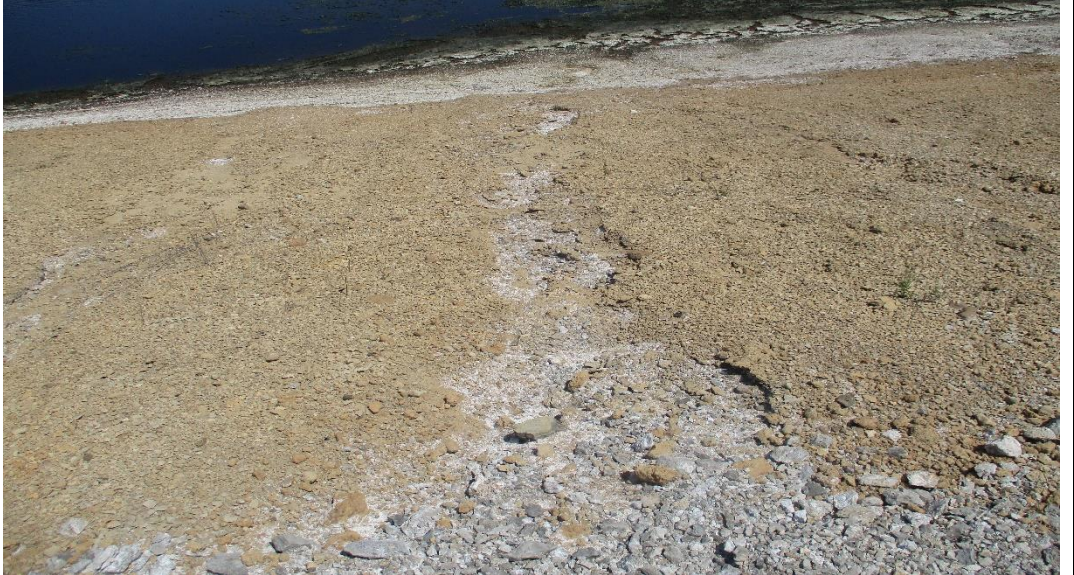
<p>Photograph No. 19 Minor erosion.</p>

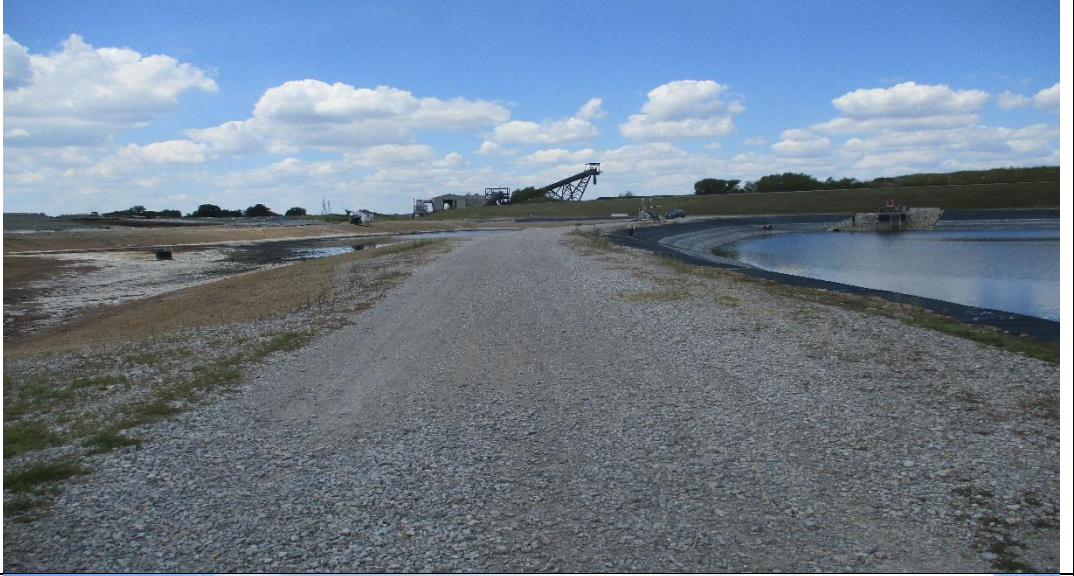
<p>Photograph No. 20 Splitter dike between the leachate pond and Basin C.</p>

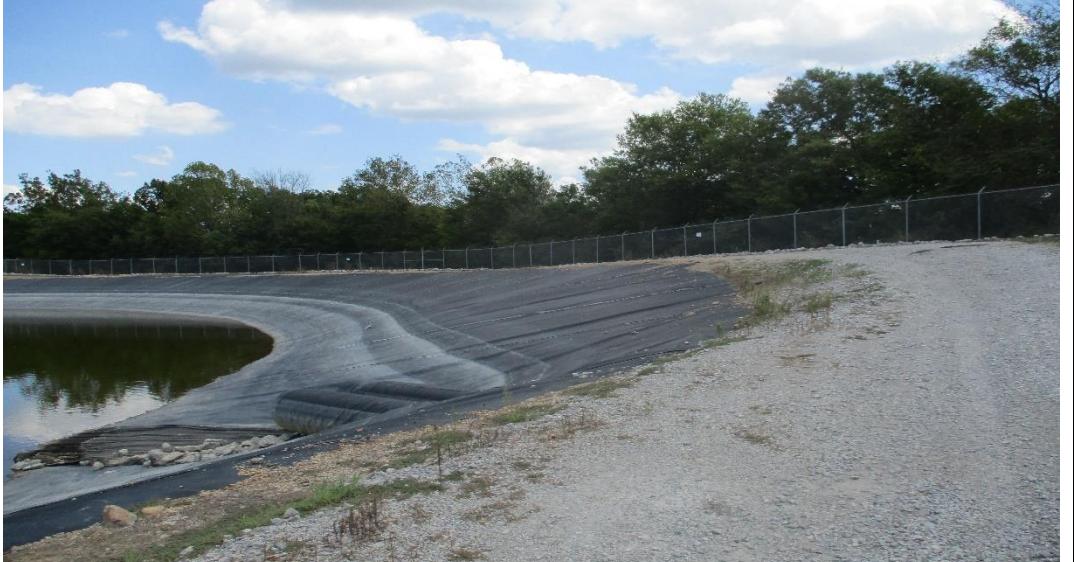
12. The crest and interior slope of Basin C appeared in good condition (Photograph Nos. 21 and 22). The geosynthetic liner was in place, intact and in good condition without any tear or damage. The crest also used as haul road of the north dike appeared in good and stable condition.
13. The runoff from the landfill is discharged into Basin C. Photograph Nos. 23 and 24 illustrates the inlets of the north discharge pipes and overflow discharge structure. At the time of inspection, the condition was dry and no water flowing from the pipes. The overflow discharge structure appeared in good, functional condition.

<p>Photograph No. 21 Interior slope and south runoff water pipe at Basin C.</p>
