2022 ANNUAL DAM AND DIKE INSPECTION REPORT

BOTTOM ASH PONDS

**PIRKEY POWER PLANT
HALLSVILLE, TEXAS**

Dam & Dike Inspection Report (CCR - Bottom Ash Ponds)

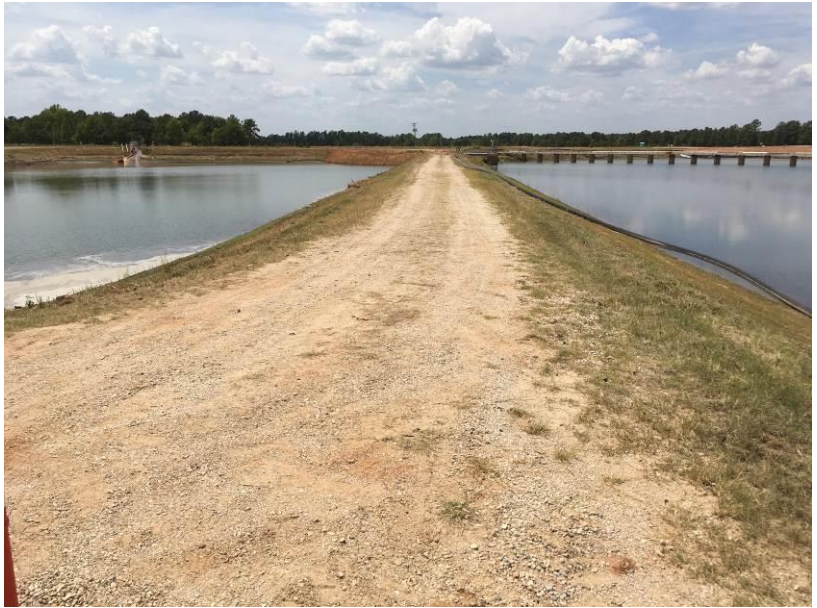
Photo # 1

1. Photographs No. 1 illustrates the crest of the southern side of the east bottom ash pond. The crest has signs of minor rutting from truck traffic. There were no other signs of settlement, misalignment and cracking observed.

View of the East Bottom Ash Pond Crest. Crest Conditions are Satisfactory with Some Minor Tire Ruts.

- Overall, the crest and slope conditions of the dam and levees are generally fair with the exception of some minor tire ruts caused from truck traffic and mowing activities. The tire rut areas should be repaired/regraded as part of regular maintenance activities. These areas overtime can lead to significant erosion and stability problems.
- Vegetation management for the facilities is considered satisfactory. However, some areas are overgrown and the vegetation should be maintained and controlled to promote adequate growth and aid in inspection activities.
- The perimeter ditches should be maintained for overgrown vegetation and damage from mowing activities should be repaired in a timely manner to promote positive flow along the ditches.

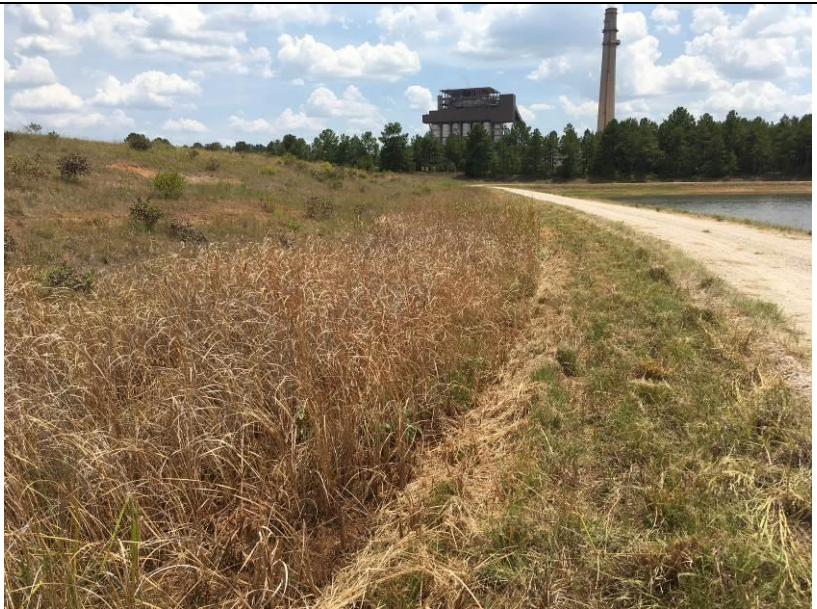
Photo # 2

2. Photographs No. 2 illustrates the condition of the perimeter ditch on the east side of the pond. The perimeter ditch shows overgrown cattails and some standing water. The relative flatness of the ditch, overgrown cattails and tire ruts from mowing activities is causing standing water in the bottom of the ditch.

- There was standing water observed in the perimeter ditches along the east and south side of the pond. The perimeter ditch flow lines are relatively flat but they do maintain positive flow. However, overgrown cattails and tire ruts from mowing activities have develop isolated areas of standing water along the ditch.

View of the East Bottom Ash Pond perimeter ditch. Perimeter ditch has overgrown a cattails and tire ruts from mowing activities.

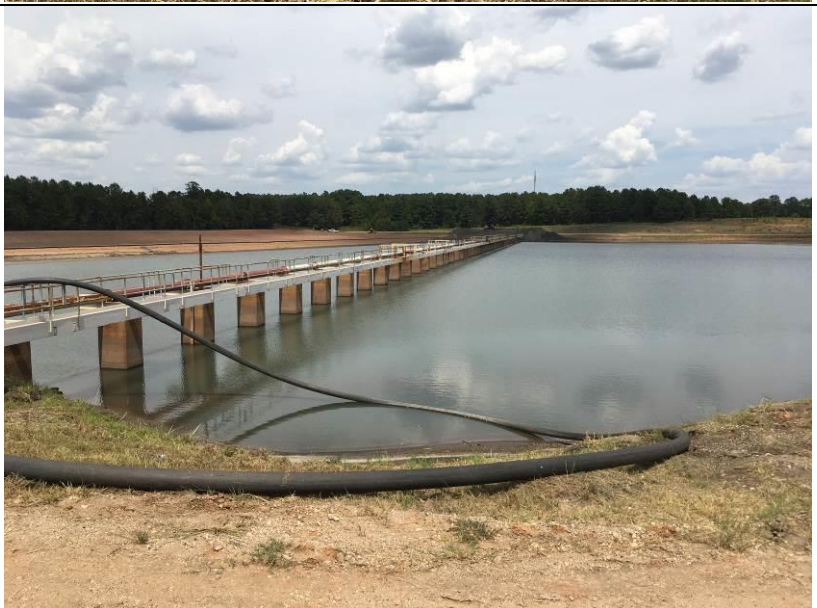
Photo # 3

3. Photograph No. 3 shows the general condition of the interior area of the East Bottom Ash Pond. The east bottom ash pond was in service at the time of inspection.

View of the East Bottom Ash Pond Interior Area. East Bottom Ash Pond is currently in service.

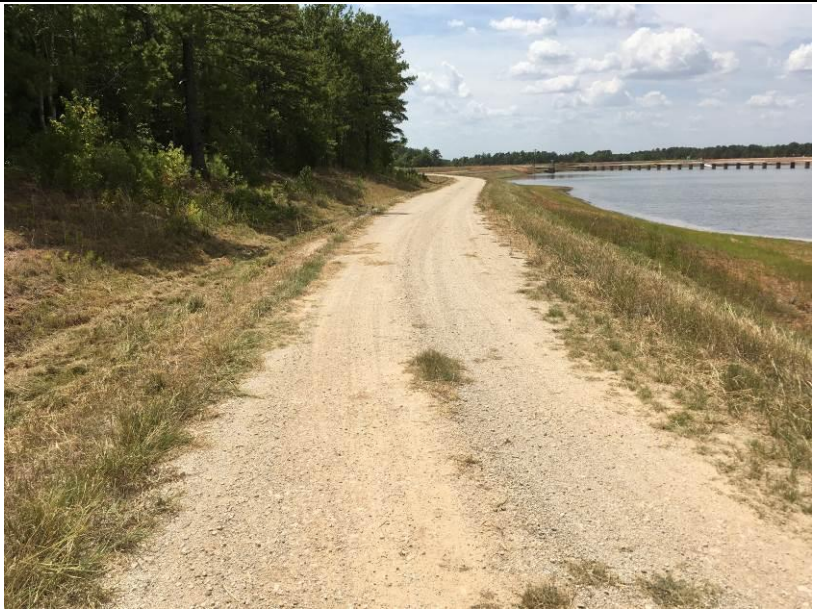
Photo # 4

4. Photograph No. 4 illustrates the typical condition of the crest on the west side of the pond. The crest has signs of minor rutting from truck traffic. There were no other signs of settlement, misalignment and cracking.

View of the East Bottom Ash Pond Crest. Crest conditions are satisfactory with some minor tire ruts.

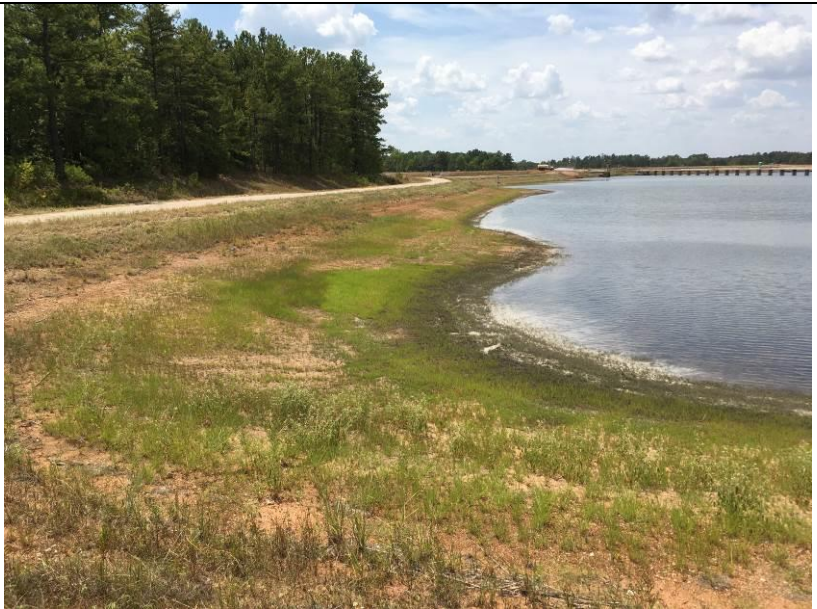
Photo # 5

5. Photographs No. 5 and No. 6 shows the general condition of the interior slopes of the east bottom ash pond. The slope appeared in satisfactory and stable condition. There were no signs of settlement, misalignment, sloughing or erosion.

View of the East Bottom Ash Pond interior area and slope conditions. East Bottom Ash Pond is currently in service.

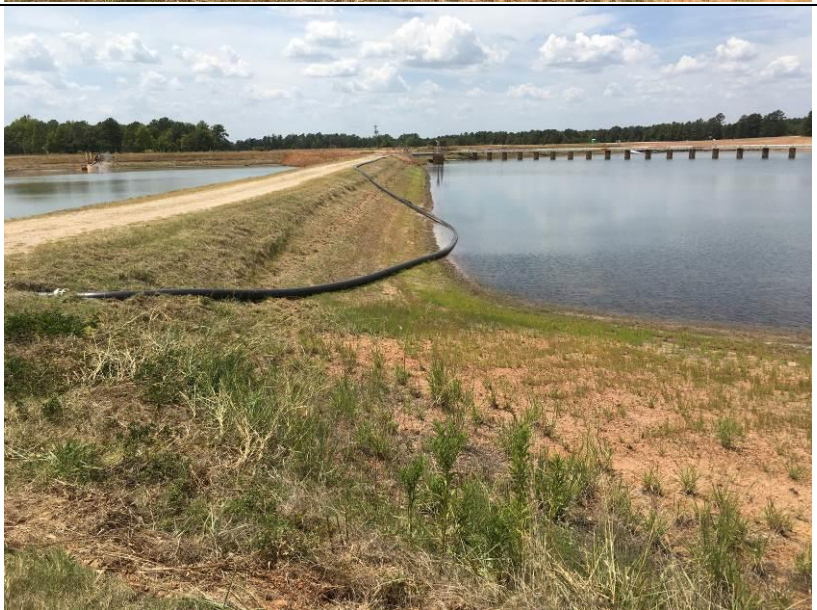
Photo # 6

View of the East Bottom Ash Pond interior area and slope conditions. East Bottom Ash Pond is currently in service.

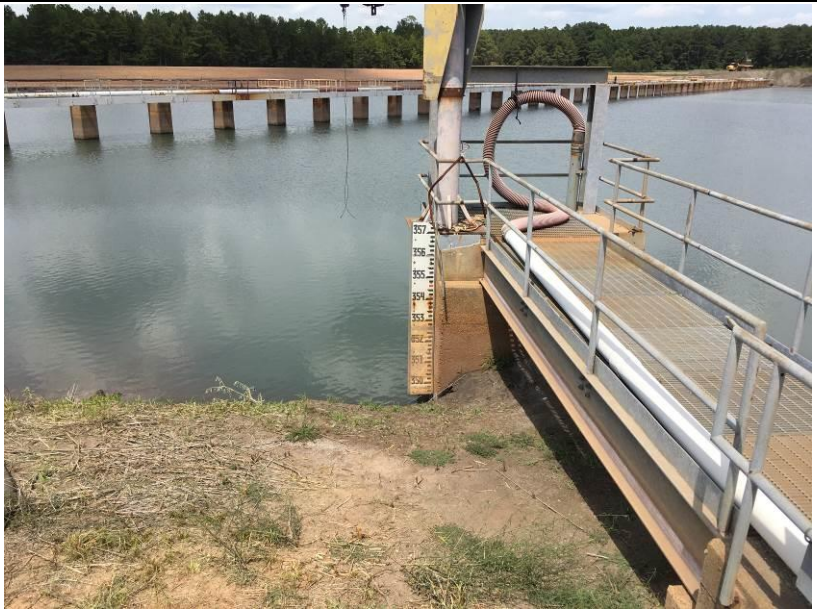
Photo # 7

6. The overflow discharge structure walkway, railings, metal decking, and visible concrete were found to be in satisfactory, functional condition. Photographs No. 7 illustrate the access stairs, metal walkway, metal deck, and concrete structure of the overflow discharge structure.

View of the discharge structure at the East Bottom Ash Pond.

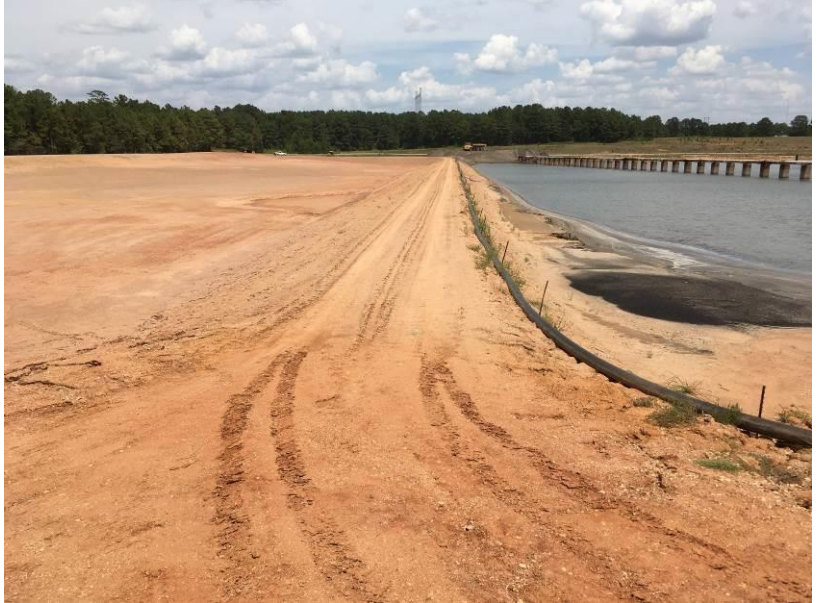
Photo # 8

7. Photograph No. 8 shows the general condition of the East Bottom Ash Pond interior berm. This interior berm will allow the north section of the east bottom ash pond to be closed by removal while the rest of the east bottom ash pond remains in service. The interior berm is performing as intended and show no signs of settlement, misalignment, sloughing or erosion.

View of the East Bottom Ash Pond interior separation berm. This berm will allow the northern section of the East Bottom Ash Pond to be closed by removal.

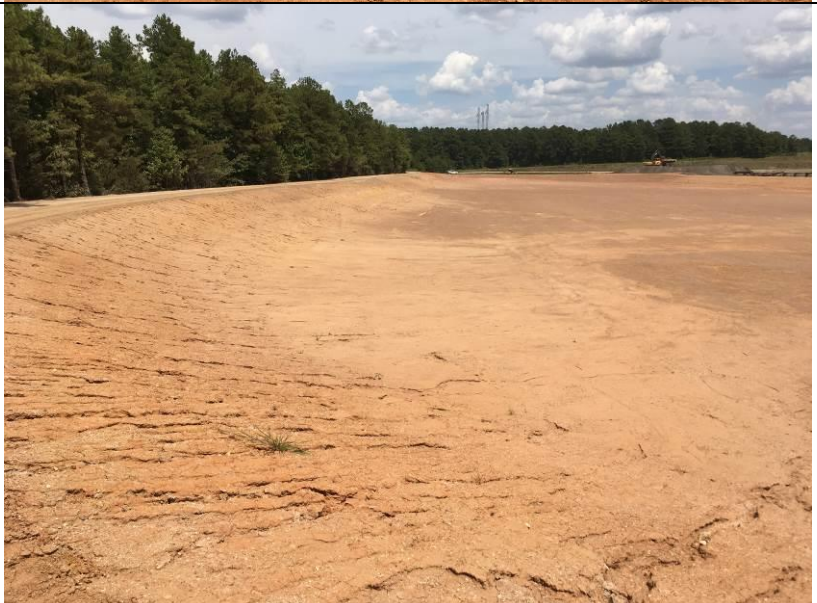
Photo # 9

8. Photograph No. 9 show the general conditions of the interior north section of the east bottom ash pond. This section is currently out of service and is being closed by removal.

View of the interior of the northern section of the East Bottom Ash Pond Area. This area is out of service and is currently being closed by removal.

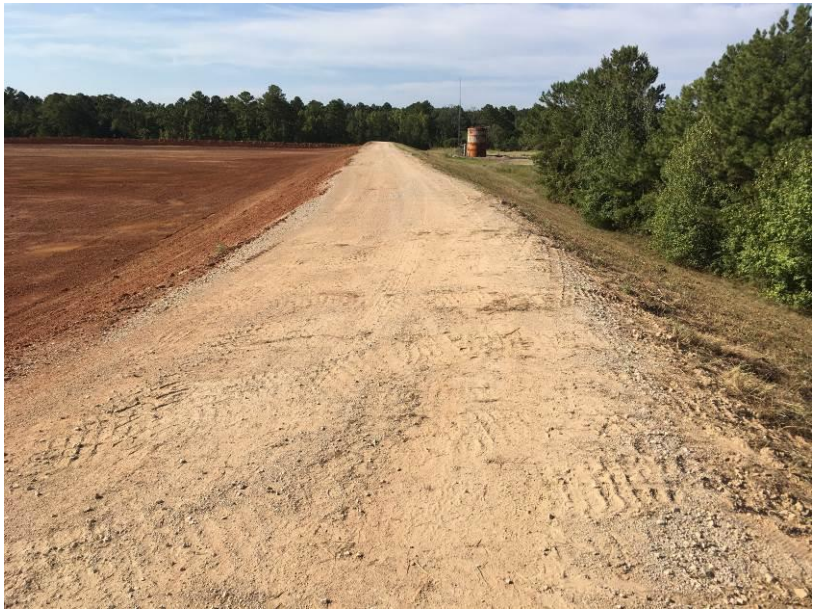
Photo # 10

9. Photographs No. 10 and 11 illustrate a typical overview of the dike crest. The crest appears to be in good and stable condition. Minor rutting from truck traffic was observed during the inspection. There were no other signs of settlement, misalignment and cracking observed.
10. Photographs No. 12, 13 and 14 illustrate the condition of the interior slopes and bottom area of the west bottom ash pond. The southern berm is being excavated and lowered as

View of the West Bottom Ash Pond crest looking south. Crest conditions are satisfactory with some minor tire ruts. West Bottom Ash Pond is currently out of service and is being closed by removal.

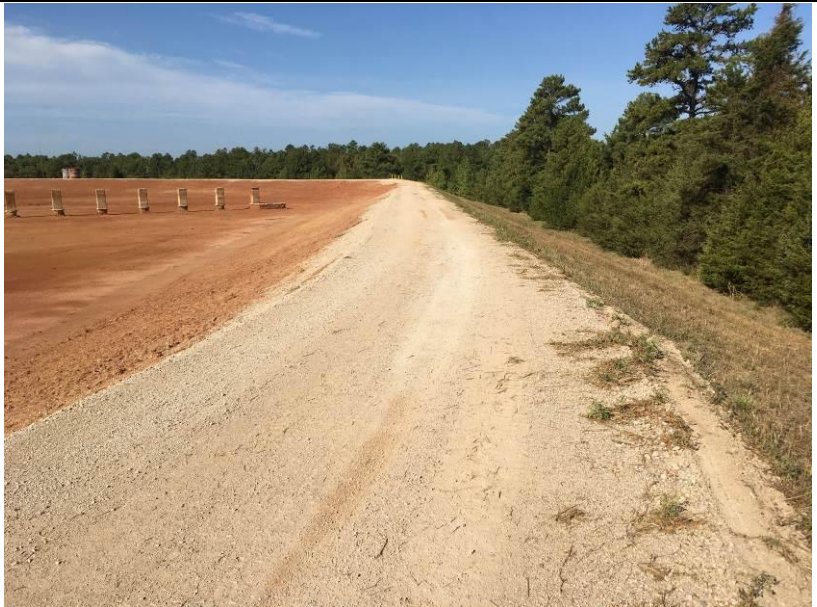
Photo # 11

View of the West Bottom Ash Pond crest looking west. Crest conditions are satisfactory with some minor tire ruts. West Bottom Ash Pond is currently out of service and is being closed by removal.

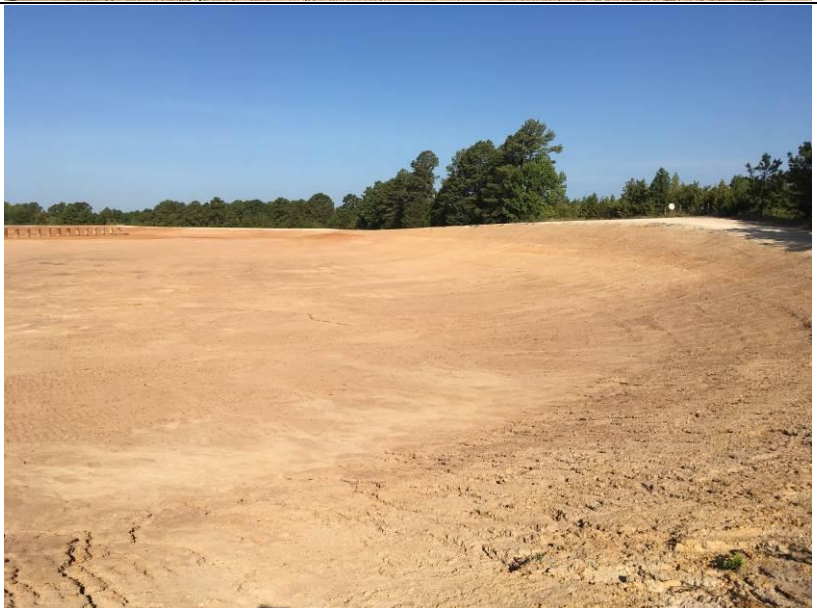
Photo # 12

View of the interior slope conditions of the West Bottom Ash Pond. West Bottom Ash Pond is currently out of service and is being closed by removal.

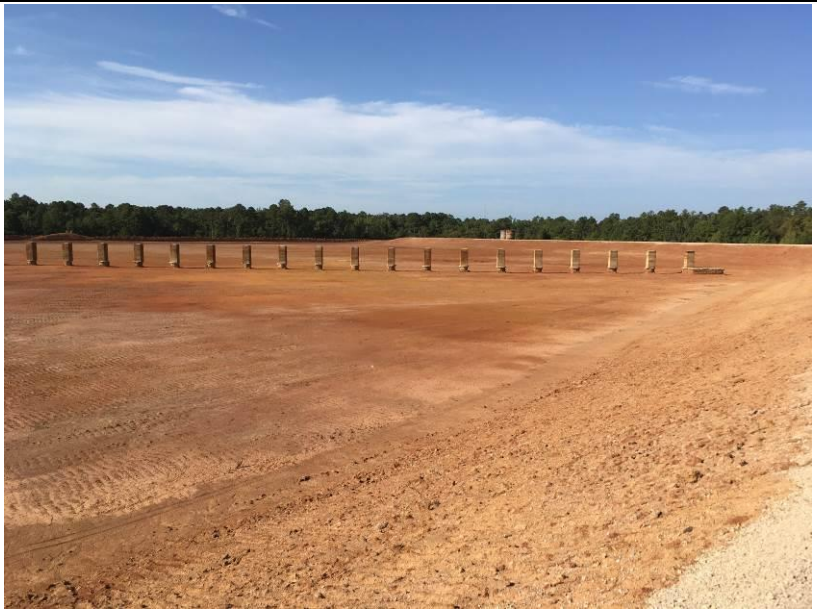
Photo # 13

View of the interior slope conditions of the West Bottom Ash Pond. West Bottom Ash Pond is currently out of service and is being closed by removal.

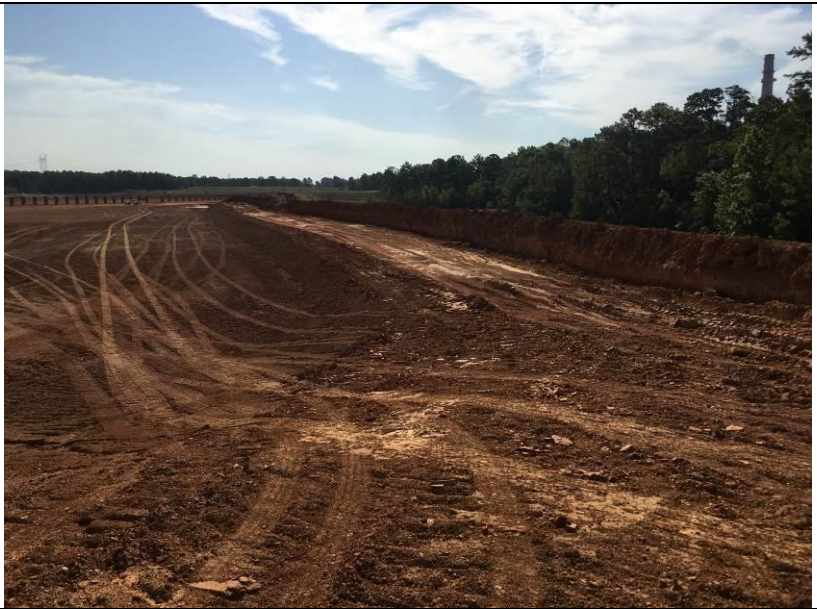
Photo # 14

View of the sluicing pipe structure of the West Bottom Ash Pond. West Bottom Ash Pond is currently out of service and is being closed by removal.

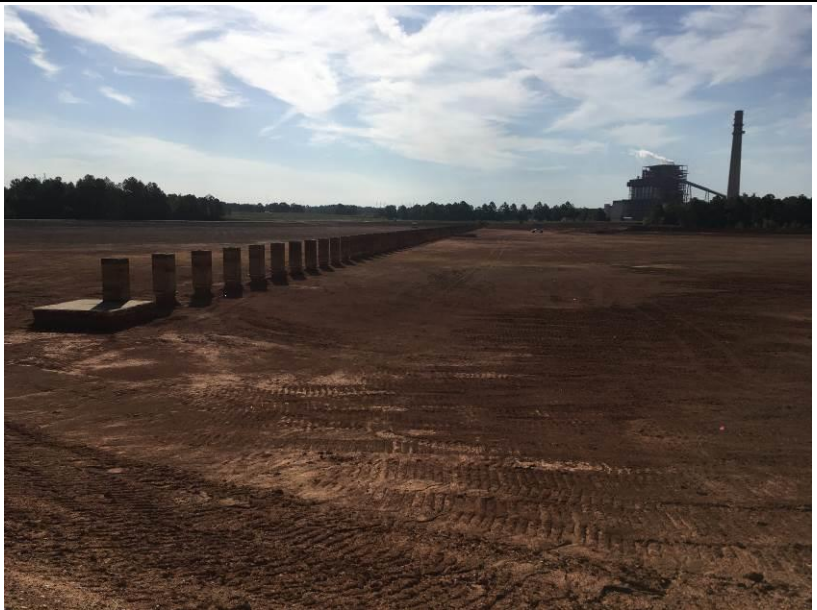
Photo # 15

11. Photograph No. 15 show the general condition of the interior area of the west bottom ash pond and the sluicing pipe platform concrete columns that extends out into center of the pond. The pipe platform structure has been removed as part of the closure activities.

View of the interior slope conditions of the West Bottom Ash Pond southern berm. West Bottom Ash Pond is currently out of service and is being closed by removal. The southern berm is being lowered as part of the closure activities.

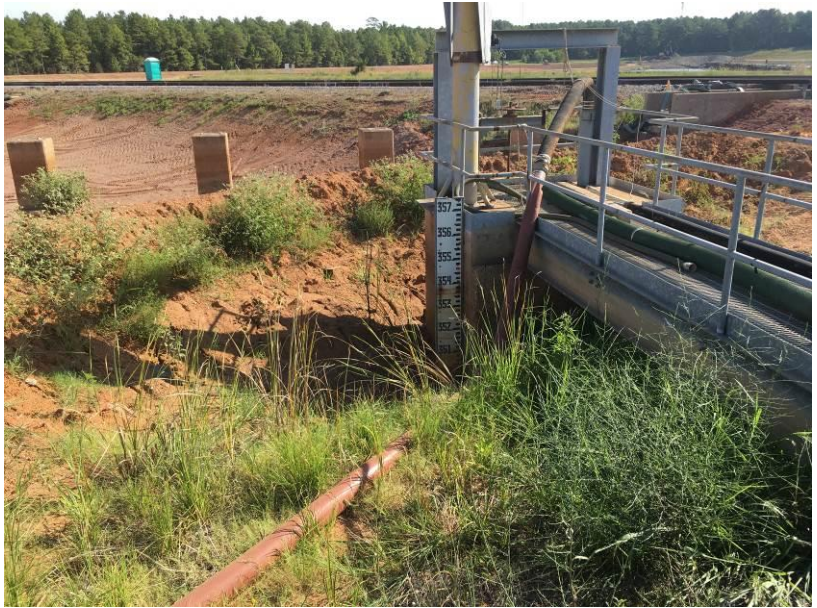
Photo # 16

12. The overflow discharge structure walkway, railings, metal decking, and visible concrete were found to be in satisfactory condition. Photographs No. 16 illustrates the access metal walkway, metal deck, and concrete structure of the overflow discharge structure. The West Bottom Ash Pond is out of service and is being closed by removal.

View of the discharge structure of the West Bottom Ash Pond. West Bottom Ash Pond is currently out of service and is being closed by removal.

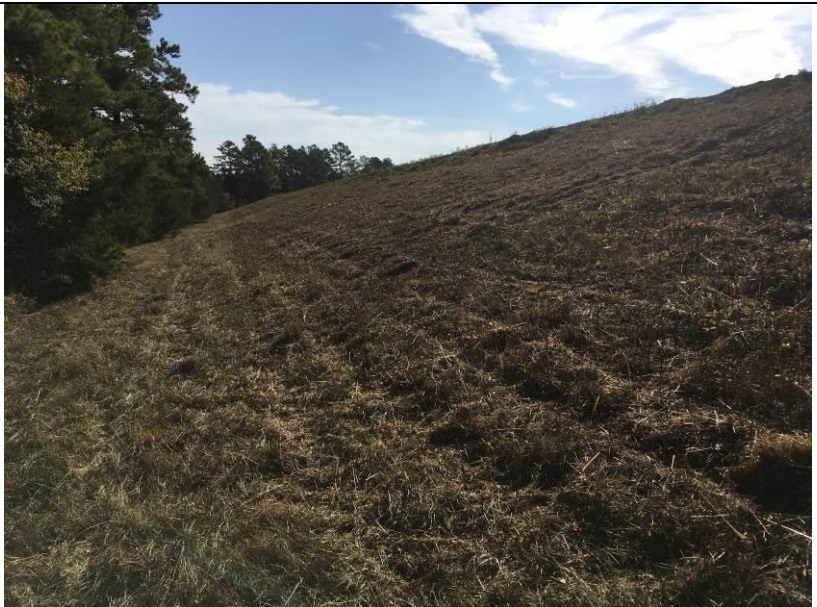
Photo # 17

13. Photographs No. 17, 18 and 19 shows the general condition of the exterior slope and toe areas of the west bottom ash pond. The southern berm is being excavated and lowered as part of the closure activities. The slopes appeared in satisfactory and stable condition. There were no signs of wet areas, settlement, misalignment, sloughing or erosion.

View of the north exterior slope of the West Bottom Ash Pond. Slope vegetation is well managed.

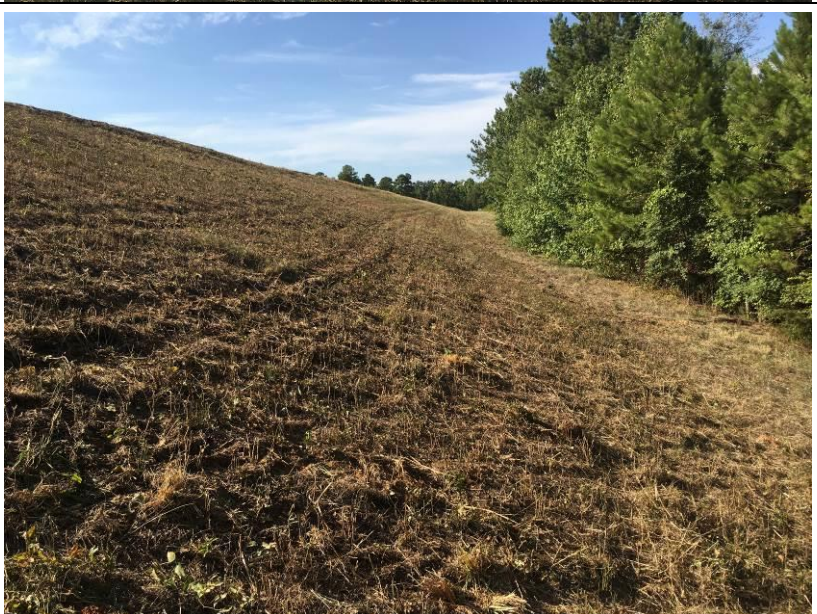
Photo # 18

View of the west exterior slope of the West Bottom Ash Pond. Slope vegetation is well managed.

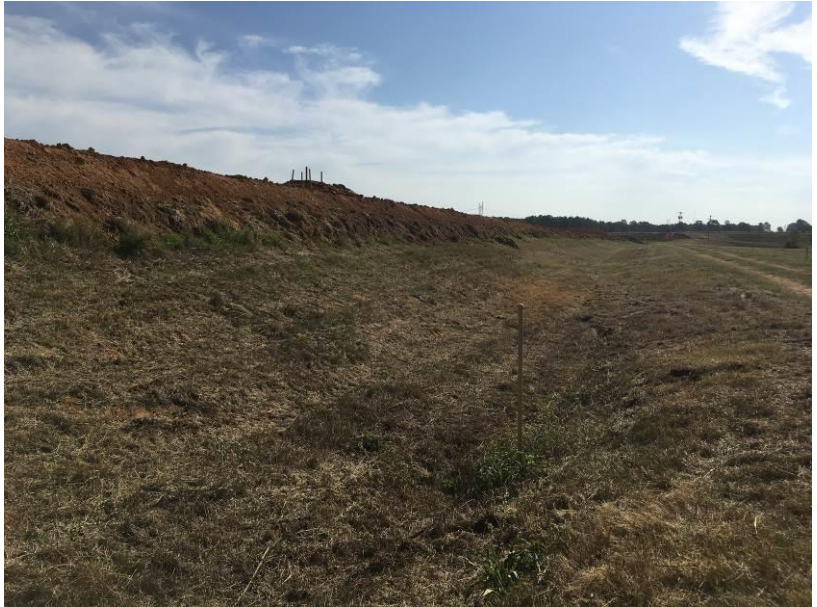
Photo # 19

View of the south exterior slope of the West Bottom Ash Pond. Slope vegetation is well managed.

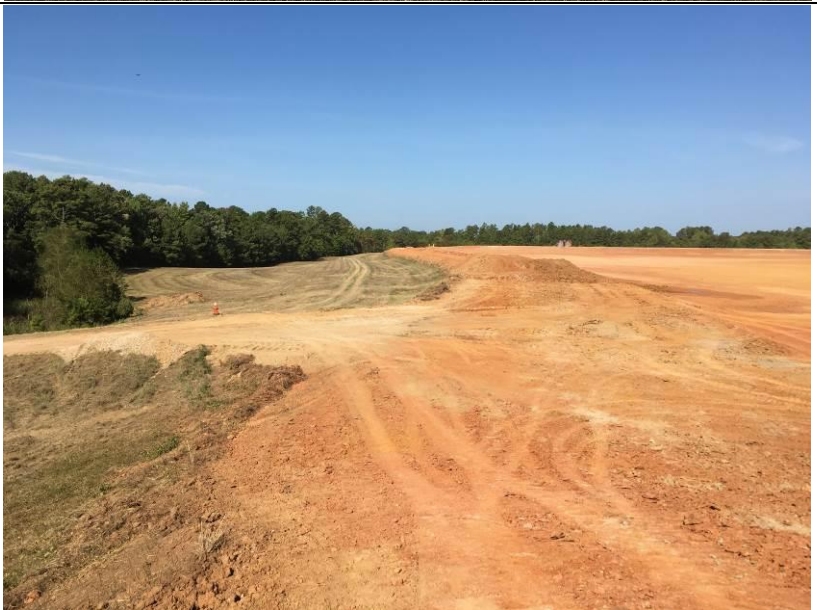
Photo # 20

14. Photograph No. 20 shows the general condition of the southern slope near the east end of the pond. A notch has been excavated out of berm to allow for the installation of a drainage culvert to drain the pond area after closure by removal activities are complete.

View of the south exterior slope of the West Bottom Ash Pond. Upper section of the southern slope is being removed as part of the closure activities.

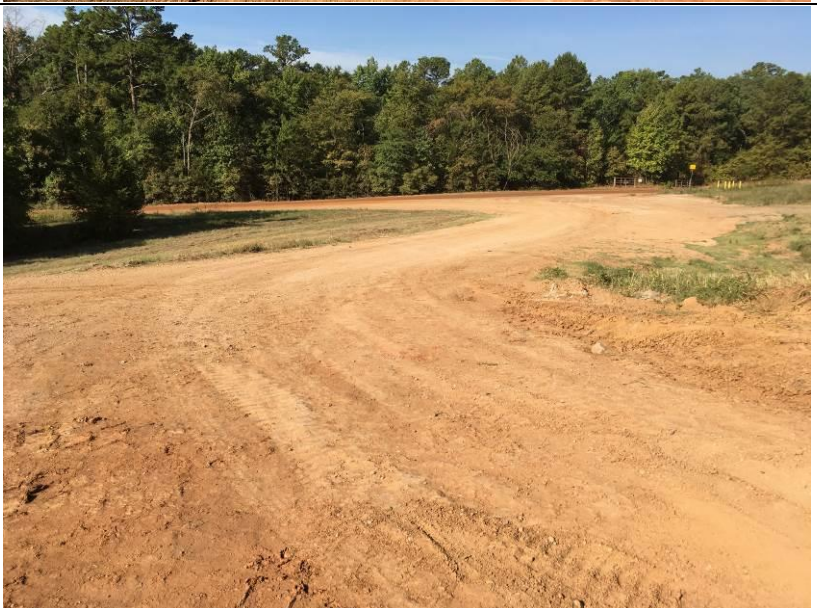
Photo # 21

15. Photograph No. 21 shows the condition of the access ramp on the southeast side of pond. In general, the access ramp appears to be in satisfactory conditions with no signs of cracking, misalignment or erosion. There are some minor tire ruts from the construction traffic of the closure by removal activities.

View of the access ramp to the crest area on the southeast corner of West Bottom Ash Pond. Access road is in fair condition due to construction activities.
