2023 Annual Dam and Dike Inspection Report

Primary Bottom Ash Dam

Flint Creek Plant

Document Number: GERS-23-020

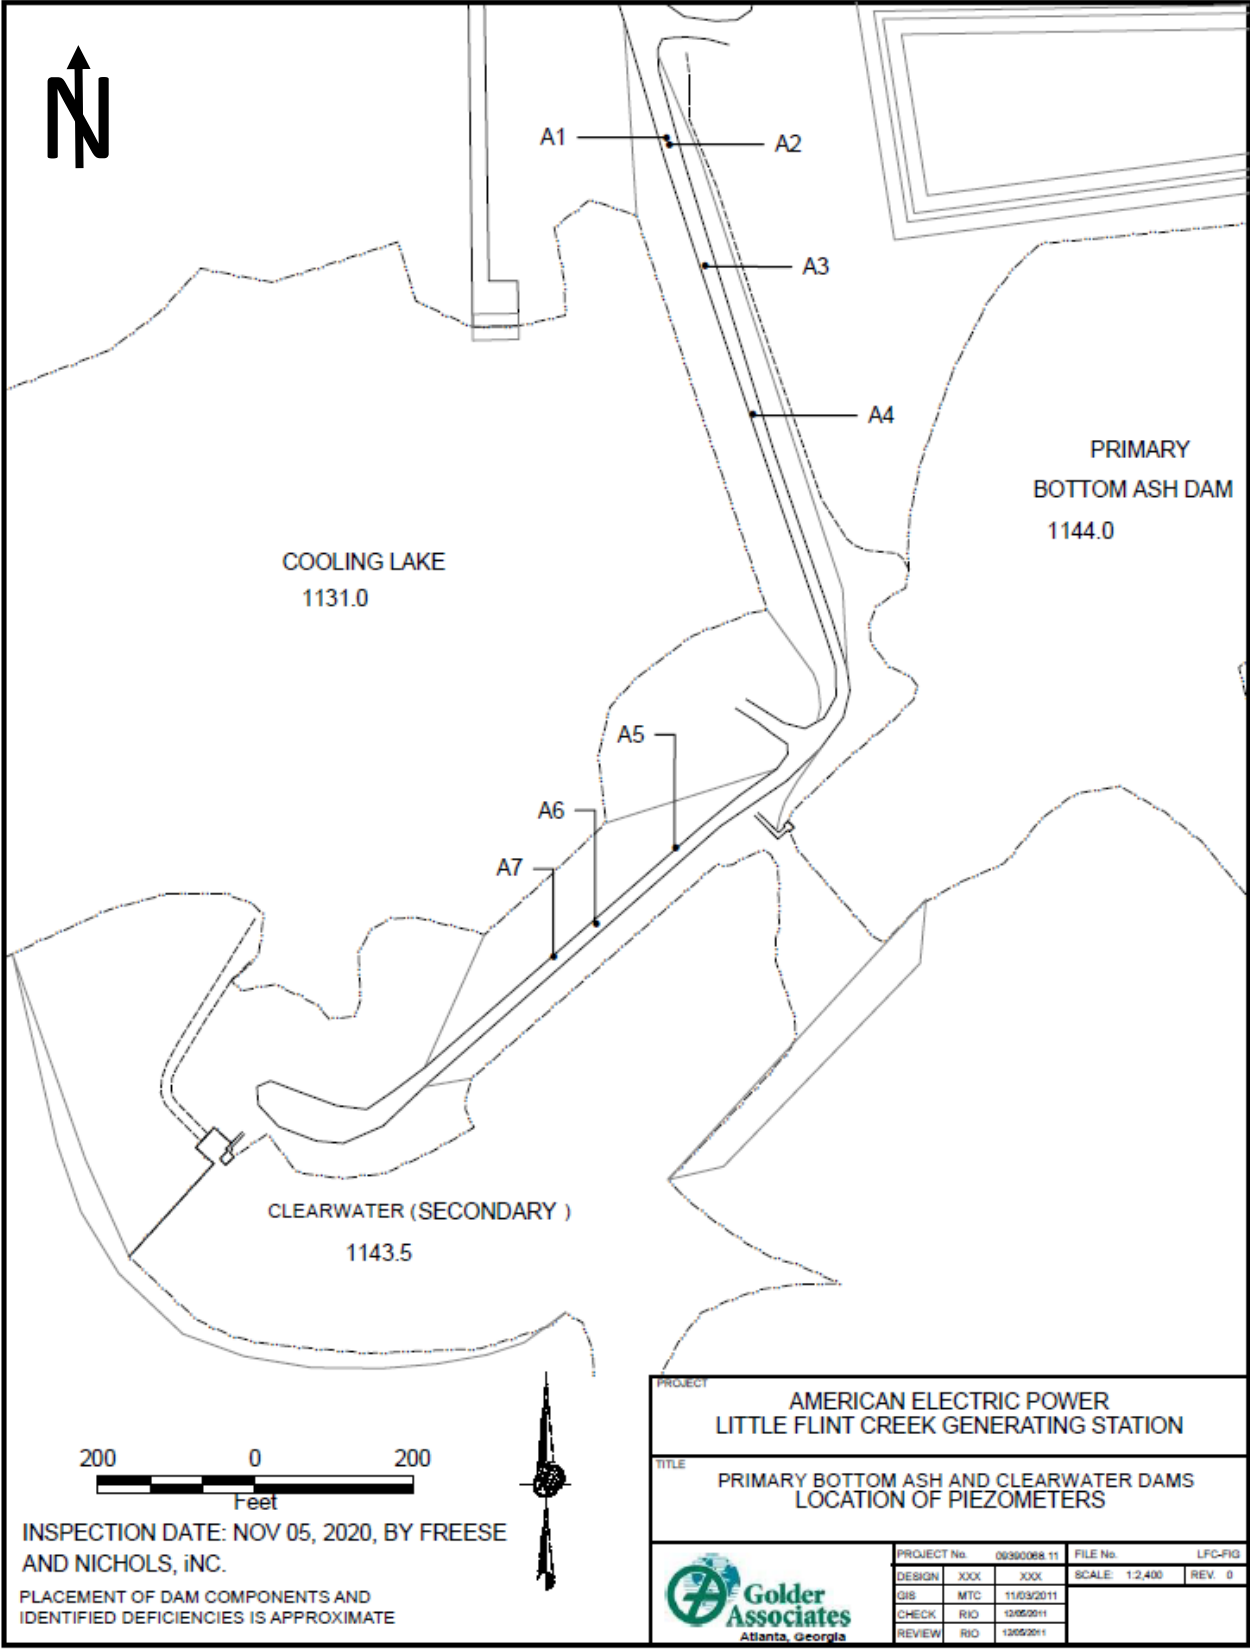
Figure 2 – Piezometer Location Map
Primary Bottom Ash Pond
Flint Creek Plant, Gentry, AR

There are four piezometers located along the crest of the dam as shown on Figure 2. These are the only instrumentation related to this facility. A review of readings since the last inspection and historical readings (2017-2023) indicate the levels are consistent and respond to the fluctuation of the cooling lake level. The piezometers are more influenced by the level of the cooling lake than the elevation of the Primary Bottom Ash Pond. A spike was noticed in Piezometers A1-A3 in April 2023 and A4 in August 2023. Piezometers A1-A3 were damaged by construction equipment and were replaced in June 2023. Typically, the trend in the historical data between the piezometers reading, lake level, and pond levels are consistent. Once the pond resume to its normal operating condition, the piezometer reading shall be checked and compared to its historical readings. Table 1 lists the maximum piezometer reading since the last annual inspection. Figure 3 provides historical data plot of the piezometer readings over the past several years.

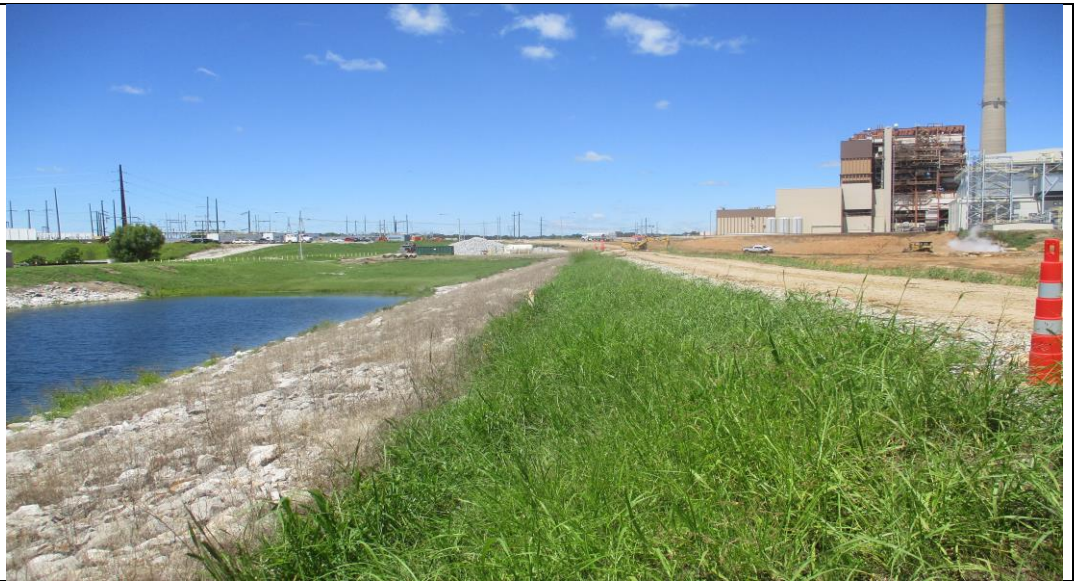
- (iv) Photograph Nos. 7 and 8 illustrates the downstream slope of the dam. The downstream slope of the primary dam appeared in satisfactory condition. Most of the slope was protected with riprap cover except for the upper 12-15 feet of the slope is covered with vegetation. Slightly excessive vegetation was observed in the upper section of the slope. There was no observed displacement or movement of the riprap. There was no seepage observed along the face of the slope.

Photograph No. 7
Downstream slope
(looking north).

- Continue the vegetation control plan of mowing and spraying.
- Make sure the piezometers are in functional condition after they were replaced following the completion of construction activities.

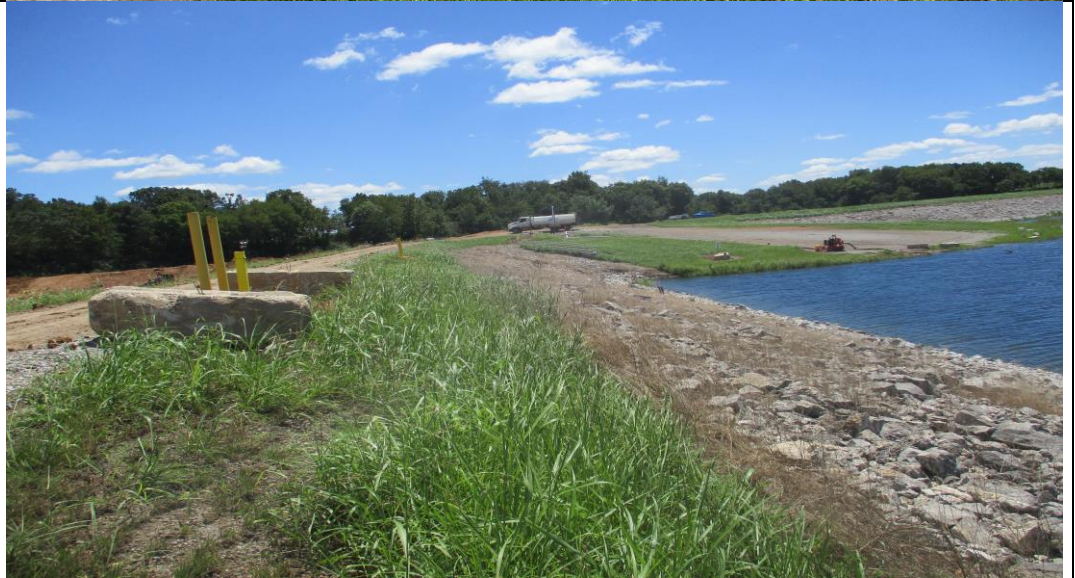
Photograph No. 8
Downstream slope
(looking south).

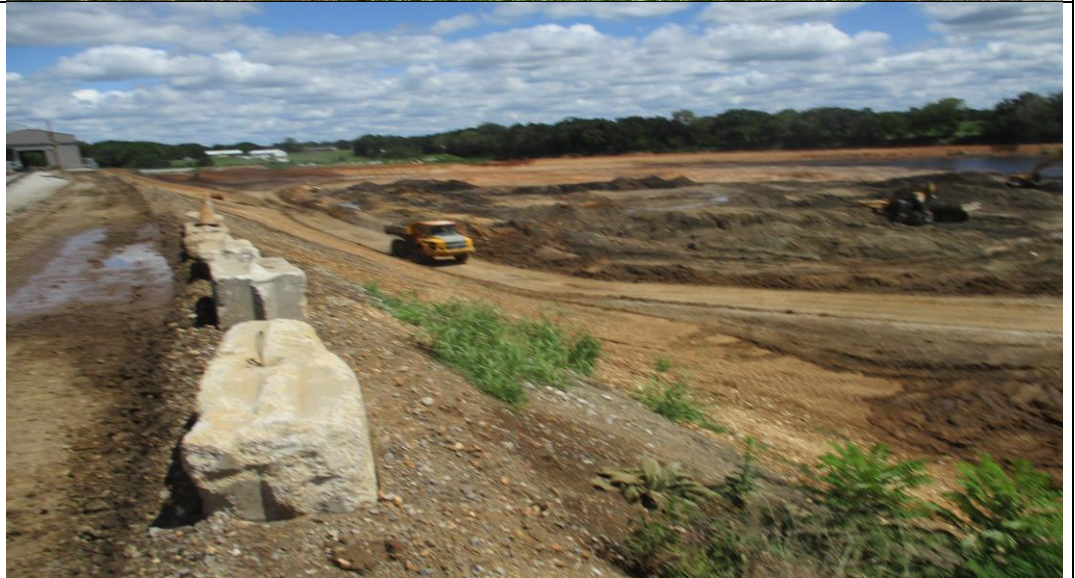
- (v) Typical condition of the north dike is illustrated in Photograph No. 9. North dike crest also supports the railroad loop of the coal-yard. The north dike slope was regraded and vegetation was cleared due to the pond closure activities.

Photograph No. 9
The north embankment
(looking east).

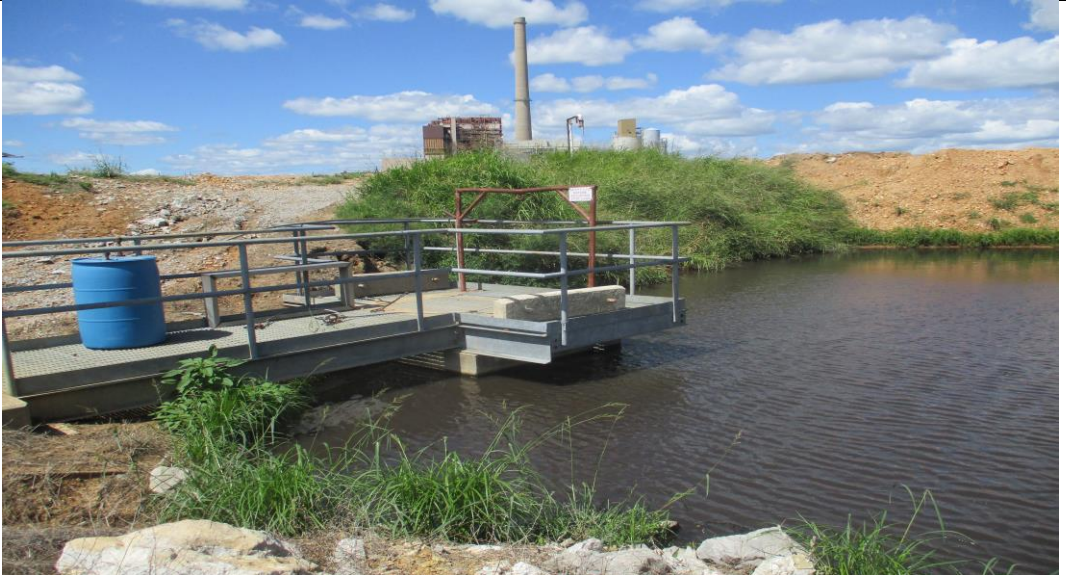
- (vi) The principal spillway for the pond is a concrete drop-inlet structure with stop logs used to control the pool elevation. The overflow discharge structure was in generally fair condition. The access platform and flow through the principal spillway was unobstructed (Photograph No. 10).

<p>Photograph No. 10 Overflow discharge structure.</p>

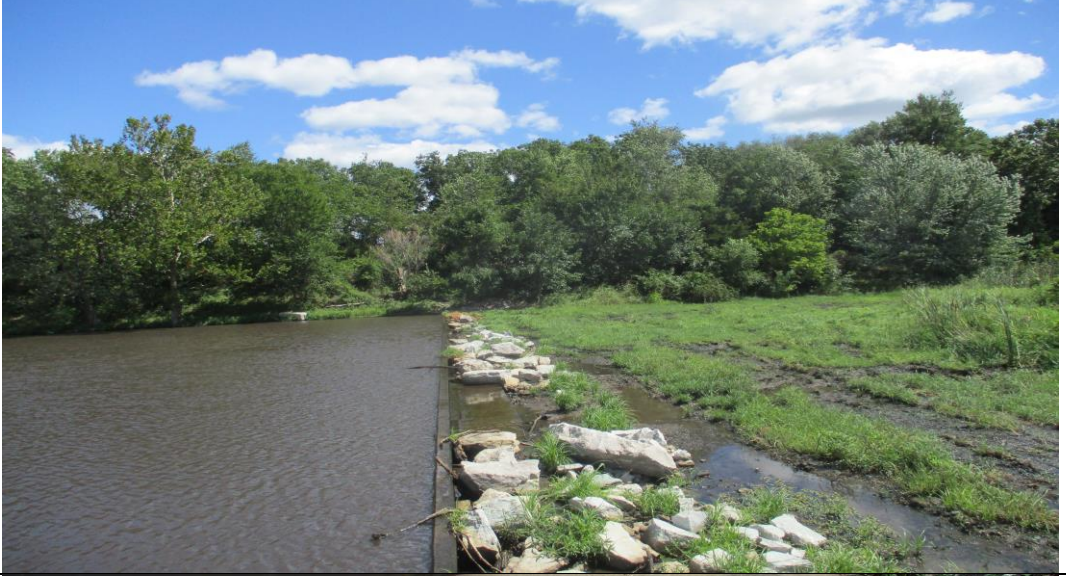
- (vii) The emergency spillway (Photograph No. 11) is an incised channel in natural ground with a concrete weir control section, 1 ft. in height, across the channel width. The spillway was in generally good condition at the time of inspection. The spillway appeared to be generally stable. Vegetation control in this natural ground area is good. Hairline cracks were noticed along the concrete spillway and at the buttress to the north of the spillway (Photograph No. 12).

A photograph showing a concrete overflow discharge structure with metal railings. A blue barrel is on the structure. In the background, there is a large industrial facility with a tall chimney and a large earthen embankment under a blue sky with scattered clouds.
<p>Photograph No. 11 Emergency spillway concrete sill (looking south).</p>

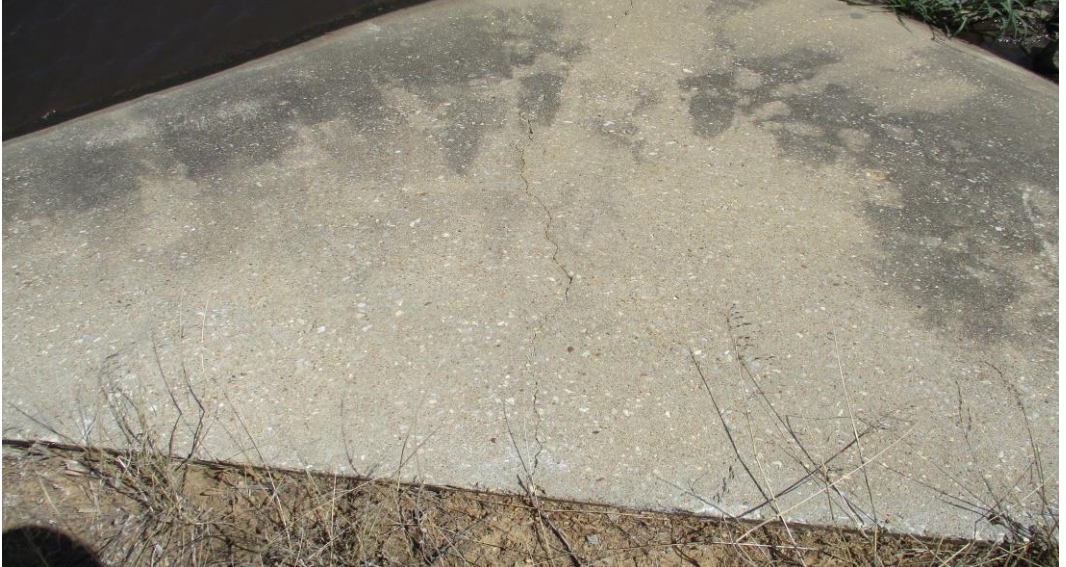
In general, there was minor erosion, cleanup work, and replacement of riprap on the upstream slope. Few hairline cracks were noticed at the concrete spillway.

A photograph of a concrete spillway sill. The structure is partially covered with rocks and green vegetation. A river flows to the left, and a dense line of trees is in the background under a blue sky with white clouds.
<p>Photograph No. 12 Hairline crack at the spillway concrete buttress.</p>
