2023 Annual Landfill Inspection Report

**Northeastern Power Plant
Public Service Company of Oklahoma
Oologah, OK**

Document Number: GERS-23-050

Inspection Date: November 14, 2023

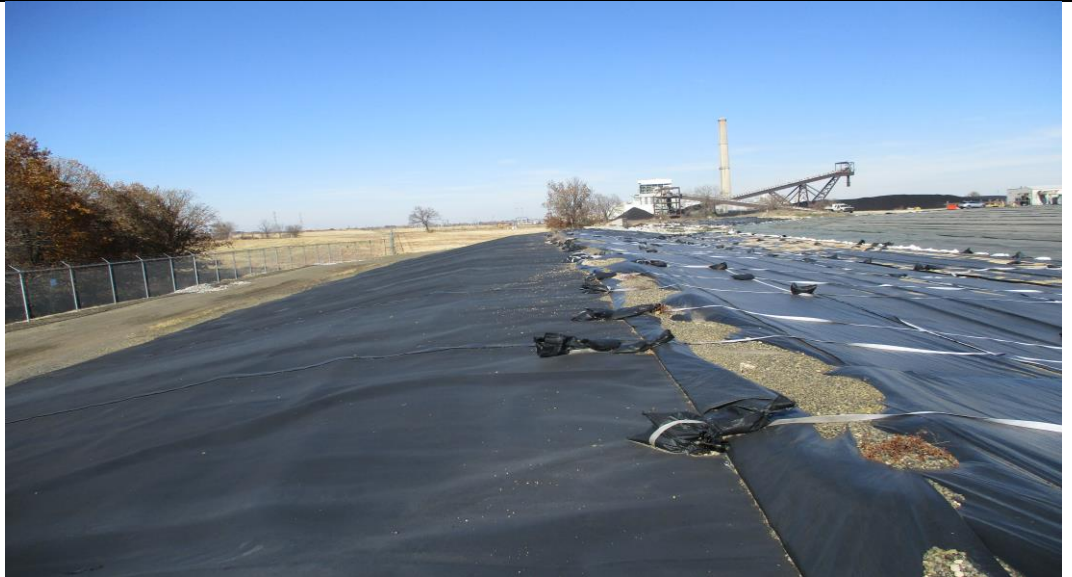
1. Landfill area (Cell 4) was already covered with temporary rainflap and wind defender at the time of inspection. Photographs No. 1-3 illustrate the condition of the landfill area Cell 4. The access road appeared in good condition with no sign of misalignment, settlement, or excessive erosion. The perimeter ditch was functioning as designed and the liner was intact and in good condition. The temporary rainflap and wind defender appeared in intact and good condition. Minor rutting at the access road was noticed (Photograph No. 4).

Photograph No. 1
Cell 4 berm and access
road (looking north).

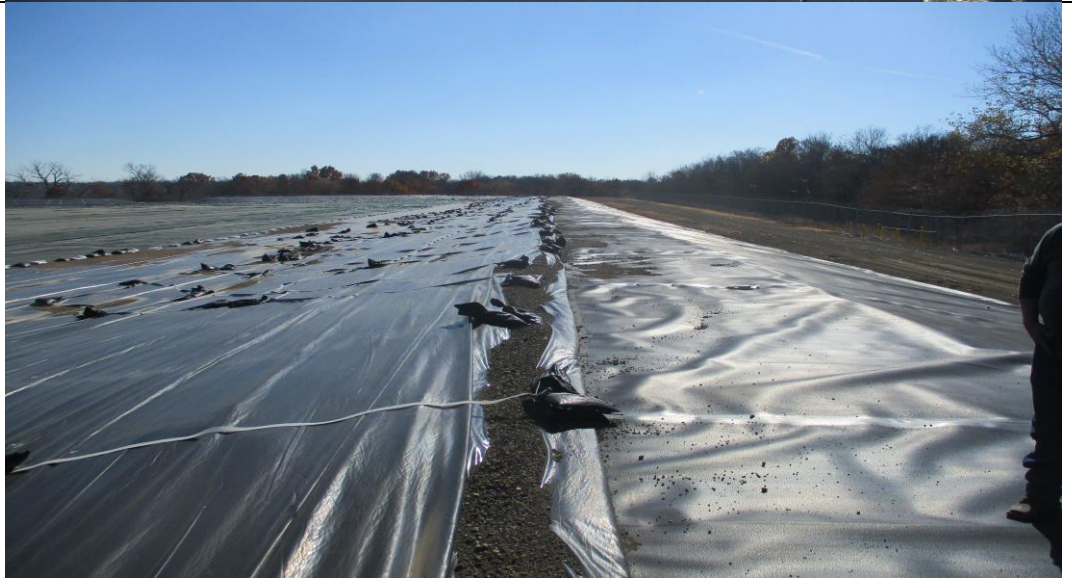
Photograph No. 2
Cell 4 and berm (looking
south).

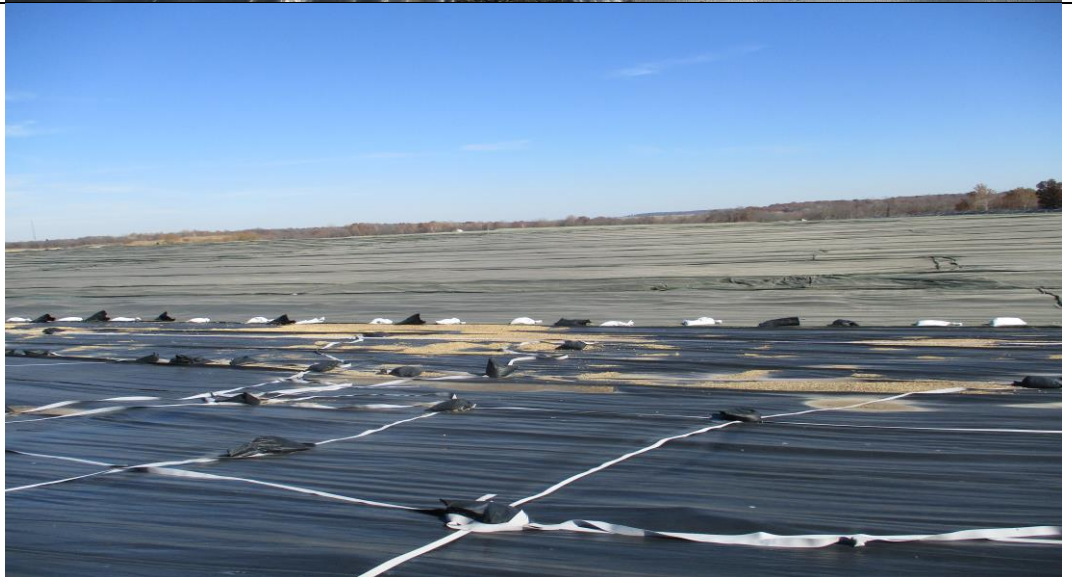
Photograph No. 3
Overall view of Cell 4.

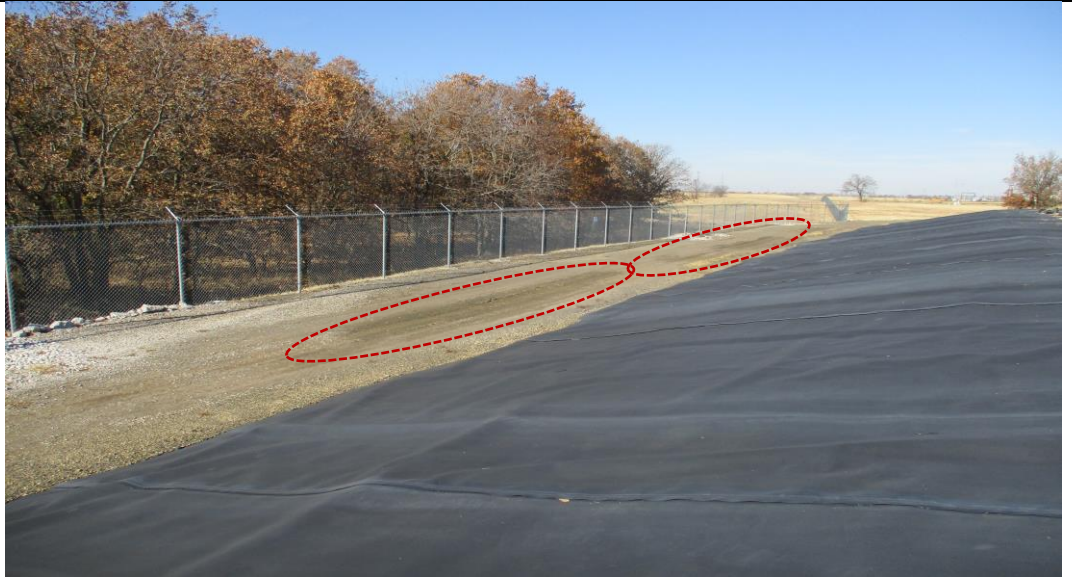
- 1) In general, the landfill is functioning as intended. All areas of the facility are maintained and in good condition.
- 2) The Plant is performing regular maintenance and inspections as required.
- 3) The north side drainage ditch at the east end shows excessive vegetation.
- 4) The repair of the south ditch subgrade at the box culvert apron location was completed.
- 5) Minor rutting was observed on the perimeter access road and leachate pond west slope.

Photograph No. 4
Minor erosion at the
access road.

- 2) Repair rutting at the access road and any significant erosion at the leachate pond slopes.

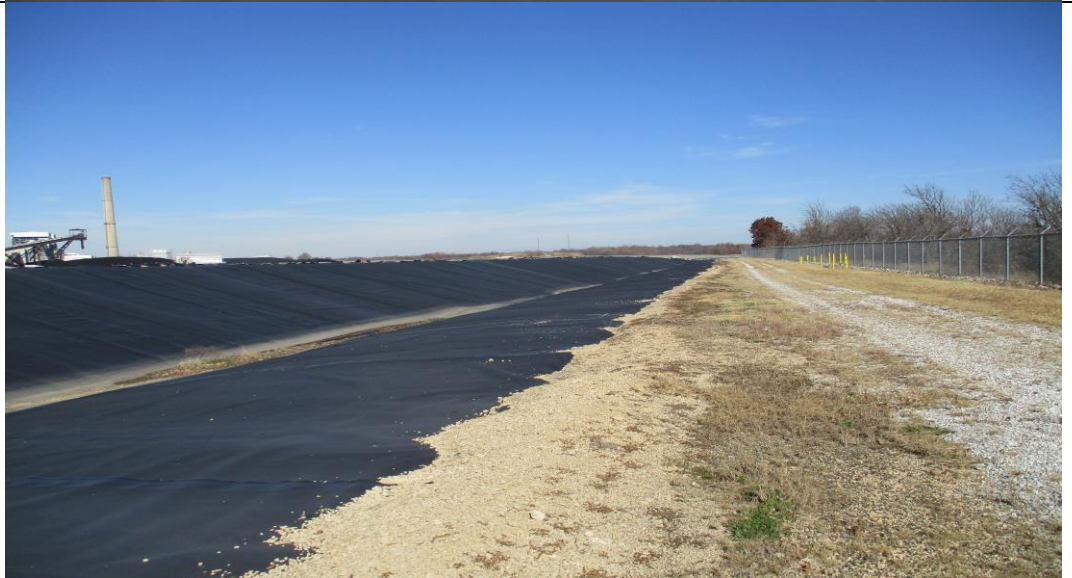
2. Cell 3 exterior south slope and access perimeter road (Photograph No. 5) appeared in good and stable condition. The access road appeared in good condition without any signs of settlement, misalignment, or excessive erosion.

Photograph No. 5
Cell 3 perimeter berm
and access road (looking
northeast).

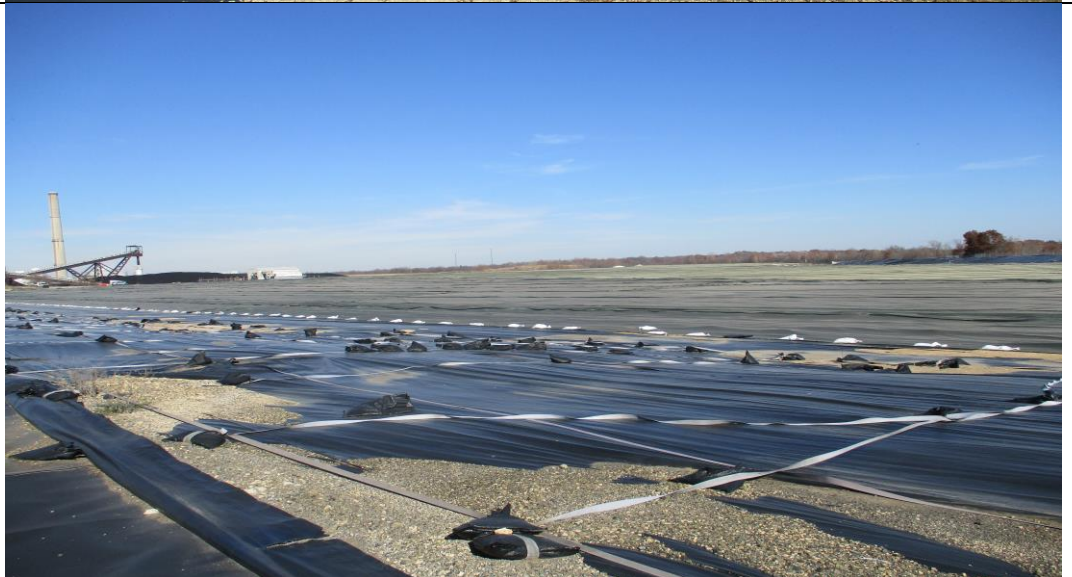
3. Cell 3 area is illustrated in Photographs No. 5 and 6. This area is also covered with the rainflap and wind defender. The containment berm, access road and the geomembrane lined perimeter ditch appeared in good and stable condition. The perimeter berm and ditch are functioning as designed and the liner was intact. There were no observations of erosion or other unsatisfactory conditions of the Cell 3 areas.

Photograph No. 6
Overall view of Cell 3
with rainflap and wind
defender.

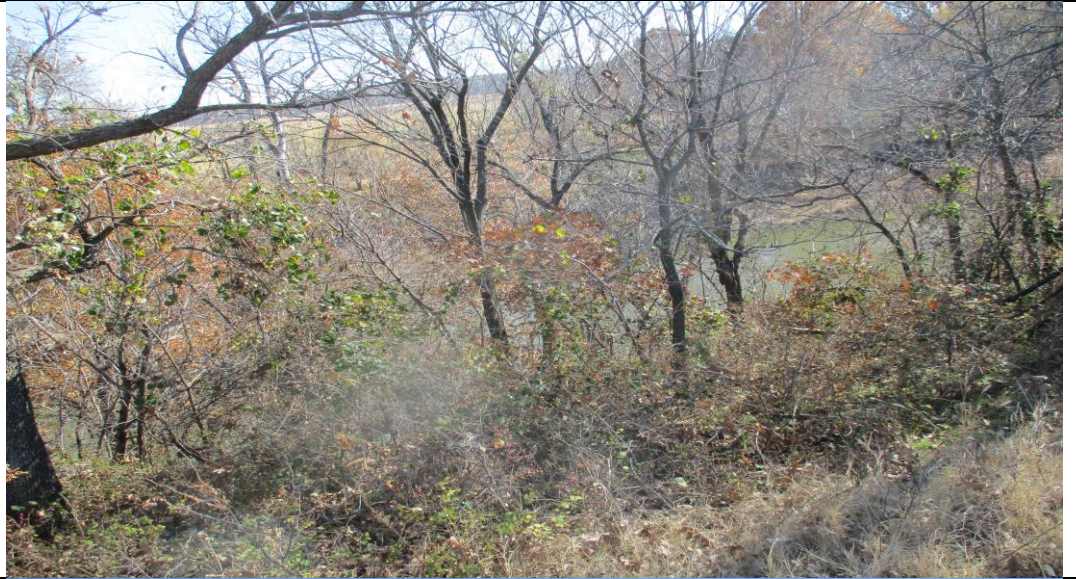
4. The slope adjacent to the river is very steep and observation of the slope from the chain link fence indicated the slope was heavily vegetated with mature trees and small bushes (Photograph No. 7). A temporary weir is cut into the perimeter berm (Photograph No. 8) for stormwater management appeared in good functional condition.

Photograph No. 7
Stability support berm slope adjacent to the river to the southeast side.

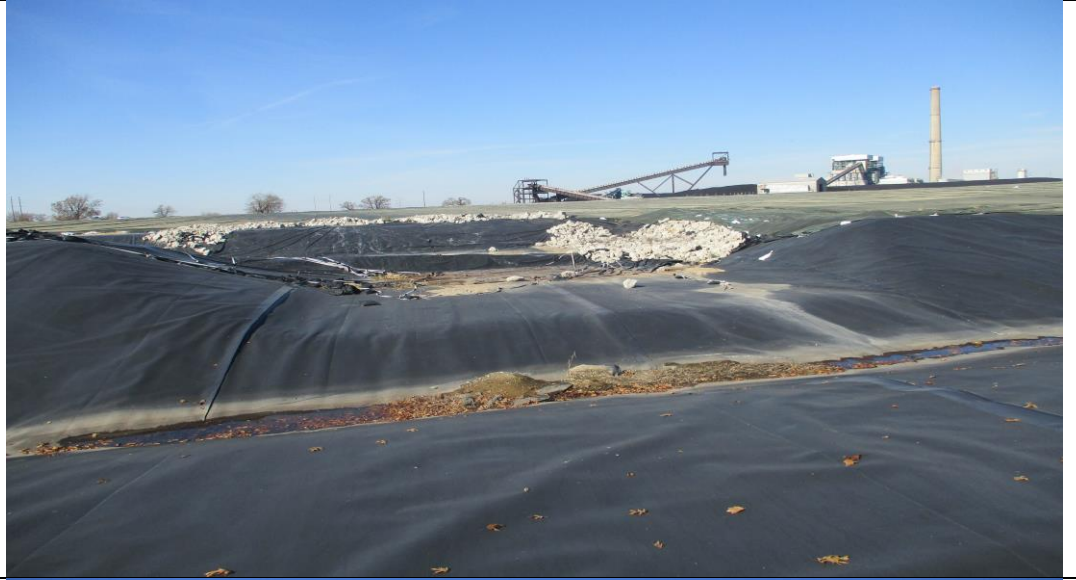
Photograph No. 8
Temporary stormwater control weir.

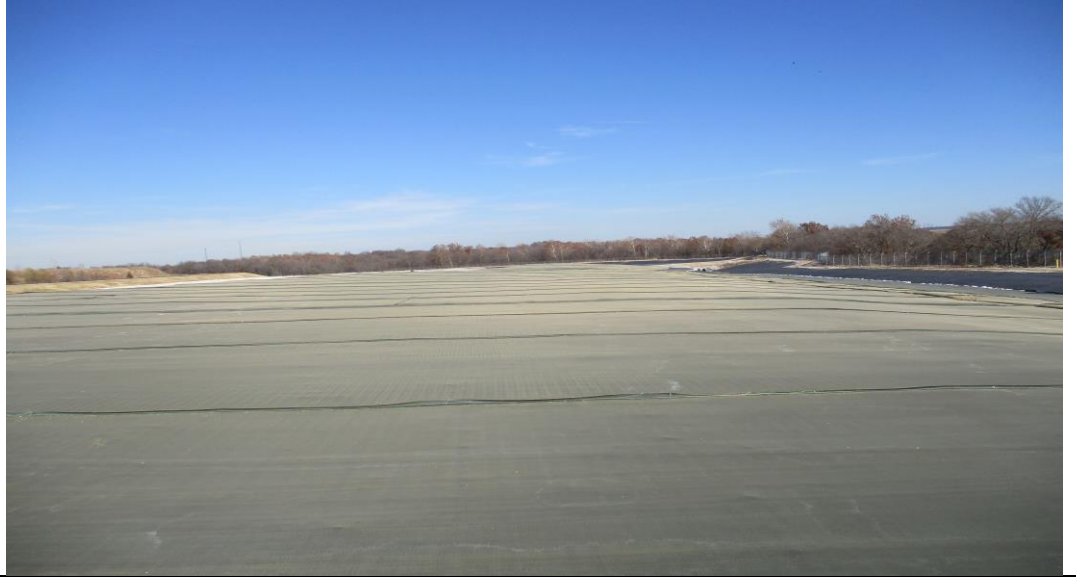
Photograph No. 9
Cell 2 area with rainflap and wind defender.

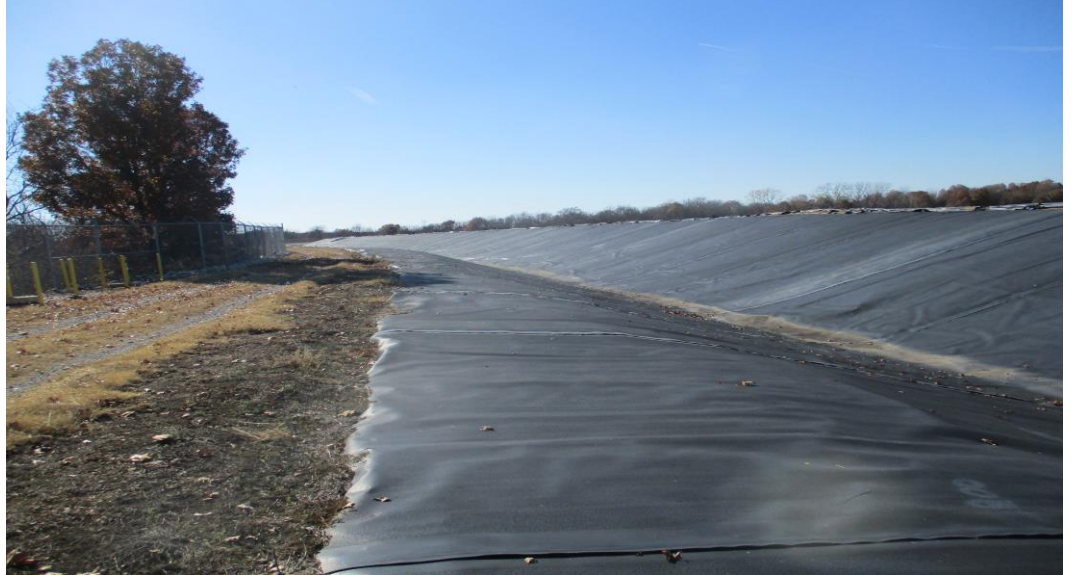
5. Photographs No. 10 and 11 illustrates Cell 2 surface of the inactive disposal areas covered with temporary geomembrane (rainflap) and wind defender, access road, and perimeter berm. Overall, the condition of Cell 2 area appeared good.

Photograph No. 10
Cell 2 access road and
perimeter berm.

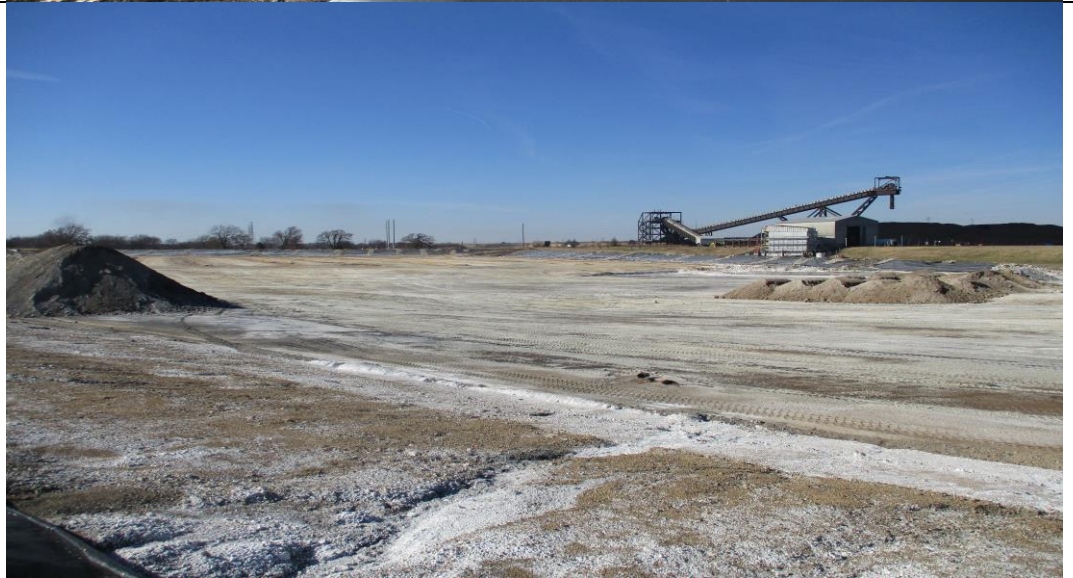
6. Photograph No. 11 illustrate typical condition of Cell 1 which is currently the active landfill disposal area. The surface appeared graded and free of ponding water. Temporary grades are maintained to direct runoff to the perimeter ditch to the north.
7. A temporary drainage channel is located at the north of Cell 1 boundary that let into the perimeter ditch (Photographs No. 12 and 13). The channel and the ditch is functioning, standing water and slightly overgrown vegetation was noticed in the ditch.

Photograph No. 11
Overall view of Cell 1.

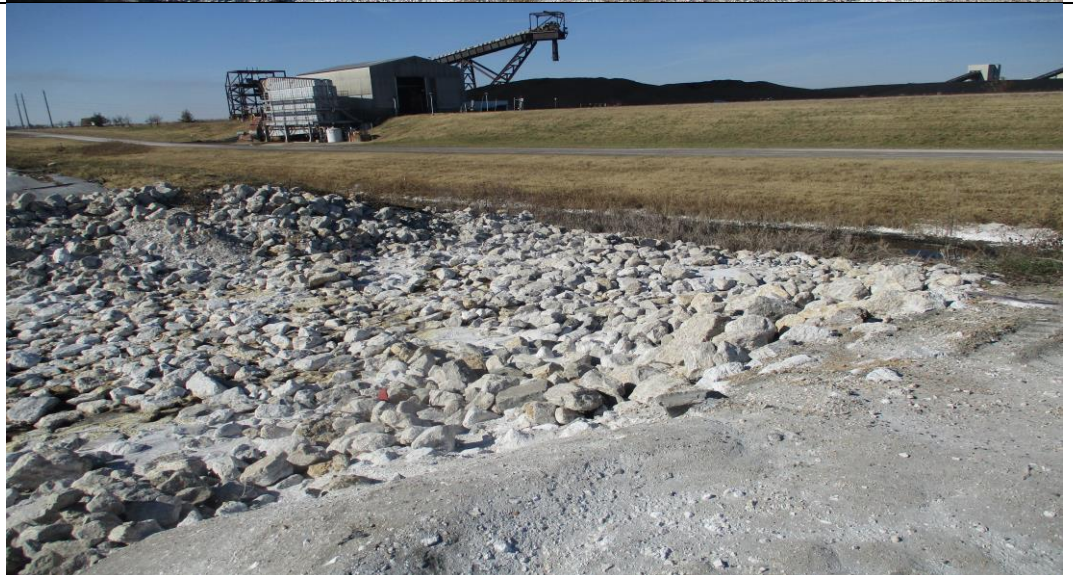
Photograph No. 12
Contact water channel of
Cell 1.

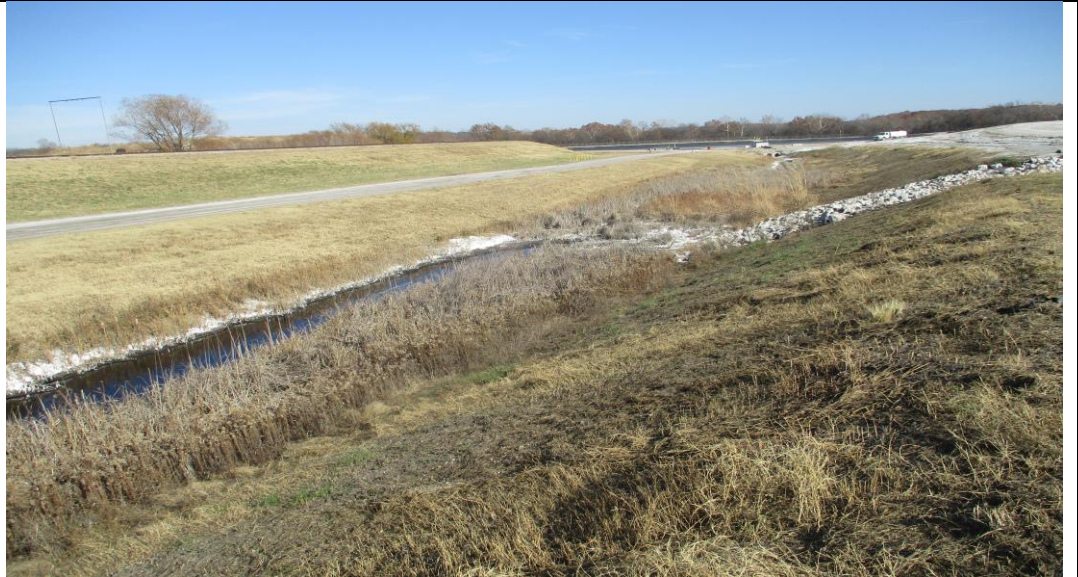
Photograph No. 13
Contact water ditch.

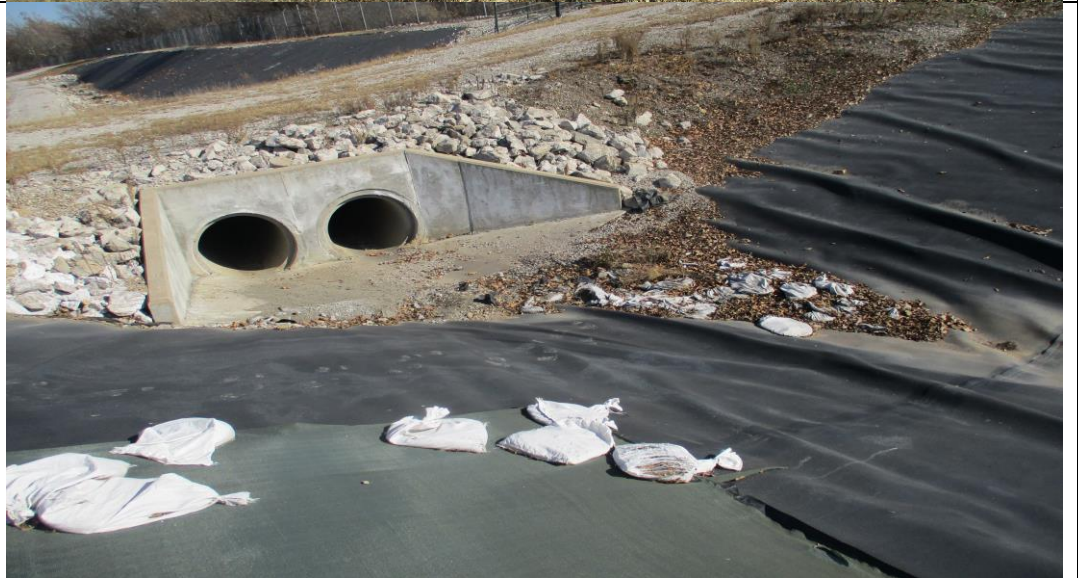
9. The north and south perimeter ditches at the eastern, downstream end of the landfill consists of pipe box culverts (Photographs No. 14-18). These pipe box culverts were clear of any debris and indicated no obstruction to flow or standing water. The drainage structures are functioning as designed.

Photograph No. 14
South perimeter ditch pipe culvert inlet.

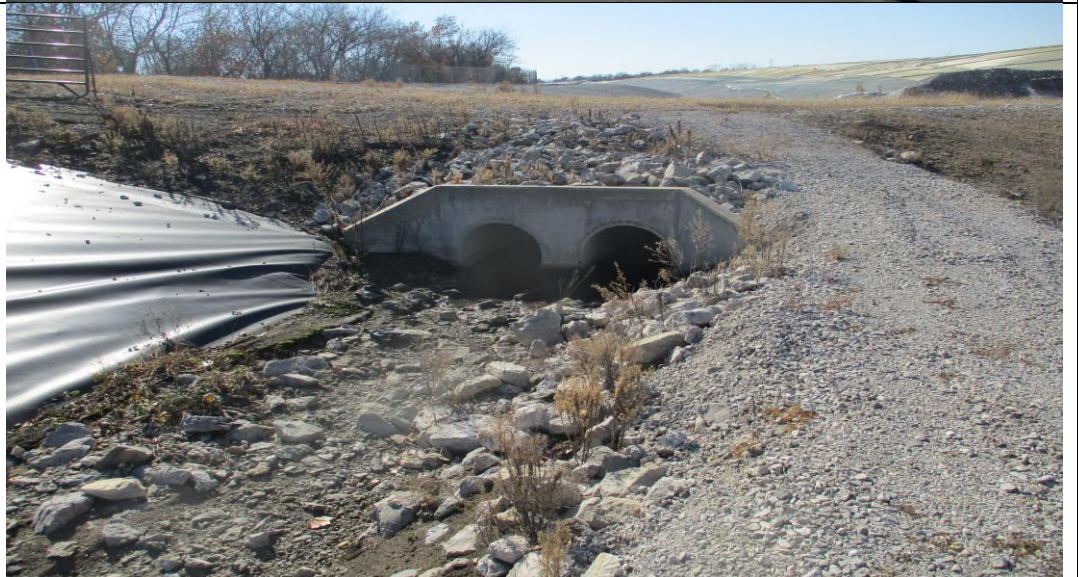
Photograph No. 15
South perimeter ditch pipe culvert outlet.

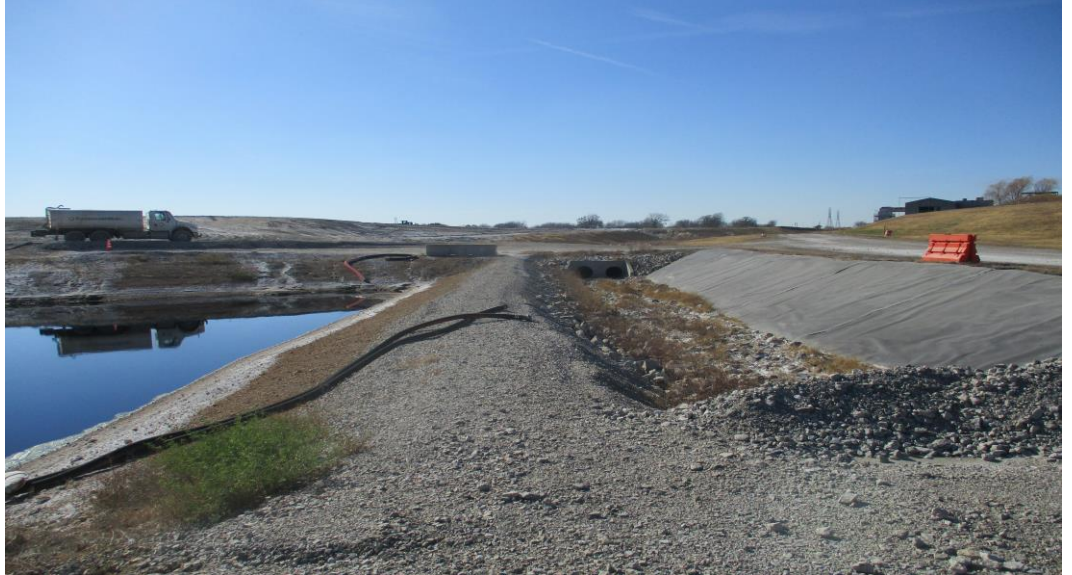
Photograph No. 16
North side ditch adjacent
to the leachate pond.

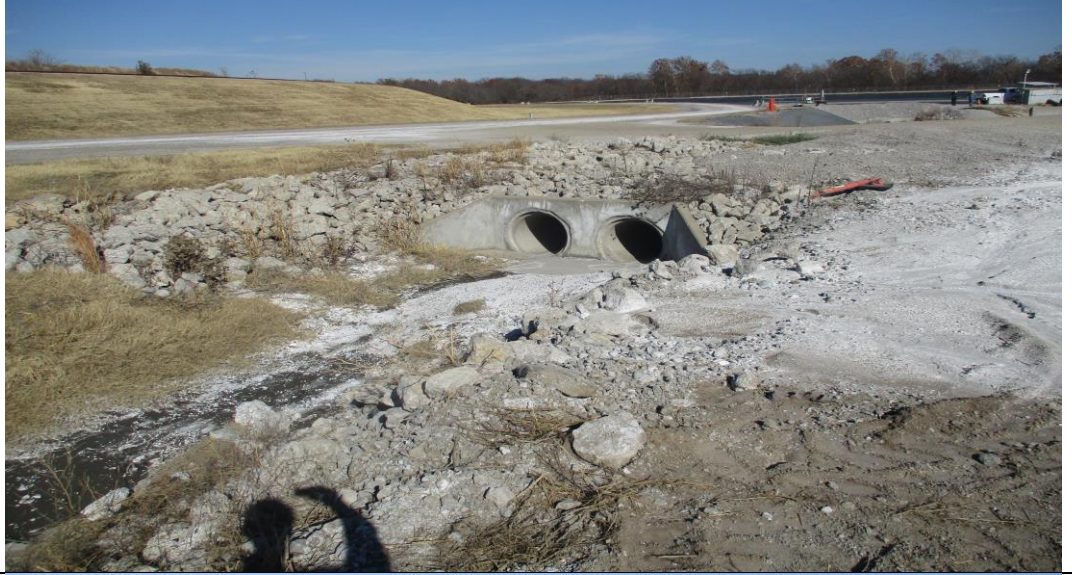
Photograph No. 17
North side ditch adjacent
to Cell 1.

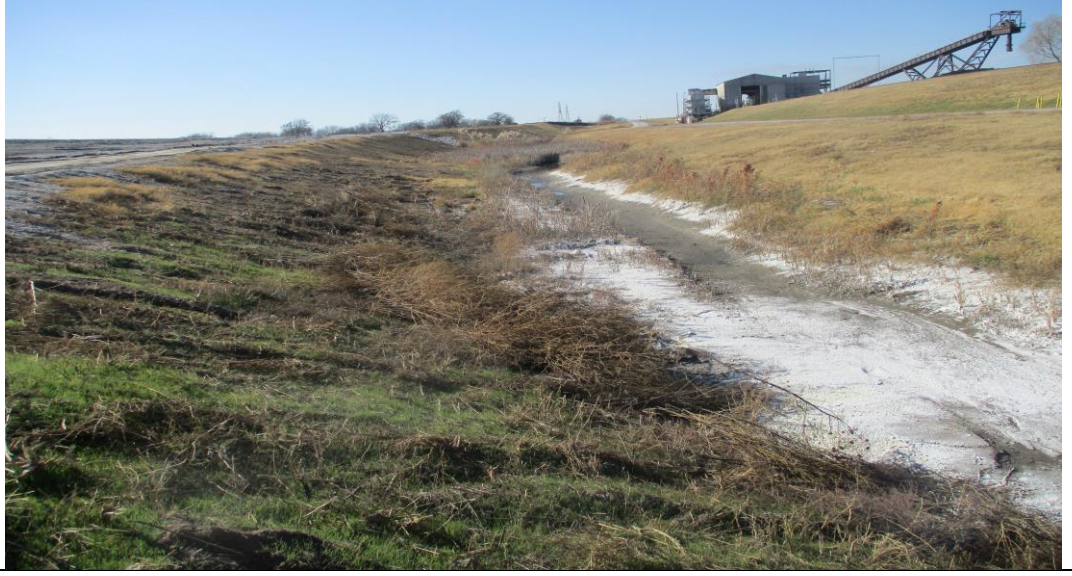
Photograph No. 18
North ditch (looking
west).

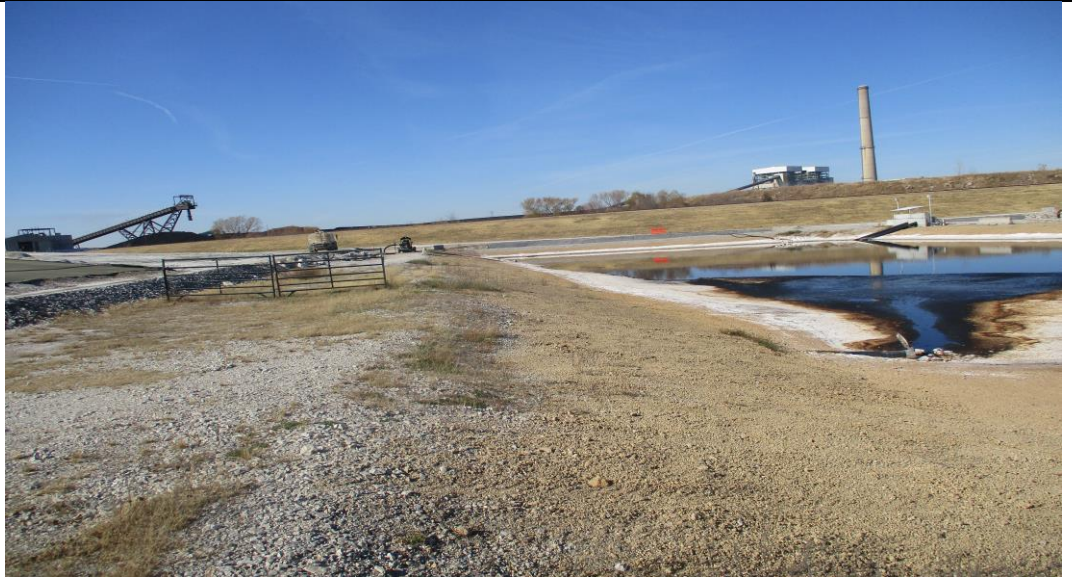
10. Typical condition of the west dike and interior slope is illustrated in Photographs No. 19 and 20. The dike crest located adjacent to the landfill appeared in fair condition and the slope indicated minor erosion.

Photograph No. 19
West dike of the leachate pond (looking northwest).

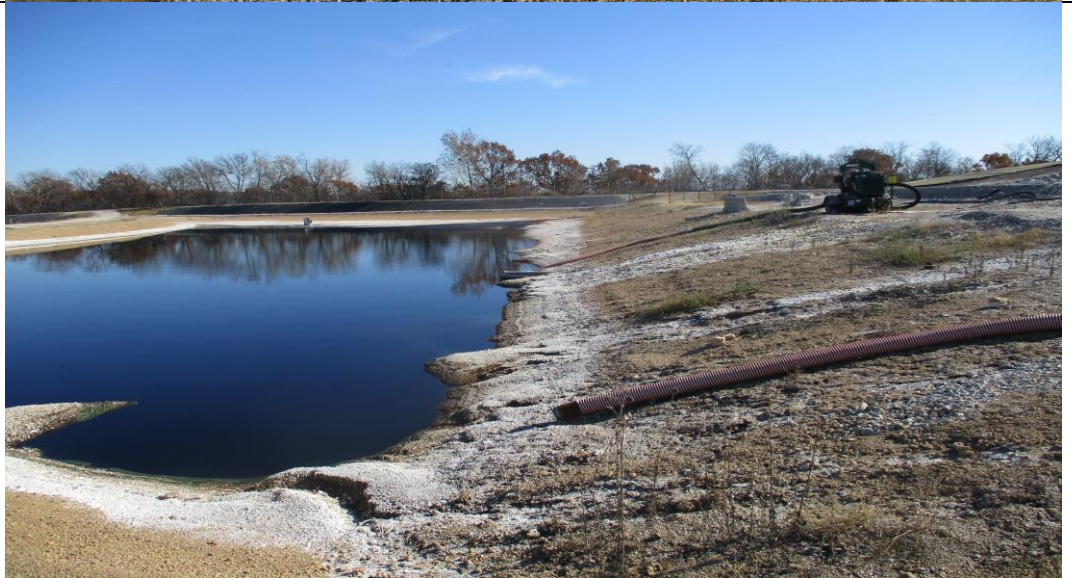
Photograph No. 20
Interior slope of the west dike, minor erosion.

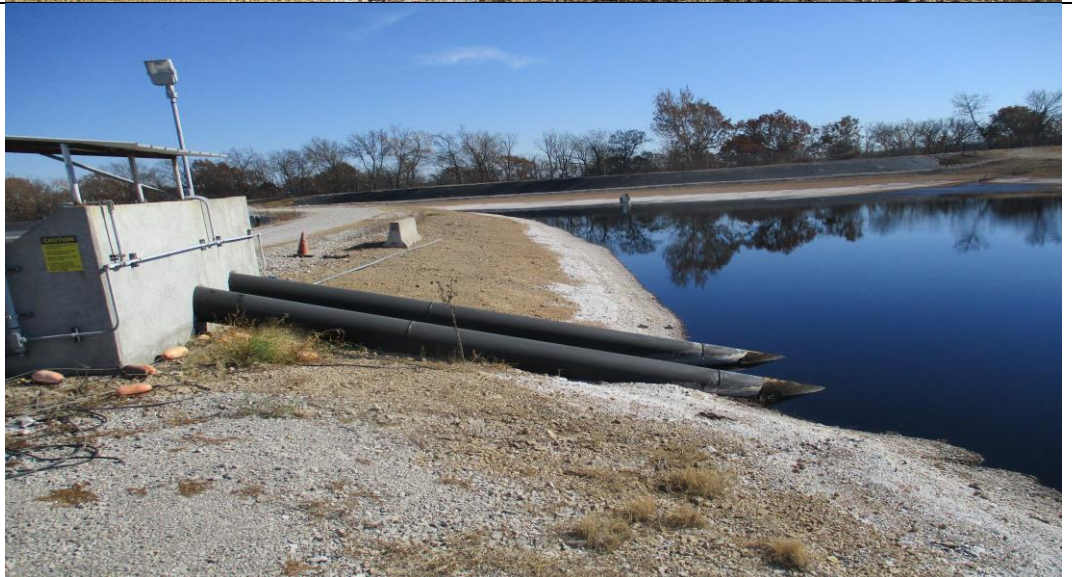
11. The north and the west dikes are illustrated in Photographs No. 21 and 22. A north conveyance channel is also illustrated in Photograph No. 22. Overall, the dikes and interior slopes appeared in good condition without any sign of significant erosion, settlement, or cracks.

Photograph No. 21
Interior slope of the east dike.

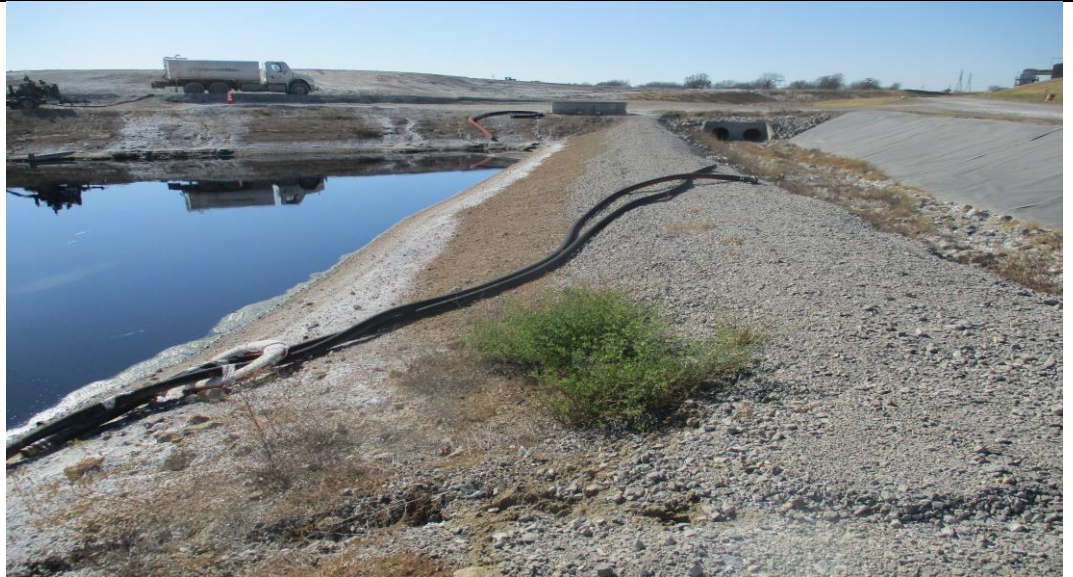
Photograph No. 22
North dike of the
leachate pond.

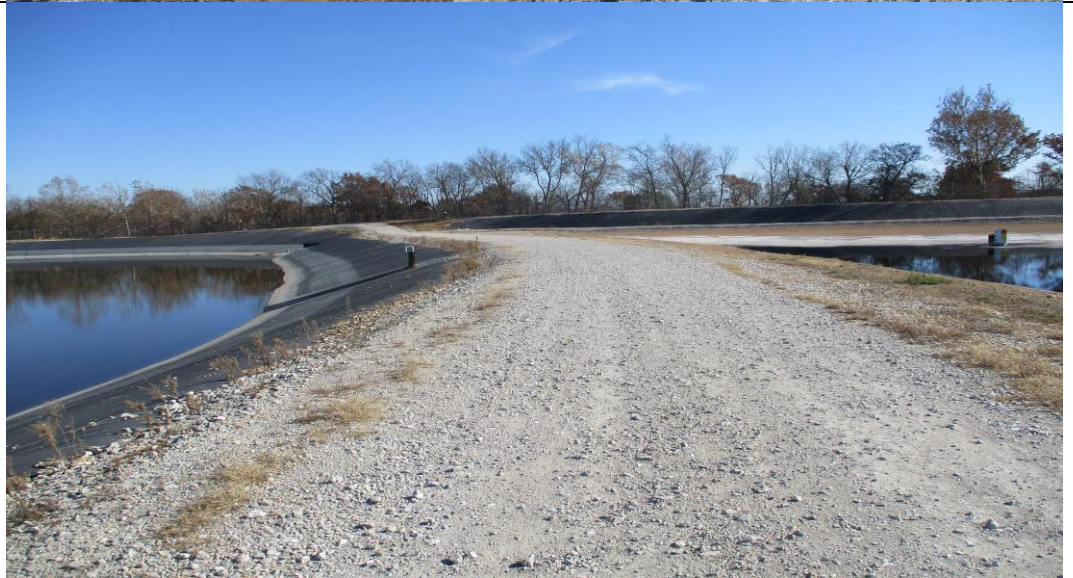
12. The splitter dike between the leachate pond and Basin C is illustrated in Photograph No. 23. The splitter dike appeared in good and stable condition without any settlement or misalignment.

Photograph No. 23
Dike between the Basin
C and the leachate pond

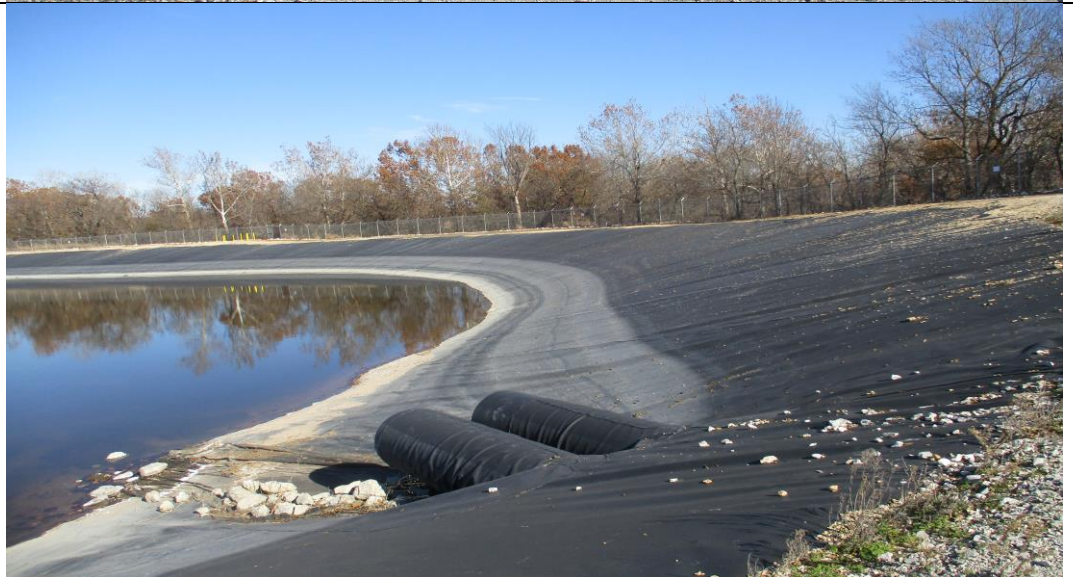
13. The crest and interior slope of Basin C appeared in good condition (Photographs No. 24 and 25). The geosynthetic liner was in place, intact and in good condition without any tear or damage. The crest also used as haul road of the north dike appeared in good and stable condition. Photograph No. 24 illustrates the north discharge pipes from the landfill runoff and appeared to be functioning.

Photograph No. 24
Interior slope of Basin C.
