**2017 LANDFILL INSPECTION REPORT
LITTLE BROAD RUN LANDFILL
CLASS F INDUSTRIAL WASTE LANDFILL**

**GERs-17-023
Revision 0**

**AMERICAN ELECTRIC POWER
APPALACHIAN POWER COMPANY
MOUNTAINEER POWER PLANT
NEW HAVEN, WEST VIRGINIA**

INSPECTION DATE August 15 & 16, 2017

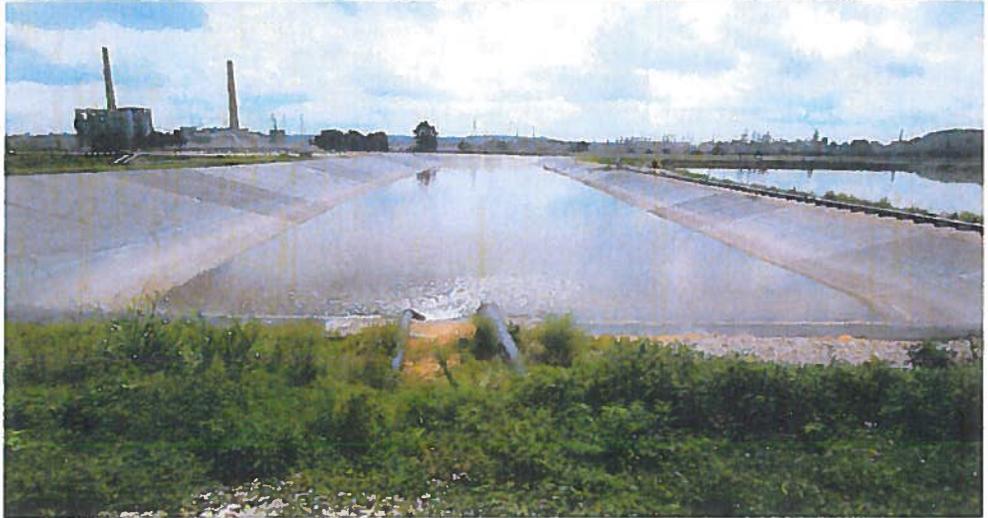
<p>Photo #1</p>

- (i) Photograph No. 1 illustrates part of the wastewater pond system. The leachate water from the landfill after going through the leachate collection pond system is discharge into the wastewater pond located at the power plant. The discharge pipes are illustrated in the photo and appeared to be in good functional condition.

<p>This photograph illustrates wastewater and landfill leachate discharge pipes.</p>	
<p>Photo #2</p>

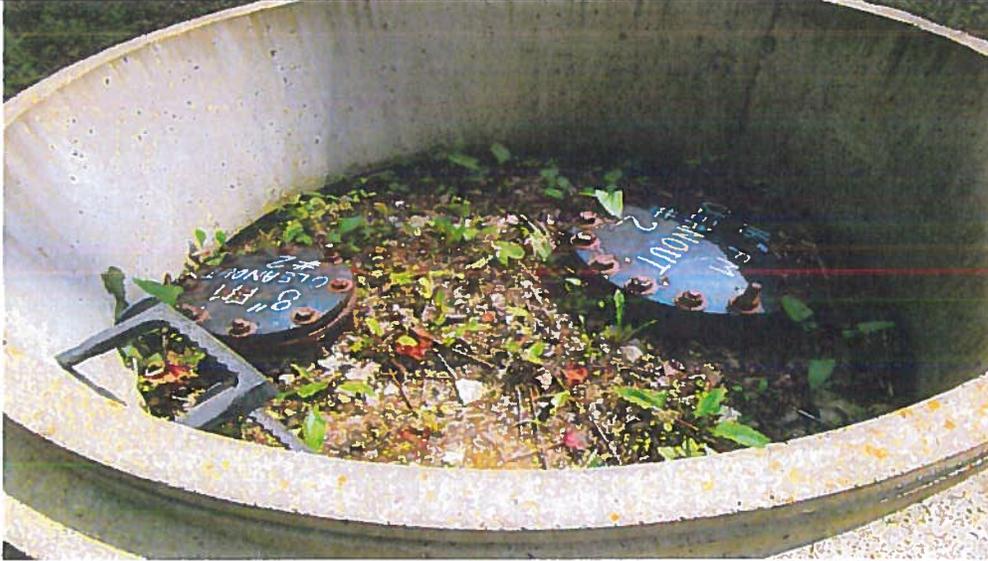
- (ii) The two discharge HDPE pipes (8" and 16" diameter) are installed between the leachate collection pond and the wastewater pond. There are numerous cleanouts between the wastewater pond and the leachate collection pond. Typical condition of the cleanout and the concrete manhole is illustrated in Photographs No. 2-4. All the cleanouts were inspected and appeared to be in good functional condition and no leaks were observed.

<p>Typical condition of the cleanout #2 and protective concrete manhole.</p>	
<p>Photo #3</p>

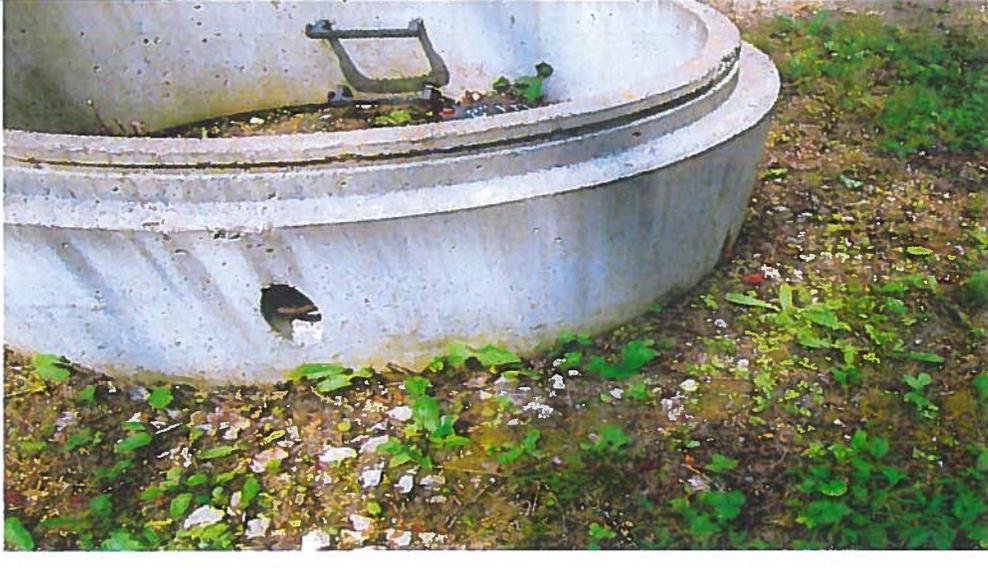
<p>This photograph illustrates existing ground around the manhole.</p>

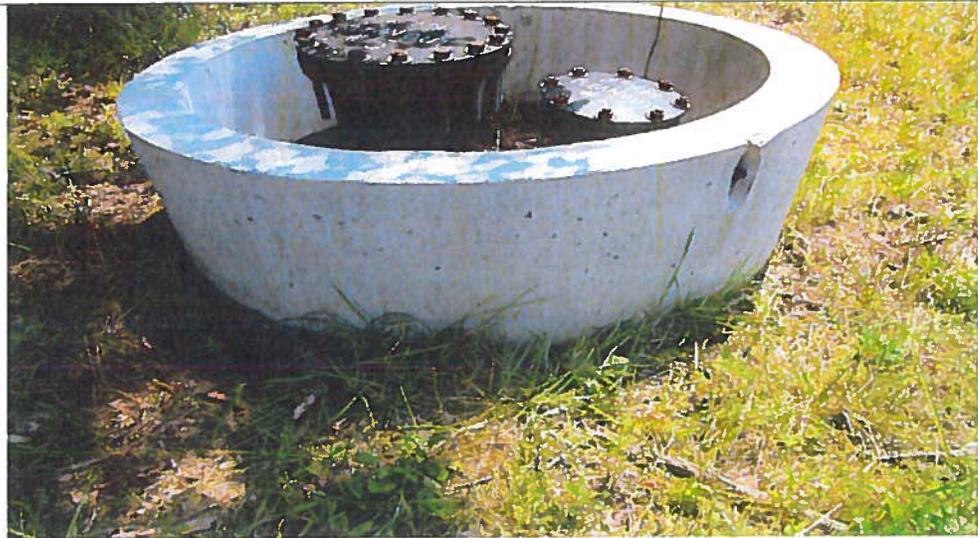
Photo #4

This photograph illustrates cleanout #5 and good condition.

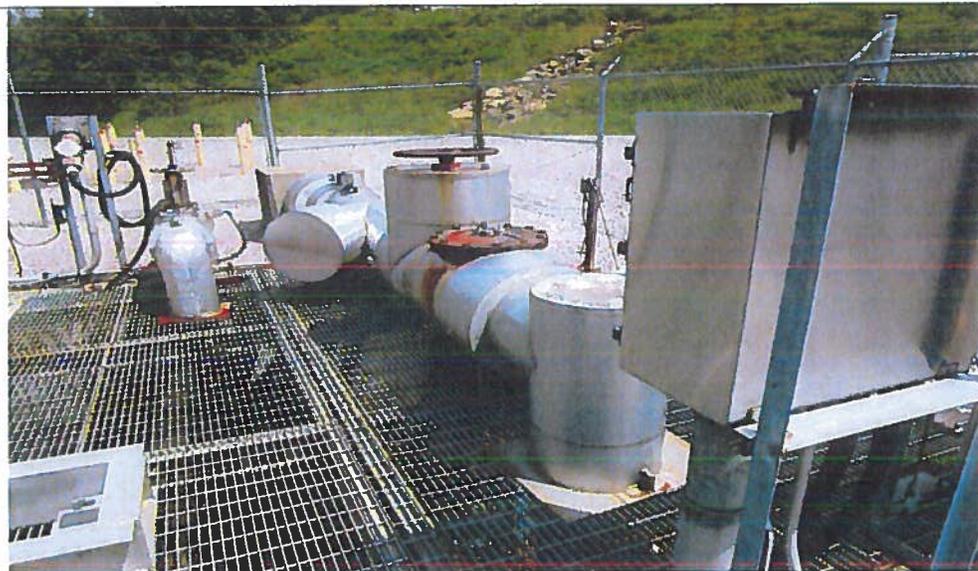
Photo #5

- (iii) Photograph No. 5 shows the leachate pond collection, sump, and pumping system. Two pumps are installed connected to the 8" and 16" HDPE pipes. For normal flow conditions, the 8" pipe and related pump is used and for high flows during

heavy rain events, the higher flow pump (16" pipe) could be used. The sump concrete structure, piping, and equipment appeared in good functional condition.

Leachate pond pumping system.

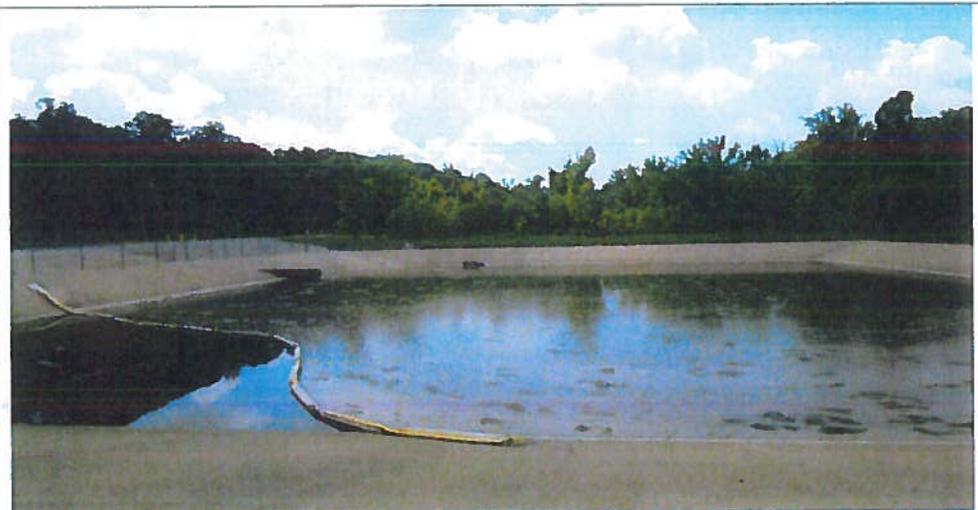
Photo #6

- (iv) A typical view of the leachate pond is illustrated in Photograph No. 6. There are two leachate collection ponds that receive waste streams from the landfill and the gypsum stacker pad. Both ponds are lined with concrete. The side slopes and concrete appeared in good condition and no significant cracks or settlement was noticed. The ponds appeared in good functional condition as designed.
(Note: The pipe boot tears noticed in the previous inspection were repaired)

Typical condition of the Leachate pond.

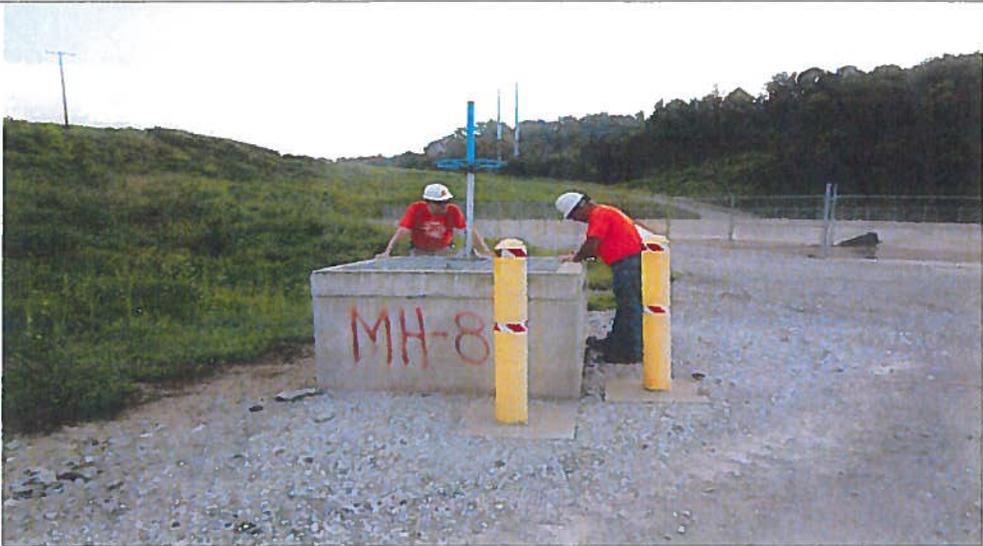
<p>Photo #7</p>

- (v) There are several manholes and cleanouts between the leachate ponds and the landfill. A typical view of the manhole (#8 and 2A) is illustrated in Photographs No. 7 and 8. All the manholes and cleanouts appeared in good functional condition as designed.

<p>Manhole #8</p>	
<p>Photo #8</p>

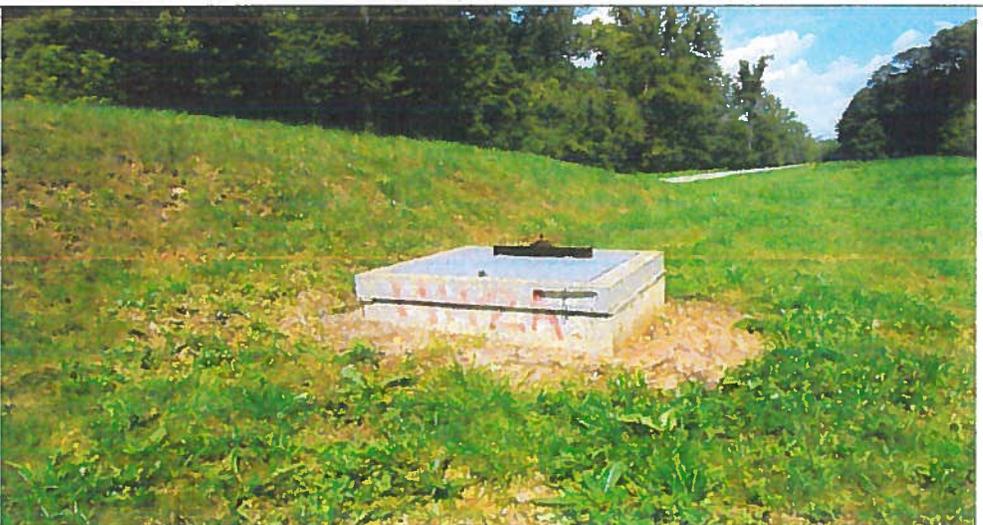
<p>Manhole # 2A.</p>	
<p>Photo #9</p>

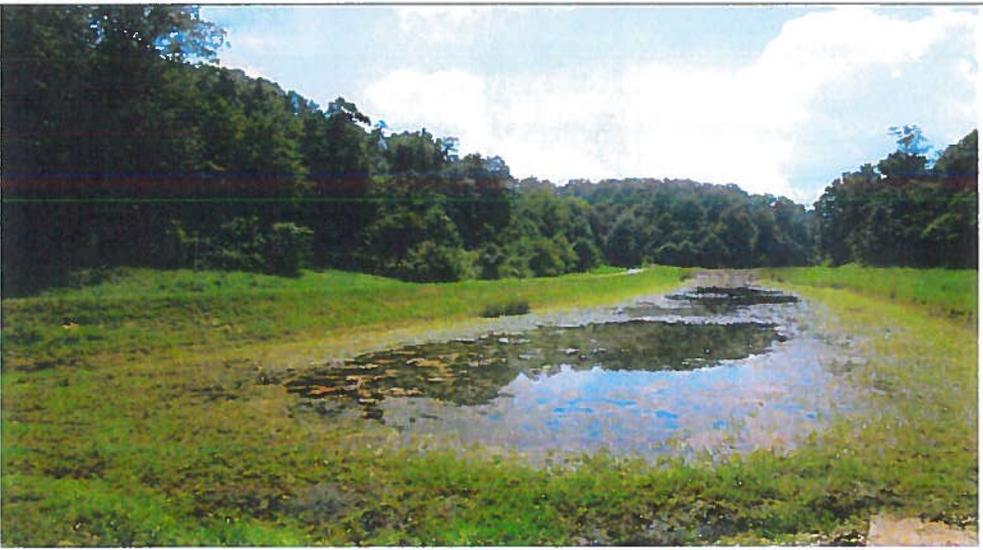
- (vi) Area 7 sediments ponds are located at the toe of the northeast corner of the landfill. Area 7 is located upstream of the sediment ponds. Photographs No. 9 and 10 illustrate the general condition of the sediment ponds. Initially there was one sediment pond and the second sediment pond was added later. The interior slopes of the ponds are relatively steep but appeared in stable condition. The ponds appeared to be in good functional condition. Photograph No. 11 illustrate the permitted outfall (outlet #024) in good functional condition without any obstruction to flow.

<p>Sediment pond (addition) upstream of the outfall.</p>

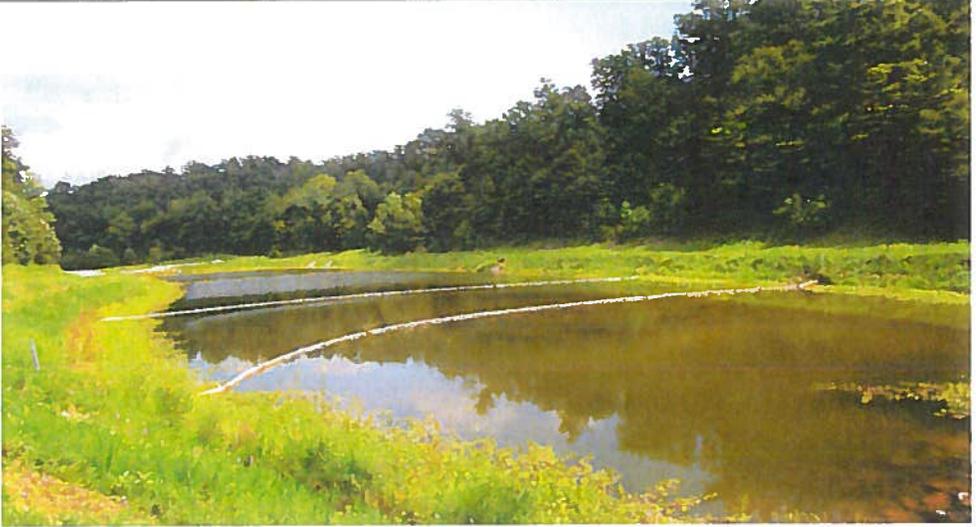
<p>Photo #10</p>

<p>Original Sediment pond.</p>	
<p>Photo #11</p>

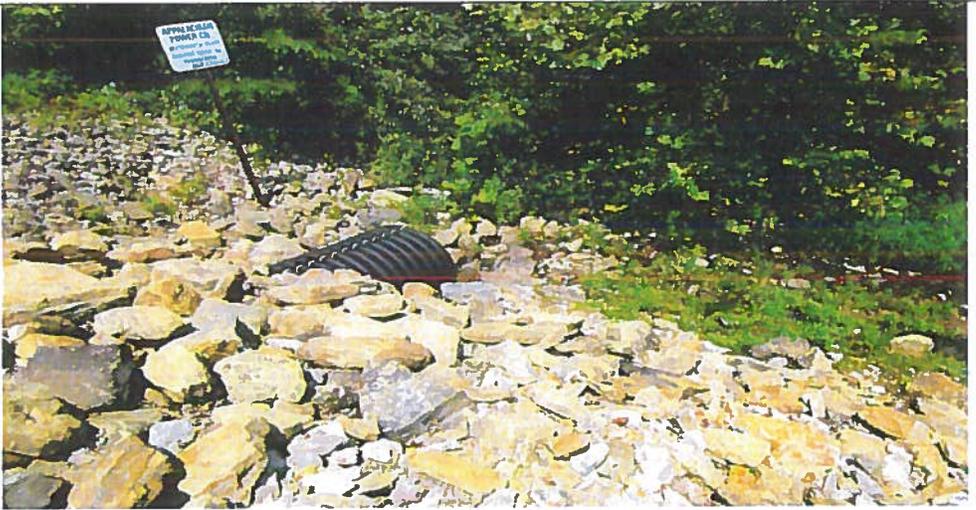
<p>Outfall #024.</p>	
<p>Photo #12</p>

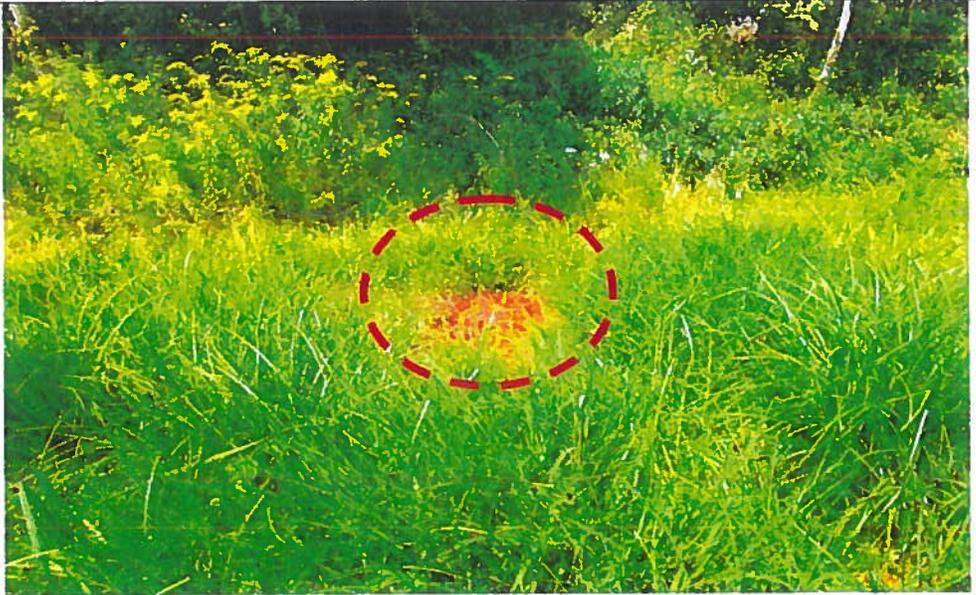
- (vii) The lower section of Area 3 indicated seepage to the south and a slip to the north (Photographs No. 12 and 13).

Seep and Slip: This item was noted as potential deficiency during the 7-day inspection. This item was discussed by the plant staff with the Geotechnical Engineering and temporary repair was performed in June 2017.

<p>Area 3 seepage.</p>

- (i) The seepage and the potential slip area at the Area 3 of the landfill shall be investigated to determine the root cause of the deficiencies and appropriate corrective action in terms of monitoring and/or remediation shall be implemented.
- (ii) Some type of sediment control structure (e.g. barrier or curtain) shall be properly designed and installed that will minimize flow of solids to the sump.

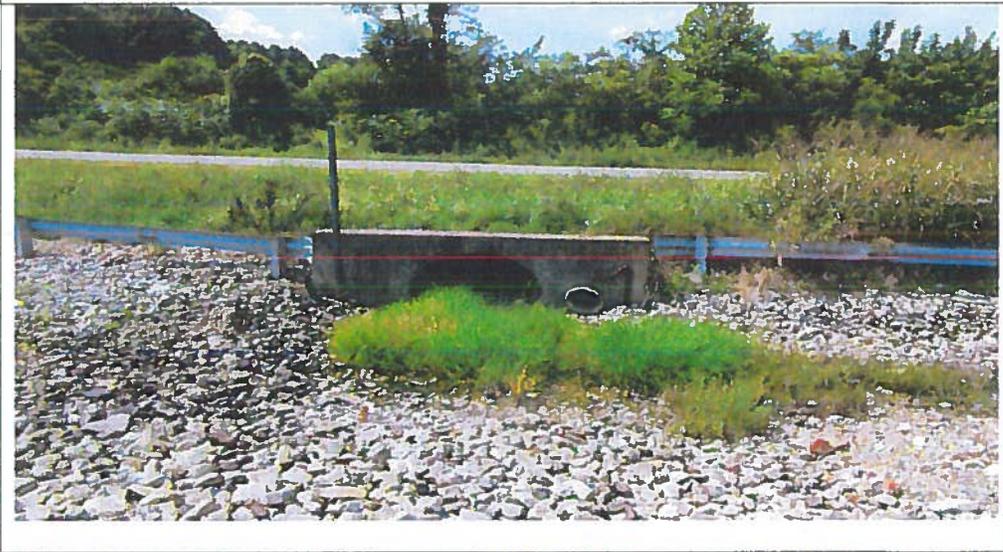
- (viii) Previously repaired area along the outfall (outlet #002) is illustrated in Photograph No. 14. This area and the riprap appeared in good condition. A small area in front of the outfall consists of minor brush growth and the sign post was missing.

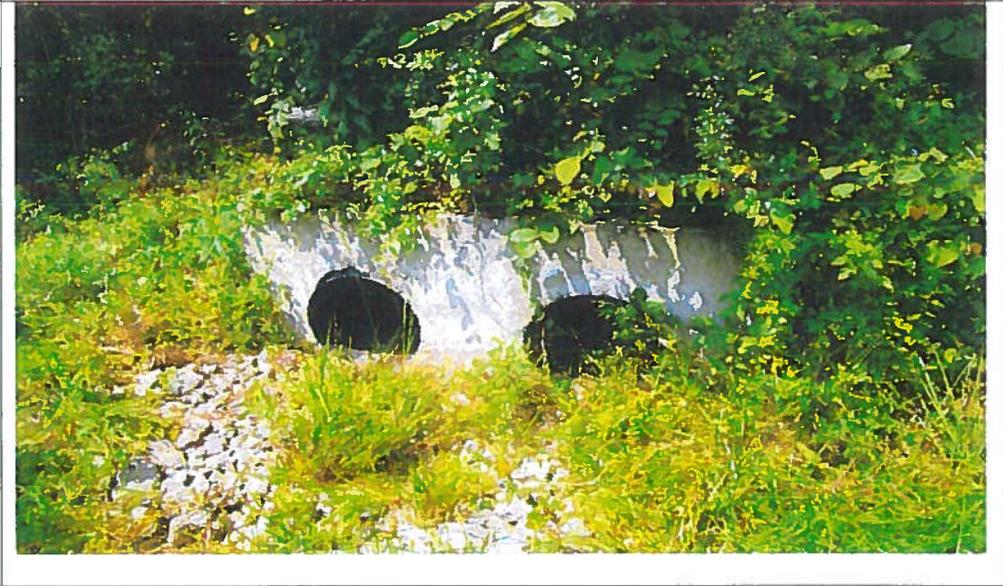
- (ix) A typical condition of the outfall (outlet #025) is illustrated in Photograph No. 15. Both the outfall pipes were dry and did not indicate any standing water in the pipe. Minor brush was noticed in an area adjacent to the inlet. Overall, all of the landfill outfalls were in good and functional condition.

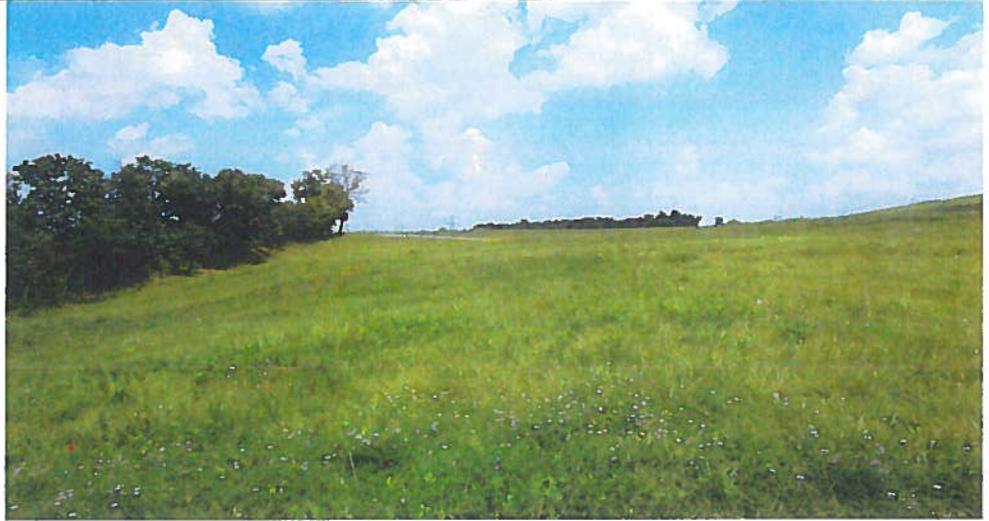
<p>Photo #16</p>

- (x) Photographs No. 16-18 illustrate generally good condition of the landfill. The landfill slopes area well maintained and are in good and stable condition. Minor vegetation growth was noticed in the lower section of the landfill.

<p>Typical condition of landfill Area 4 cover.</p>	
<p>Photo #17</p>

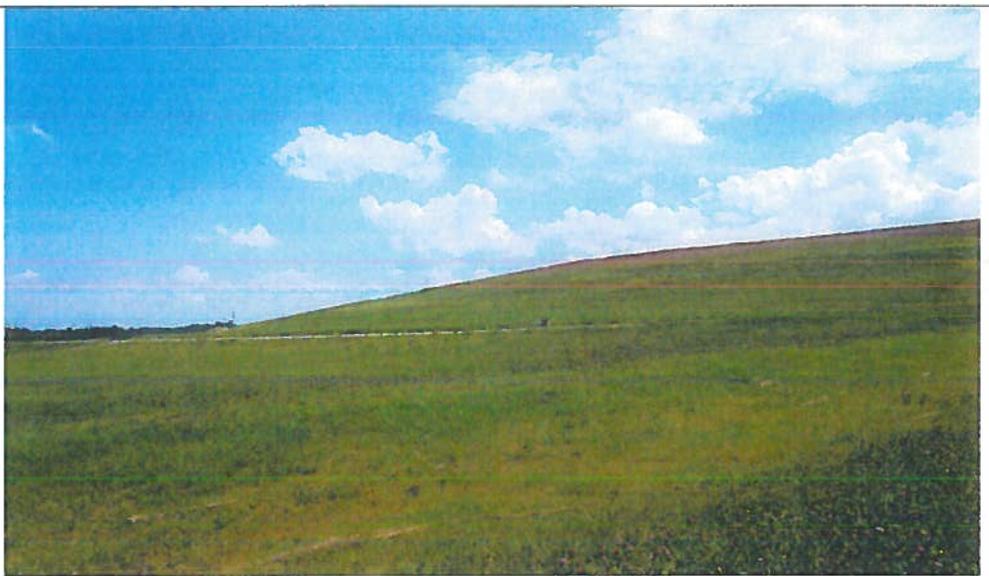
<p>Overall typical condition of the landfill cover.</p>	
<p>Photo #18</p>

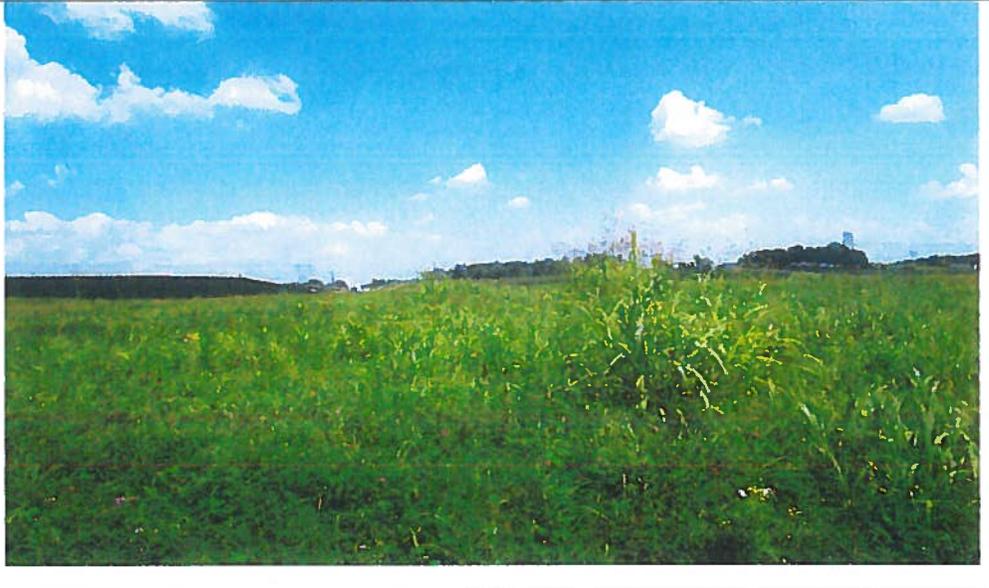
<p>Minor vegetation growth was observed.</p>

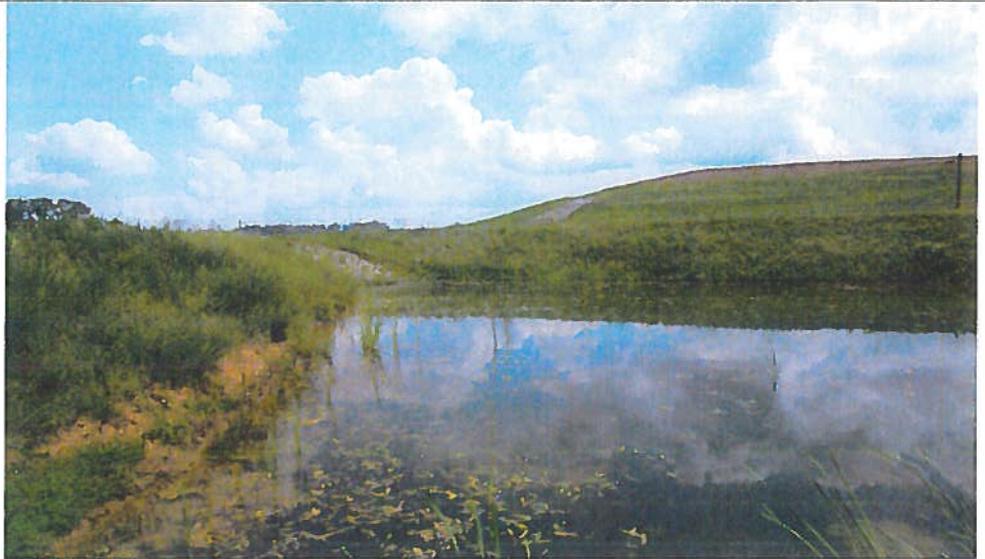
- (xi) Northwest sediment pond is illustrated in Photograph No. 19. Minor vegetation growth were noticed on the interior slopes, but were in stable condition. The pond appeared to be in good and functional condition as designed.

<p>Photo #19</p> <p>Northwest sediment pond.</p>

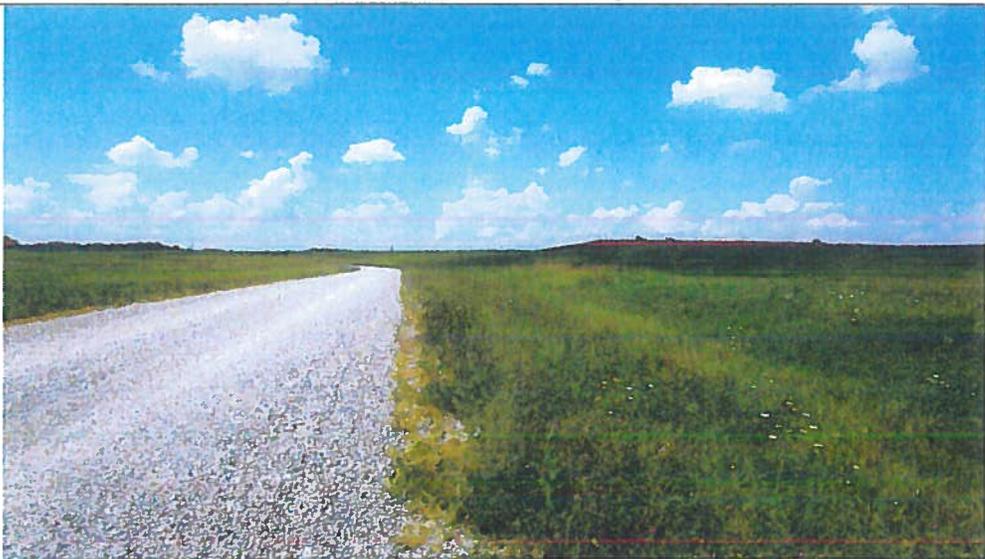
- (xii) Typical view of the landfill haul road and drainage ditch is illustrated in Photograph No. 20. The gravel road appeared in good and stable condition and no significant ruts, settlement, or misalignment were noticed. Minor vegetation growth was noticed in the ditches.

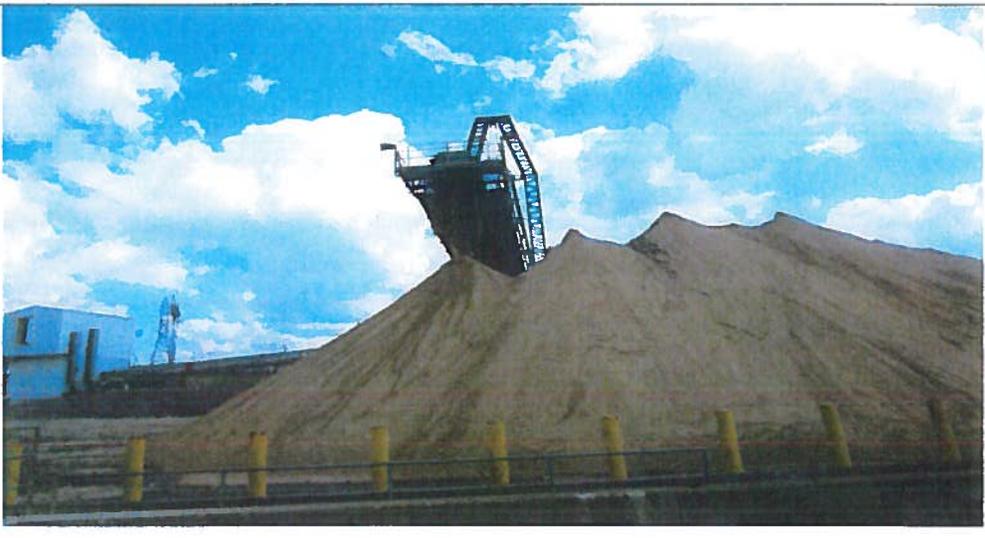
- (xiii) Gypsum stacker pad is shown in Photographs No. 21 and 22. The sump is located very close to the gypsum stockpile. Also the radial stacker is designed to spread gypsum laterally and is fixed in the vertical direction (height of gypsum). The stockpile is very close to the sump area and has a tendency to carry solids to the sump.

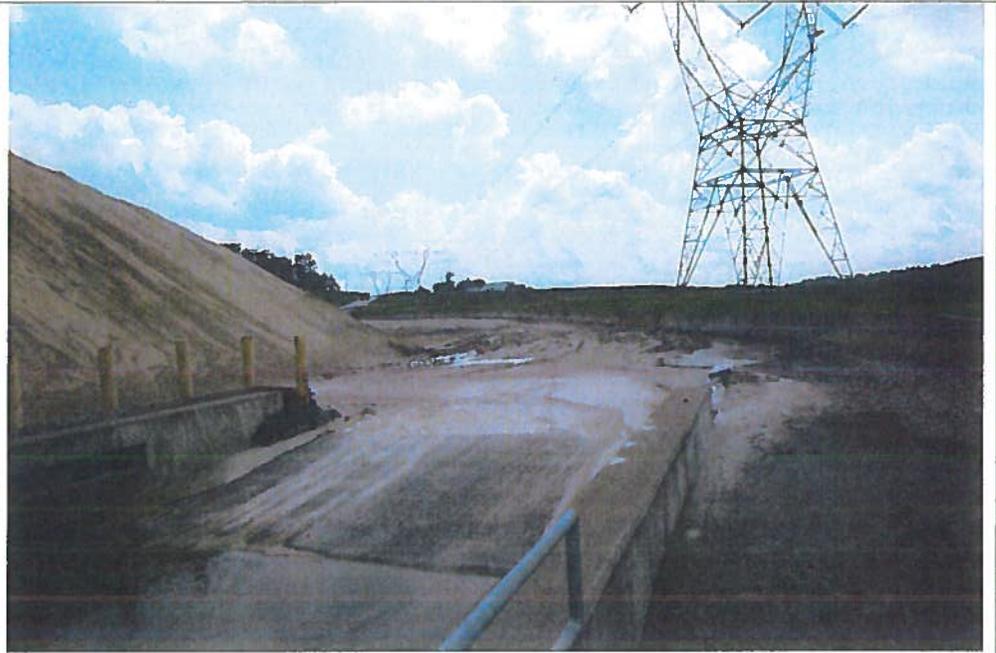
Photo #22

- (i) Overall the landfill areas were in good condition and no signs of distress or instability of the slopes were observed, except potential deficiency in Area 3 of the landfill.
- (ii) The storm-water collection system ponds, piping, manholes, cleanouts, and appurtenances were in good functional condition.
- (iii) The leachate collection management system, ponds, sump, manholes, cleanouts, and appurtenances appeared to be in good and functional condition.
- (iv) Minor vegetation growth was noticed in the lower section of the landfill.
- (v) Area 3 of the landfill indicated seepage and slip area close to the toe of the landfill.
- (vi) The gypsum stacker pad appeared to be in good functional condition. Surface runoff from the pad appeared to carry gypsum particles into the sump.

Gypsum stockpile next to the sump.
