**2017 ANNUAL DAM AND DIKE INSPECTION REPORT**

East and West Bottom Ash Pond Dams  
H.W. Pirkey Plant  
Harrison County, Texas

September 12, 2017

Document ID: GERS-17-034

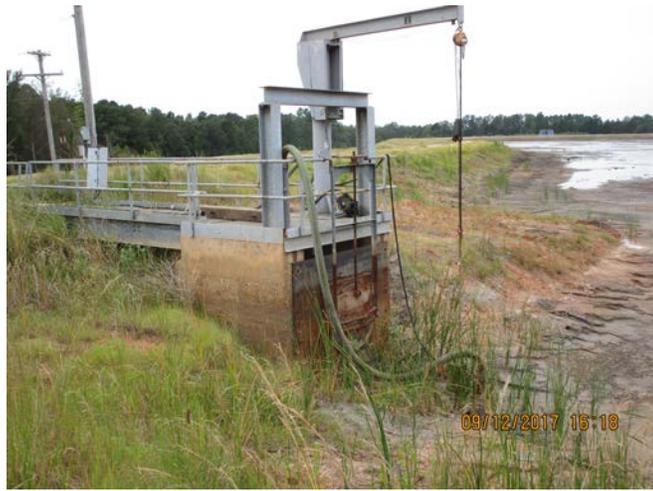
**Photo # 1**

signs of active erosion as a result of the unprotected soils. A gravel road runs along the crest. There was no evidence of rutting, cracking, instabilities or low areas along the crest. Some minor erosion rills had formed on a ramp to the crest at the southwestern corner of the embankment. There was no evidence of rodent burrows on the embankments. Brush was present on the exterior slope around a power pole by the southeastern corner of the embankment and also present around a drainage culvert beyond the southern exterior toe. There was no evidence of seepage (although the pond was dry) or instabilities on the exterior slope. A berm has been constructed out of bottom ash for water treatment purposes inside the pond area, near the northwestern corner of the pond. The 36-inch-diameter gate valve on the discharge structure was observed to have corrosion on the exterior surface and components. The interior of the discharge structure was inundated and could not be inspected.

View of the discharge structure at the West Bottom Ash Pond.

1. Perform a detailed inspection of the corrugated metal pipe conduits which discharge into the Secondary Bottom Ash Pond. Results of the detailed inspection should be used during an evaluation of the structural integrity of the corrugated metal pipe conduits.
2. Protect the soils in the perimeter ditch of the Eastern Bottom Ash Pond from erosion. This can be accomplished by establishing a grass cover in the area or using alternative means of erosion protection.
3. Repair the erosion rills on the ramp near the southwestern corner of the Western Bottom Ash Pond Dam.
4. Remove the brush growing near the southeastern corner of the Western Bottom Ash Pond Dam and around the surface drainage culvert beyond the southern exterior toe of the Western Bottom Ash Pond Dam. In addition, remove the cattails growing on the interior slope of the embankments.

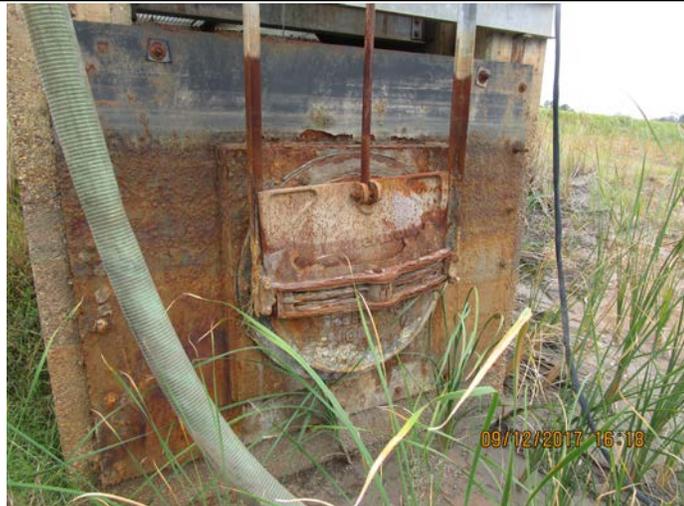
**Photo # 2**

2. The condition of the corrugated metal discharge pipes could not be inspected due to the water levels in the ponds/discharge structures. Due to the age of these conduits and the corrosive environment around the pipes, these conduits should be investigated to ensure the structural integrity of the corrugated metal pipe material. Being aware of the condition of these conduits might allow for the implementation of trenchless technologies (i.e. slip-lining) and budgeting of any repair or replacement costs.

Close-up view of the corrosion on the discharge structure of the West Bottom Ash Pond.

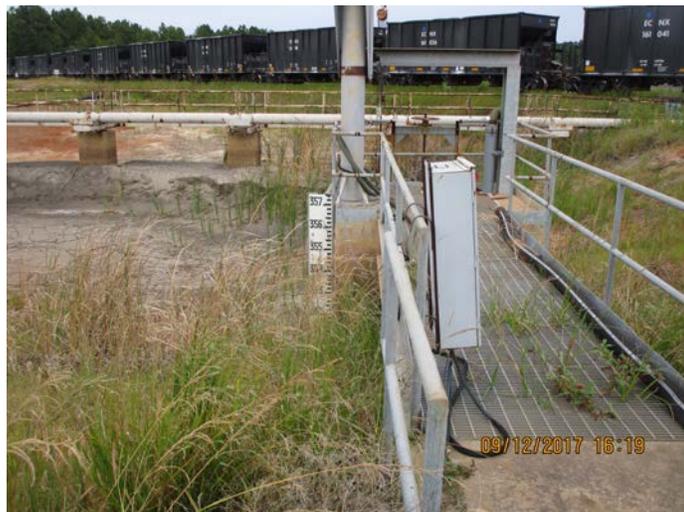
**Photo # 3**

View showing the staff gauge on the discharge structure

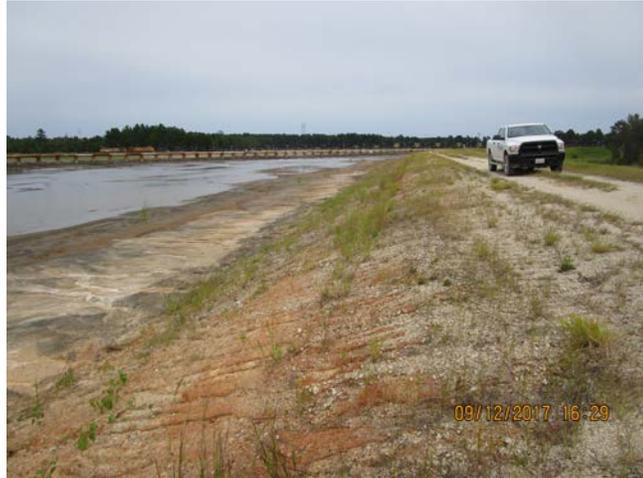
**Photo # 4**

At the time of the inspection, the West Bottom Ash Pond was dry and out of service. Minor bare areas were noted at many locations on the interior slope, although there were no

Typical view of the interior slope of West Bottom Ash Pond Dam.

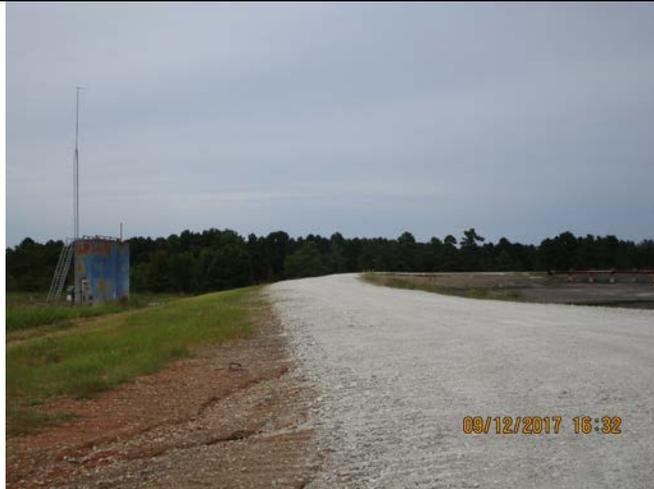
**Photo # 5**

Typical crest area of the West Bottom Ash Pond Dam.

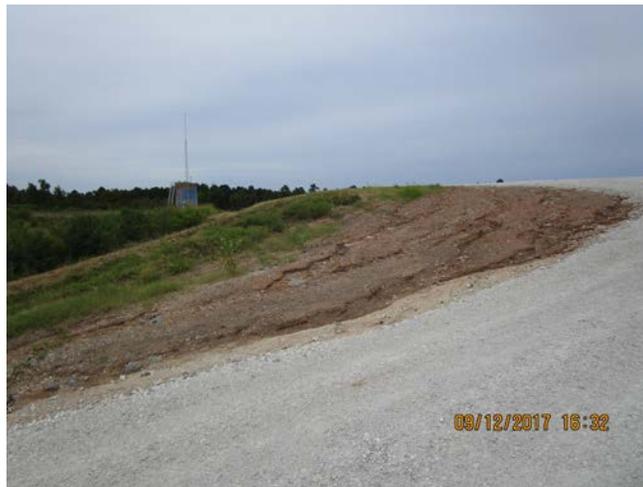
**Photo # 6**

View of the erosion rills on the ramp to the crest near the southwest corner of West Bottom Ash Pond.

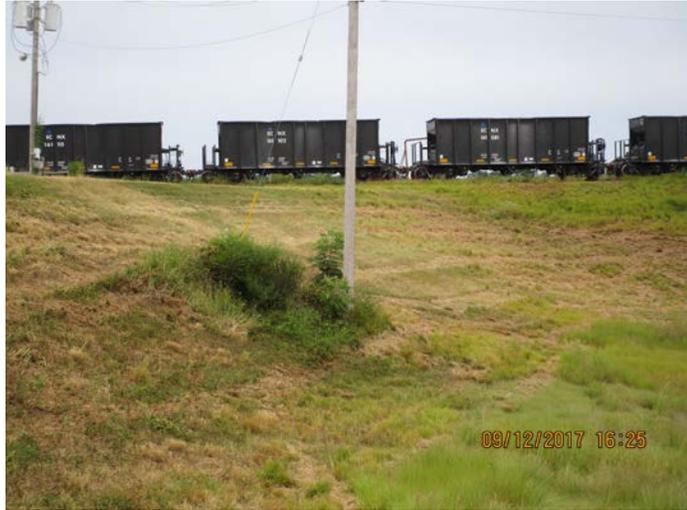
**Photo # 7**

View of some minor brush growing on the exterior slope, near the southeast corner of the West Bottom Ash Pond Dam.

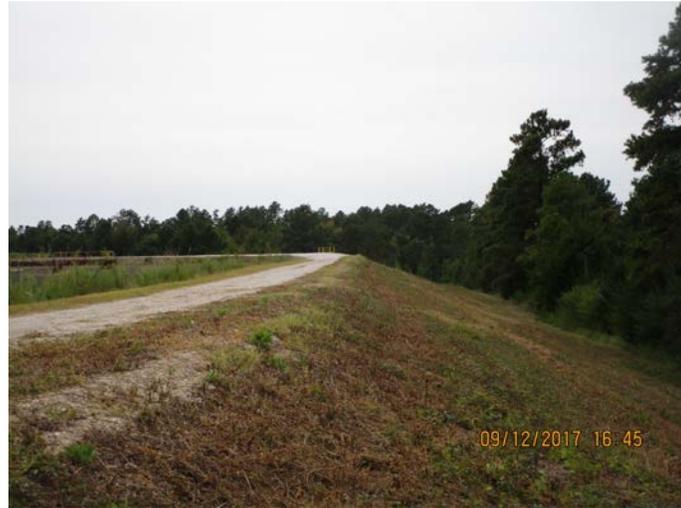
**Photo # 8**

View of the crest and exterior slope of the West Bottom Ash Pond Dam.

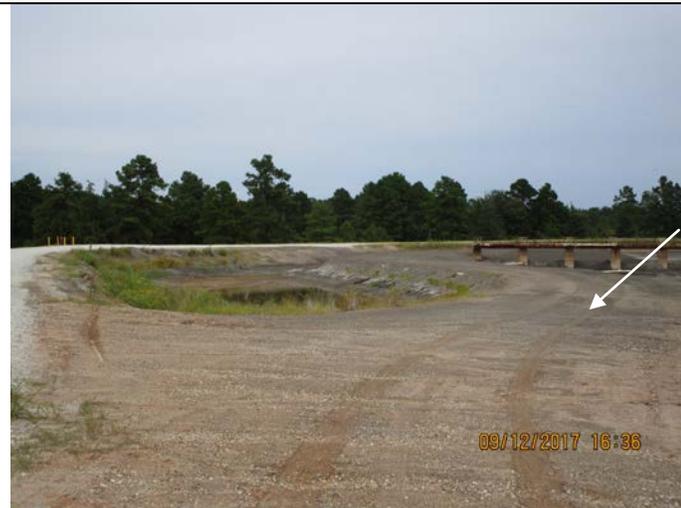
**Photo # 9**

View of a berm constructed of bottom ash inside the West Bottom Ash Pond area, indicated by a white arrow.

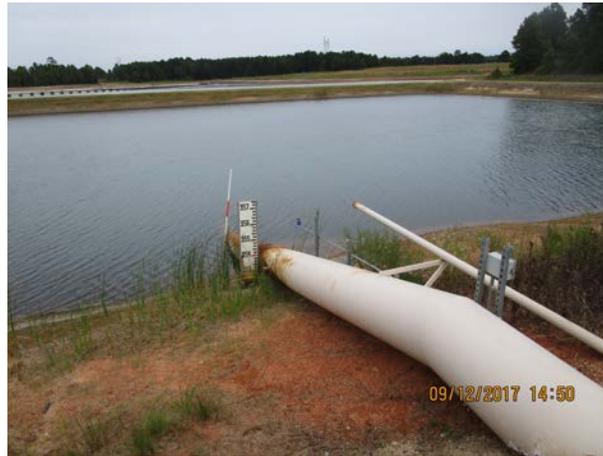
**Photo # 10**

View of the pump intake line at the secondary Bottom Ash Pond Dam.

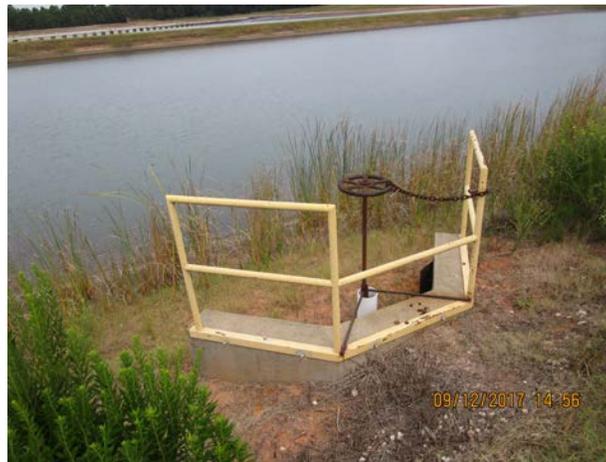
**Photo # 11**

View of a formerly used outlet at the Secondary Bottom Ash Pond Dam. This is Outfall 006.

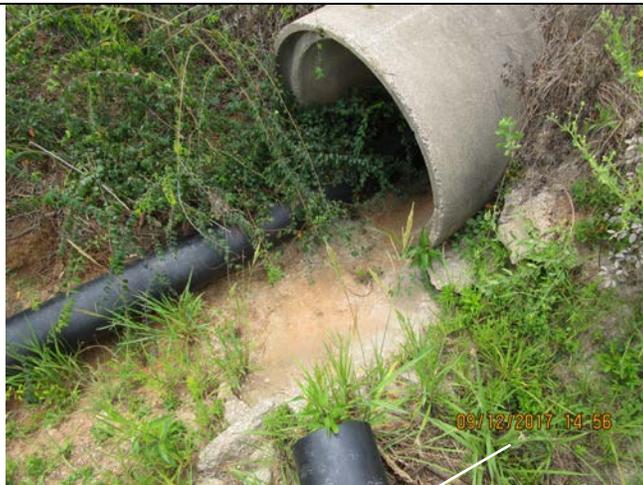
**Photo # 12**

View of the outlet of the formerly used outlet at the Secondary Bottom Ash Pond Dam, indicated by the white arrow. This is Outfall 006.

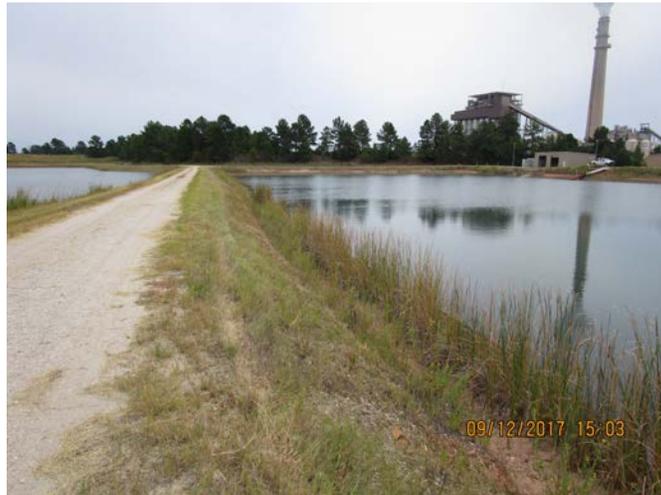
**Photo # 13**

View of the interior slope and crest of the Secondary Bottom Ash Pond Dam.

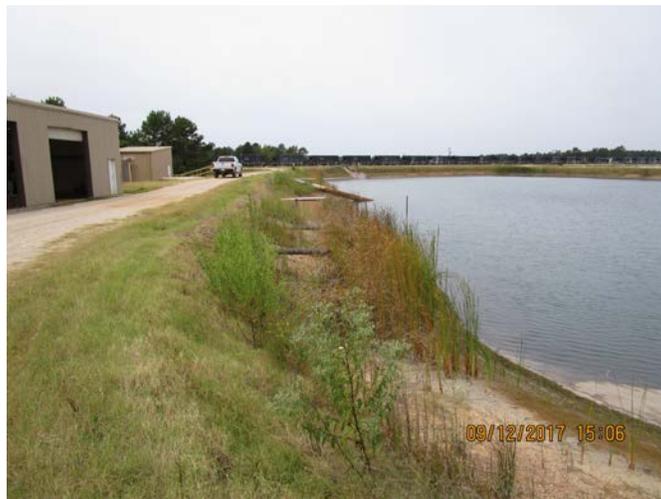
**Photo # 14**

View of the interior slope of the Secondary Bottom Ash Pond Dam.

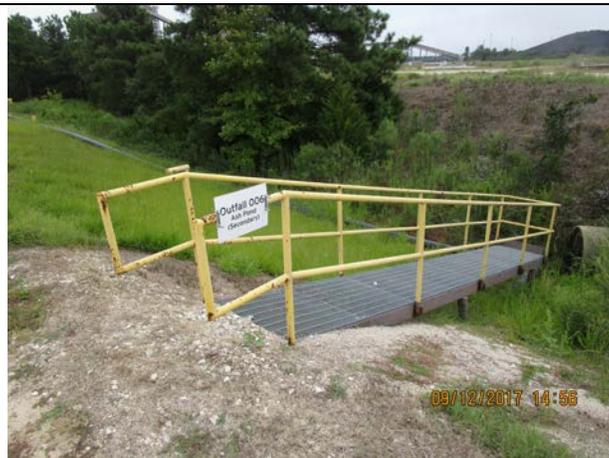
**Photo # 15**

View of the exterior slope of the Secondary Bottom Ash Pond Dam.

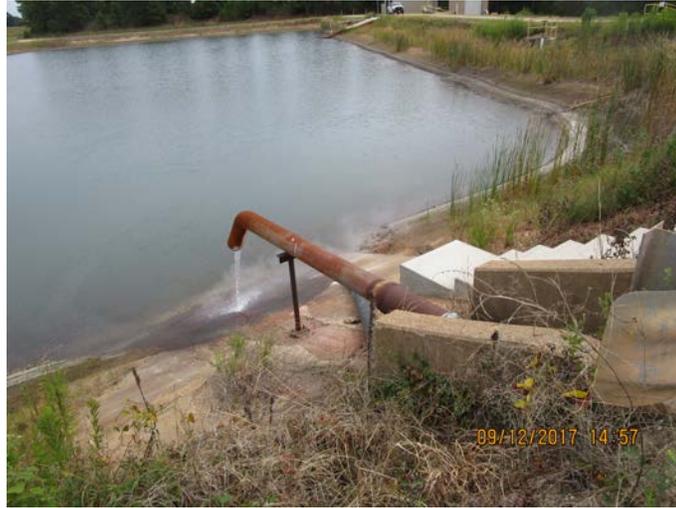
**Photo # 16**

View of the boiler-blow down pipe, which outlets on the interior slope of the Secondary Bottom Ash Pond Dam. Notice the recently constructed concrete stairs.

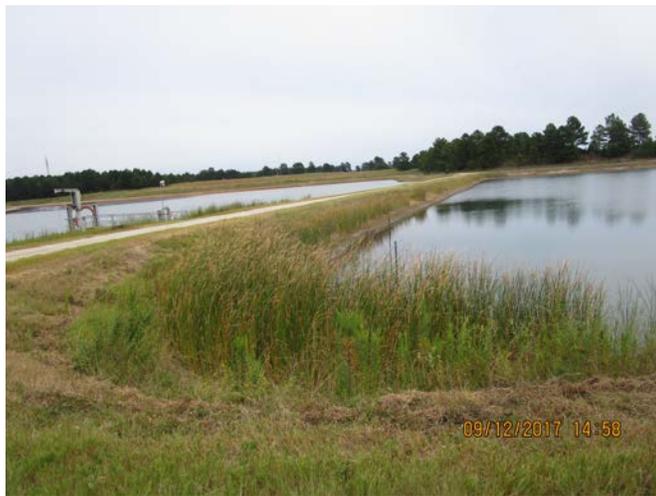
**Photo # 17**

View of the interior slope of the splitter dike between the East Bottom Ash Pond and Secondary Bottom Ash Pond.

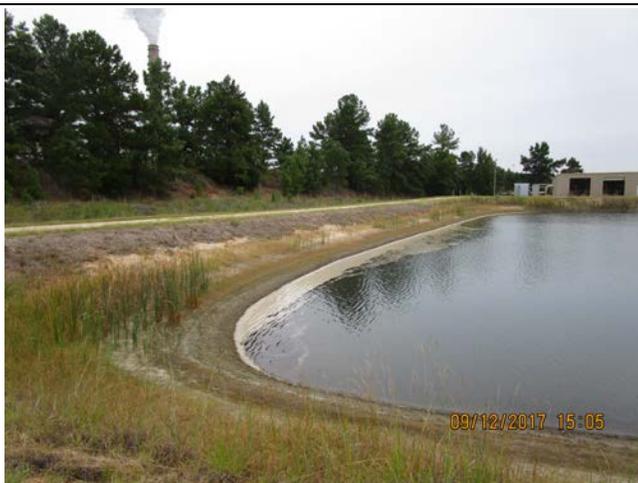
**Photo # 18**

View of the interior slope of the Secondary Bottom Ash Pond.

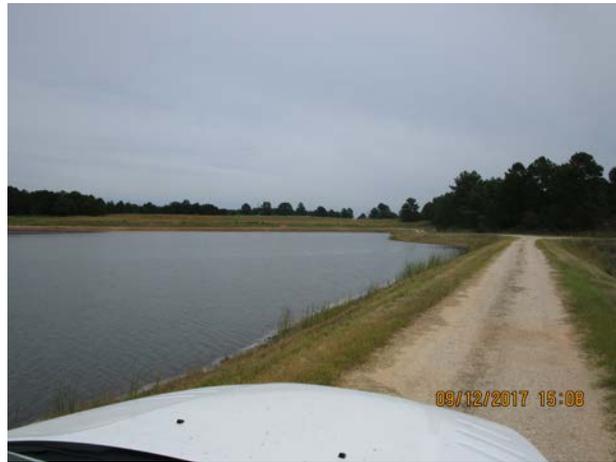
**Photo # 20**

View of the crest of the East Bottom Ash Pond Dam.

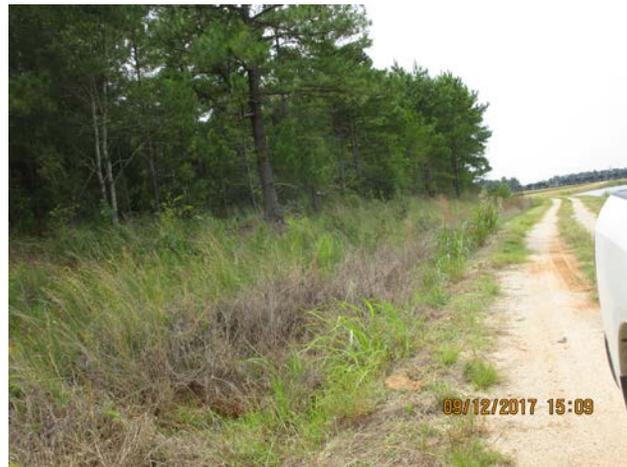
**Photo # 21**

View of the exterior slope and perimeter ditch around the East Bottom Ash Pond.

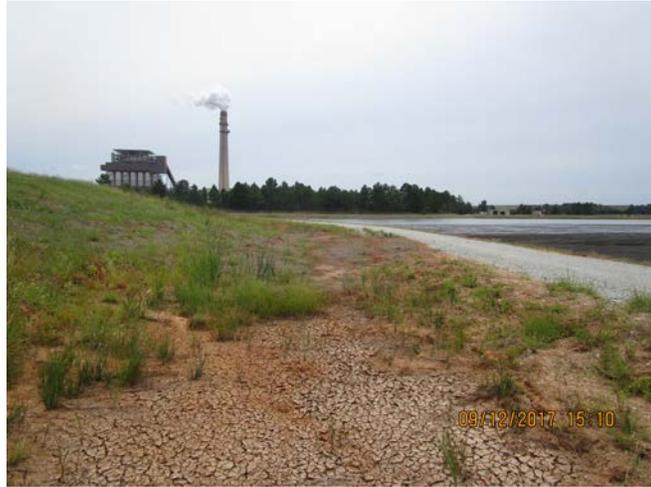
**Photo # 22**

View of the perimeter ditch around the East Bottom Ash Pond Dam.

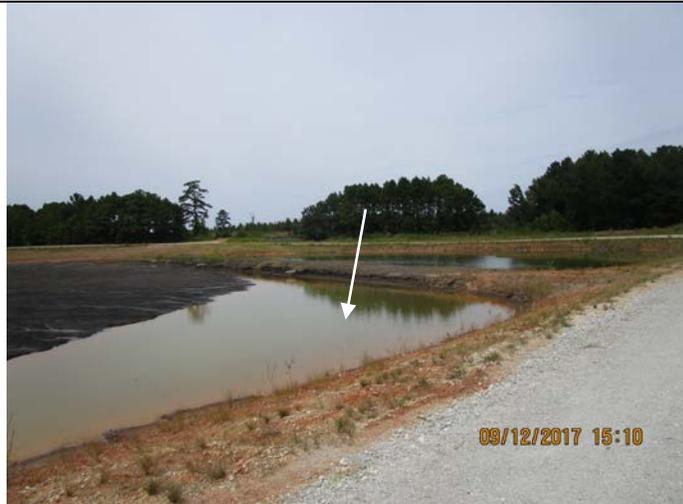
**Photo # 23**

View of a berm constructed inside the East Bottom Ash Pond area for water treatment purposes, indicated by the white arrow.

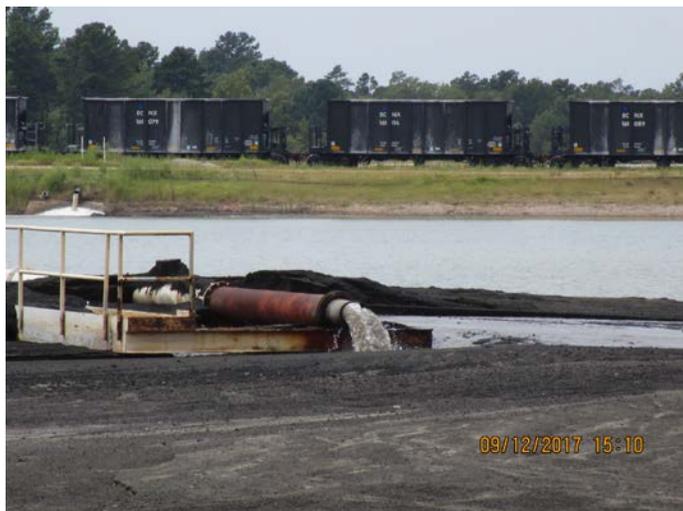
**Photo # 24**

View of the influent line, discharging sluiced bottom ash into the East Bottom Ash Pond Dam.
