2017 Annual Dam and Dike Inspection Report

Bottom Ash Pond Complex

**Rockport Plant
Indiana Michigan Power Company
Rockport, Indiana**

Document ID: GERS-17-019

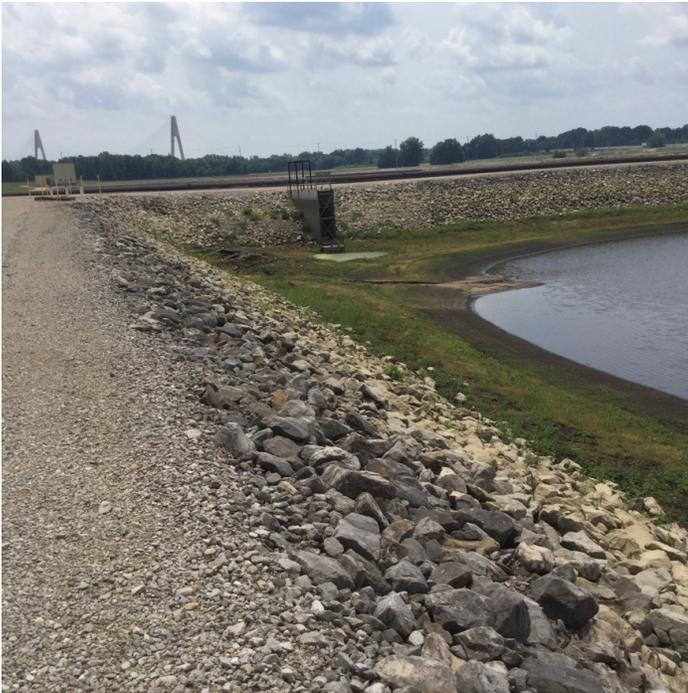
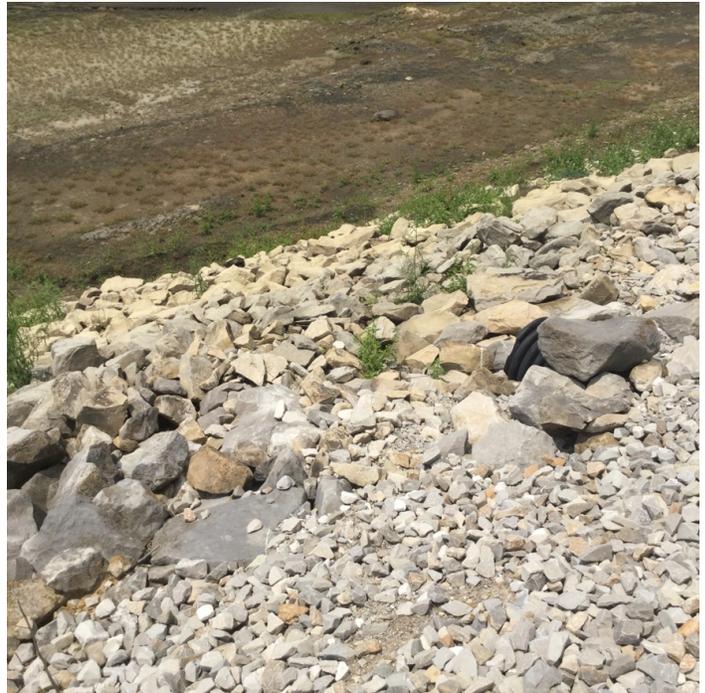
2. The interior slopes showed no signs of distress such as sloughing, bulges or erosion. The rip rap protection along the slope was visible to the toe and appeared in good condition and has not deteriorated. The area above the typical normal pool appears clean and free of vegetation. There was minor grass and weed vegetation growing within the riprap which is typically located below the normal pool. (Observation 1)

- 2) Maintain vegetation growth within rip rap areas using herbicide. (Observation 1)
- 3) Repair minor erosion within the East Bottom Ash Pond prior to bringing the pond back in service. (Observation 2)
- 4) Investigate the cause of the malfunctioning low level drain in the East Bottom Ash Pond. Continue to use temporary pumps to drain the pond or repair the low level drain. (Observation 3)
- 5) Repair erosion within the excess bottom ash along the inboard slope located along the southeast corner of the WBAP or remove the access bottom ash material. (Observation 4)
- 6) Seed and mulch bare area of soil located on the outboard slope of the WBAP in the area of the buried stormwater pipe. (Observation 5)
- 7) Repair minor erosion area on outboard slope of the WBAP by placement of soil in the erosion rills. The area should be revegetated once the repair is made. (Observation 6)

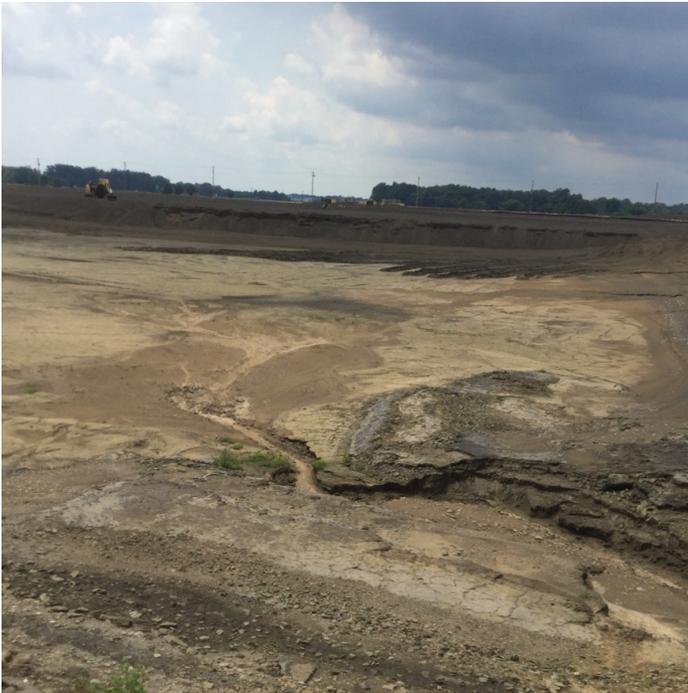
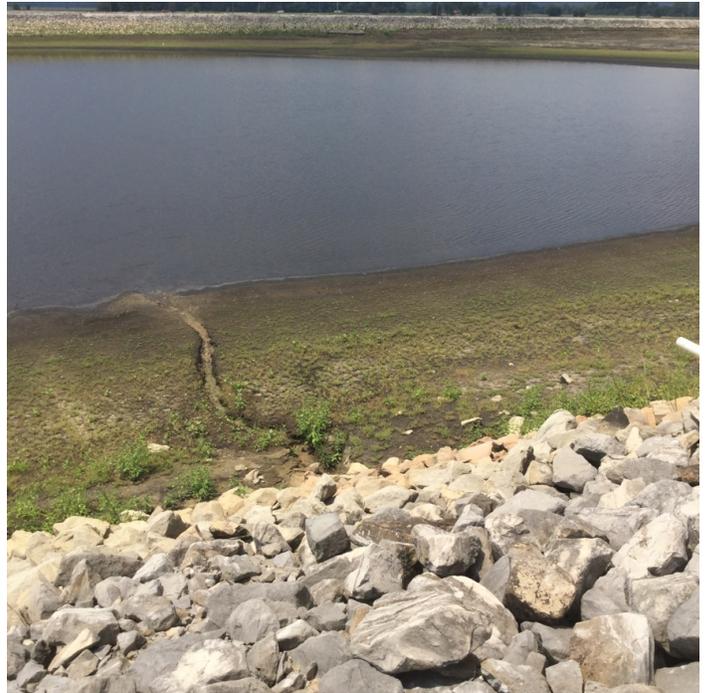
3. There was minor erosion observed in the bottom of the pond within the remaining bottom ash material. This erosion was attributed to the pond being drained and rainfall runoff flowing across the pond bottom. This erosion was visible at several of the storm water entry points. (Observation 2)

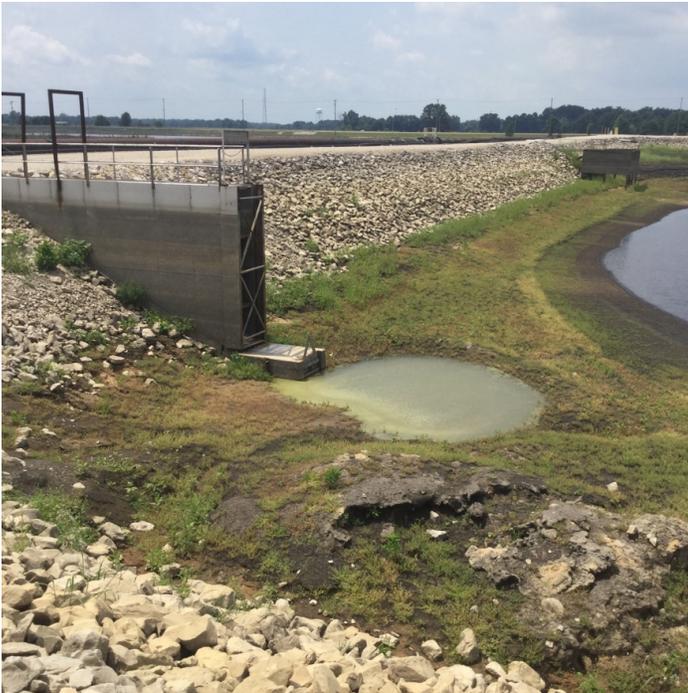
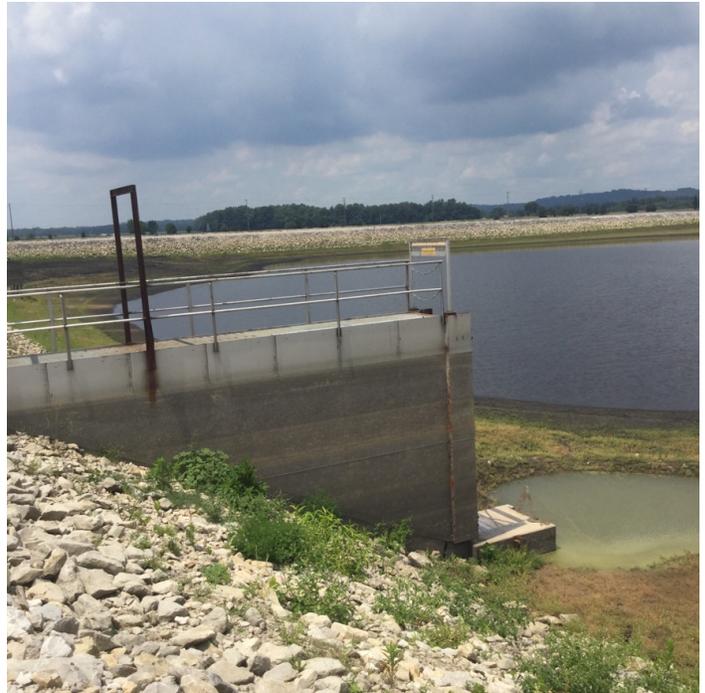
5. Plant personnel noted that the low level drainage structure used to drain pond during cleaning operations was not operational. During the recent draining the stop logs were pulled but flow did not exit through the structure. A pumping system was instead used to drain the pond. It was unknown from visual inspection if the pipe was clogged with material or has failed for other reasons. (Observation 3)

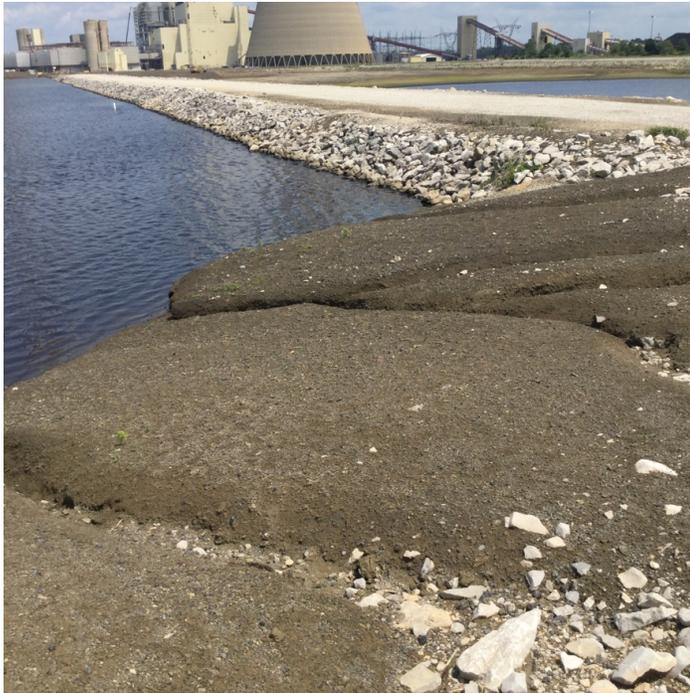
10. The splitter dike separating the WBAP and the EBAP was not accessible due to the barricades set up to protect Least Tern bird nests. The splitter dike appeared to be in good condition and showed no signs of distress. The splitter dike separating the WBAP from the WWWP was also in good condition and showed no signs of distress. There was one area of erosion at the south east corner of the impoundment which appears to be within the excess bottom ash and not within the soil of the splitter dike. (Observation 4)

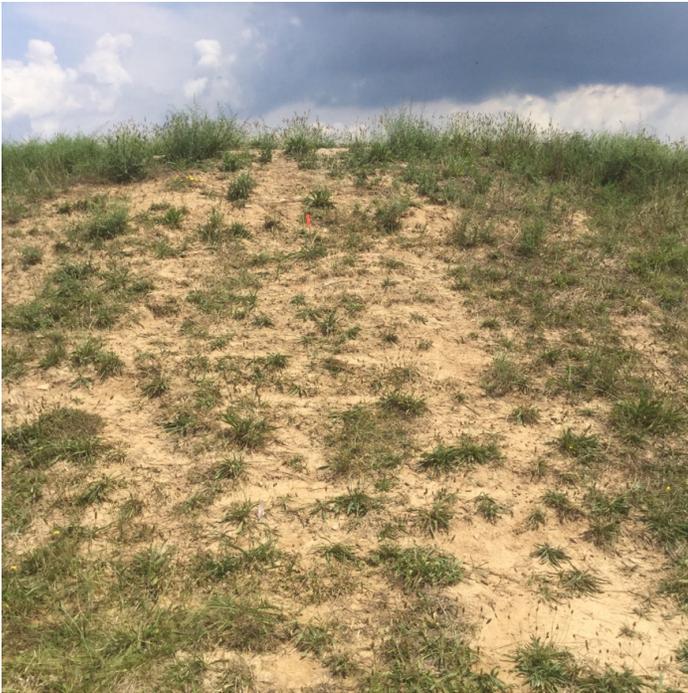
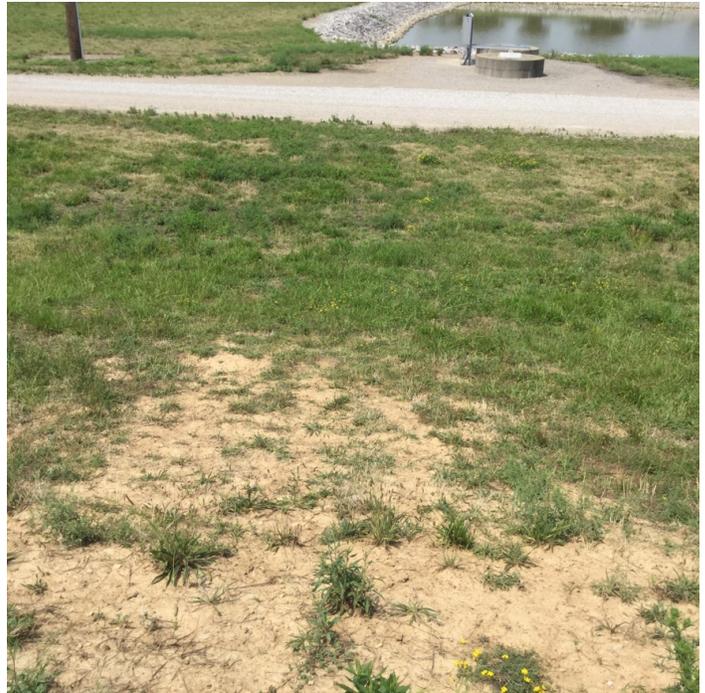
11. The outboard slope of the WBAP was in good condition. The grass was recently mowed and there were no signs of movement or misalignment, sloughing or bulges. There was an area of bare ground from construction activities where the stormwater discharge pipe was trenched in the embankment. The area was flagged for repair (Observation 5).

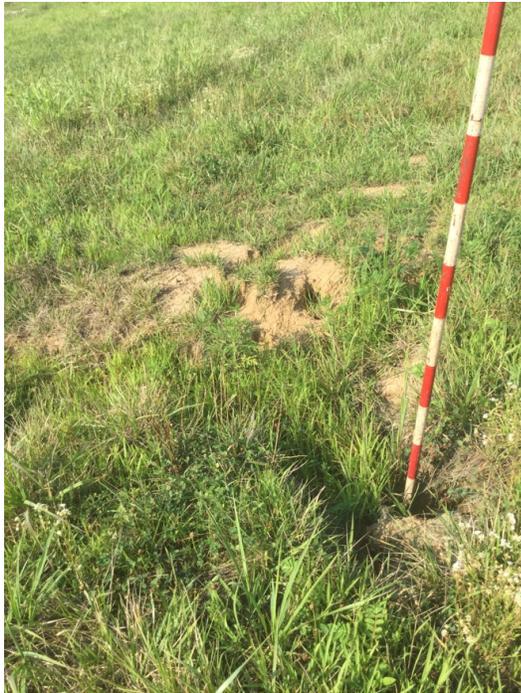
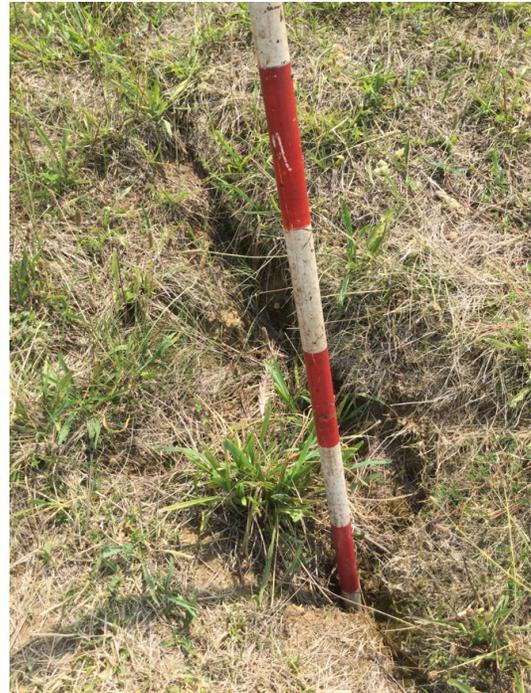
12. There was an isolated area of erosion located along the outboard slope of the west embankment with erosion approximately 6" deep. This area has been flagged for repair (Observation 6).

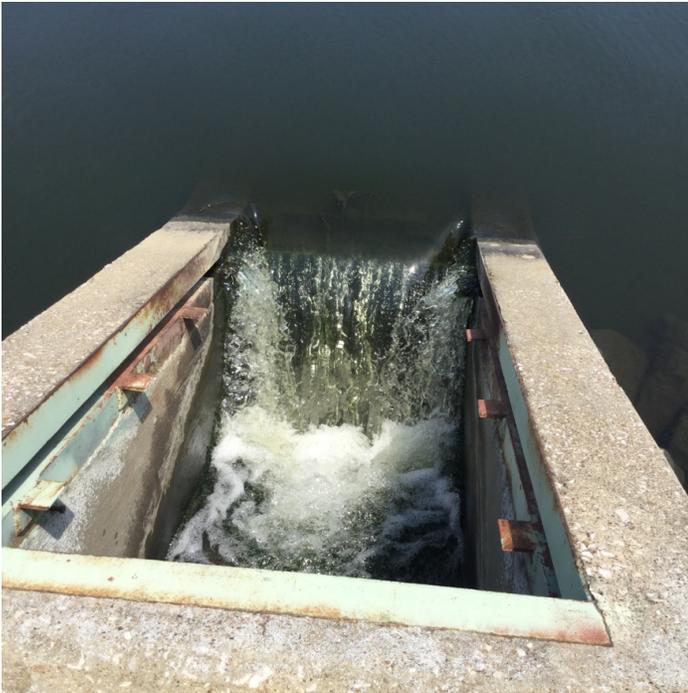
15. Flow was discharging into the low level drain structure. While this structure is typically used for draining the pond it appears to be functioning properly as part of the primary discharge for the pond. The structure appeared in good condition. (Observation 7)
