# 2019 Annual Landfill Inspection Report

**H.W. Pirkey Plant  
Southwestern Electric Power Company  
Hallsville, Texas**

**October 18, 2019**

**Document ID: GERS-19-024**

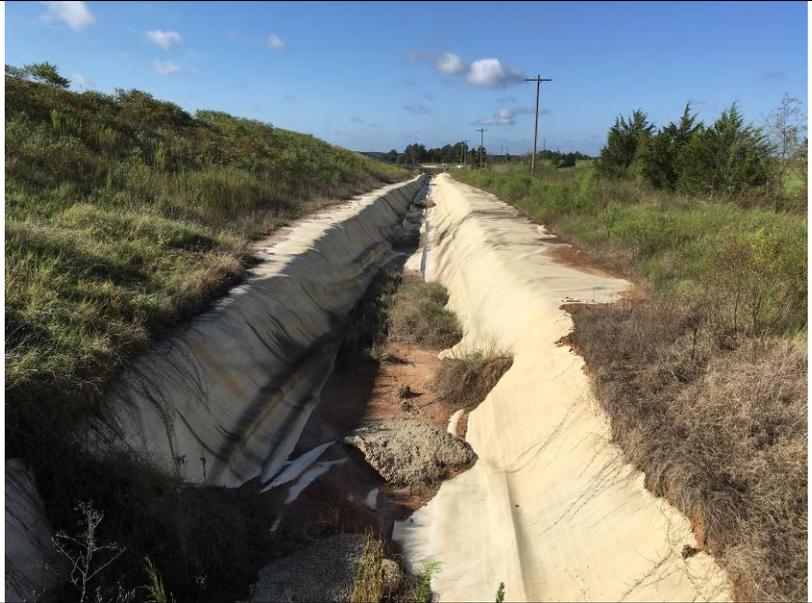
Photo # 1

18. A contact water ditch runs along the western edge of the landfill area and is lined with a geomembrane. The ditch was observed to be clear of any obstructions but there was some sediment build up in the lower portion of the ditch. Water flowing through this ditch eventually ends up in the Landfill Runoff Pond.

View of the contact-water perimeter ditch on the northwest side of the landfill area. Notice the sediment buildup in the bottom of the ditch.

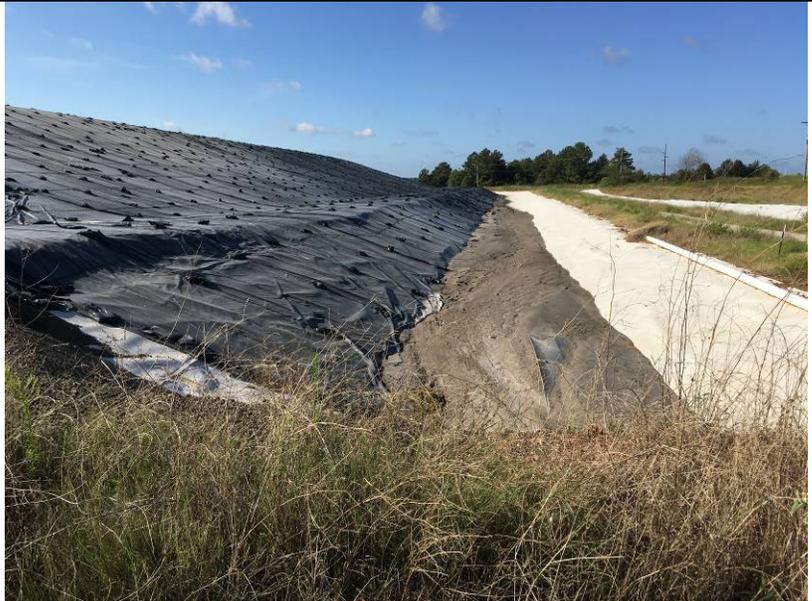
Photo # 2

View of the contact-water perimeter ditch on the southwest side of the landfill area. Notice the sediment buildup in the bottom of the ditch.

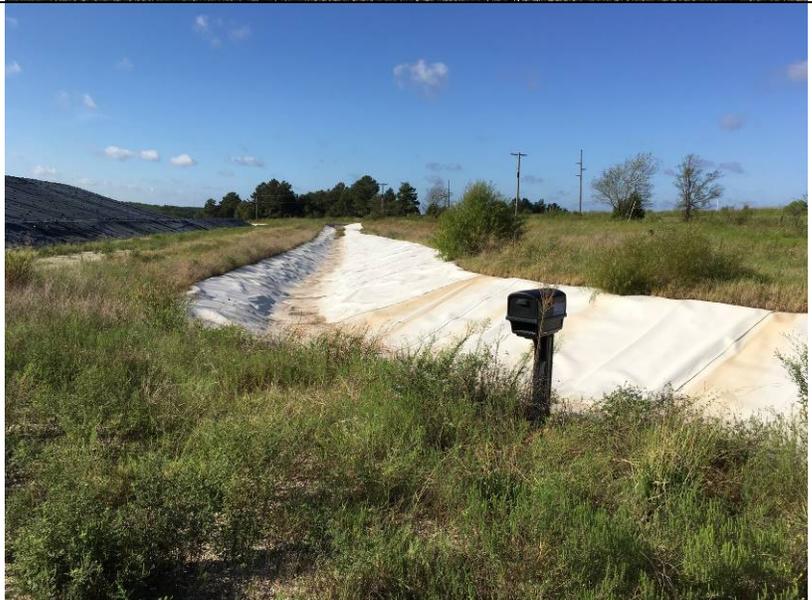
Photo # 3

View of the non-contact water perimeter ditch on the west side of landfill area.

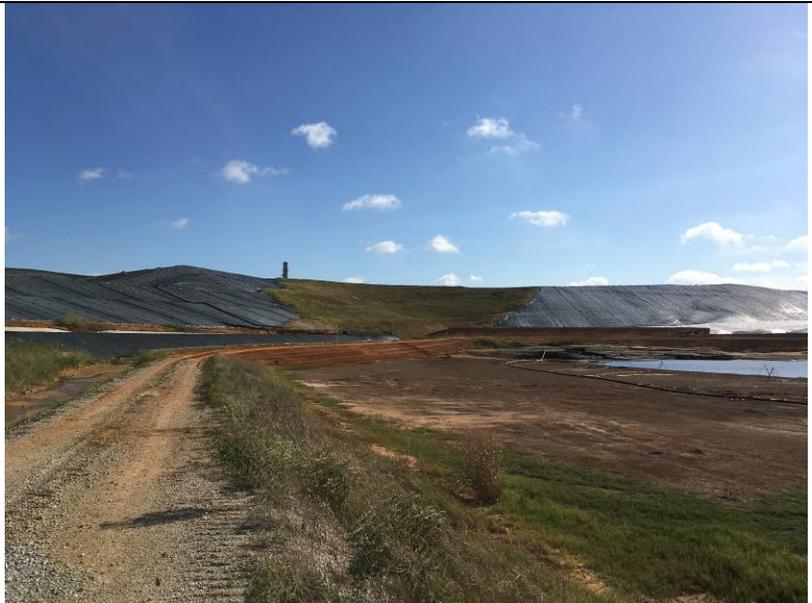
Photo # 4

View of the temporary cover (rain flap and soil cover) on the outside slopes of the 2015, 2012 and 1993 cells.

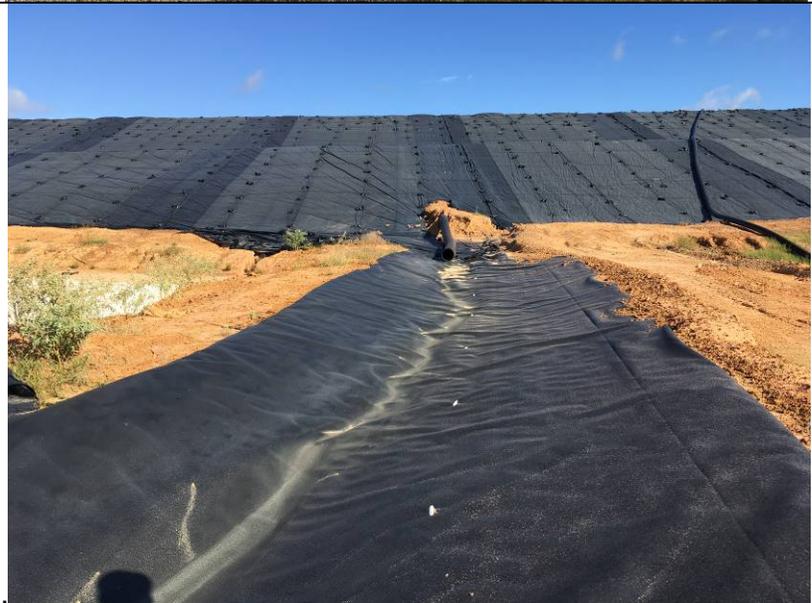
Photo # 5

View of the let-down ditch of the non-contact water coming off the rain flap material on the southern end of the landfill.

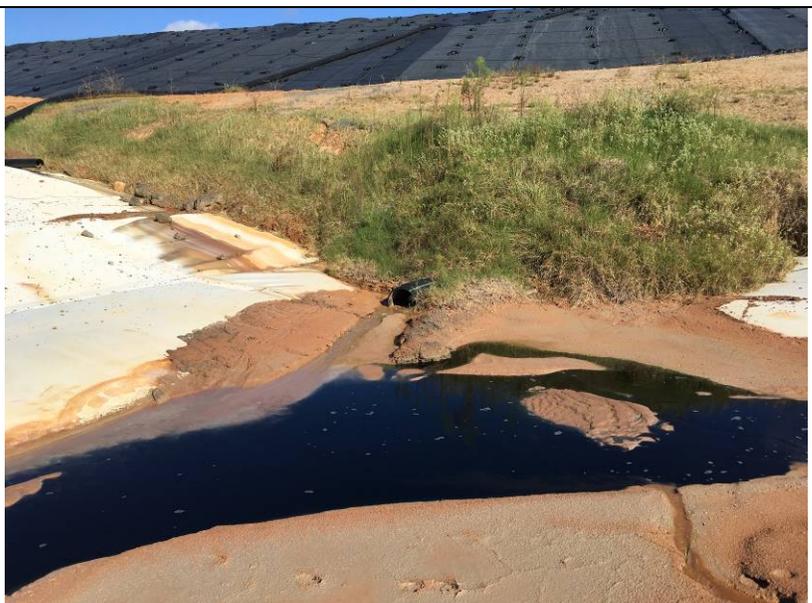
Photo # 6

View of the 18-inch diameter leachate pipe coming out of southern end of landfill.

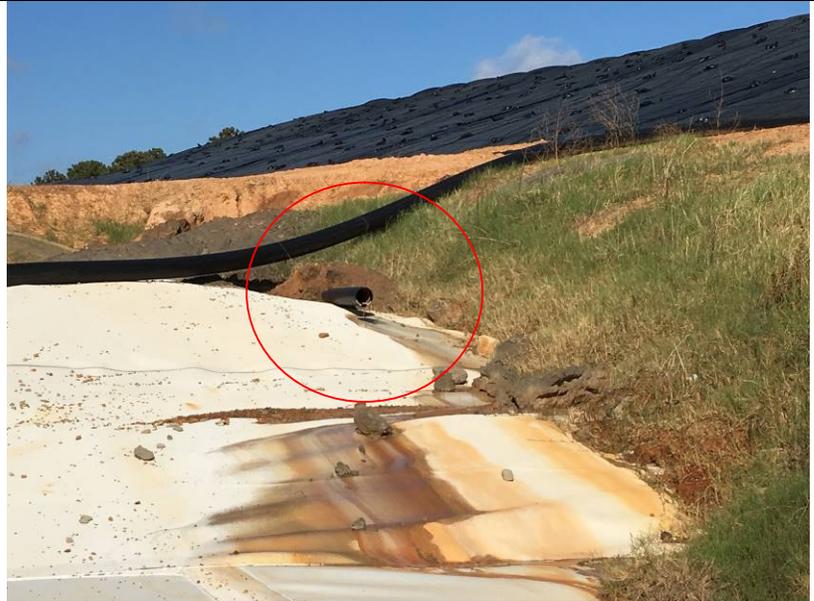
Photo # 7

View of the 6-inch diameter leachate pipe coming out of southern end of landfill.

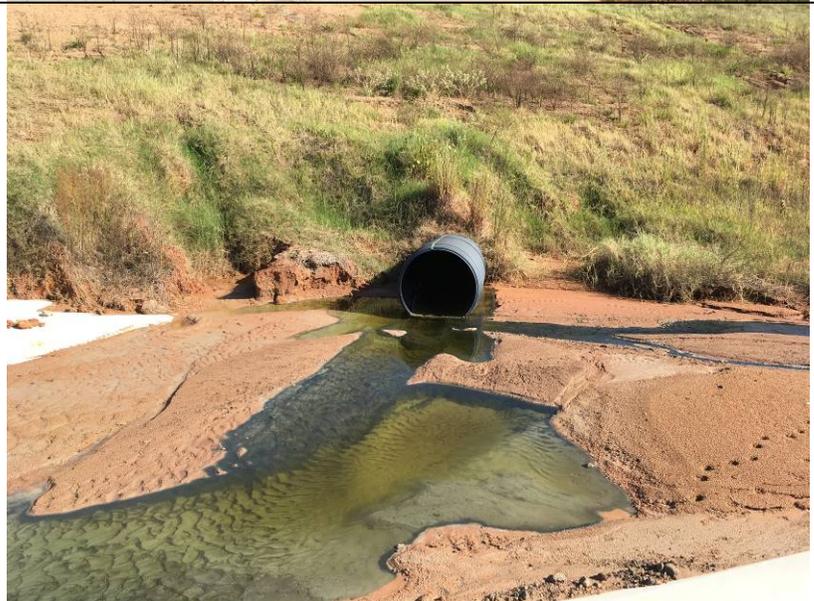
Photo # 8

View of the 36-inch diameter leachate pipe coming out of southern end of landfill.

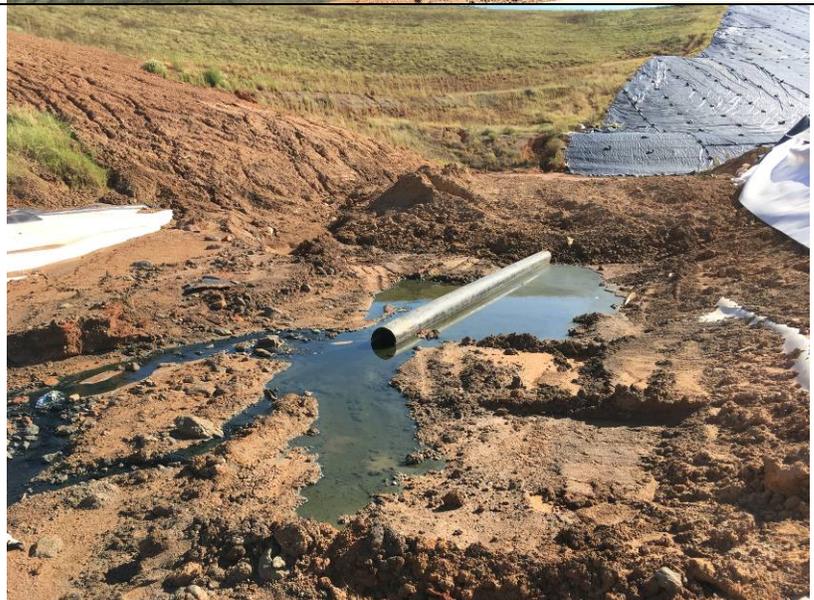
Photo # 9

View of the 18-inch diameter leachate pipe coming out of southern end of landfill.

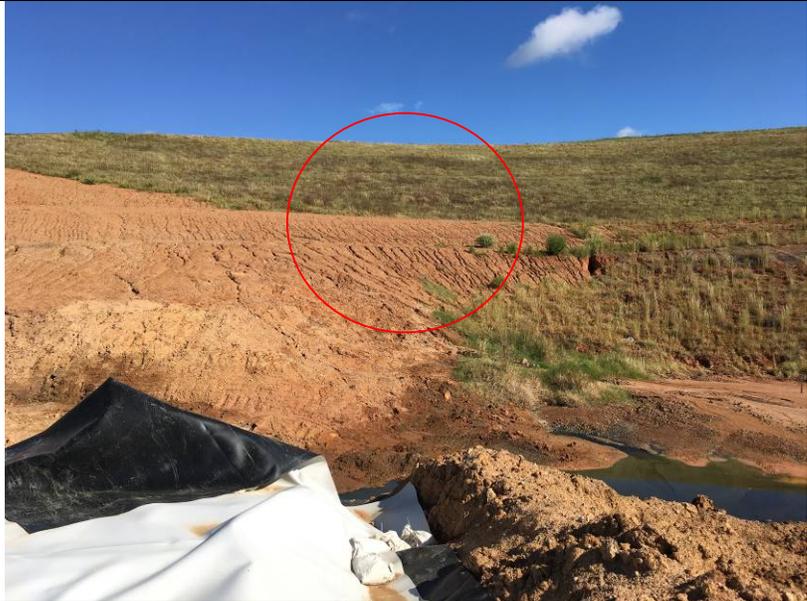
Photo # 10

Landfill Cover – View of erosion rill in the temporary soil cover on the south end of landfill.

- 1) Repair the erosion rills in the temporary soil cover on the lower portion of the 2012 cell near the 1985 pond area on the south side.

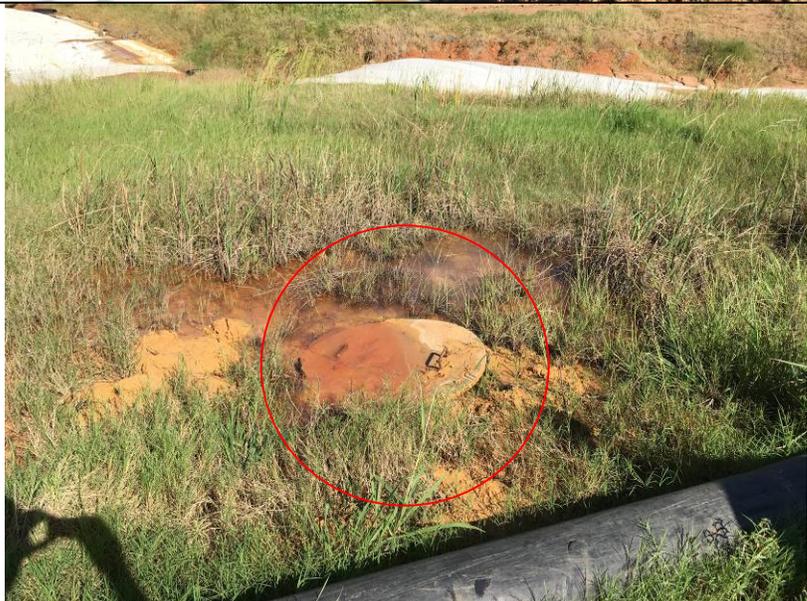
Photo # 11

9. There is standing water at the surface near the groundwater interceptor drain manhole on the southern side of the landfill. Groundwater is also pushing up on the liner system in the perimeter ditch near the groundwater interceptor drain manhole. The check valve drain leading from the manhole to the pond is closed causing the ground water to back up and push to the surface.

View of groundwater interceptor drain manhole cover. The check vale drain into the landfill pond is closed and groundwater is pushing to the surface.

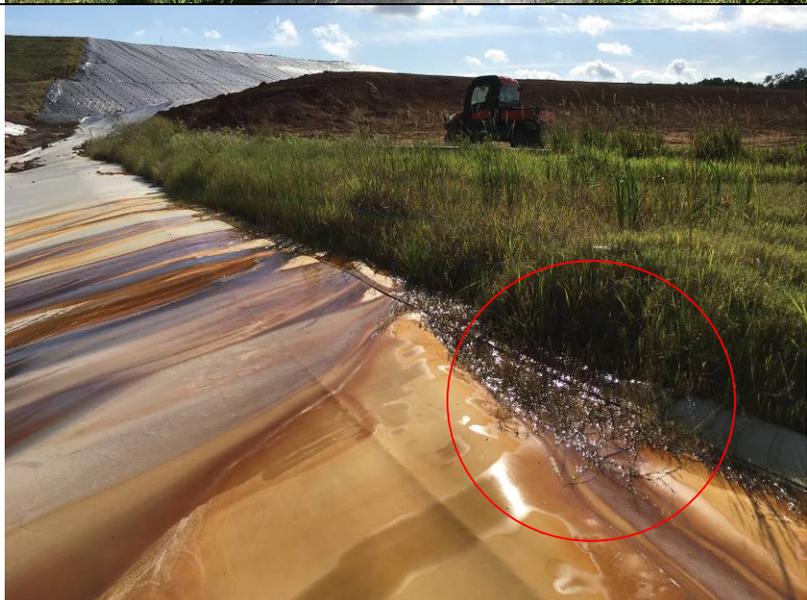
Photo # 12

View of groundwater pushing up under liner in the perimeter ditch on the southern side of landfill.

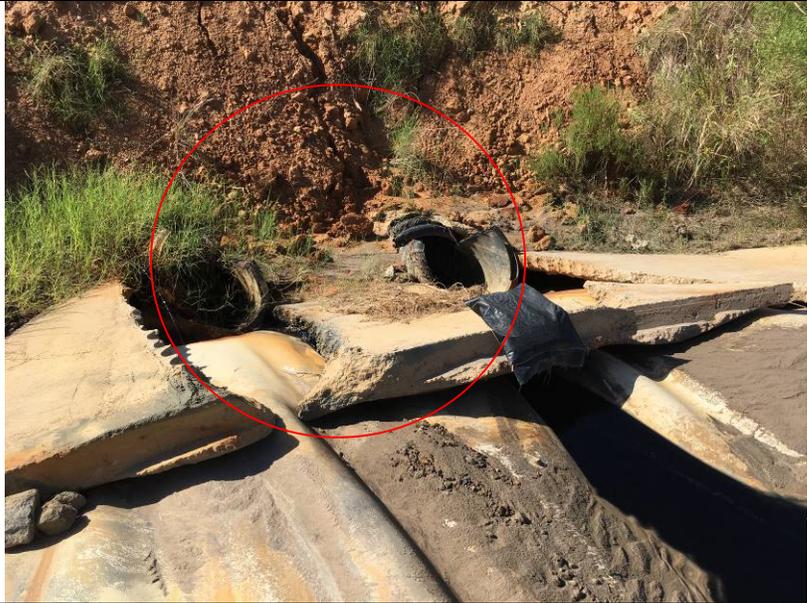
Photo # 13

16. Concrete slope protection installed on the inlet side of two, 36-inch-diameter culverts, which discharge leachate and contact water into the Landfill Runoff Pond was observed to be broken

and distressed. The geomembrane landfill liner extends underneath the entire length of the culverts and does not appear to be damaged. An access road is present over the top of the culverts.

View looking at the dual 36-inch culvert pipe that drain the perimeter ditches from the landfill into the runoff pond.

- 2) Remove the soil/ash accumulation from the 18-inch diameter leachate collection discharge pipe outlet area on the south side of the 1985 Pond Cell so that the outlet has free draining conditions.
- 3) Remove the broken and distressed concrete slab slope protection at the inlet of the two, 36-inch-diameter culverts. After removing the concrete slab, monitor this area for erosion. If it is deemed necessary, additional erosion protection can be re-installed.
- 4) Remove the brush and/or cattails growing around the outlets of the “let down” piping on the east side of the landfill. Establish grass cover on any disturbed areas.
- 5) Repair the erosion scarp on the temporary soil cover in the 2015 cell area.
- 6) Open the check valve drain in the ground water interceptor manhole to allow the ground water pipes to drain into the landfill pond.

- 1) After removing the broken and distressed concrete slope protection around the two pipes, monitor the 36-inch-diameter culverts underneath the access road along the southern edge of the landfill for erosion. If excessive erosion is observed, install additional erosion protection.
- 2) Monitor the riprap armored earthen berm at the outlet of the non-contact water ditch near the southwestern corner of the landfill area after heavy rain events for erosion or overtopping of the berm.

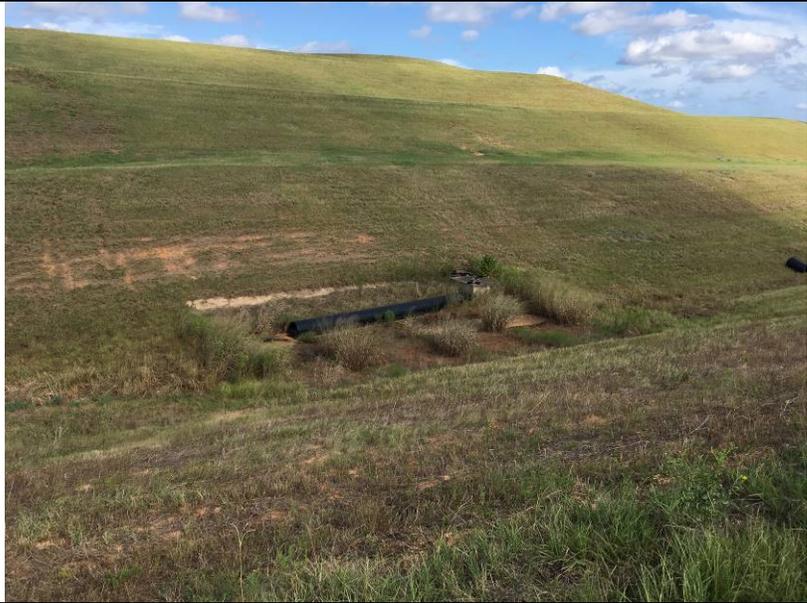
Photo # 14

View of the storm water let-down pipe on the east side of the landfill area.

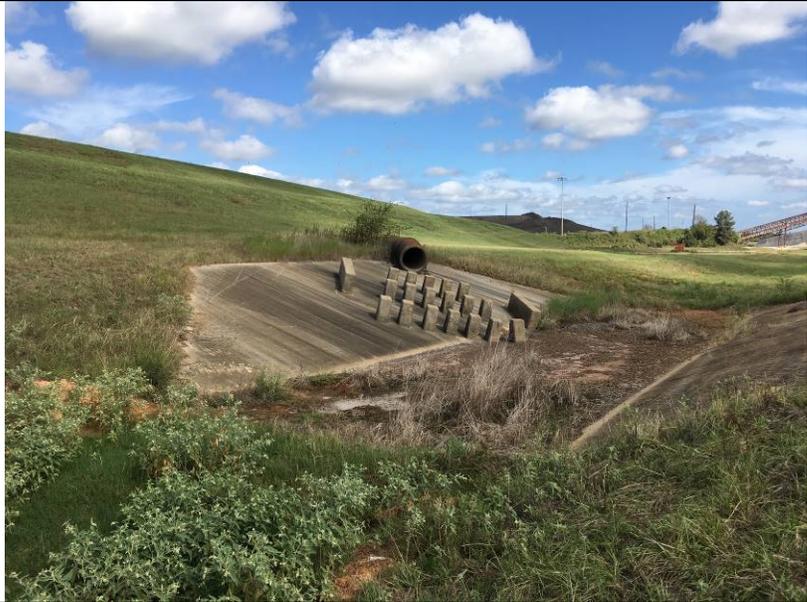
Photo # 15

4. Minor brush and some cattails were observed to be growing in the perimeter ditch and around the energy dissipater structures for the “let down” piping on the eastern edge of the landfill area.

View of the storm water let-down pipe and energy dissipater structure on the east side of the landfill area.

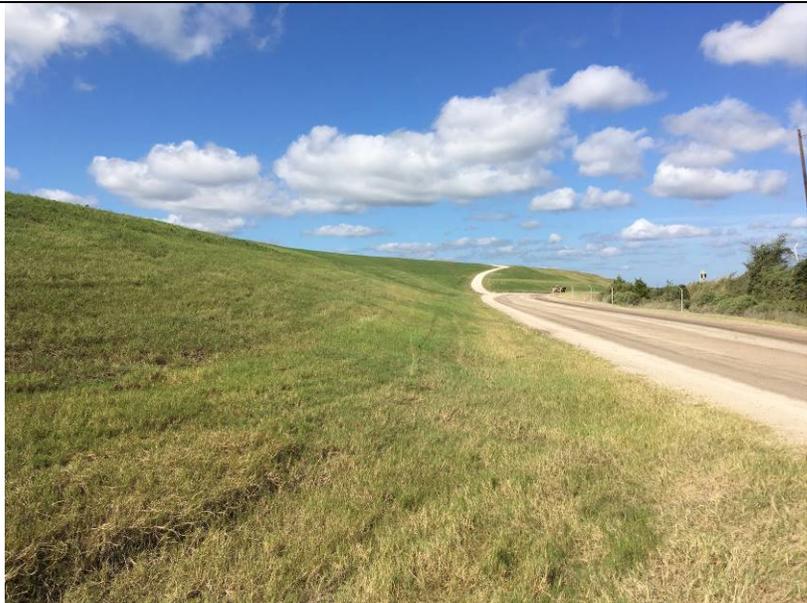
Photo # 16

Typical condition of the northern slope areas above the haul road.

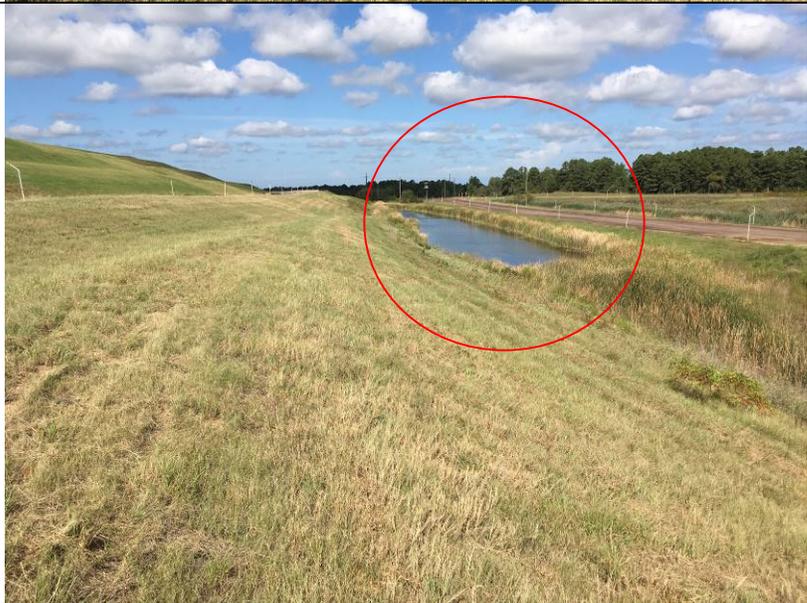
Photo # 17

5. There is ponded water in the downstream end of the perimeter ditch on the north side of the landfill.

Typical condition of the northern slope areas below the haul road. Notice the ponded water at the downstream end of the perimeter ditch.

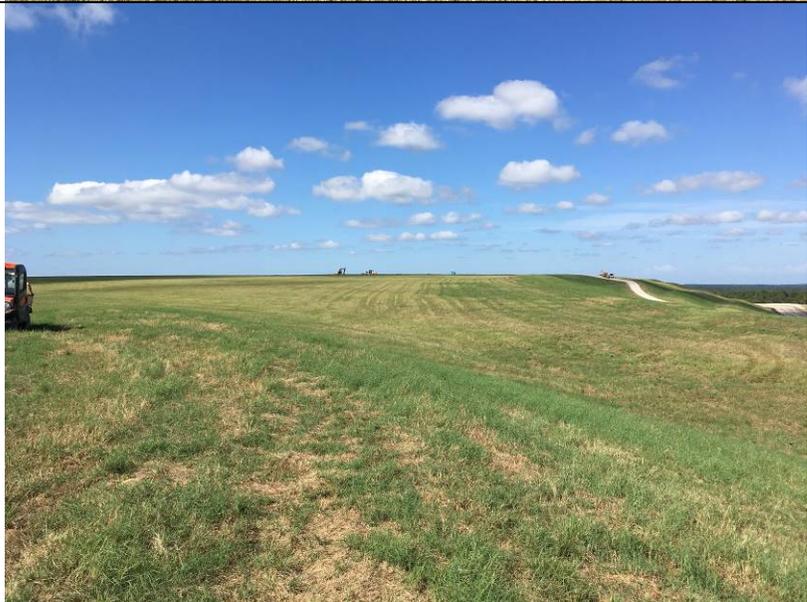
Photo # 18

Typical condition of the vegetative cover over the northern and eastern areas of the landfill cap.

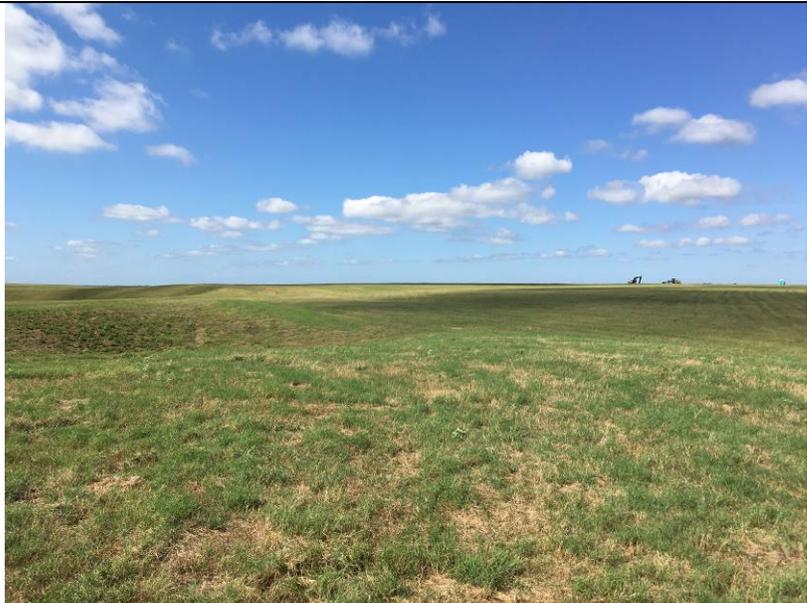
Photo # 19

Typical condition of the vegetative cover over the eastern and southern areas are of the landfill cap.

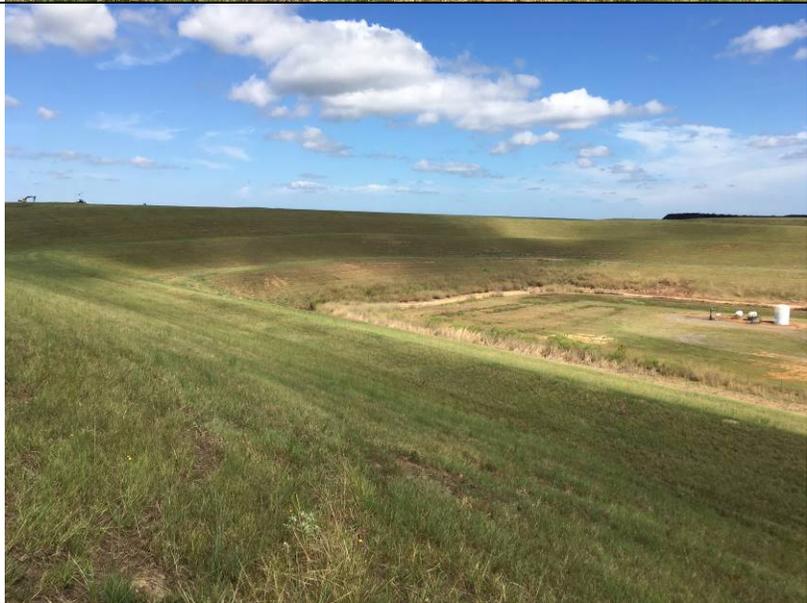
Photo # 20

Typical view of the eastern side slopes areas around the Mohan Well location.

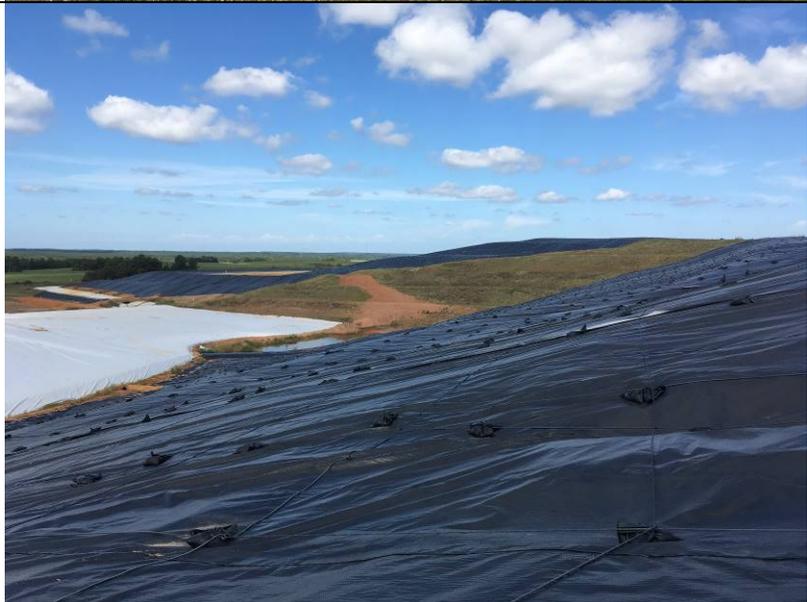
Photo # 21

View of the southern slopes covered with temporary soil cover and rain-flap material.

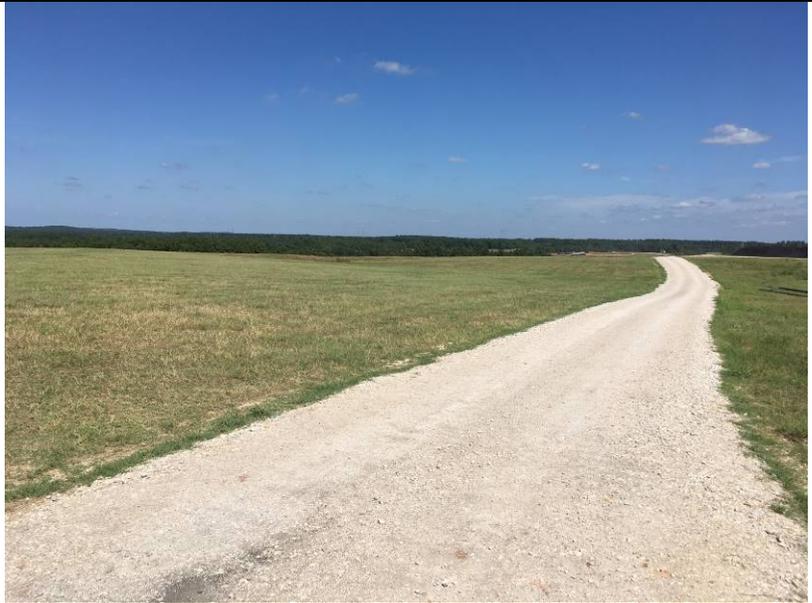
Photo # 22

View of the vegetative cover and access road on the Landfill final cap area.

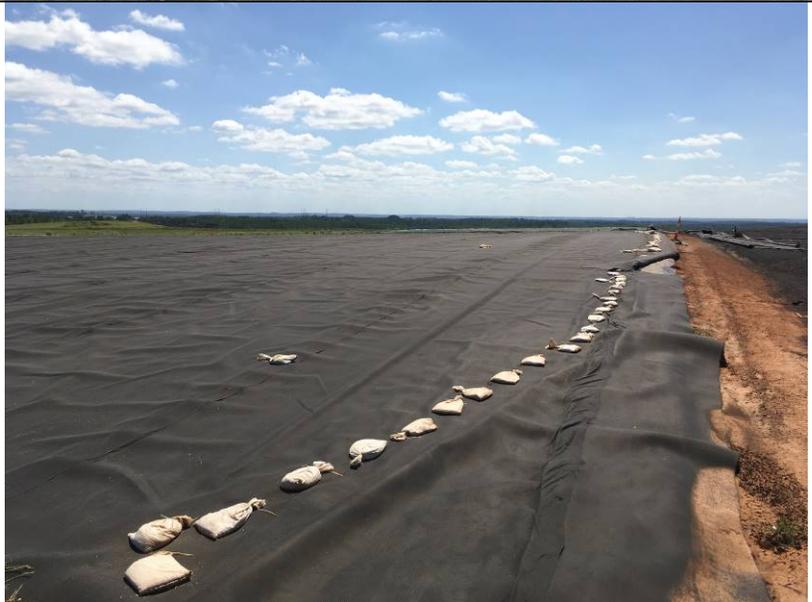
Photo # 23

8. The remaining top portions of the 2012 cell area are currently under construction of a final cap system. At the time of inspection, the area under construction consisted of geo-composite layer overlying a geo-membrane and clay cap layer. The geo-composite layer still needs to be covered with 18-inches of topsoil to complete the cap system.

View of the geo-composite layer over parts of the 2012 Cell final cap. This area needs to be covered with 18-inches of topsoil to complete the final cap.

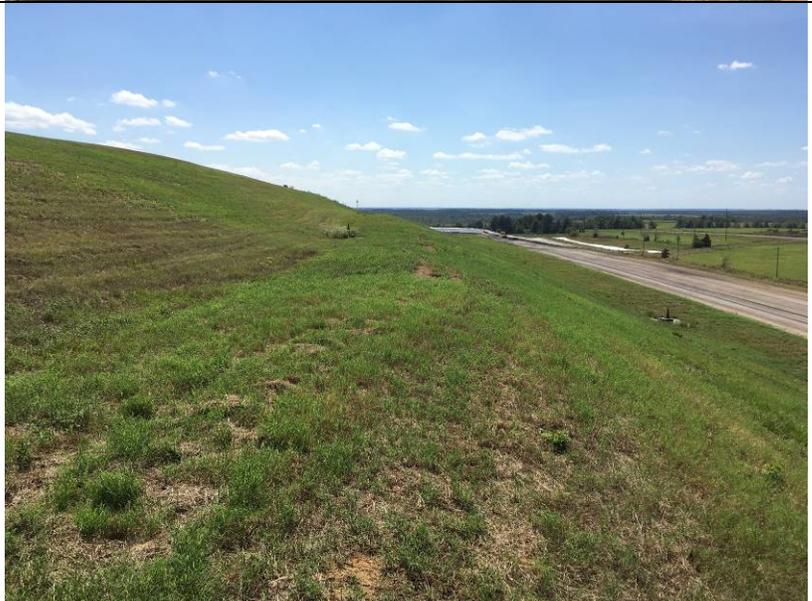
Photo # 24

View of the vegetative cover on the landfill final cap on the western slope areas.

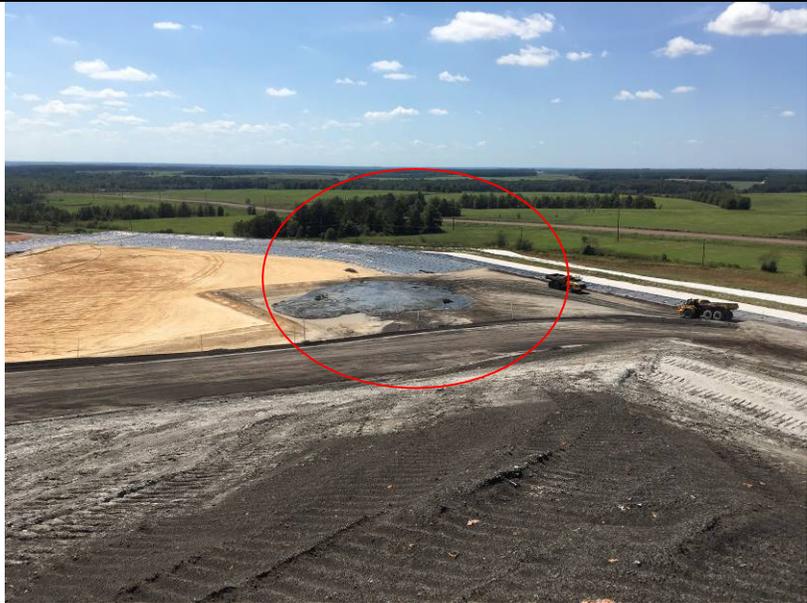
Photo # 25

View of the 2015 active cell area. Looking at area receiving waste by dump truck.

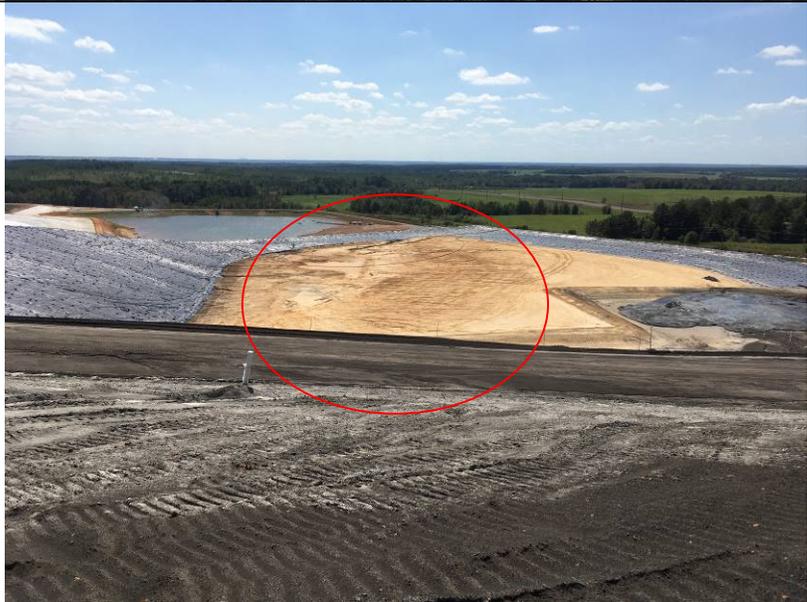
Photo # 26

View of the 2015 Cell with temporary soil cover and rain flap material to reduce contact water volume going to the landfill runoff pond.

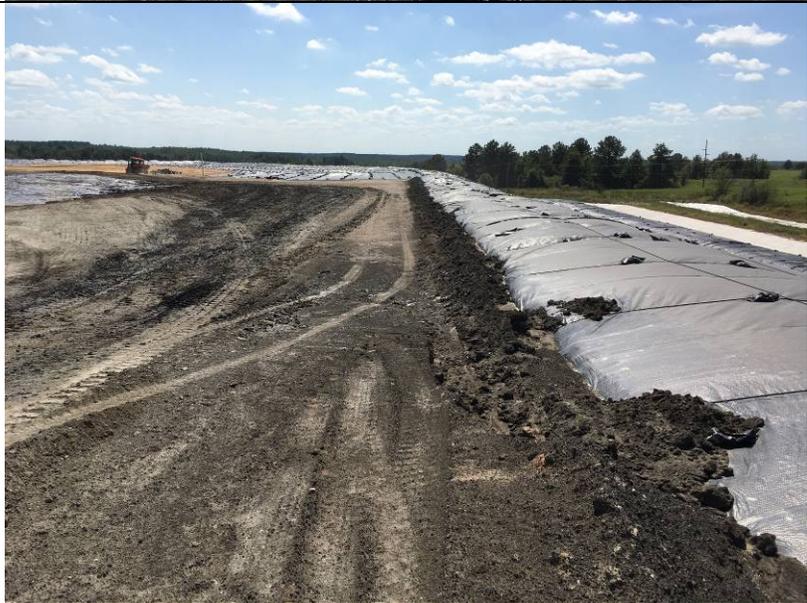
Photo # 27

View of the active material placement inside the 2015 cell looking south. Notice the rain flap material protecting the outside slope.

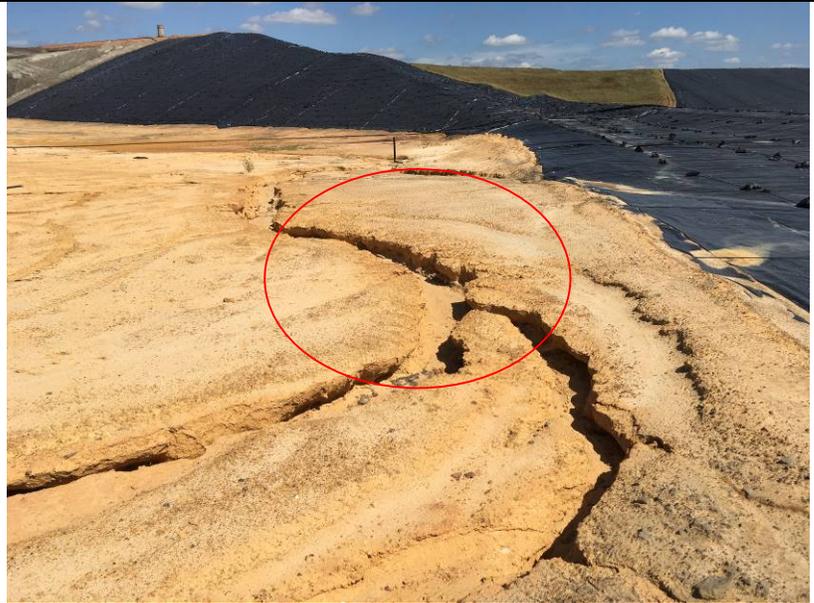
Photo # 28

12. An erosion scarp (gully) of about 1 to 2 deep has cut through the temporary soil cover as concentrated flow moves toward the outlet pipe. The erosion scarp appears to be occurring due to concentrated flow coming off the adjacent rain flap areas.

View of the temporary soil cover over the 2015 active cell area. Notice the erosion scarp created from concentrated runoff flow.

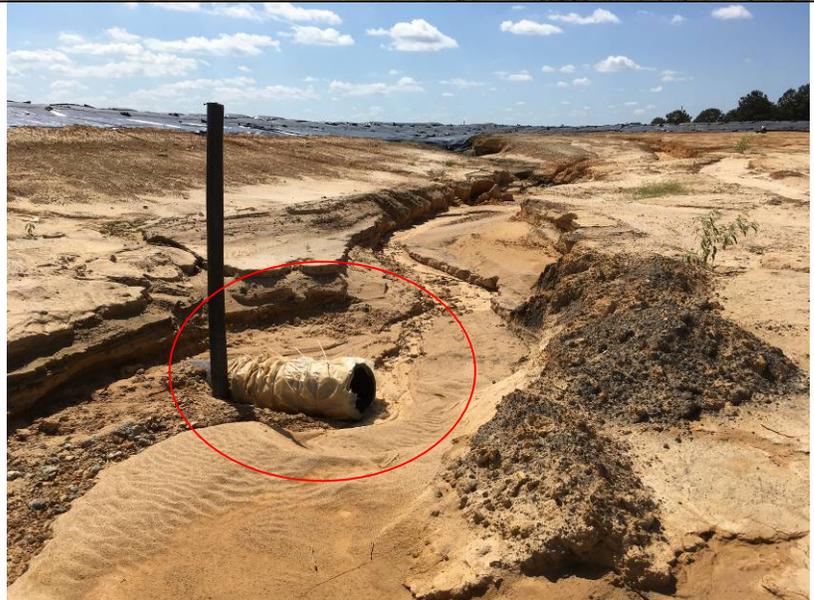
Photo # 29

View of the temporary soil cover over the 2015 active cell area. Notice the significant erosion scarp near the outlet pipe. Temporary soil cover eroded almost down to ash level.
