CCR GROUNDWATER MONITORING SYSTEM DEMONSTRATION

MITCHELL LANDFILL MITCHELL POWER GENERATION PLANT MARSHALL COUNTY, WEST VIRGINIA

KENTUCKY POWER COMPANY d/b/a AMERICAN ELECTRIC POWER, INC. COLUMBUS, OHIO

Prepared By:
CIVIL & ENVIRONMENTAL CONSULTANTS, INC.
CINCINNATI, OHIO

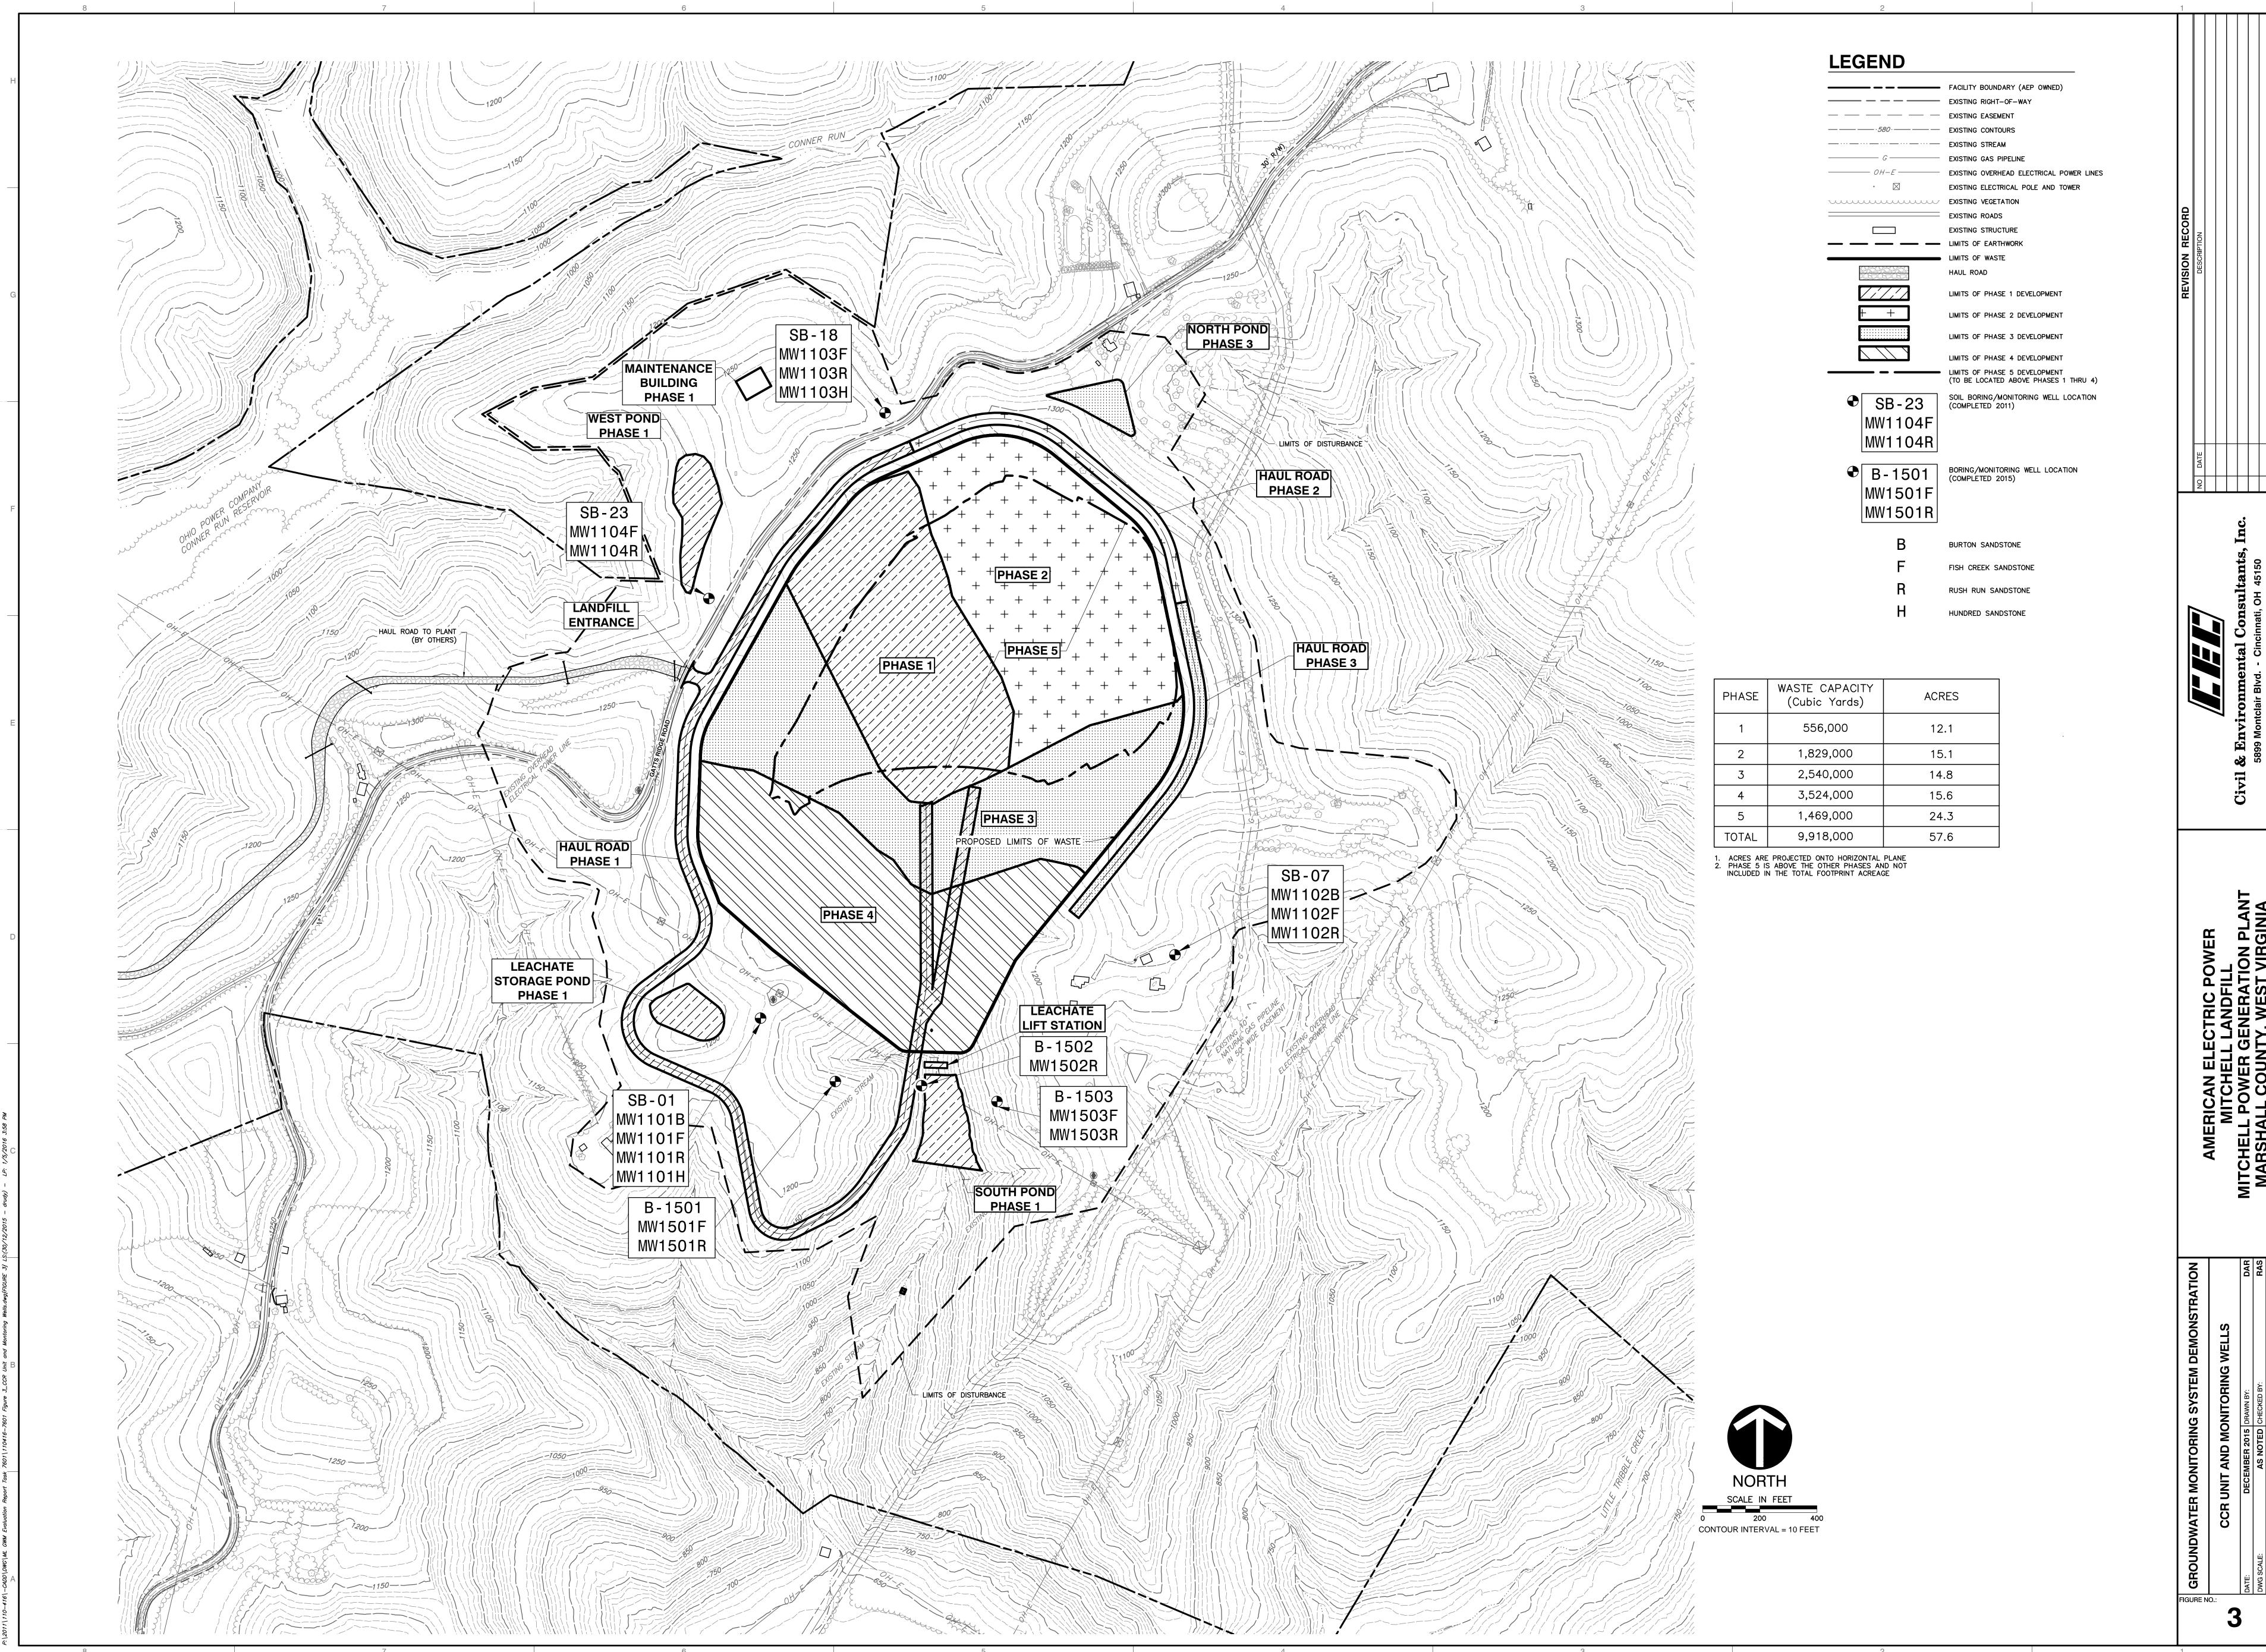
- Figure 1 Site Location Map
- Figure 2 Plant and CCR Unit Location Map
- Figure 3 CCR Unit and Monitoring Wells
- Figure 4 Geologic Cross Section Location Map
- Figure 5 Geologic Cross Section D-D'
- Figure 6 Geologic Cross Section C-C'
- Figure 7 Top of Rush Run Sandstone Contours
- Figure 8 Rush Run Sandstone Isopach Contours
- Figure 9 Base of Fish Creek Sandstone Contours
- Figure 10 Fish Creek Sandstone Isopach Contours
- Figure 11 Rush Run Sandstone Potentiometric Surface Map
- Figure 12 Fish Creek Sandstone Potentiometric Surface Map
- Figure 13 Isolation from Uppermost Aquifer Isopach
