2017 Annual Dam and Dike Inspection Report

Bottom Ash Pond Complex

John E. Amos Plant

Document Number: GERS-17-040

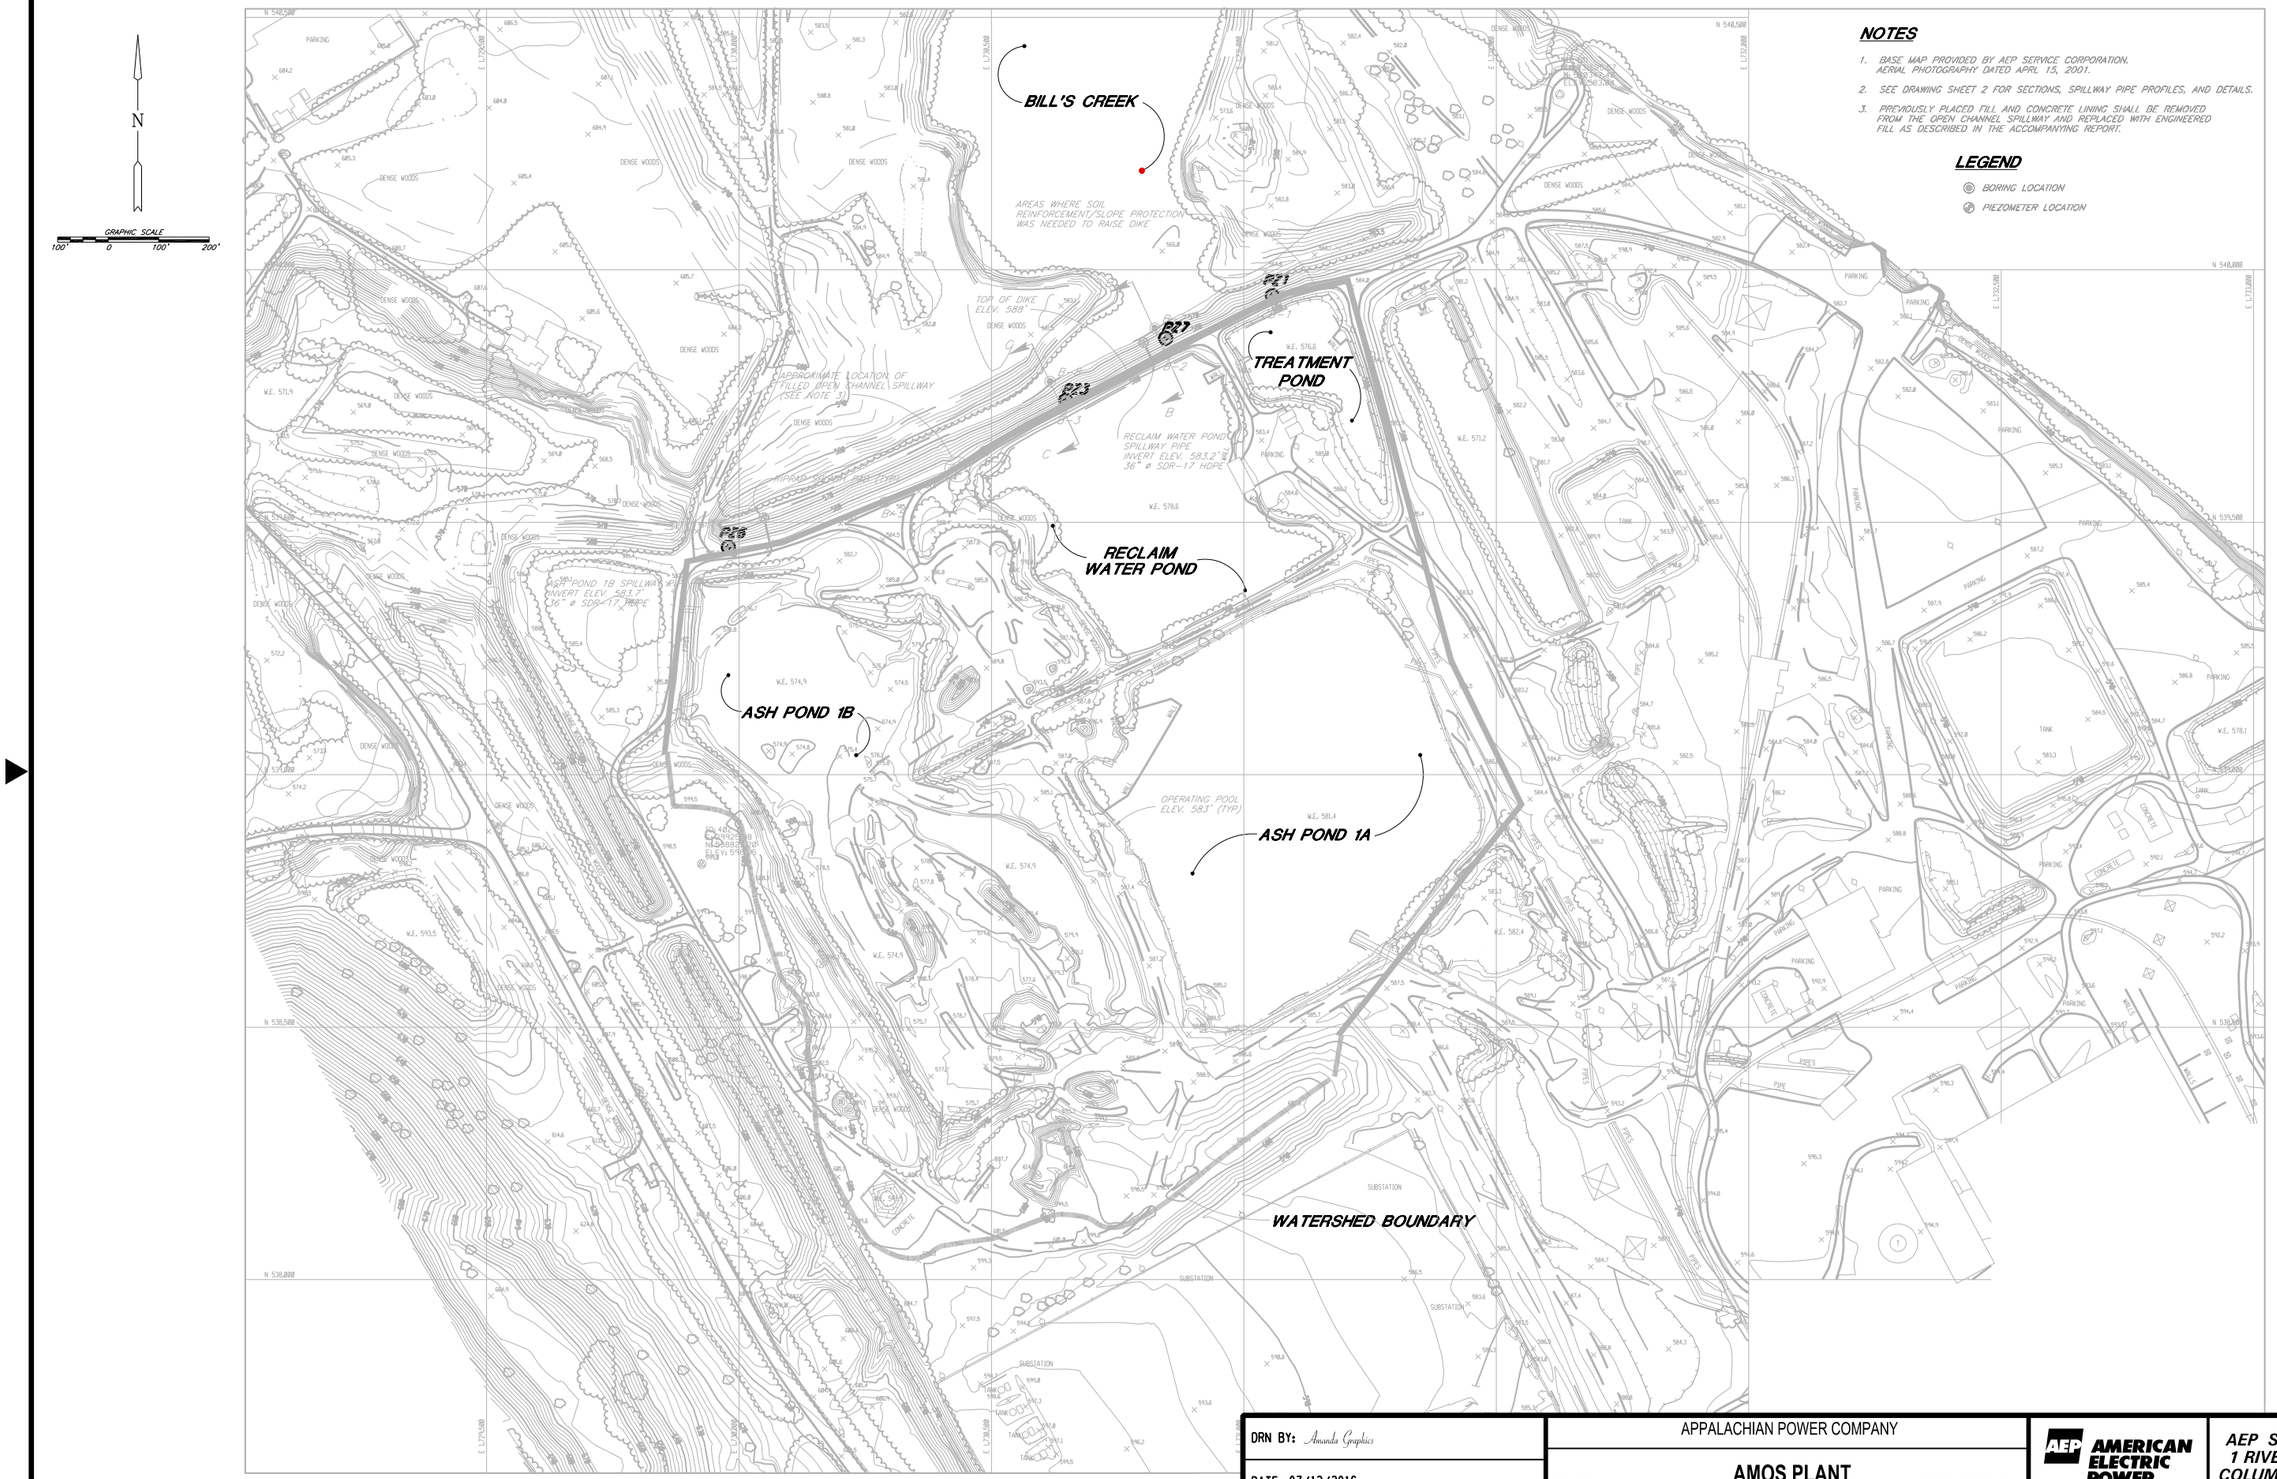
DRN BY: Amanda Graphics	APPALACHIAN POWER COMPANY	AMERICAN ELECTRIC POWER	AEP SERVICE CORP. 1 RIVERSIDE PLAZA COLUMBUS, OH 43215
DATE: 07/12/2016	SCARY **AMOS PLANT** WEST VIRGINIA		
SCALE: N. T. S	BOTTOM ASH POND COMPLEX		FIGURE 2

The location and type of instrumentation is shown on Figure 2 and select piezometers are depicted in cross section along the perimeter dike embankment in Figure 3. The maximum recorded readings of each instrument since the previous annual inspection is shown in the table below.

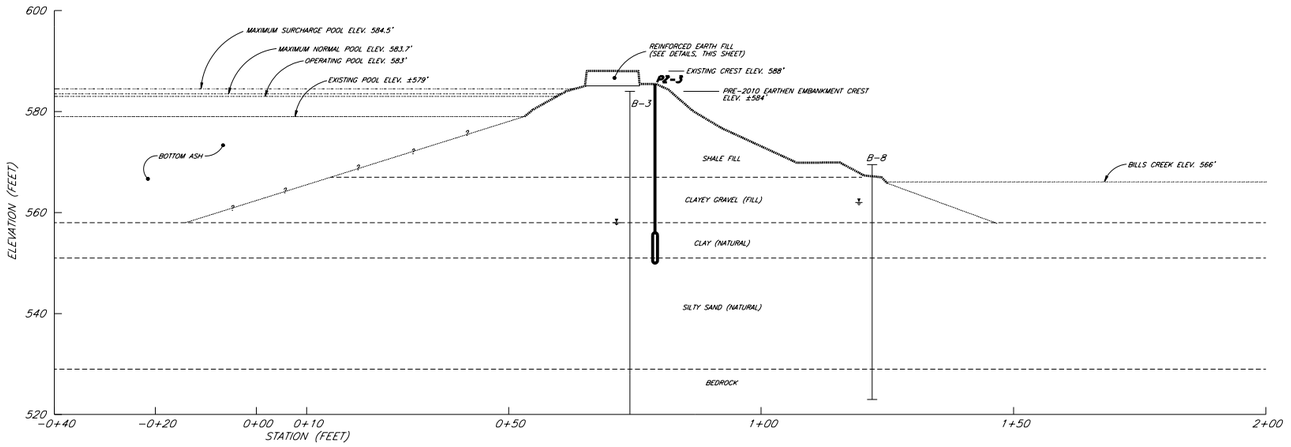
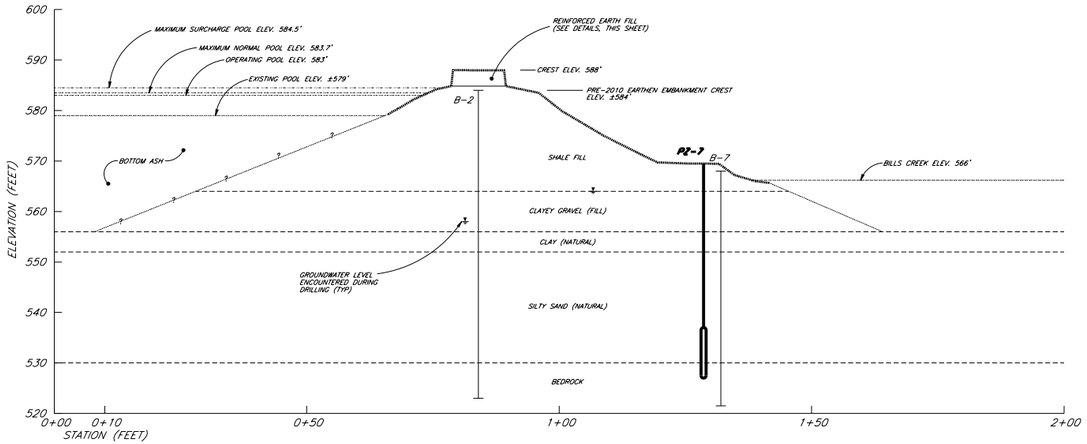
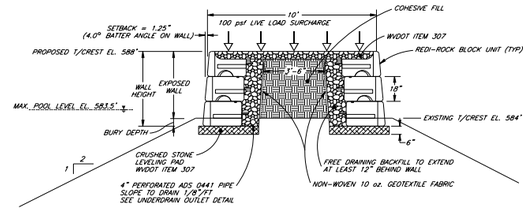
DRN BY: Amanda Graphics	APPALACHIAN POWER COMPANY	AEP AMERICAN ELECTRIC POWER	AEP SERVICE CORP. 1 RIVERSIDE PLAZA COLUMBUS, OH 43215
DATE: 07/12/2016	SCARY **AMOS PLANT** WEST VIRGINIA		
SCALE: N. T. S	EMBANKMENT SECTIONS & DETAILS		FIGURE 3

The north dike of the Reclaim Water Pond and Treatment Basin is approximately 800 feet long. The height of the dam is about 29 feet and the design crest width is 10 feet using concrete block face filled with compacted cohesive soil. The top of the dike is at elevation 588.0 feet with the natural ground surface beneath the dikes is at about elevation 559 feet. Field measurements indicate that dam side slopes are 2.5:H to 1:V (Figure 3).

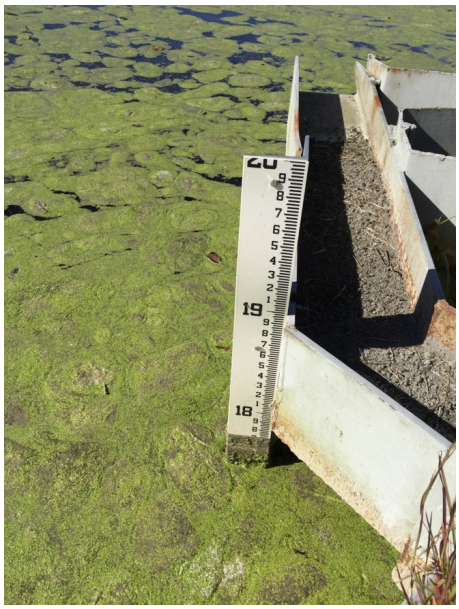
Photo #: 10

IMPOUNDMENT CHARACTERISTICS **Bottom Ash Pond Complex**		
	Bottom Ash Pond 1A	**Bottom Ash Pond 1B**
Water Surface Elevation at time of the inspection	~560 ft.	~581.6 ft.
Approximate **Minimum, Maximum, and Present** depth of impounded water since last annual inspection	4 ft. 6 ft. <1 ft.	5 ft. 6 ft. 6 ft.
Approximate **Minimum Maximum and Present** depth of CCR since last annual inspection	<2 ft. 17 ft. Varies (<2-17 ft.)	16 ft. 16 ft. 16 ft.
Storage Capacity of impounding structure at the time of the inspection	137 AC-Ft	141 AC-Ft
Approximate volume of impounded water at the time of the inspection	<10 AC-Ft.	58 AC-Ft
Approximate volume of CCR at the time of the inspection	~80 AC-Ft	90 AC-Ft

Notes: Staff gauge in BAP 1B ~17.5 = ~581.6

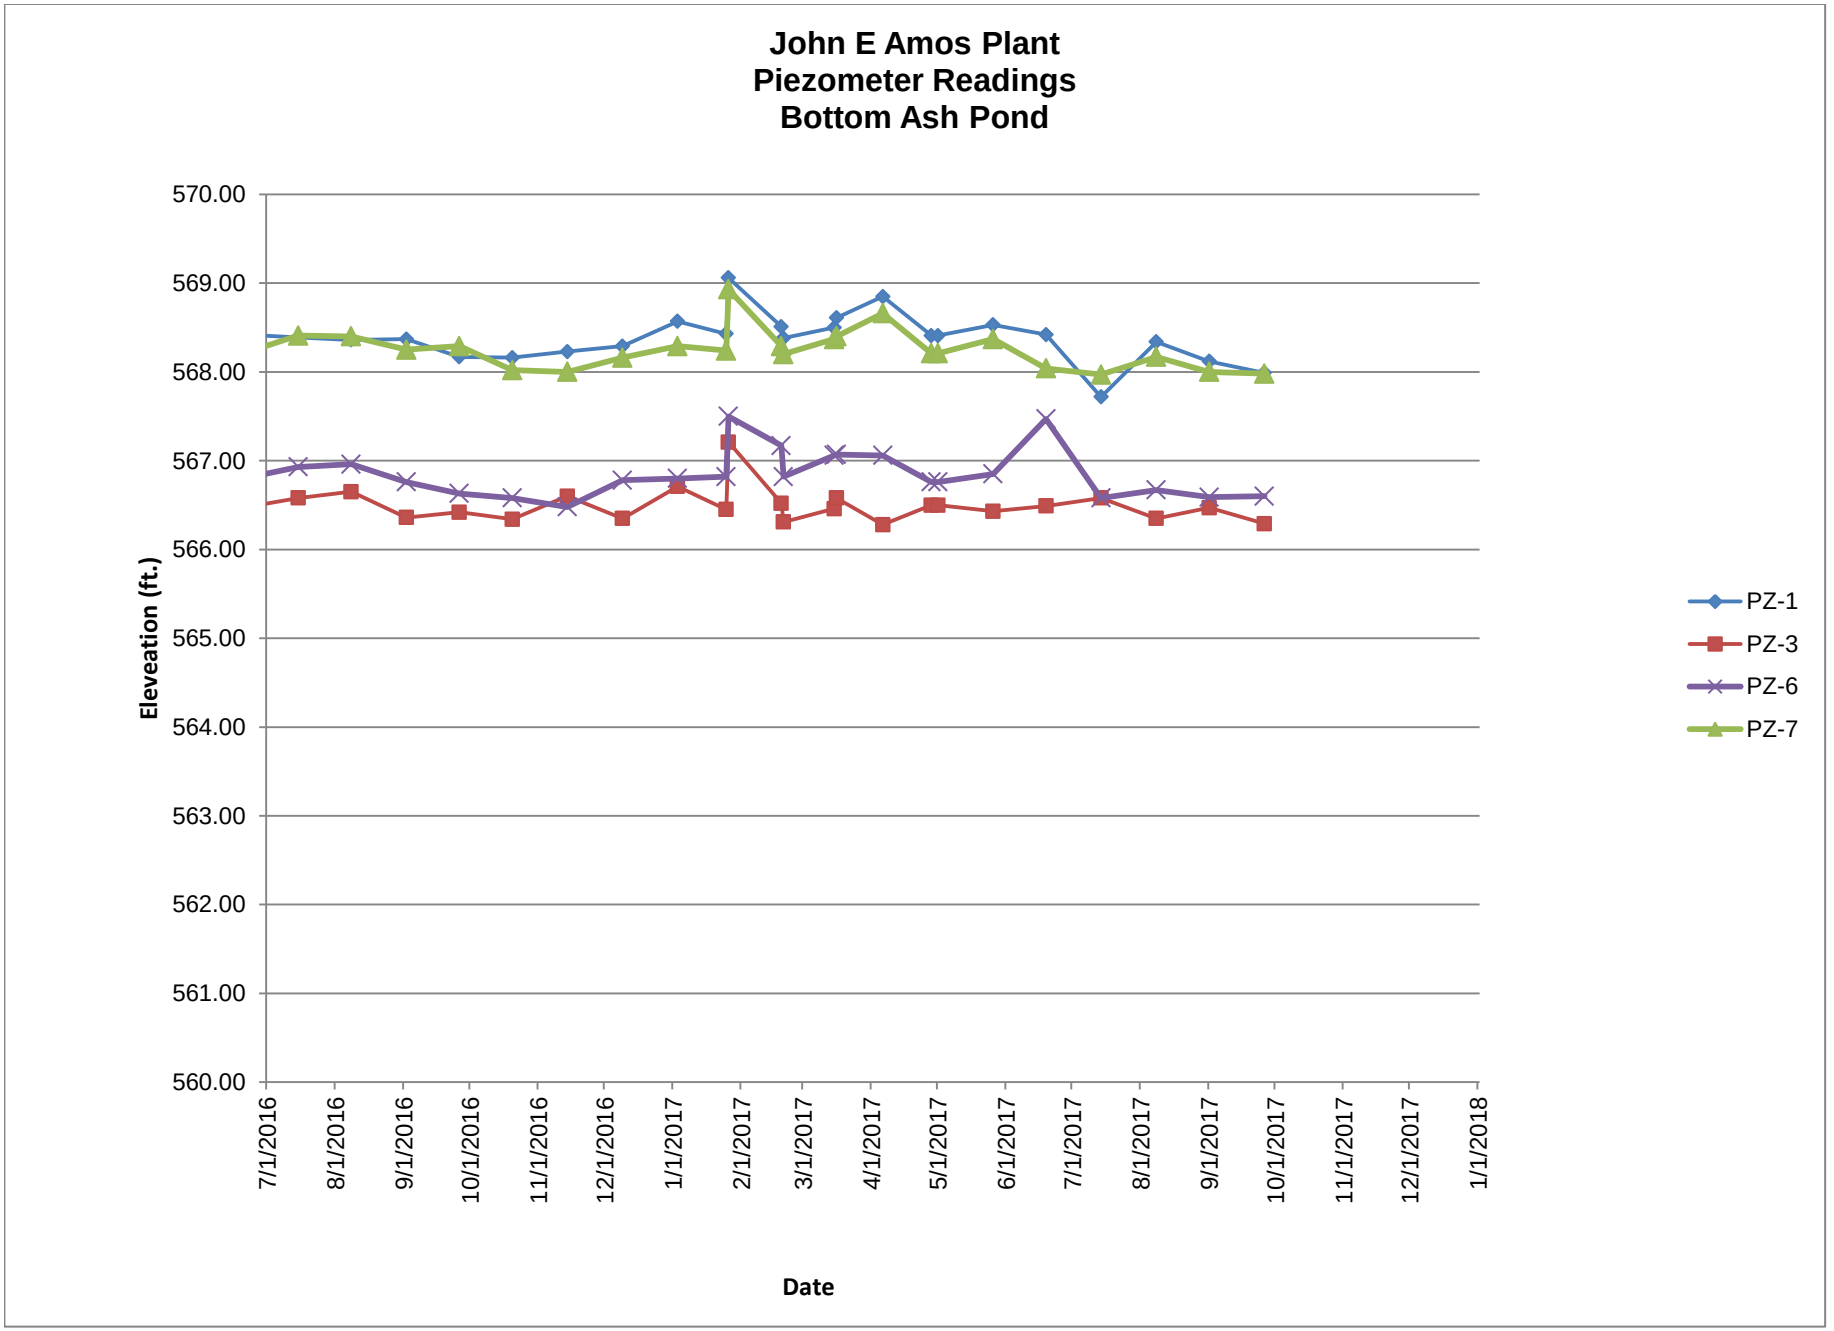
Instrument	Type	Maximum Reading since last annual inspection	Date of reading
PZ-1	Piezometer	569.06	January 26, 2017
PZ-3	Piezometer	567.21	January 26, 2017
PZ-6	Piezometer	567.50	January 26, 2017
PZ-7	Piezometer	568.93	January 26, 2017

The elevations of pond water levels and respective piezometer water levels have remained fairly constant with no adverse trends observed that would impair the structural stability of the perimeter dike. Piezometer hydrographs are contained in Attachment C.

1. Piezometers PZ-1, PZ-3, PZ-6 & PZ-7 should be read monthly and the Stage level of the Kanawha River should also be recorded at the same time using the closest USGS staff gauge.
2. The pond pool stages should continue to be recorded on a periodic basis.
