2021 ANNUAL DAM AND DIKE INSPECTION REPORT

CCR ASH PONDS

WELSH POWER PLANT
CASON, TEXAS

December, 2021

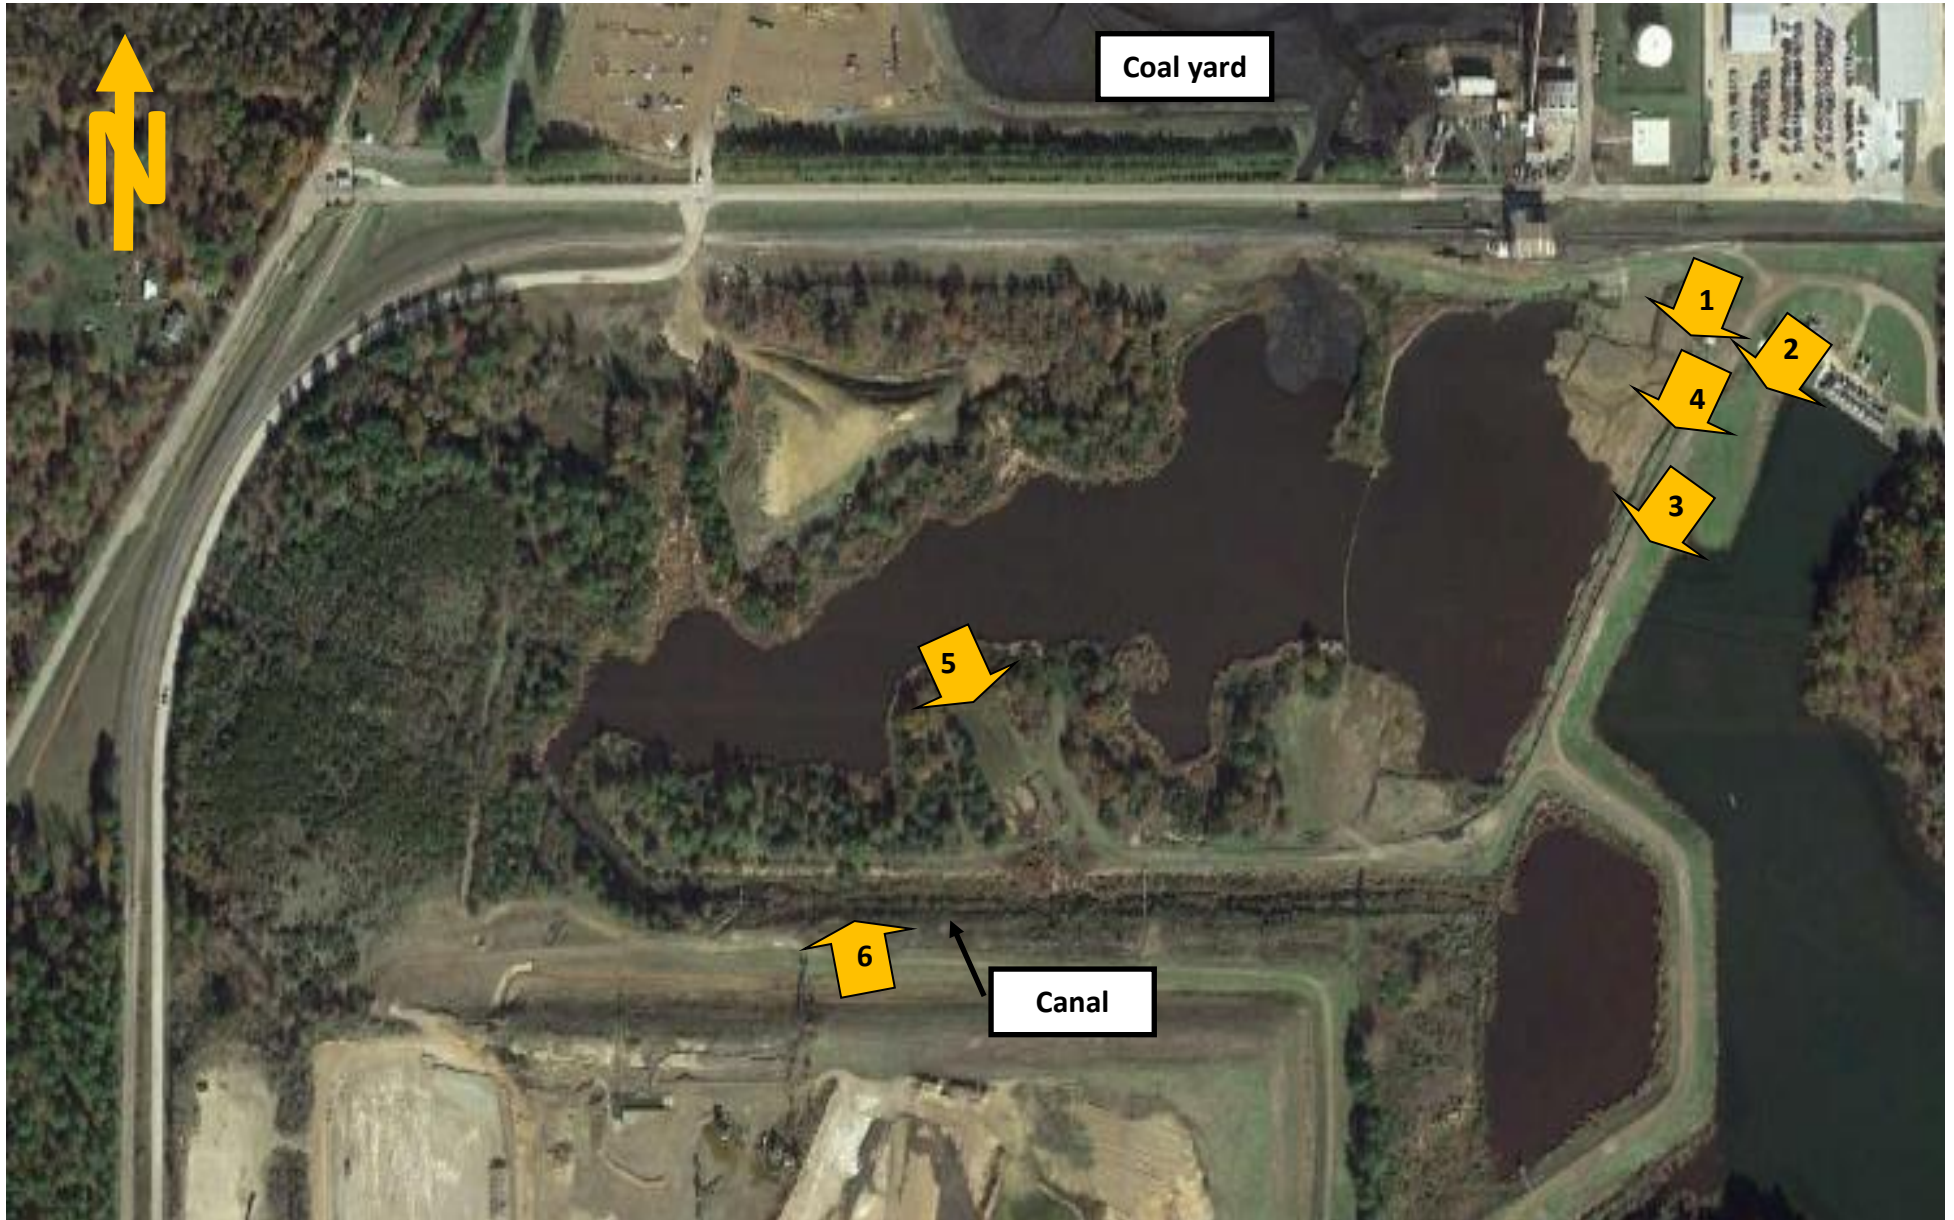
Photo # 1

- (i) Typical condition of the upstream slope, crest, and downstream slope is illustrated in Photographs No. 1-4. The dike appeared in satisfactory and stable condition. There were no signs of settlement, misalignment, sloughing or erosion. Slightly overgrown vegetation was noticed along the upstream slope and on the downstream slope near the rock rip rap. There was some minor damage of the downstream slope near the crest from mowing activities (Photograph No. 3)

Typical view of Primary Bottom Ash Pond upstream slope and interior conditions.

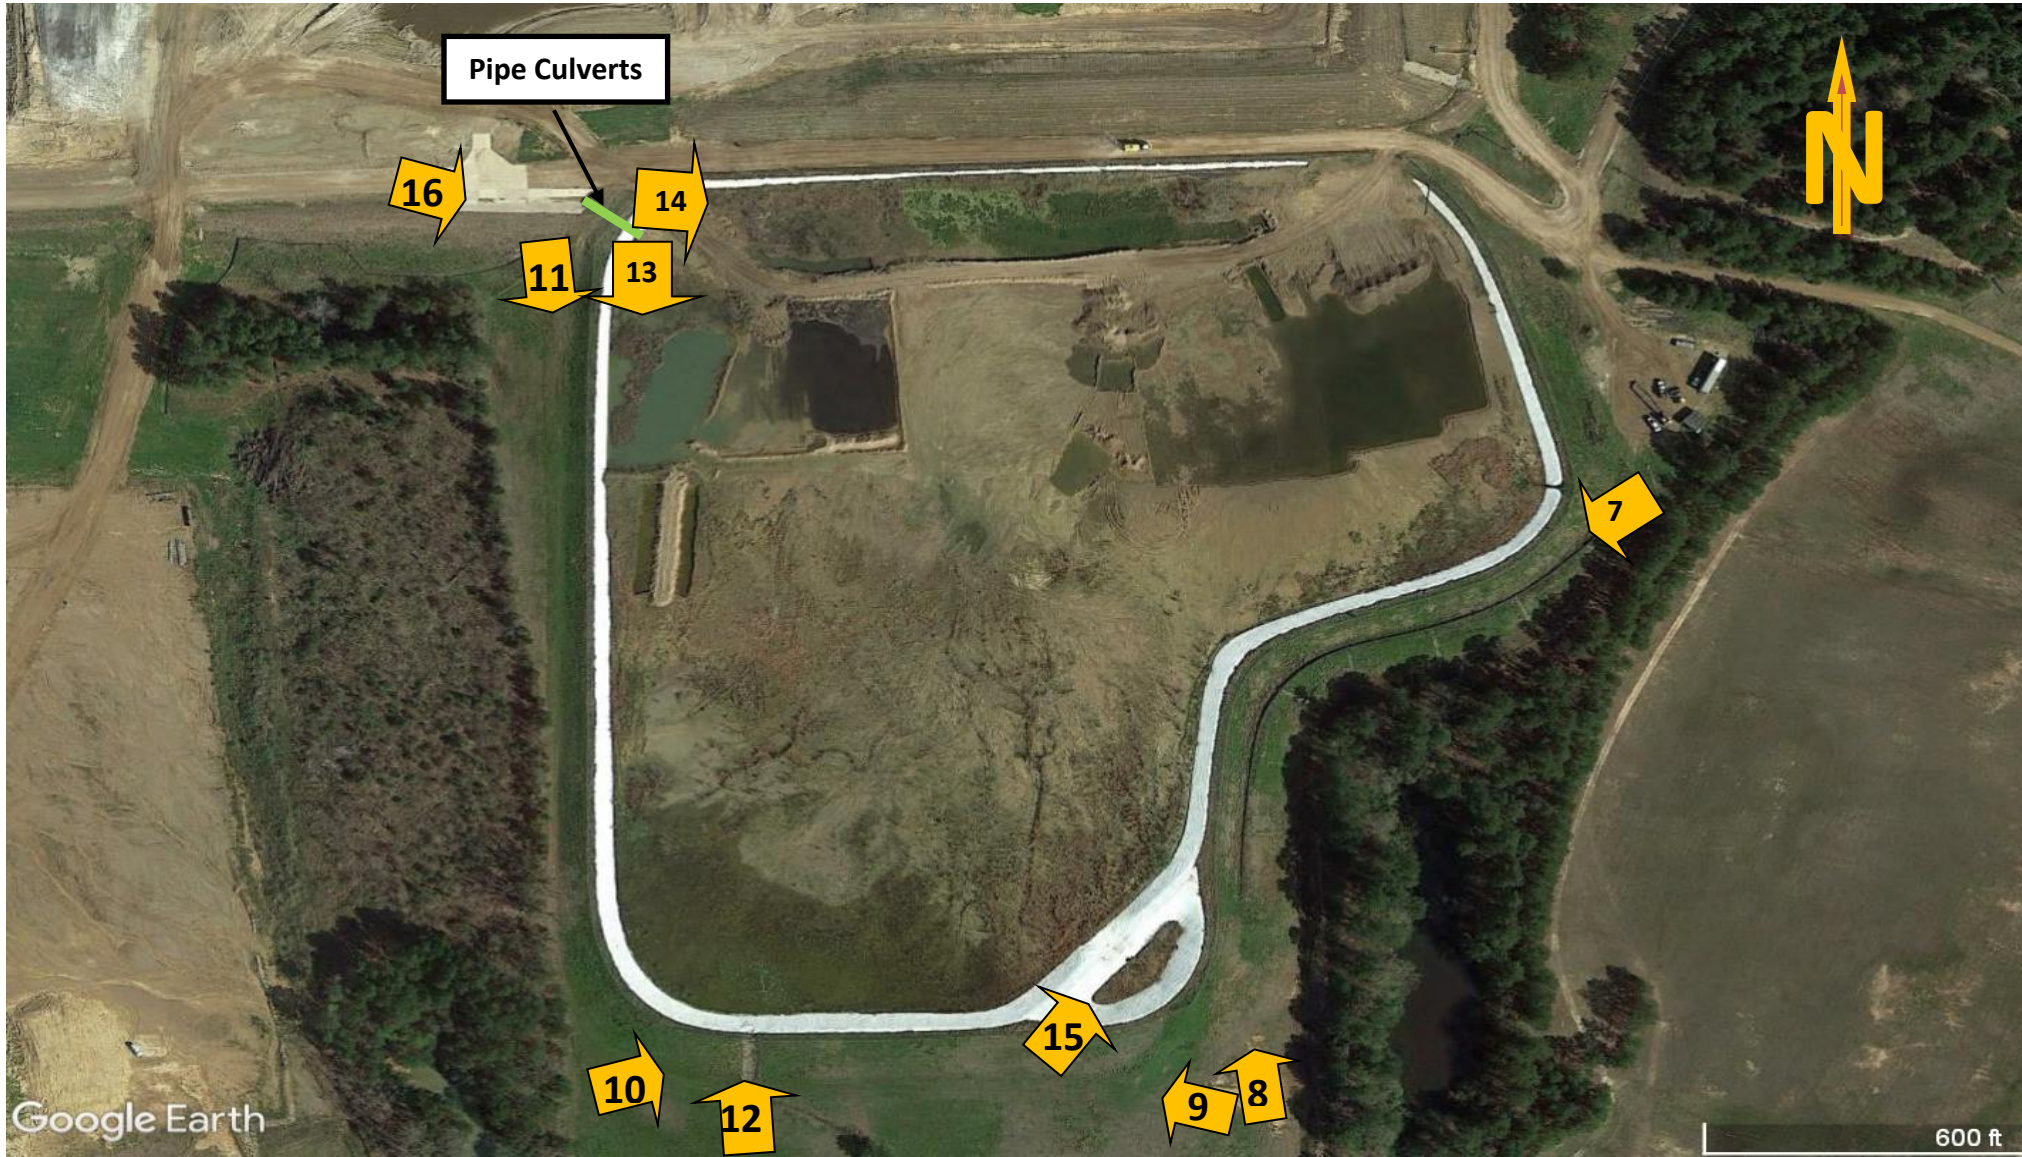
Photo # 7

- (i) The east portion of the downstream slope is illustrated in Photographs No. 7 and 8. Slightly overgrown vegetation was noticed on these slopes. The slope appeared in satisfactory and stable condition with no signs of settlement, misalignment, sloughing or erosion.

Bottom Ash Storage Pond (Winston Pond) looking at downstream slope conditions on east side.
