2022 Annual Landfill Inspection Report

CCR Landfill

Flint Creek Plant

Inspection Date: July 20, 2022

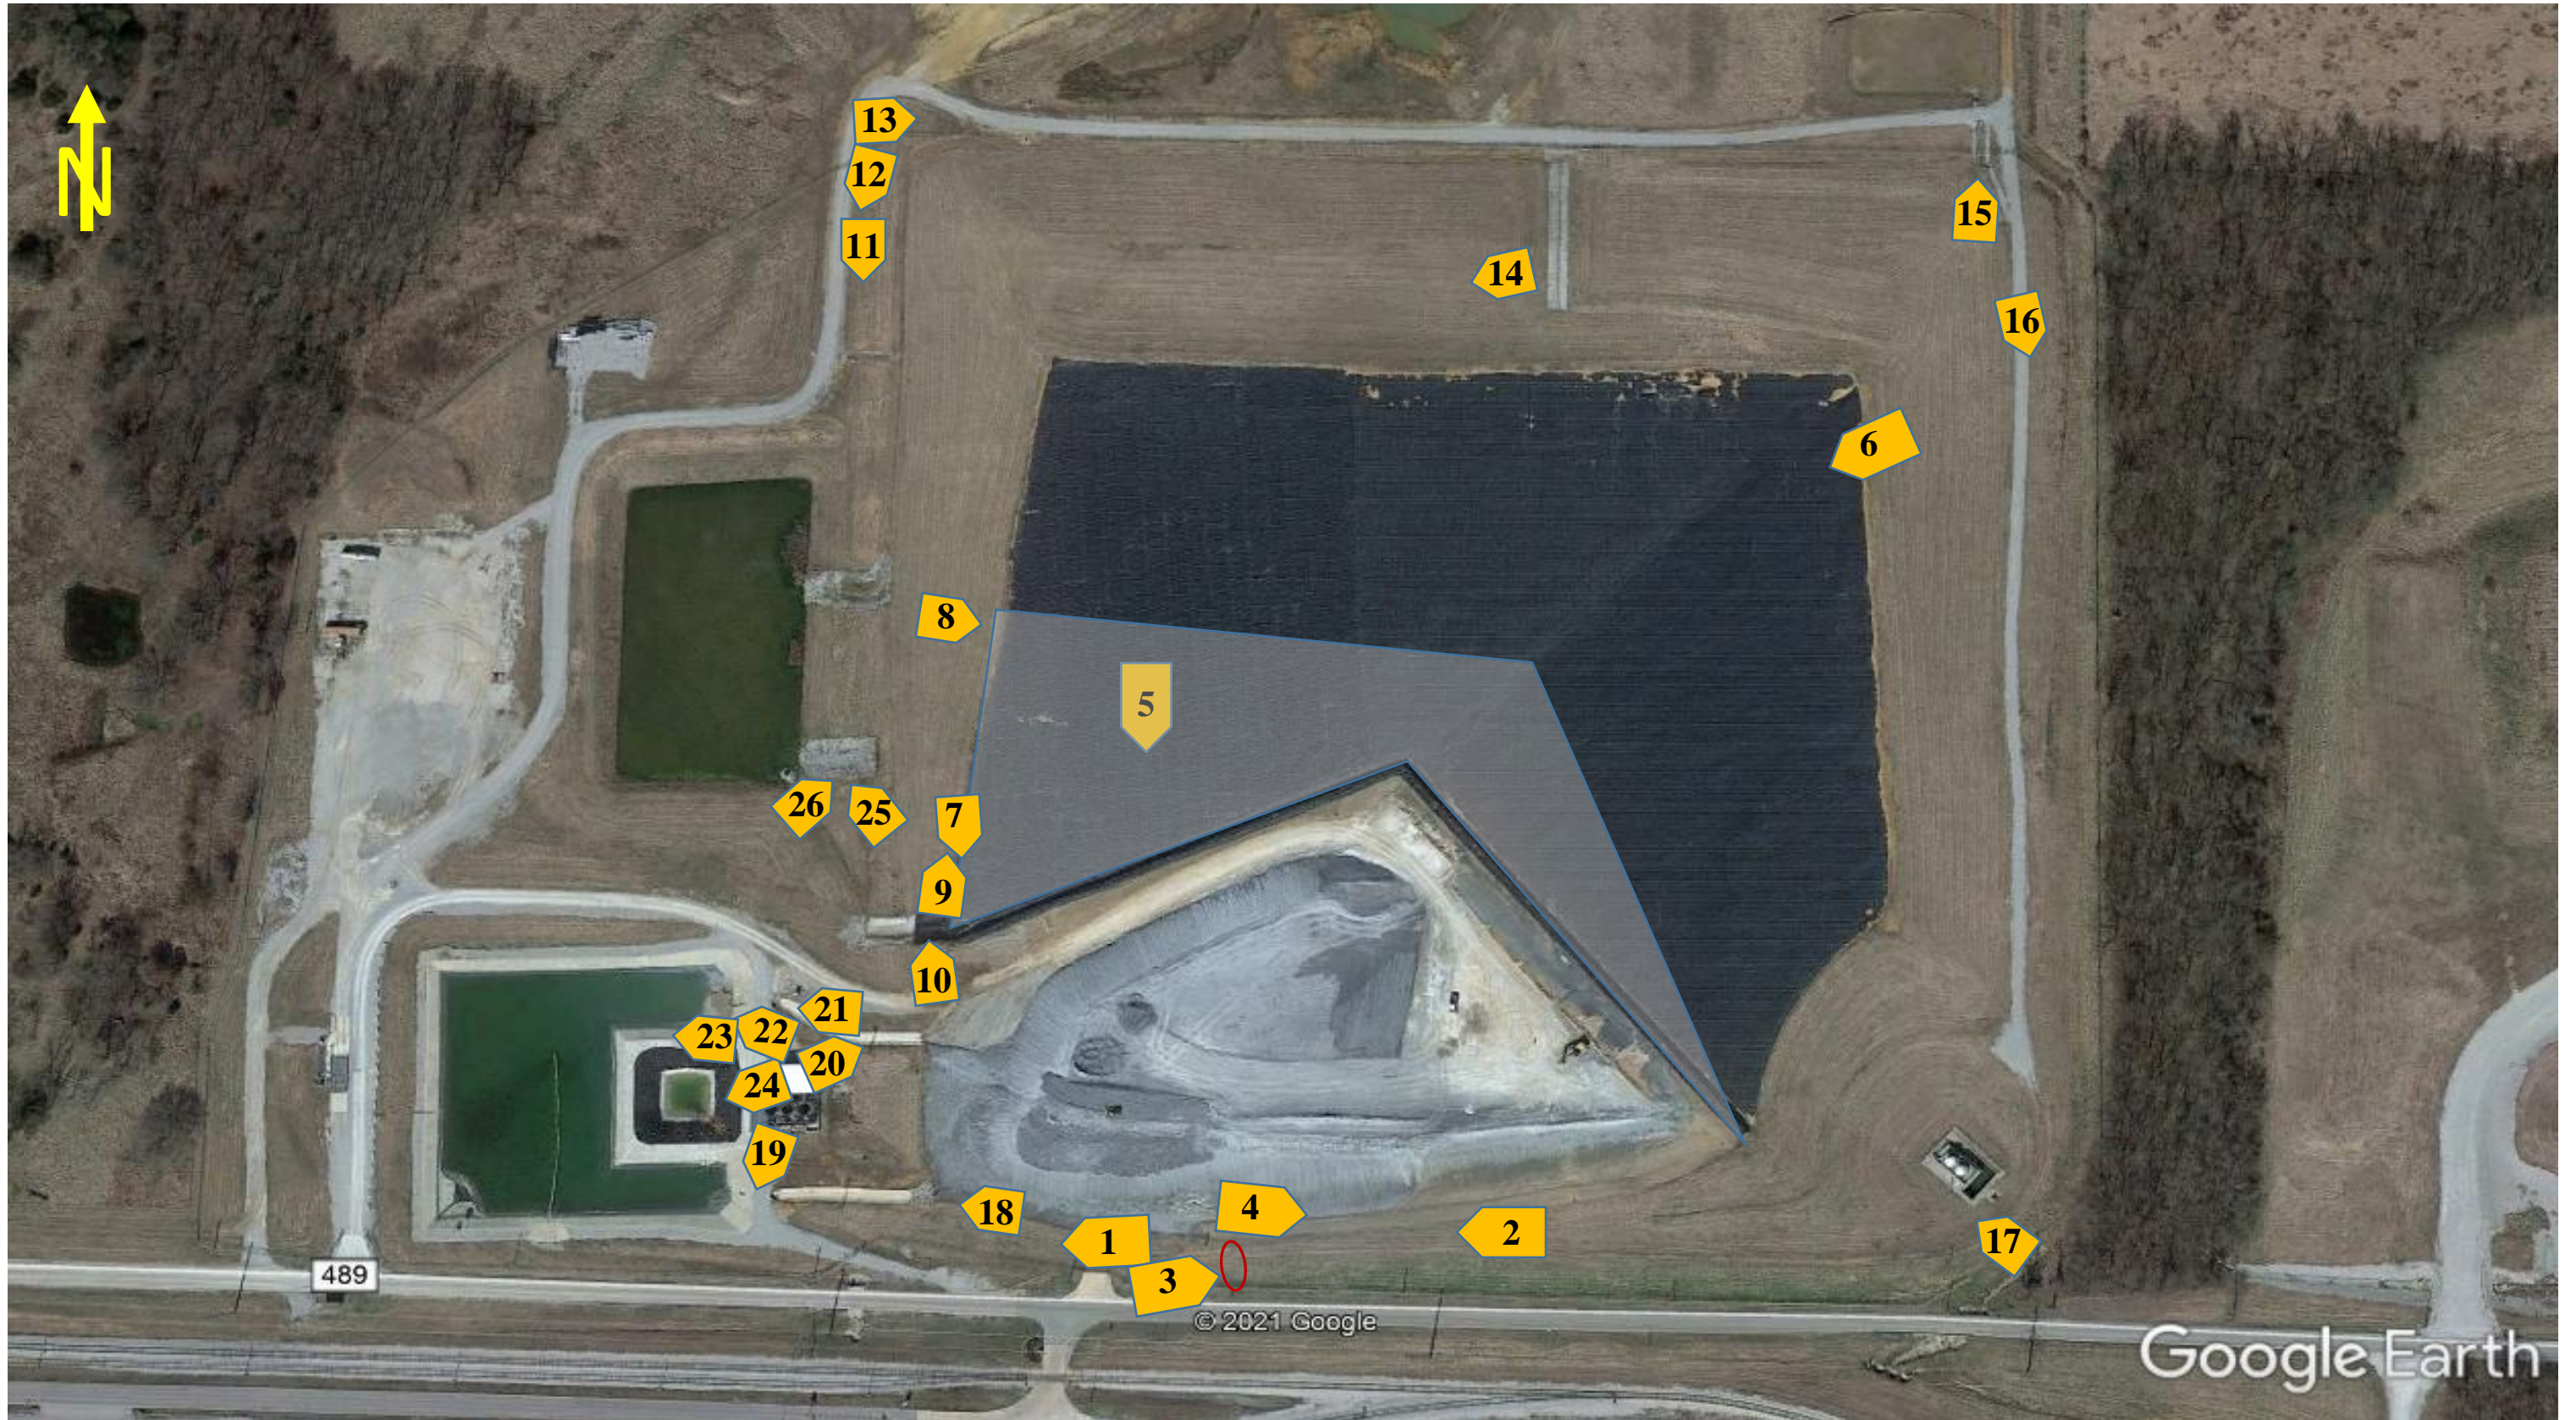
Figure 3 – Inspection Photograph Location Map
Flint Creek Landfill, Gentry, AR

Overall, the facility is in good condition. The Landfill is functioning as intended with no signs of potential structural weakness or conditions which are disrupting to the safe operation of the Landfill. Inspection description are illustrated in Figure 3, Inspection Photograph Location Map and inspection photographs. Additional pictures taken during the inspection are available upon request.
