2022 Annual Dam and Dike Inspection Report

Primary Bottom Ash Dam

Flint Creek Plant

Inspection Date: July 21, 2022

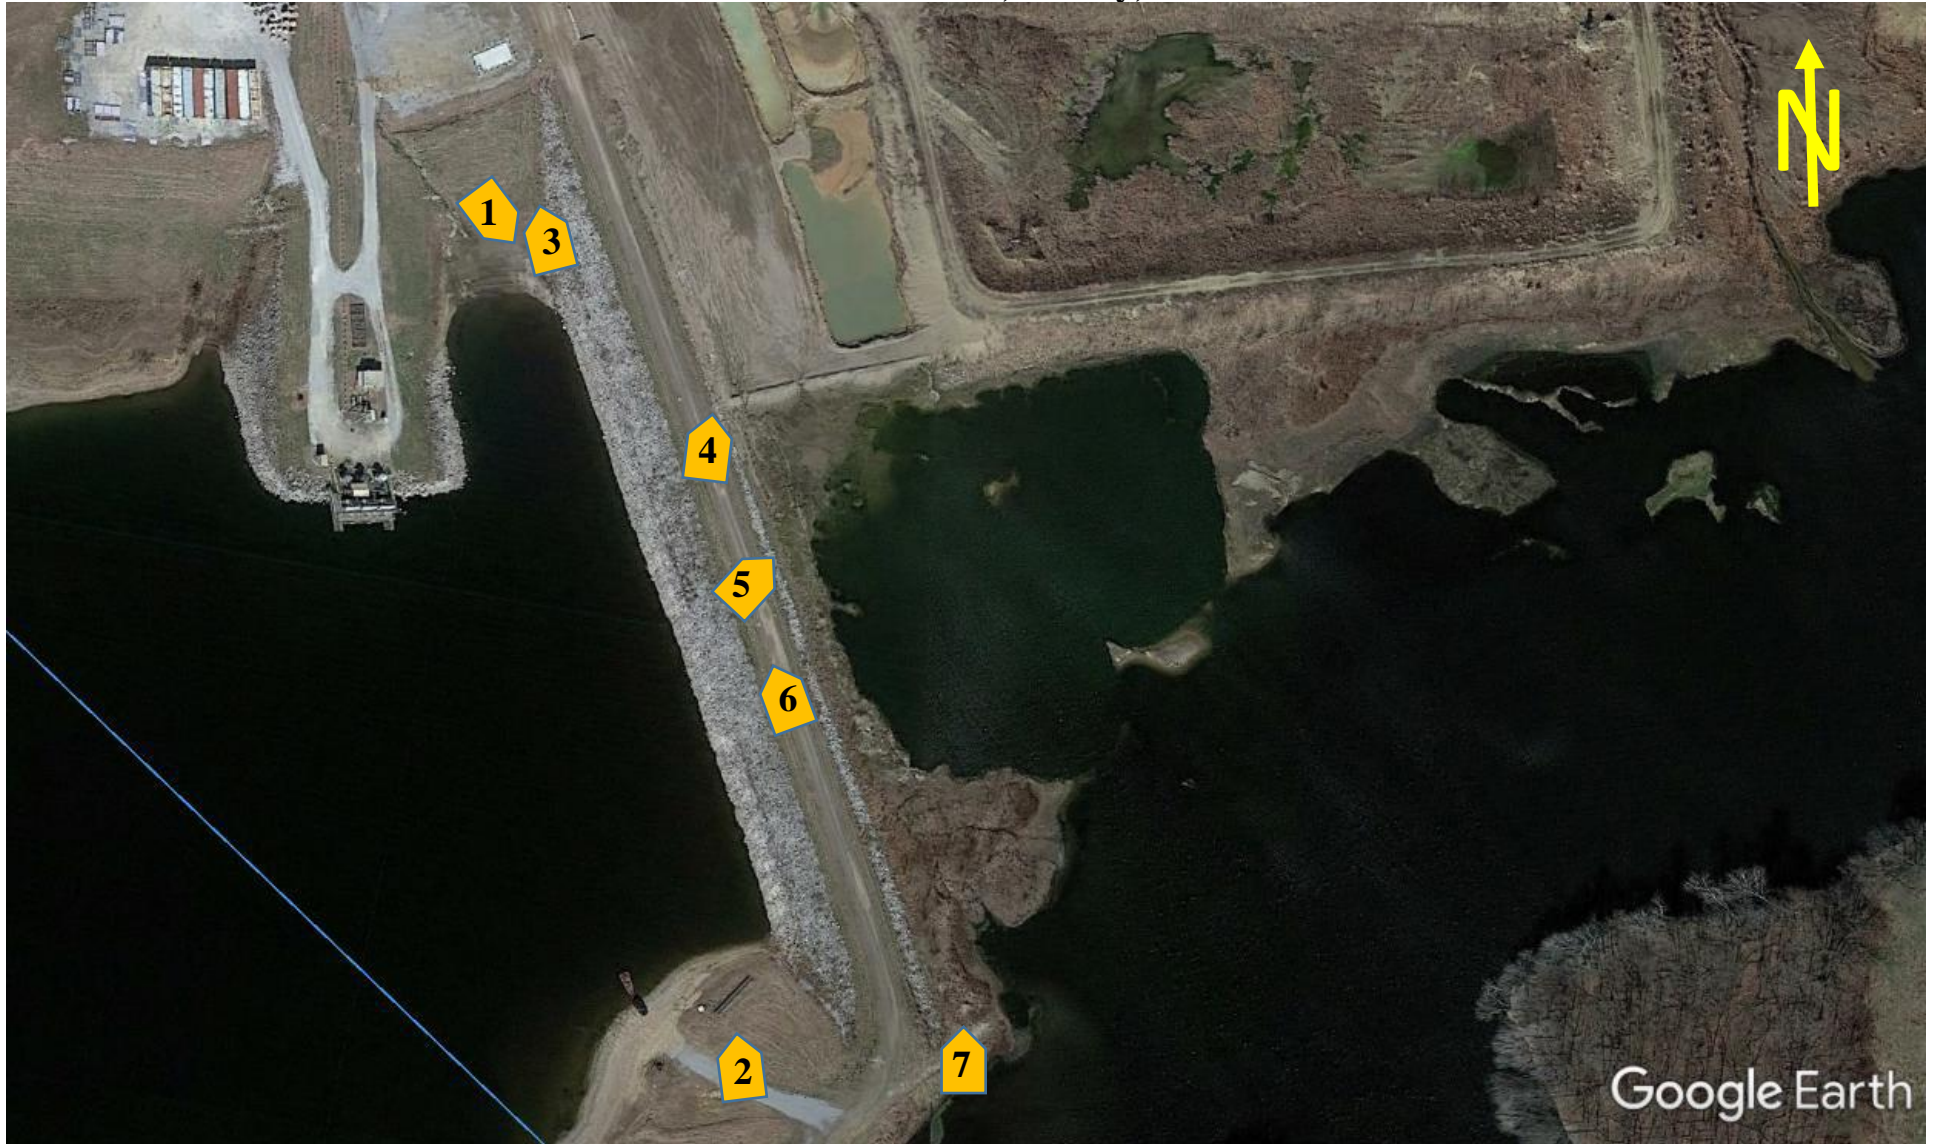
Figure 4A – Photograph Location Map
Primary Bottom Ash Dam
Flint Creek Plant, Gentry, AR

Overall, the facility is in good condition. The impoundment is functioning as intended with no signs of potential structural weakness or conditions that are disrupting the safe operation of the impoundment. Currently, the bottom ash from the impoundment has been removed as part of the pond closure work. Inspection photograph location map (Figures 4A and 4B) and inspection photos are included.
