# **2022 Annual Landfill Inspection Report**

**CCR Landfill**

**Turk Power Plant  
Southwestern Electric Power Company  
Fulton, Arkansas**

**Document Number:** GERS-22-031

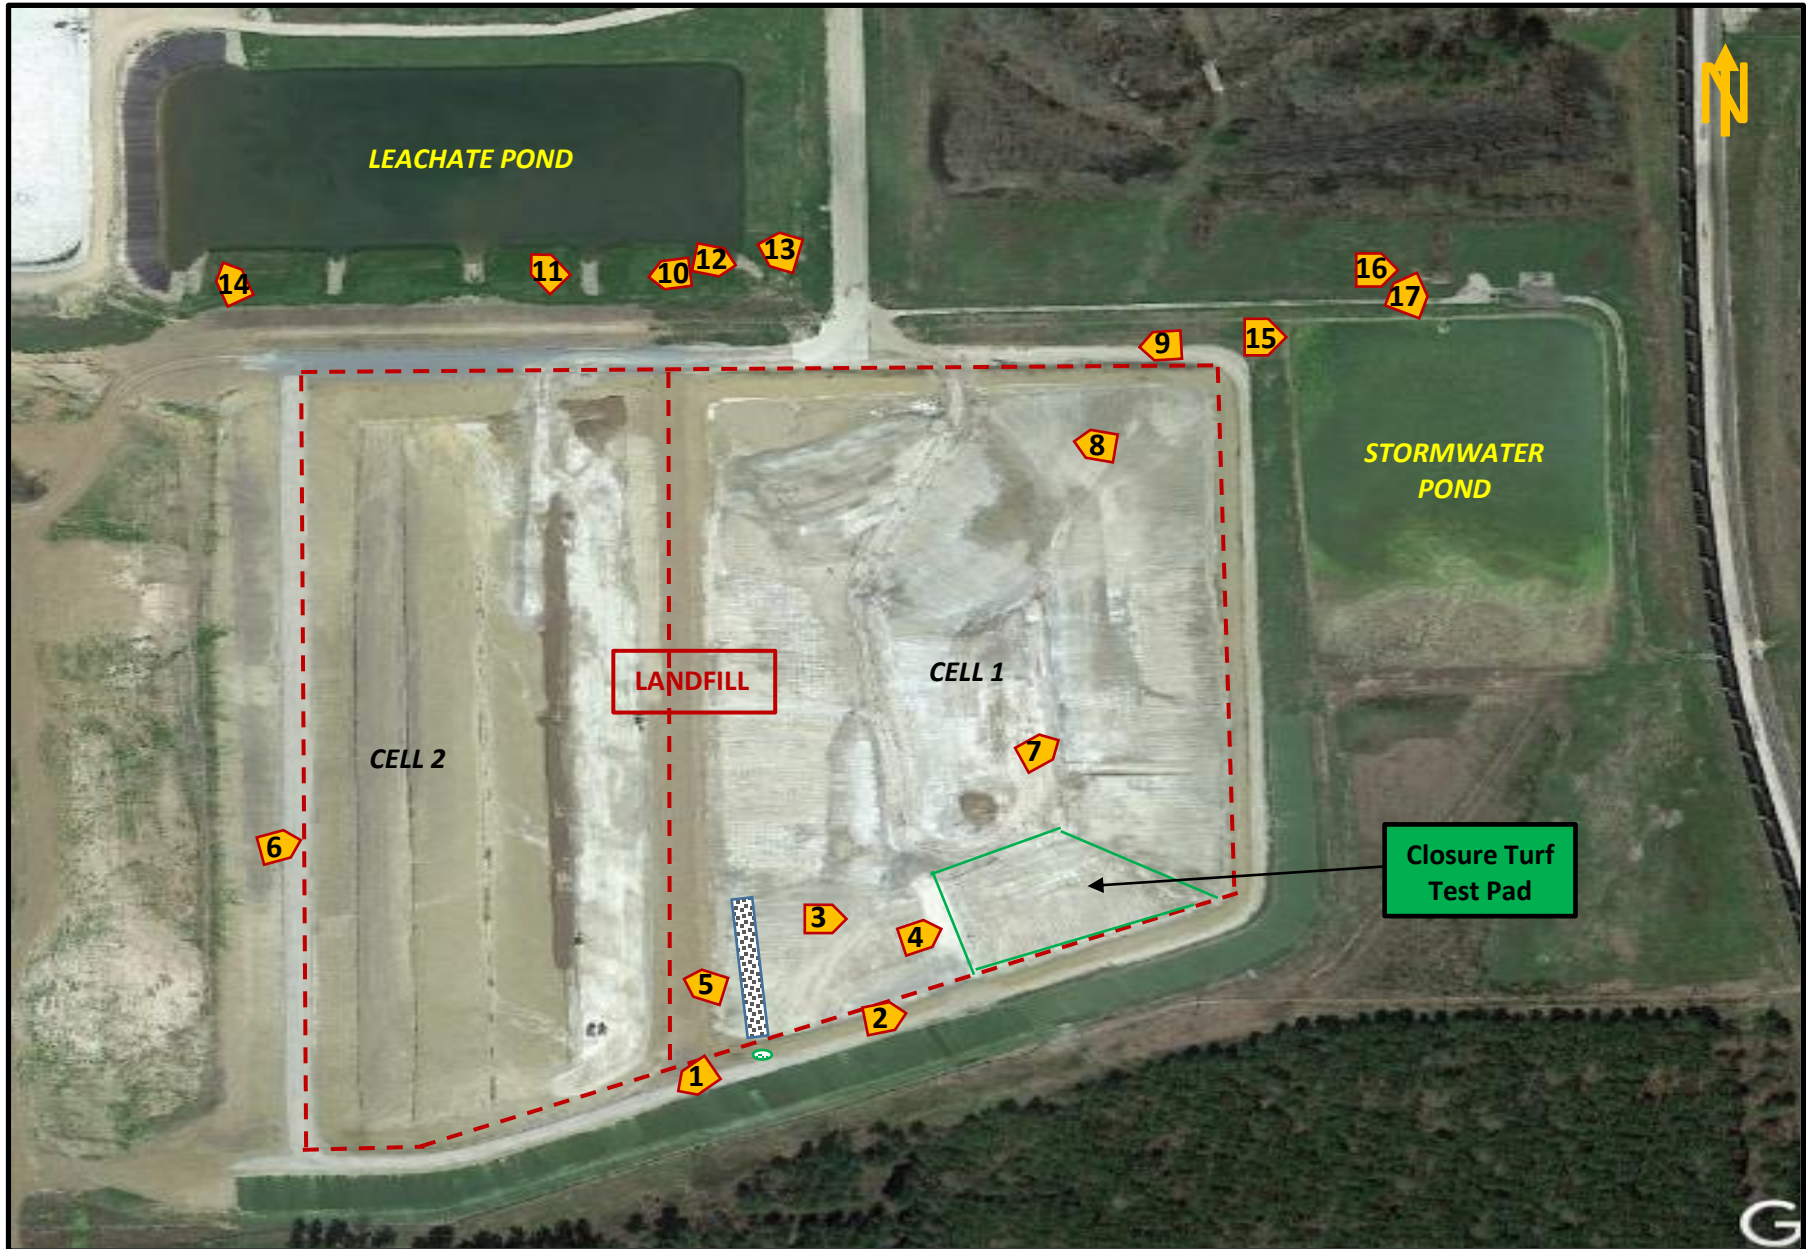
1. Photographs No. 1 and 2 illustrate south perimeter berm and toe ditch. The berm and ditch were constructed for the landfill to support the landfill and control runoff from the landfill. The slope of the berm consists of artificial turf (alternate to the natural grass

<p><b>Photograph No. 1</b> South side of the landfill, support berm, and storm water ditch (looking west).</p>
