# **2023 Dam and Dike Inspection Report**

**Bottom Ash Pond**

**Northeastern 3&4 Plant  
Public Service Company of Oklahoma  
Oologah, OK**

**Document ID: GERS-23-049**

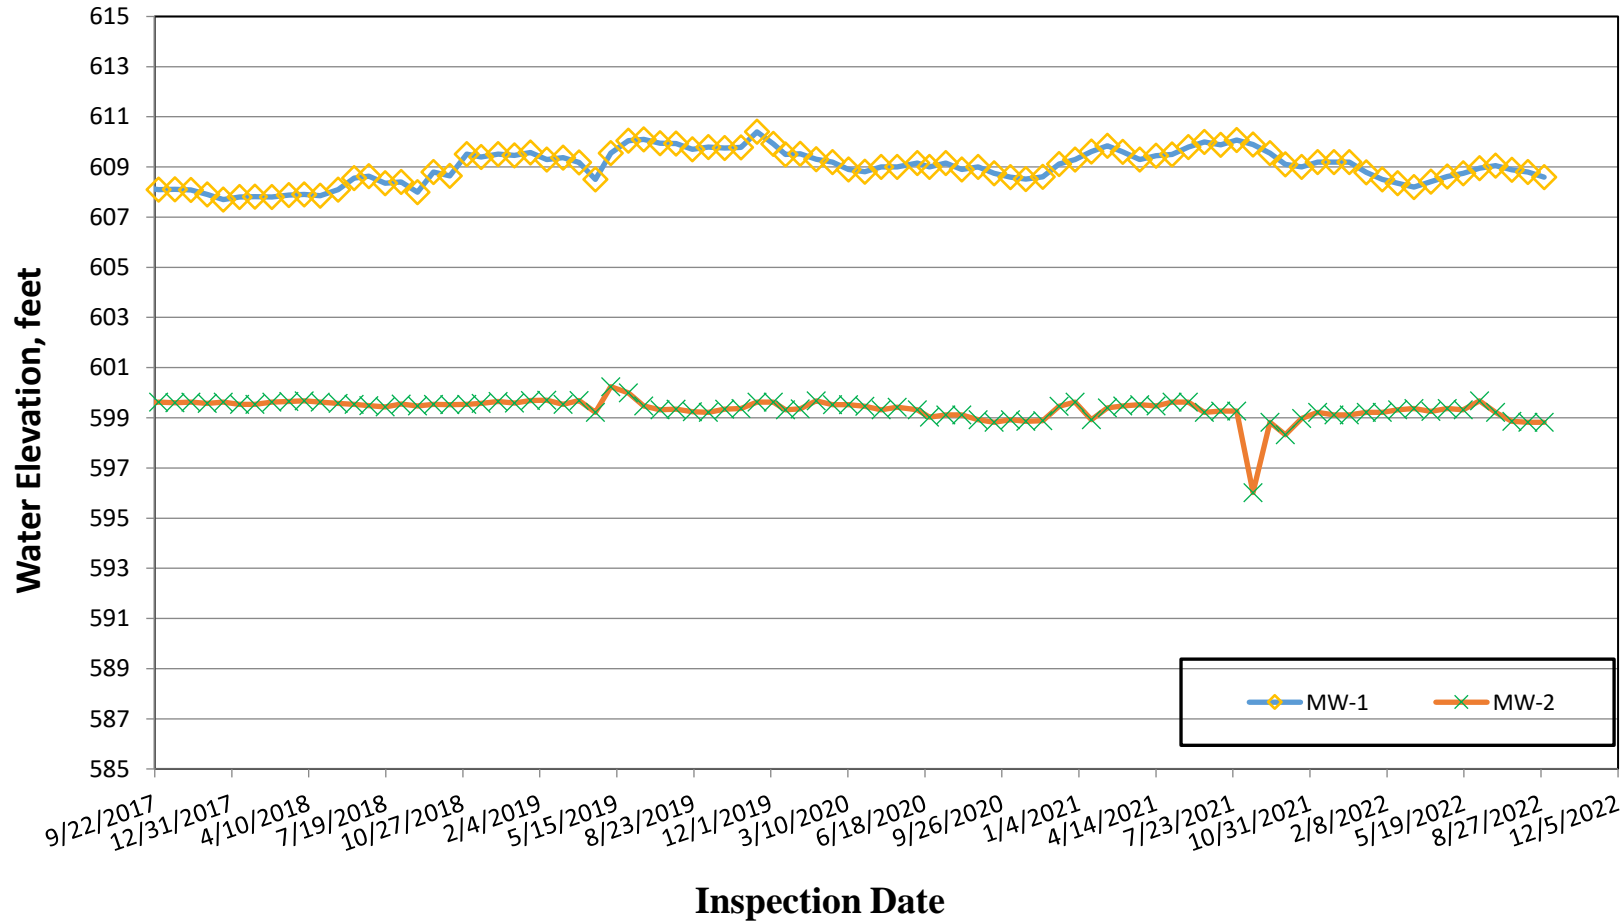
### Figure 3 – Historical Piezometer Data

There are two piezometers and a seepage collection pipe as part of the instrumentation for this facility. The locations of the instrumentations are shown on Figure 2. The maximum and minimum recorded readings of each piezometer since the previous annual inspection is shown in Table 1 below. The readings collected since the last inspection were all within their normal safe operating ranges. MW-01 is located on the crest of the dam and MW-02 is located at the toe of the dam. The water level in the pond ranged from elevation 622.17-623.17 feet. Figure 3 illustrates the historical piezometer data.

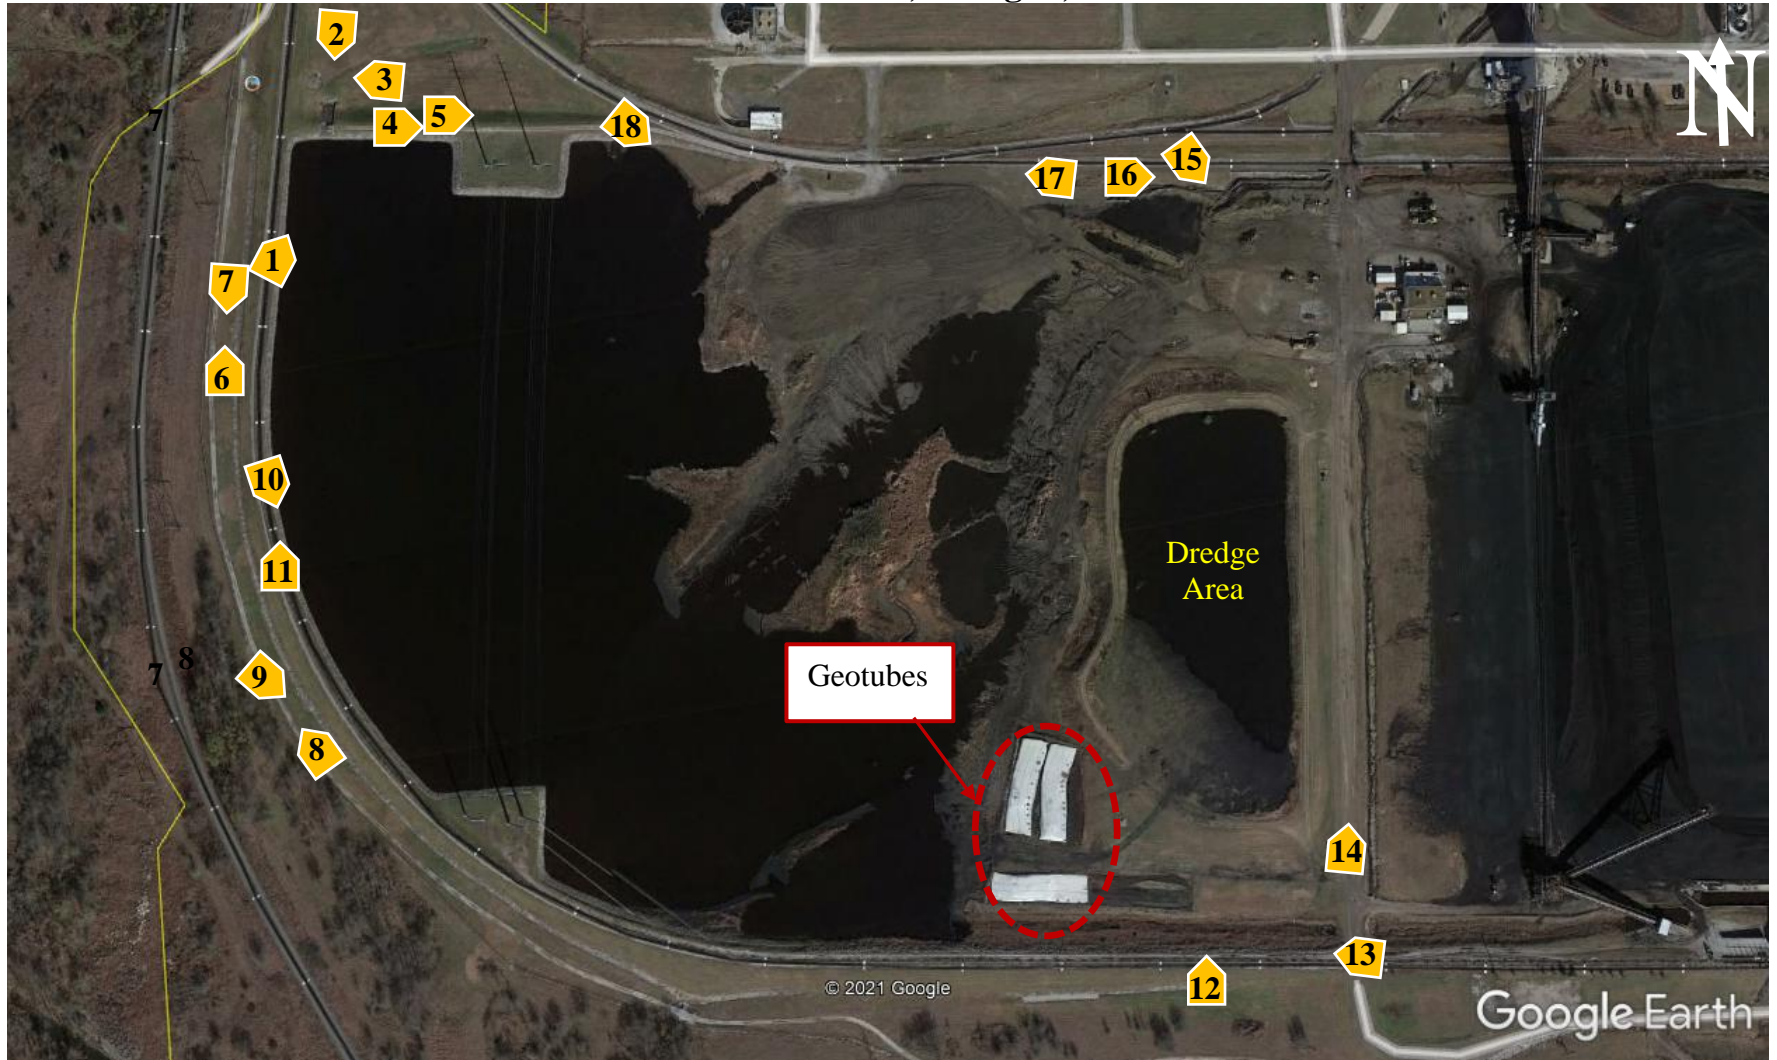
**Figure 4 – Inspection Photograph Location Map**  
**Bottom Ash Pond**  
**Northeastern Plant, Oologah, OK**

A visual inspection of the Bottom Ash Pond was conducted to identify any signs of distress or malfunction of the impoundment and appurtenant structures. Specific items inspected included all structural elements of the dam such as inboard and outboard slopes, crest, and toe; as well as appurtenances. Figure 4 illustrate the visual inspection photograph location.
