2023 Annual Dam and Dike Inspection Report

Primary Bottom Ash Dam

Flint Creek Plant

Document Number: GERS-23-020

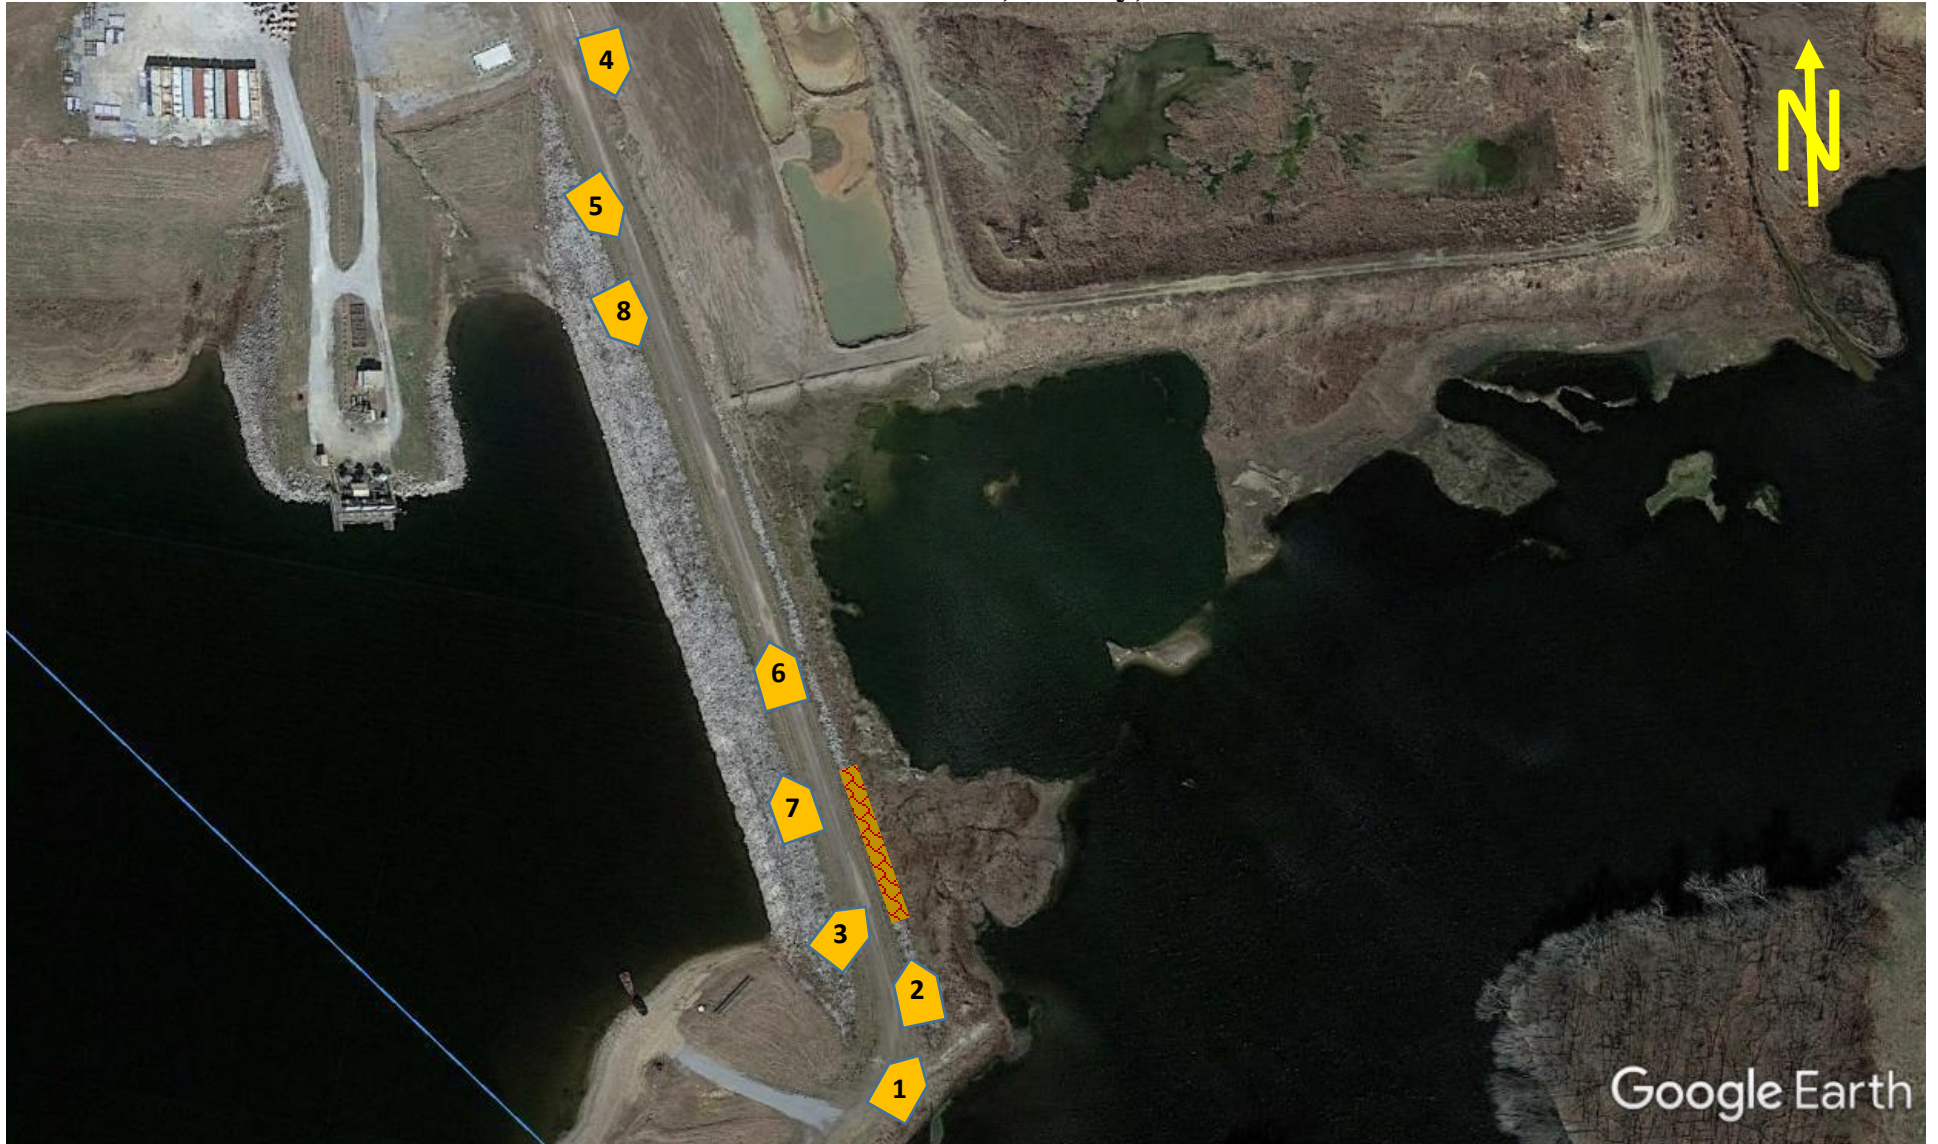
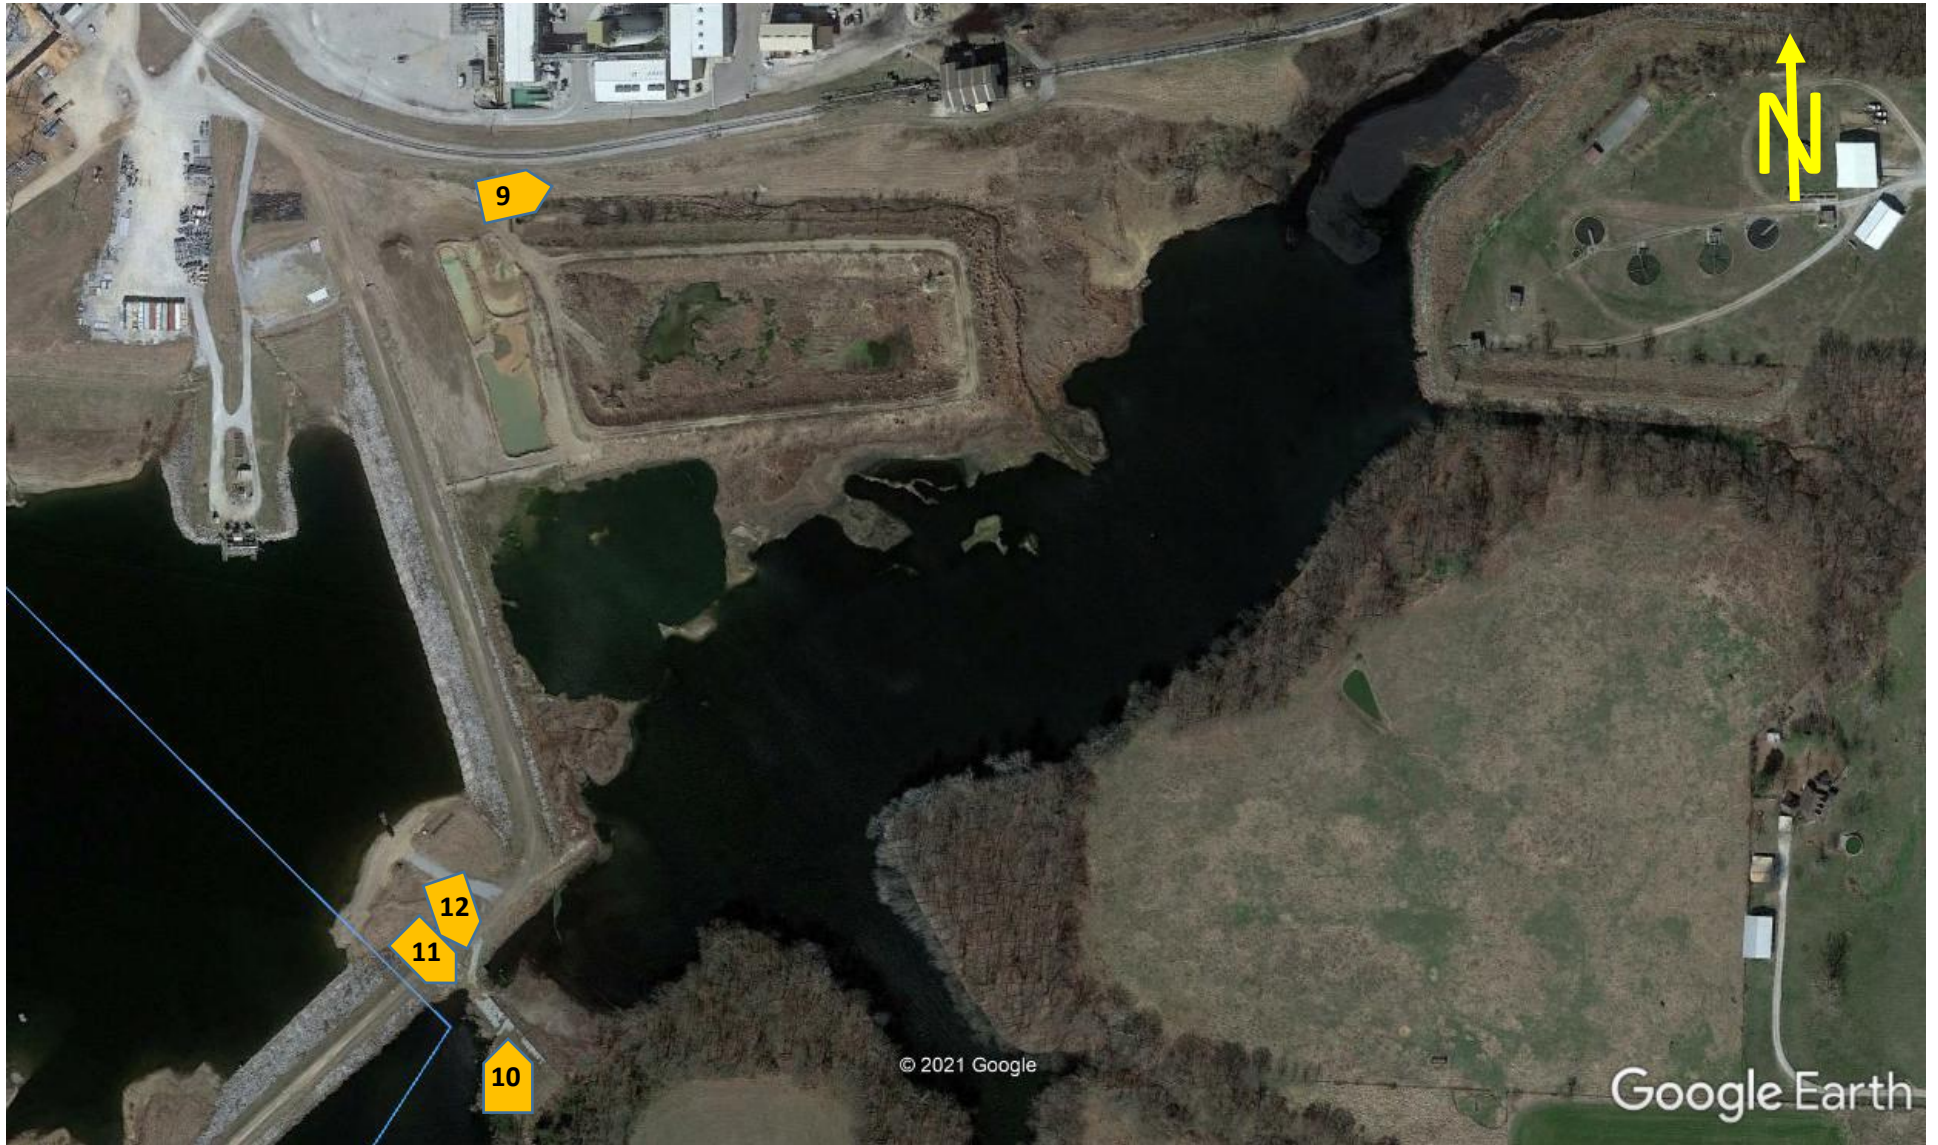
Overall, the facility is in good condition. The impoundment is functioning as intended with no signs of potential structural weakness or conditions that are disrupting the safe operation of the impoundment. Currently, the bottom ash from the impoundment has been removed as part of the pond closure work. Inspection photograph location map (Figures 4A and 4B) and inspection photos are included.
