HISTORY OF CONSTRUCTION

CFR 257.73(c)(1)

Fly Ash Pond

Big Sandy Plant
Louisa, Kentucky

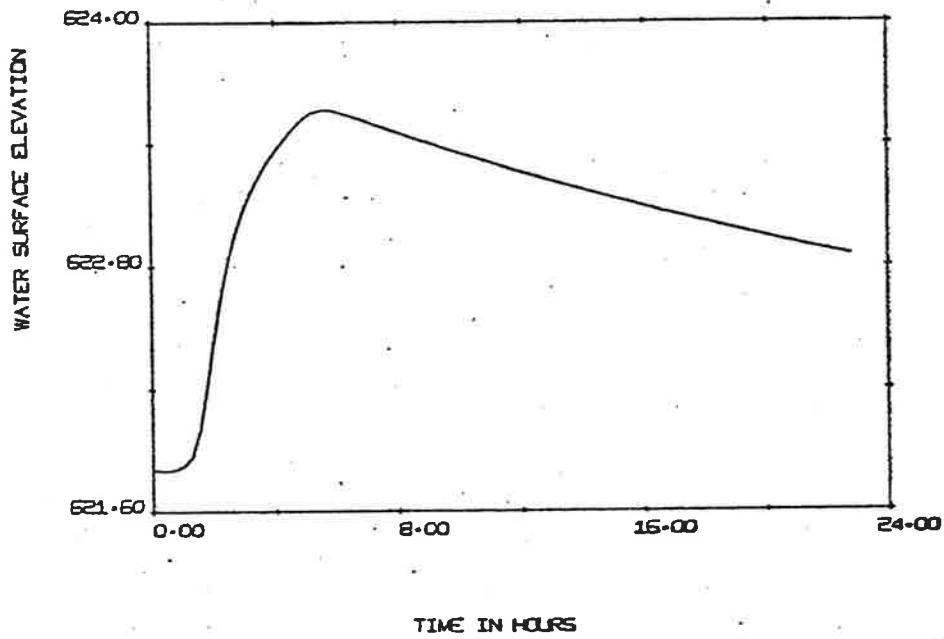
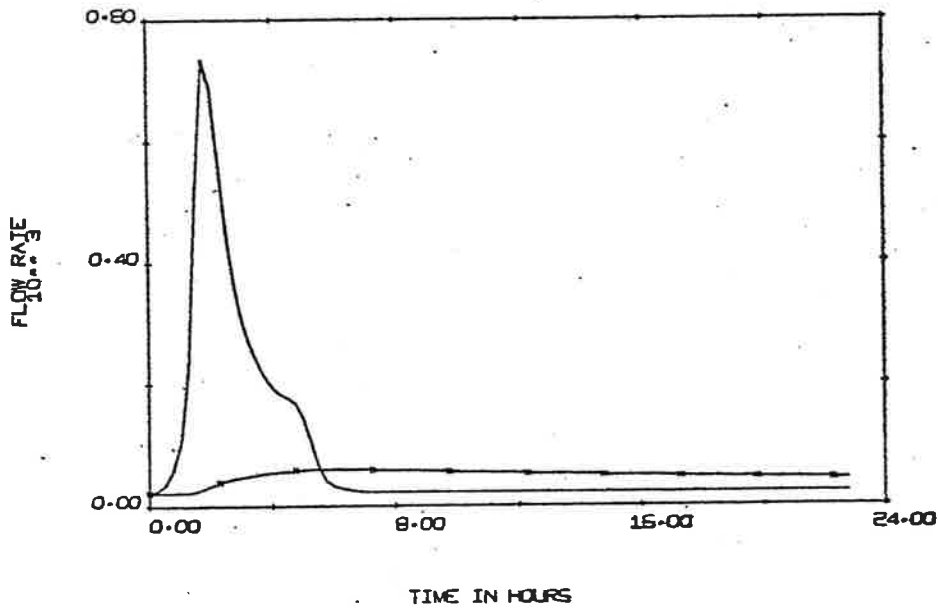
FIGURE 1

BIG SANDY - 25 YEAR FLOOD - EXISTING PRIN- SPIN- CREST 620, DAM CREST 625-
—— INFLOW HYDROGRAPH
——●—— OUTFLOW HYDROGRAPH

The results of the flood routing through the existing service spillway are given on Figures 1 and 2. The flood routing reveals that the existing service spillway is adequate to pass the 100 year storm without overtopping the existing dam crest El. 625.0.

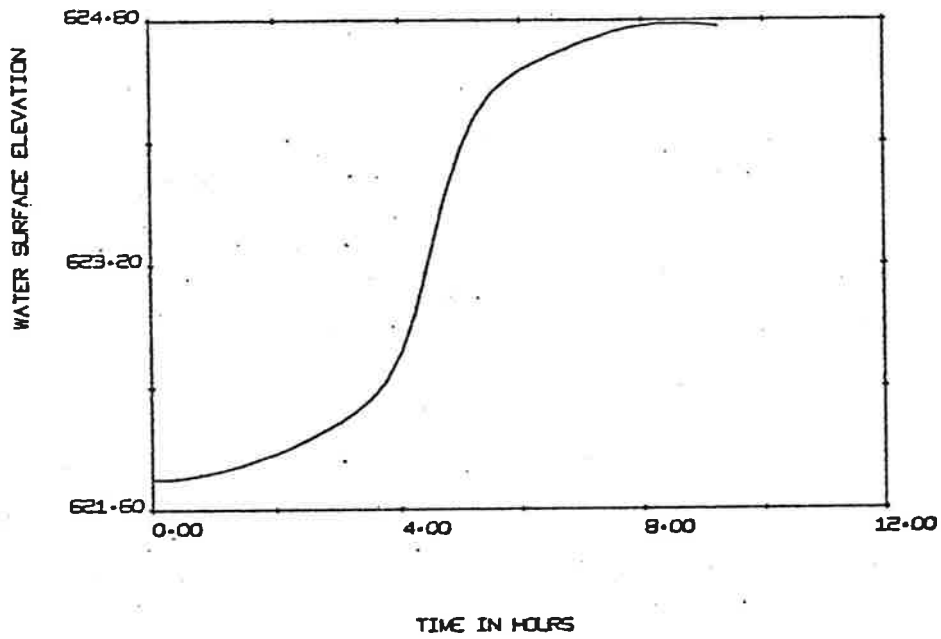
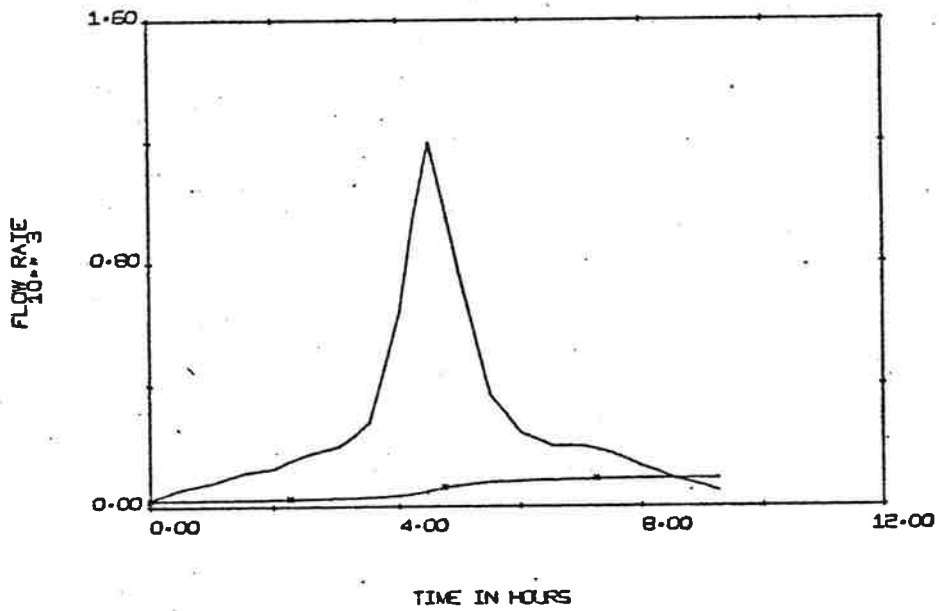
FIGURE 2

BIG SANDY - 100 YEAR FLOOD - EXISTING PRIN. SPWY. CREST 620. DAM CREST 625.
—— INFLOW HYDROGRAPH
- - - - - OUTFLOW HYDROGRAPH

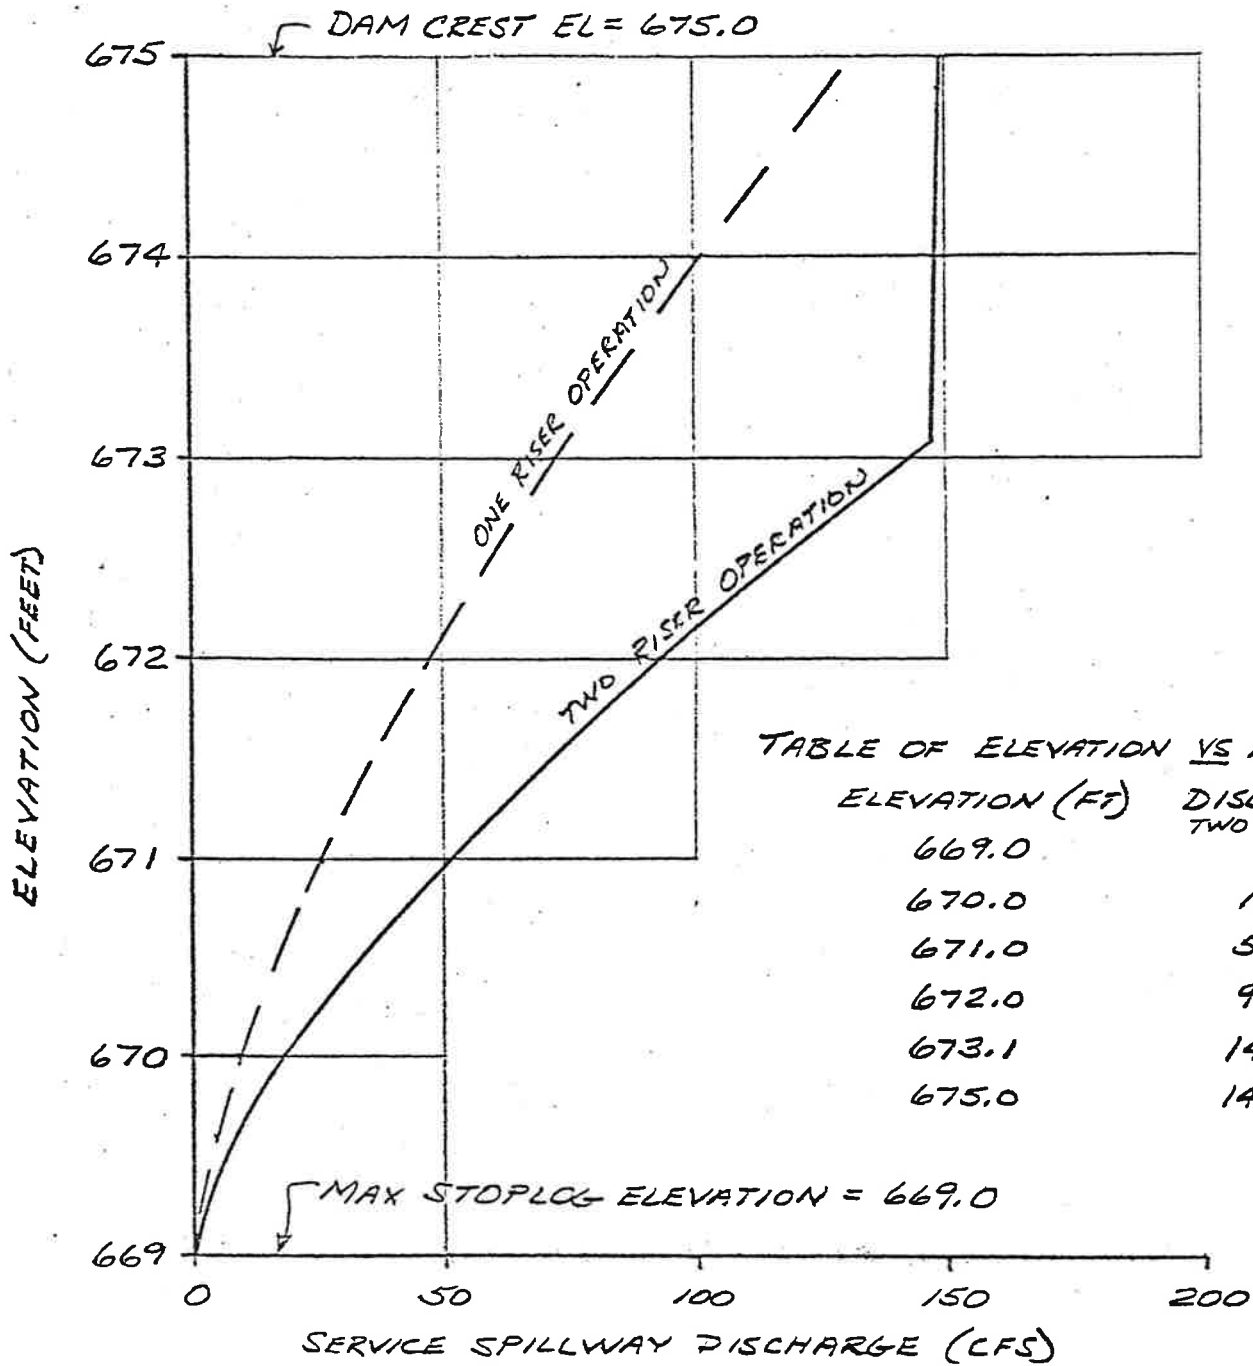
FIGURE 3

BIG SANDY PROJECT
 SPILLWAY RATING CURVE
 SERVICE SPILLWAY @ MAX W.S.

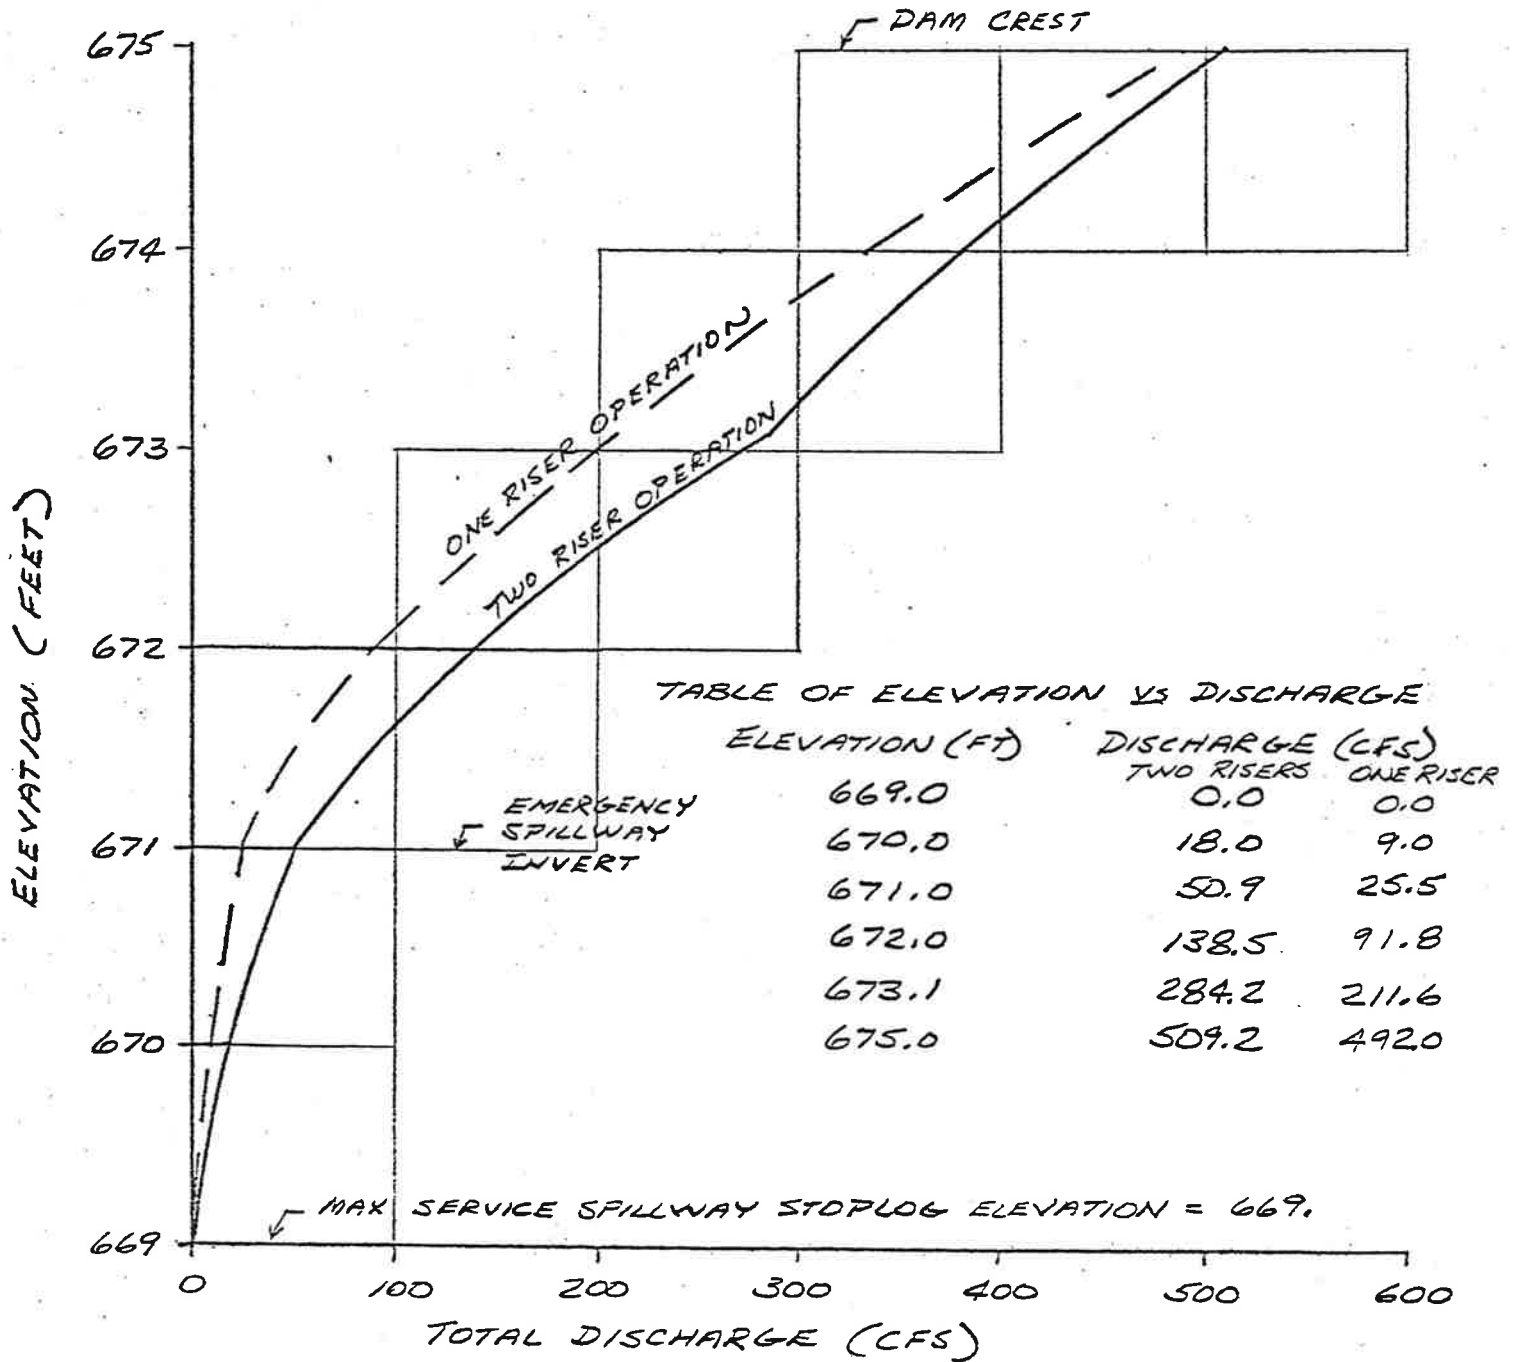
FIGURE 4

BIG SANDY PROJECT
TOTAL SPILLWAY CAPACITY
RATING CURVE

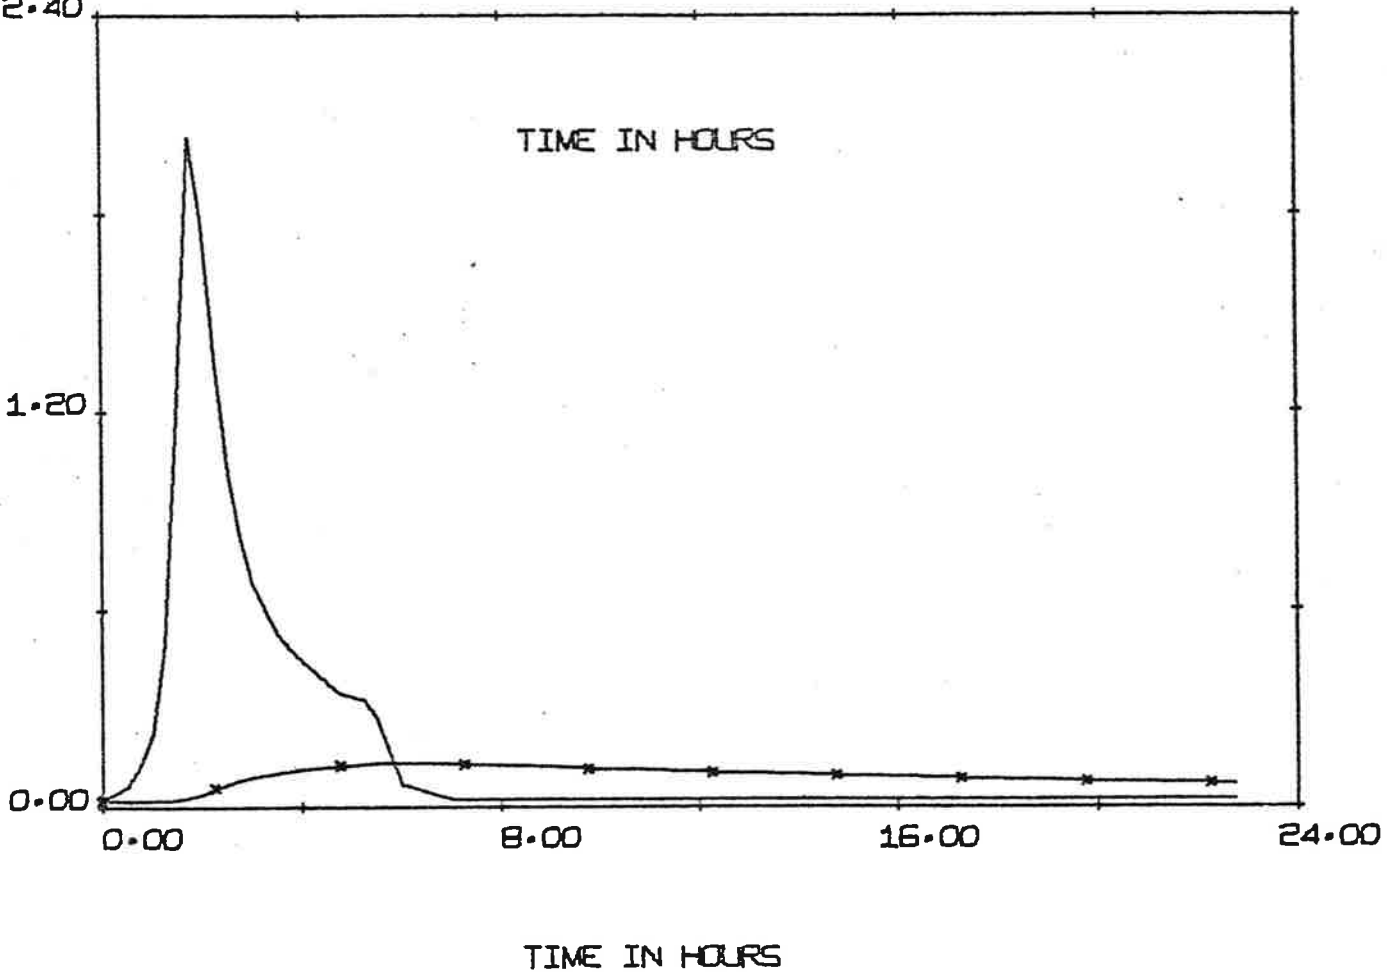
BIG SANDY - EMERGENCY HYDROGRAPH - DOUBLE RISER - EM SPIL CREST=671.0

———— INFLOW HYDROGRAPH

×××××××× OUTFLOW HYDROGRAPH

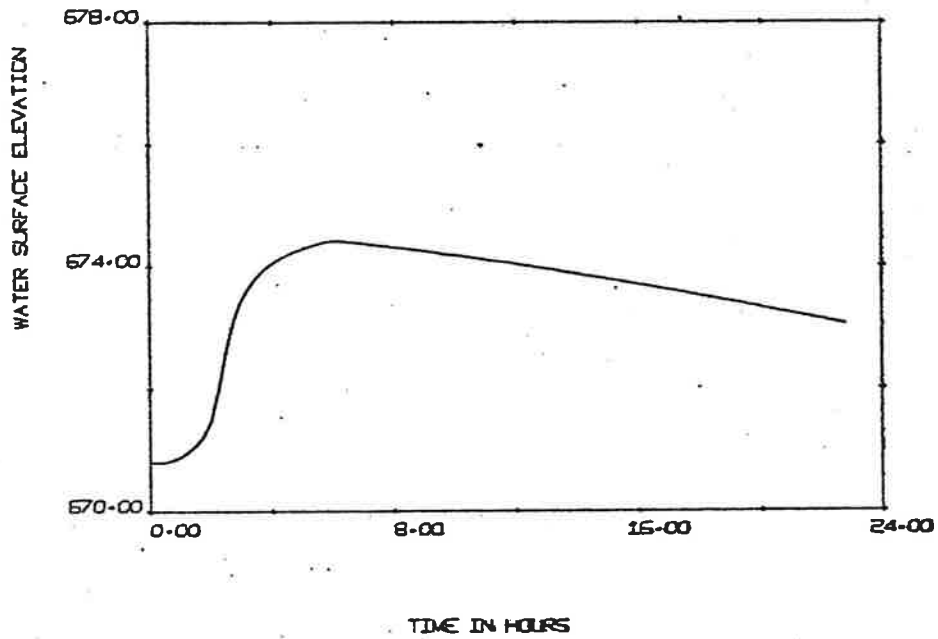
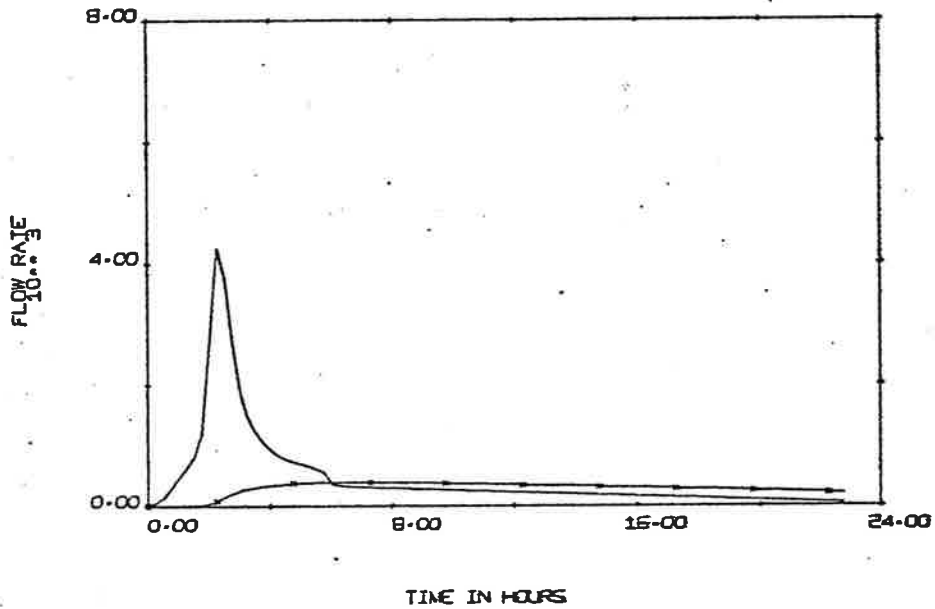
FIGURE 10

BIG SANDY - FREE BOARD HYDROGRAPH - SINGLE RISER - EM SPIL CREST=671.0 L=15-

—— INFLOW HYDROGRAPH

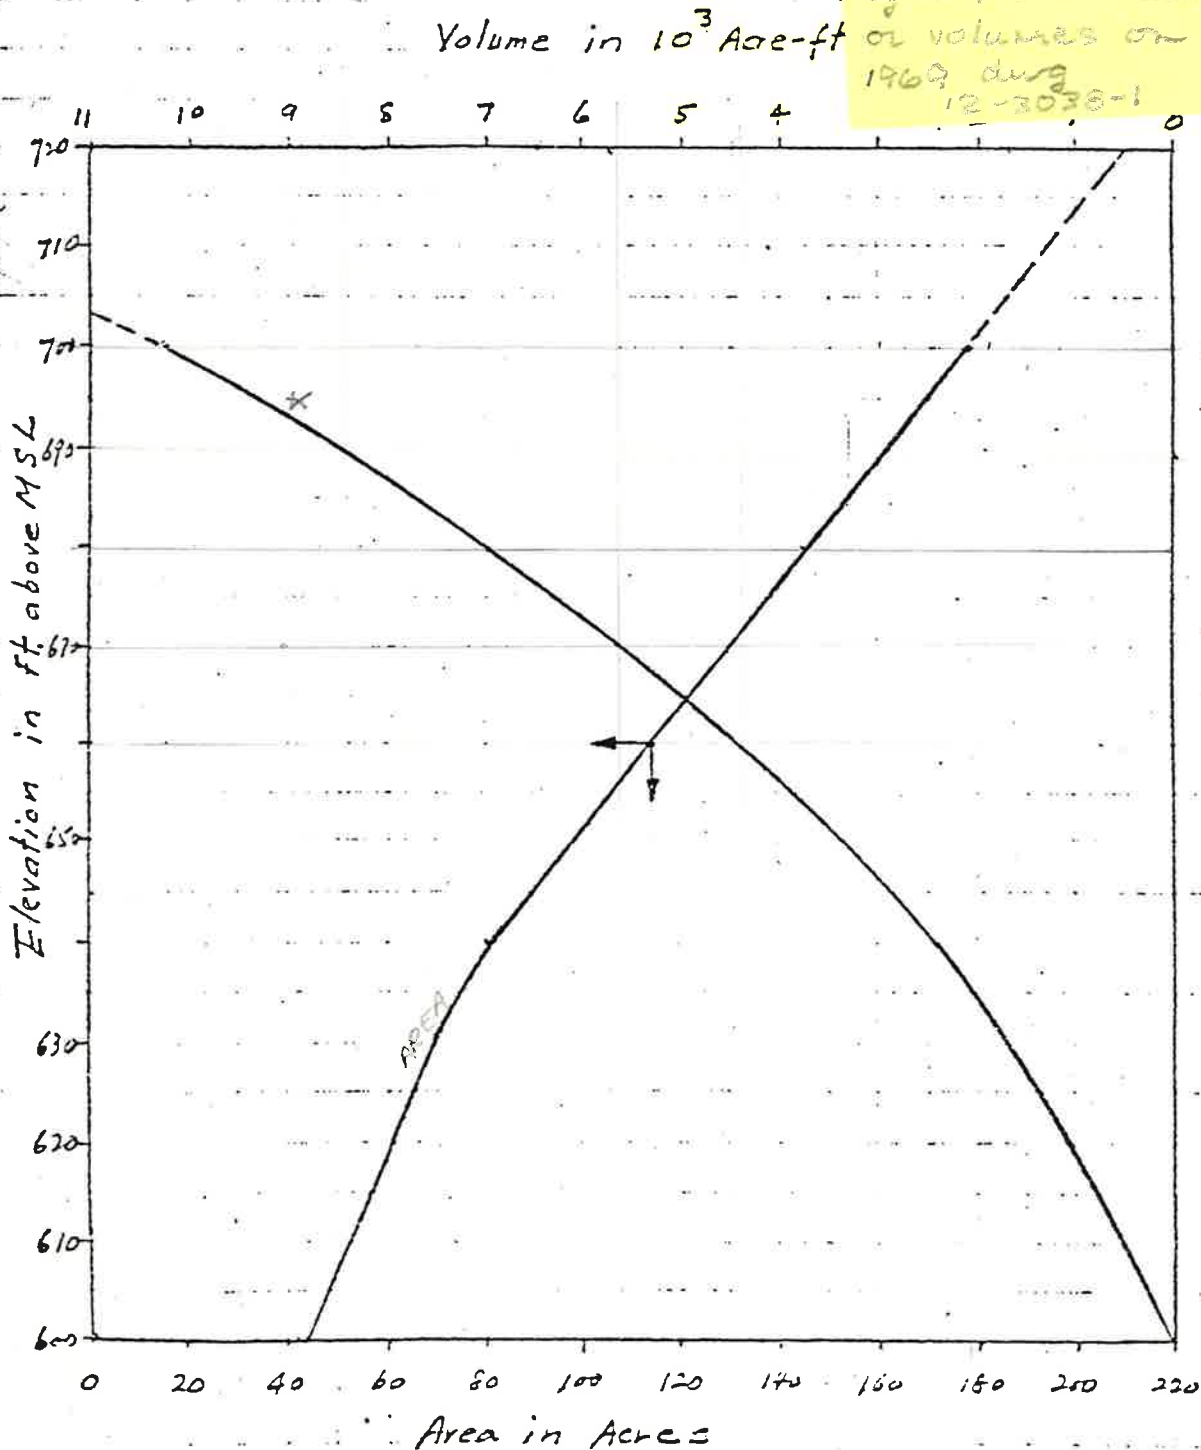
SUBJECT Big Sandy - Area - Capacity Curves

This curve does not agree with areas calculated by AP&M in 1936 or volumes on 1969 dwg 12-3038-1

Note: Volume below Ele. 600.0 is assumed zero.

Area – Capacity curves have been developed for each stage of construction. For the Stage I construction it is reported as a table on drawing 12-3038 included in Attachment C. For Stage II and III it is included graphically as part the hydrology and hydraulics evaluation included in Attachment B. It should be noted that the Stage II and Stage III Area-Capacity curves are based on Elev. 600 and Elev. 650 having zero storage respectively.

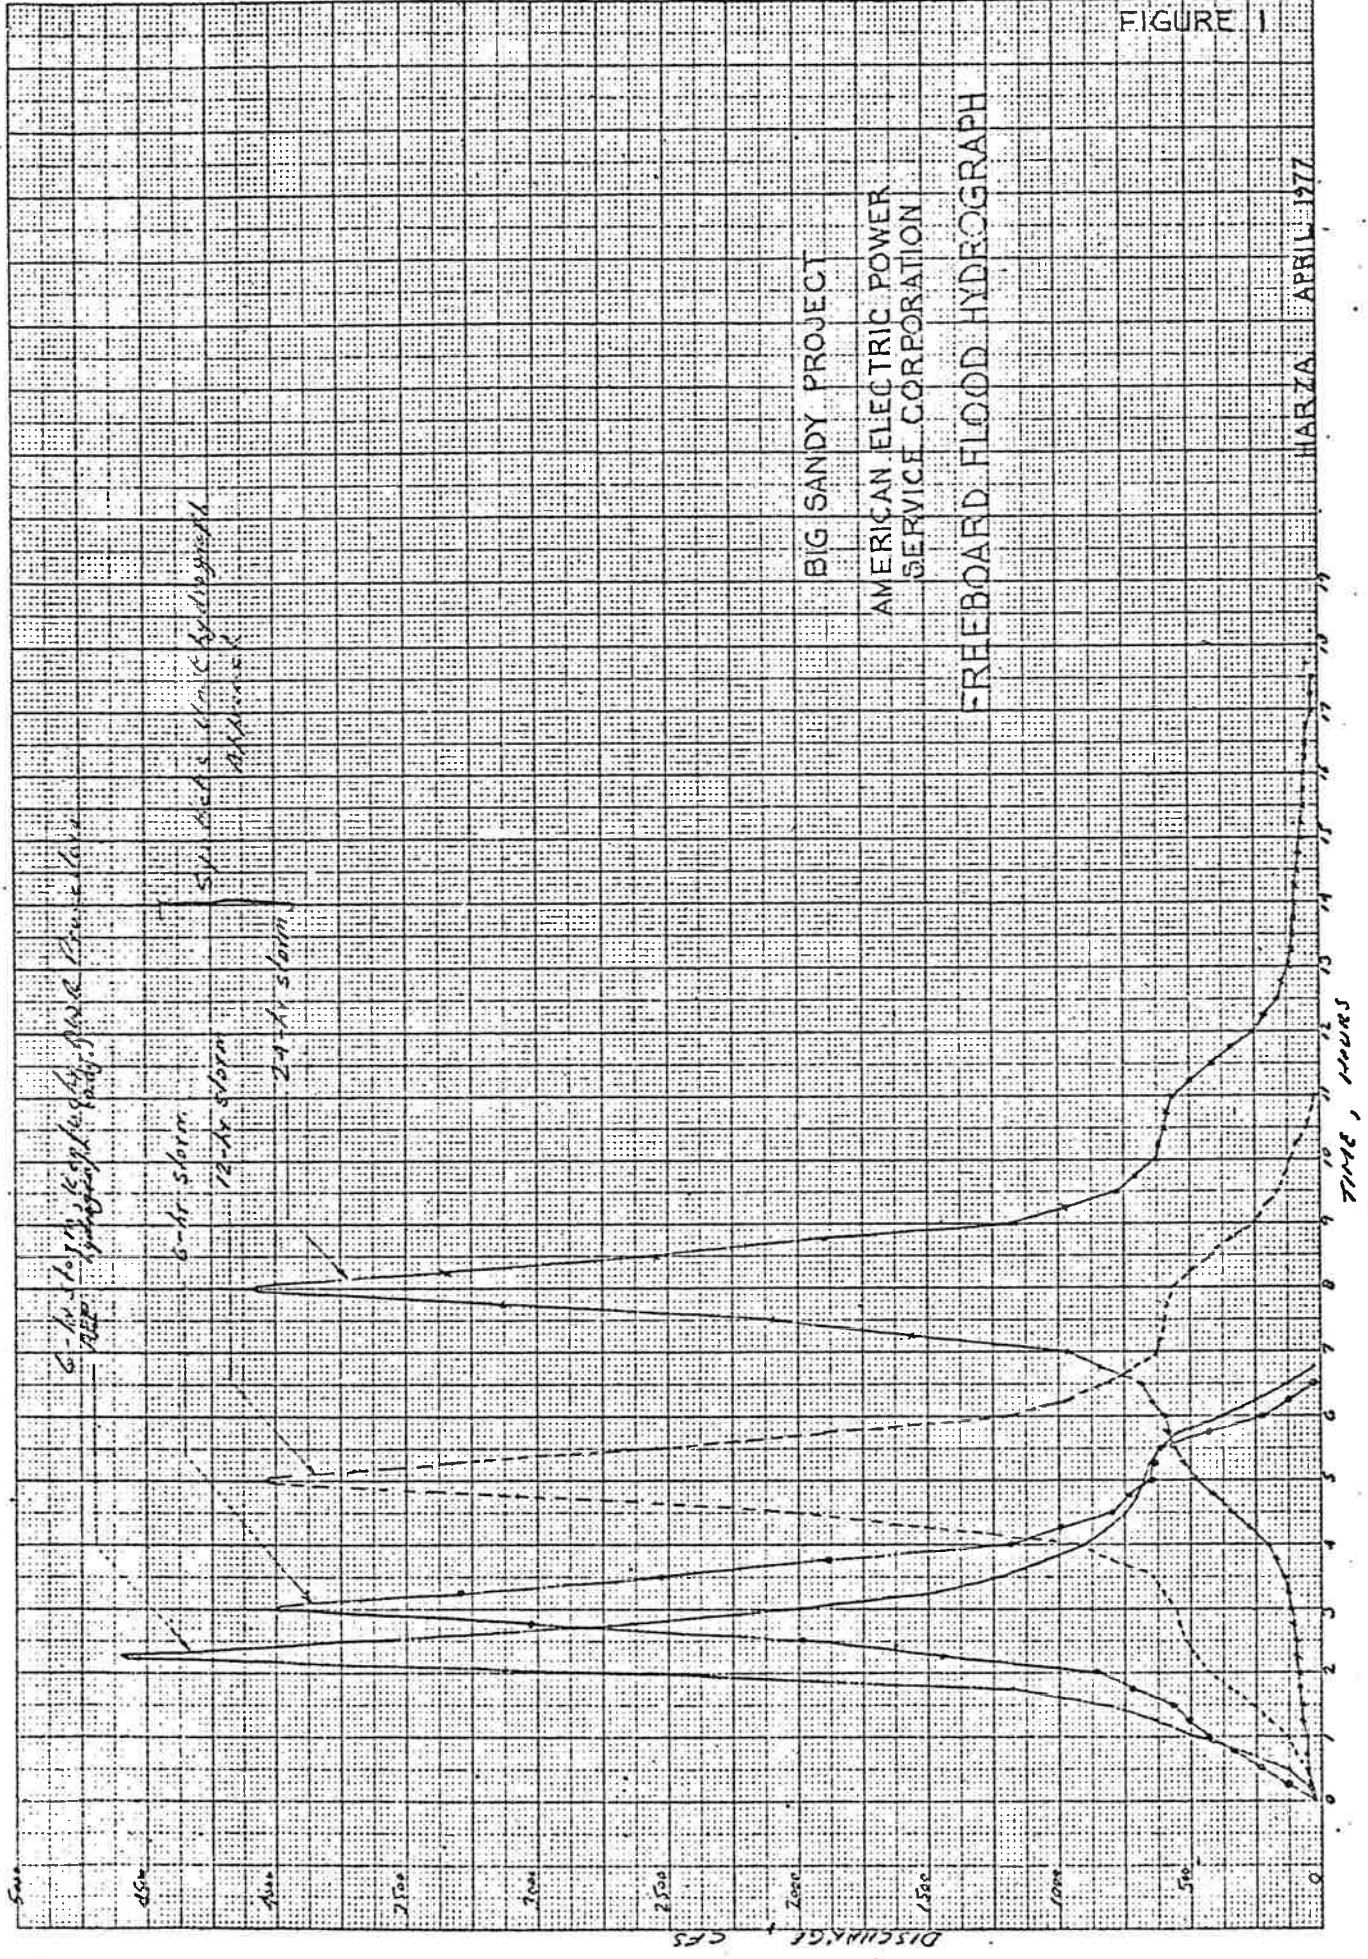
FIGURE 1

HARZA, APRIL 1977

The derived unit hydrograph was used to determine flood hydrographs for the 6-, 12- and 24-hour freeboard design storms and the 100-year 24-hour storm. These hydrographs are given in tables 4 and 5 respectively. Figure 1 shows the freeboard flood hydrographs resulting from the Kentucky DWR procedure and the unit hydrograph approach.

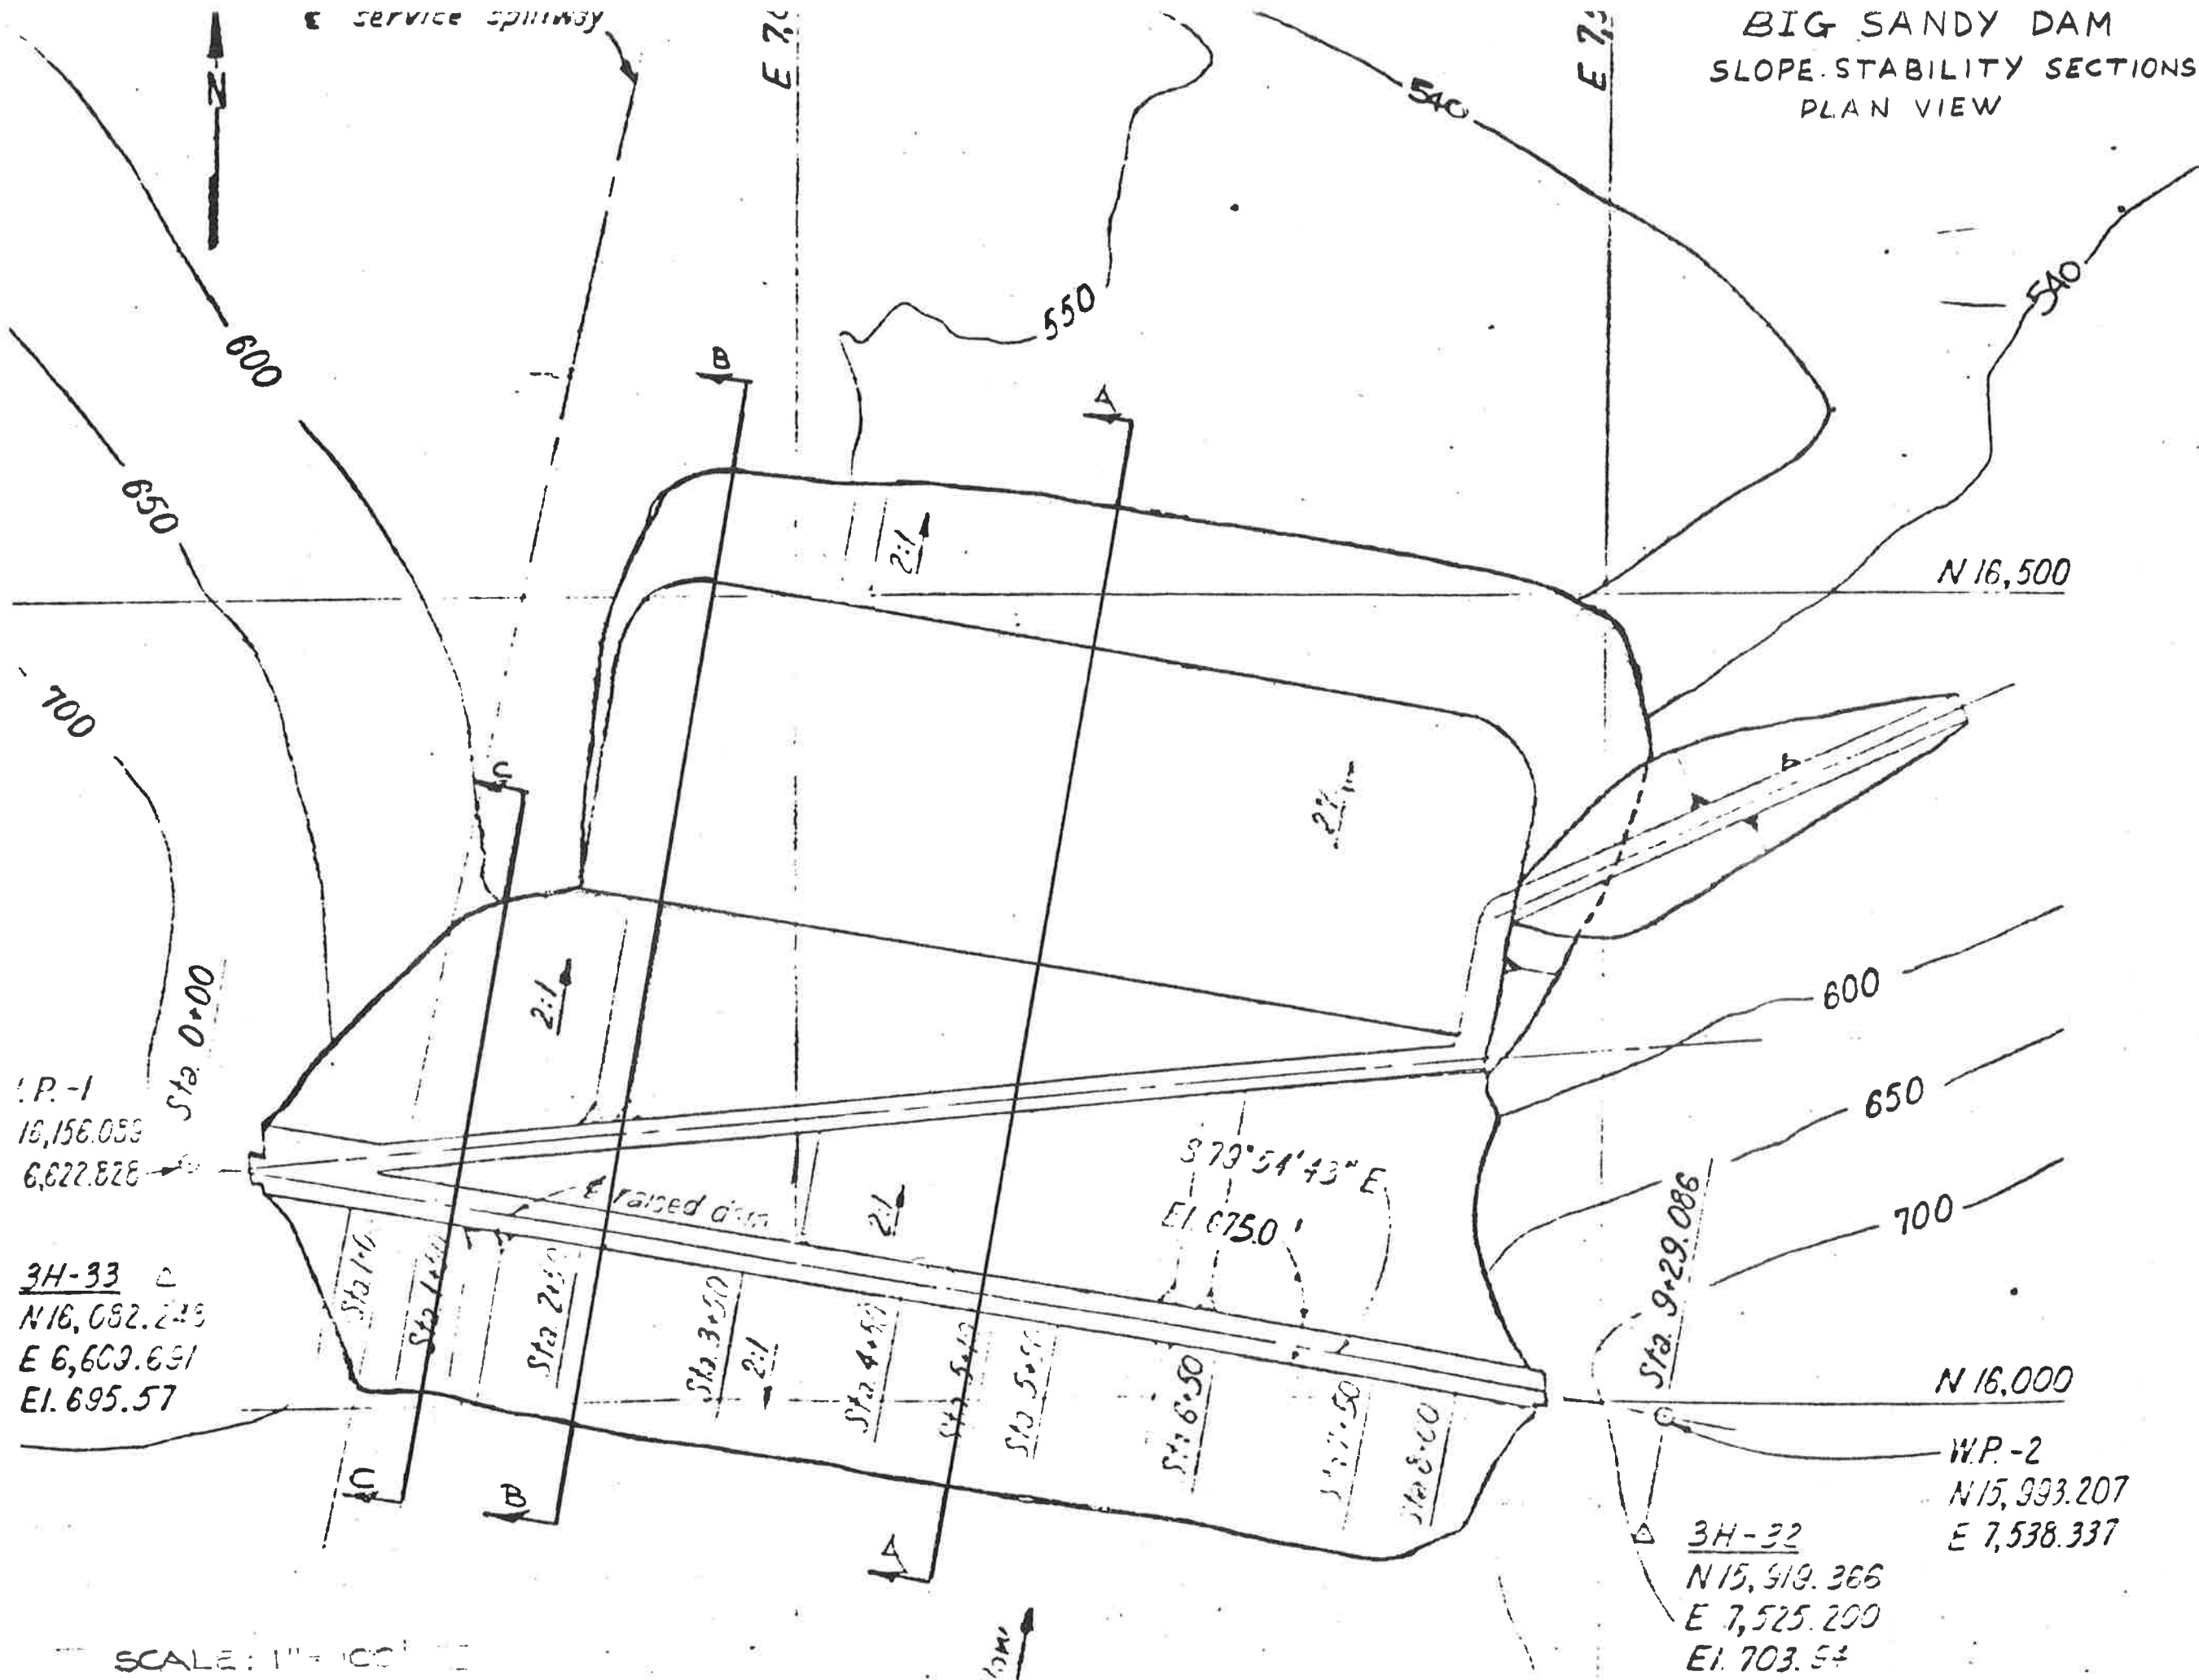
**BIG SANDY DAM
SLOPE STABILITY SECTIONS
PLAN VIEW**

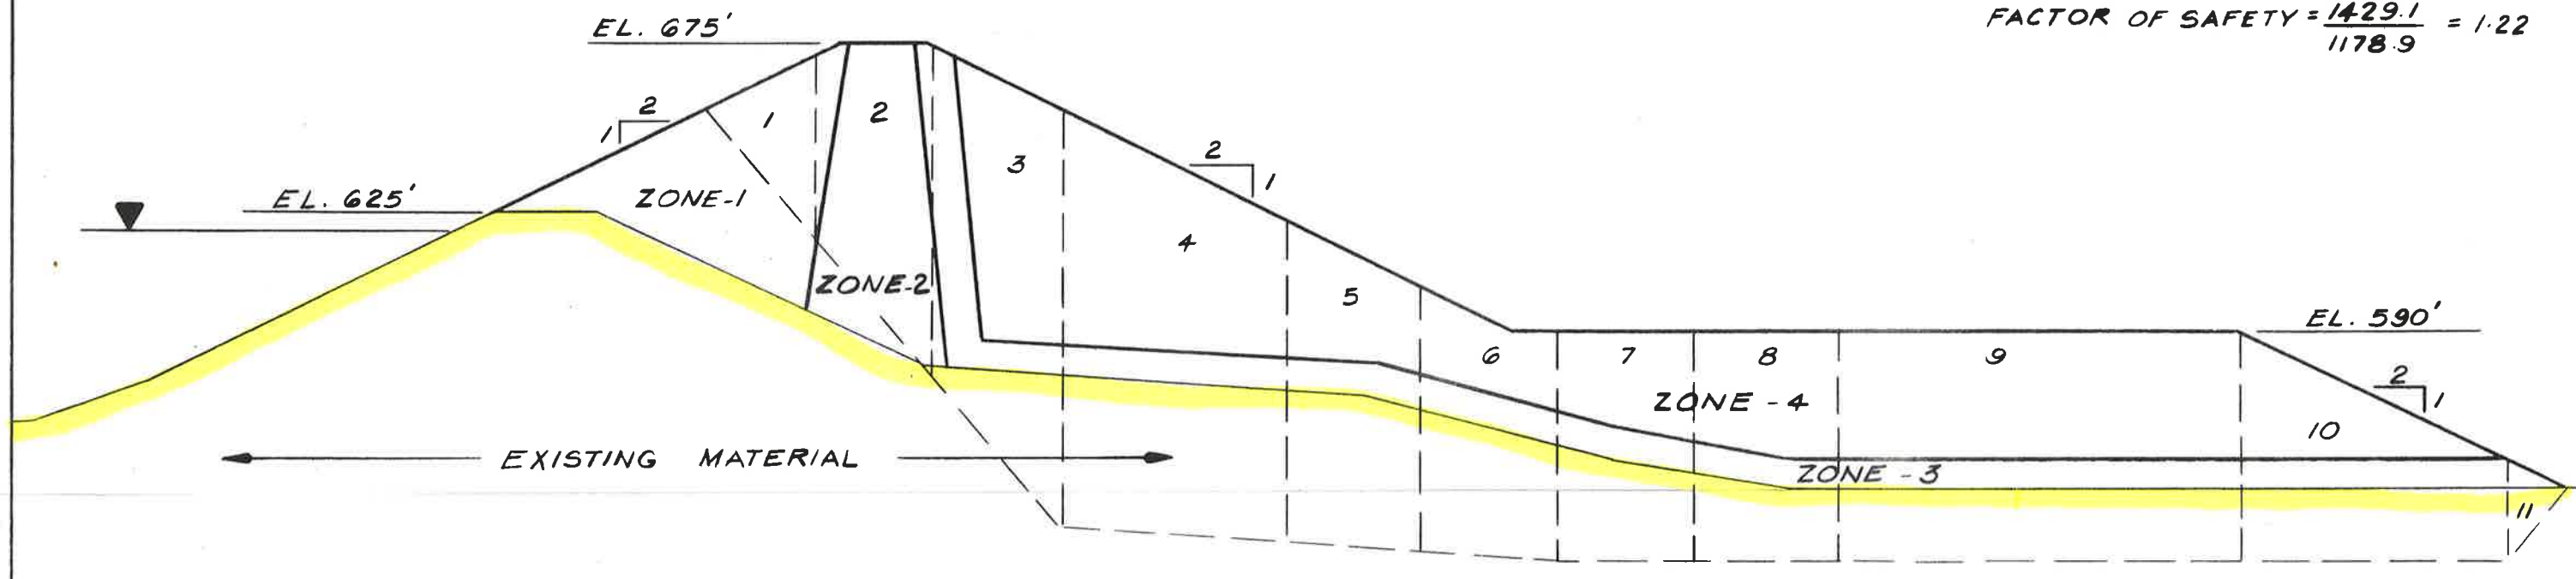
FACTOR OF SAFETY = $\frac{1429.1}{1178.9} = 1.22$

- ZONE -1 - RANDOM ROCKFILL - $\gamma_t = 135 \text{ PCF}$; $\bar{C} = 3.2 \text{ KSF}$
- ZONE -2 - CLAY CORE - $\gamma_t = 130 \text{ PCF}$; $\bar{C} = 3.2 \text{ KSF}$
- ZONE -3 - DRAINAGE MATERIAL - $\gamma_t = 70 \text{ PCF}$; $\phi = 40^\circ$
- ZONE -4 - SANDSTONE - $\gamma_t = 135 \text{ PCF}$; $\phi = 32^\circ$
- EXISTING DAM AND FOUNDATION MATERIAL - $\gamma_t = 130 \text{ PCF}$; $\bar{C} = 1.2 \text{ KSF} - 3.2 \text{ KSF}$

<u>TYPE OF ANALYSIS</u>	<u>LOADING CONDITION</u>	<u>SECTION</u>	<u>FACTOR OF SAFETY</u>
TOTAL STRESS	CONSTRUCTION (D.S.)	A-A	1.22
TOTAL STRESS	CONSTRUCTION (U.S.)	A-A	1.22
TOTAL STRESS	CONSTRUCTION (D.S.)	B-B	1.26
TOTAL STRESS	CONSTRUCTION (D.S.)	C-C	1.24
EFFECTIVE STRESS	LONG TERM (D.S.)	A-A	2.03
EFFECTIVE STRESS	LONG TERM (U.S.)	A-A	2.17
EFFECTIVE STRESS	EARTHQUAKE (D.S.)	A-A	1.32

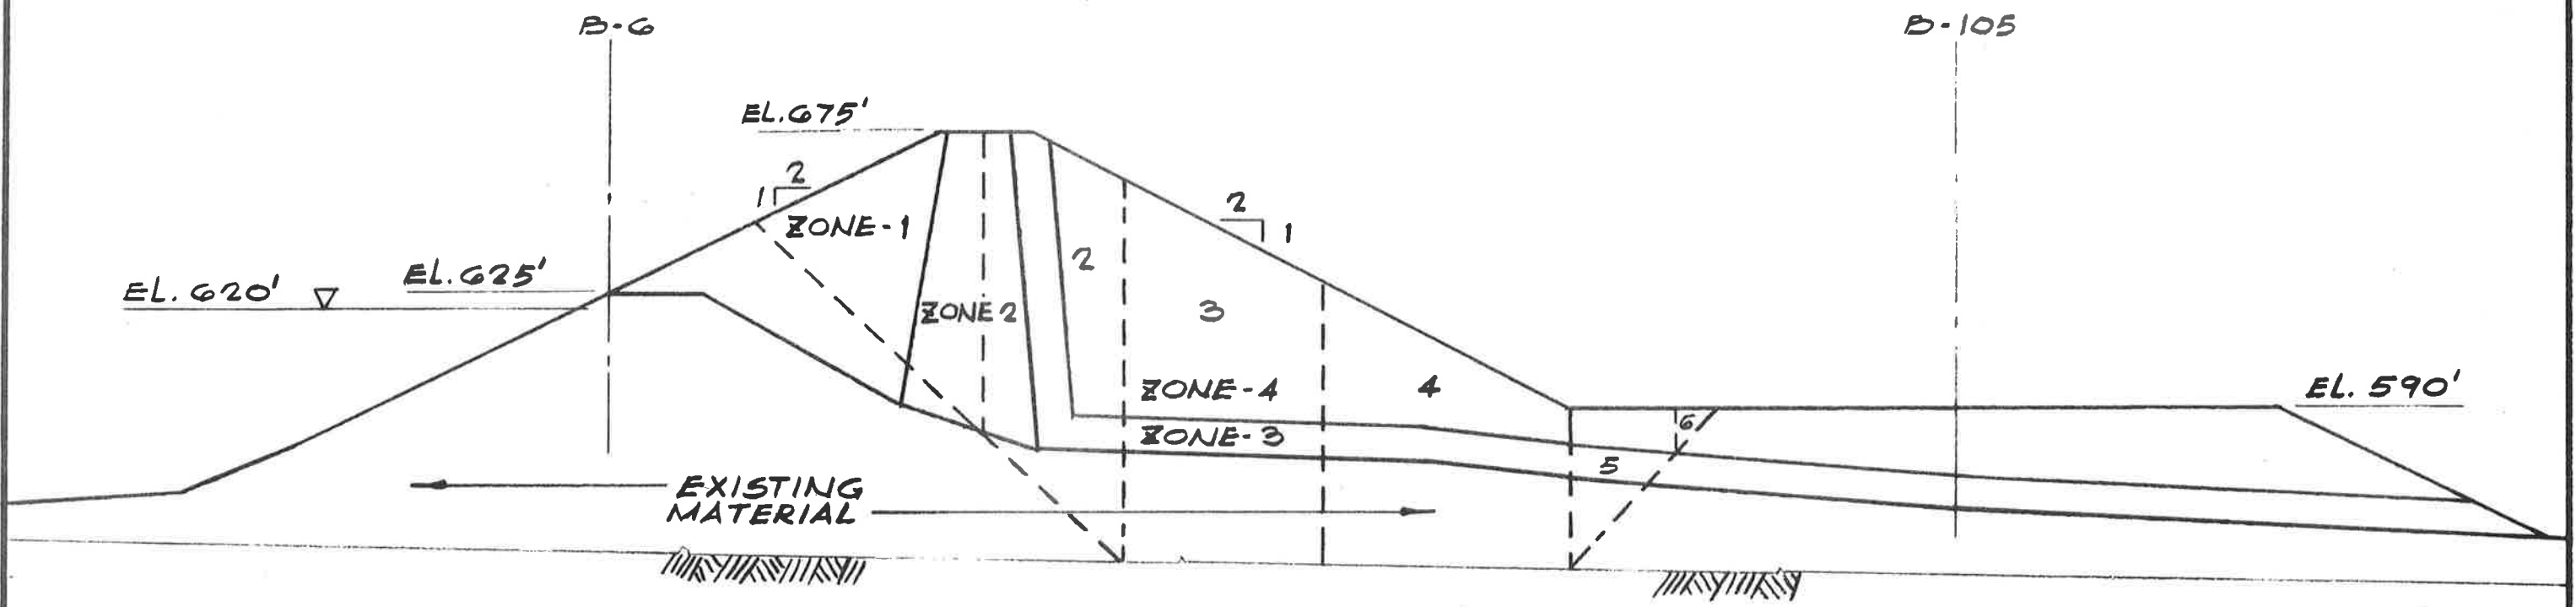
SECTION B-B
1" = 50'

FACTOR OF SAFETY = $\frac{967.39}{767.9} = 1.26$

- ZONE - 1 - RANDOM ROCKFILL - $\gamma_t = 135$ PCF, $C = 3.2$ KSF
- ZONE - 2 - CLAY CORE - $\gamma_t = 130$ PCF, $C = 3.2$ KSF
- ZONE - 3 - DRAINAGE MATERIAL - $\gamma_t = 70$ PCF, $\phi = 40^\circ$
- ZONE - 4 - SANDSTONE - $\gamma_t = 135$ PCF, $\phi = 32^\circ$
- EXISTING DAM & FOUNDATION - $\gamma_t = 130$ PCF, $C = 1.2$ KSF-3.2 KSF

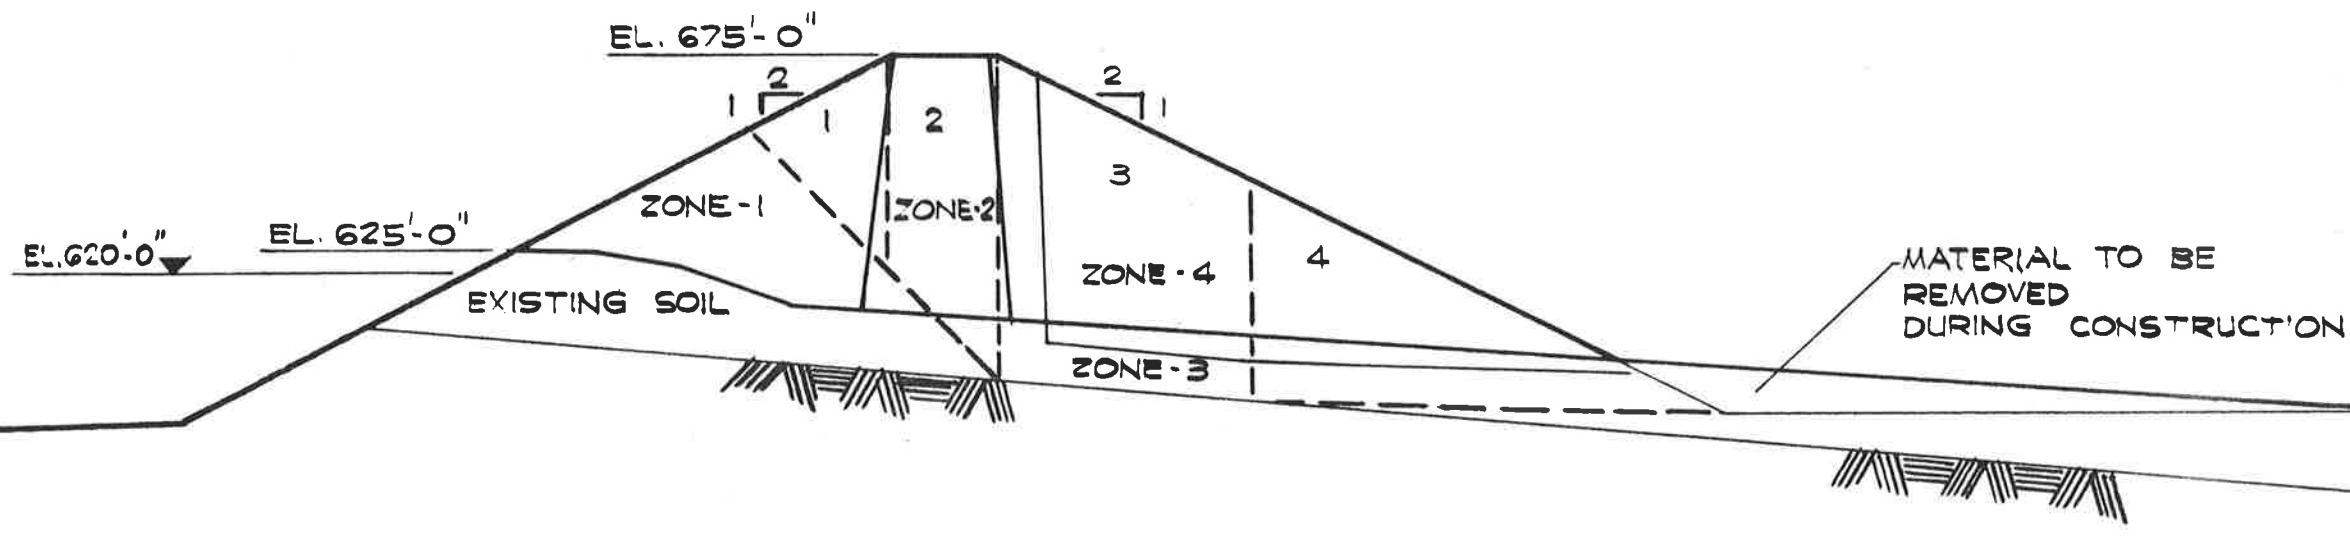
SECTION C-C

$$\frac{631.6}{433.8} = 1.45$$

- ZONE - 1 - RANDOM ROCKFILL - $\gamma_t = 135$ PCF , C = 3.2 KSF
- ZONE - 2 - CLAY CORE - $\gamma_t = 130$ PCF , C = 3.2 KSF
- ZONE - 3 - DRAINAGE ZONE - $\gamma_t = 70$ PCF , $\phi = 40^\circ$
- ZONE - 4 - SANDSTONE - $\gamma_t = 135$ PCF , $\phi = 32^\circ$
- EXISTING DAM & FOUNDATION - $\gamma_t = 130$ PCF , C = 1.2 KSF - 3.2 KSF
