HISTORY OF CONSTRUCTION

CFR 257.73(c)(1)

Fly Ash Pond

Big Sandy Plant
Louisa, Kentucky

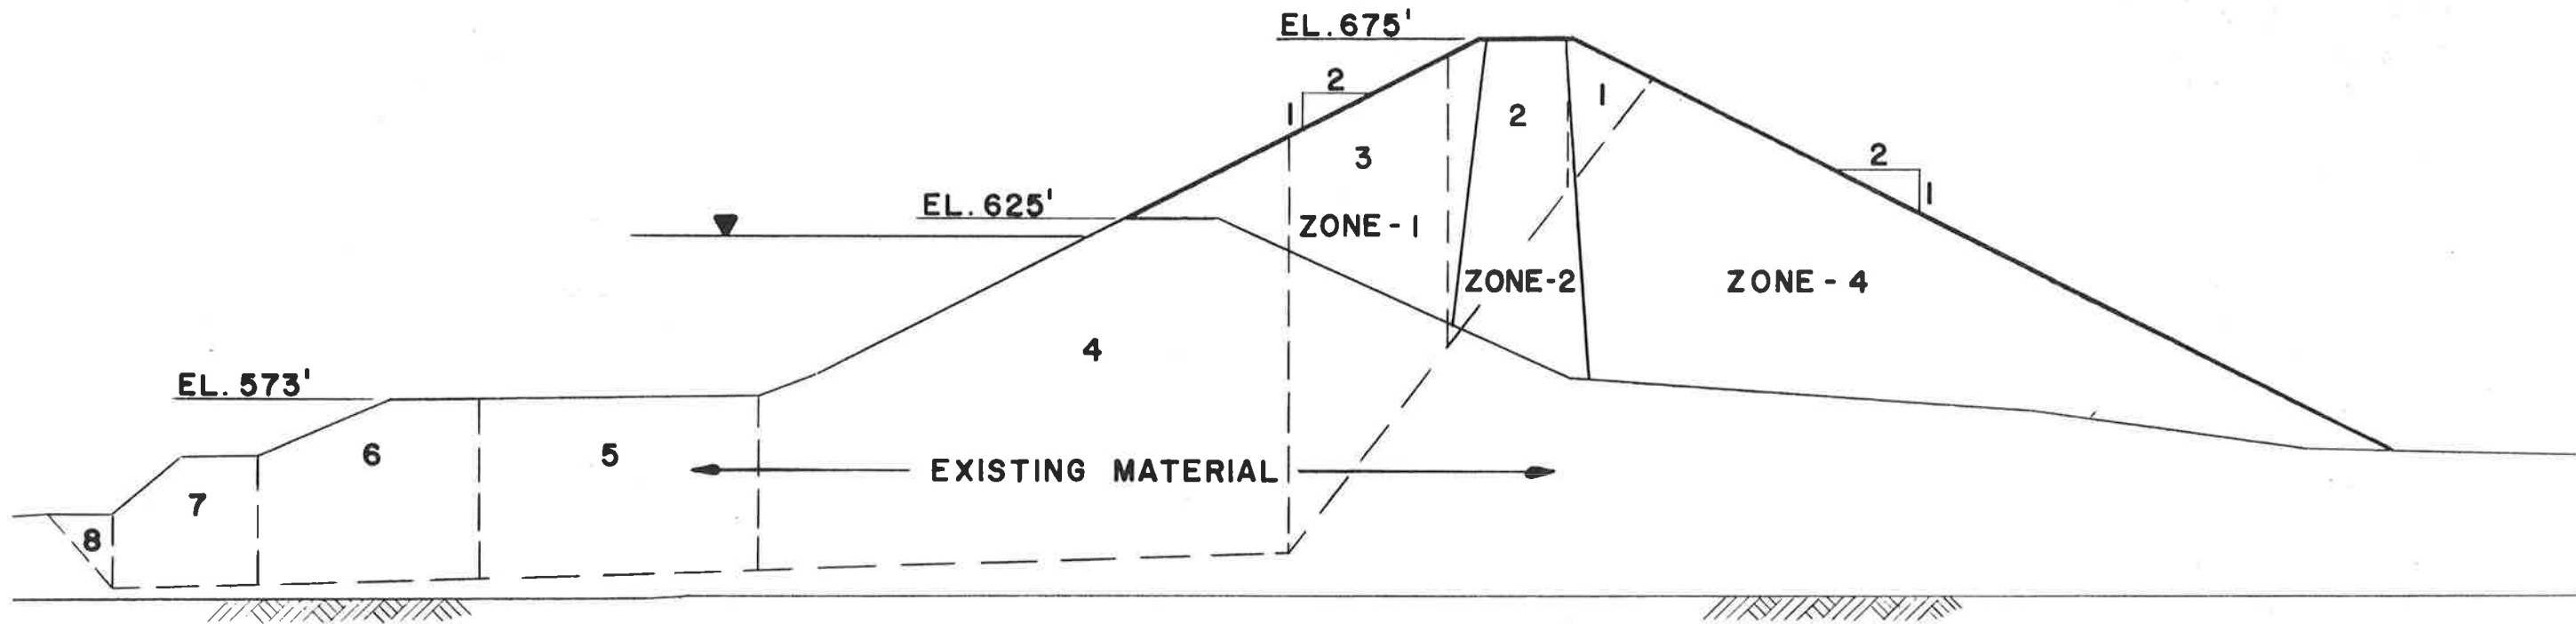
Factor of Safety = $1593.2 / 1308.8$
= 1.22

- ZONE - 1 - RANDOM ROCKFILL - $\gamma_t = 135$ PCF ; C = 3.2 KSF
- ZONE - 2 - CLAY CORE - $\gamma_t = 130$ PCF ; C = 3.2 KSF
- ZONE - 4 - SANDSTONE - $\gamma_t = 135$ PCF ; $\phi = 32^\circ$
- EXISTING DAM AND FOUNDATION - $\gamma_t = 130$ PCF ; C = 1.2 KSF - 3.2 KSF

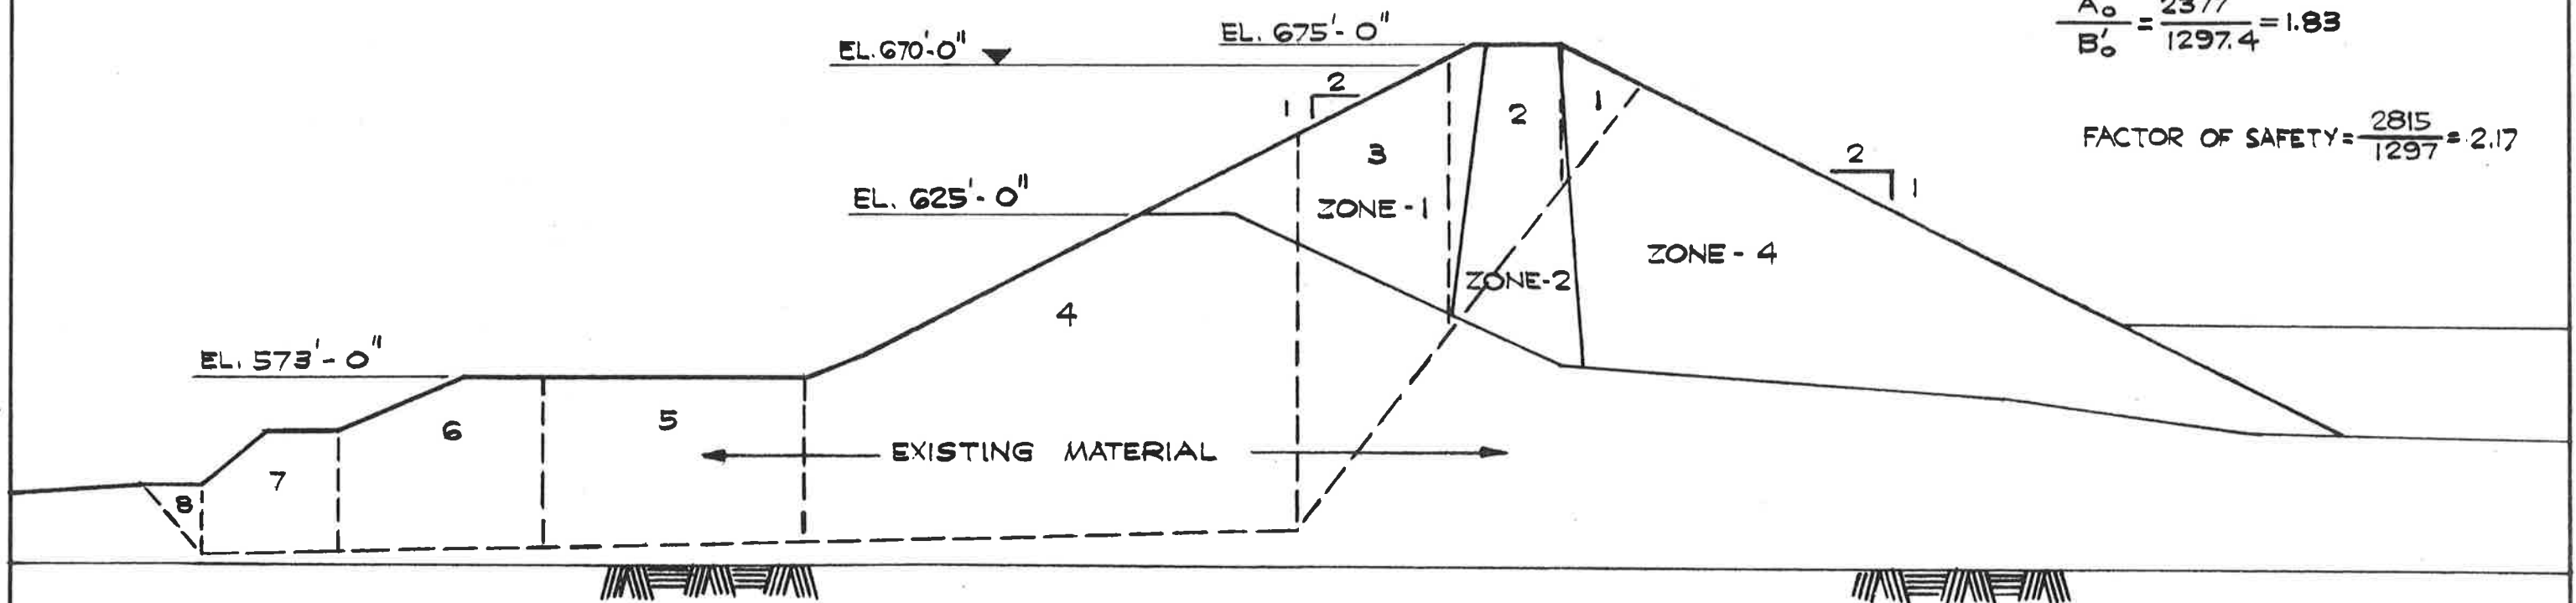
SECTION A'-A'

$$\text{FACTOR OF SAFETY} = \frac{2815}{1297} = 2.17$$

ZONE - 1 - RANDOM ROCKFILL - $\gamma_t = 135$ PCF, $\phi = 32^\circ$
 ZONE - 2 - CLAY CORE - $\gamma_t = 130$ PCF, $\phi = 31^\circ$
 ZONE - 4 - SANDSTONE - $\gamma_t = 135$ PCF, $\phi = 32^\circ$
 EXISTING MATERIAL - $\gamma_t = 130$ PCF, $\phi = 31^\circ$

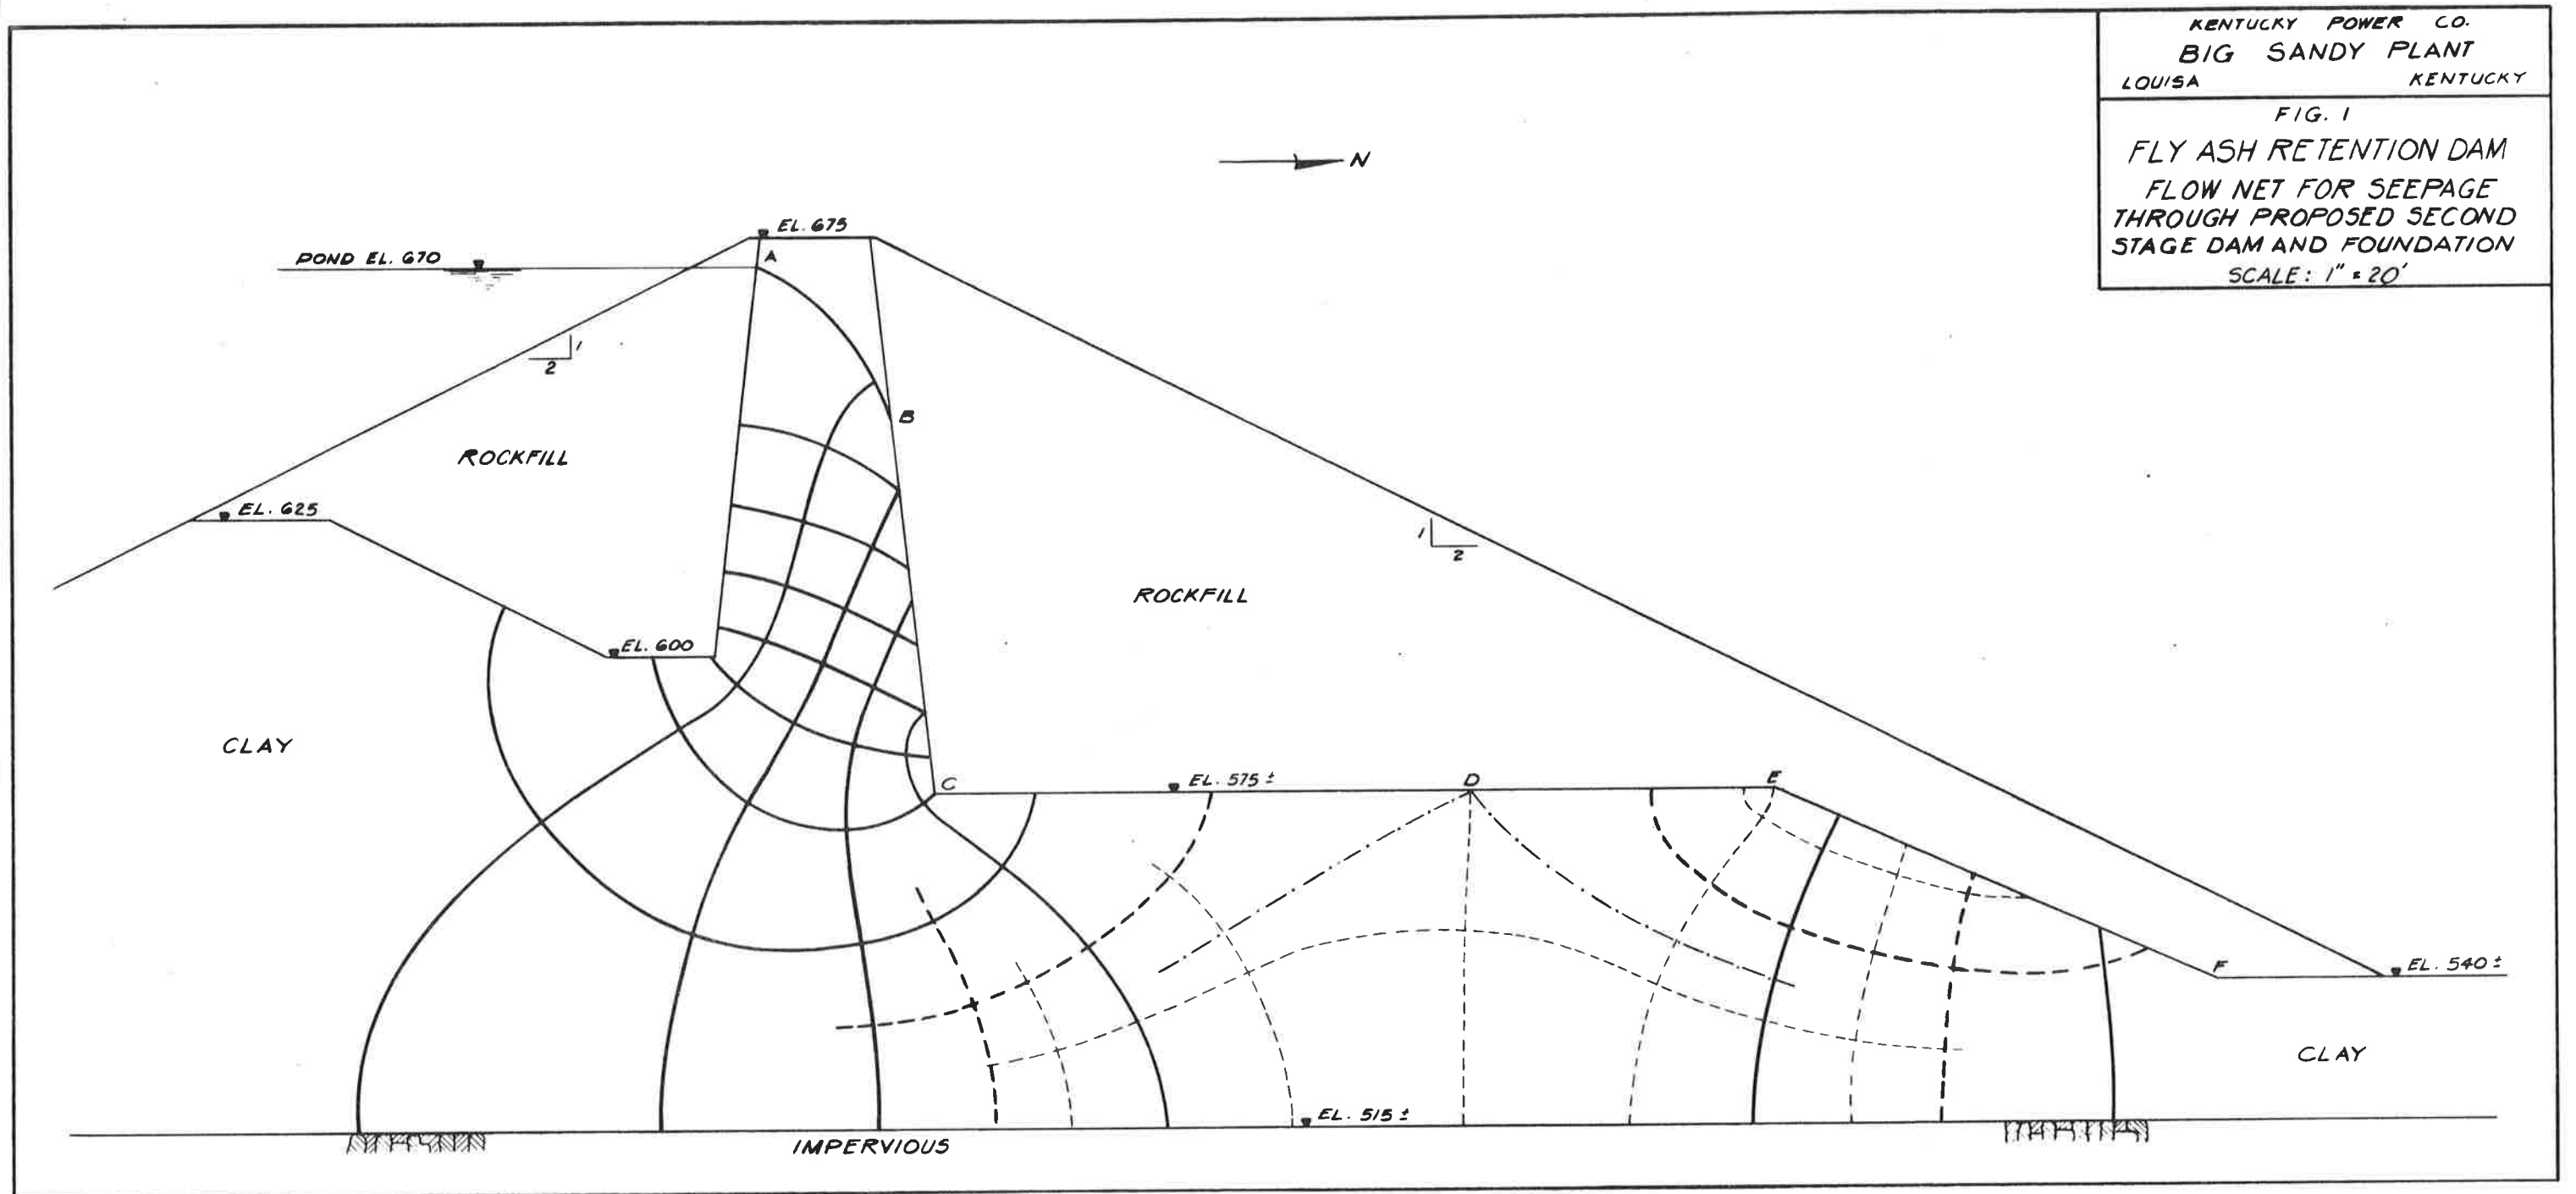
FIG. 1
FLY ASH RETENTION DAM
FLOW NET FOR SEEPAGE
THROUGH PROPOSED SECOND
STAGE DAM AND FOUNDATION
SCALE: 1" = 20'

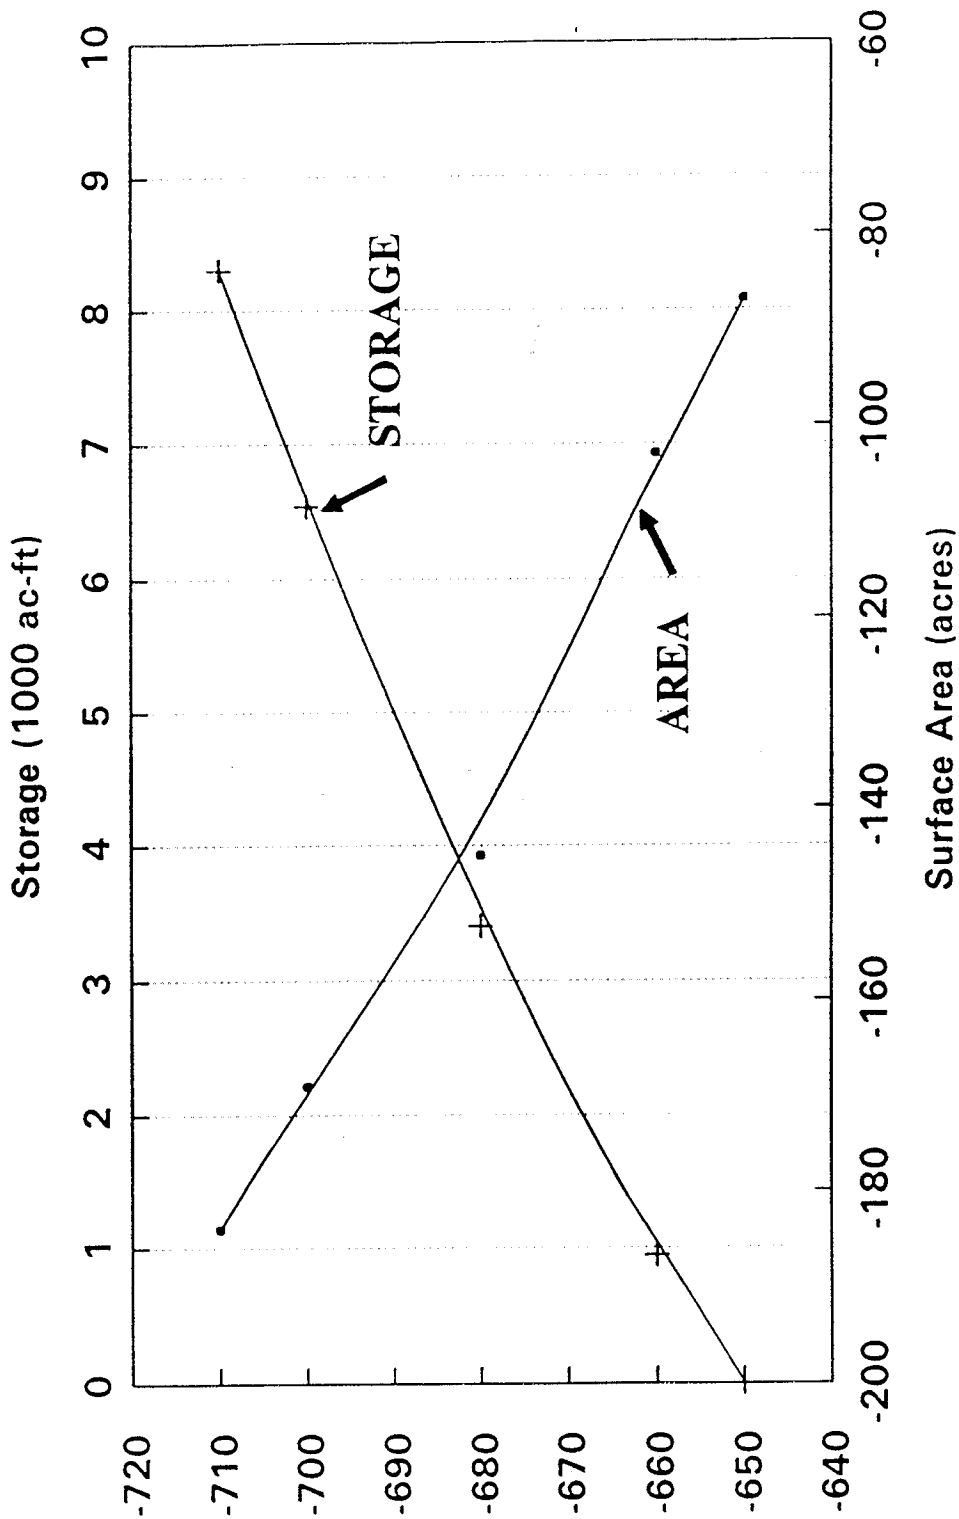
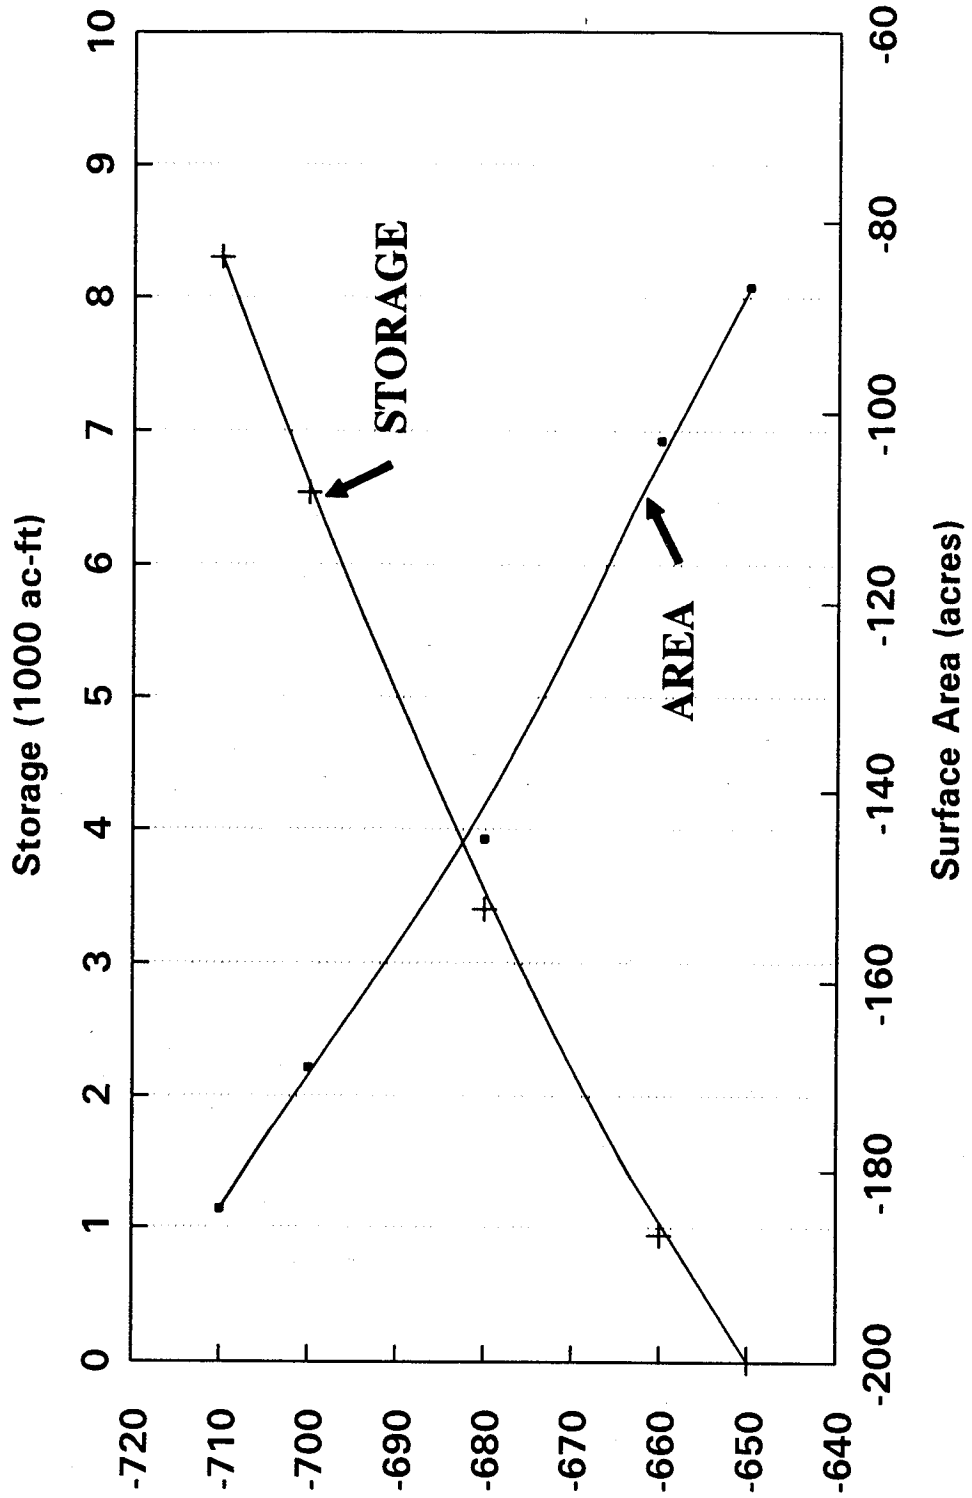
FIGURE 6.2

Big Sandy Plant
 Horseford Creek Fly Ash Dam
 Stage-Area-Volume Curves

Fig. 6.2 illustrates the stage-area-volume relationship for the fly ash pond.

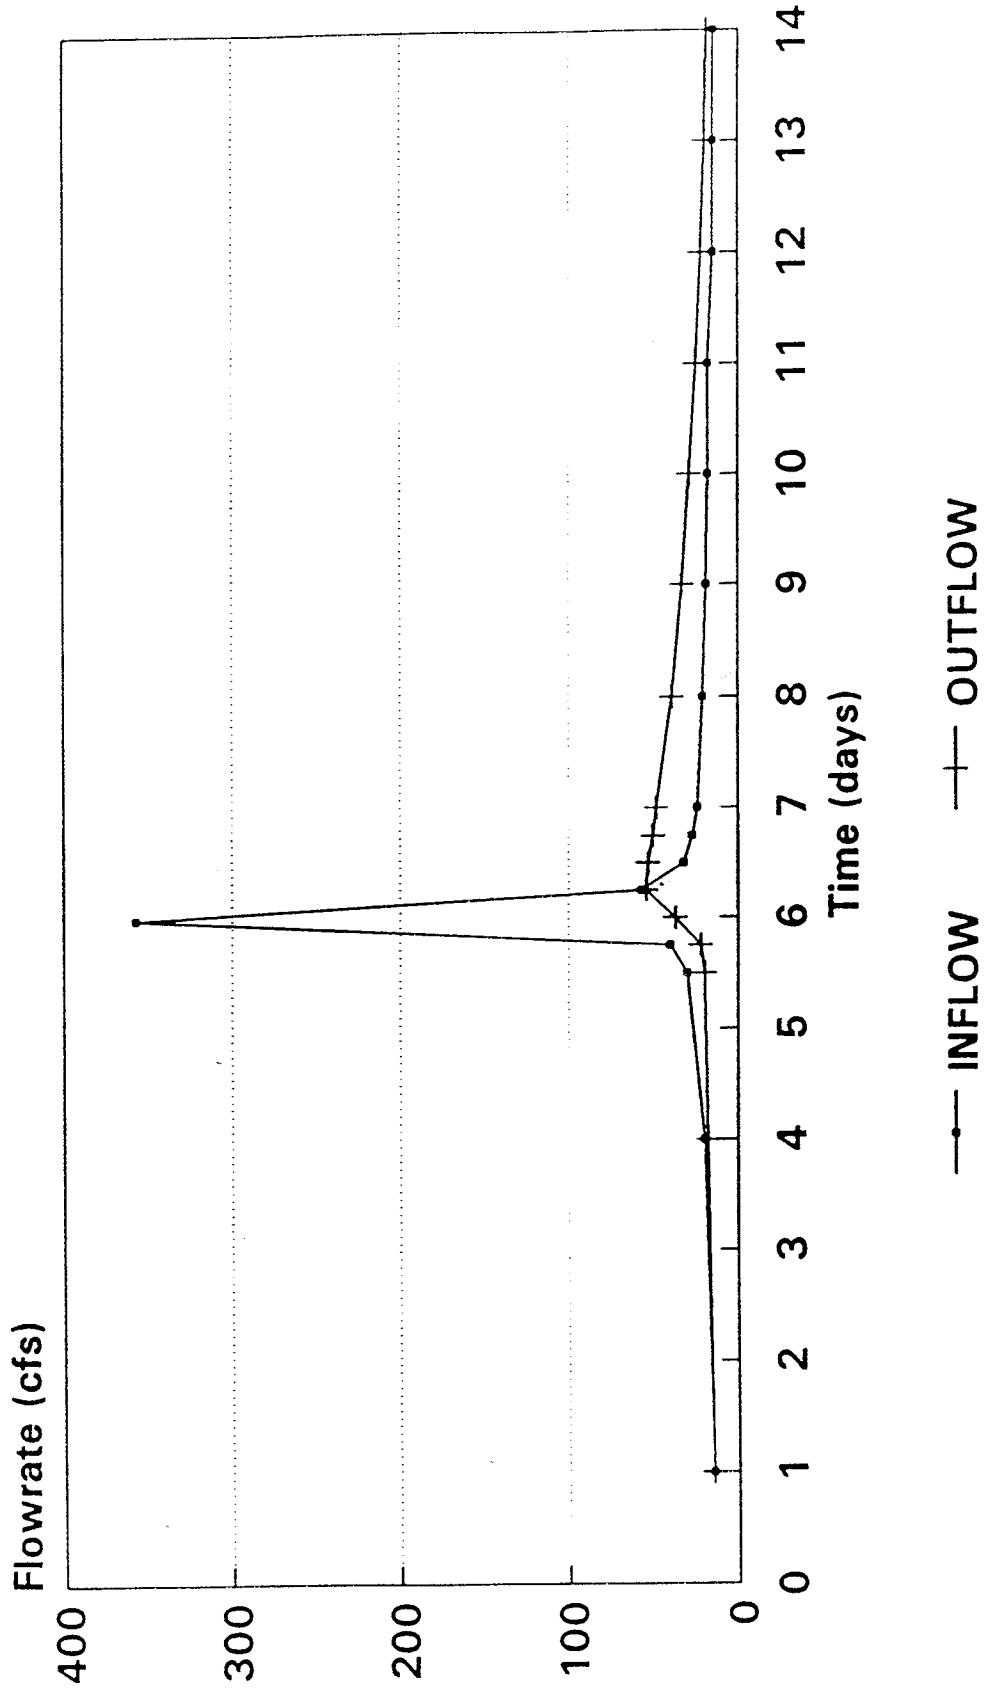
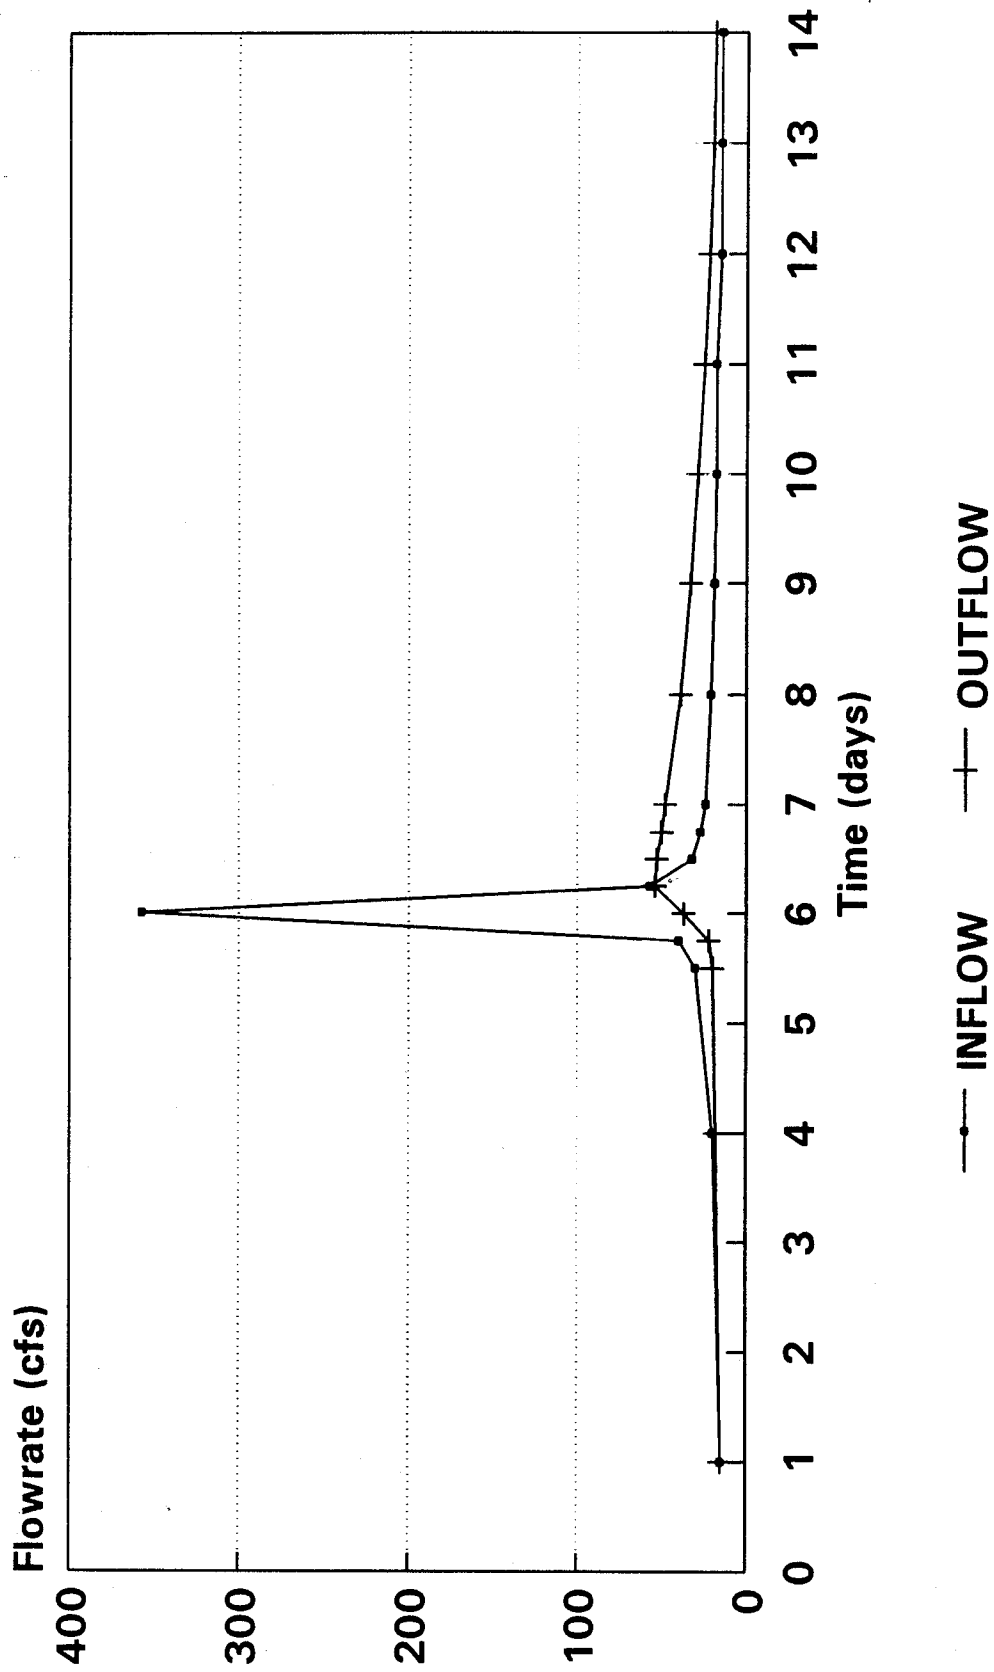
FIGURE 6.3

**Big Sandy Fly Ash Dam
Principal Spillway Hydrograph
50 Yr - 10 Day Design Storm**

A maximum operating pool level has been set at elevation 705. This corresponds to a maximum stop-log elevation of 704. Final flood routings of the PSH started at an initial pool level equivalent to the maximum operating level. The reservoir rises to a maximum elevation of 706.0 feet. The peak outflow through the principal spillway is 54 cfs. Fig. 6.3 is a plot of the inflow and outflow principal spillway hydrographs. The receding flood pool is drained within eight days and six hours after the peak pool level is attained. Therefore, the requirements of Section E-I of Engineering Memorandum No. 5 are satisfied.

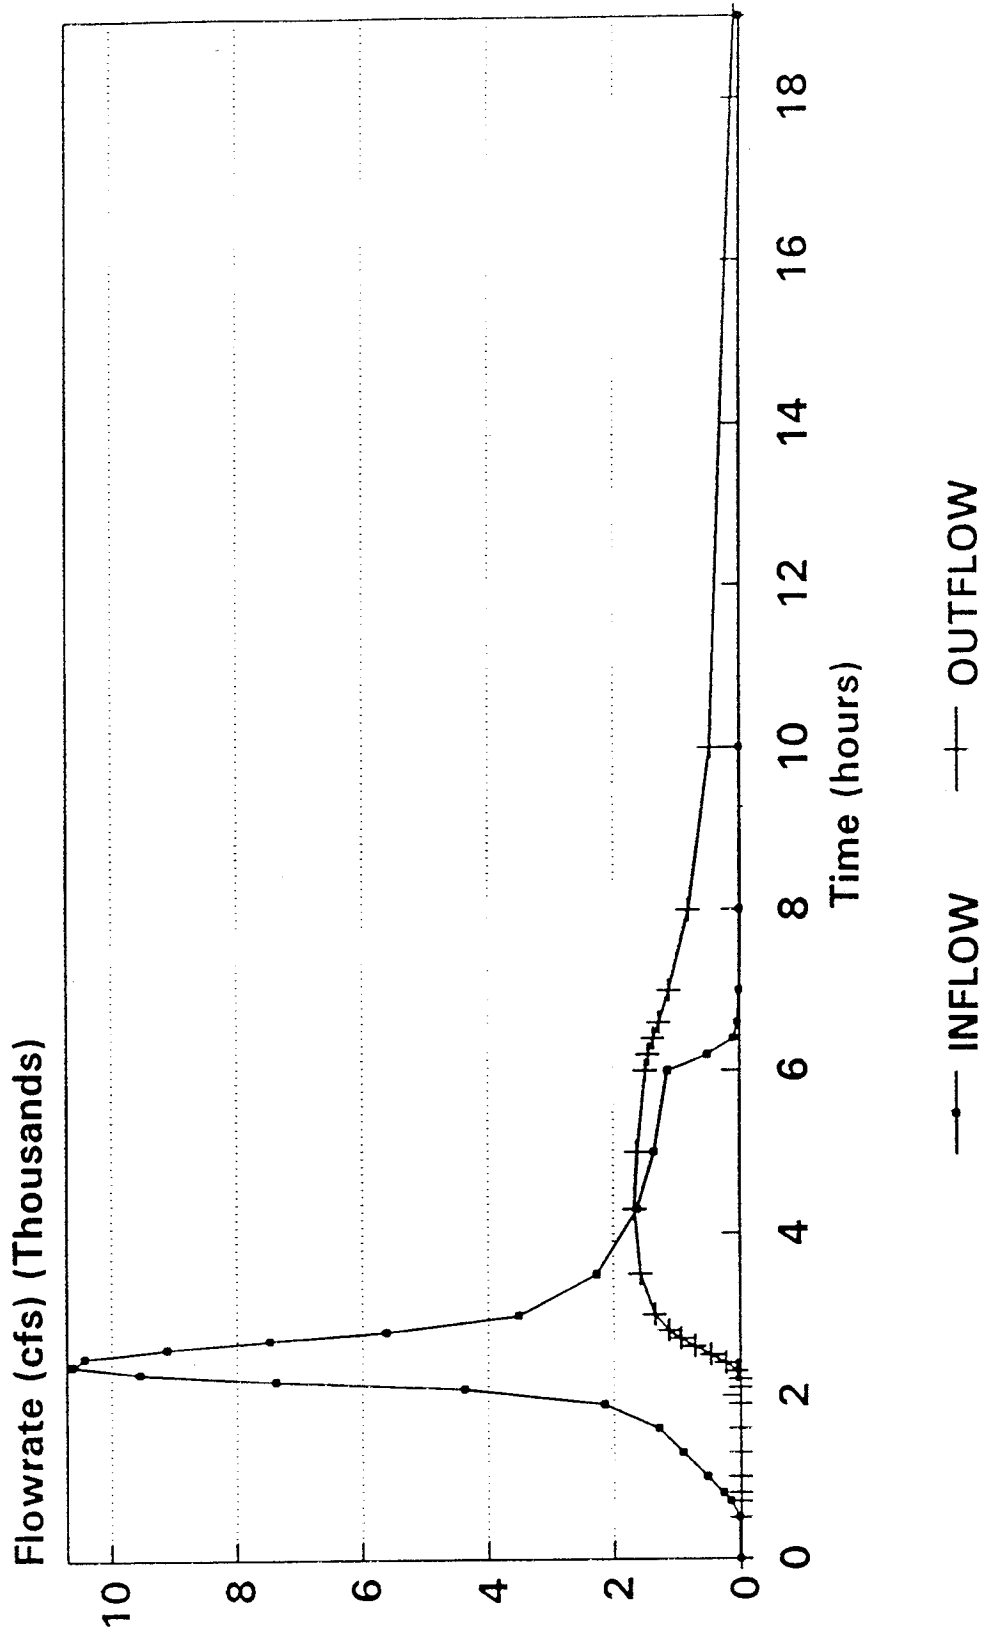
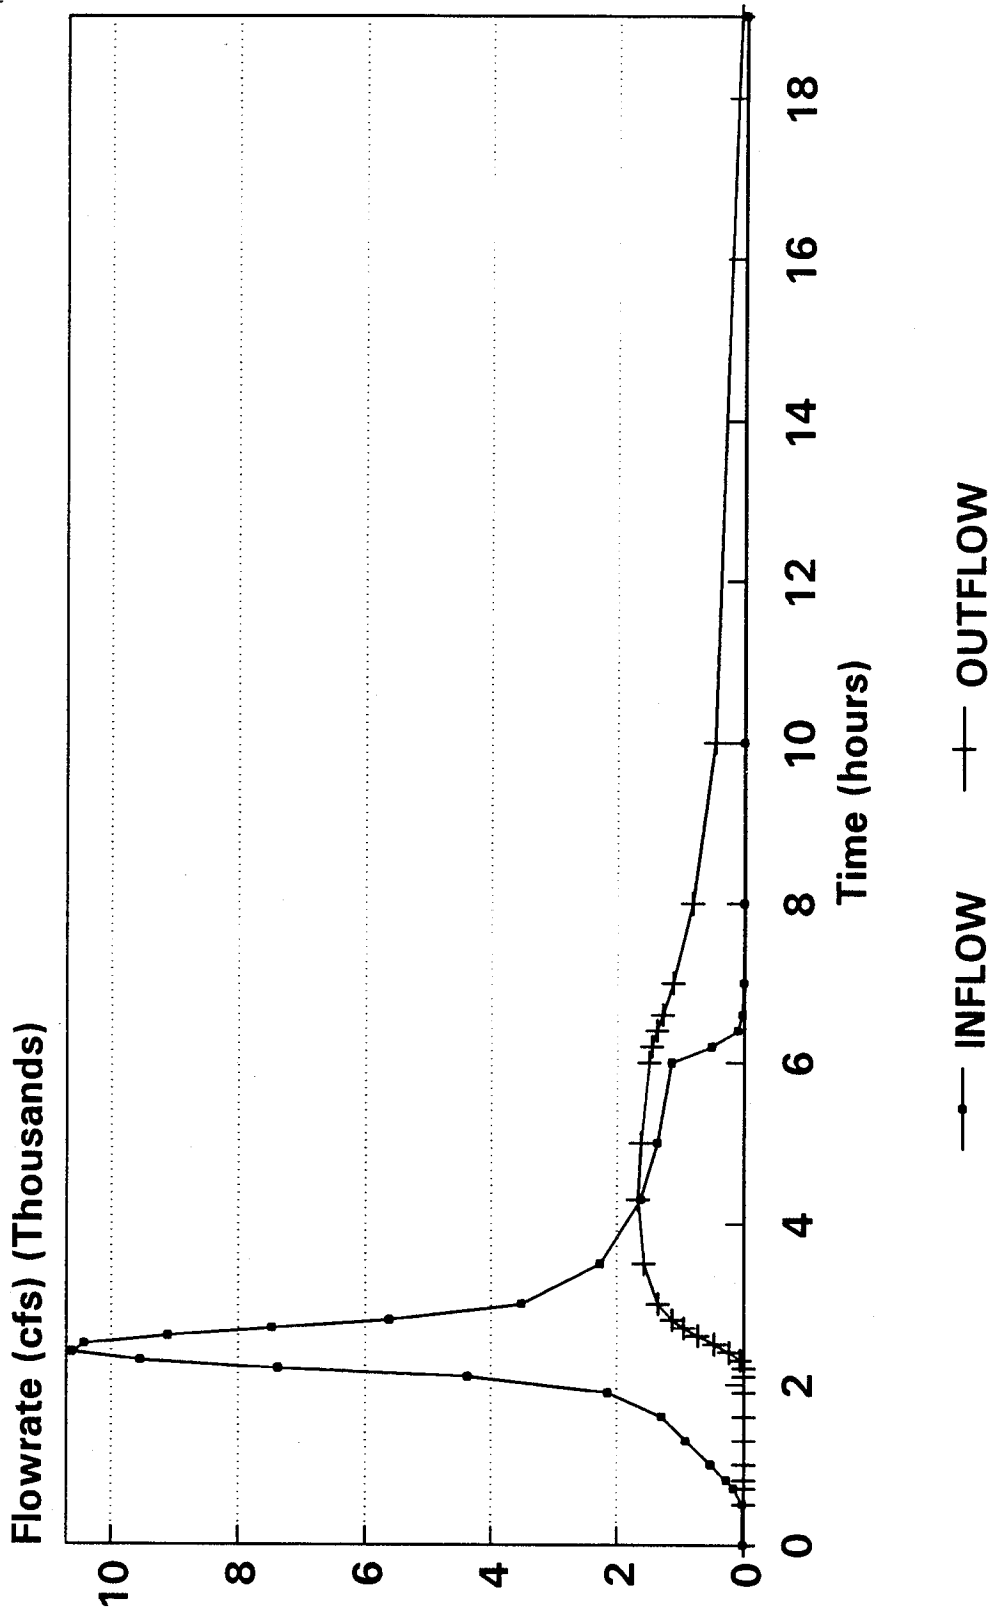
FIGURE 6.4

**Big Sandy Fly Ash Dam
Emergency Spillway
6 Hr PMF Design Flood**

during passage of the PMF. This is based on an initial pool level of 705 feet and a 100 foot wide emergency spillway section. The flood routing was based on the principal spillway being plugged, a conservative condition. The peak outflow from the facility is 1672 cfs. Fig. 6.4 is a plot of the inflow and outflow emergency spillway hydrographs.

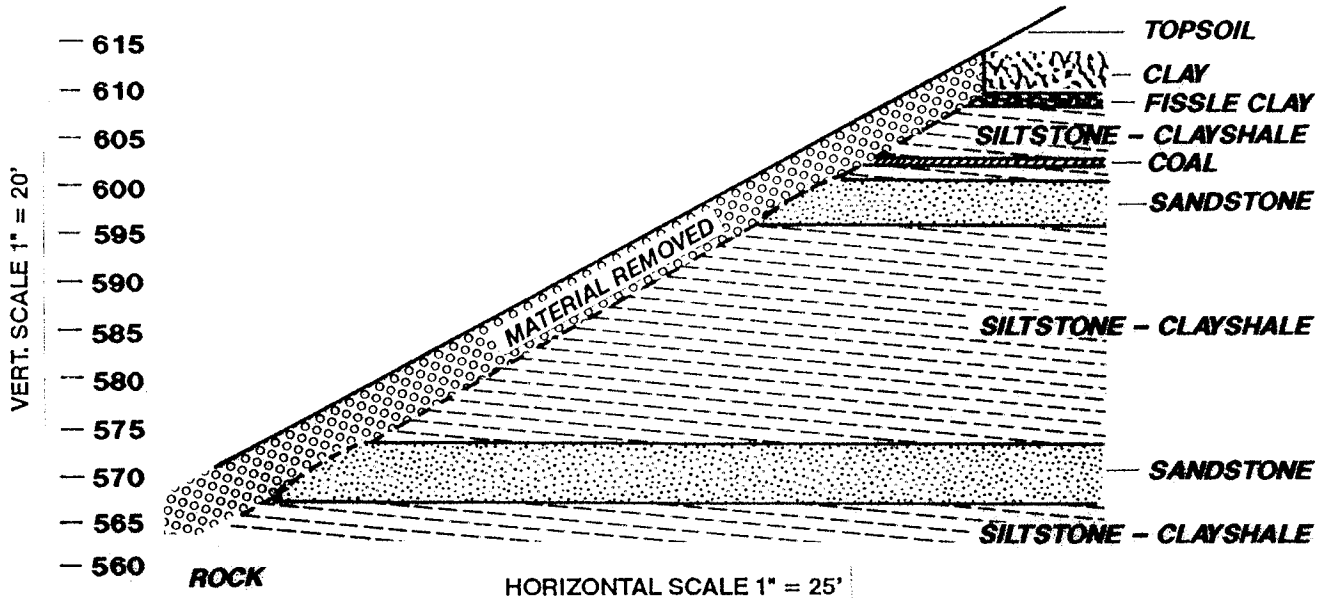
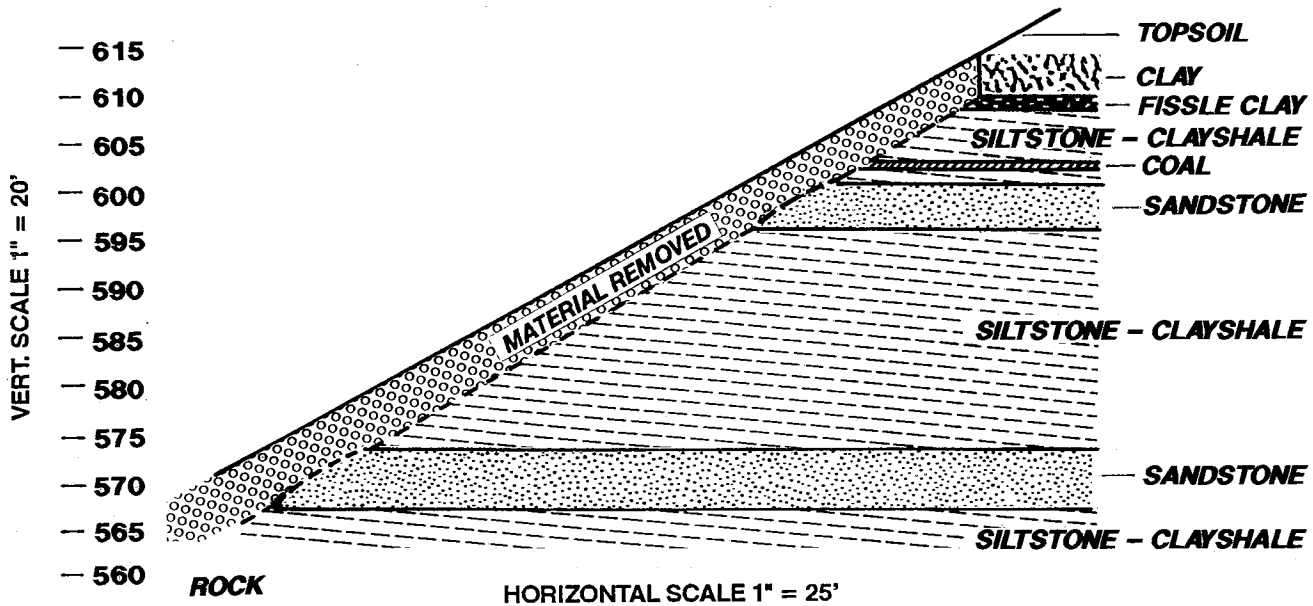
FIG 3.1 SITE GEOLOGY

CROSS SECTIONAL VIEW OF EXCAVATION AND GEOLOGY

GEOLOGICAL LOG OF ABUTMENT:		
615 -614	TOPSOIL, ORGANIC, VEGATATION, ROOFS, SOME CLAY	
614 -609	(HIGHWALL) CLAY, TAN, LT BROWN, SOME SAND, SOME SANDSTONE FRAGMENTS, MOIST	
609 -608	CLAY, SLIGHTLY FISSLE, SLIGHTLY WEATHERED, TAN, LT BROWN, GRAY, SOME SAND	
608 -603	SILTSTONE - CLAYSHALE SHALEY, GRAY, LT BROWN, TAN, SOME IRON, PRECIPITATOR	
603 -602.2	COAL, BLACK, SOFT	
602.2 -600	SILTSTONE - CLAYSHALE, SHALEY, FISSLE GRAY, TAN, LT BROWN	
600 -596	SANDSTONE, TAN, LT BROWN, HARD, MEDIUM GRAINED	
596 -573	SILTSTONE - CLAYSHALE, SHALEY, FISSLE GRAY, LT BROWN, MODERATLY HARD	
573 -567	SANDSTONE, TAN, LT BROWN, RED GIA	
567	SILTSTONE - CLAYSHALE, TAN, LT BROWN, FISSLE

GEOLOGICAL LOG OF ABUTMENT:	Elevation Range	Description
	615 - 614	TOPSOIL, ORGANIC, VEGATATION, ROOFS, SOME CLAY
	614 - 609	(HIGHWALL) CLAY, TAN, LT BROWN, SOME SAND, SOME SANDSTONE FRAGMENTS, MOIST
	609 - 608	CLAY, SLIGHTLY FISSLE, SLIGHTLY WEATHERED, TAN, LT BROWN, GRAY, SOME SAND
	608 - 603	SILTSTONE - CLAYSHALE SHALEY, GRAY, LT BROWN, TAN, SOME IRON, PRECIPITATOR
	603 - 602.2	COAL, BLACK, SOFT
	602.2 - 600	SILTSTONE - CLAYSHALE, SHALEY, FISSLE GRAY, TAN, LT BROWN
	600 - 596	SANDSTONE, TAN, LT BROWN, HARD, MEDIUM GRAINED
	596 - 573	SILTSTONE - CLAYSHALE, SHALEY, FISSLE GRAY, LT BROWN, MODERATLY HARD
	573 - 567	SANDSTONE, TAN, LT BROWN, RED GIA
	567	SILTSTONE - CLAYSHALE, TAN, LT BROWN, FISSLE

The area which was cleaned for the dam abutment extends from the existing dam's east abutment, approximately 175 feet north along the existing hillside. The height of the cleaning extends from the edge of the existing haul road up the slope of the hillside approximately 125 feet to elevation 614.0, Fig. 3.1.

Between 3.0 and 4.5 feet of material was removed from the area to expose the rock. The surface of the cleaned slope is primarily a siltstone/clayshale material. Two sandstone units and a thin coal seam were also located, Fig. 3.1 and 3.2.
