HISTORY OF CONSTRUCTION

CFR 257.73(c)(1)

Fly Ash Pond

Big Sandy Plant
Louisa, Kentucky

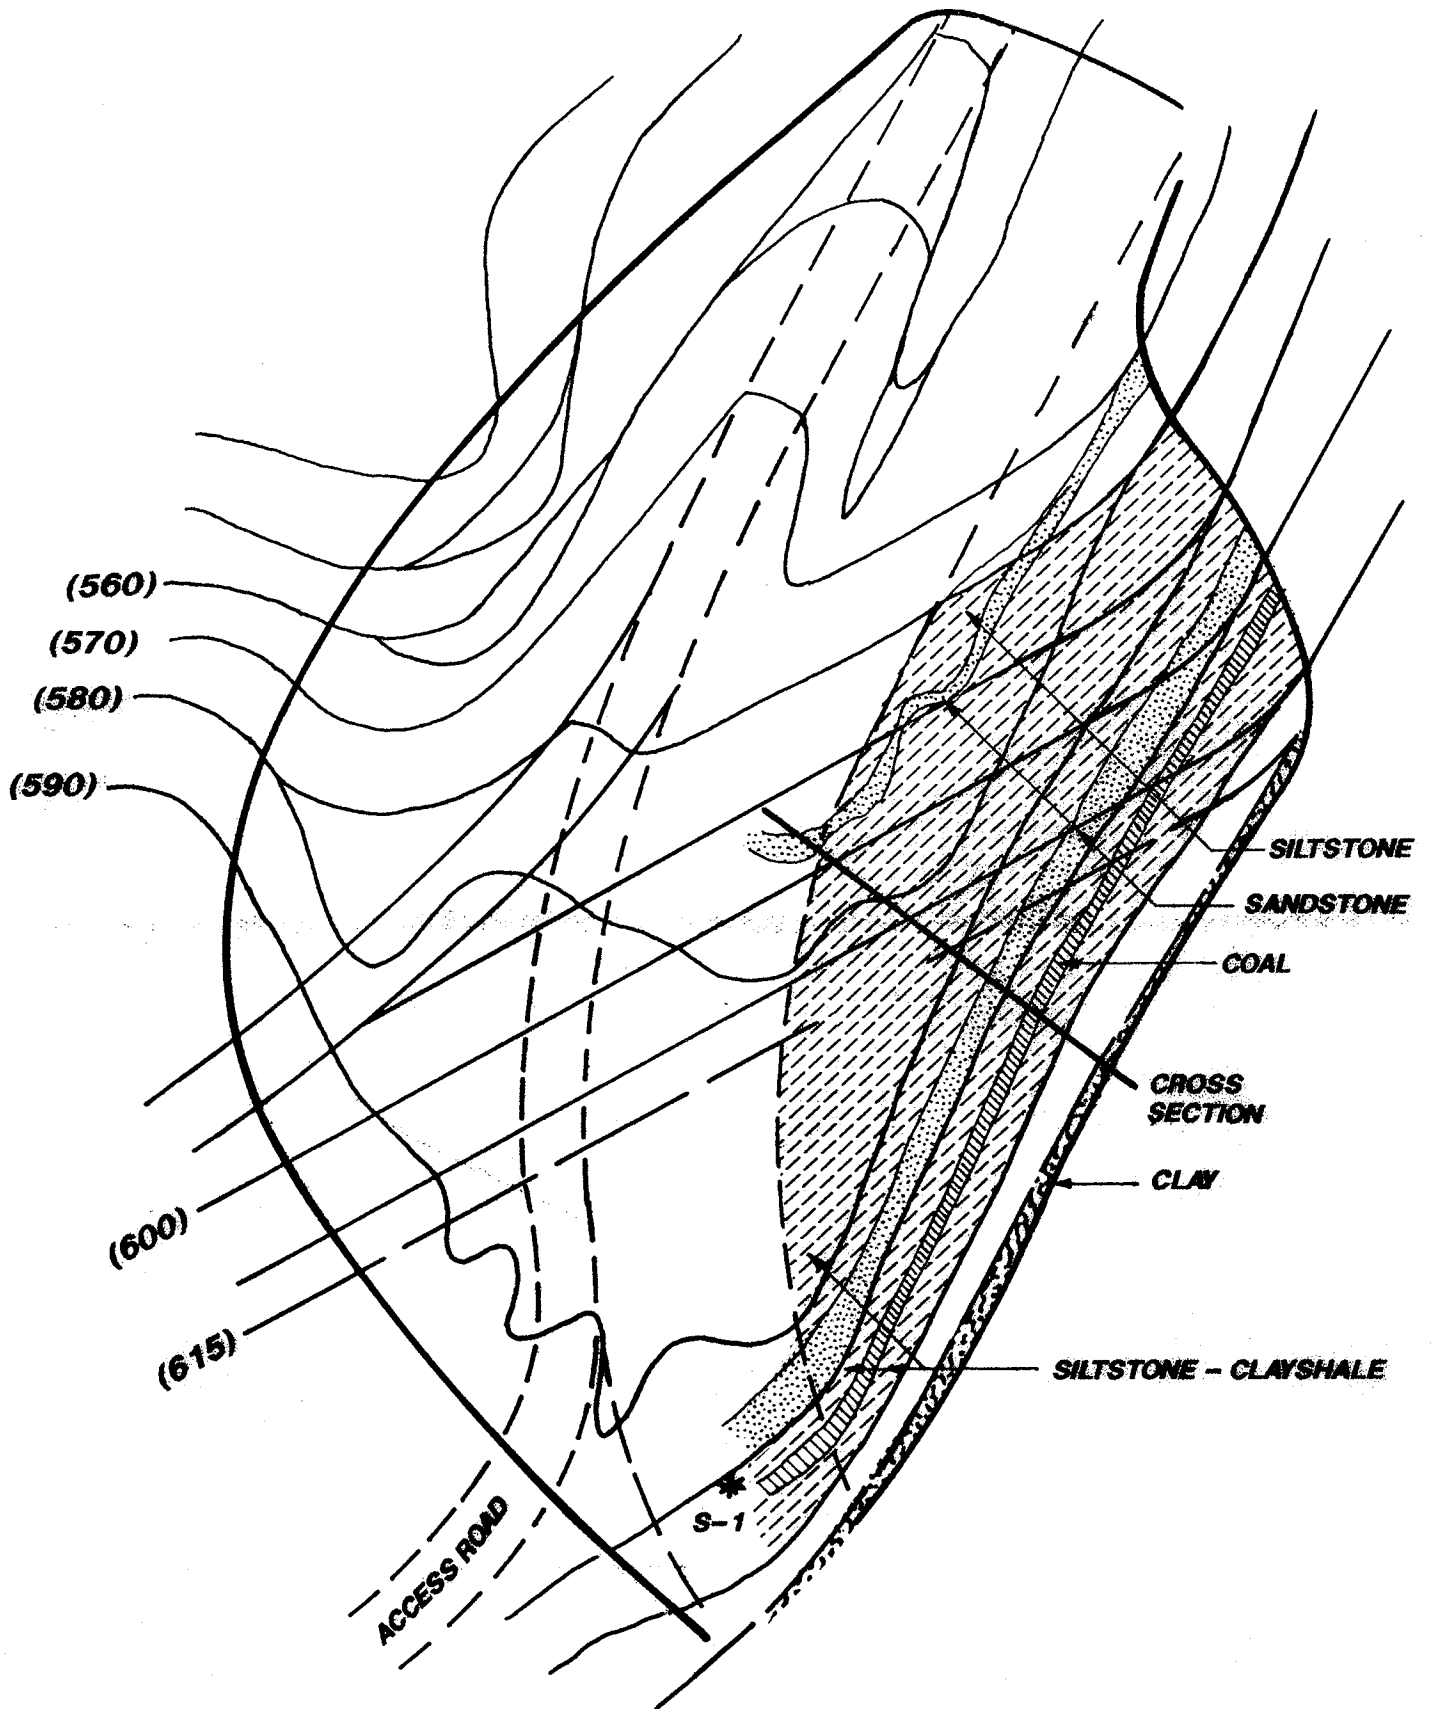
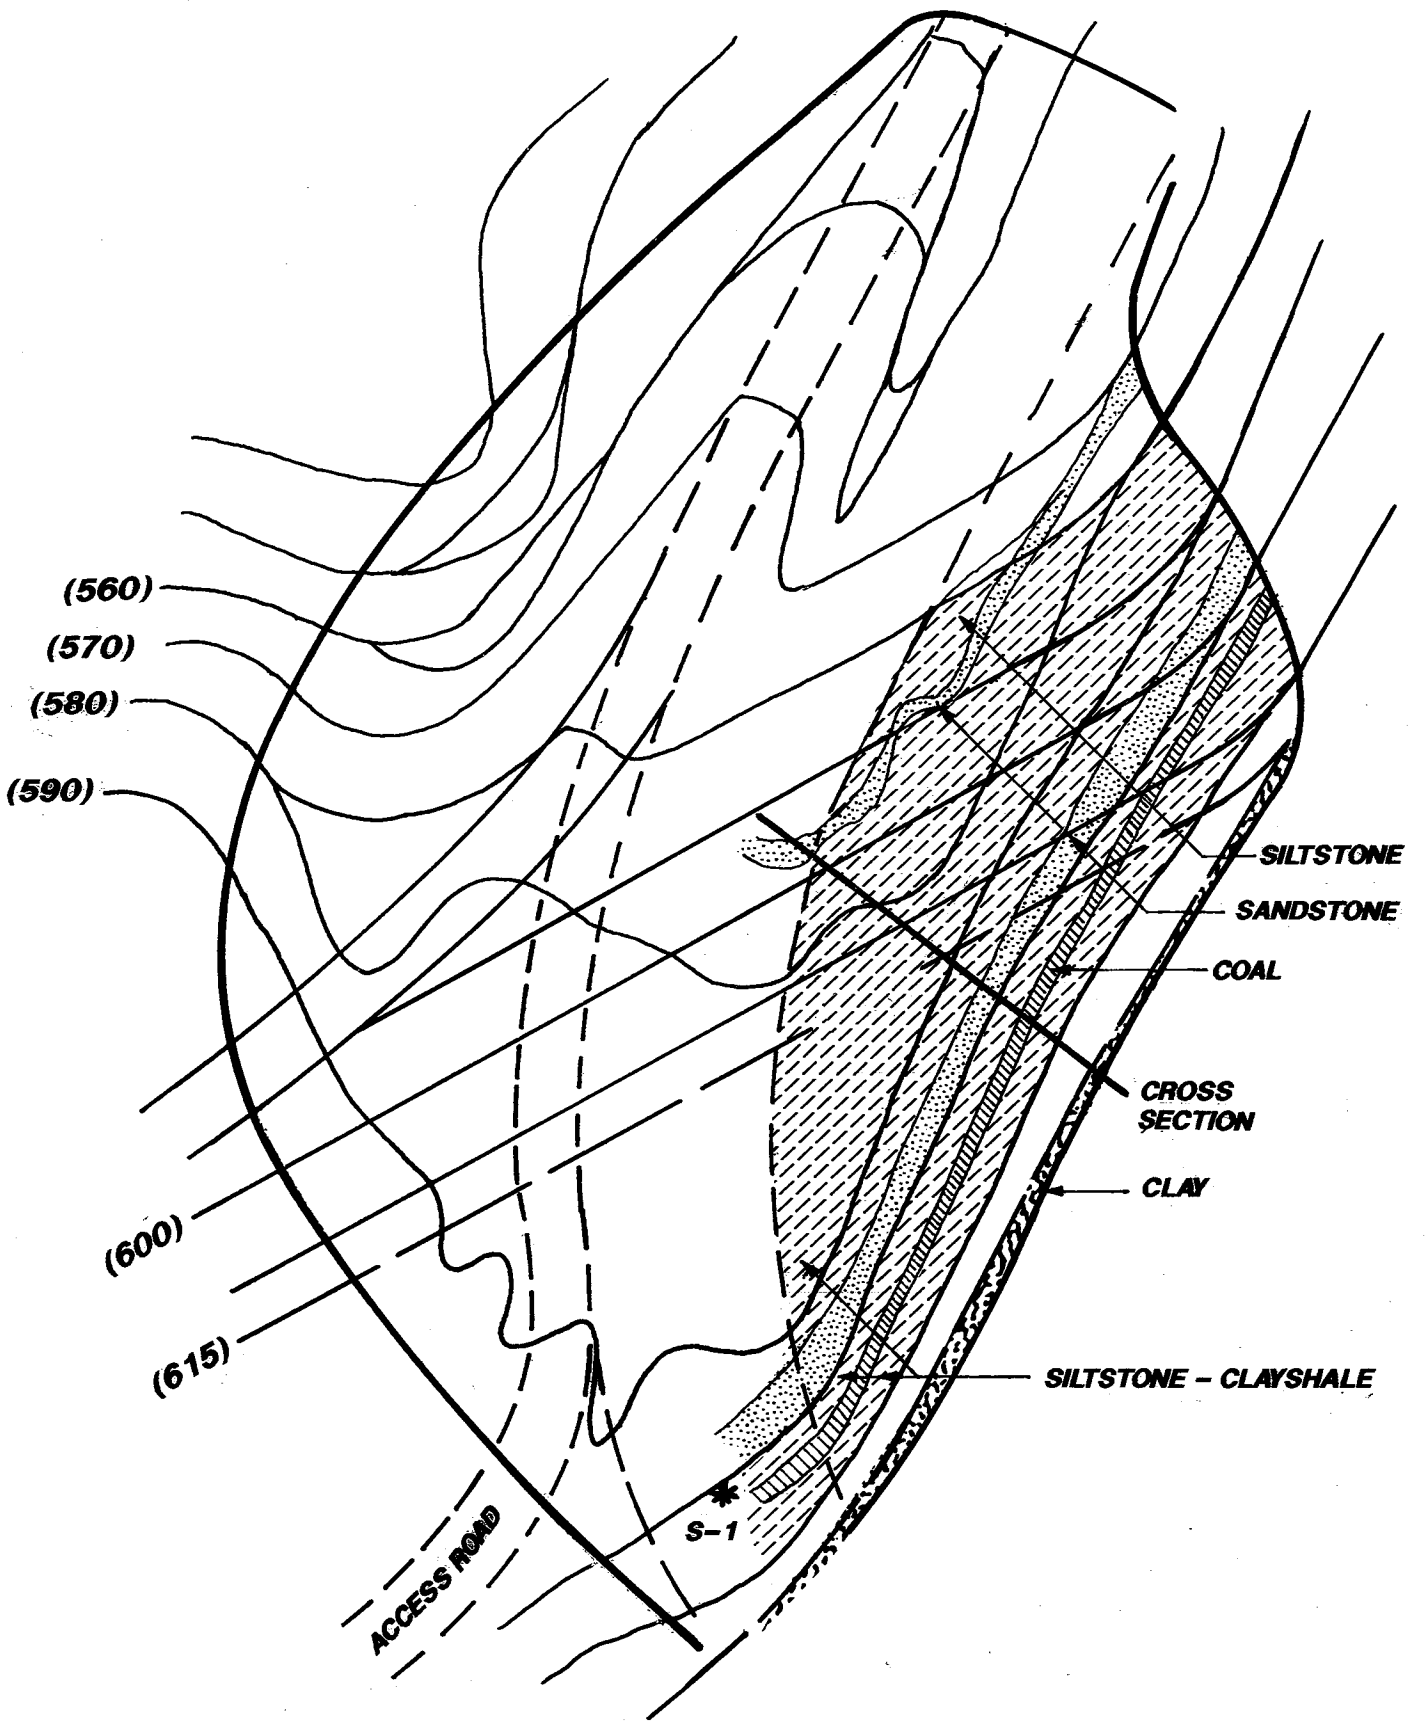
FIG. 3.2 PLANVIEW OF EXCAVATION AREA

A measurable flow of water was located below the groin of the existing dam. The water appeared to be flowing along the top of a sandstone unit at elevation 600. The seep was estimated to be flowing at one gallon per 6 minutes or 1.6×10^{-1} GPM. The location of the seep is indicated on Fig. 3.2 and labeled as S-1.

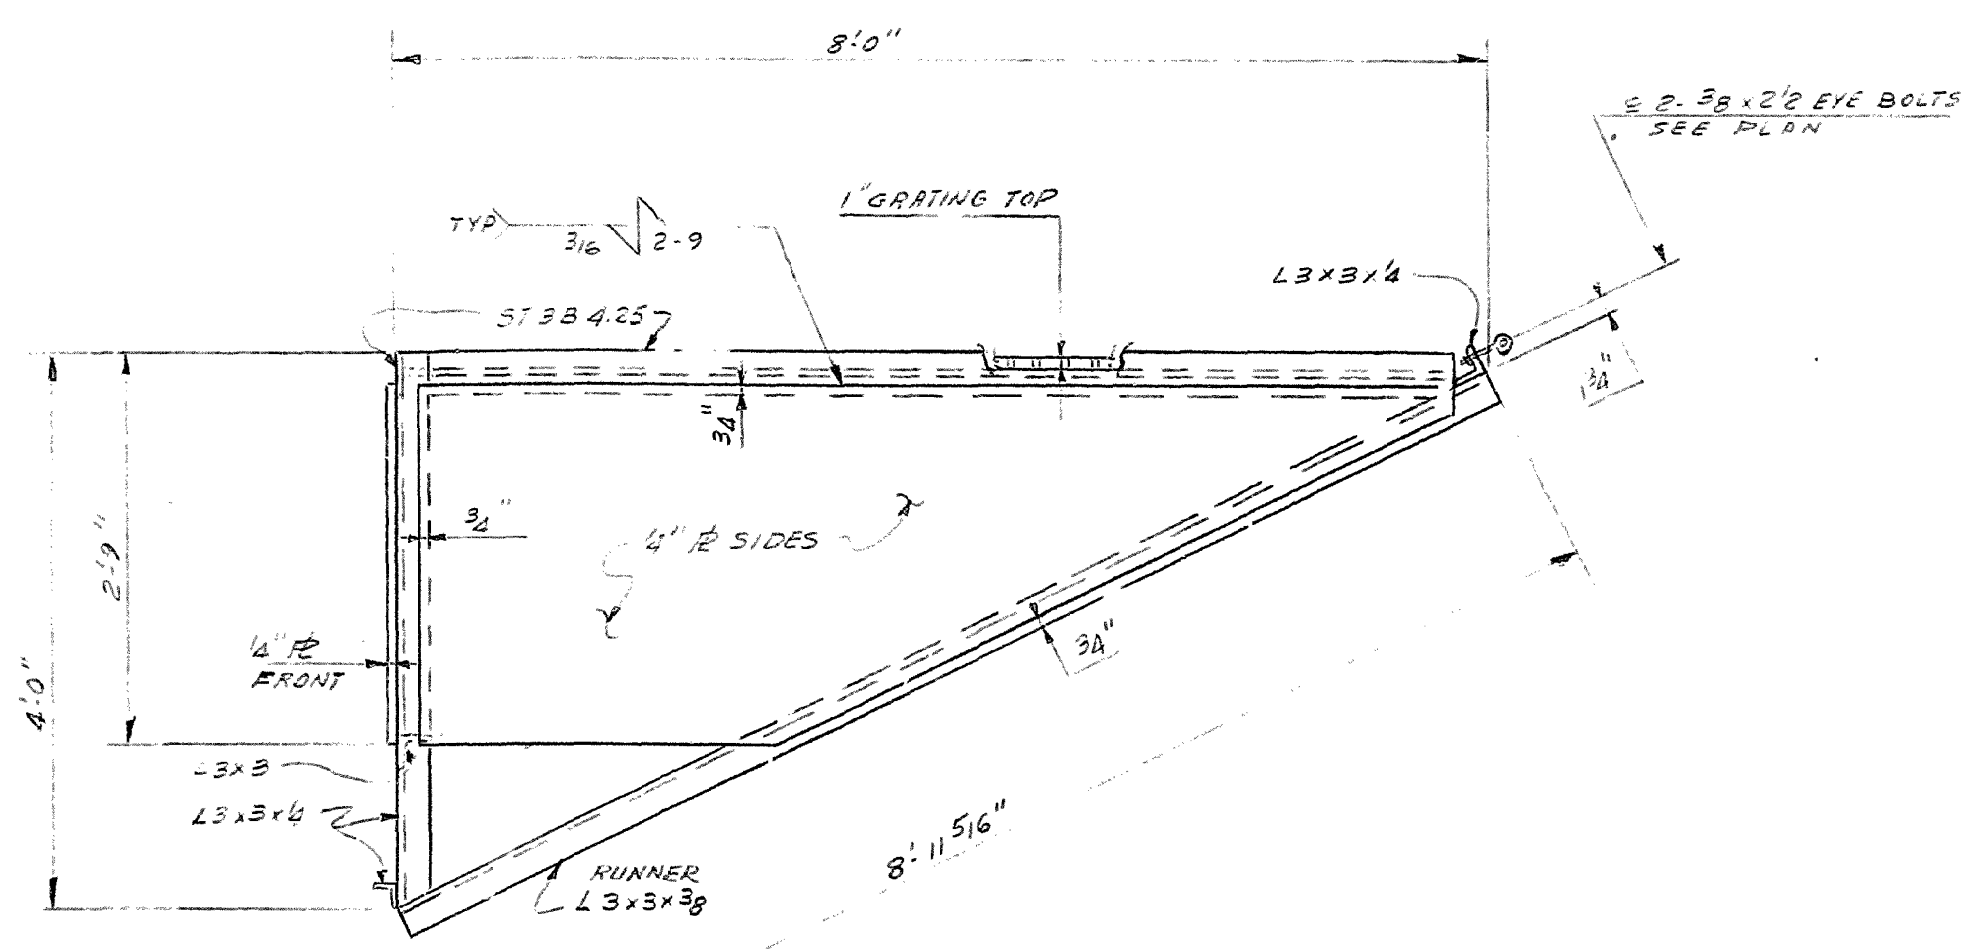
SECT 2-C
3/4"=1'-0"

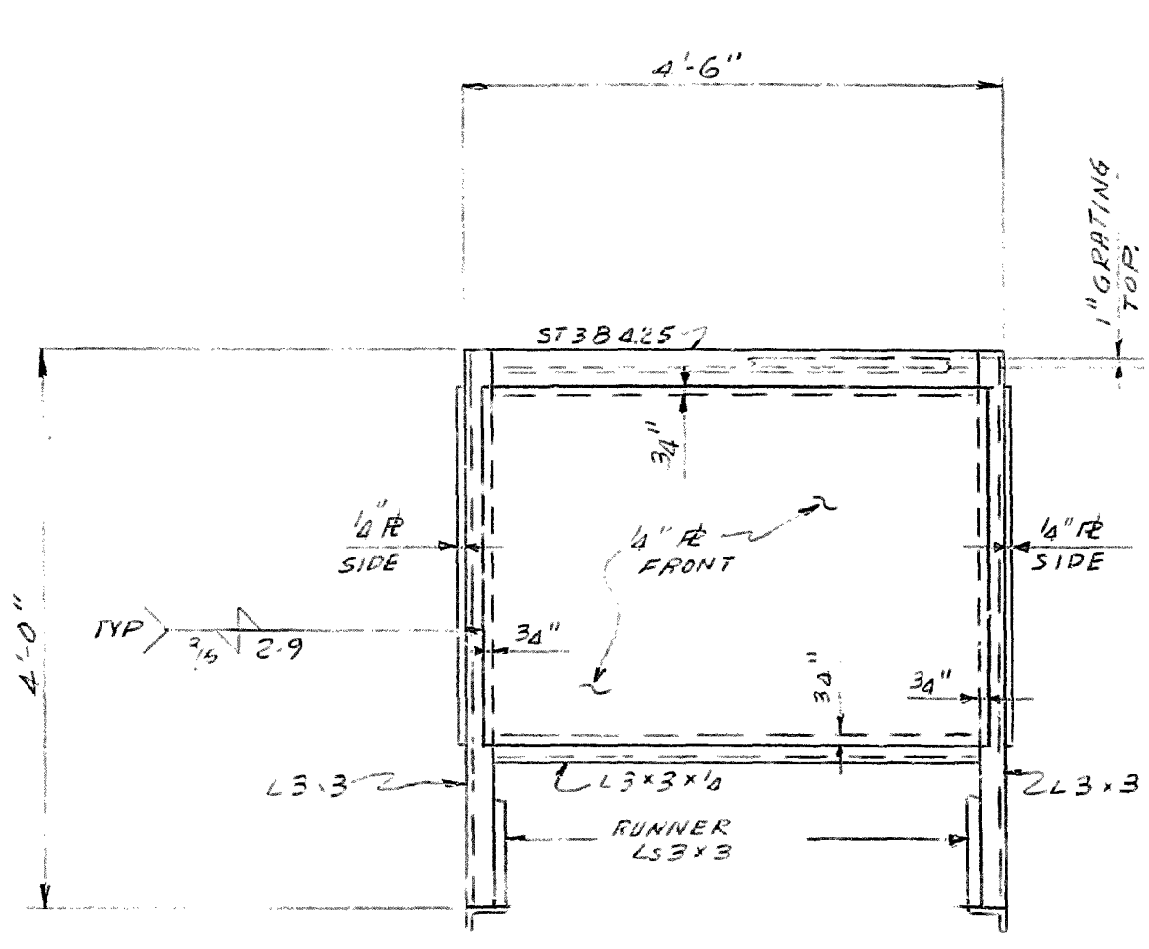
SECT 2-G
3/4"=1'-0"

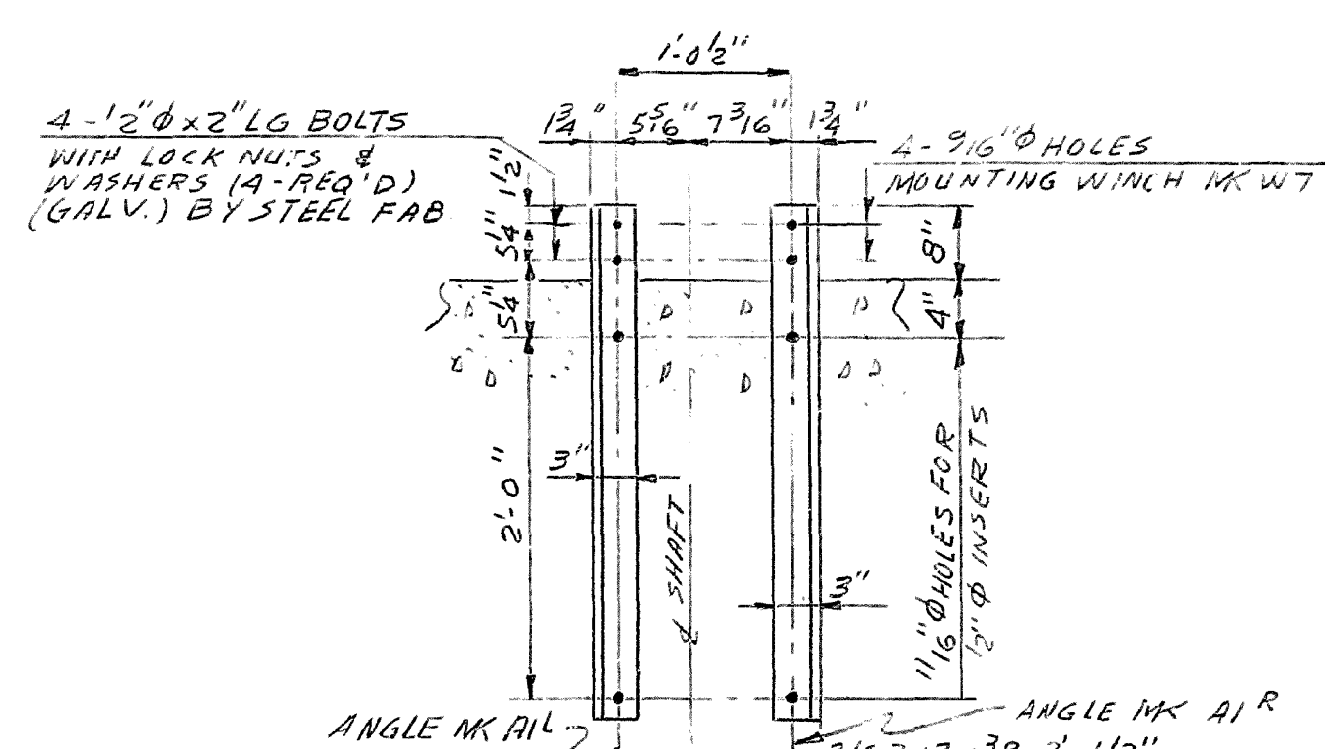
ANGLE MK AIR (1-REQ'D)
ANGLE MK AIR (1-REQ'D)
WINCH SUPPORT
PAINT: (1) SHOP COAT OF BITUMINOUS PAINT (N.T.S.)

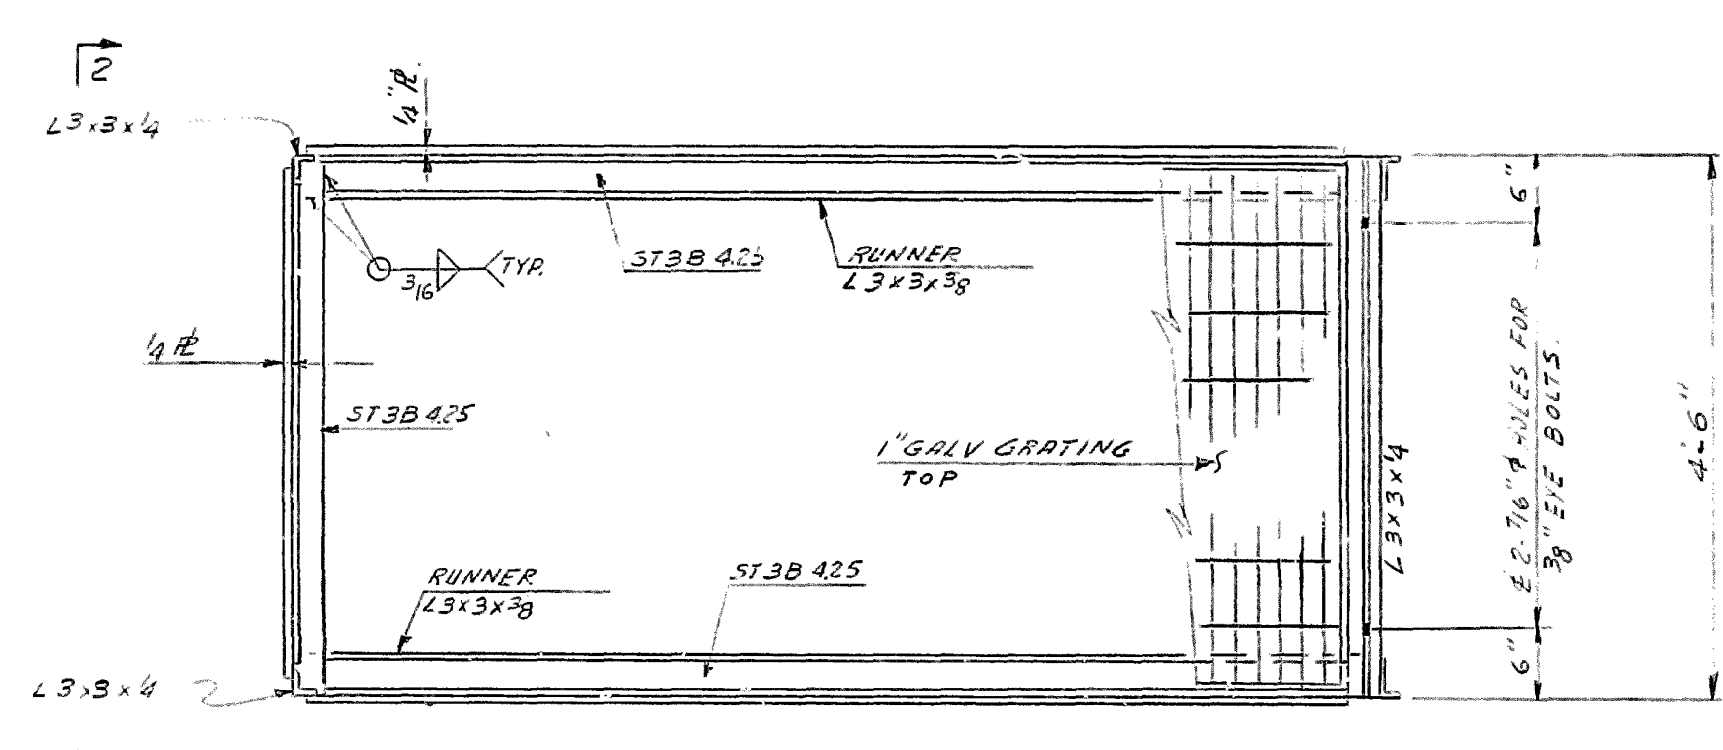
PLAN
SKIMMER MK 3543-S1
READINGS 12-3548 & 12-3549
STEEL TO BE HOT DIPPED GALVANIZED

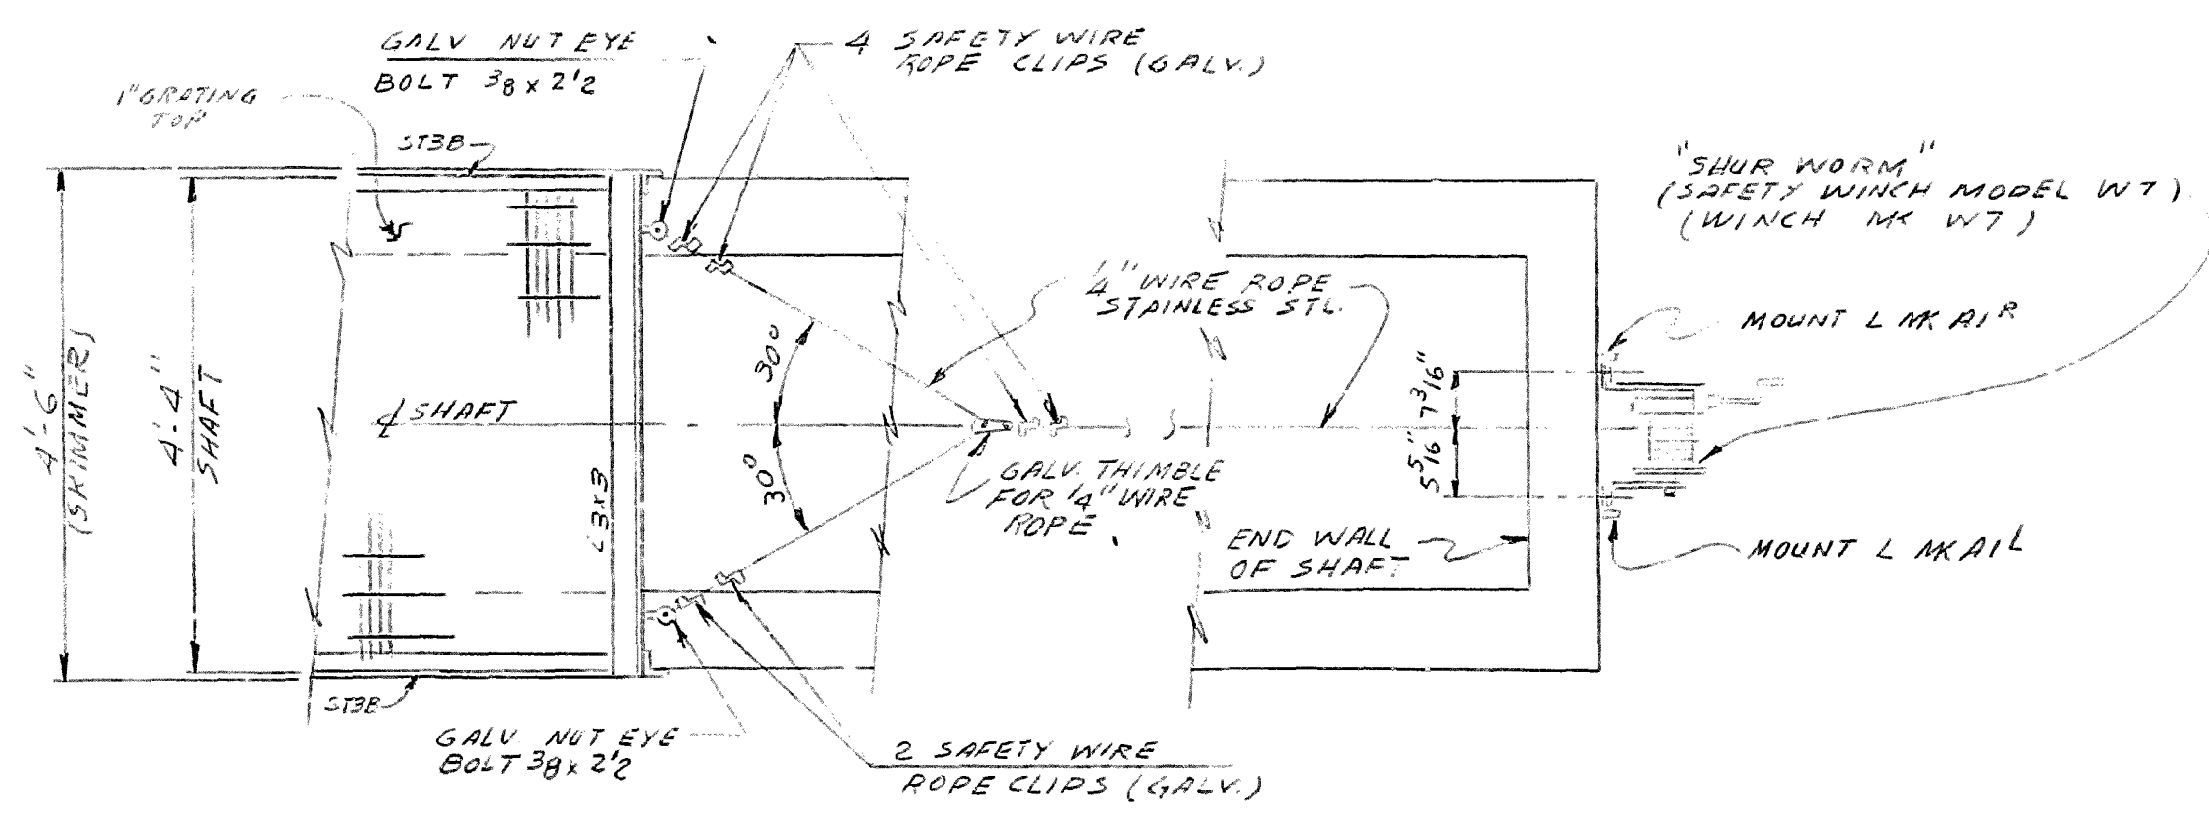
ARRANGEMENT FOR MOUNTING SKIMMER MK 3543-S1
PLAN

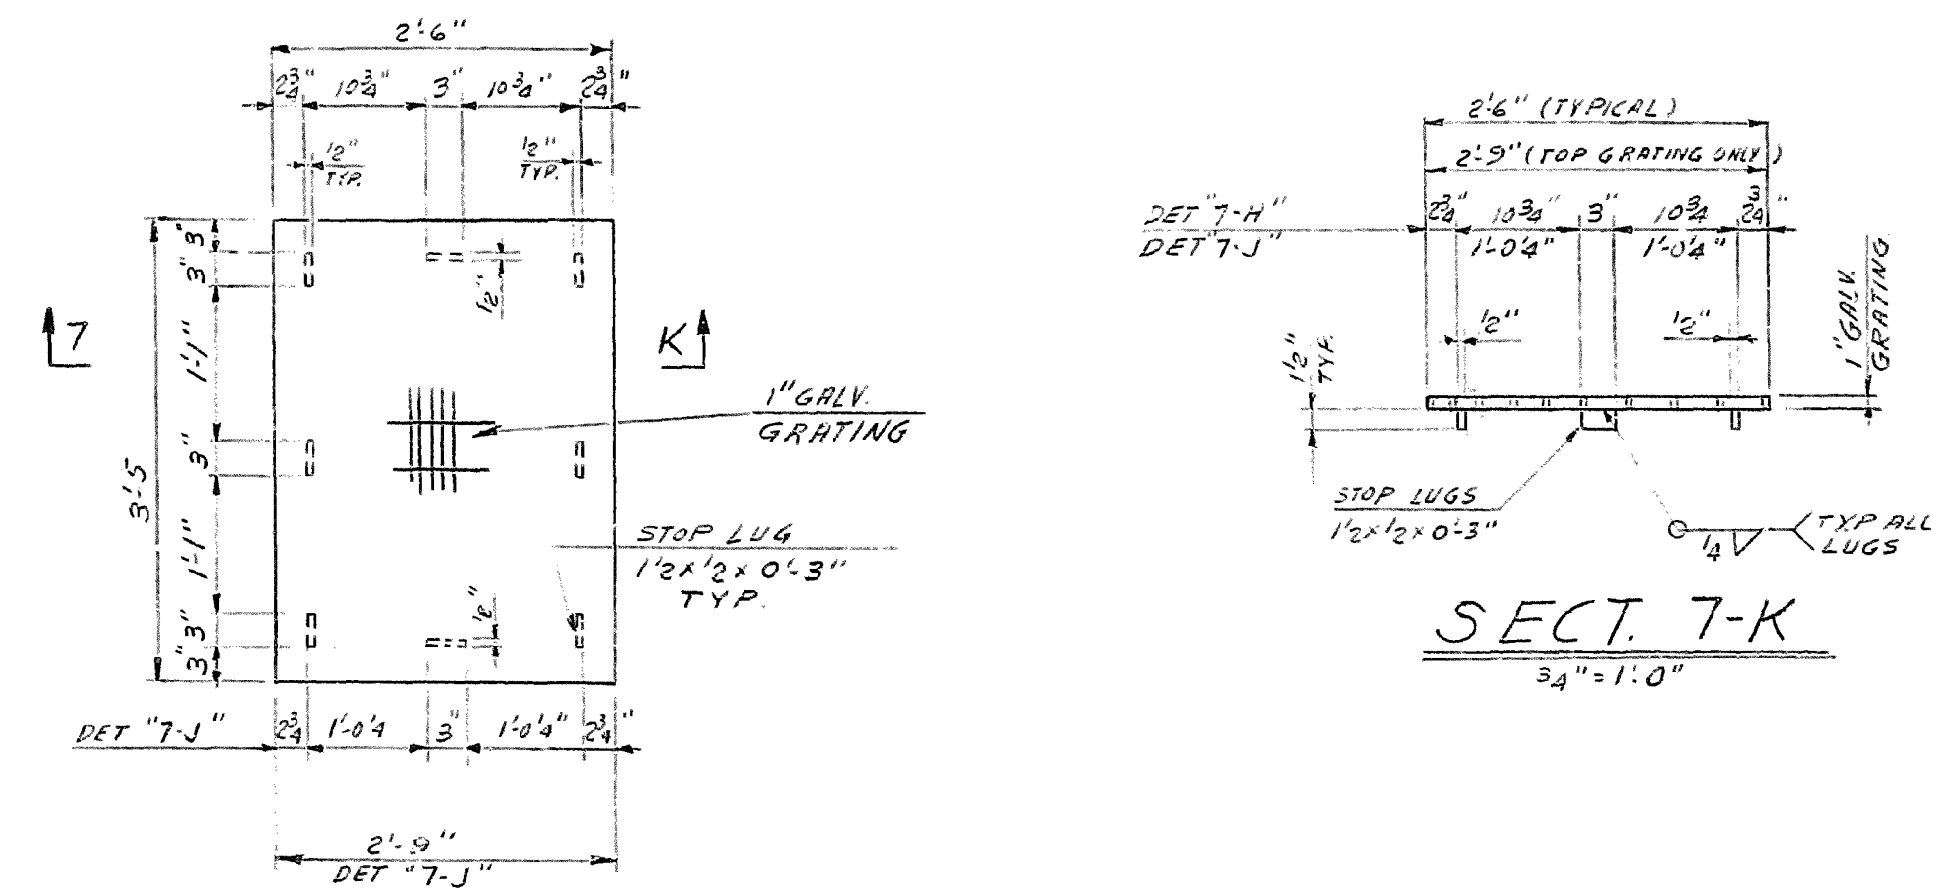
PLAN
GRATING COVERS FOR DRAINAGE SHAFT
1/2"=1'-0"

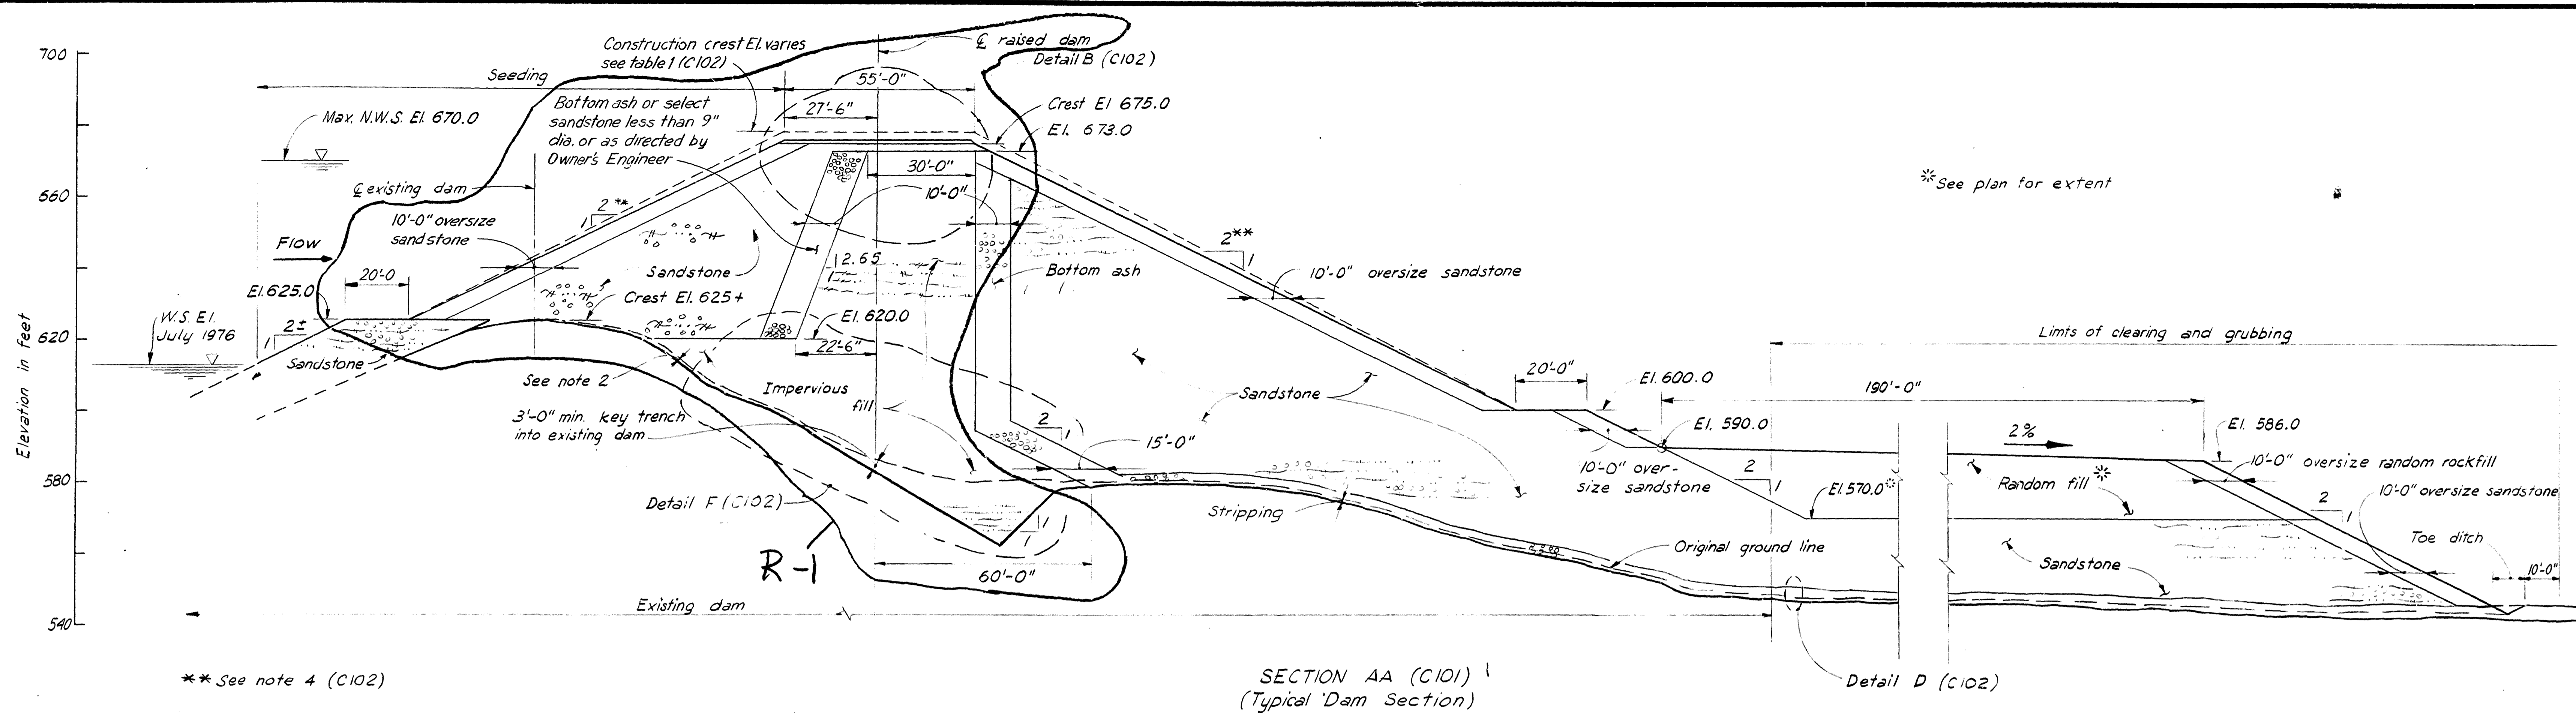
SECTION AA (C101)
(Typical Dam Section)

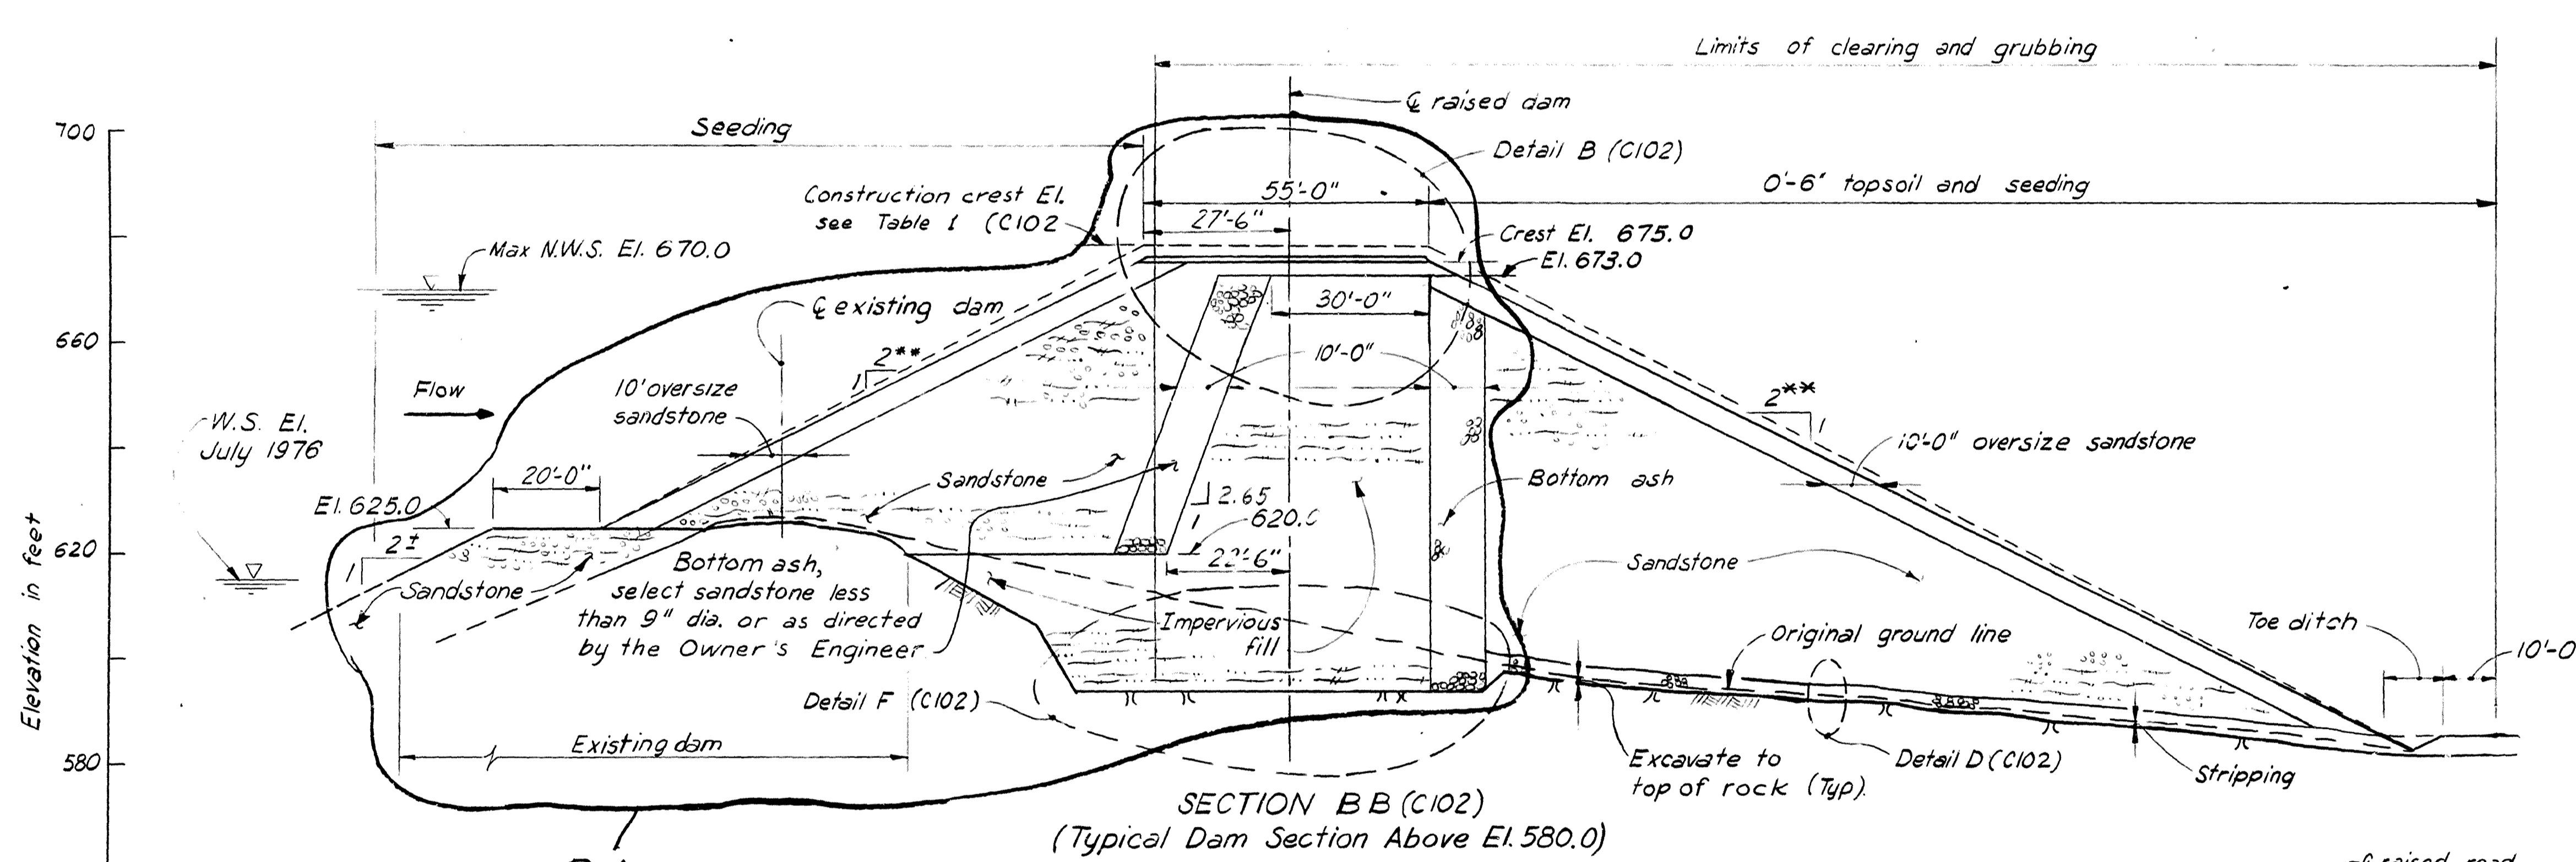
SECTION BB (C102)
(Typical Dam Section Above El. 580.0)

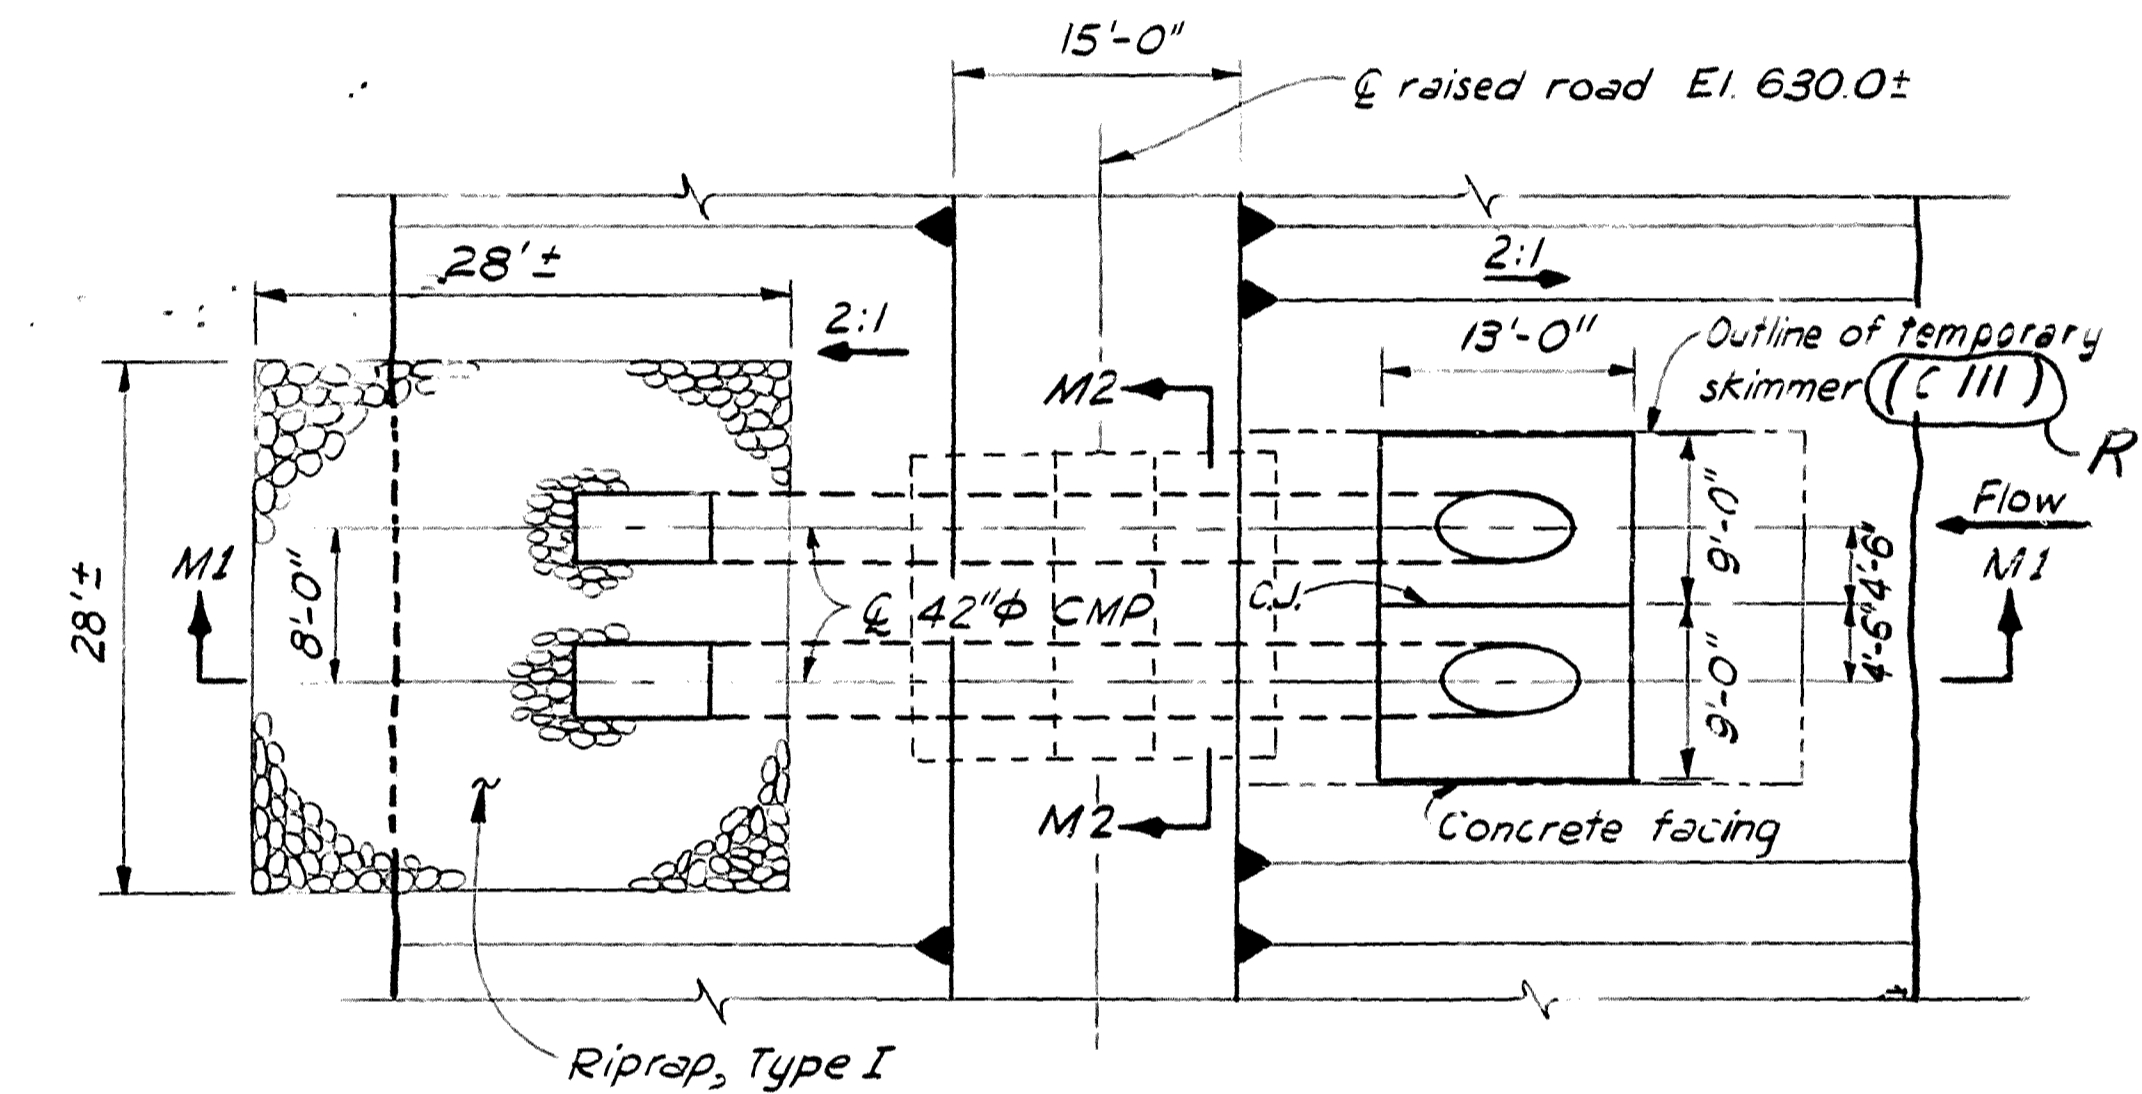
TEMPORARY SPILLWAY DIVERSION & SKIMMER
DETAIL M (C101)

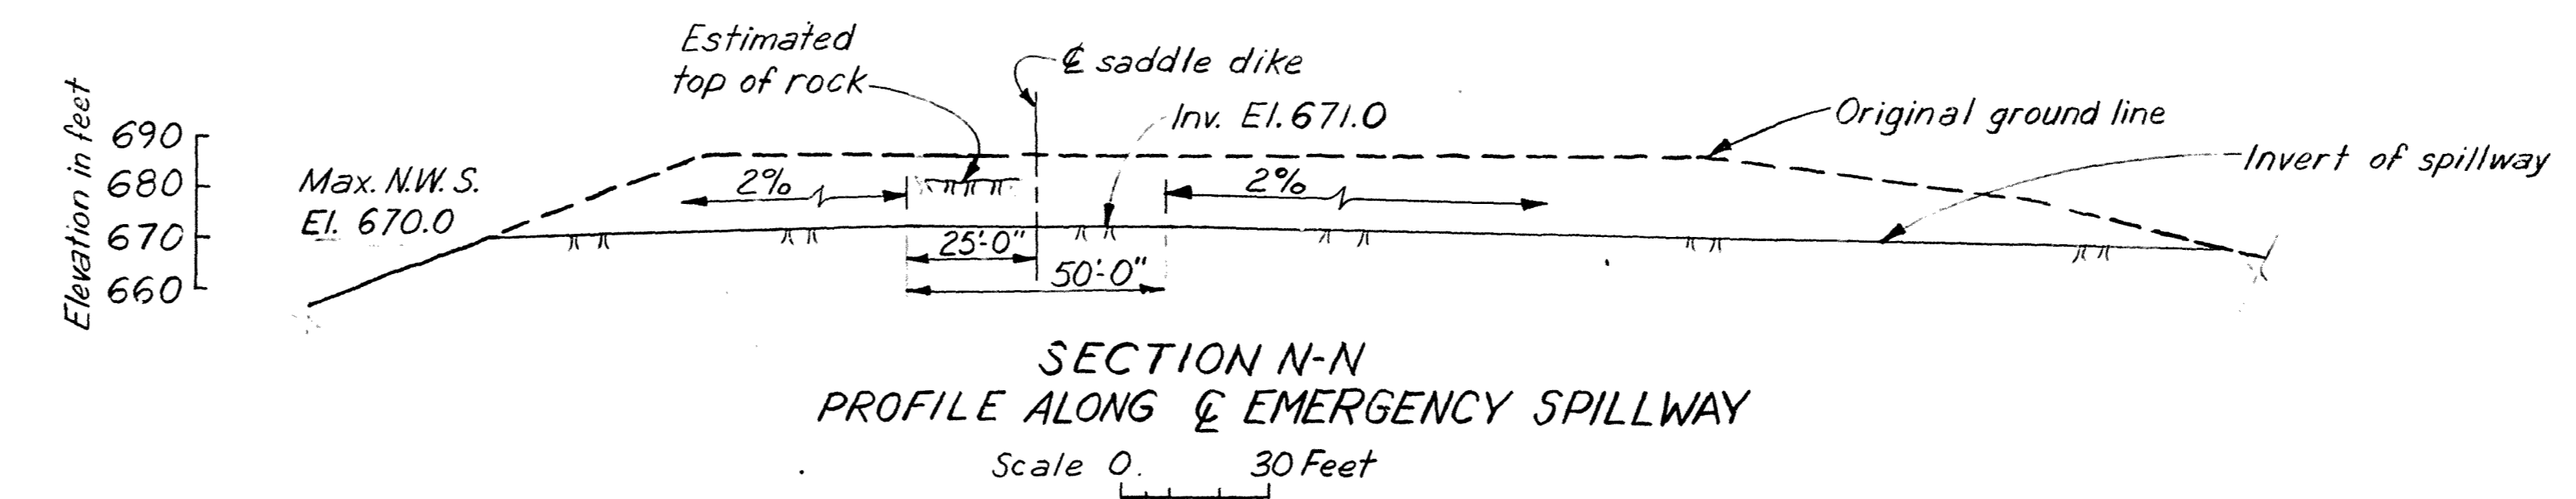
SECTION N-N
PROFILE ALONG EMERGENCY SPILLWAY
Scale 0 30 Feet

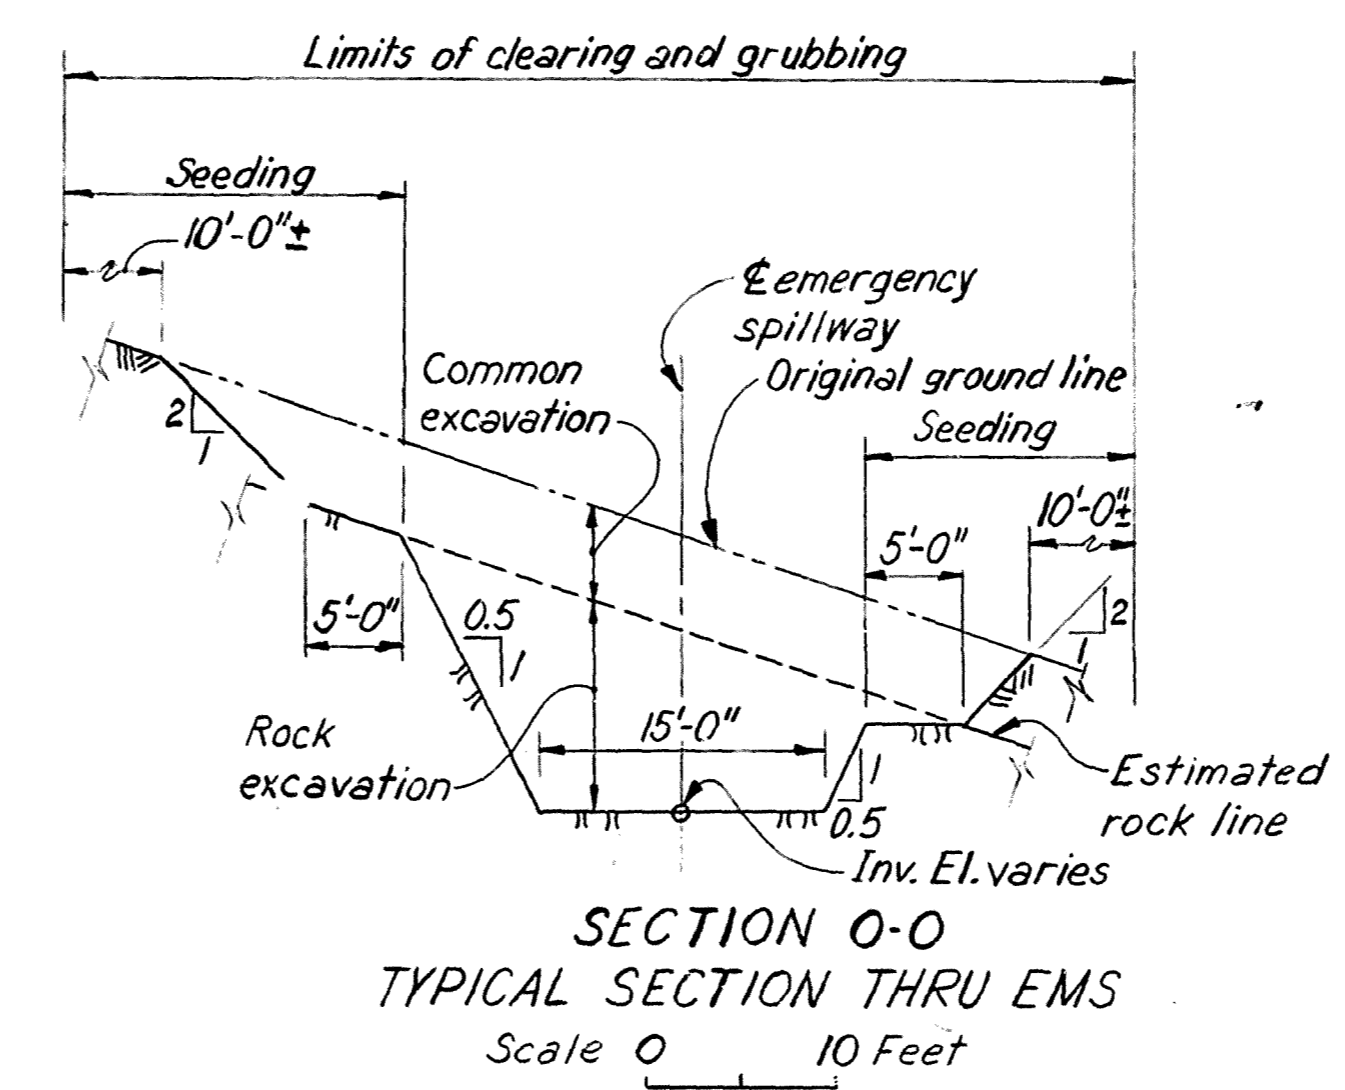
SECTION O-O
TYPICAL SECTION THRU EMS
Scale 0 10 Feet
