HISTORY OF CONSTRUCTION

CFR 257.73(c)(1)

Fly Ash Pond

Big Sandy Plant
Louisa, Kentucky

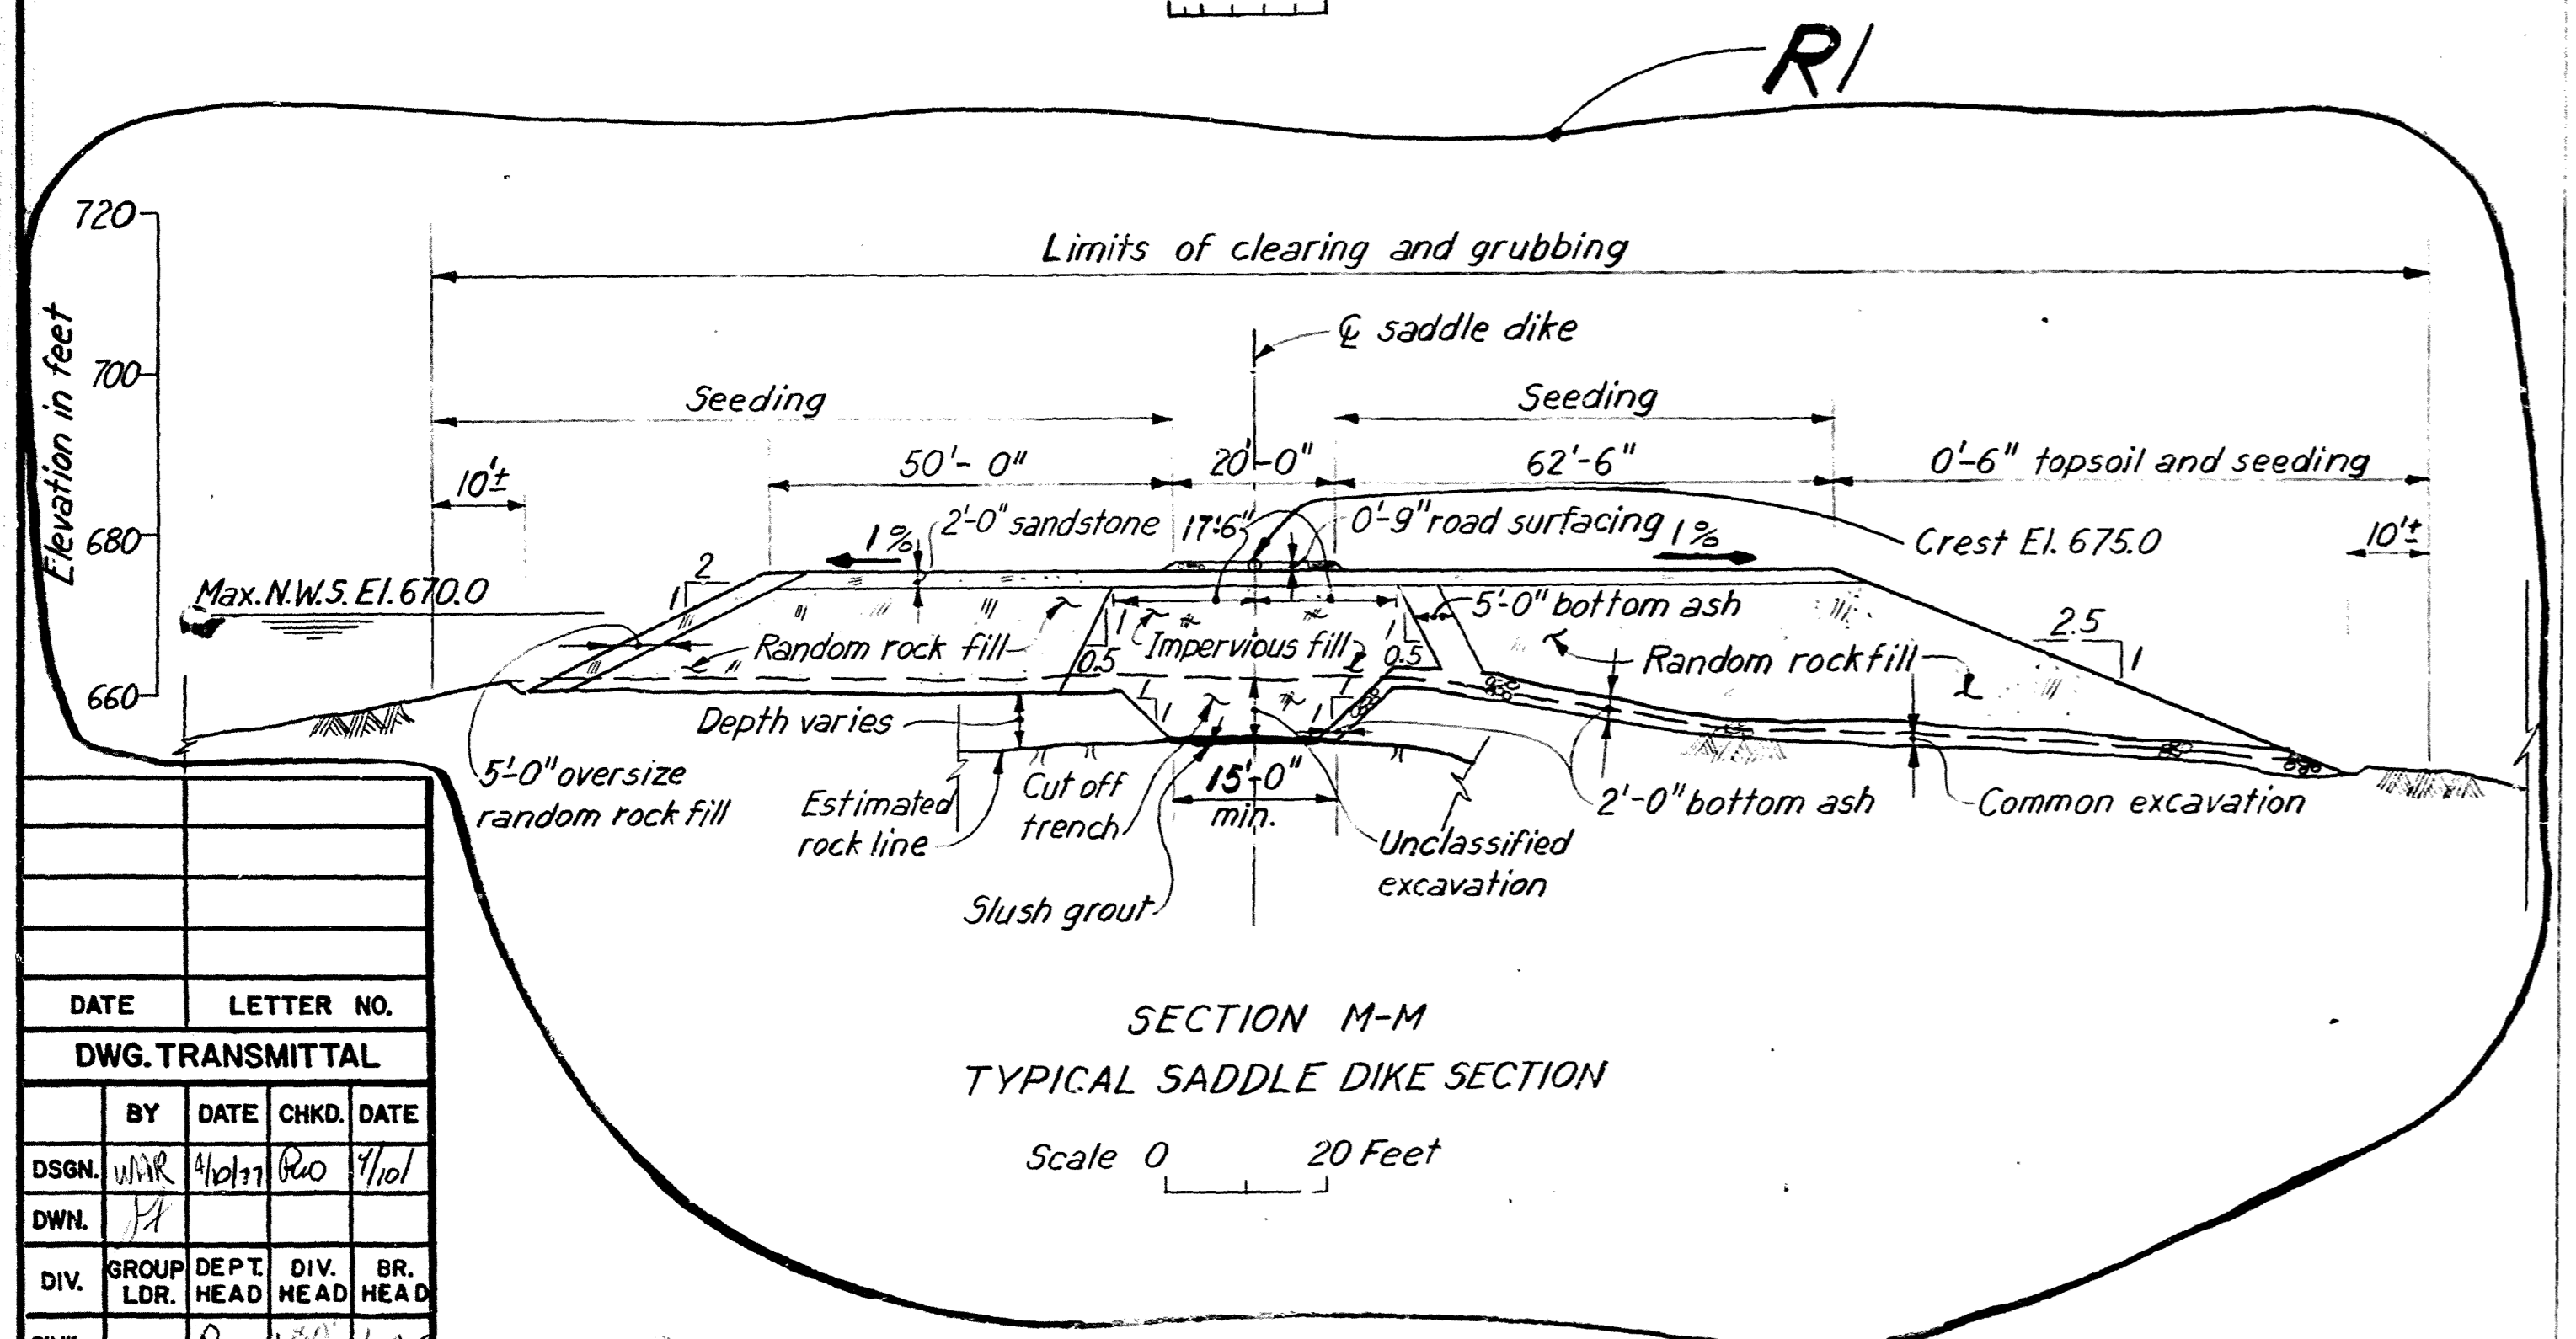
SECTION M-M
TYPICAL SADDLE DIKE SECTION
Scale 0 20 Feet

Similar to the main dam, the downstream shell of the saddle dam will be constructed using bottom ash and graded at a slope of 1-3/4 H:1V. The stability of the downstream shell was evaluated for the applicable conditions using the computer program XSTABLE. Wedge type foundation failure surfaces were analyzed using a random technique for generating sliding block failures. The active and passive portions of the sliding surfaces were generated according to the Rankine Theory. In addition, an "infinite slope" type analysis was performed to evaluate the stability of the shell with regard to shallow failures within the bottom ash material. A summary of the factors of safety associated with the different design conditions expected, is presented on Table No. 7.5. Summaries of the analyses are presented on Fig. F.38 through F.45. Data associated with the complete stability analyses of the downstream shell is submitted in Appendix F of this report.

The upstream shell for the saddle dam will be constructed using clay from the proposed borrow site and graded to a slope of 2-3/4H:1V. The upstream shell will also perform as the impervious core of the dam from to the present ground surface elevation of 675 to elevation 711. The stability of the downstream slope of the dam was evaluated for the applicable conditions using the XSTABLE computer program. Circular type failure surfaces were analyzed using a random technique for generating sliding surfaces. In addition, an "infinite slope" type analysis was performed to evaluate the stability of the clay core with regard to shallow failures within the compacted clay. A summary of the factors of safety, associated with the different design conditions is presented on Table 7.6. Summaries of the analyses are depicted on Fig. F.46 through F.53. Data associated with the complete stability analyses of the upstream slope is submitted in Appendix G of this report. It should be pointed out that for the partial pool case water levels in the reservoir of 680, 690 and 700 were studied.

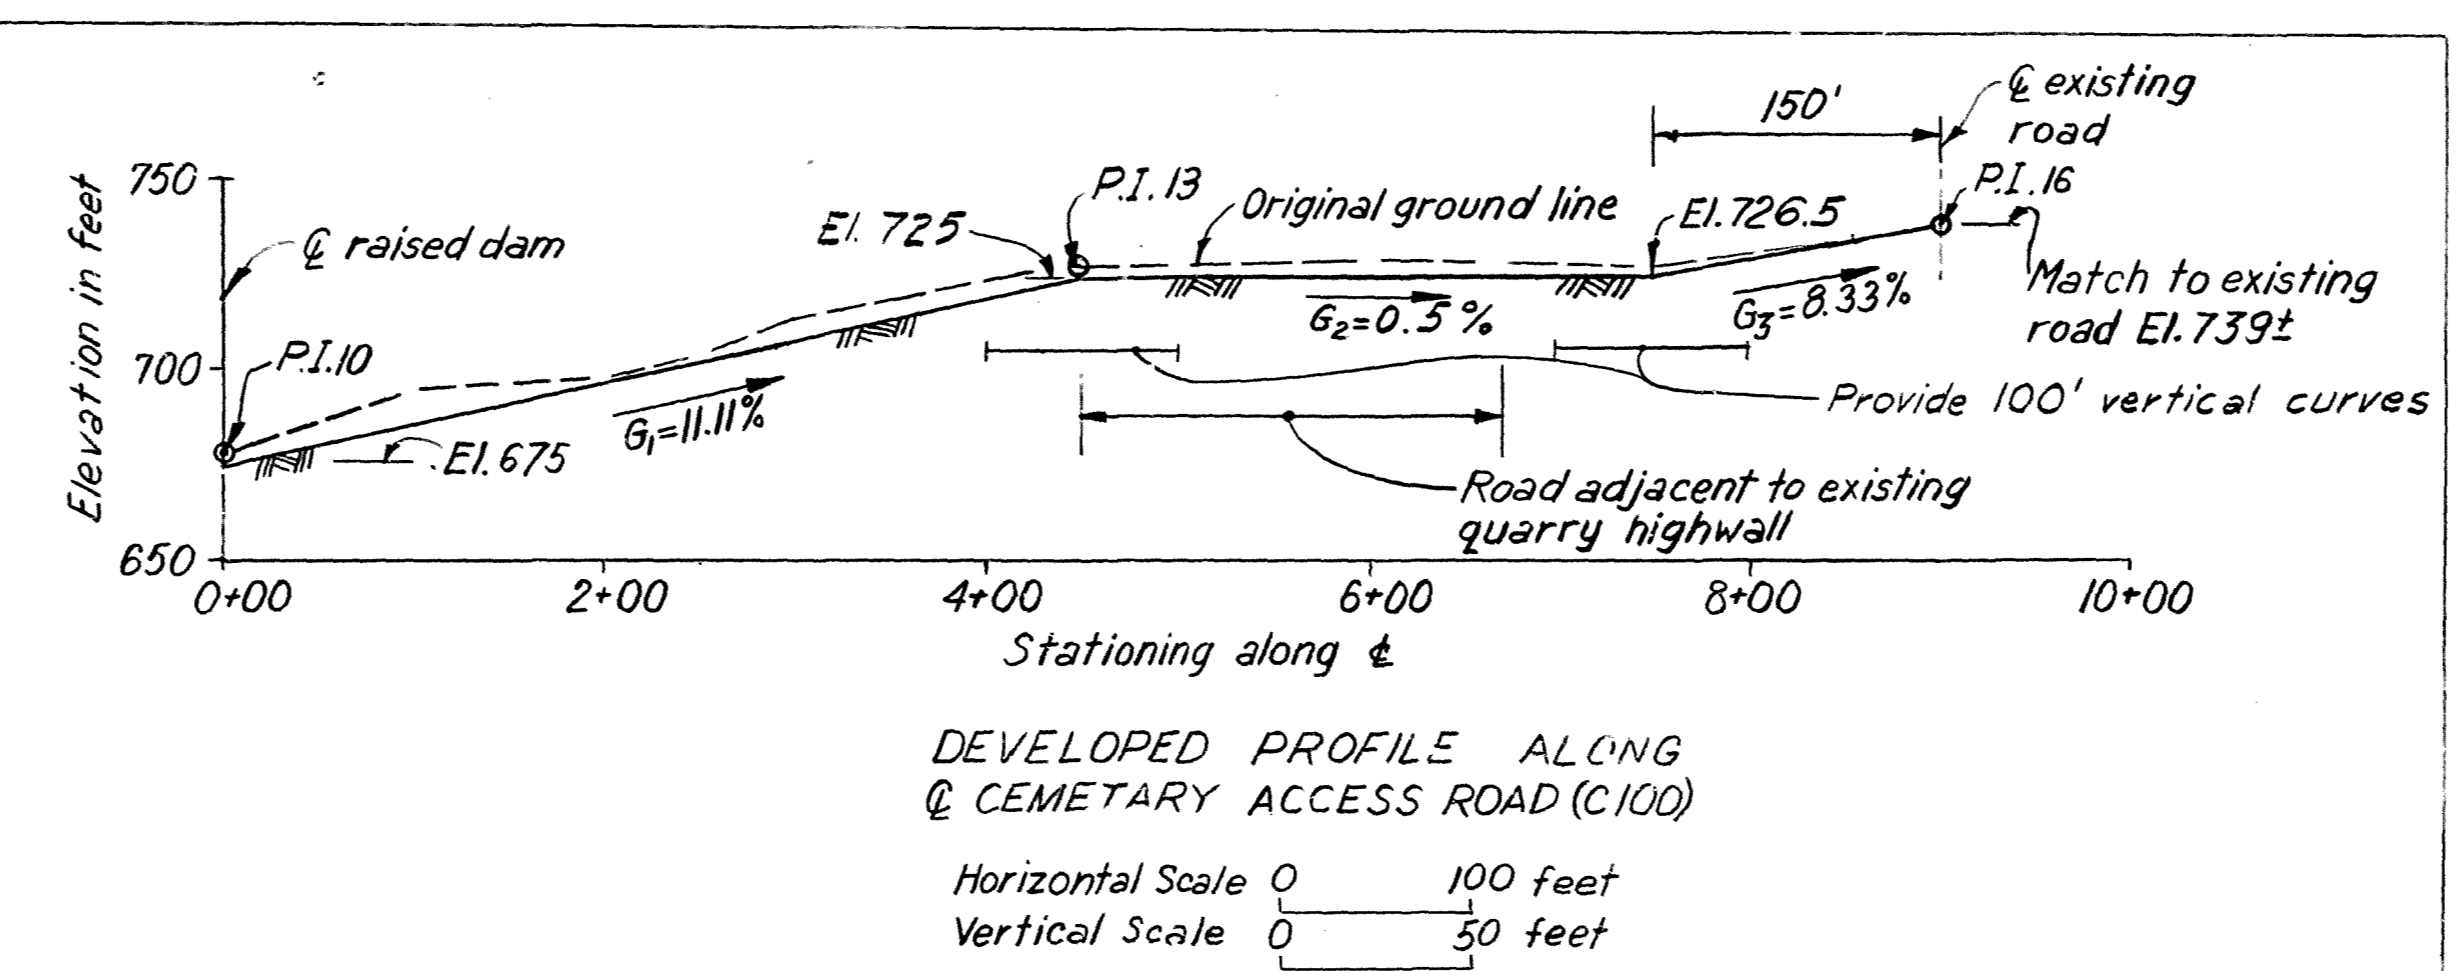
DEVELOPED PROFILE ALONG
CEMETARY ACCESS ROAD (C100)
Horizontal Scale 0 100 feet
Vertical Scale 0 50 feet

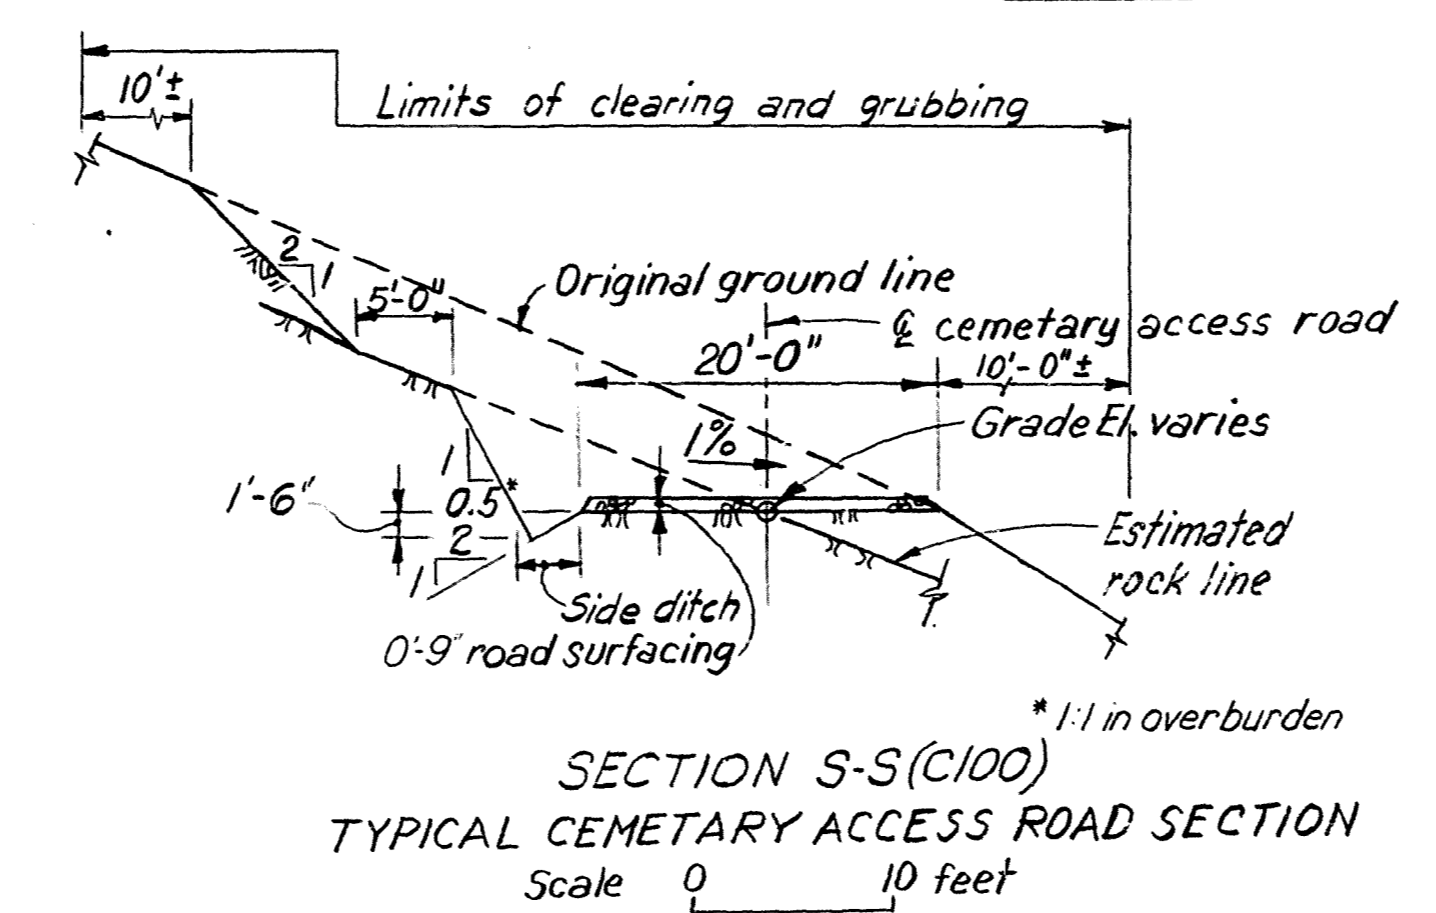
SECTION S-S (C100)
TYPICAL CEMETARY ACCESS ROAD SECTION
Scale 0 10 feet

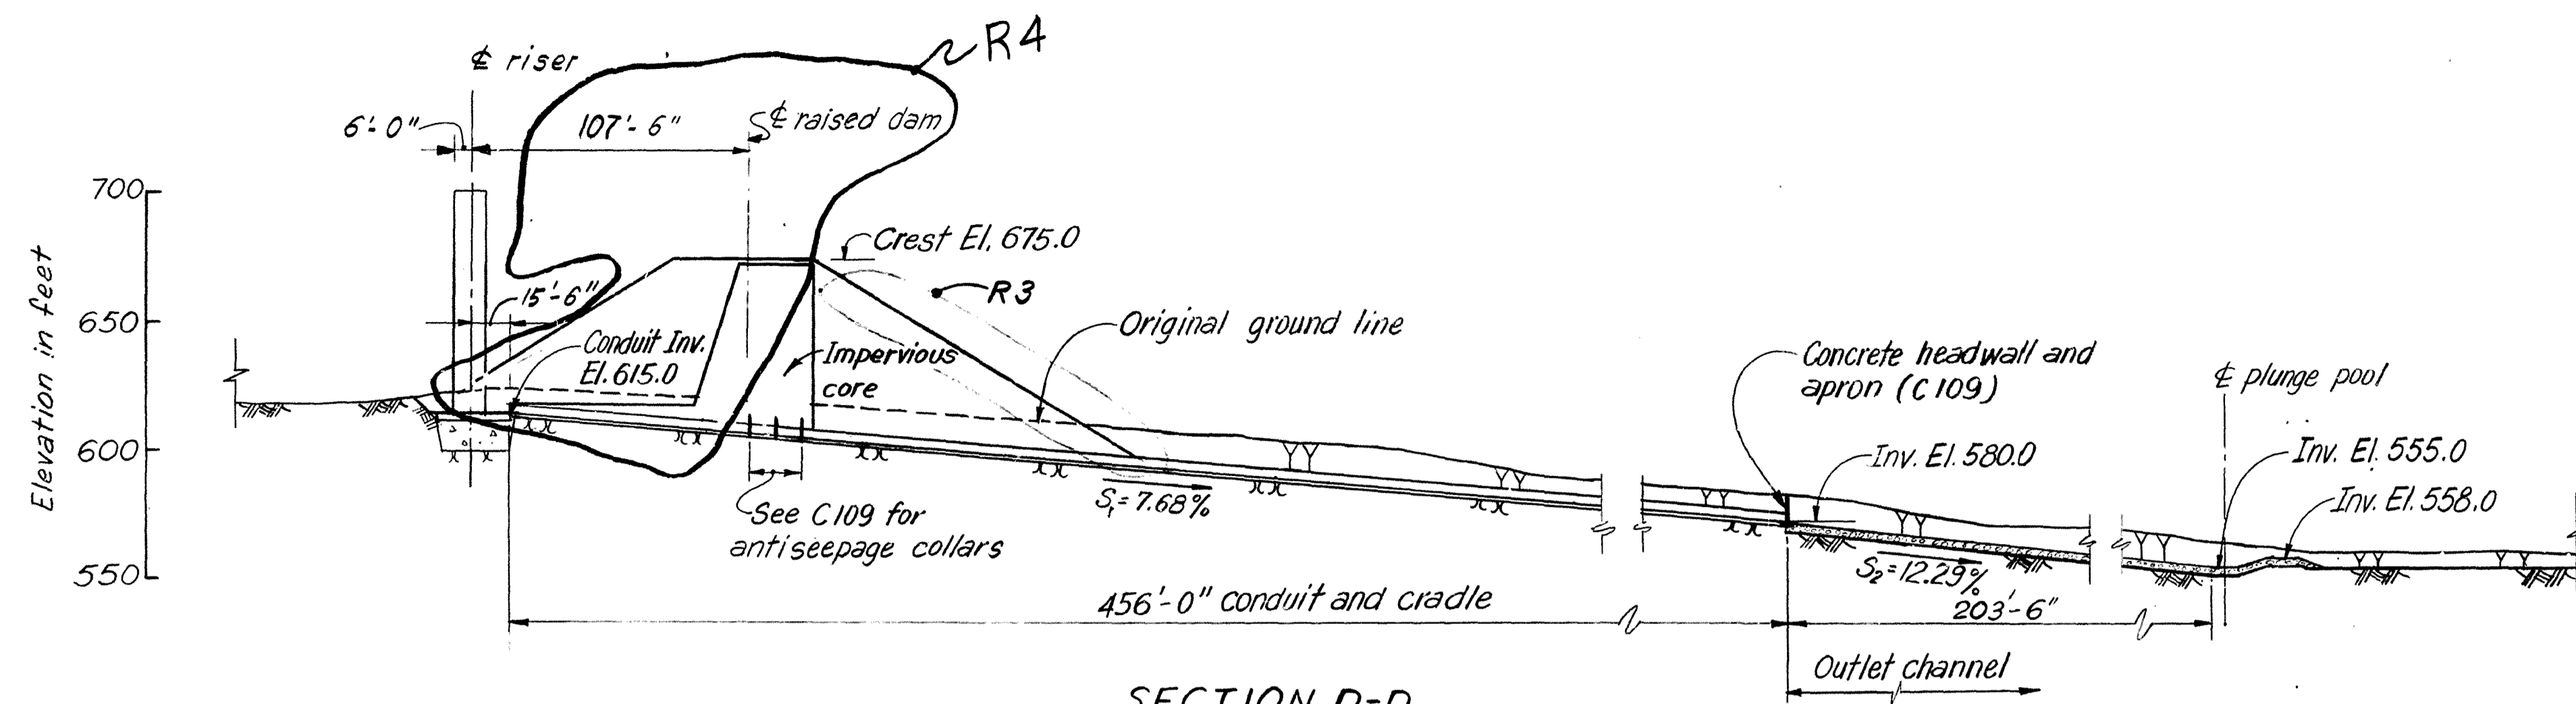
SECTION D-D
DEVELOPED PROFILE ALONG PRINCIPAL
SPILLWAY CENTERLINE
Scale 0 50 Feet

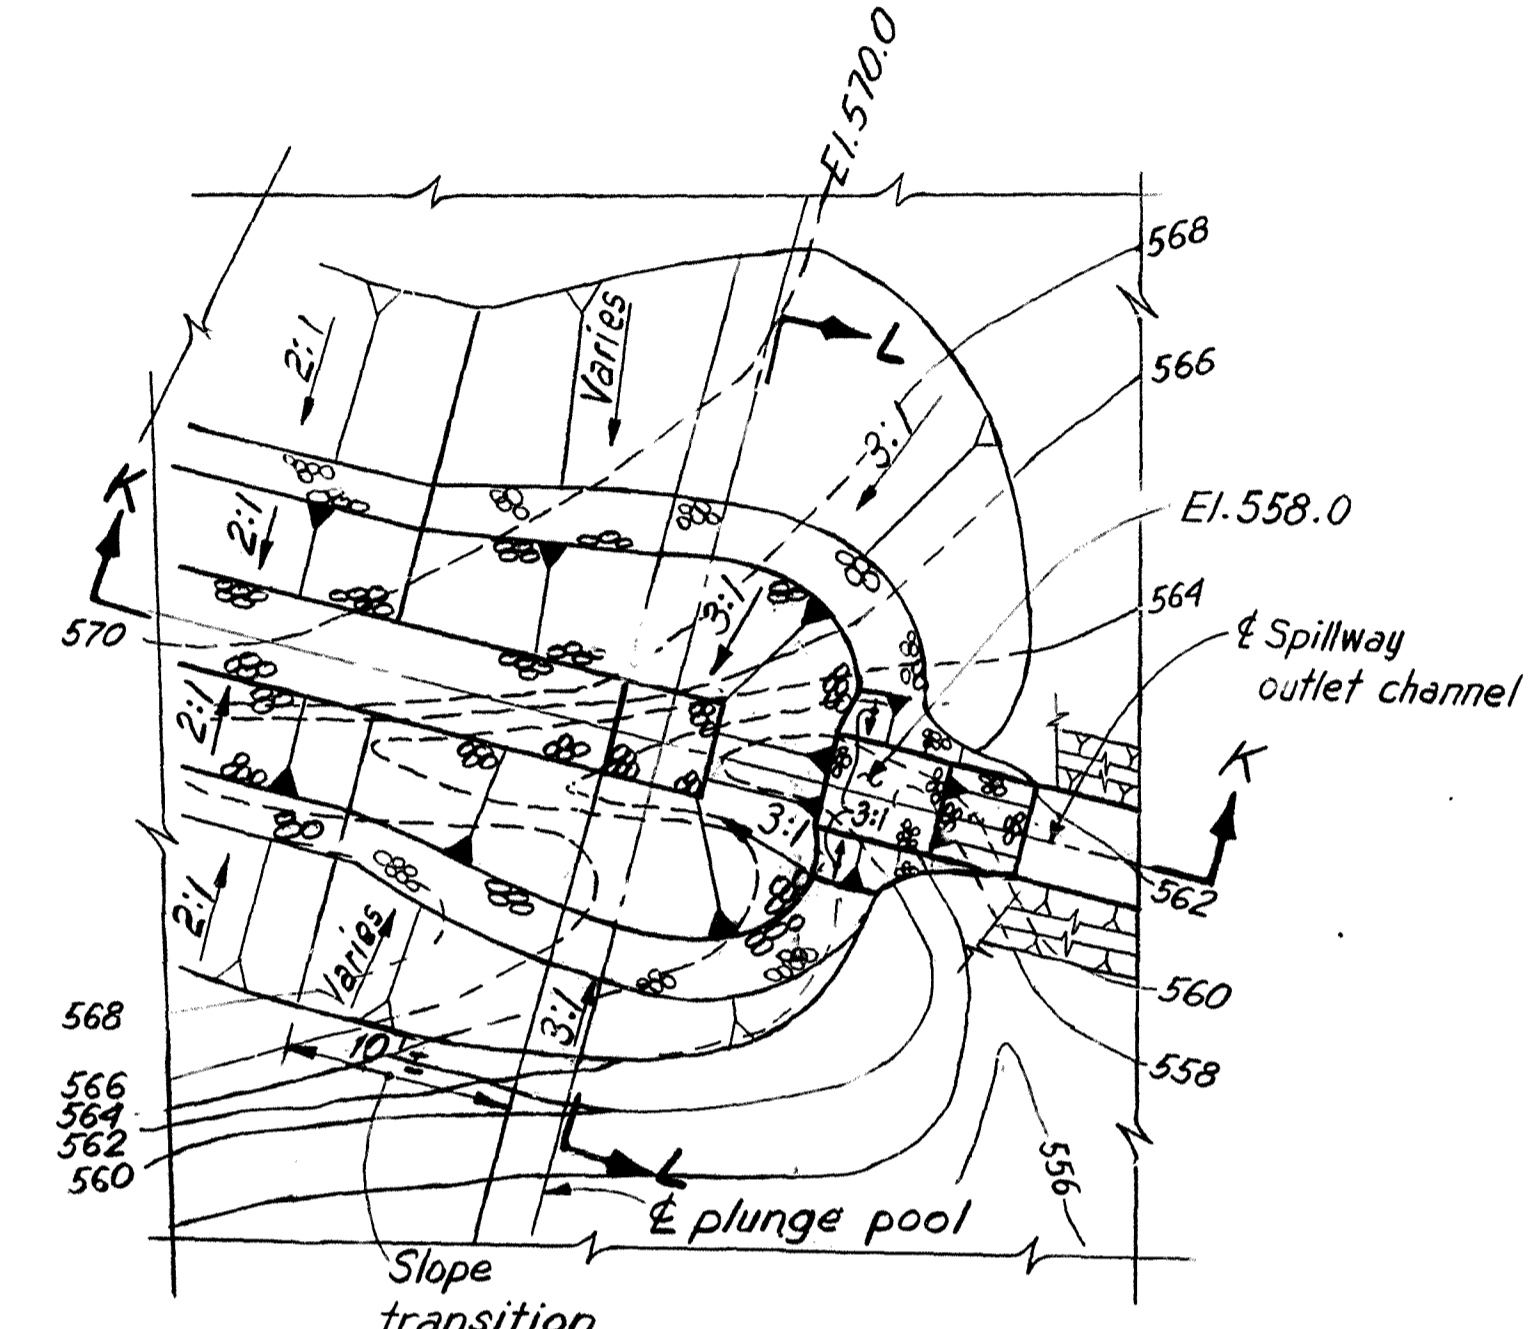
DETAIL A
(984 C 101)
PLAN - PLUNGE POOL
Scale 0 20 Feet

- NOTES:
1. Work this drawing with C101.
 2. All riprap for the service spillway outlet channel and plunge pool is Riprap - Type I.
 3. Topsoil and seeding to be at the direction of Owners Engineer.

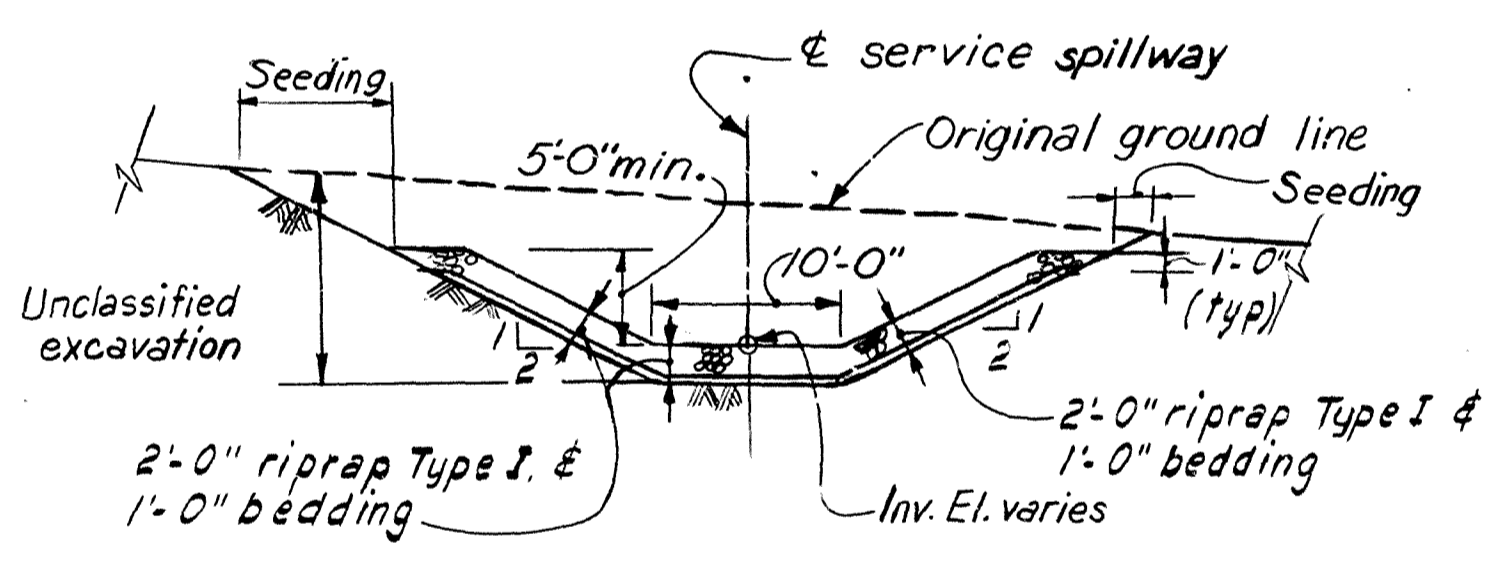
SECTION H-H
(984 C 101)
TYPICAL OUTLET CHANNEL SECTION
Scale 0 10 Feet

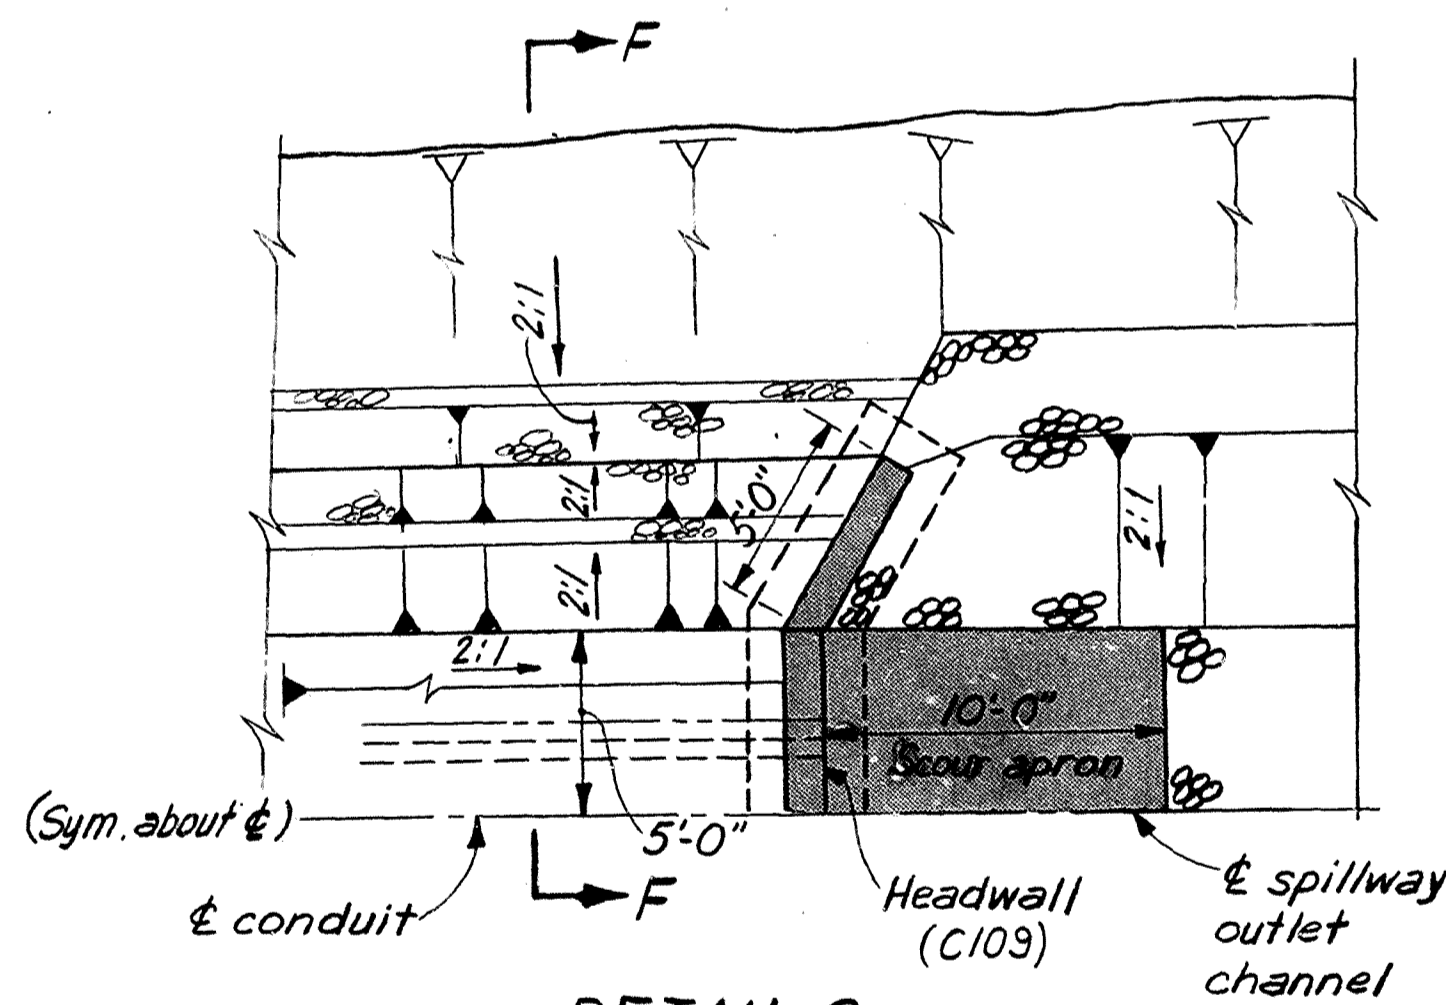
DETAIL C
(984 C 101)
CONDUIT OUTLET DETAIL
N.T.S.

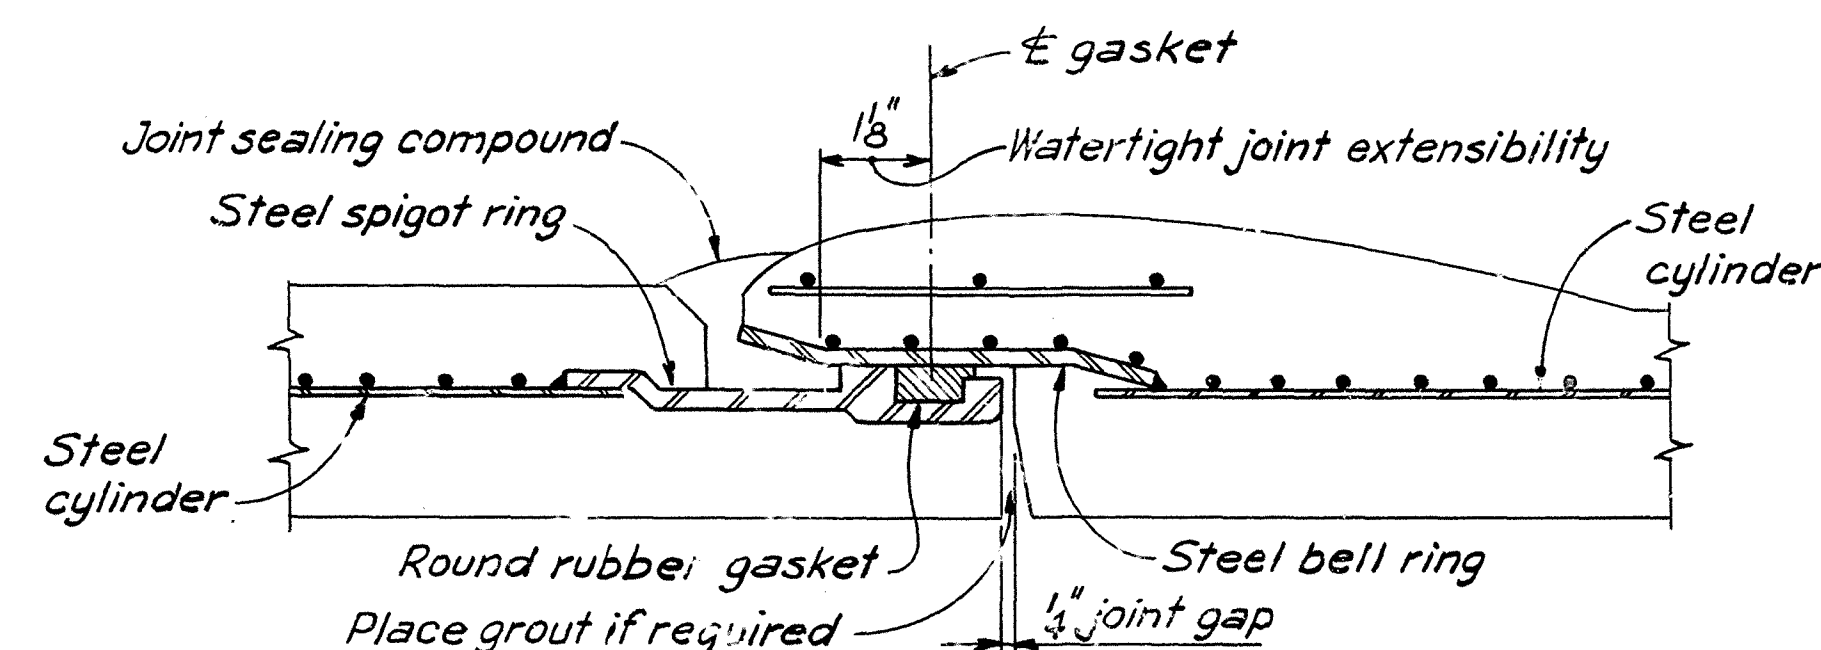
DETAIL B
N.T.S.

The pipe shall be drawn together so that maximum joint gap does not exceed 1/4 inch for pipe laid on a straight line.

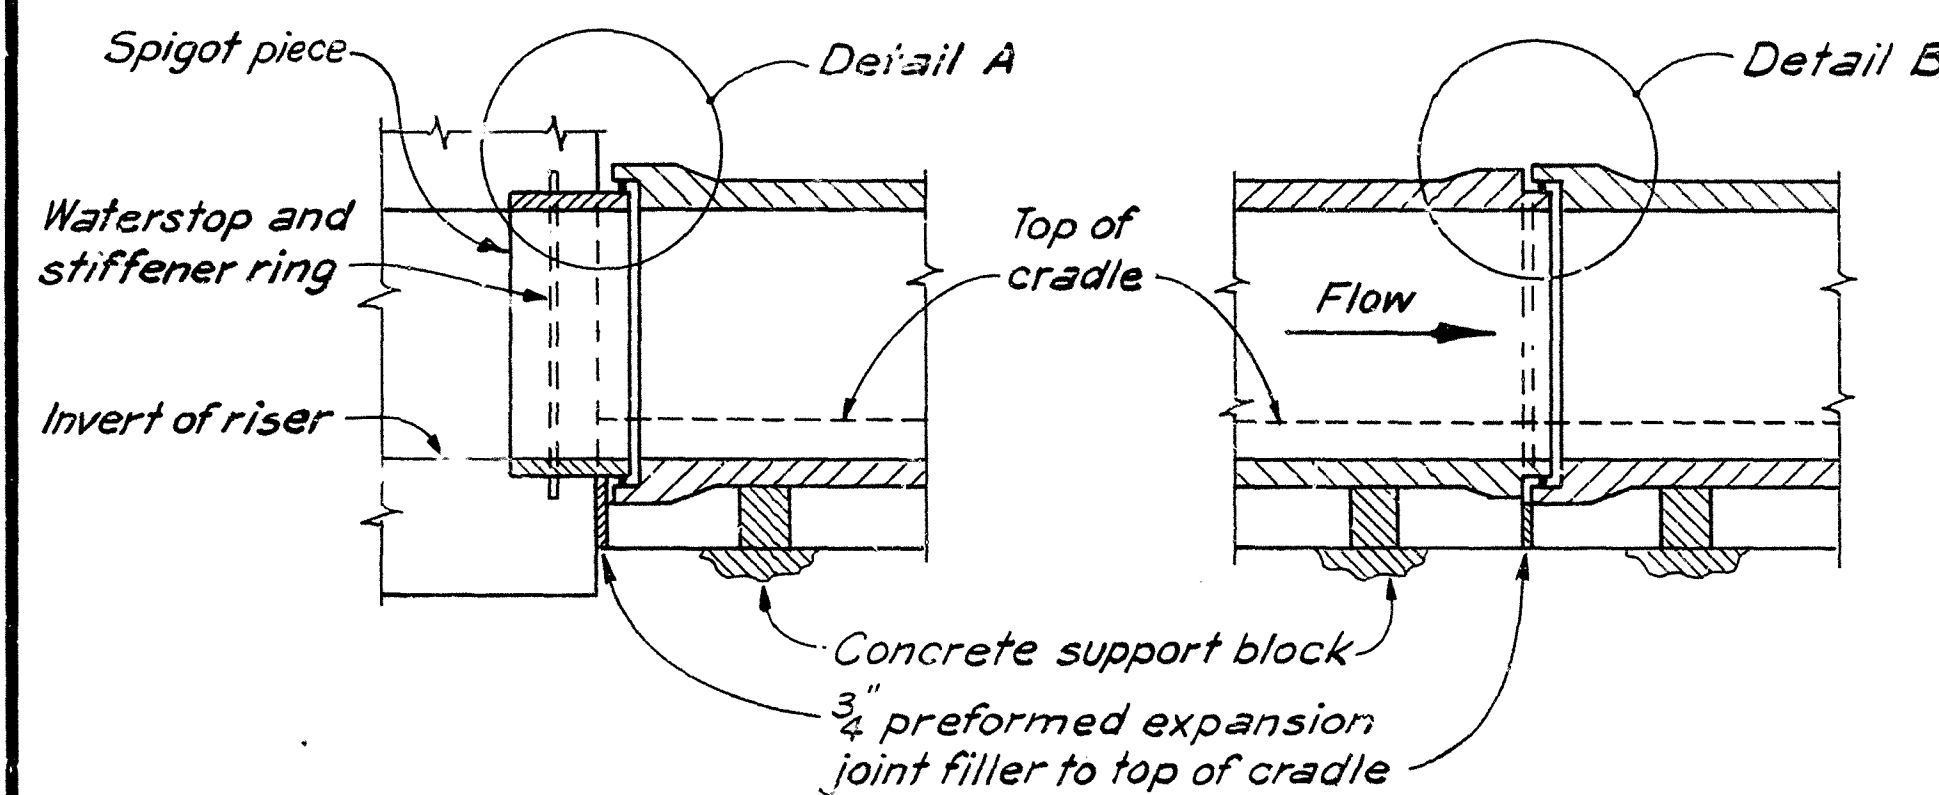
DETAIL OF SPIGOT WALL FITTING
N.T.S.

DETAIL OF PIPE JOINT
N.T.S.

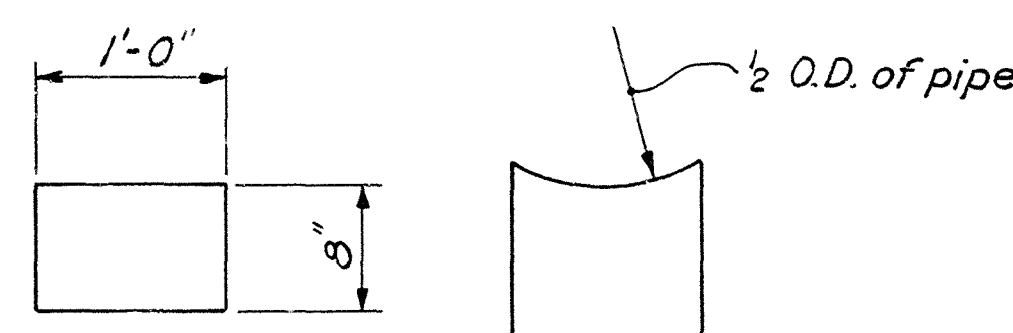
SUGGESTED SUPPORT BLOCKS
N.T.S.

Sufficient blocks shall be provided to support the pipe to the required line and grade. The contractor shall determine the number and size of blocks required. Wedges may be used as an alternate.

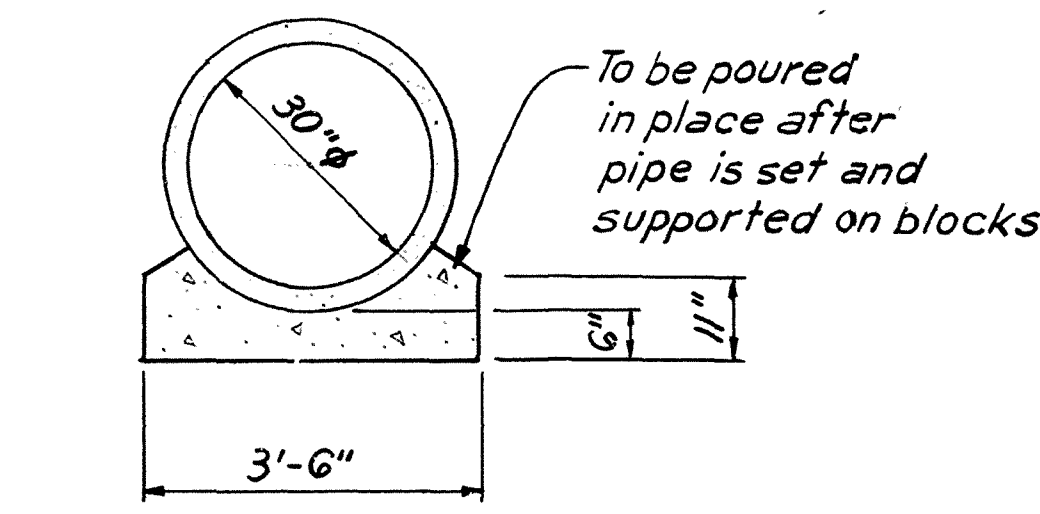
PIPE CRADLE DETAIL
1/2" = 1'-0"
(lean concrete)

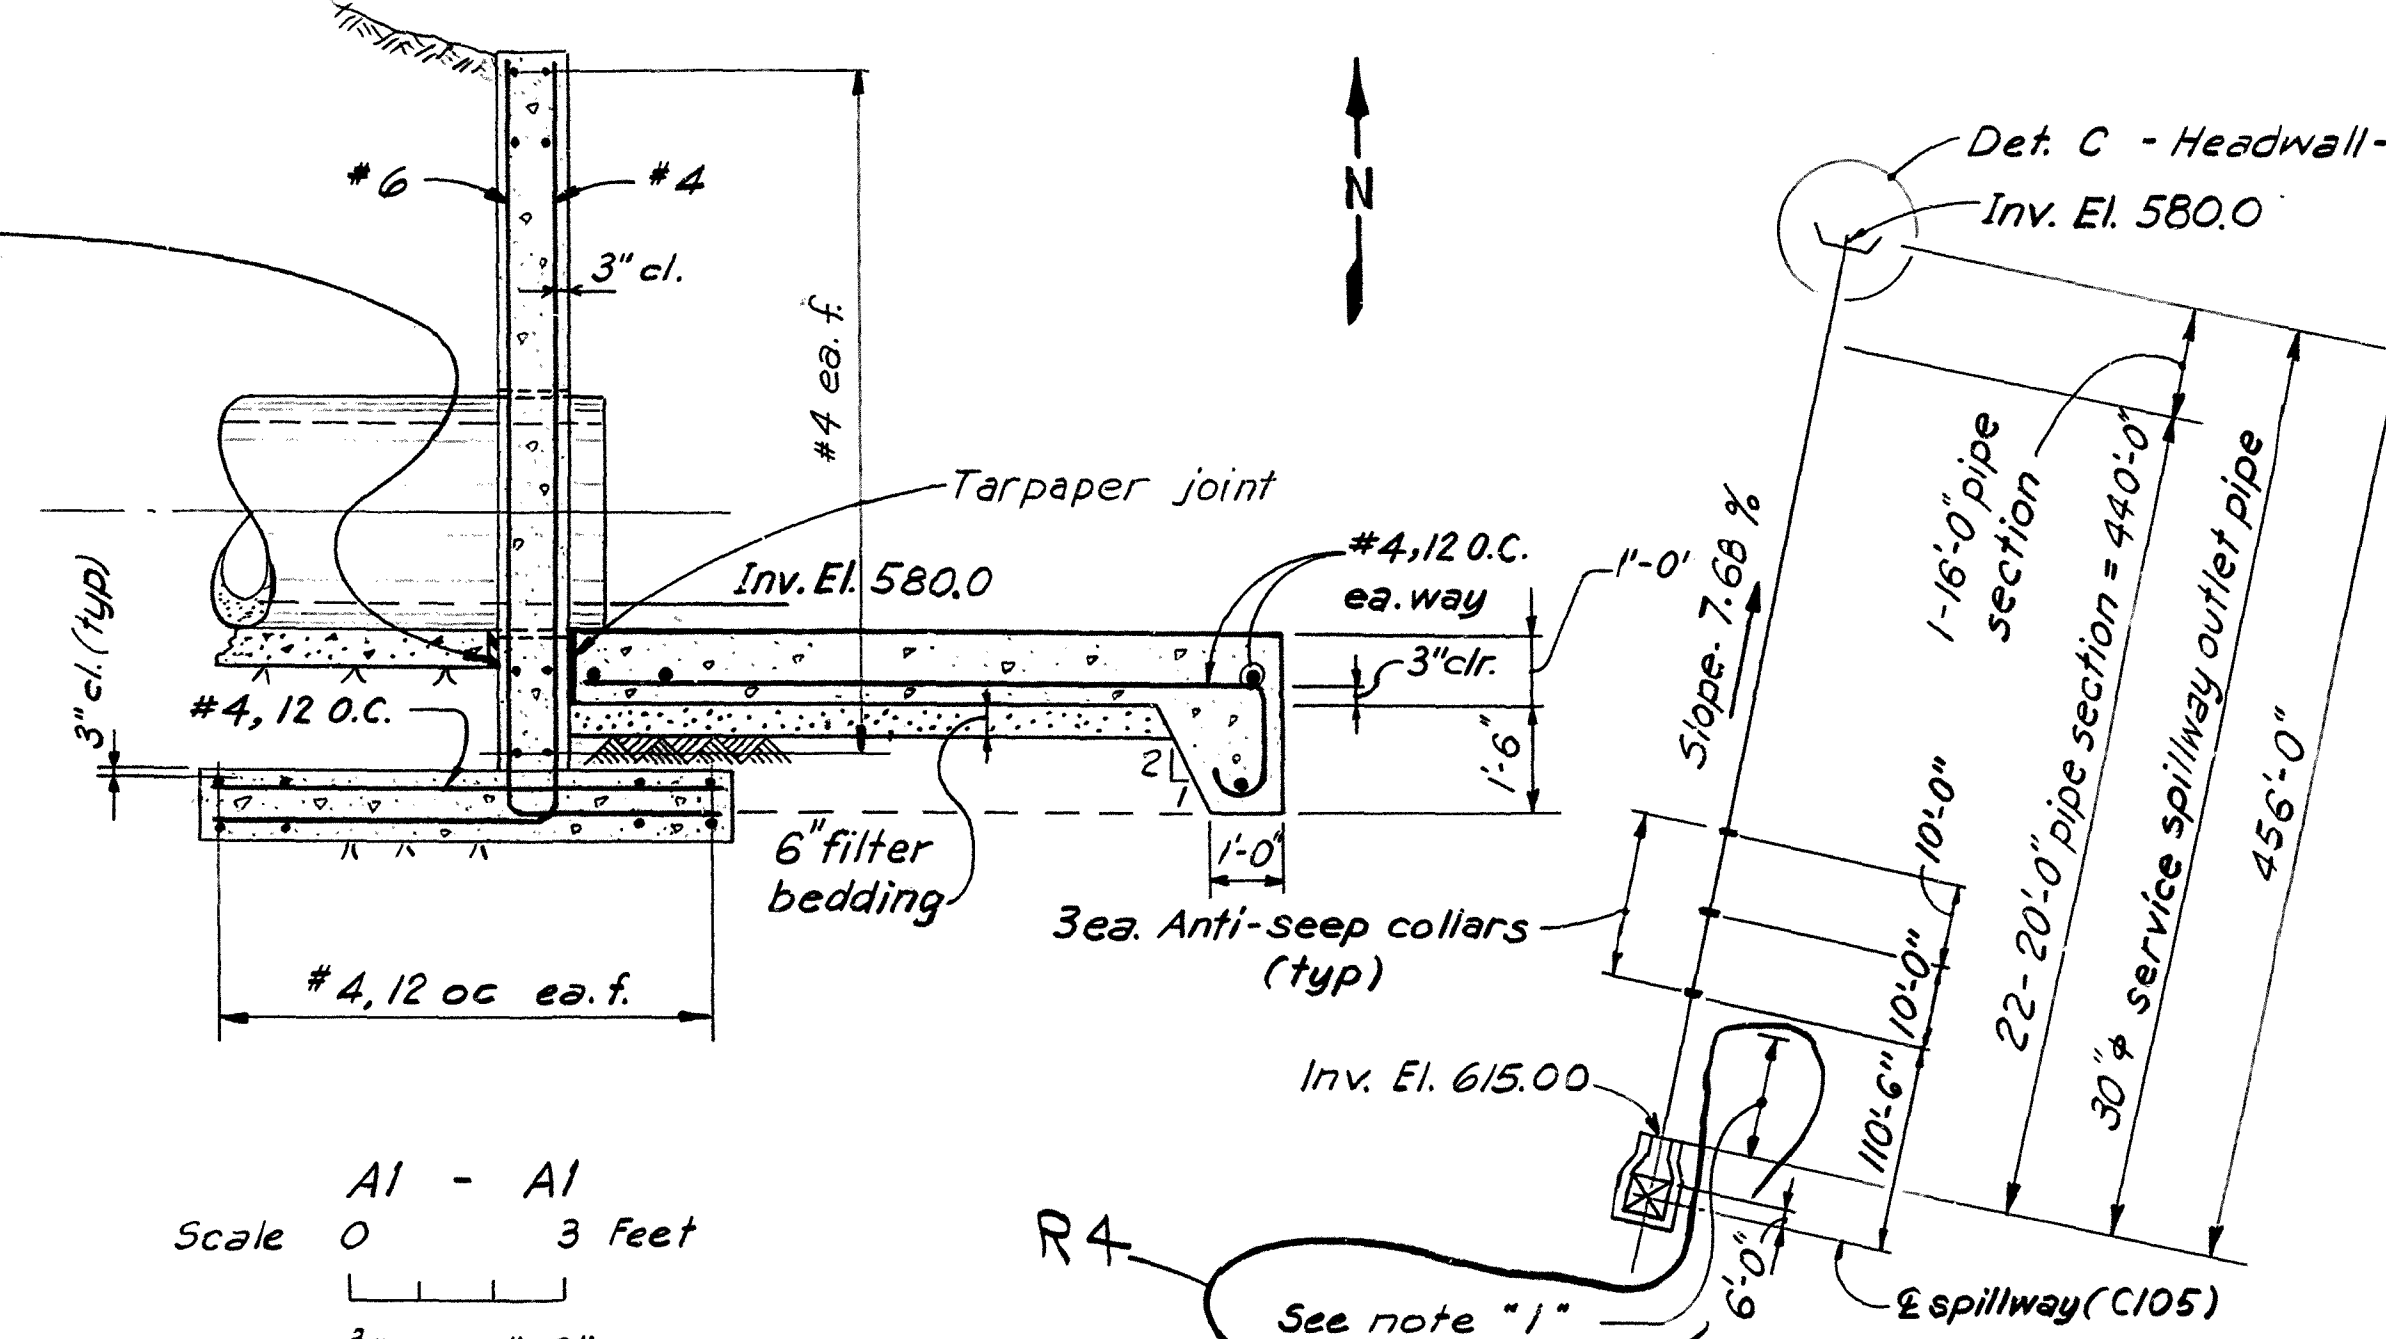
CONDUIT INSTALLATION LAYOUT

Minimum Joint Limiting Angle should be used as recommended by Pipe Manufacturer.

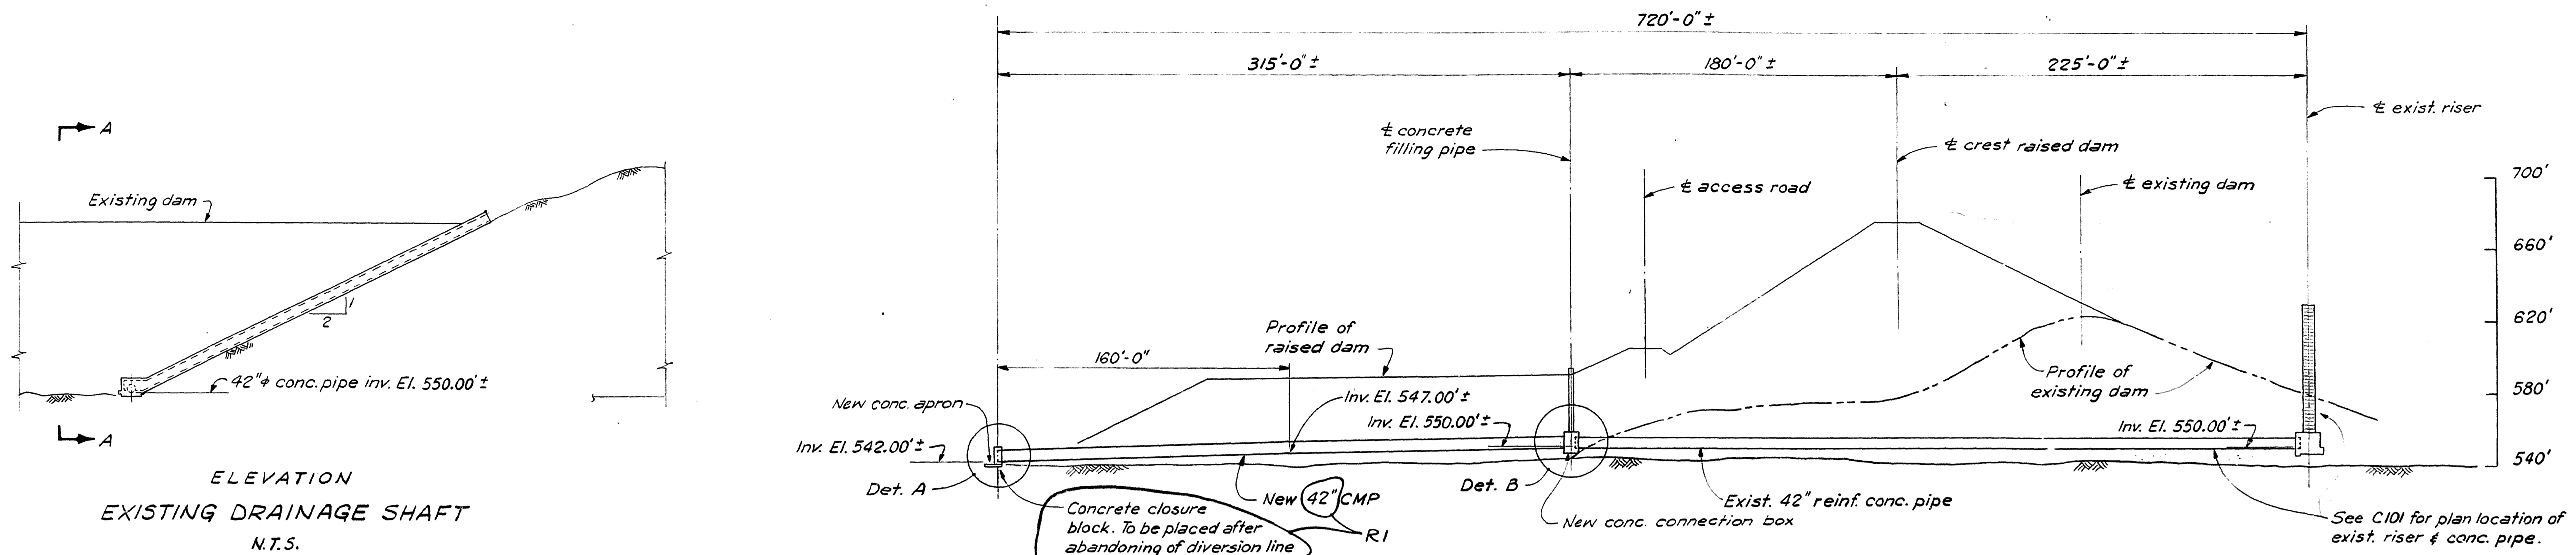
ELEVATION
EXISTING DRAINAGE SHAFT
N.T.S.

A - A
NOTE: After abandoning of diversion line, pipes shall be filled with concrete mixture as designed and directed by AEP
