HISTORY OF CONSTRUCTION

CFR 257.73(c)(1)

Fly Ash Pond

Big Sandy Plant
Louisa, Kentucky

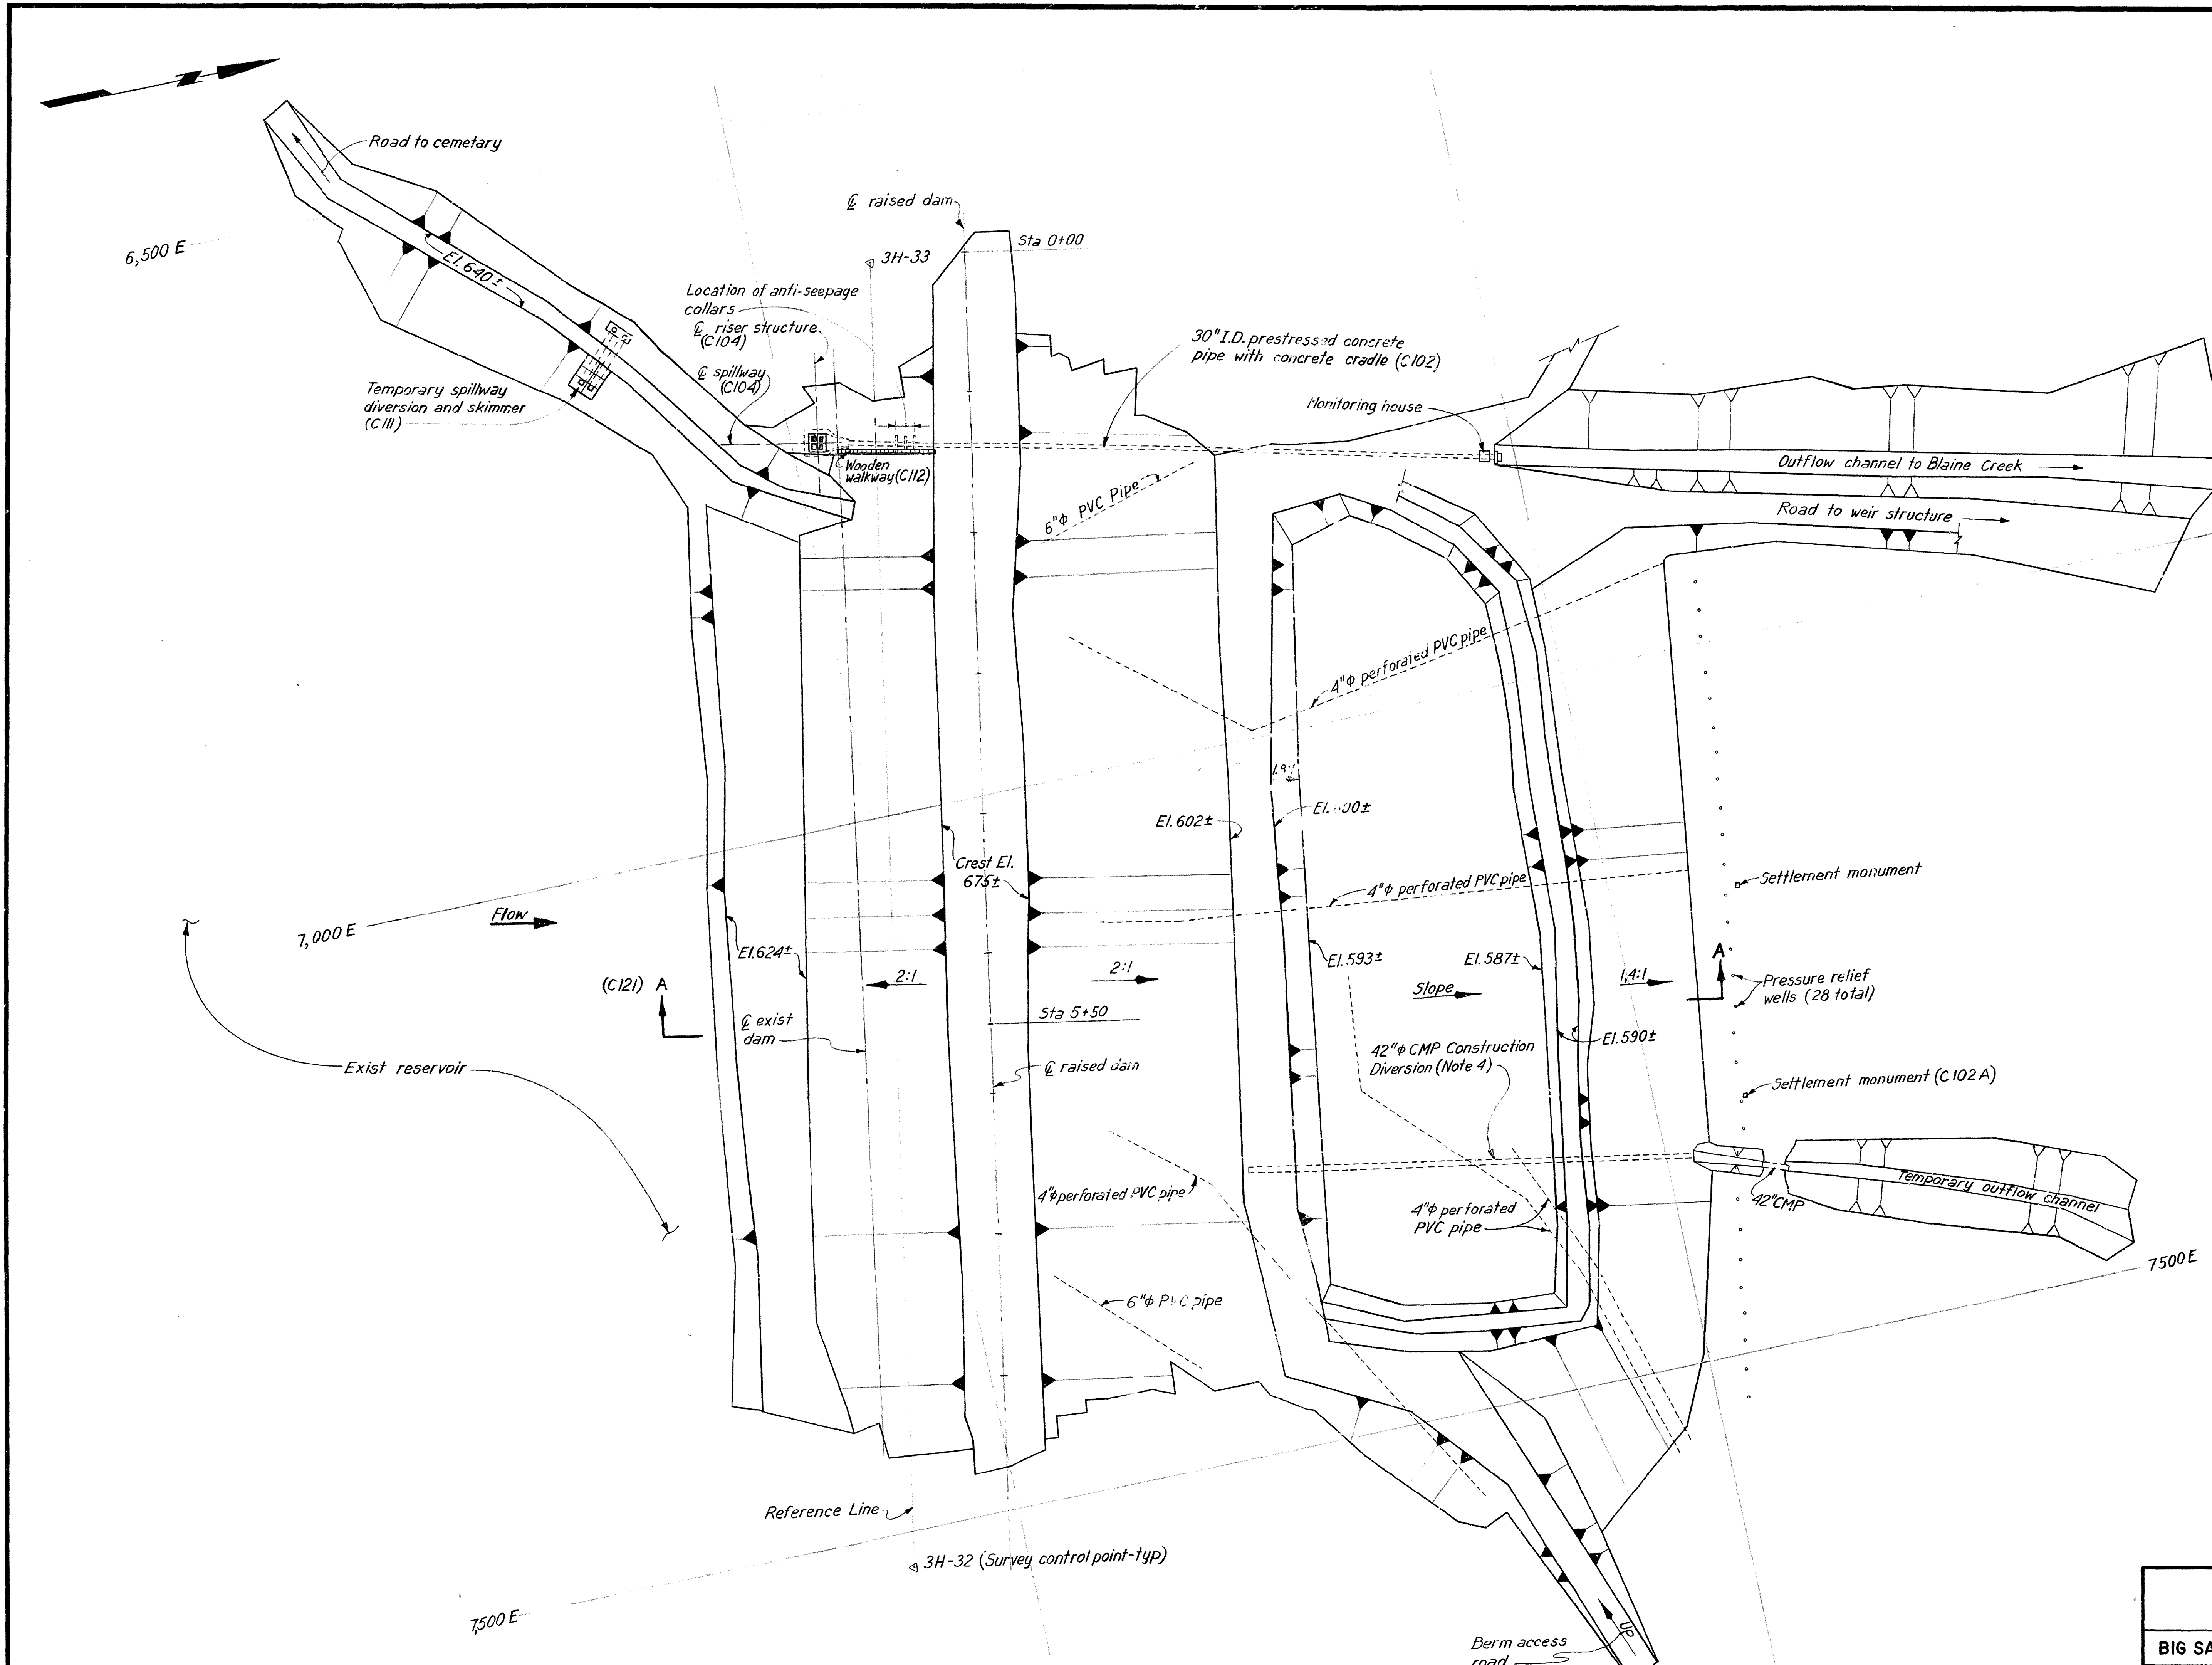
KENTUCKY POWER COMPANY BIG SANDY PLANT BIG SANDY, KENTUCKY	
BIG SANDY FLYASH DAM	DAM RAISING
DRAWING OF RECORD: DAM	
AMERICAN ELECTRIC POWER SERVICE CORP.	
APPROVED _____	
CHICAGO, ILLINOIS	DATE FEB. 1979 DWG. NO. 984 C 120

- NOTES:**
1. Work this drawing with C100, 101, 102, 102A, 102B, 104, 110 and 111, and C121
 2. Plan view reproduced from Kentucky Power Co. drawing by J.P. Diaz, dated 12/12/78
 3. Plan outline and other information shown obtained from field records and survey information supplied Kentucky Power Co.
 4. Construction diversion pipe filled with concrete and abandoned from service

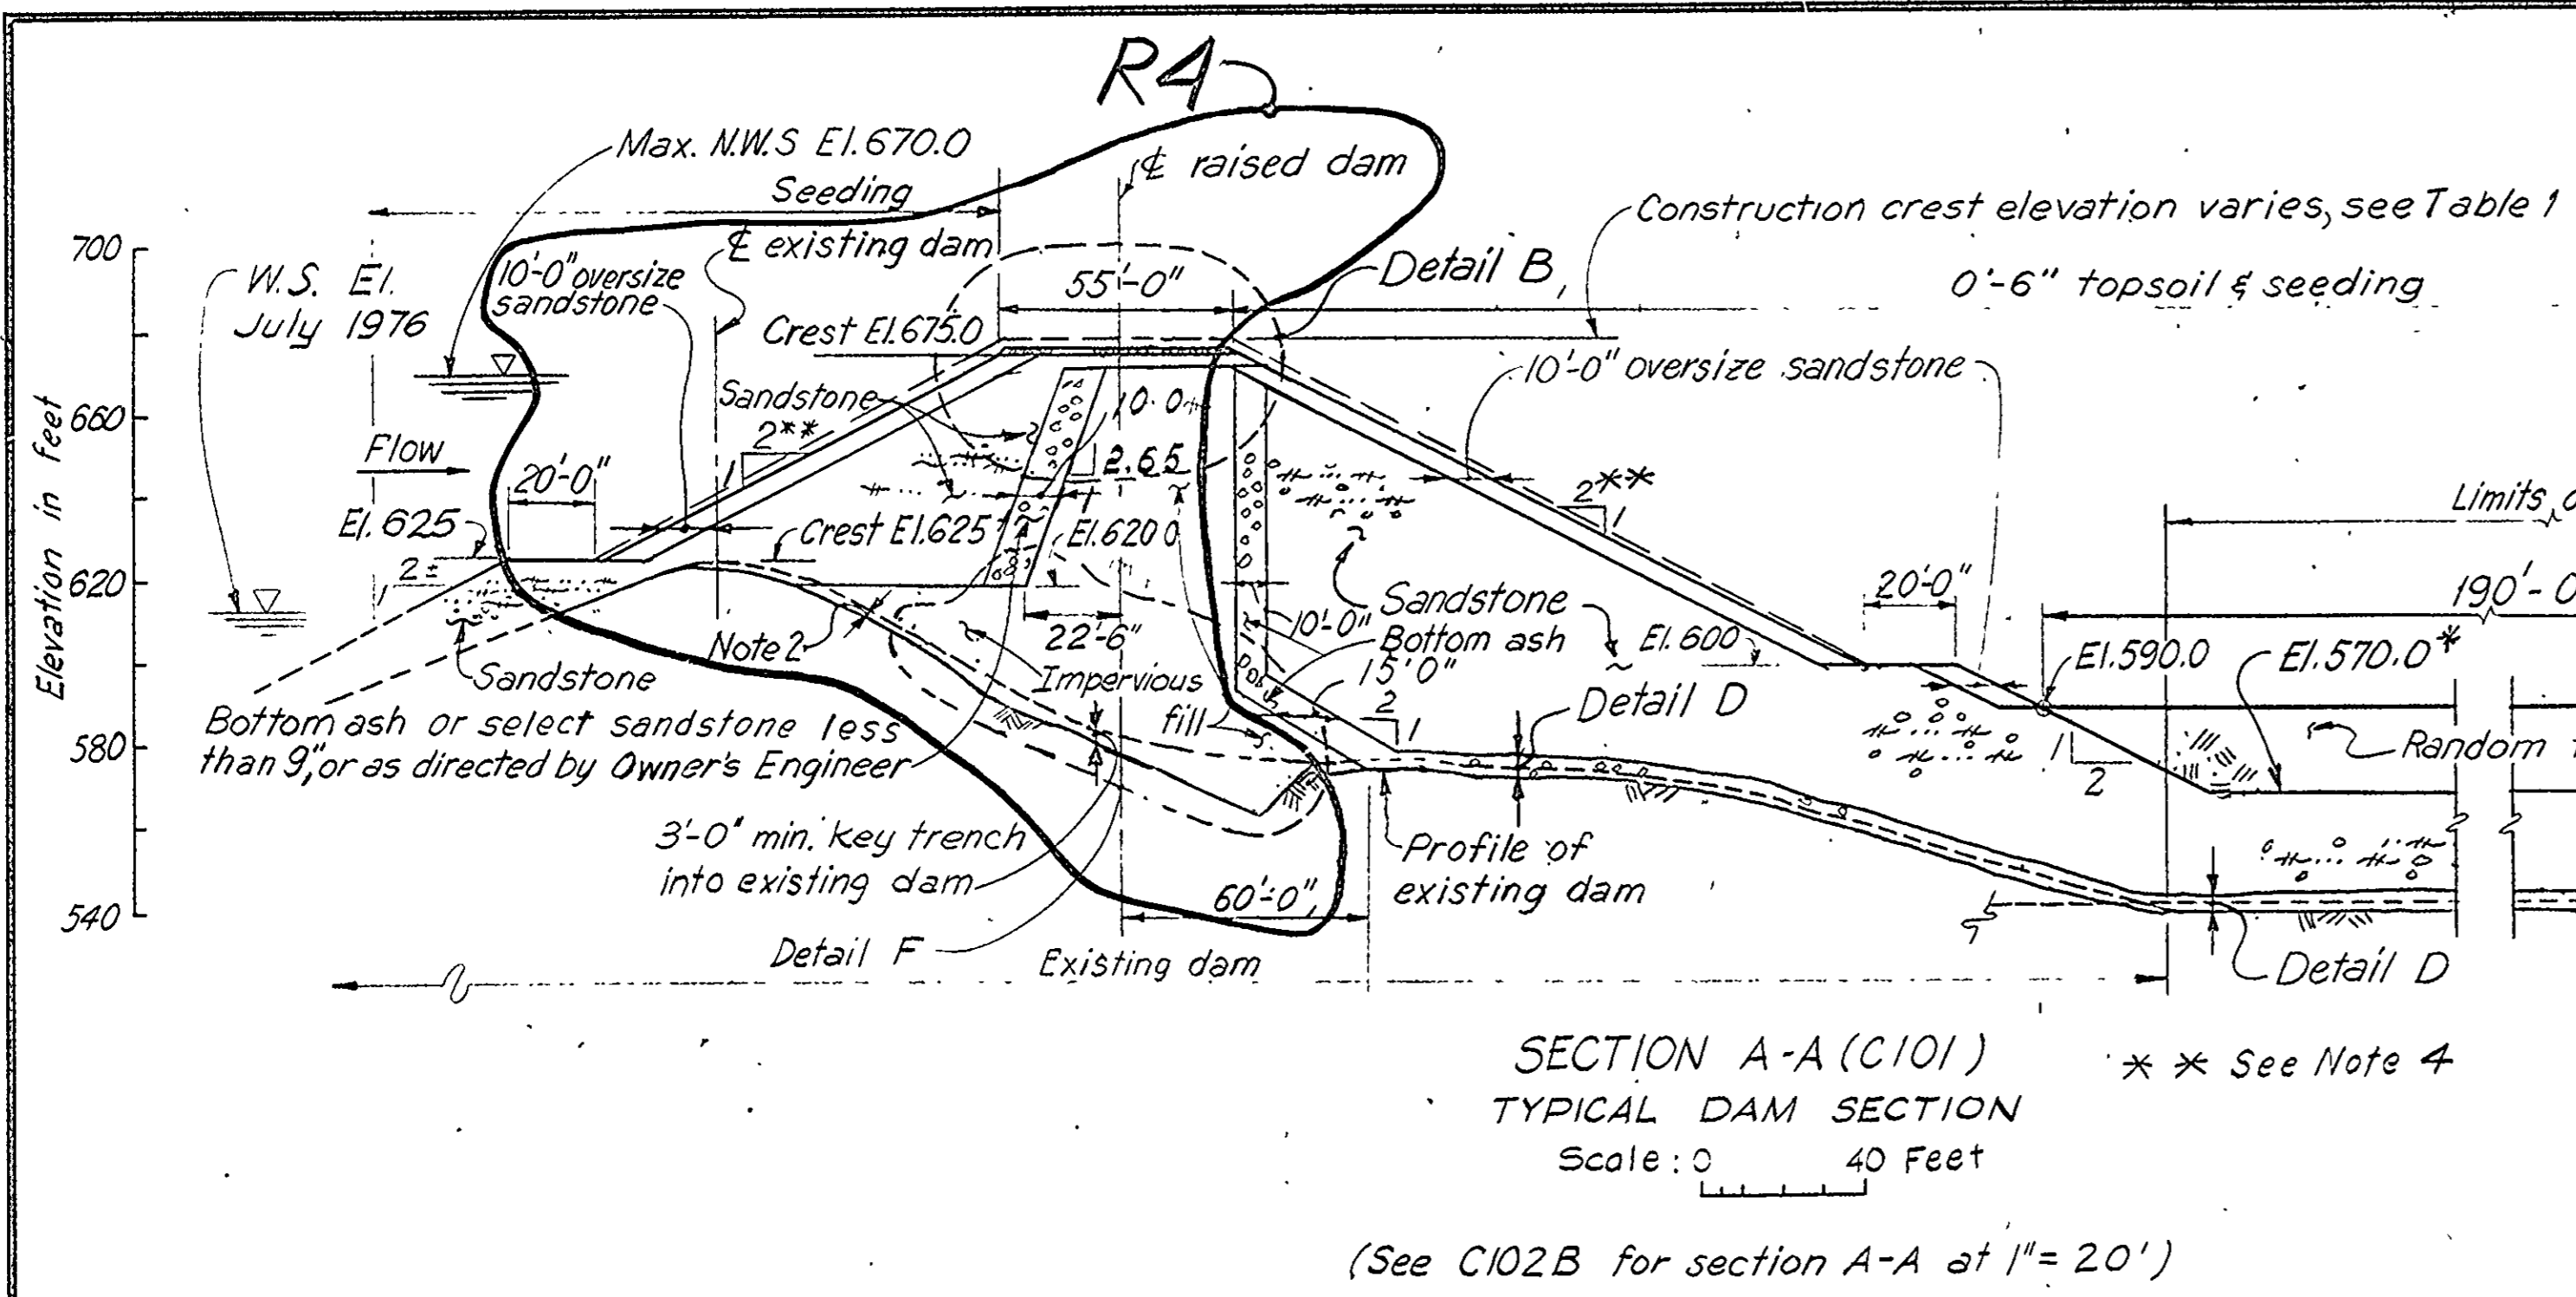
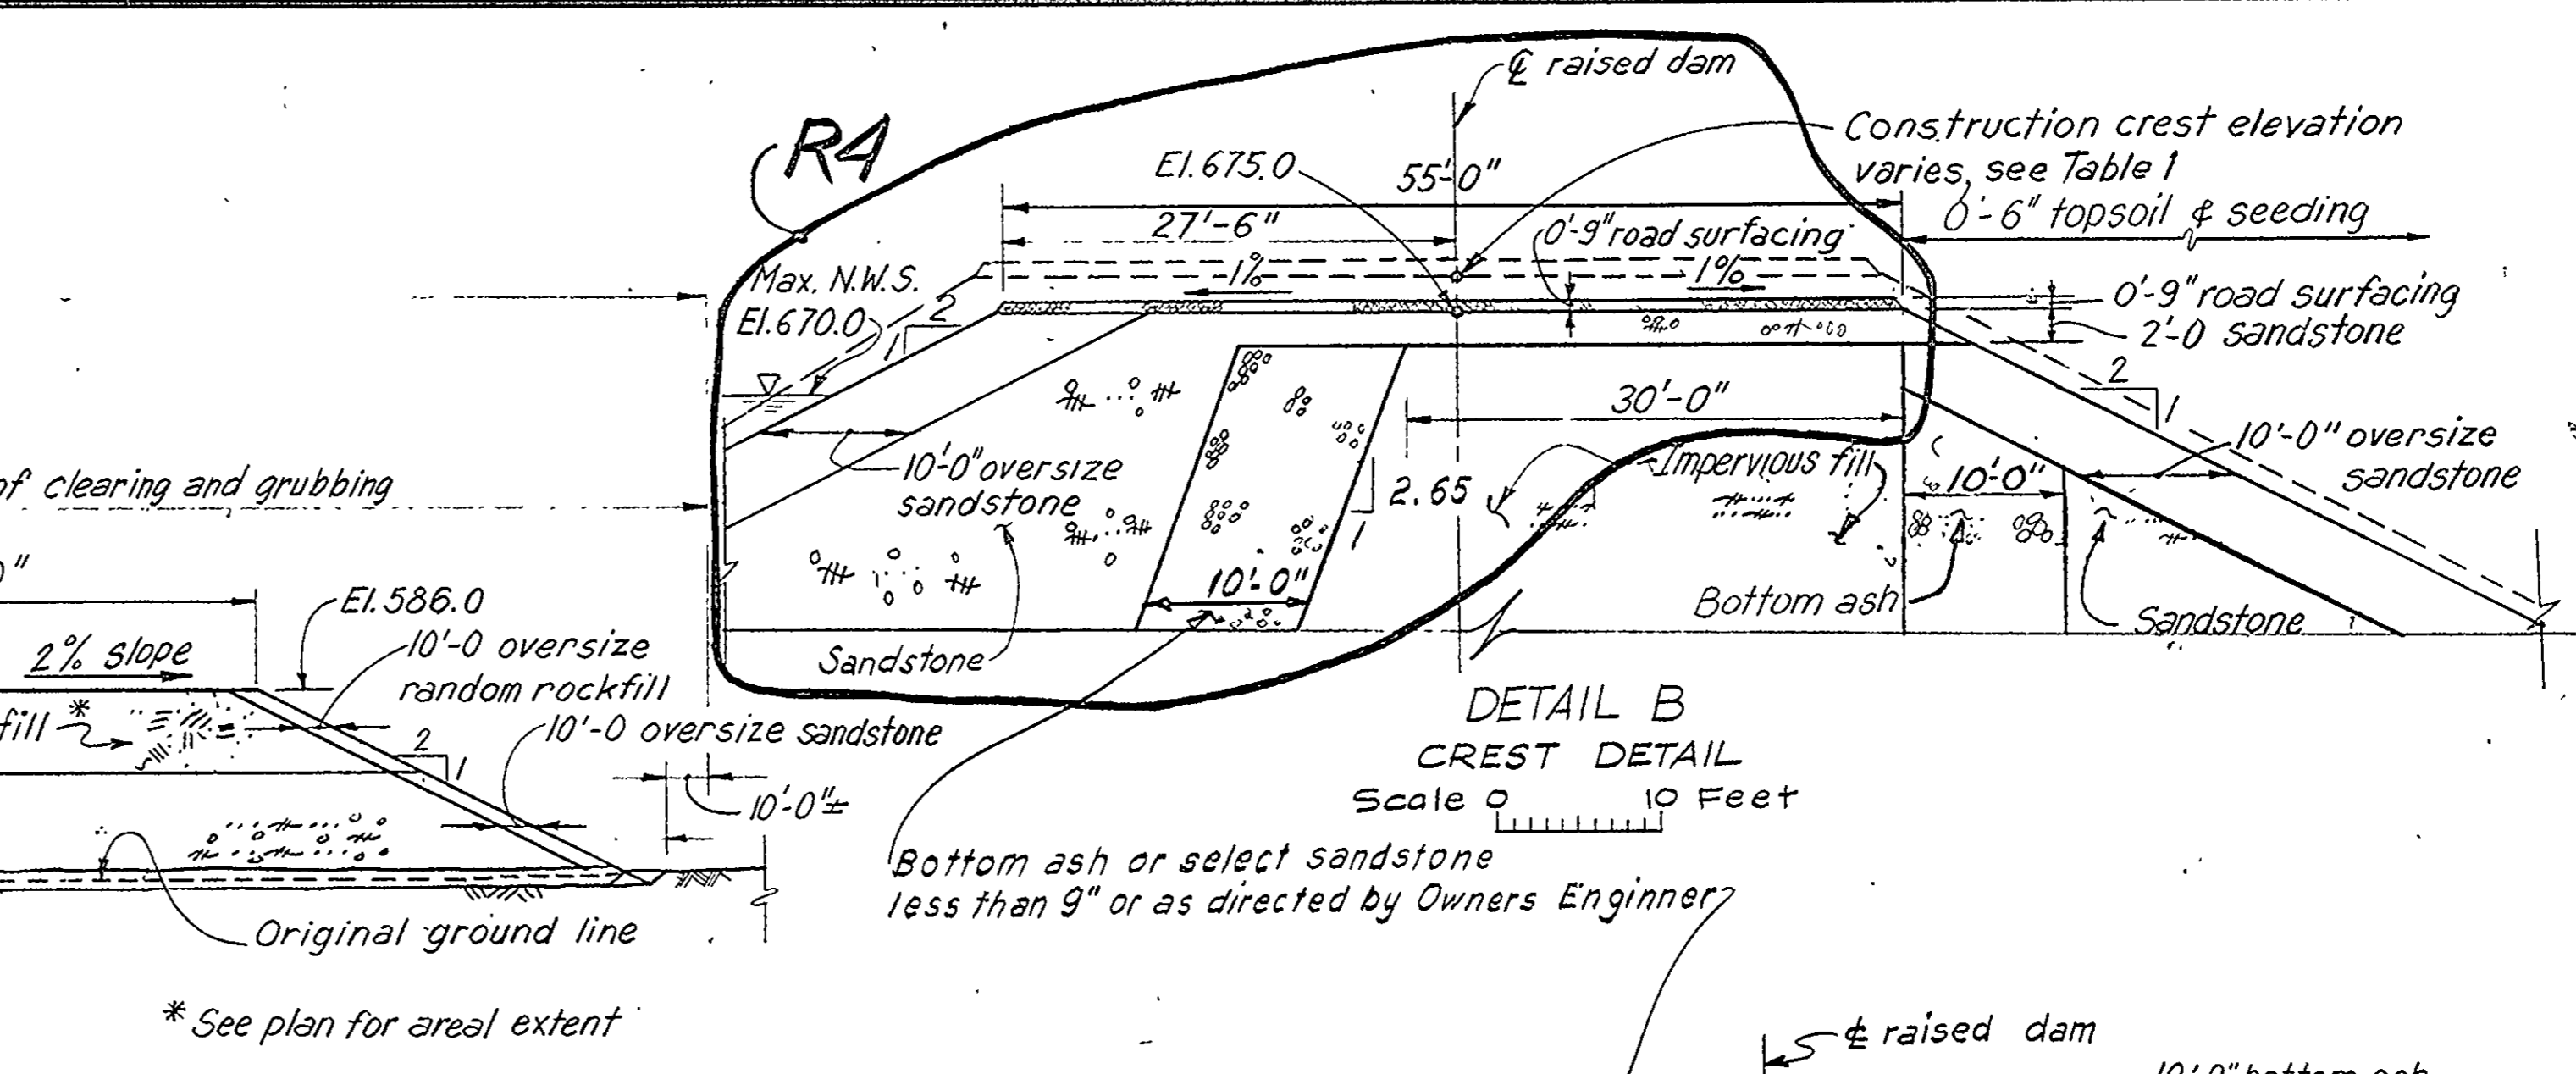
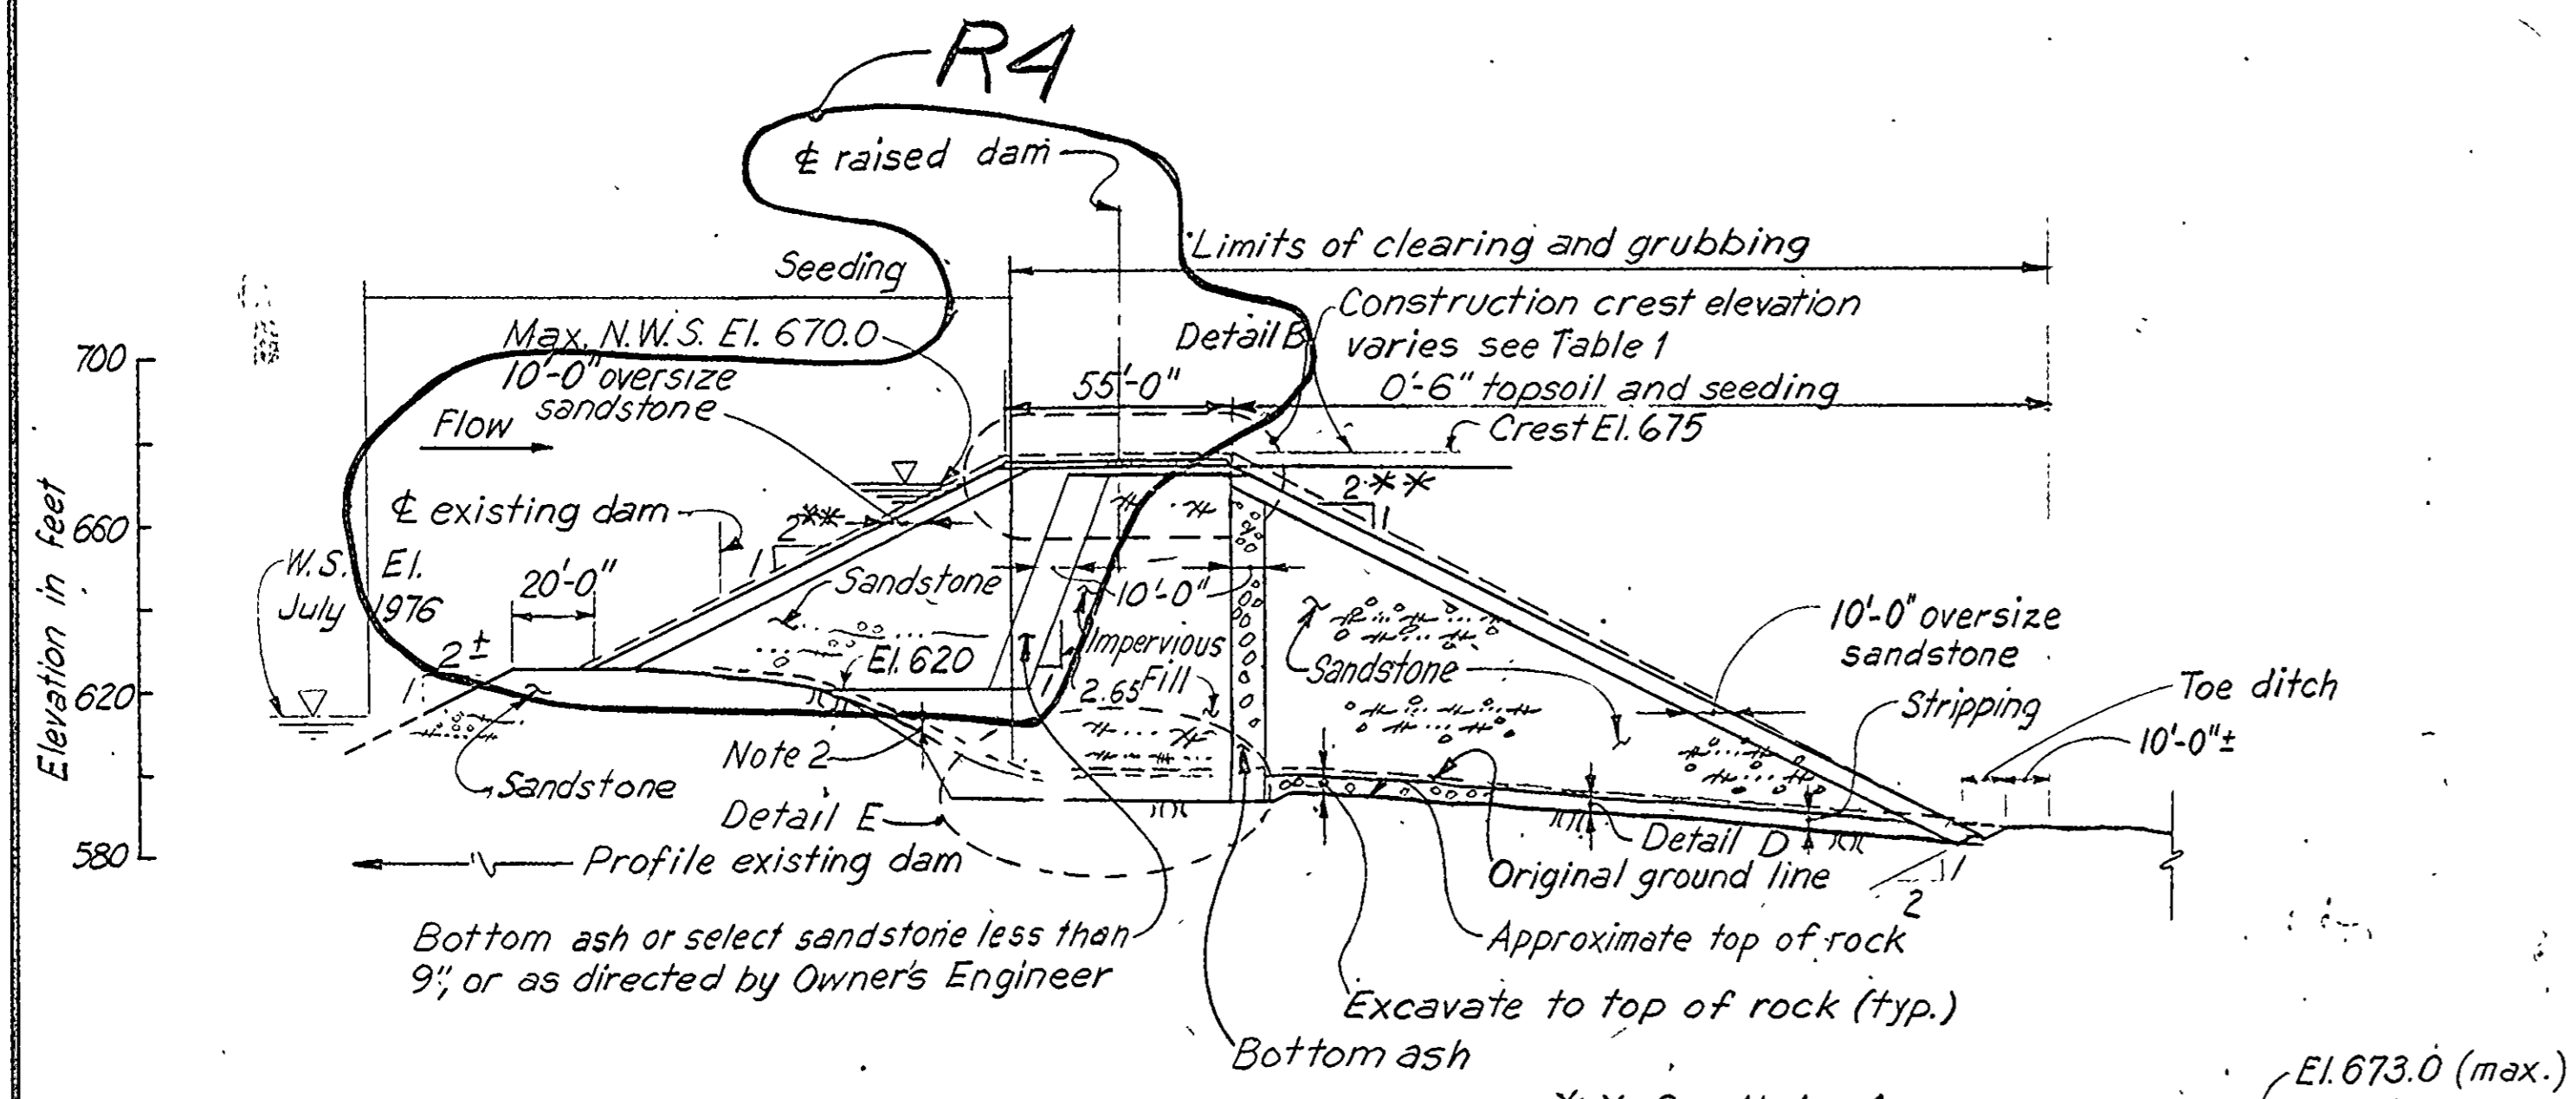
TABLE 1
CONSTRUCTION CREST ELEVATIONS

Station	Elevation
0+40	675.0
3+00	677.0
6+50	677.0
8+60	675.0

* Vary crest elevation linearly between stations

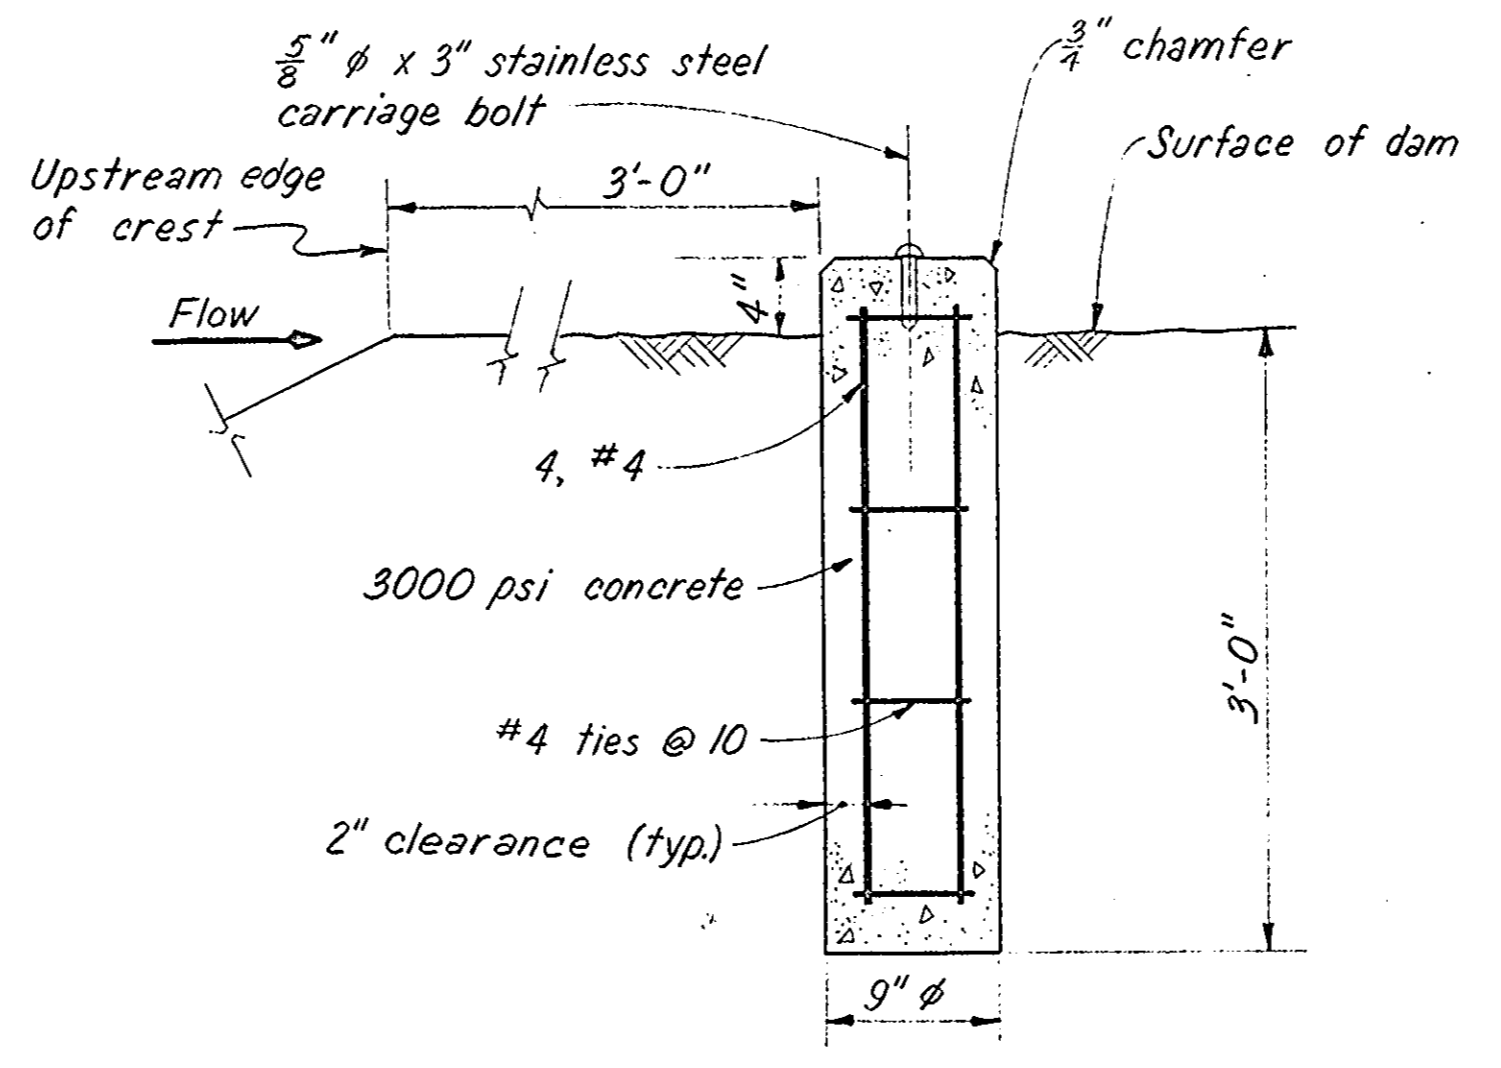
SURFACE SETTLEMENT MONUMENT (19 REQ'D)
(SEE C 100)
N.T.S.

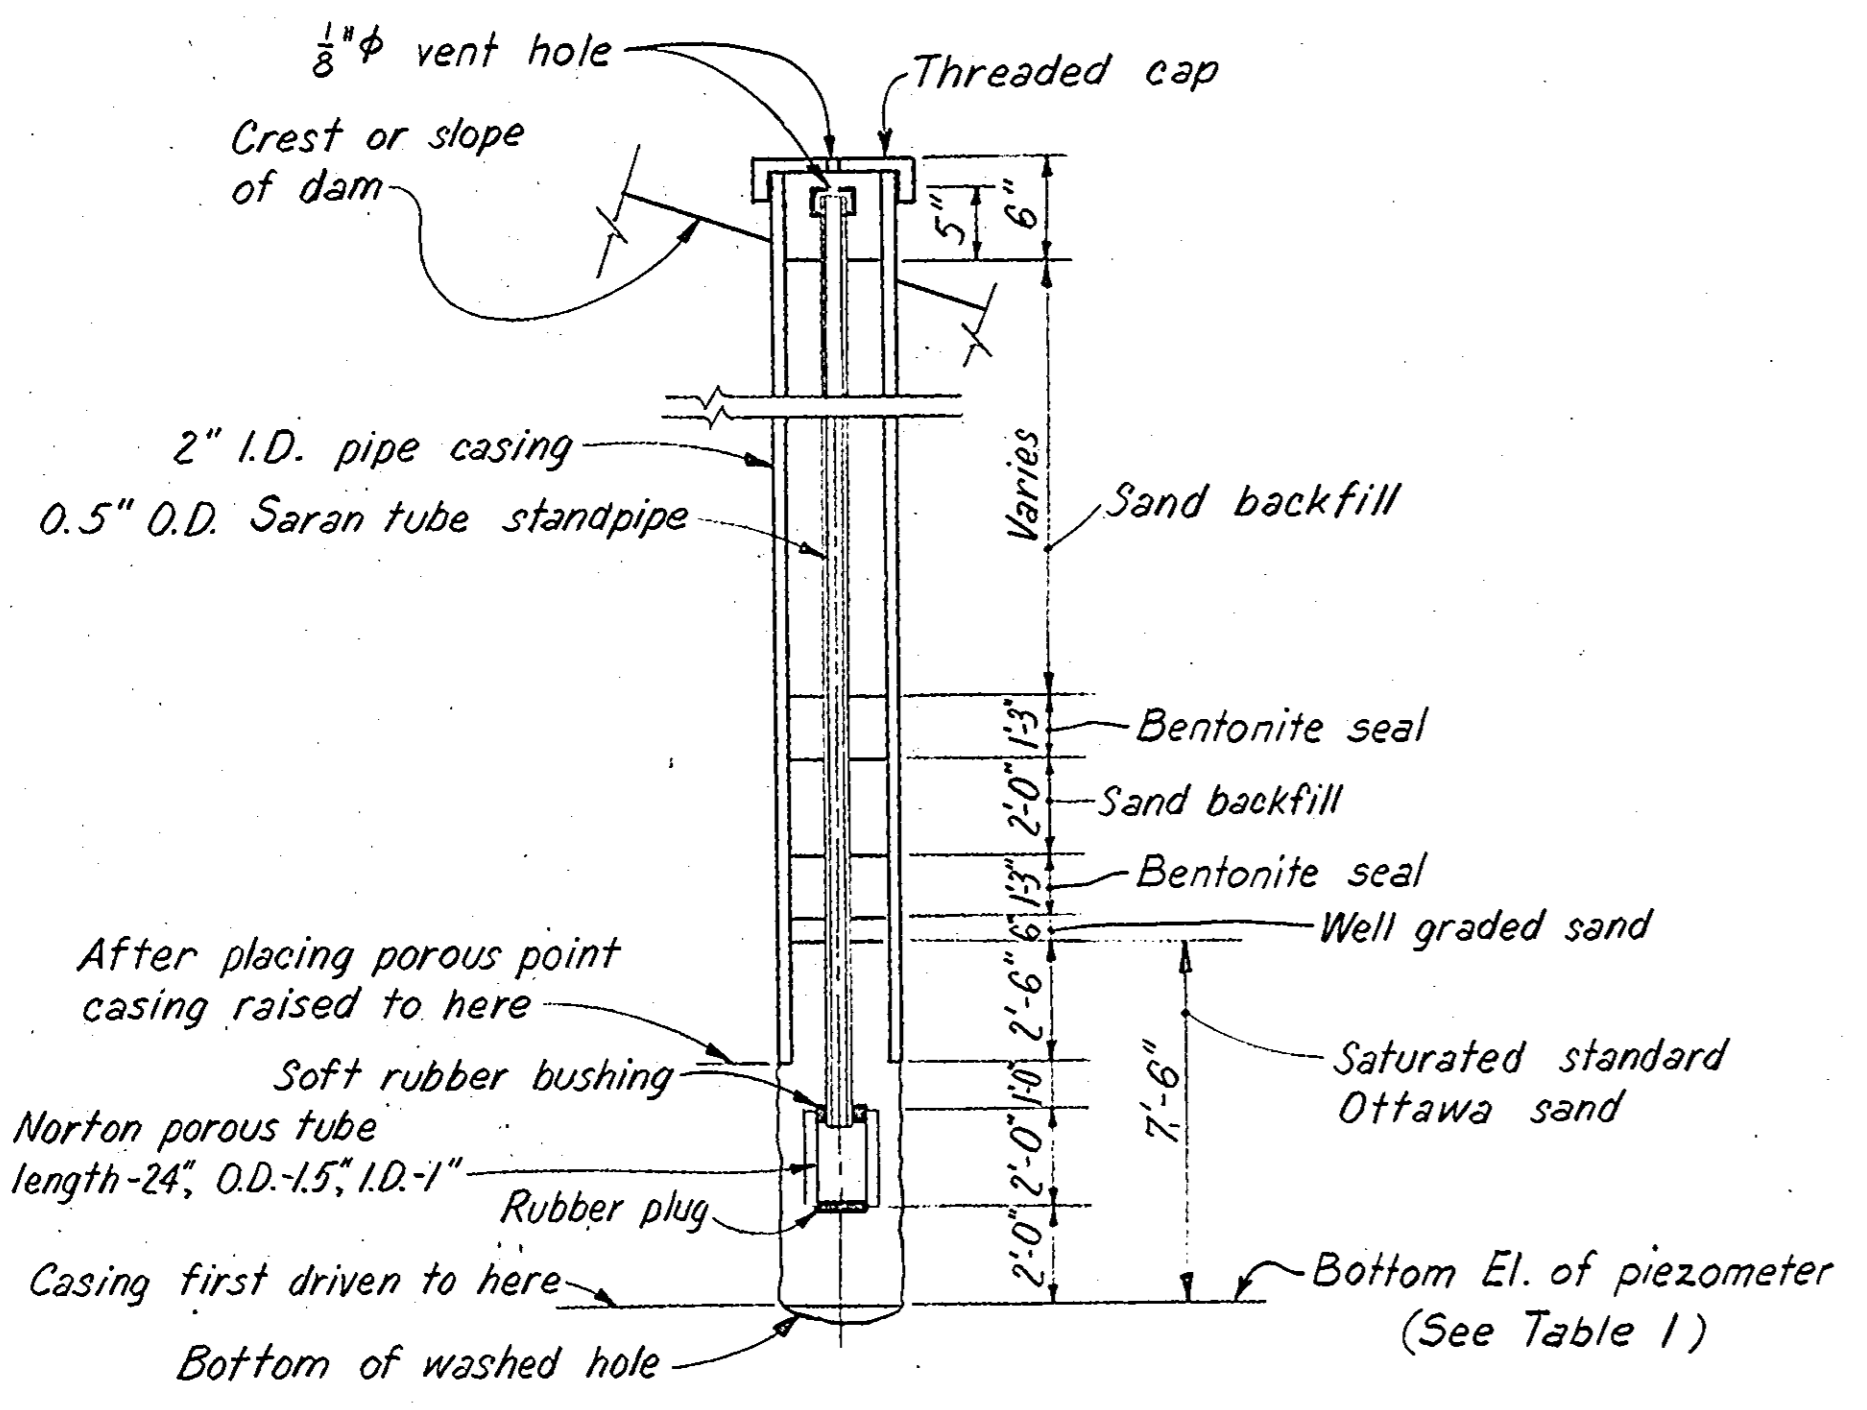
TYPICAL PIEZOMETER DETAIL
N.T.S.

TABLE I
BOTTOM ELEVATION OF PIEZOMETER

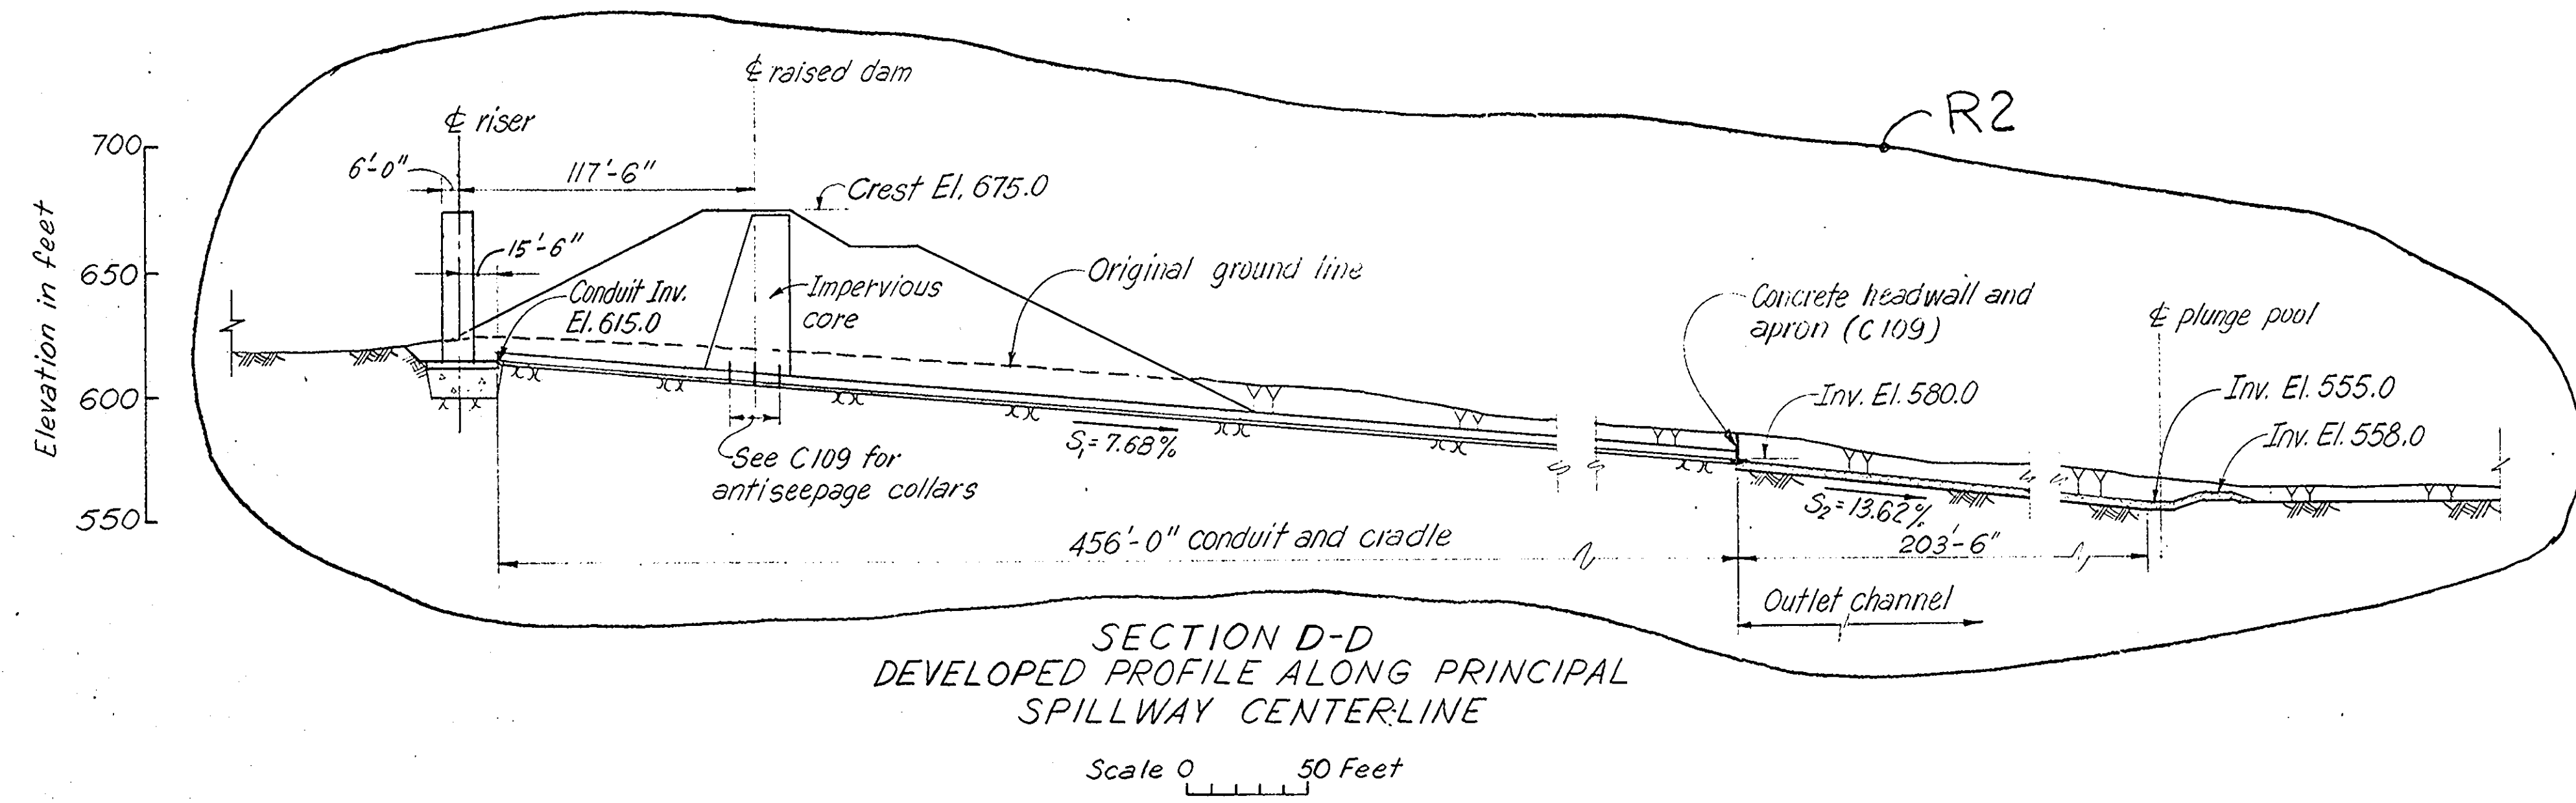
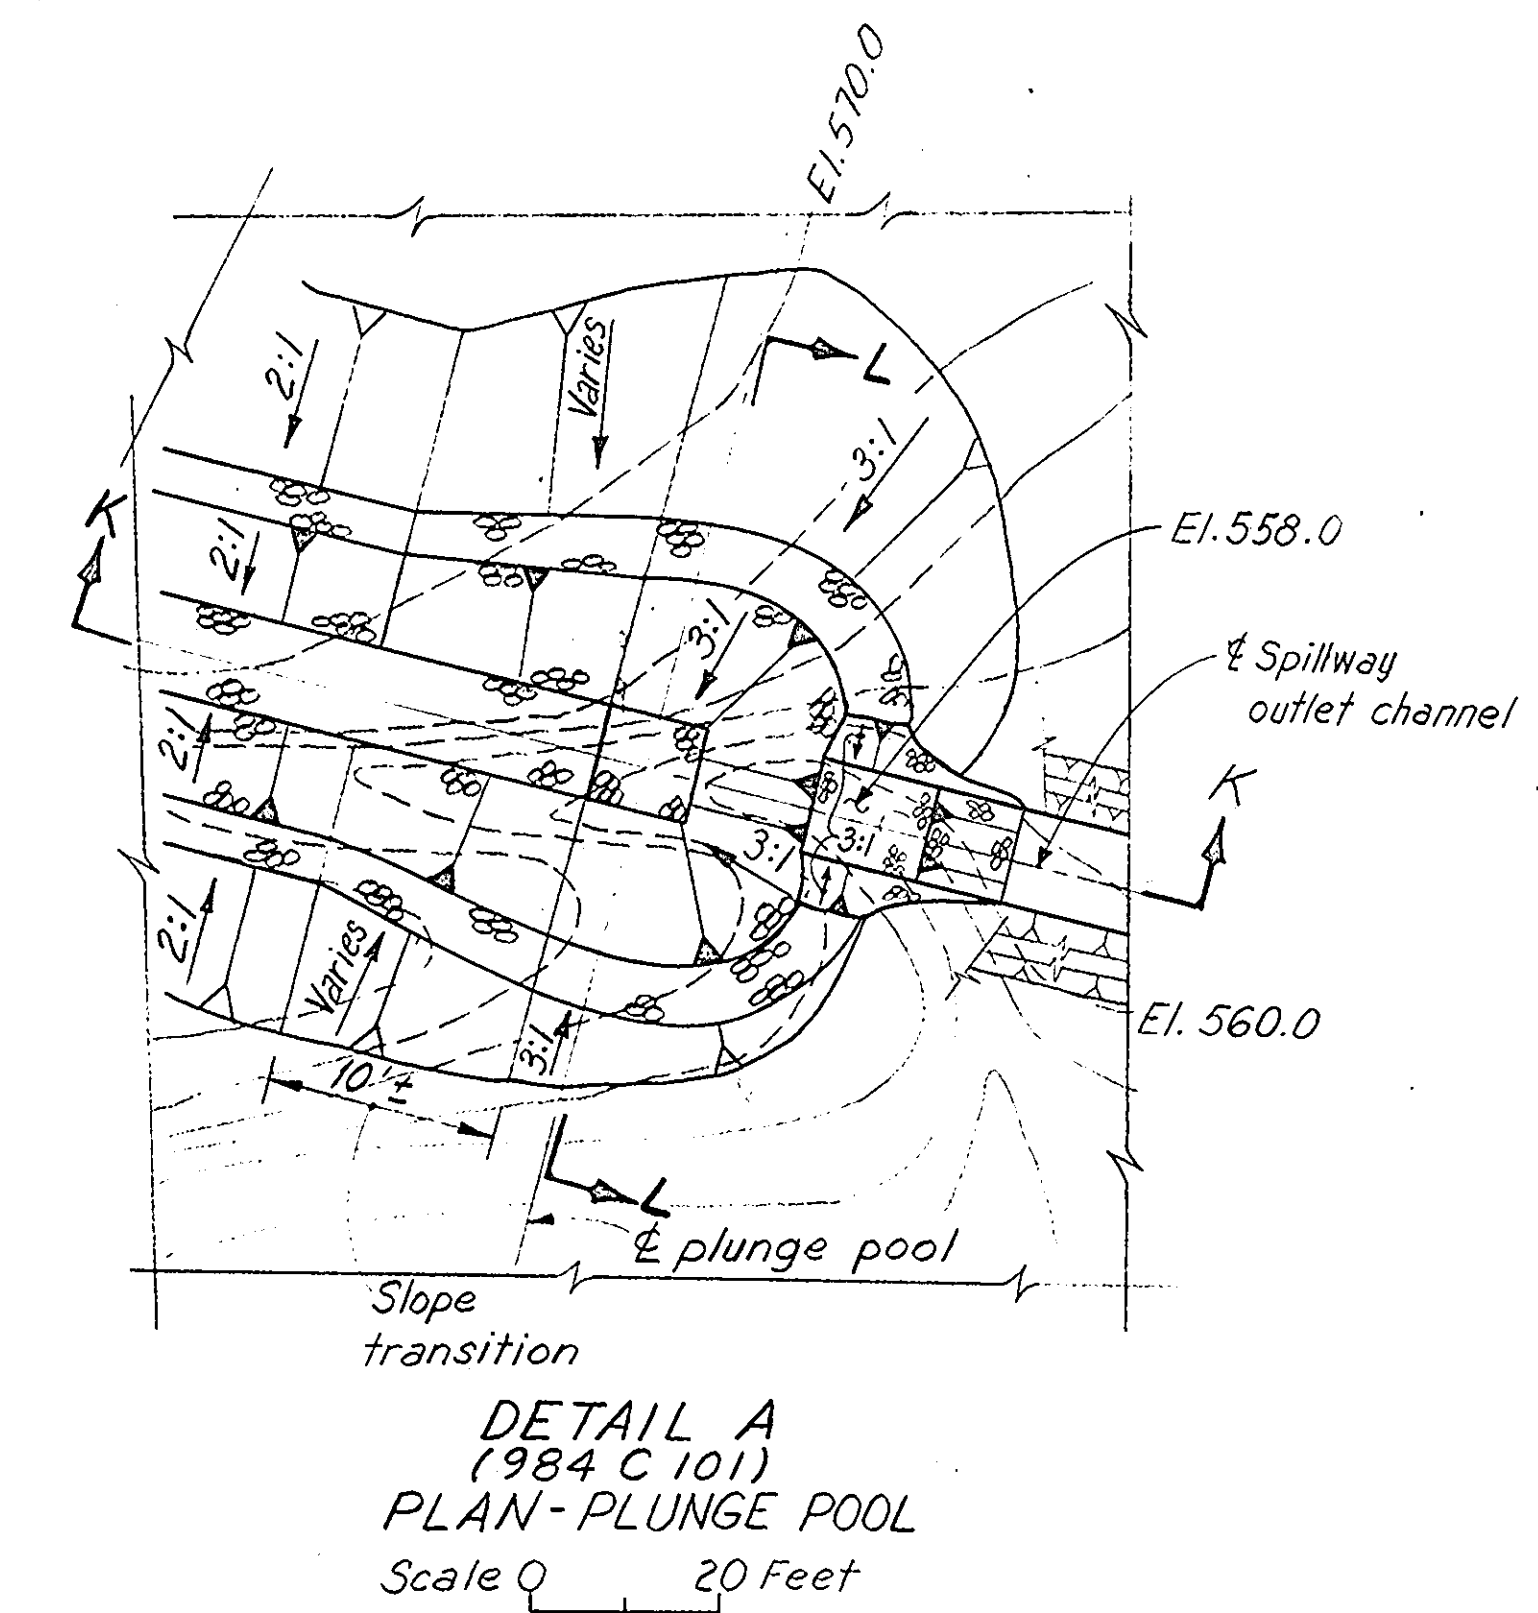
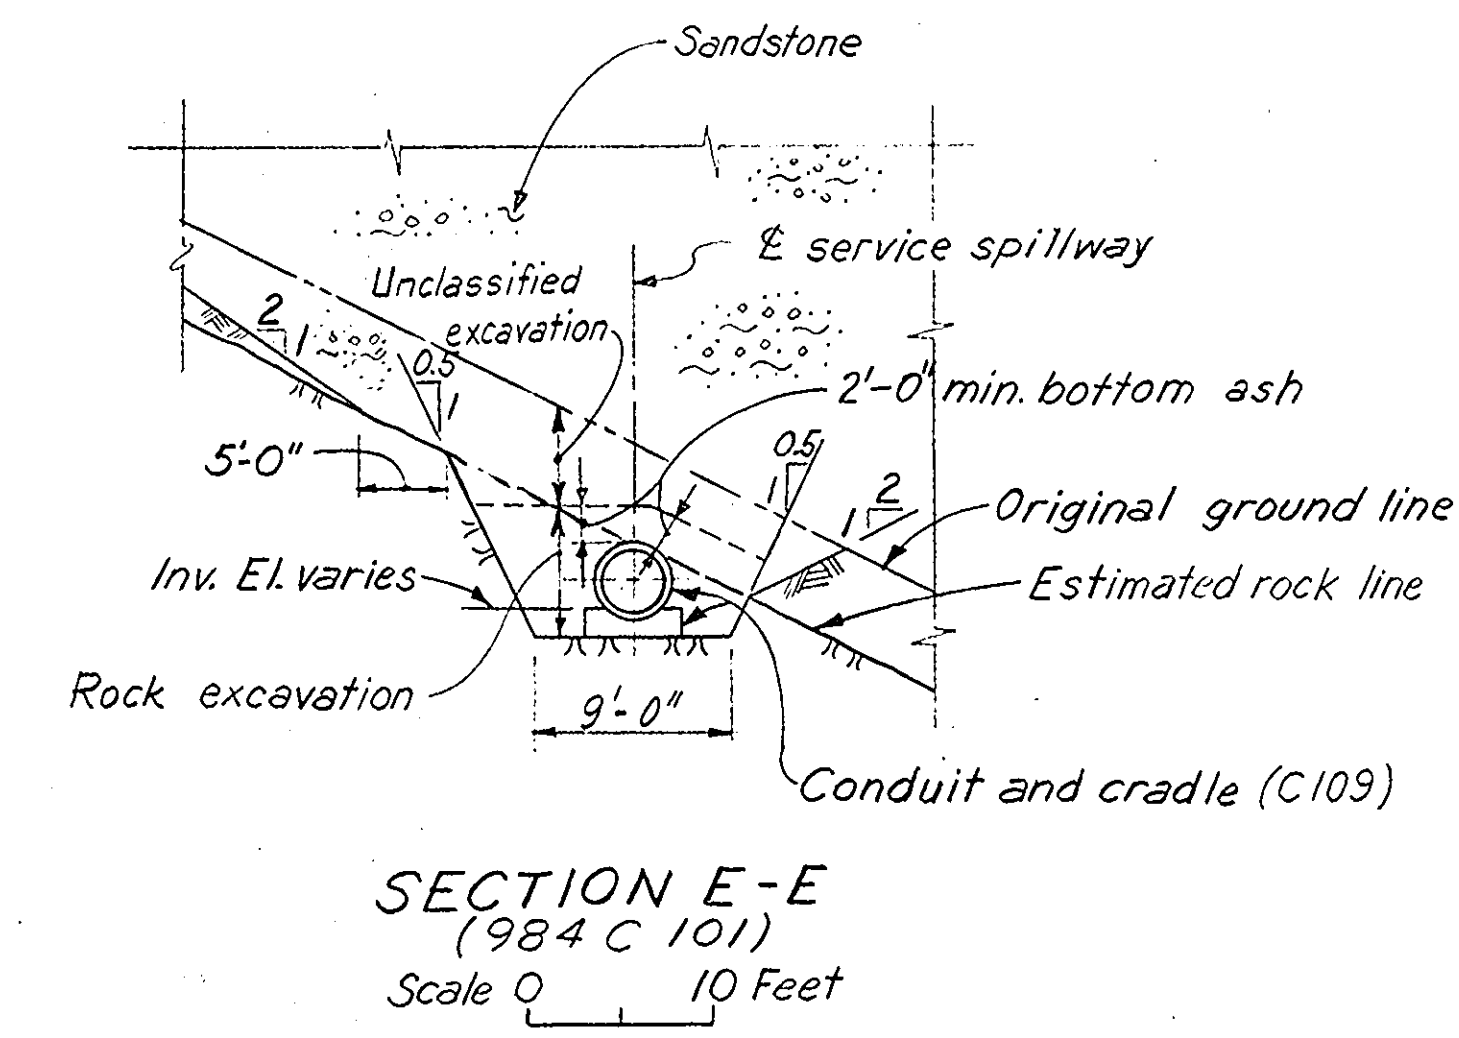
KENTUCKY POWER COMPANY BIG SANDY PLANT BIG SANDY, KENTUCKY	
BIG SANDY FLYASH DAM	DAM RAISING
SERVICE SPILLWAY EARTHWORK DETAILS	
CONSULTING ENGINEERS HARZA ENGINEERING COMPANY APPROVED <i>[Signature]</i>	
CHICAGO, ILLINOIS	DATE <i>April, 1977</i> DWG. NO. 984 C 104 R2

- NOTES:
1. Work this drawing with C101.
 2. All riprap for the service spillway outlet channel and plunge pool is Riprap - Type I.
 3. Topsoil and seeding to be at the direction of Owner's Engineer.

REV. NO.	DWG. TRANSMITTAL LETTER NO.	DATE	NATURE OF REVISION	BY	CHKD.	APPD.
R2		6/23/77	Revised inv. El. and length of conduit	ECB	WAR	SWD
R1		5/16/77	Service Spillway Conduit Extension	JF	WAR	DWO
