HISTORY OF CONSTRUCTION

CFR 257.73(c)(1)

Fly Ash Pond

Big Sandy Plant
Louisa, Kentucky

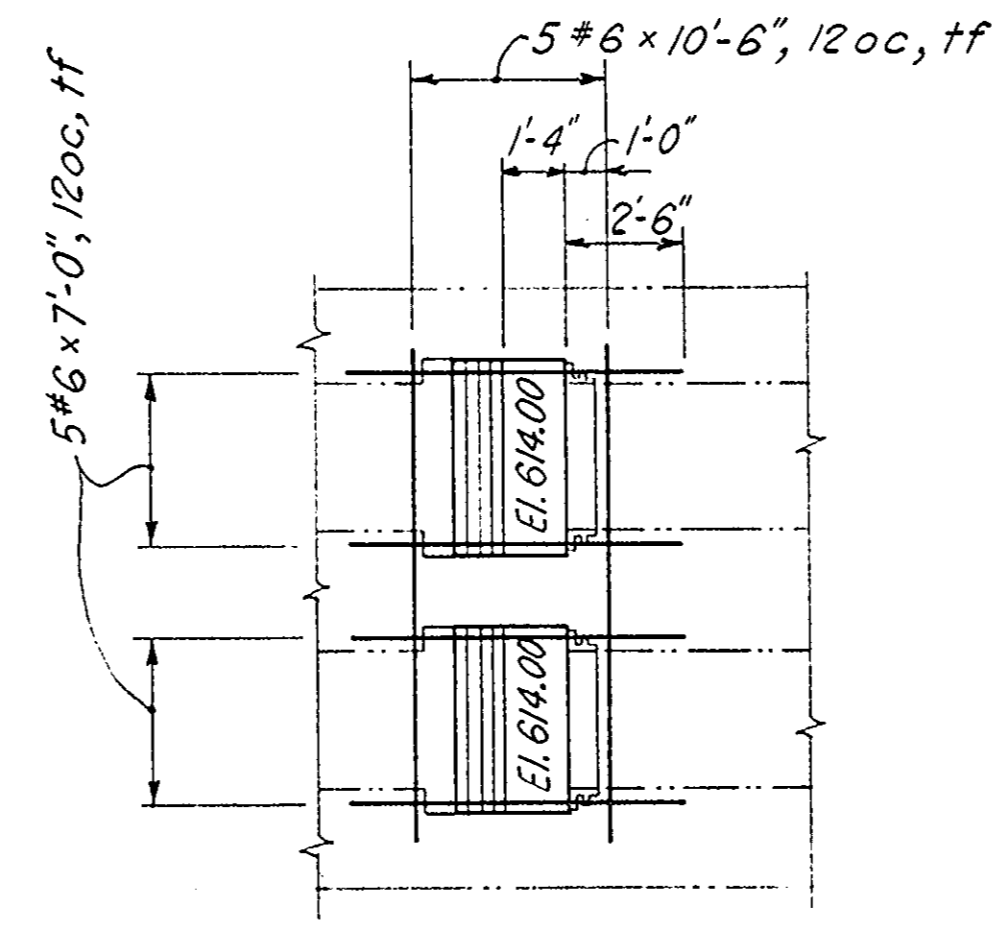
DETAIL A

Top face reinf. at blockouts

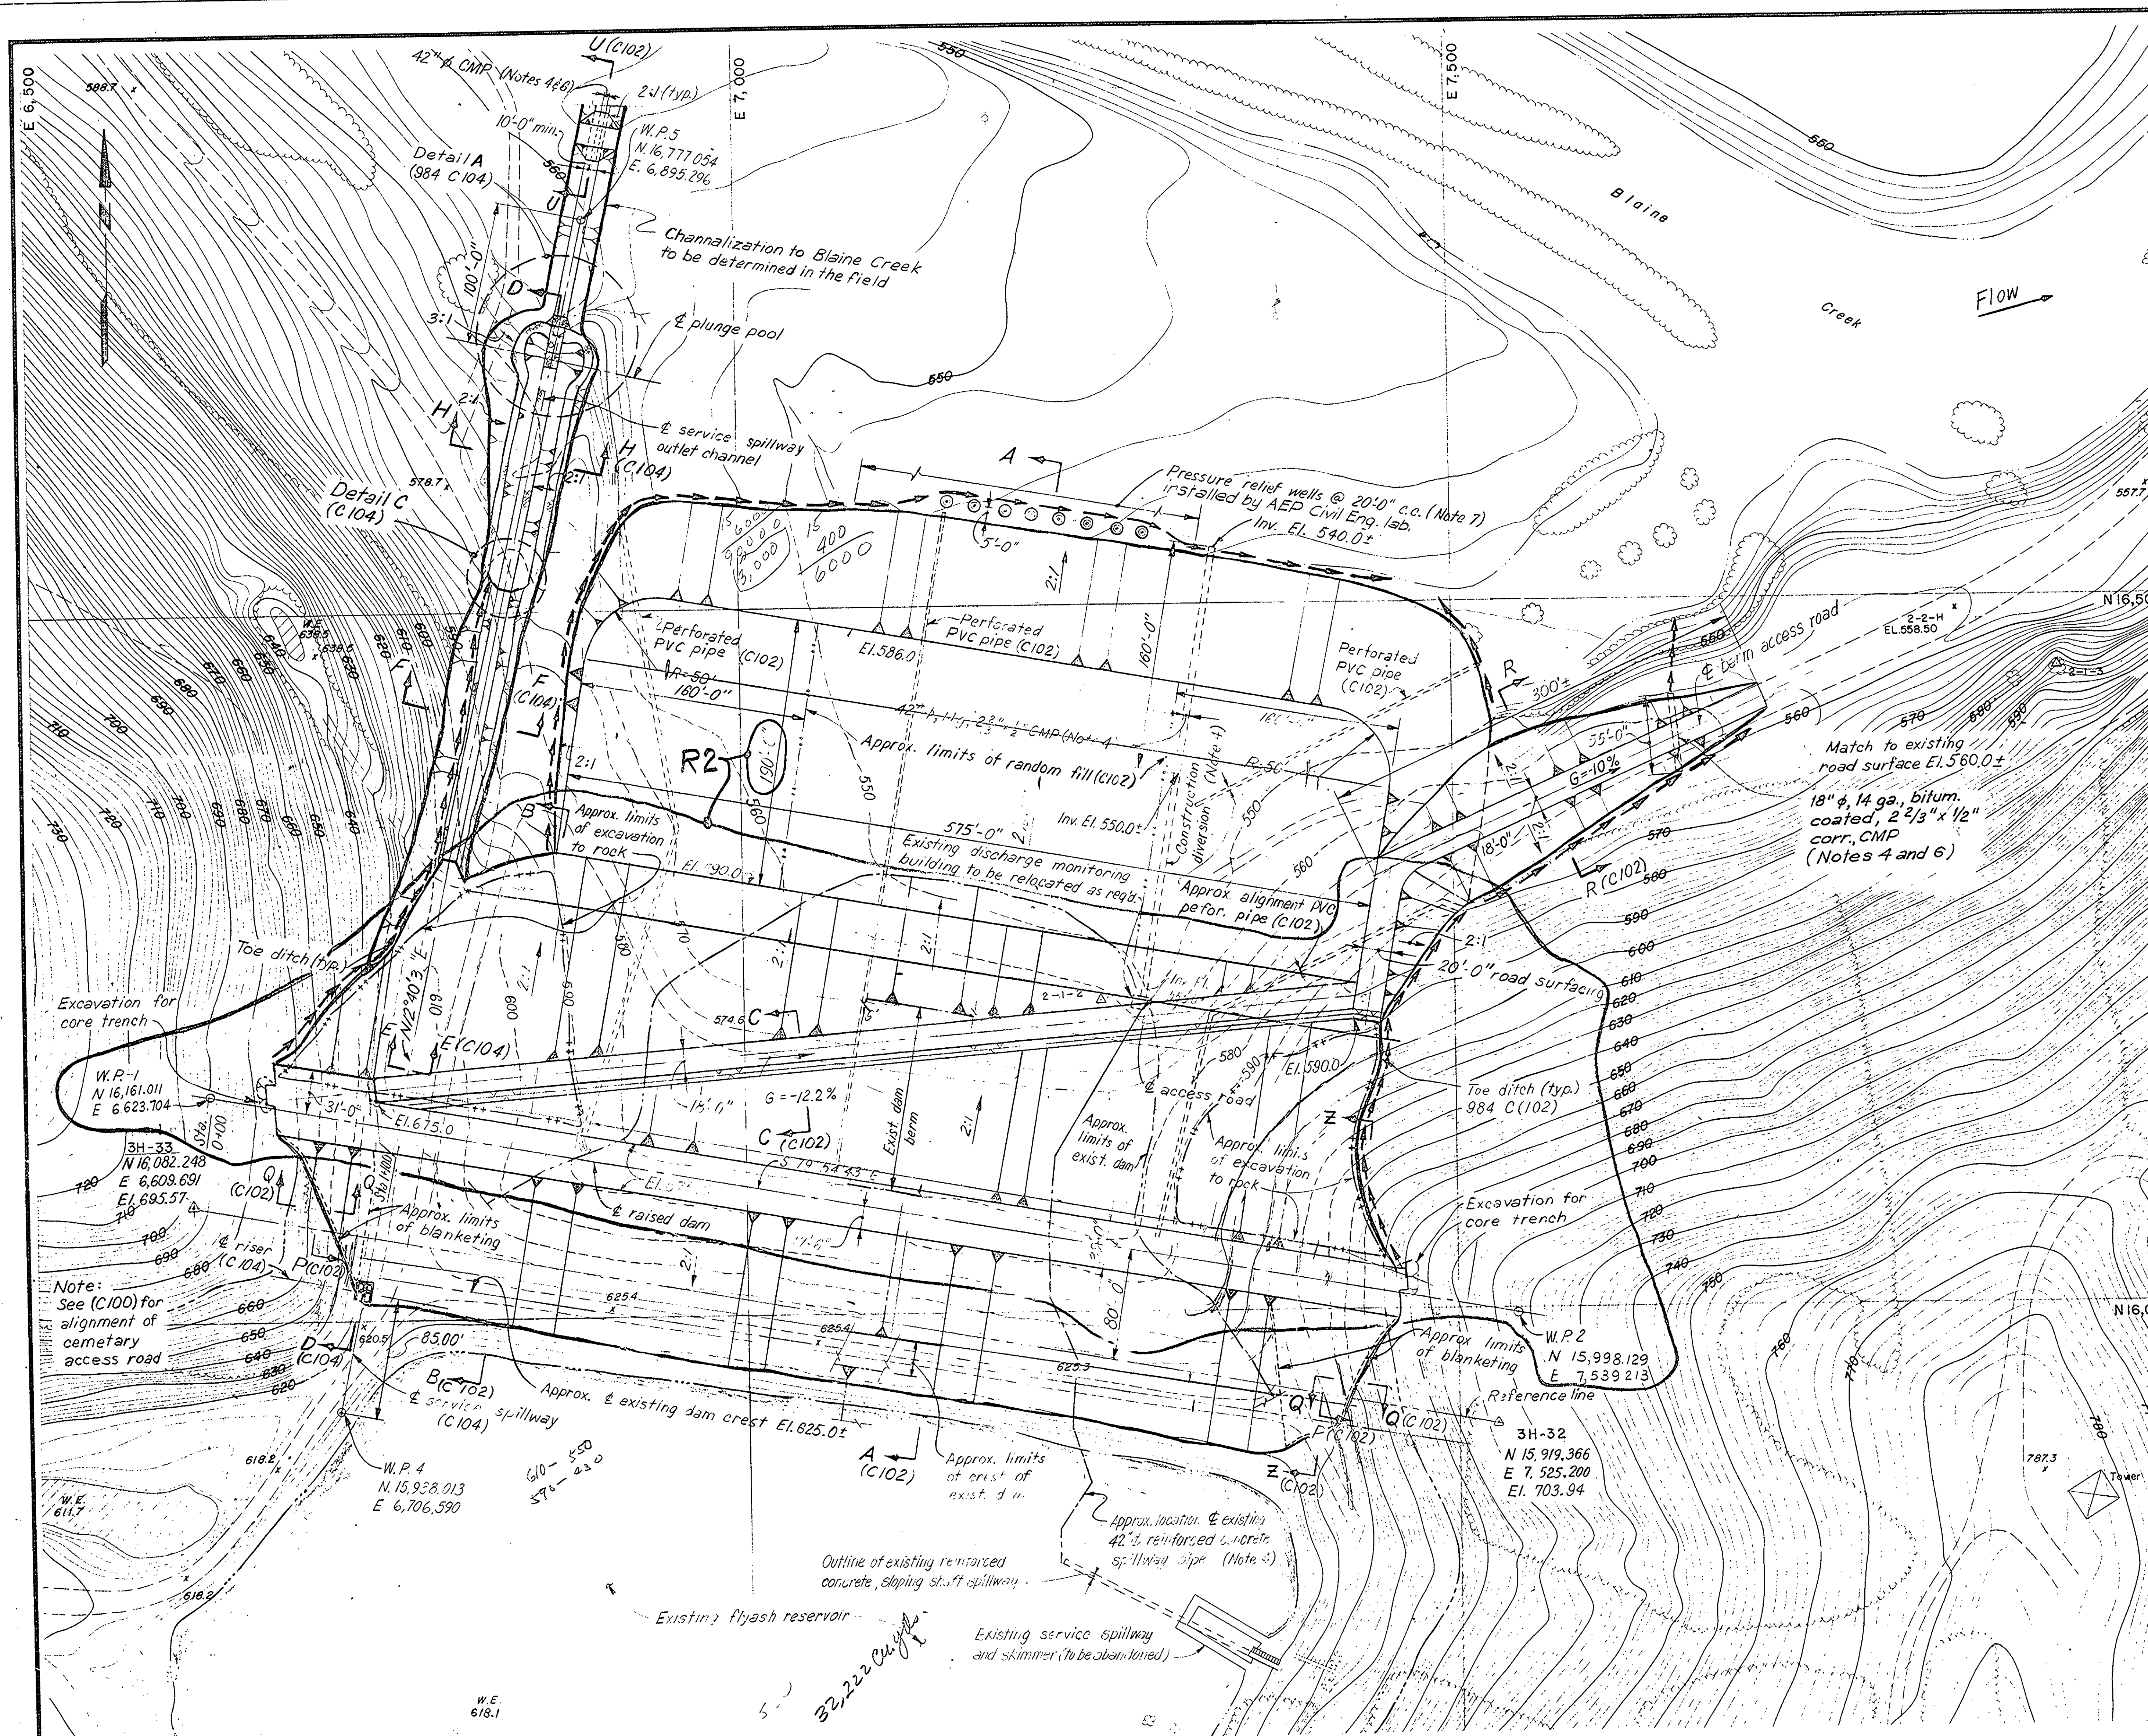
PLAN

- LEGEND:**
- ▲ Kentucky Power Co. benchmark
 - ▽ Fill slope
 - ▲ Cut slope
 - Limits of max. normal water surface El. 670.0
 - Toe ditch (C102)
 - ⊙ Pressure relief well

- NOTES:**
1. Work this drawing with C102, C102A, and C104.
 2. Topography supplied by Kentucky Power Co. Date of mapping 1976.
 3. All exploration performed by Kentucky Power Co.
 4. Corrugated metal pipe as manufactured by Aranco or equal.
 5. Both existing concrete spillway pipe and construction diversion to be concreted upon completion of construction as directed.
 6. A minimum 2'-0" cover shall be placed over top of pipe. Location of CMP shall be determined in the field.
 7. Pressure relief wells to extend 25'-0" into rock. Number of wells to be determined in the field.

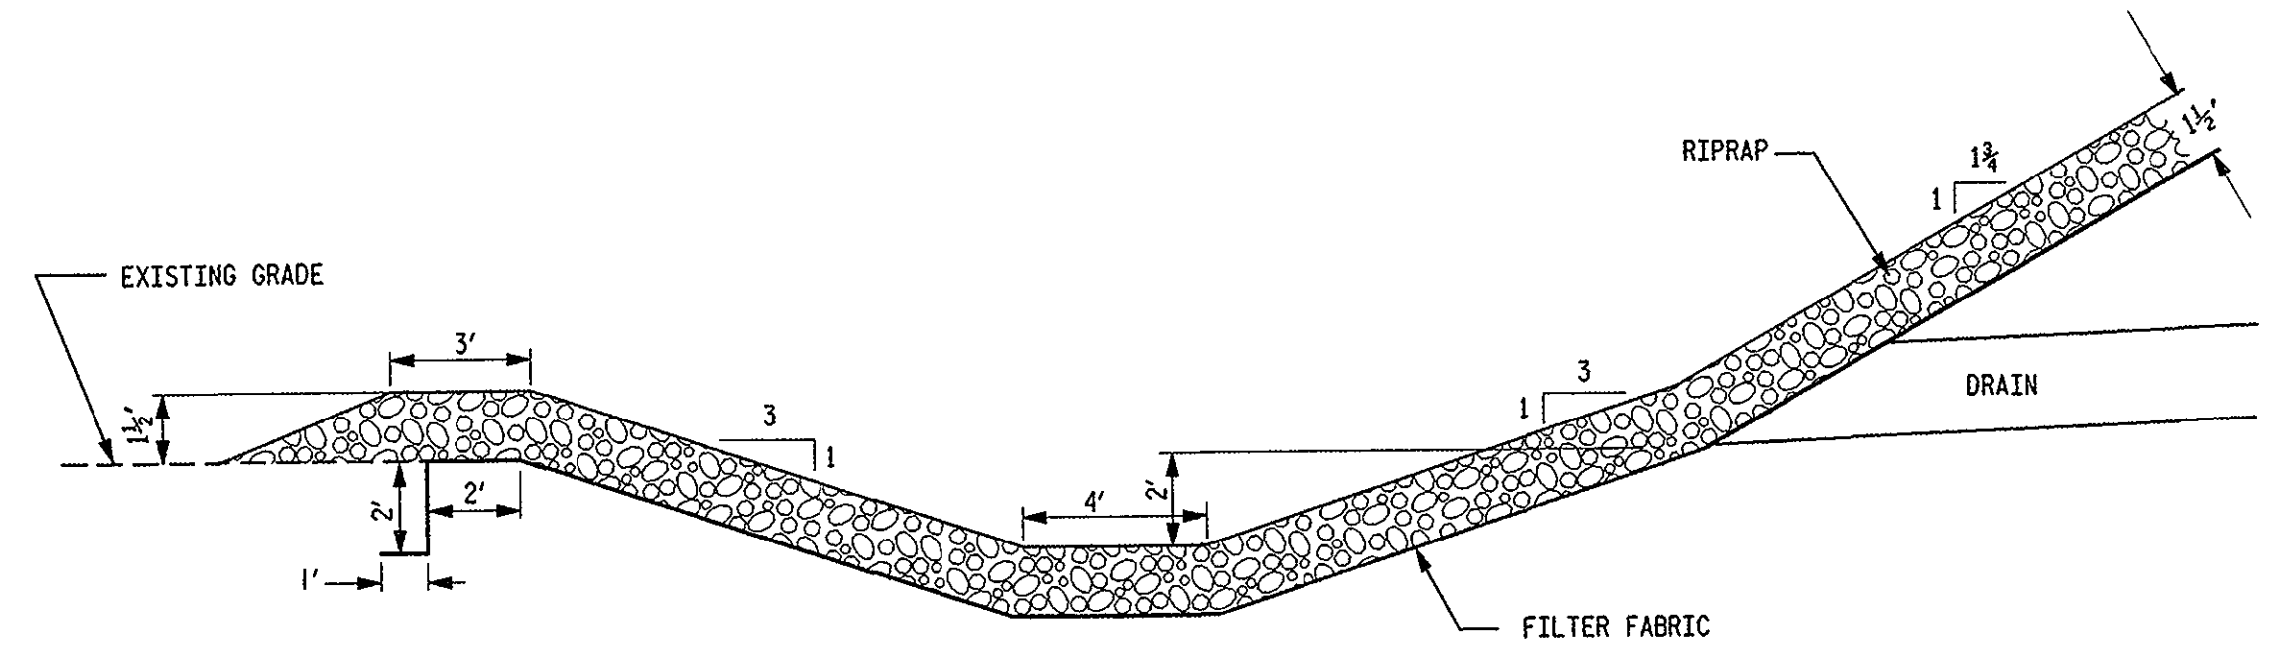
SECTION 2-L
DITCH DETAIL
SCALE: 1" = 4'

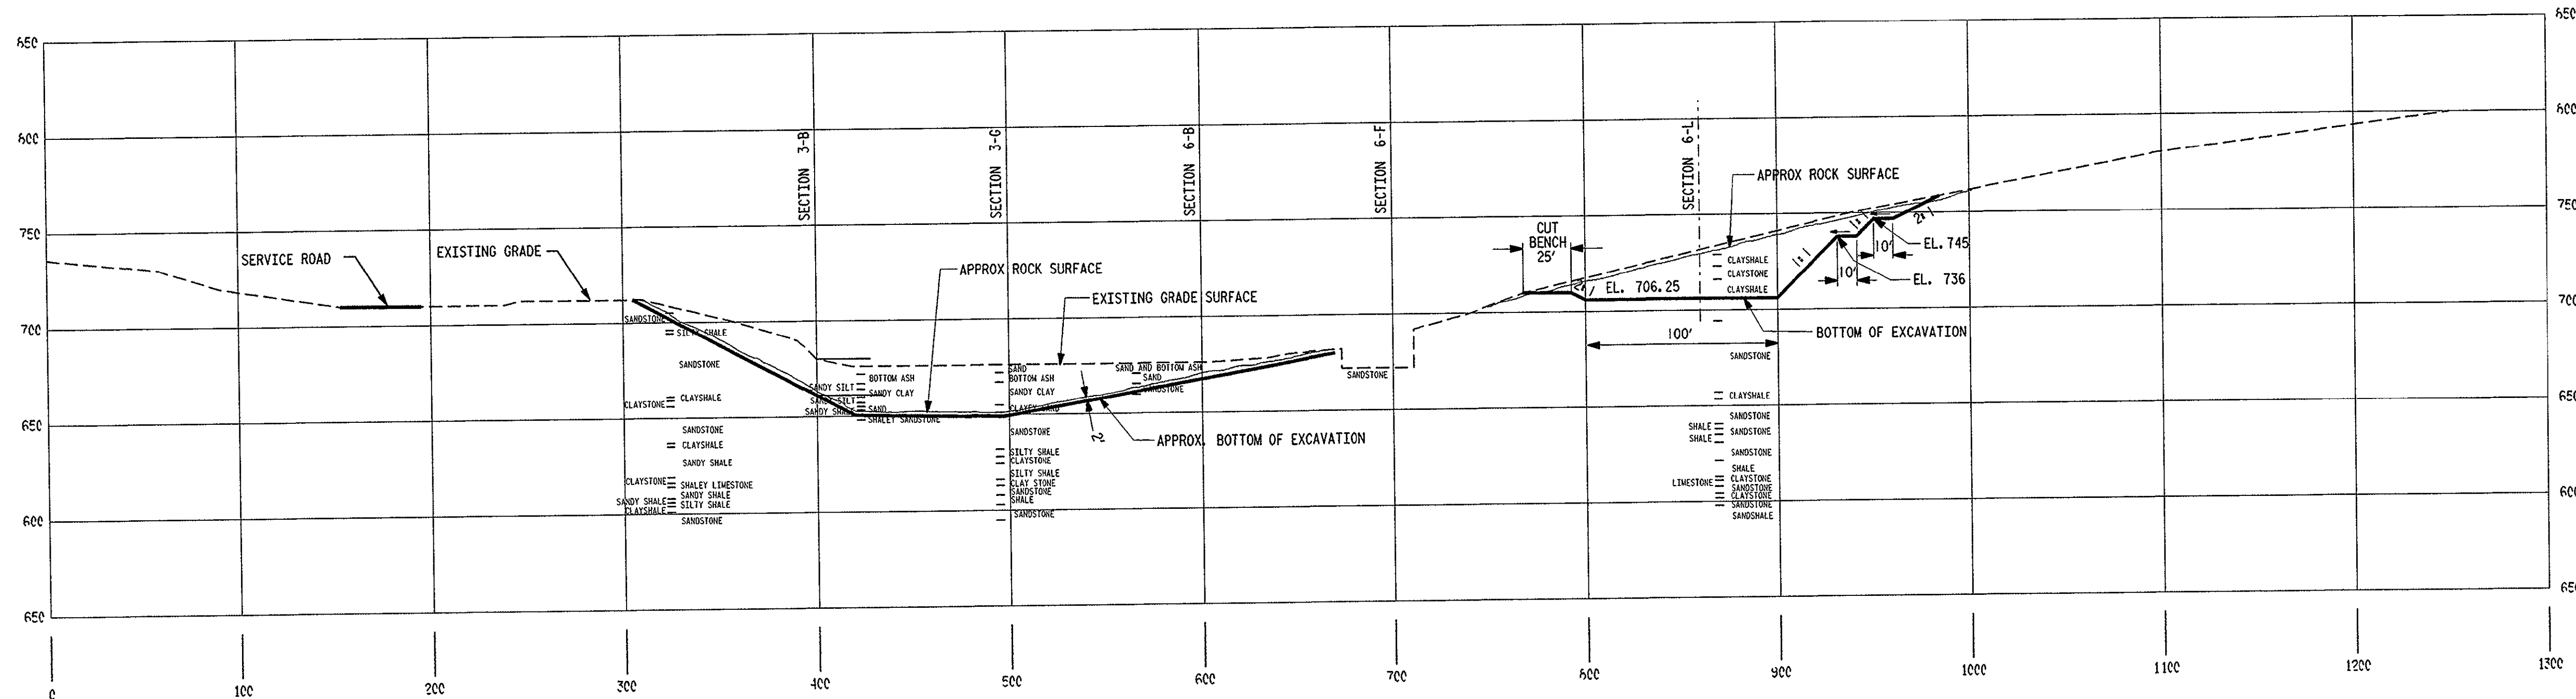
SADDLE DAM SECTION 9-G
SCALE: 1" = 50' HORIZ & VERT
(FOR LOCATION SEE DWG. NO. 12-30034)

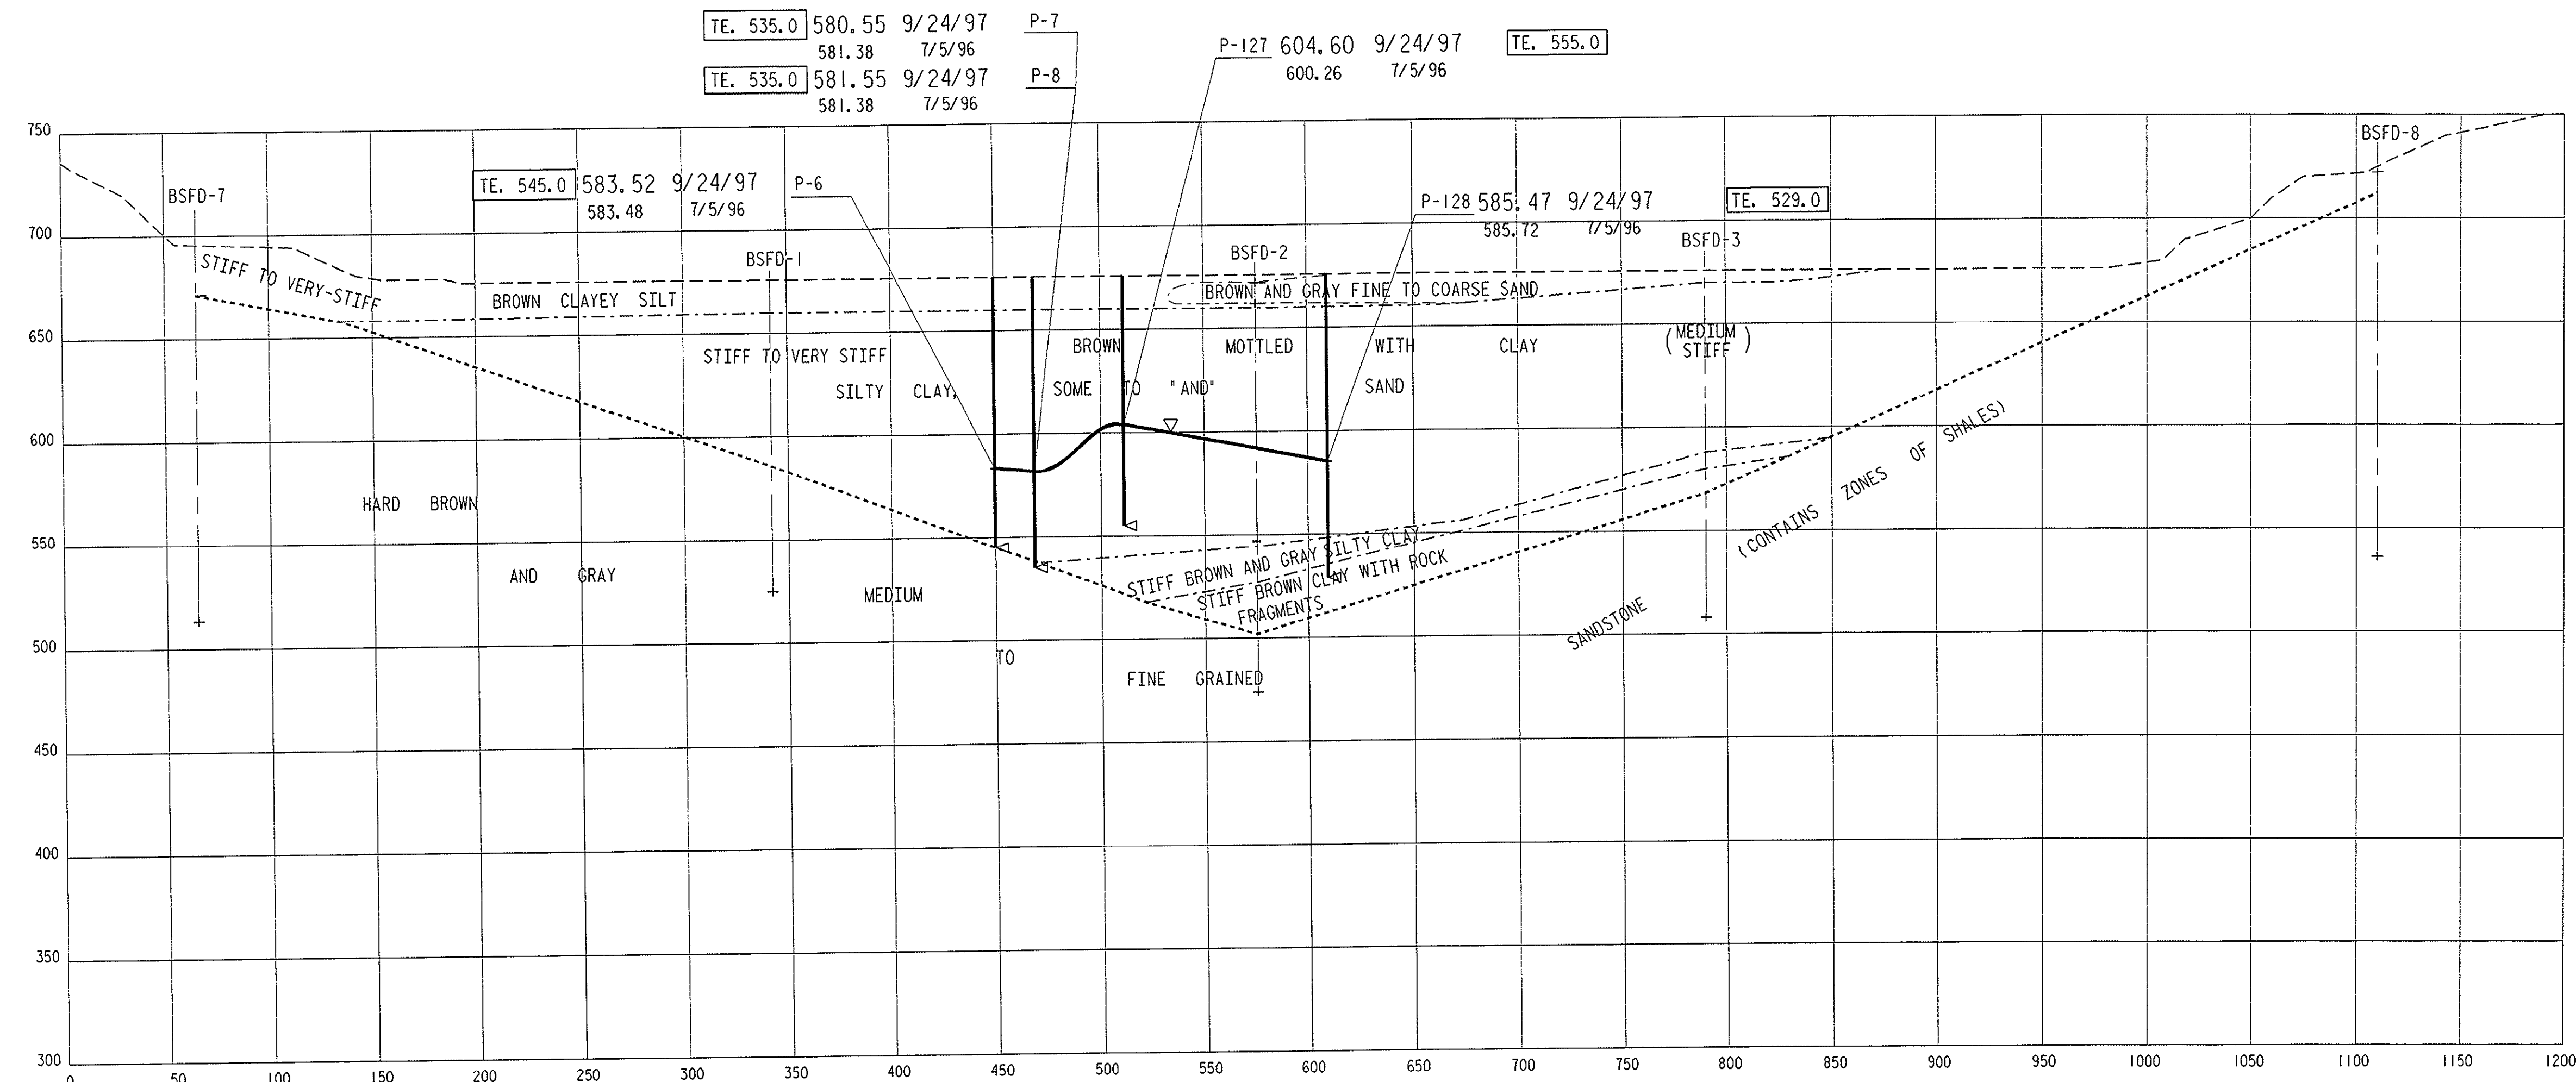
SECTION A-A
BIG-SANDY PLANT
HORSEFORD FLY ASH DAM
675 CREST - PIEZOMETER DATA

NOTES:
BSFD-1 = BORINGS DRILLED IN 1989 FOR THE DESIGN AND CONSTRUCTION OF STAGE II
B-100 = BORINGS DRILLED FOR DESIGN AND CONSTRUCTION OF STAGE II IN 1967 AND 1976 RESPECTIVELY
TE = TIP ELEVATION

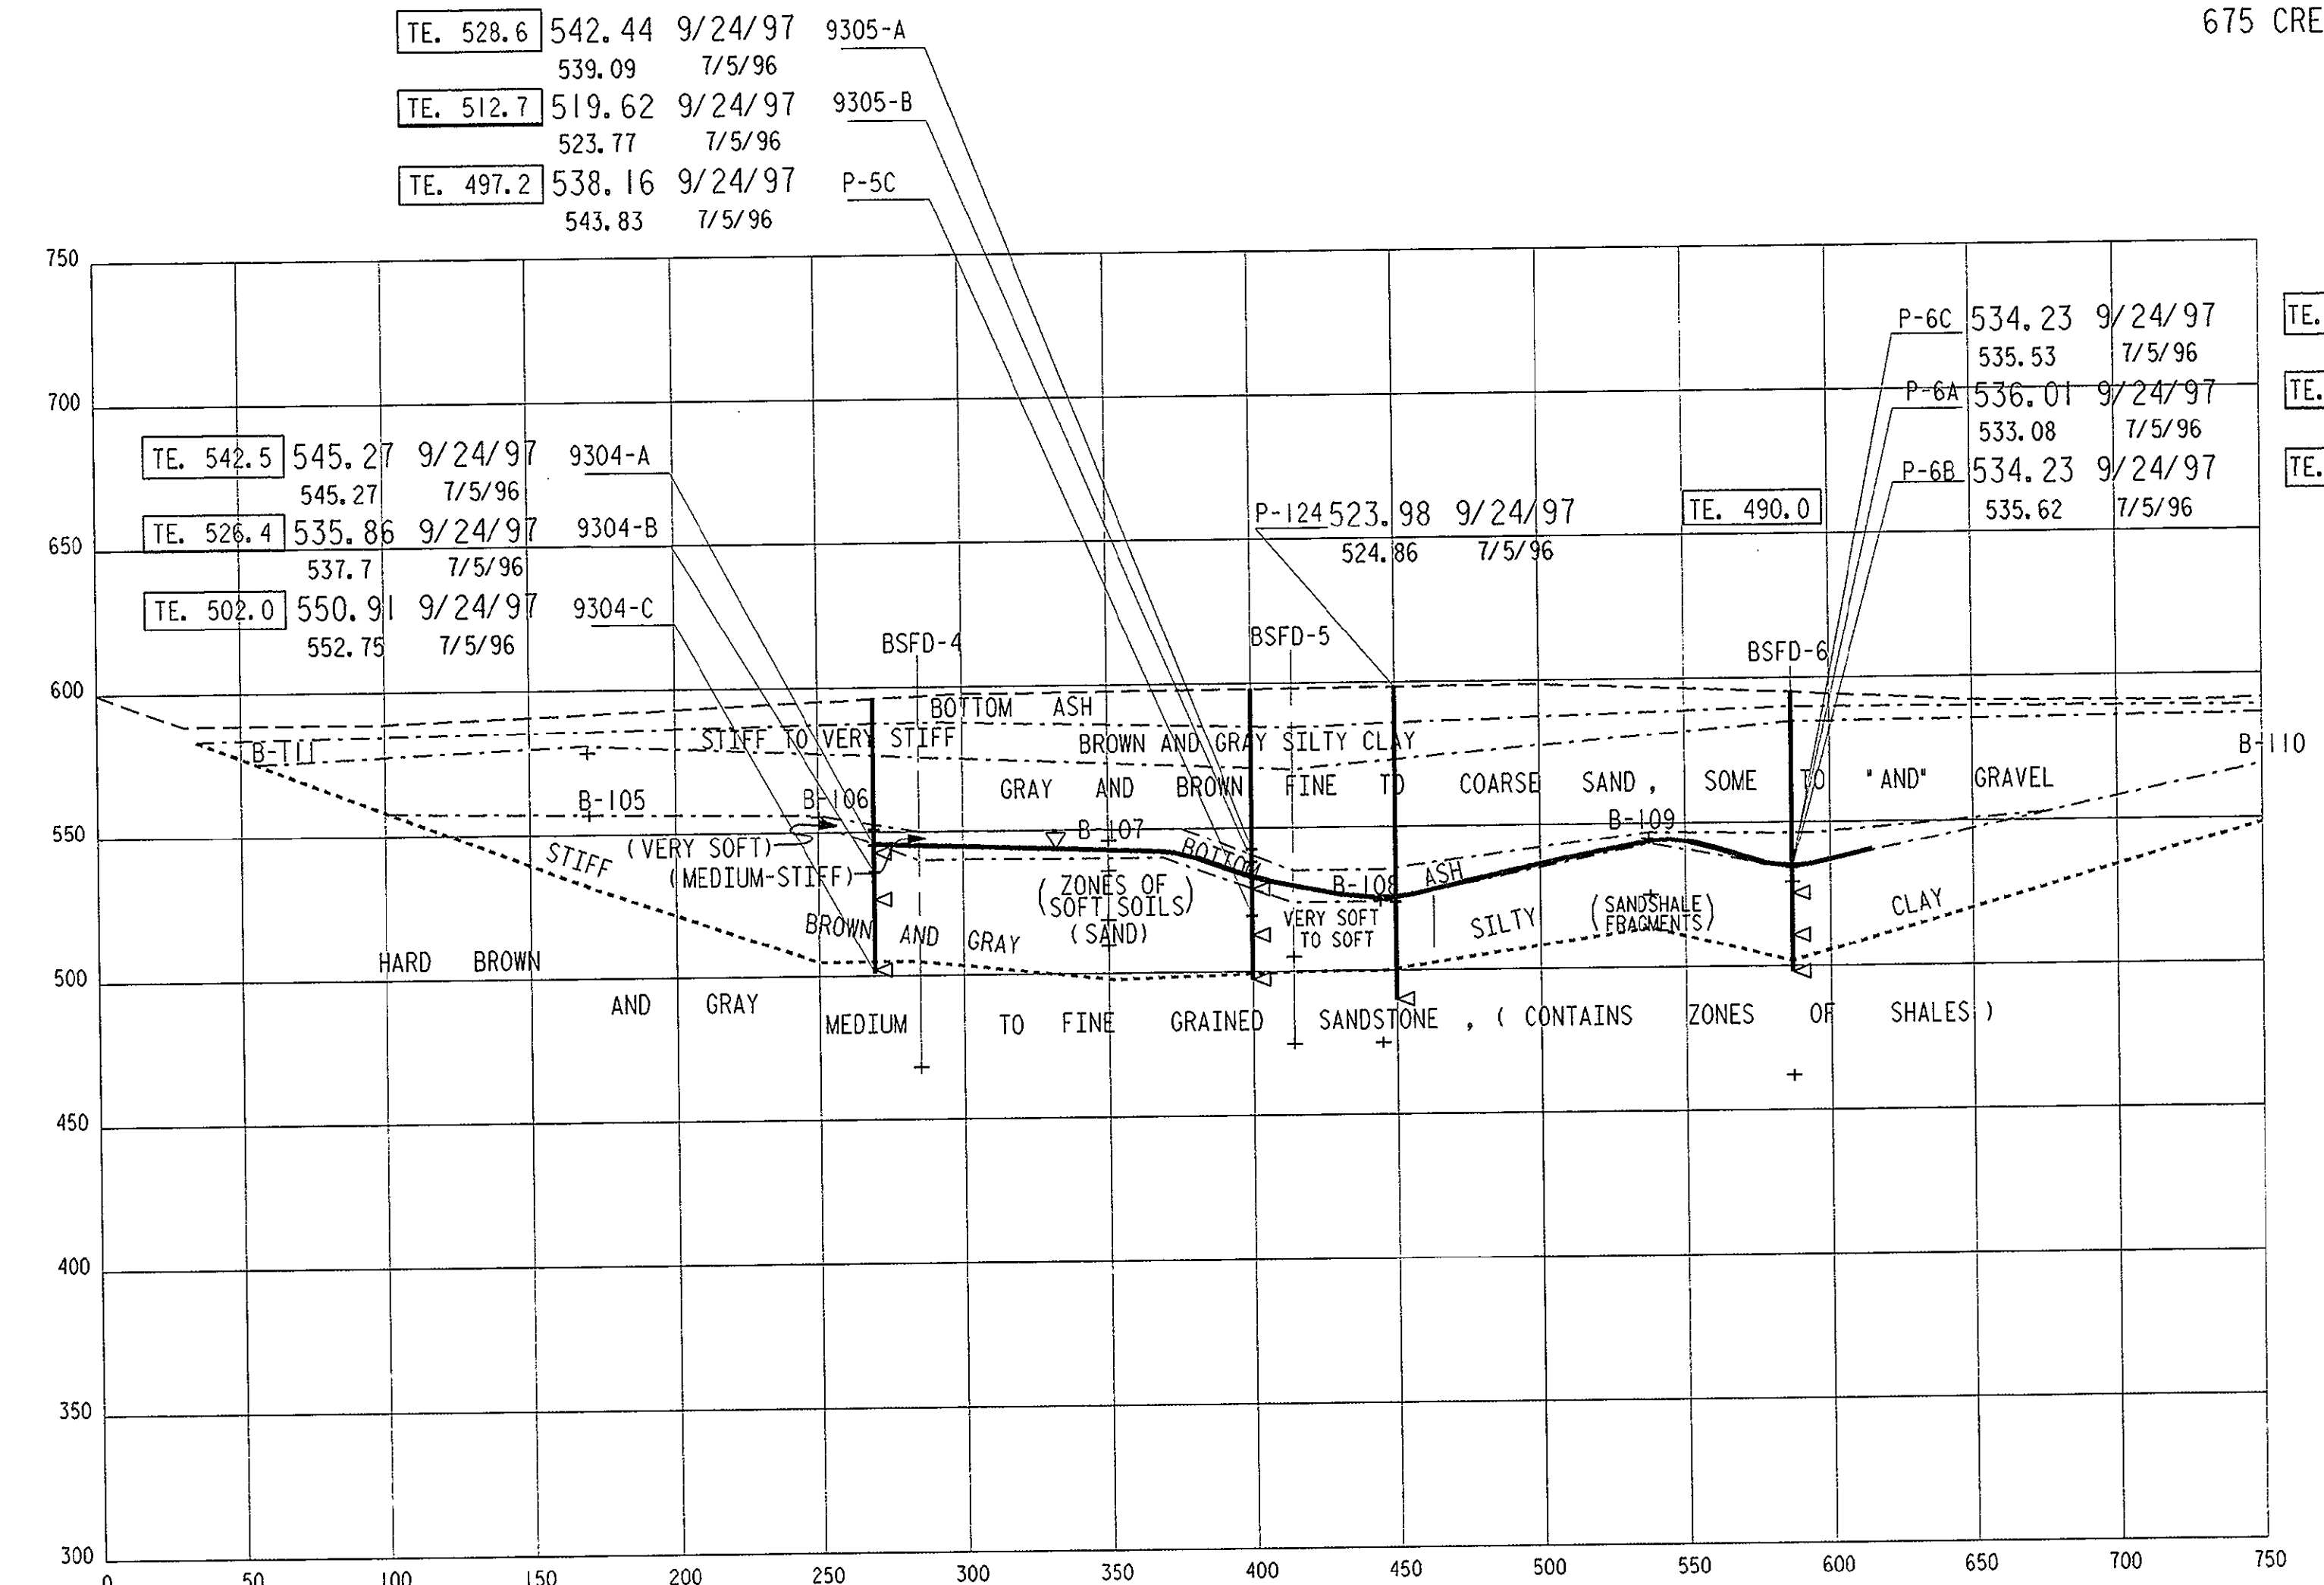
SECTION B-B
BIG-SANDY PLANT
HORSEFORD FLY ASH DAM
590 BERM - PIEZOMETER DATA

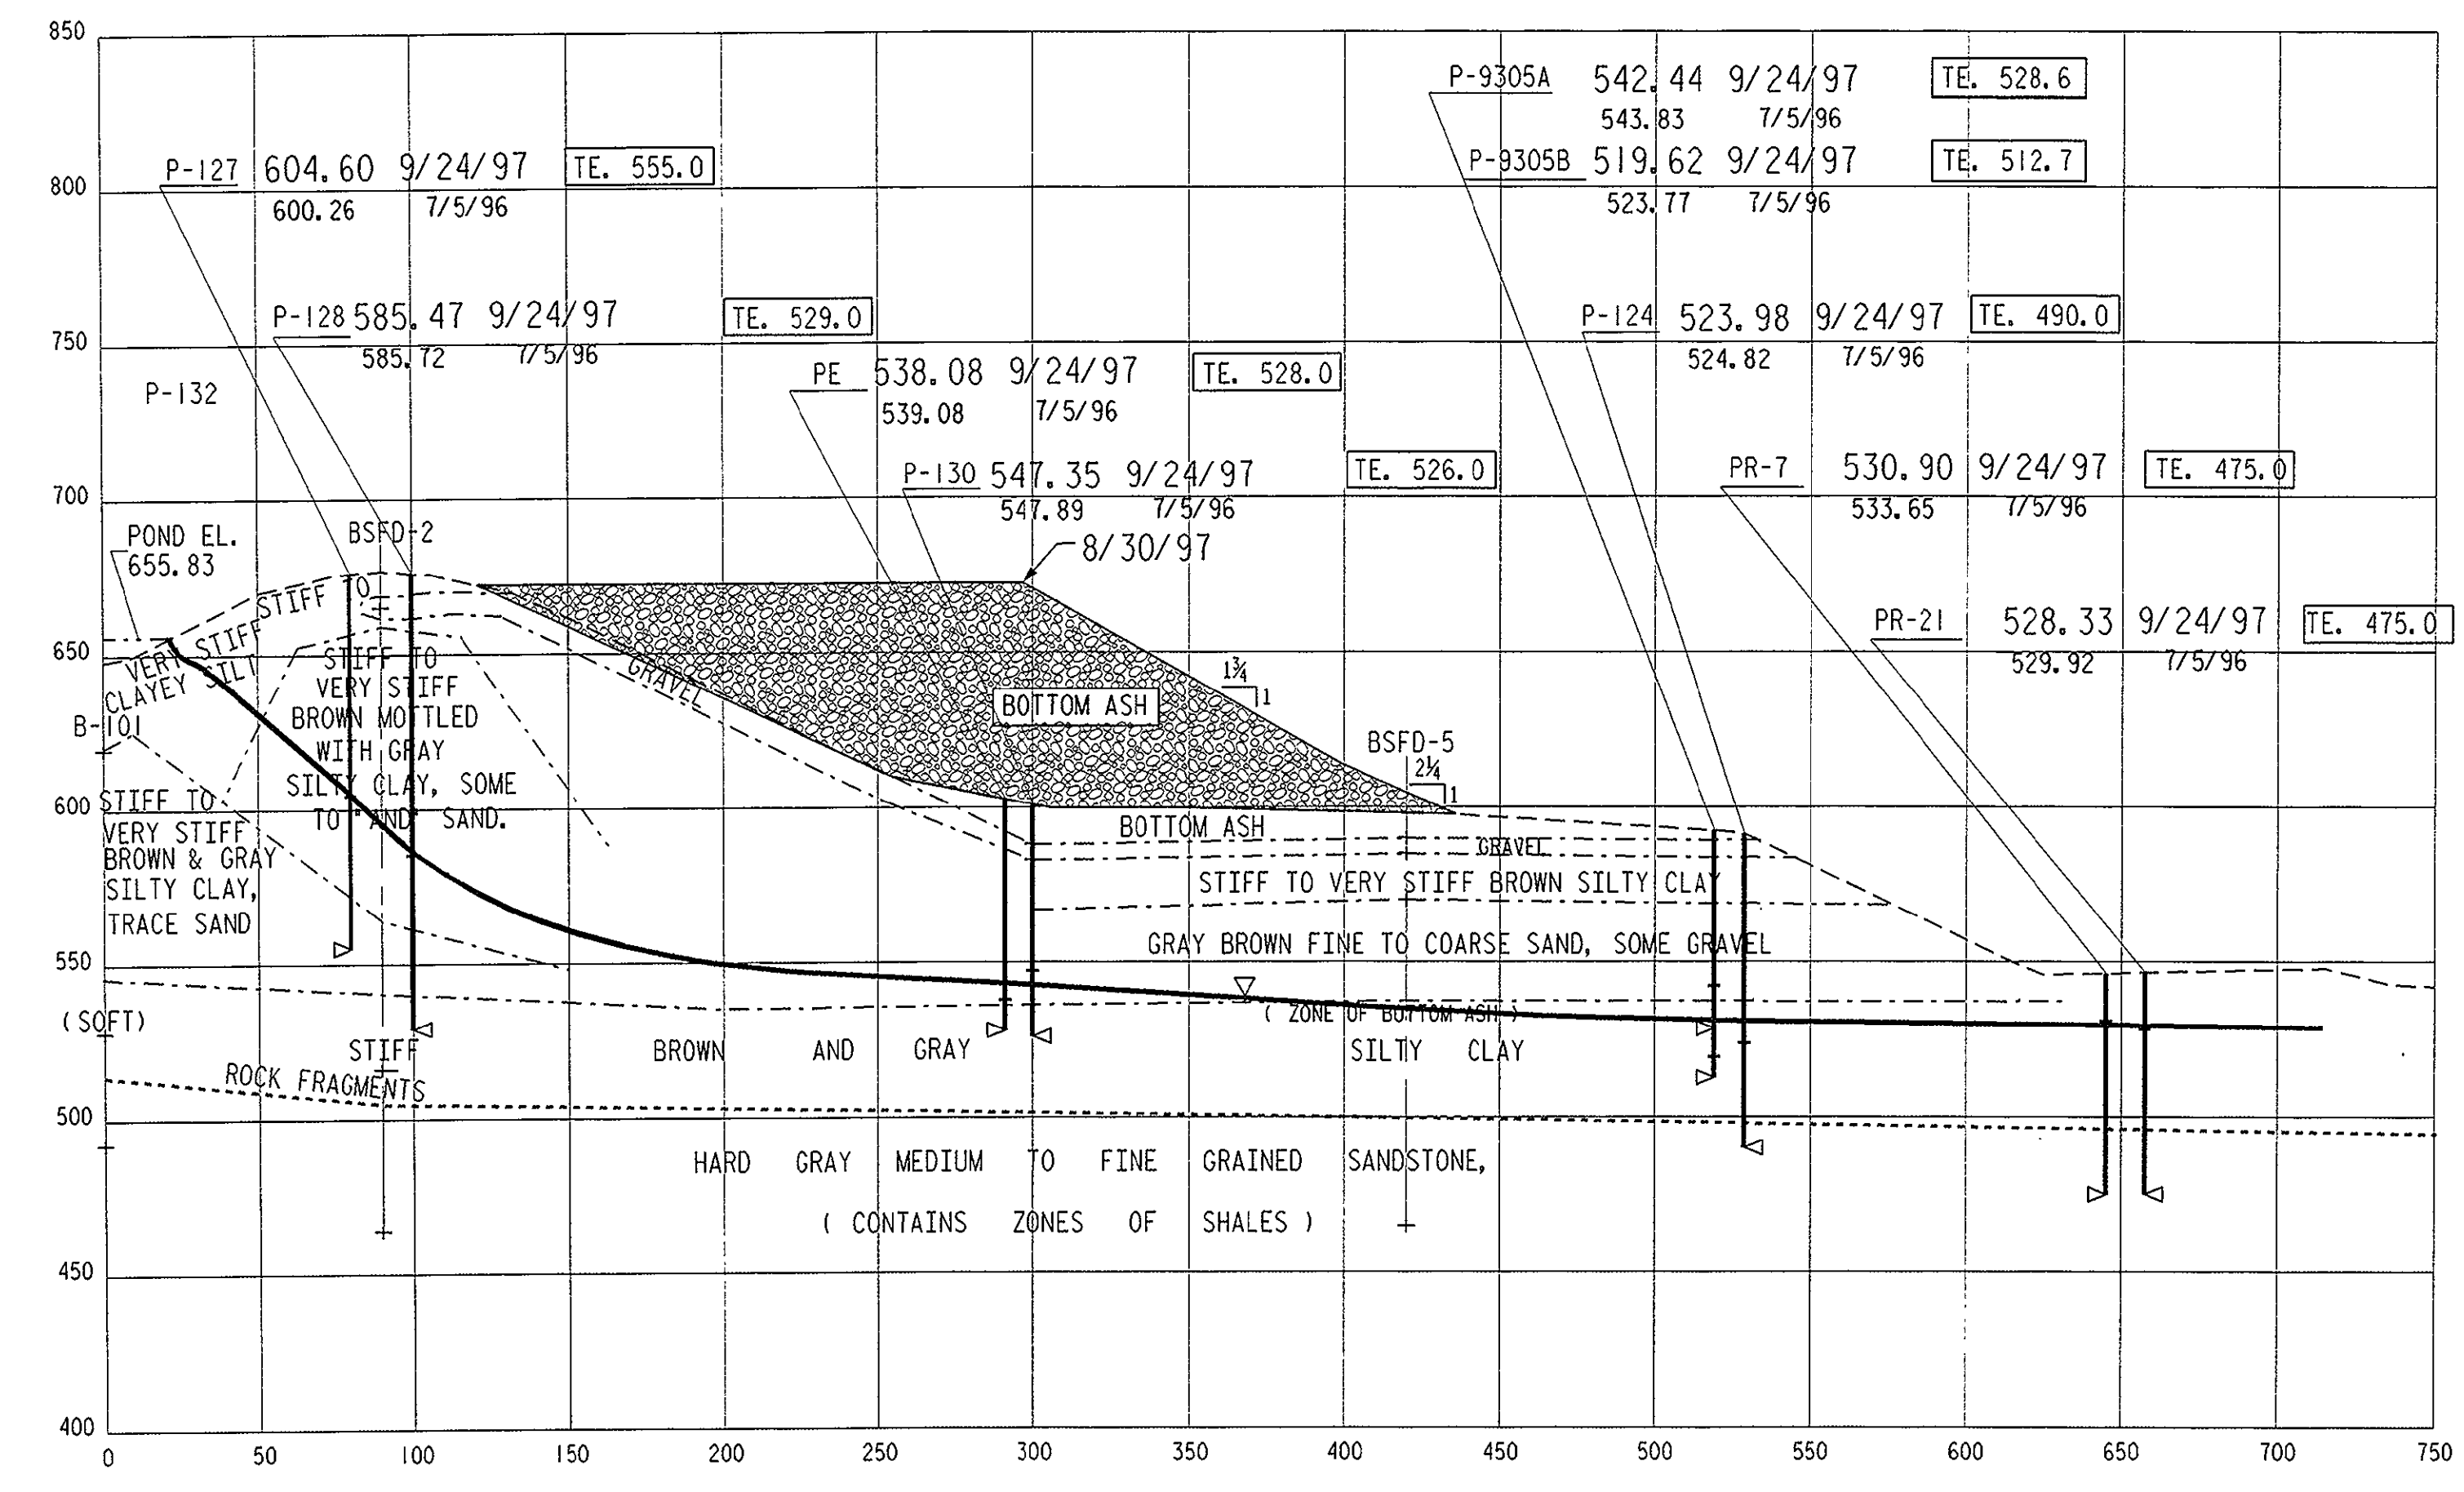
SECTION C-C
BIG-SANDY PLANT
HORSEFORD FLY ASH DAM
CROSS-SECTION - PIEZOMETER DATA
